# UPGRADING THE PACIFIC HIGHWAY

### Woolgoolga to Ballina Upgrade

### Supplementary Biodiversity Assessment

**November 2013**

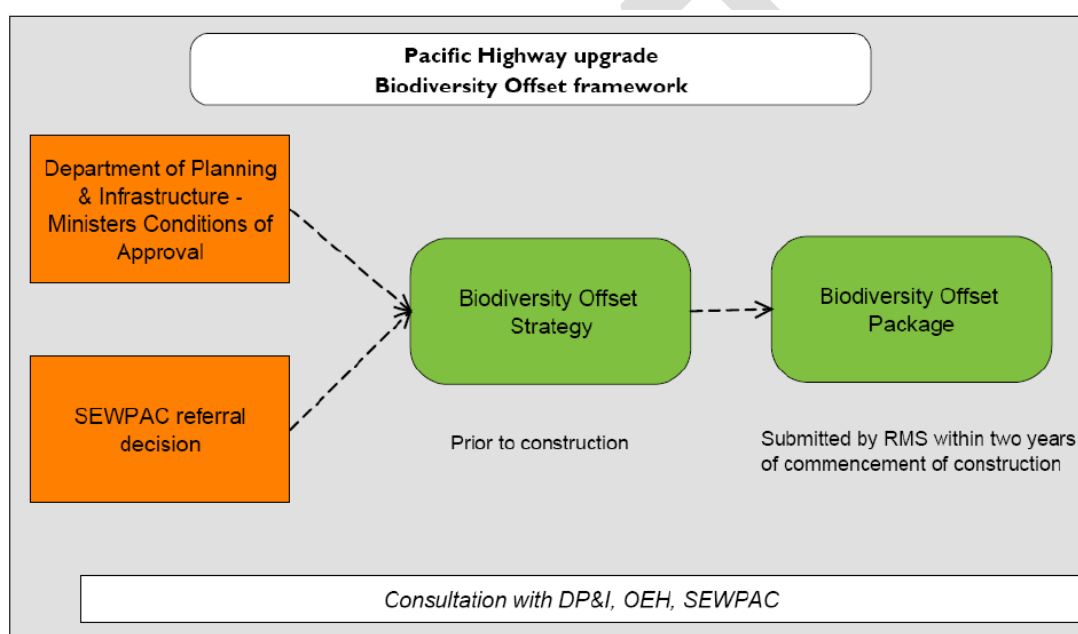
**Figure 3-1: Biodiversity offset framework for Pacific Highway Upgrade**

Project approval conditions for the Pacific Highway Upgrade projects usually contain requirements to provide details of the Biodiversity Offsets Framework to the approval authority once approval has been received. There are two components to the approval requirements, the *Biodiversity Offset Strategy* and the *Biodiversity Offset Package*. The relationship between the approval and offset requirements are detailed in Figure 3-1, and further details of the Biodiversity Offset Strategy and Packages are detailed in Sections 3.2.1 and 3.2.2 below. This Biodiversity Offset Strategy has been prepared as a work-in-progress to inform the approval process. This is ahead of the timing suggested in the framework in Figure 3-1. This document would be updated after approval to provide a completed offset strategy to the Department of Planning and Infrastructure.
