Woolgoolga to Ballina Pacific Highway upgrade

Threatened Fish Monitoring Program Annual Report 2017

Construction Phase Annual Report 2017, Year 1

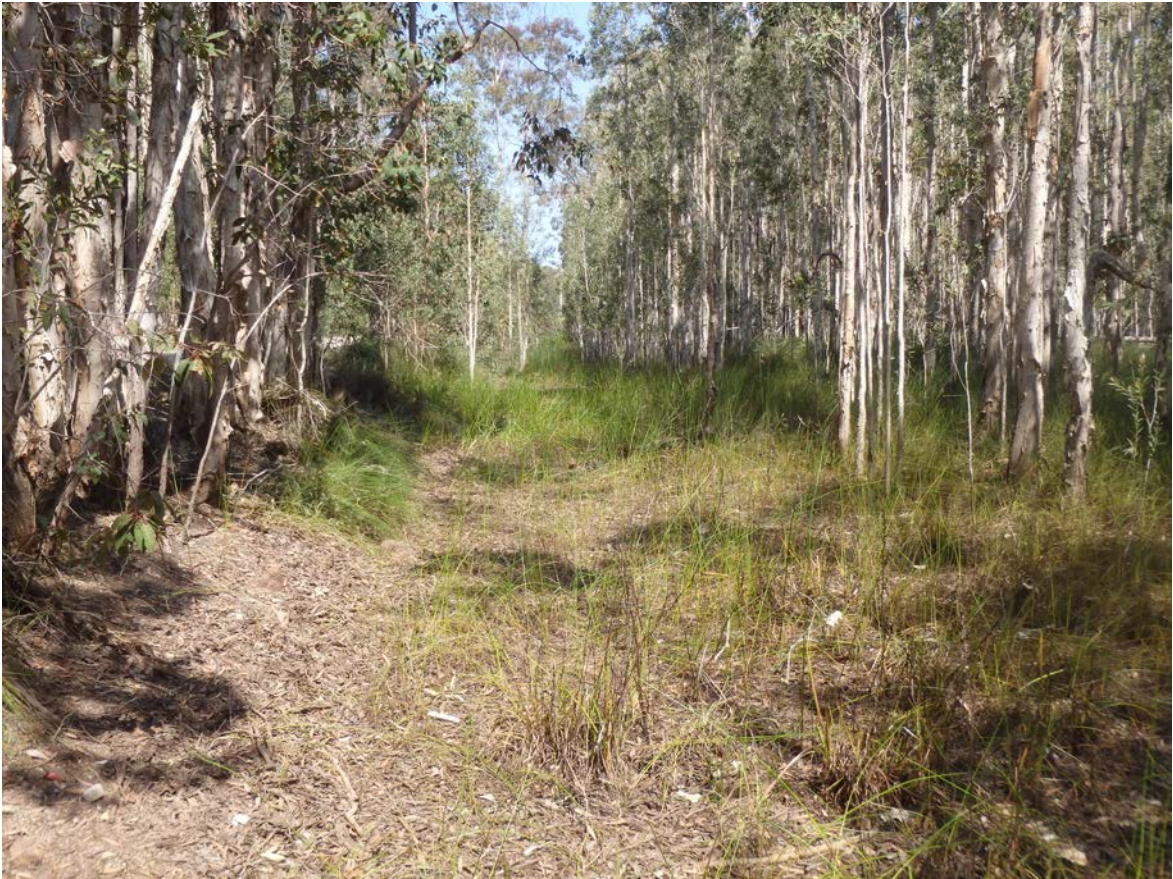
Plate 3.1 Site C14 was dry at the time of the September 2017 survey

No fish capture was attempted at control site C14 during the September 2017 survey due to a lack of water at the time of the survey.
