WOOLGOOLGA TO BALLINA | PACIFIC HIGHWAY UPGRADE THREATENED FLORA MANAGEMENT PLAN

Sections 1 to 11 (including Soft Soil Work Areas)

Version 3

August 2015

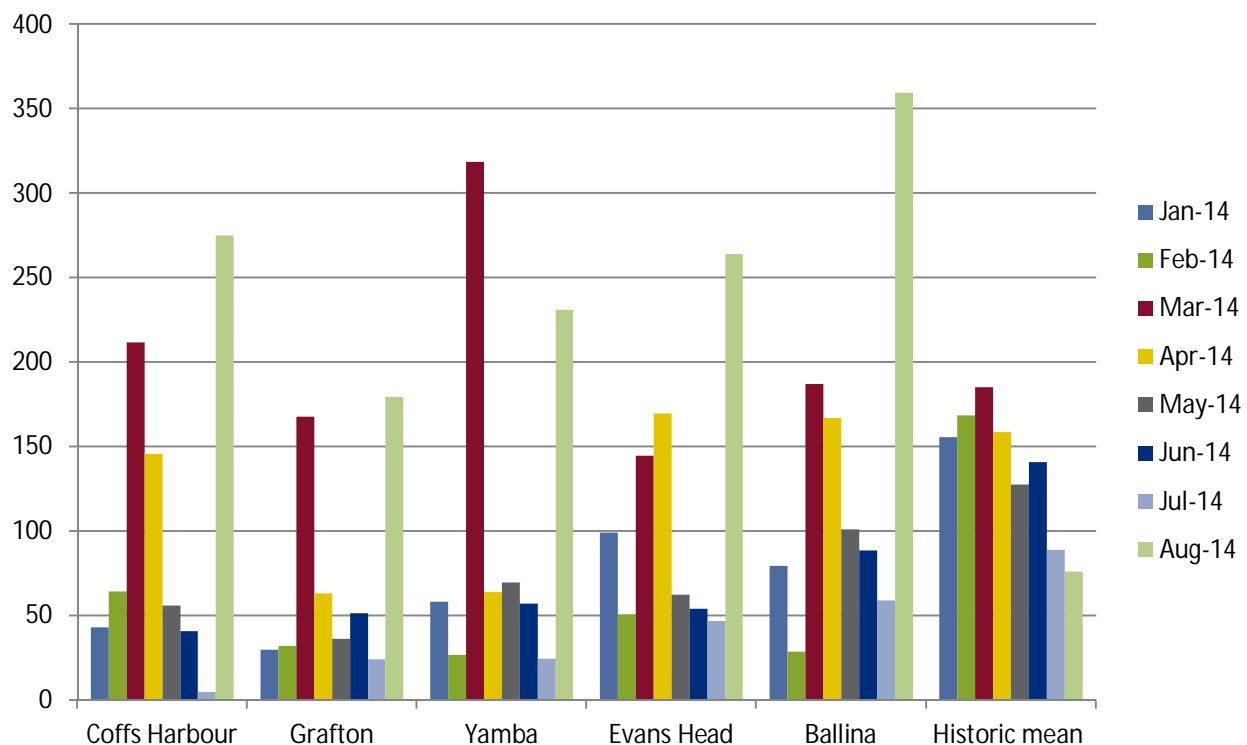
Figure 2-1: Monthly rainfall totals (mm) recorded in the study area (2014) and the historic mean (averaged across all locations). Source: BOM 2014.

The climate conditions (rainfall and temperature) within the study area at the time of the survey period is an important component of the threatened flora monitoring considering the high number of threatened flora species occurring in permanent and ephemeral wetland habitats. The health, distribution and abundance of these wetland species are closely associated with the preceding climate conditions. The health and condition of larger shrubs and trees growing in drier habitats is also closely associated with climatic conditions, however large fluctuations in distribution and abundance are not expected. The rainfall received (from north to south) at Coffs Harbour, Grafton, Yamba Evans Head and Ballina between January 2014 and August 2014 is illustrated in Figure 2-1.

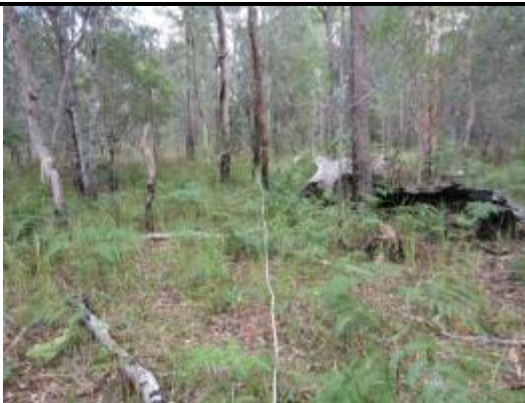
Tree 1 and 8 – dieback evident

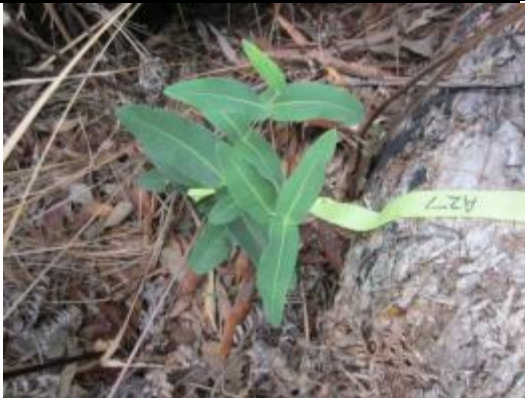
Tree 27 – healthy seedling

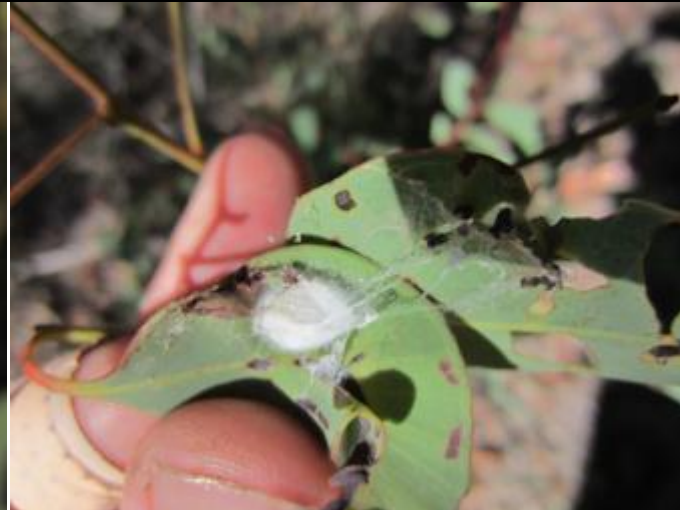
Evidence of insect damage on *Eucalyptus tetrapleura* leaves at Wells Crossing Flora Reserve

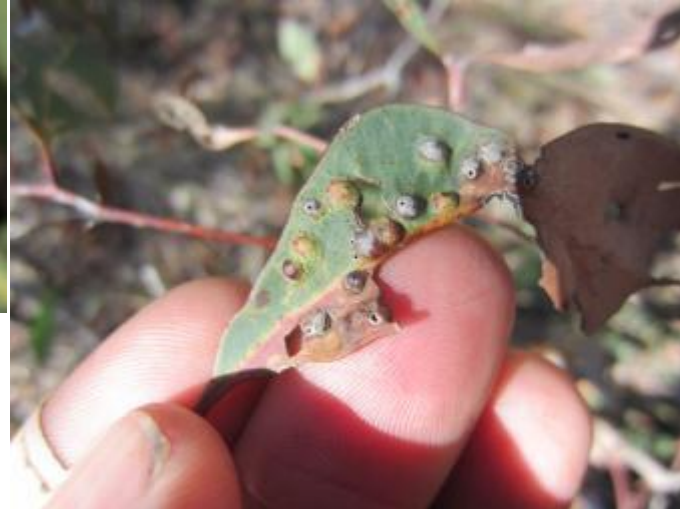
Insect galls on *Eucalyptus tetrapleura* leaves at Wells Crossing Flora Reserve

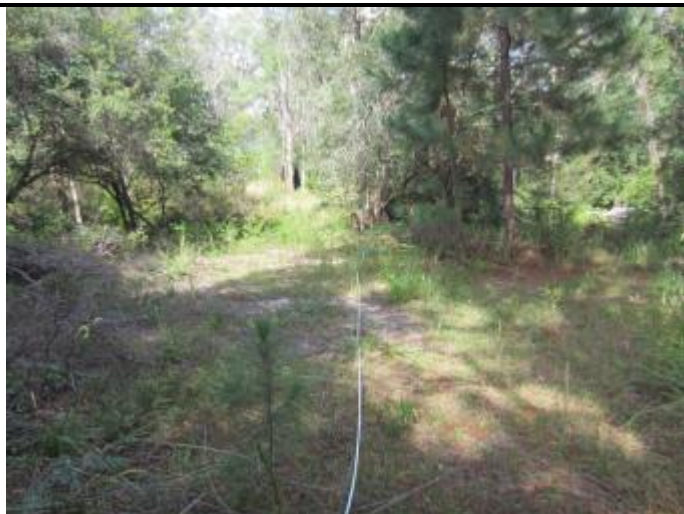
Plot location Gq-3.1 – *Grevillea quadricauda* growing on existing trail adjacent to the project

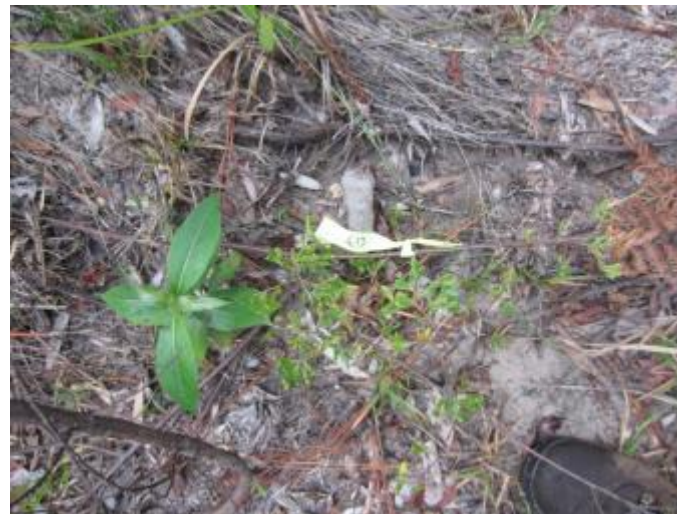
G13- knocked over, now regrowing on edge of trail

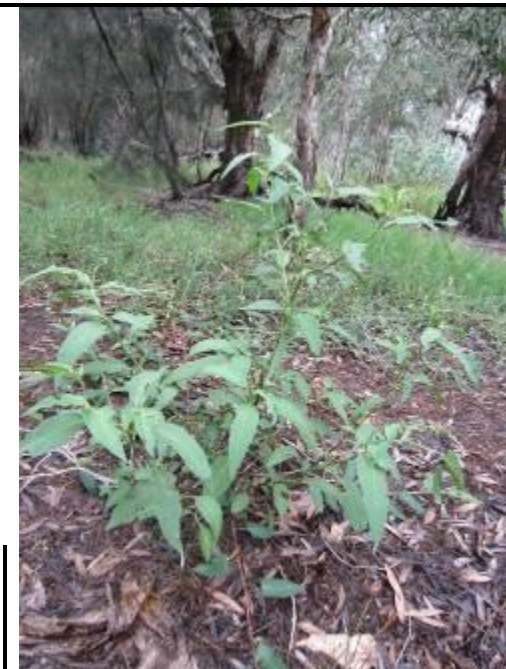
Insect damage, insect cocoons ?

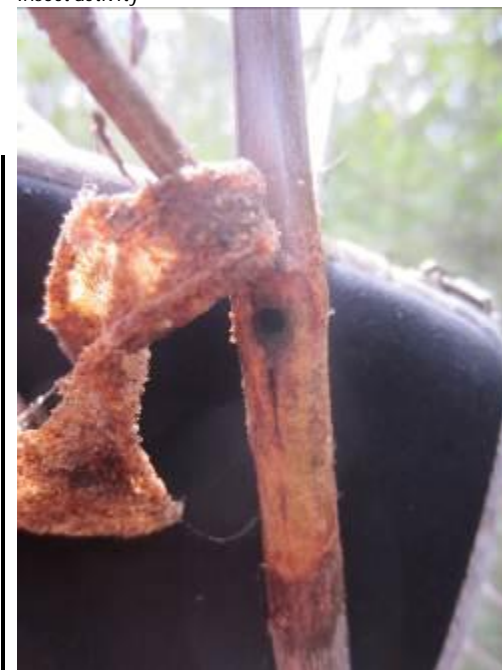
Insect damage

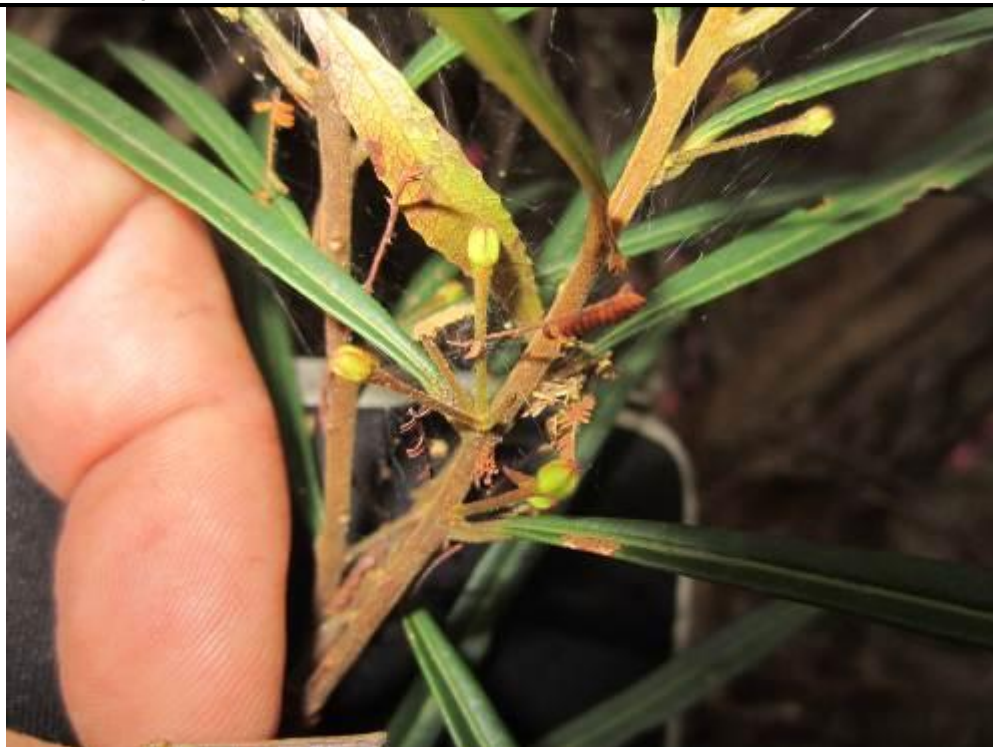
Quassia sp. Moonee Creek and webbing from caterpillars in Plot QM-C1.2

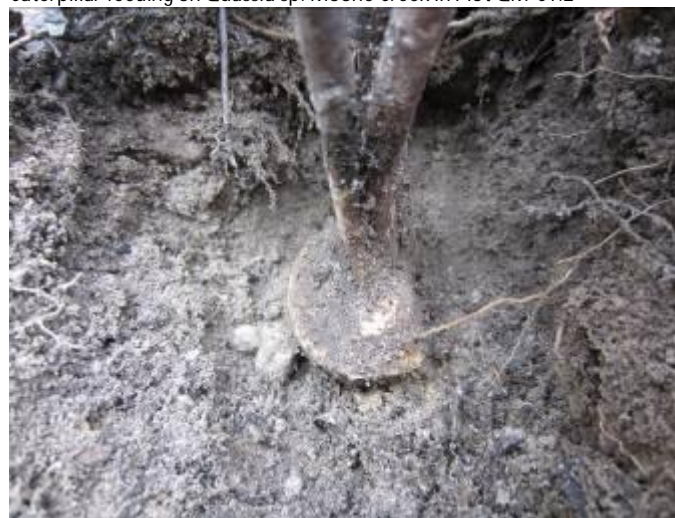
Q175 (Plot QM-1.1) - two stems arising from a single lignotuber / storage organ
