Appendix A **Site descriptions and significance assessments**

Upgrading the Pacific Highway – Woolgoolga to Ballina Upgrade

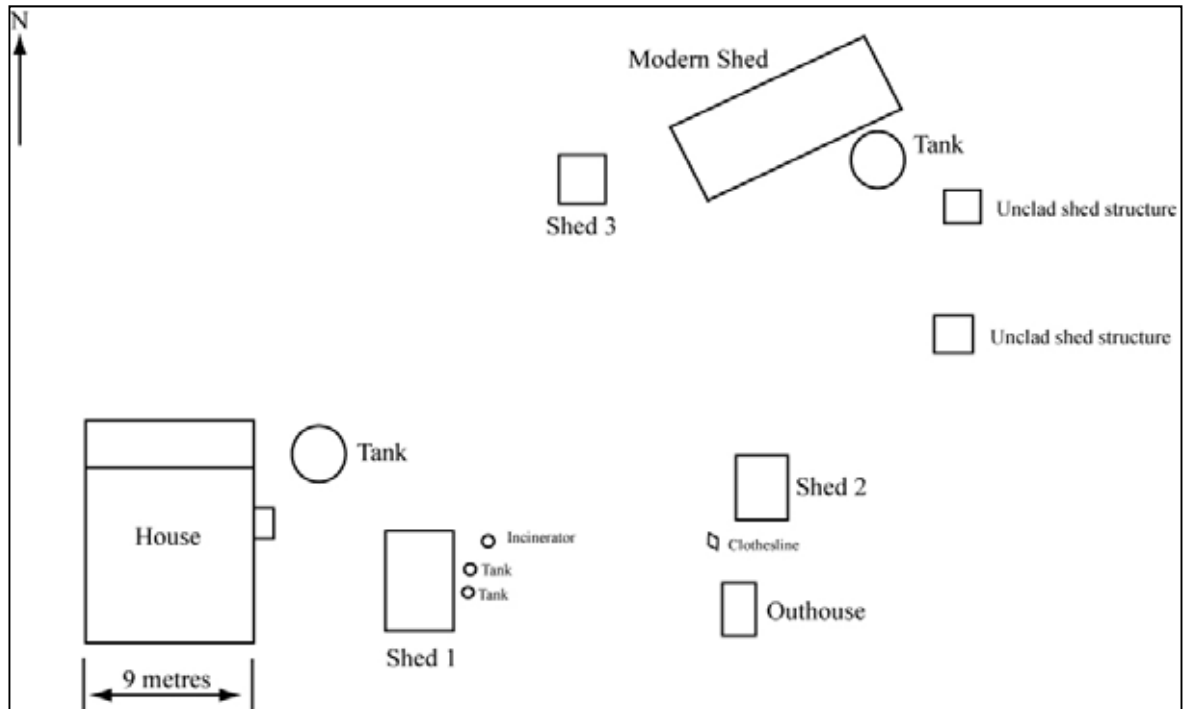
Figure 7-2: Map (not to scale) showing schematic layout of property (Kuskie and Carter 2007:31 updated based on 2011 site visit).

The largest of the three sheds, Shed 1, is of timber construction with brick stumps, timber clad walls and a corrugated iron roof. Shed 1 is located to the east of the house and is in good condition. The shed has glass louvers on the northern and southern walls and two concrete steps and a metal handrail leading up to a timber doorway on the northern end of the western wall. Modern additions include PVC plumbing connections to a corrugated iron water tank located along the eastern wall of the shed.

Shed 2 and Shed 3 are of timber and corrugated iron construction and are of a similar size. Shed 2 has a timber door on the northern side and Shed 3 has a doorway with no door on the eastern side. Shed 2 is located east-north-east of the house and is in fair condition. Shed 3 is located north of the house and is in poor condition. Kuskie and Carter (2007) recorded a fourth shed which is now missing; the remains of the old shed appear to be in one of the refuse piles on the property.

An orchard of small fruit trees is situated in the south-east corner of the yard, east of the house. A large vegetable garden is located south-west of the house inside an enclosed fence.

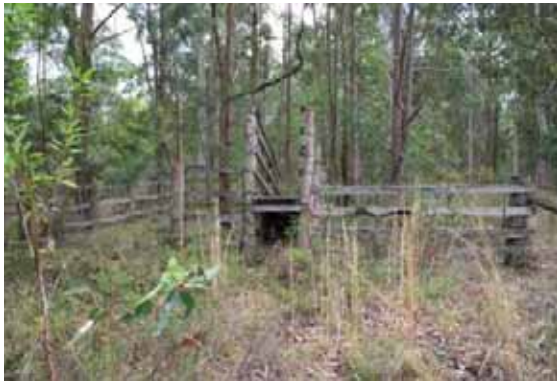
A set of stockyards is located around 100 m south of the house. This complex of yards has a number of original posts and rails, but has been modified and/or repaired over time.

The integrity of the items is fair, but some timber components are weathered and deteriorating. The archaeological potential of the item is assessed as low due to the levels of disturbance.

Figure 7-3: Stockyards, facing north, photo taken by Rachael Loizou on 28 October 2011.

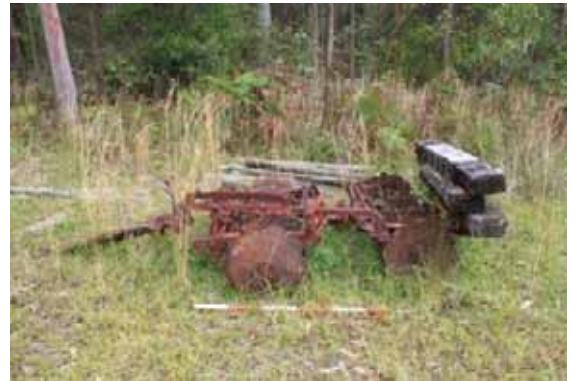
Figure 7-4: 'Sunshine' branded tilling and seeding disc plough, facing east, photo taken by Rachael Loizou on 28 October 2011.

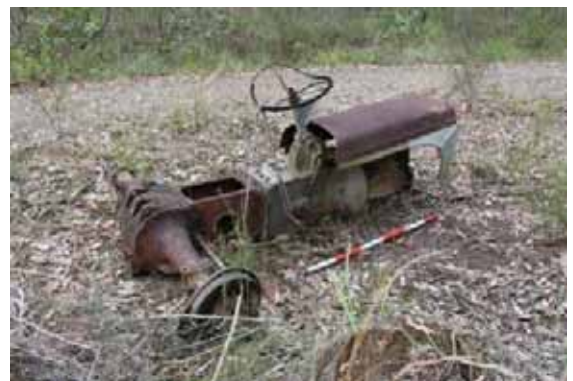
Figure 7-6: An old tractor chassis, facing west, photo taken by Rachael Loizou on 28 October 2011.

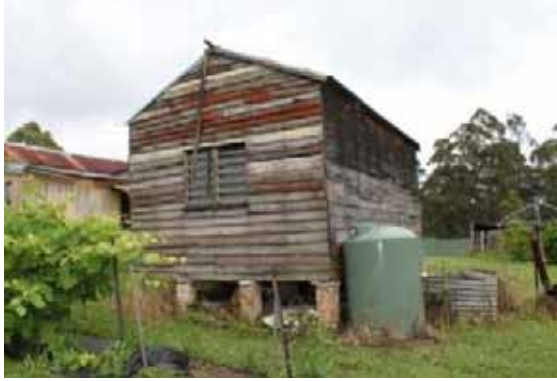
Figure 7-15: Shed 1, facing north-west, photo taken by Rachael Loizou on 28 October 2011.

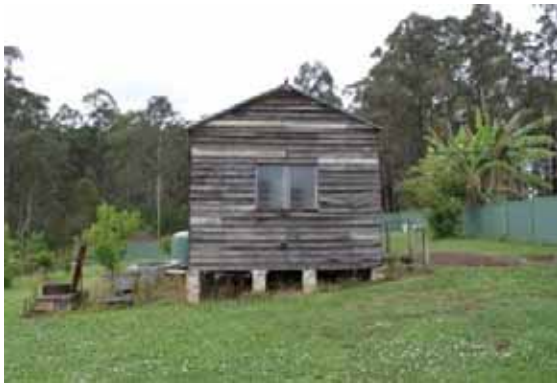
Figure 7-17: Shed 1, facing south, photo taken by Rachael Loizou on 28 October 2011.

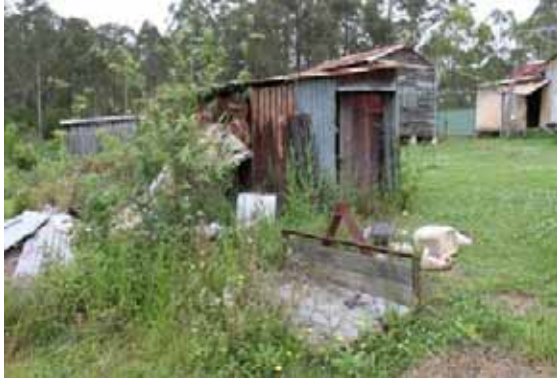
Figure 7-19: Shed 2, facing south-south-west, photo taken by Rachael Loizou on 28 October 2011.

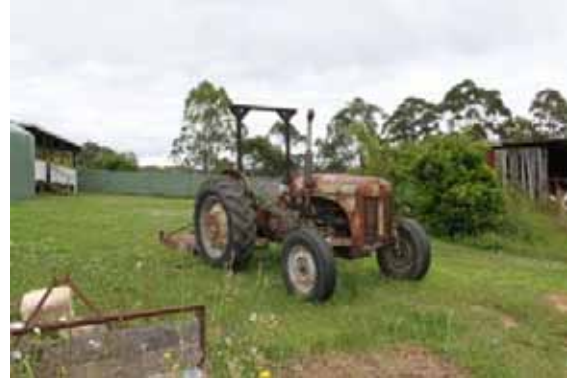
- An old tractor chassis.
- An old tractor and slasher both of which are rusted but in usable condition.
- A 'Sunshine' branded tilling and seeding disc plough.
- A 'Crown 12' branded incinerator.
- Blacksmith equipment (Kuskie and Carter 2007).
- Old timber planks and sleepers.
- Glass soft drink bottles.
- Old metal gates.
- Piles of broken bricks and concrete.

Figure 7-20: Tractor, facing west-north-west, photo taken by Rachael Loizou on 28 October 2011.

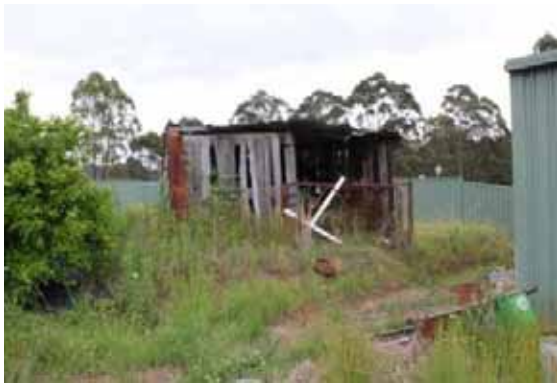
Figure 7-21: Shed 3, facing west-south-west, photo taken by Rachael Loizou on 28 October 2011.

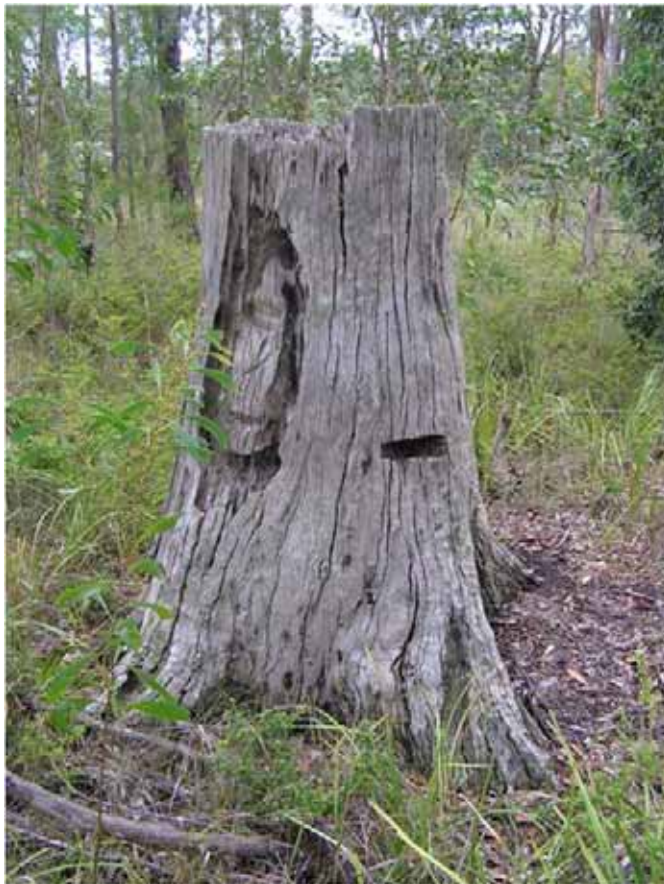
Figure 7-23: Tree stump with logging cut for spring board (Kuskie and Carter 2007).

Logging was an important industry in this region and evidence can be found throughout the landscape in a variety of forms. Two tree stumps with holes cut for spring-boards were located within the study area, these form part of an environmental landscape associated with the timber industry. Other aspects of this industry for which there may be evidence within the landscape include 'snigging' tracks and roads.

The cut holes are located between 1-2 m above ground-level. Loggers felled the tree by making a cut a certain distance from the ground based on the 'butt swell'. Generally large trees have a greater diameter at ground level and narrow some distance above the ground, where their sides become more parallel. Depending on the point at which the log sides straighten, holes were cut (morticed) into the trunk to take a spring board (or chopping board). This board was up to 2 m long and would provide the logger with a platform upon which to stand and cut the tree. It was sometimes necessary to cut a number of holes in the trunk to provide 'steps' for the logger to climb to the desired height.

The tree stumps with logging marks are considered to have local historical significance with the potential to yield information about timber harvesting methods in the North Coast. The integrity of these stumps is fair. The stumps are slowly decaying through natural processes. The archaeological potential of these items is negligible.

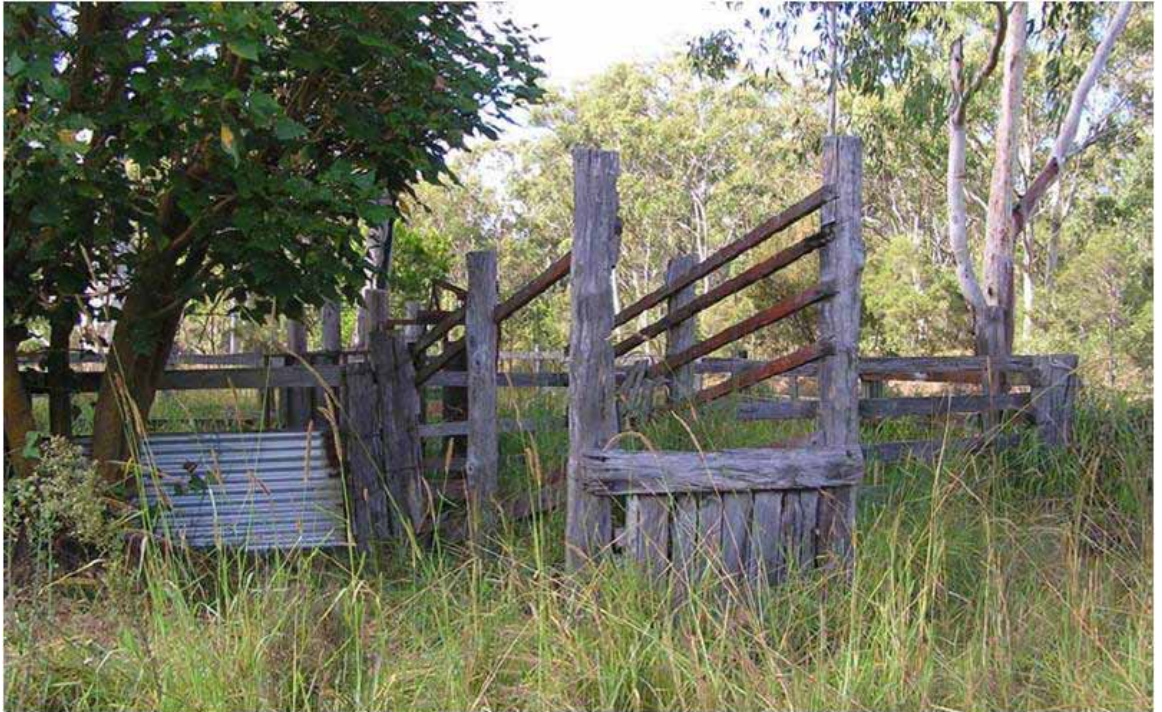
Figure 7-25: Stockyards north-west of Lemon Tree Road (Kuskie and Carter 2007).

Stockyards are located adjacent to the northern margin of the Pacific Highway, one kilometre north-west of Lemon Tree Road, Halfway Creek. The item consists of a complex of sawn post and rail yards. Some components of the yards are older than 50 years but the complex has been modified and repaired over time.

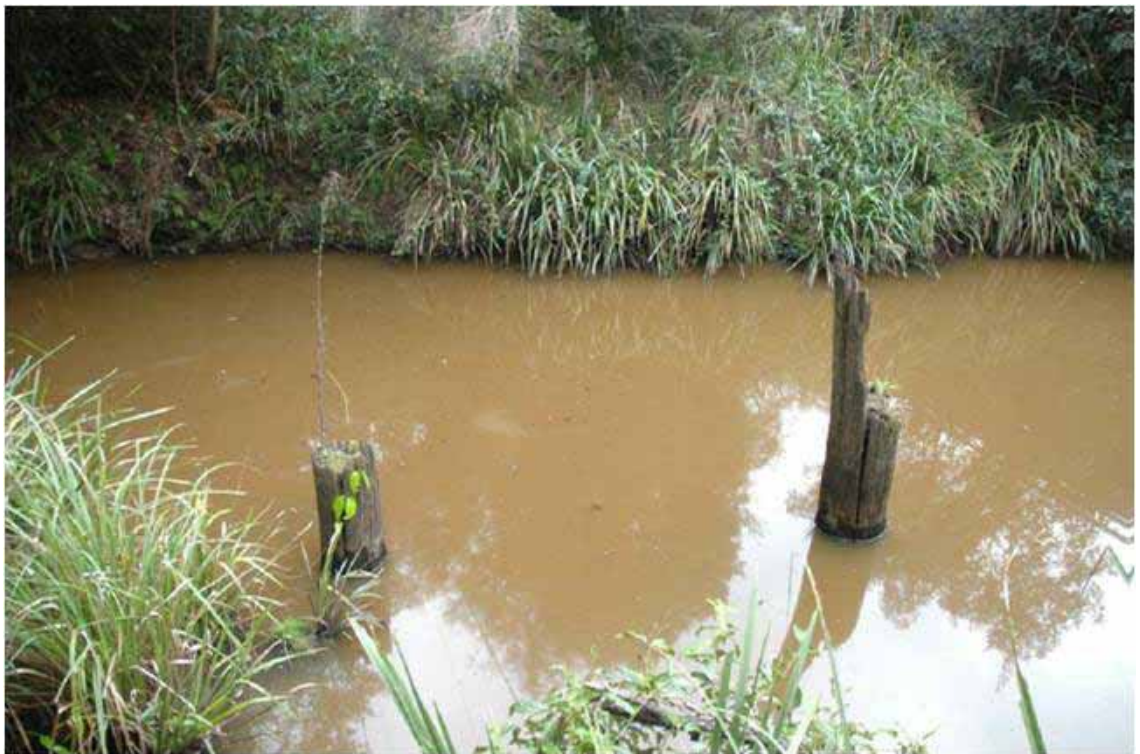
Figure 7-26: Remains of bridge uprights in Halfway Creek (Kuskie and Carter 2007).

The remains of a timber culvert and a few posts of the original road bridge over Halfway Creek are located immediately to the west of the existing Pacific Highway bridge, around 200 m north of the Halfway Creek service station.

The item is considered to have insufficient significance to fulfil the criteria for state or local listing as decay and degradation of the structure over time have reduced its potential to provide information (Kuskie and Carter 2007). The remains are in poor condition and the archaeological potential is assessed as negligible.

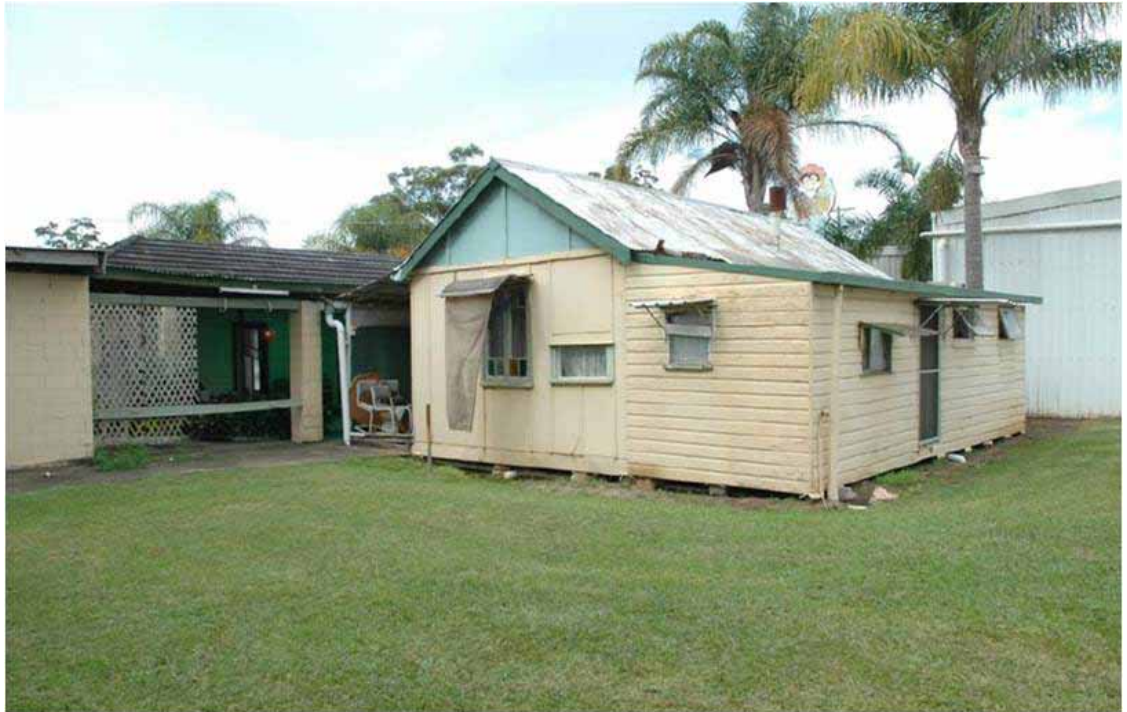
The cottage to the rear of the restaurant (Figure 7-27) has been modified over time but was originally used for accommodation for travellers. It is timber-framed and clad with fibrous sheeting with a corrugated steel roof. The restaurant and cottage are linked with a modern patio and concrete-block toilets are located between them.

Figure 7-27: Accommodation building at rear of service station complex (Kuskie and Carter 2007).

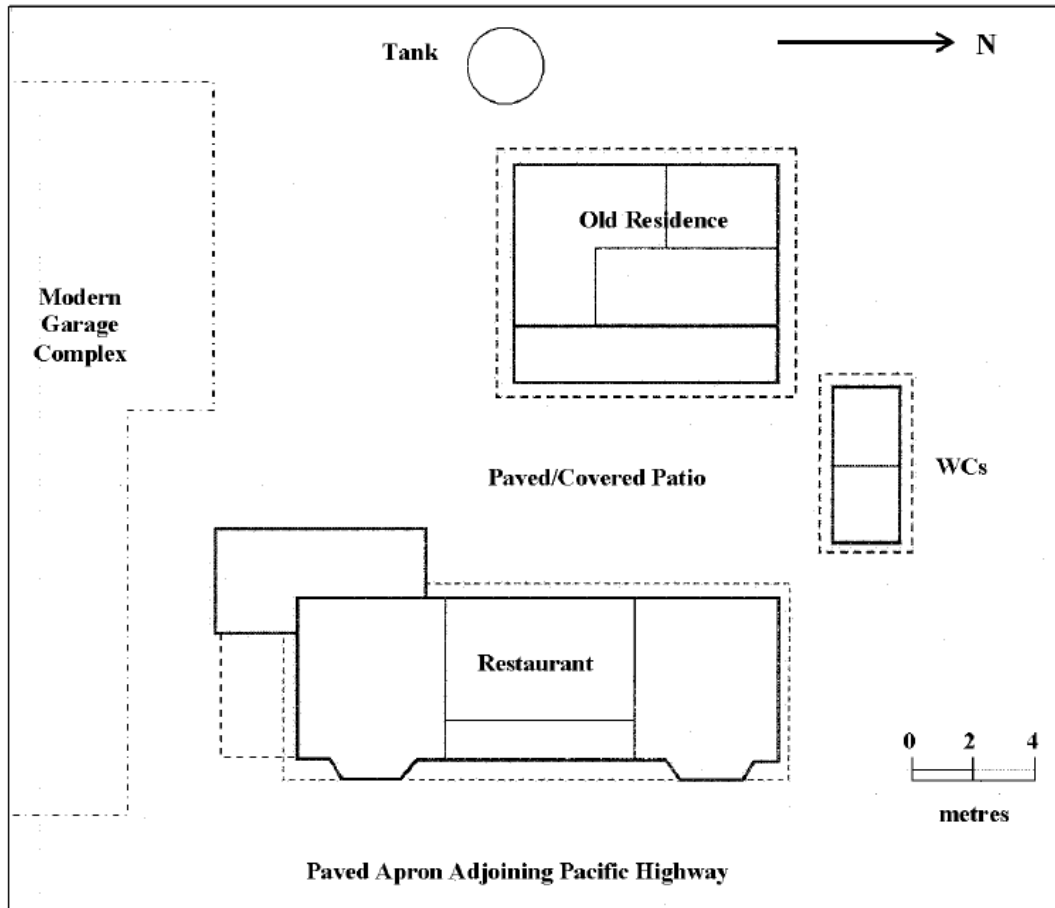
Figure 7-28: Location plan of buildings at Halfway Creek Service Station Complex (Kuskie and Carter 2007:37).

The visible elements of the site have been mapped (Figure 7-28). Additional archaeological material is likely elsewhere at the site. Because of the potential archaeological features elsewhere on the property, the curtilage of the site is recorded as the entire property Lot 411 DP 883976 north-west of the south-east wall of the modern service station building and extending eastwards to include the carpark area in front of the complex situated on road reserve (Figure 7-29).

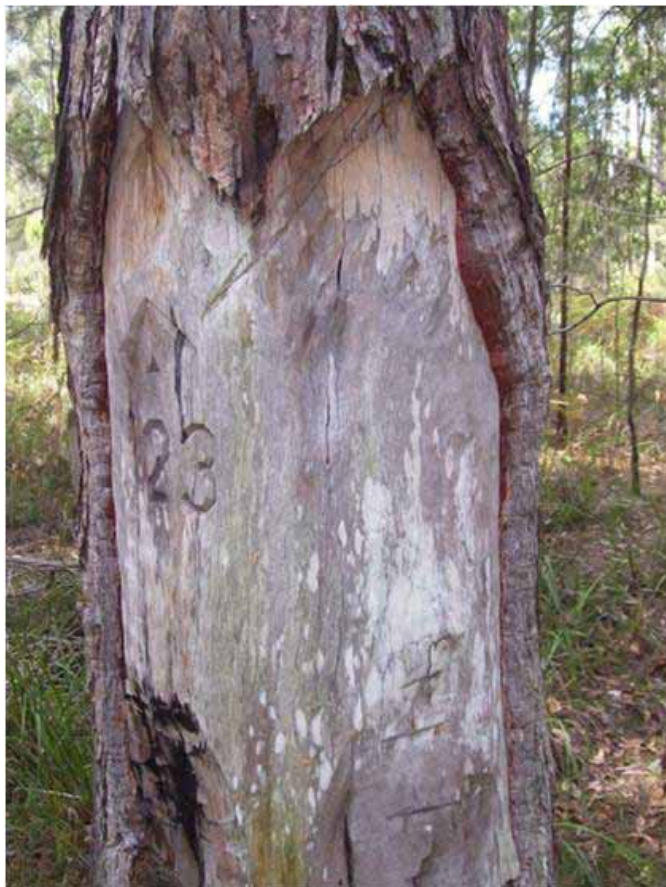
Figure 7-30: Survey mark on tree at Halfway Creek (Kuskie and Carter 2007).

A tree stump with a survey mark is located immediately north of Halfway Creek and west of the Pacific Highway. The tree stump bears the mark '223'. Research of Parish maps indicates that it is unlikely to be an early survey marker and it may have been related to the construction of the Pacific Highway.

Item does not fulfil criteria for local or state listing. Demonstrates a method commonly employed by surveyors in rural areas. The integrity of the item is fair but the timber is decaying. The archaeological potential of the item is negligible (Kuskie and Carter 2007:38).

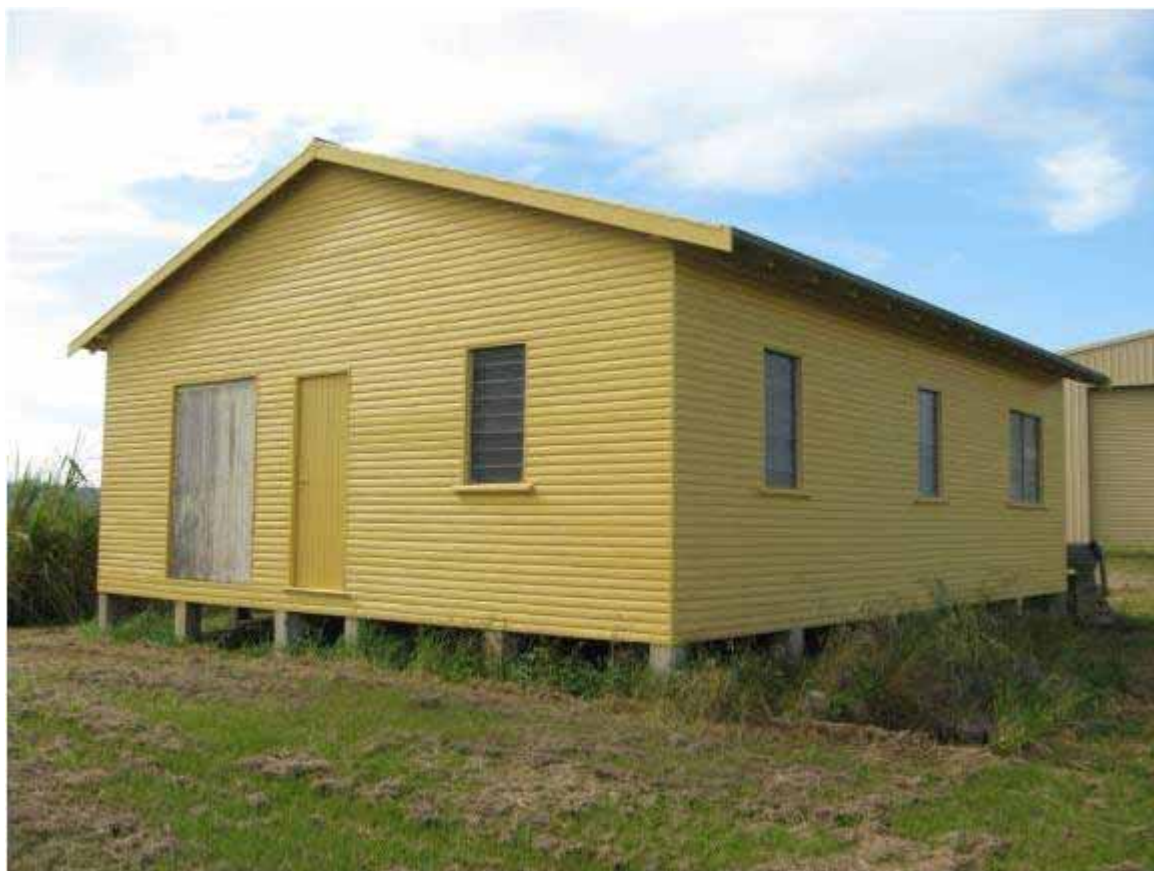
Figure 7-31: Tyndale Cane Barracks, photo taken by Joseph Brooke in November 2010.

This site represents an extremely good example of a cane cutters barracks. The rectangular weatherboard building with its corrugated fibro roofing still contains the original fire box. It has not been painted or modified. The interior is divided into five bedrooms and a kitchen /eating area. Walls are lined with particle board. Water has entered the building through the roof and some internal wall linings are missing. The associated external kitchen has been demolished but the amenities block remains. The building is currently used for storage (State Heritage Inventory 2010).

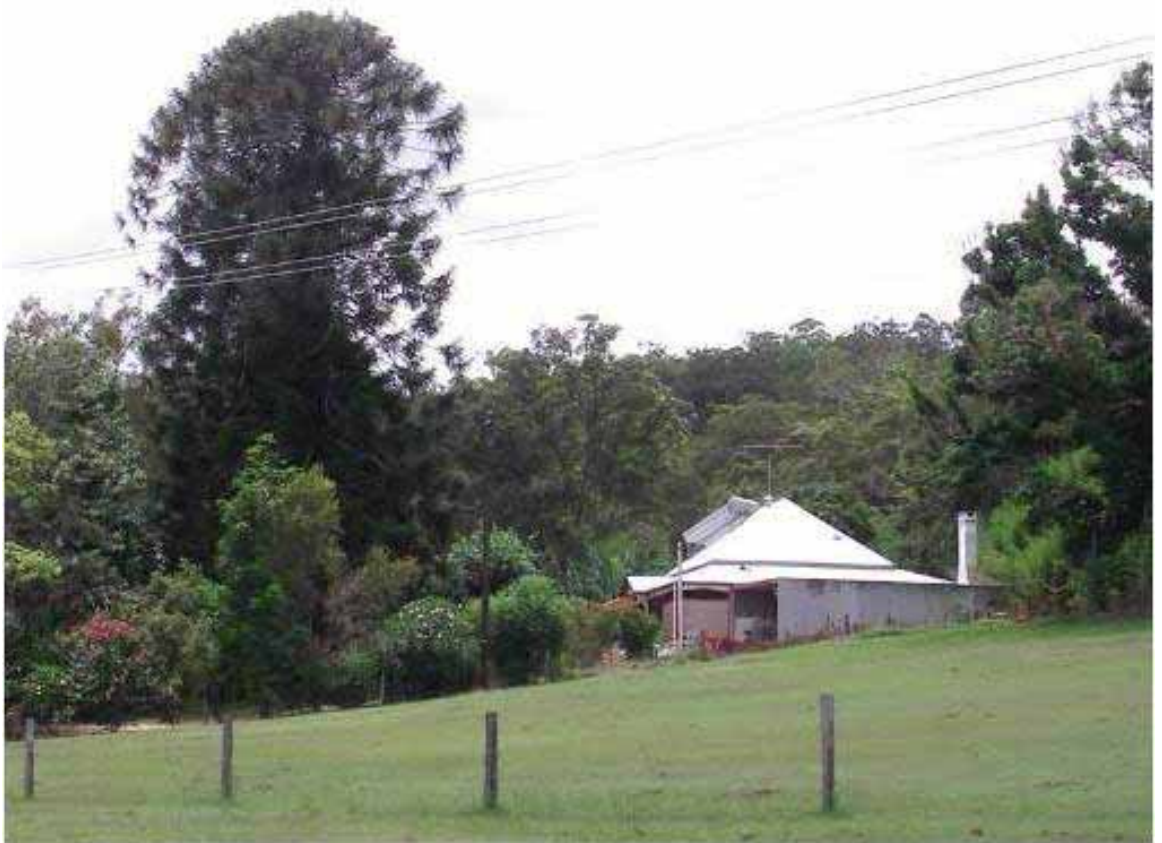
The property consists of a large Victorian residence with large hipped steep roof in galvanised iron over rectangular plan with skillion verandah encircling house to three sides. The verandah has a prominent gabled entry pediment projecting from roof of verandah supported on timber posts. Nicely detailed pediment brackets, valance boards and external joinery particularly the entry and sidelights. Since 1989 a large carport has been attached to the side of the house. Tree plantings have also obscured the house from view. The mature bunya pines are still intact.

Figure 7-33: Tyndale Residence, 2861 Pacific Highway, Tyndale (Gardiner 2006).

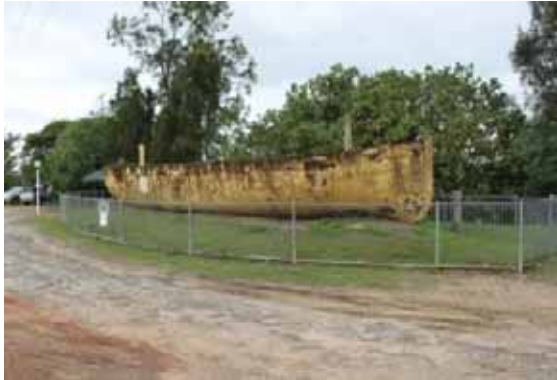
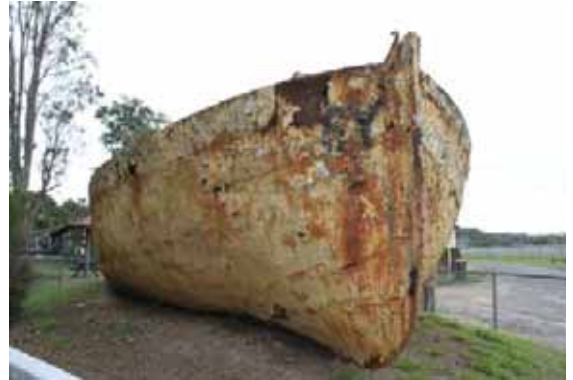
The smaller of the two vessels, a cane barge, resides on a small mound just south of the Ferry Park visitor information centre and is surrounded by metal cyclone fencing. The cane barge is yellow in colour and has steel sides, a timber hull and timber uprights at either end. The barge is in poor condition and is very rusty with lichen on the outside. Cane barges such as this operated on the Clarence River until 1981.

Figure 7-35: Cane barge, facing south-west, photo taken by Rachael Loizou on 28 October 2011.

Figure 7-36: Cane barge, facing north-north-east, photo taken by Rachael Loizou on 28 October 2011.

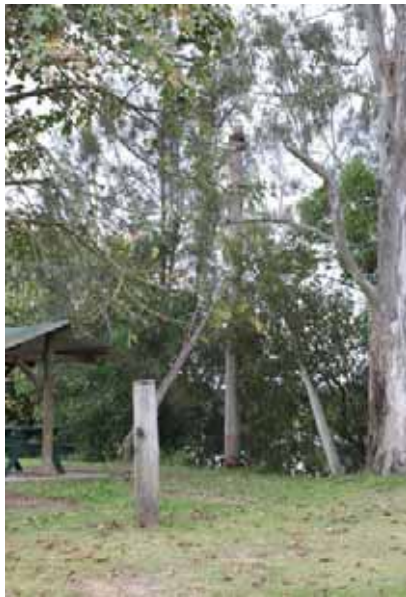
A sugarcane hoist is located between the cane barge and the Ferry Park information centre close to the river edge (Figure 7-38). Sugarcane hoists were historically used to load and unload cane barges. The hoist consists of a wooden pole with metal brackets at the top and bottom which once supported a wooden swinging arm. The wooden pole has timber supports on either side to help stabilise the structure and anchor it to the riverbank. There are offset pins either side of the main pole which are ideally spaced for climbing up the side of the pole. There is also a wire cable hanging down the side of the main pole which is tied to a shorter timber stump located around 3 m from the riverbank.

Figure 7-37: Sugarcane hoist, facing south-west, photo taken by Rachael Loizou on 28 October 2011.

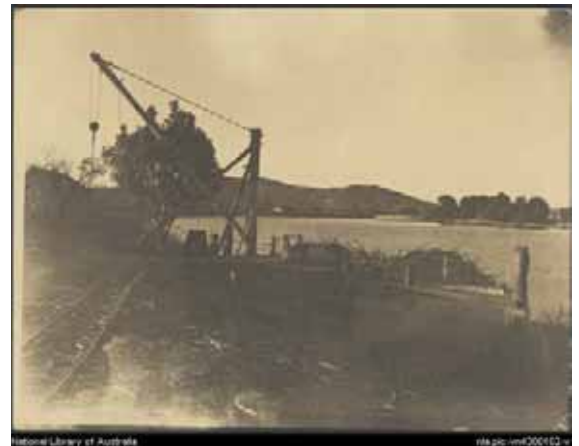
Figure 7-38: Sugarcane rail with hoist to river barges (NLA 4306162).

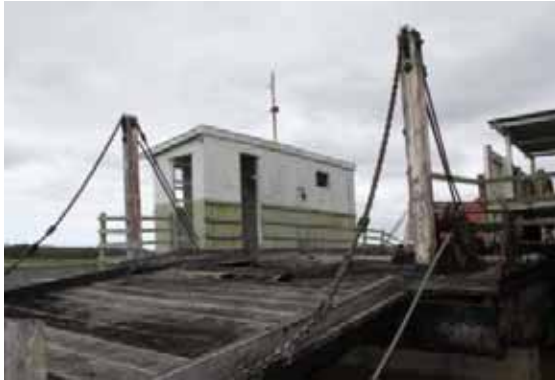
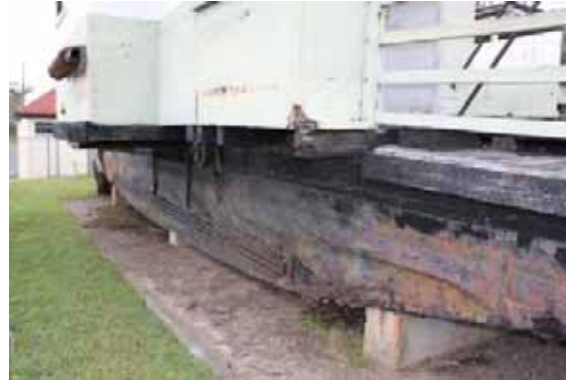
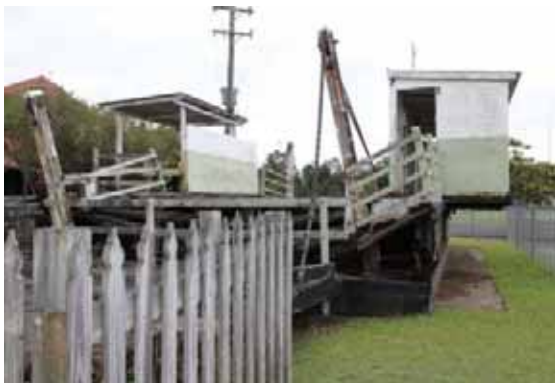
The larger of the two vessels, the former Ashby ferry, resides in front of the Ferry Park visitor information centre and is surrounded by metal cyclone fencing. The ferry is of timber construction with metal hull, cabin and workings. The decking, ramp and guard rails are all of timber construction. The ferry is intact but is in very poor condition due to prolonged exposure to the elements which has resulted in rotten timber on the decking and rusted metal. Weeds and long grass are growing around the ends of the ferry.

A ferry was established at Ashby to connect Maclean with Coraki by a route along the northern bank of the Clarence River. The Council started work on the ferry in 1890. The ferry was hand operated and operated over a very wide crossing. The service continued until 1936 when a diesel engine was installed. It quickly became obvious that a larger ferry service was required. The Ashby ferry was replaced by two bridges and in 1981 the ferry stopped services (Swan 198-).

Figure 7-39: Ferry, facing south-east, photo taken by Rachael Loizou on 28 October 2011.

Figure 7-40: Ferry, facing south-west, photo taken by Rachael Loizou on 28 October 2011.

Figure 7-41: Ferry, facing north-north-west, photo taken by Rachael Loizou on 28 October 2011.

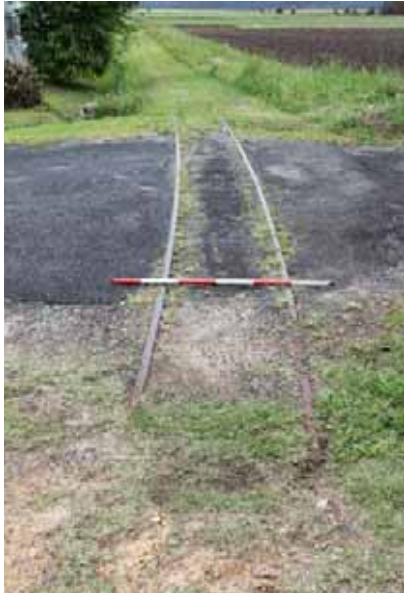
Figure 7-43: Old Pacific Highway Tram Tracks, facing west, photo taken by Rachael Loizou on 28 October 2011.

The variation in the width of the tracks is believed to be the result of interference with the tracks including being trimmed, being set in bitumen, natural movement of the ground and traffic. Both sets of tram tracks are in overall good condition with some rust.

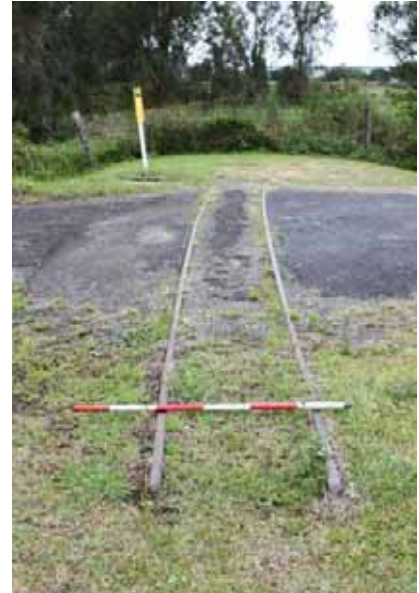
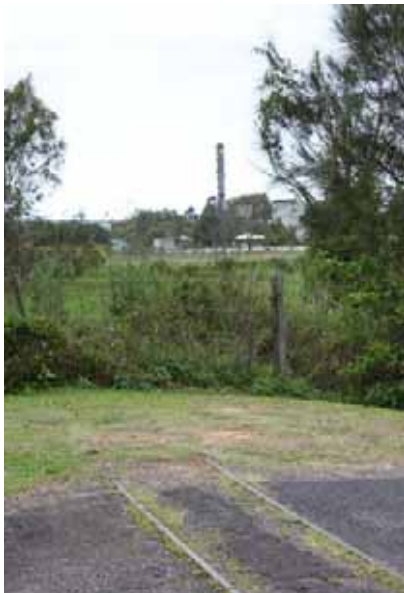
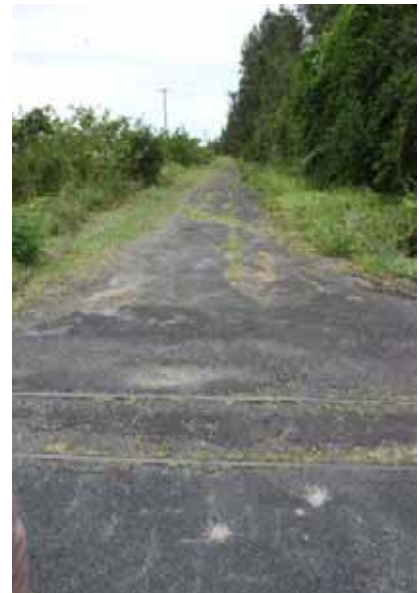
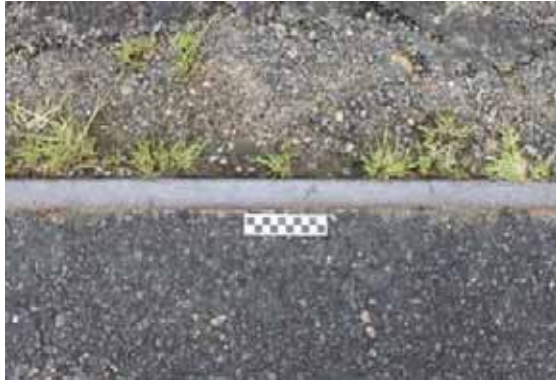
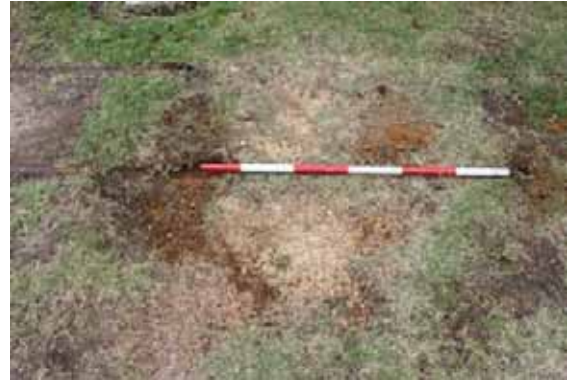
Figure 7-44: Old Pacific Highway Tram Tracks, facing east, photo taken by Rachael Loizou on 28 October 2011.

Figure 7-45: Old Pacific Highway Tram Tracks, facing east-south-east, photo taken by Rachael Loizou on 28 October 2011.

Figure 7-46: Old Pacific Highway Tram Tracks, facing north, with remnants of former Pacific Highway alignment extending north, photo taken by Rachael Loizou on 28 October 2011.

Figure 7-47: Old Pacific Highway Tram Tracks, facing north, photo taken by Rachael Loizou on 28 October 2011.

Figure 7-48: Old Pacific Highway Tram Tracks, with tramlines underground surface, facing north, photo taken by Rachael Loizou on 28 October 2011.

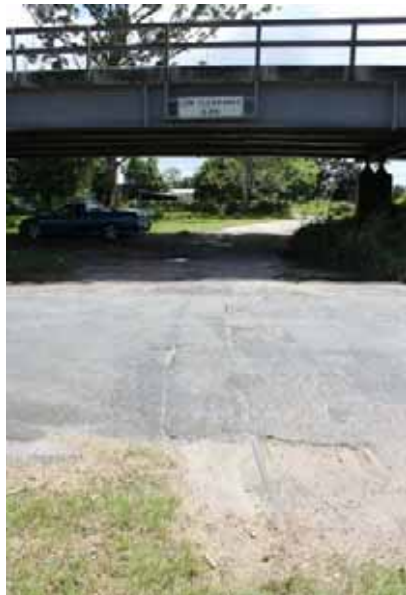
Figure 7-49: Petticoat Lane Tram Tracks, facing west, photo taken by Rachael Loizou on 31 October 2011.

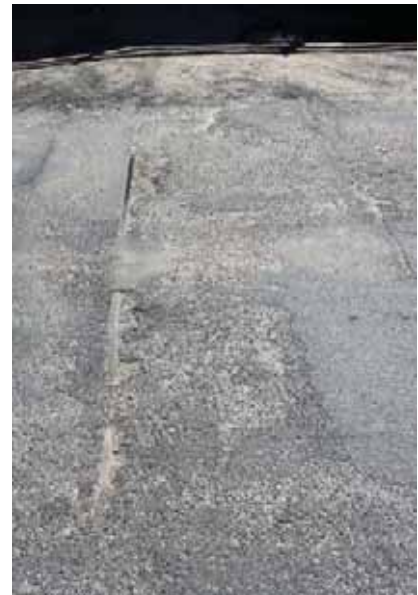
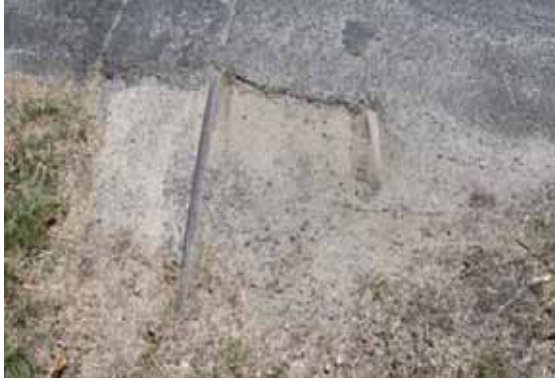
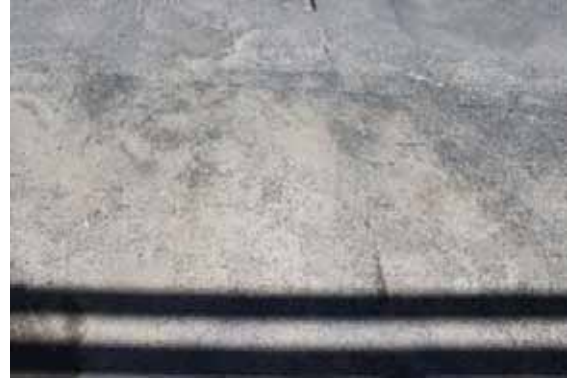
Figure 7-50: Petticoat Lane Tram Tracks, facing east, photo taken by Rachael Loizou on 31 October 2011.

Figure 7-51: Petticoat Lane Tram Tracks, facing west, photo taken by Rachael Loizou on 31 October 2011.

Figure 7-52: Petticoat Lane Tram Tracks, facing east, photo taken by Rachael Loizou on 31 October 2011.

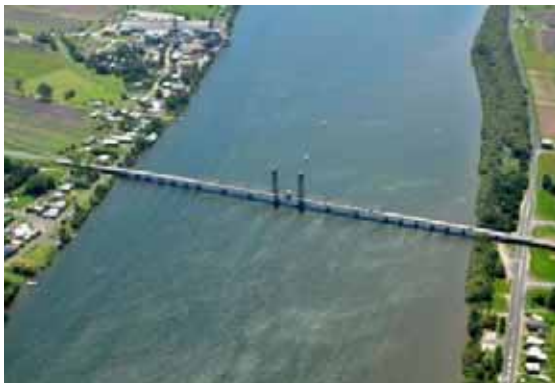
Figure 7-54: Harwood Bridge, facing east, photo taken for upgrade project aerial survey.

In the mid 1960s construction began on the Harwood Bridge, a steel-truss bridge with a vertical lift span. The Harwood Bridge was the last ever steel truss bridge constructed by the Department of Main Roads. The Harwood Bridge and Maclean Bypass were opened in August 1966 and directly replaced the Harwood Punt, the last ferry on the NSW State Highway system.

The Harwood Bridge has a total length of 888 metres and consists of seven steel truss spans of 43.1 metres and 27 steel girder approach spans; one of the steel truss spans is a vertical lift span which allows ships to pass under the bridge (a rarity these days). The bridge has two lanes for traffic and a footpath (RTA 2006a).

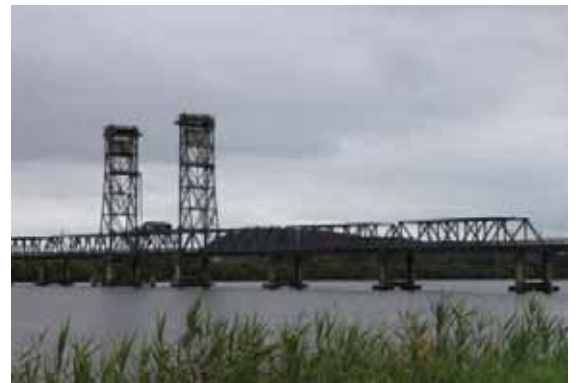
Figure 7-55: Harwood Bridge, facing south-east, photo taken by Rachael Loizou on 28 October 2011.

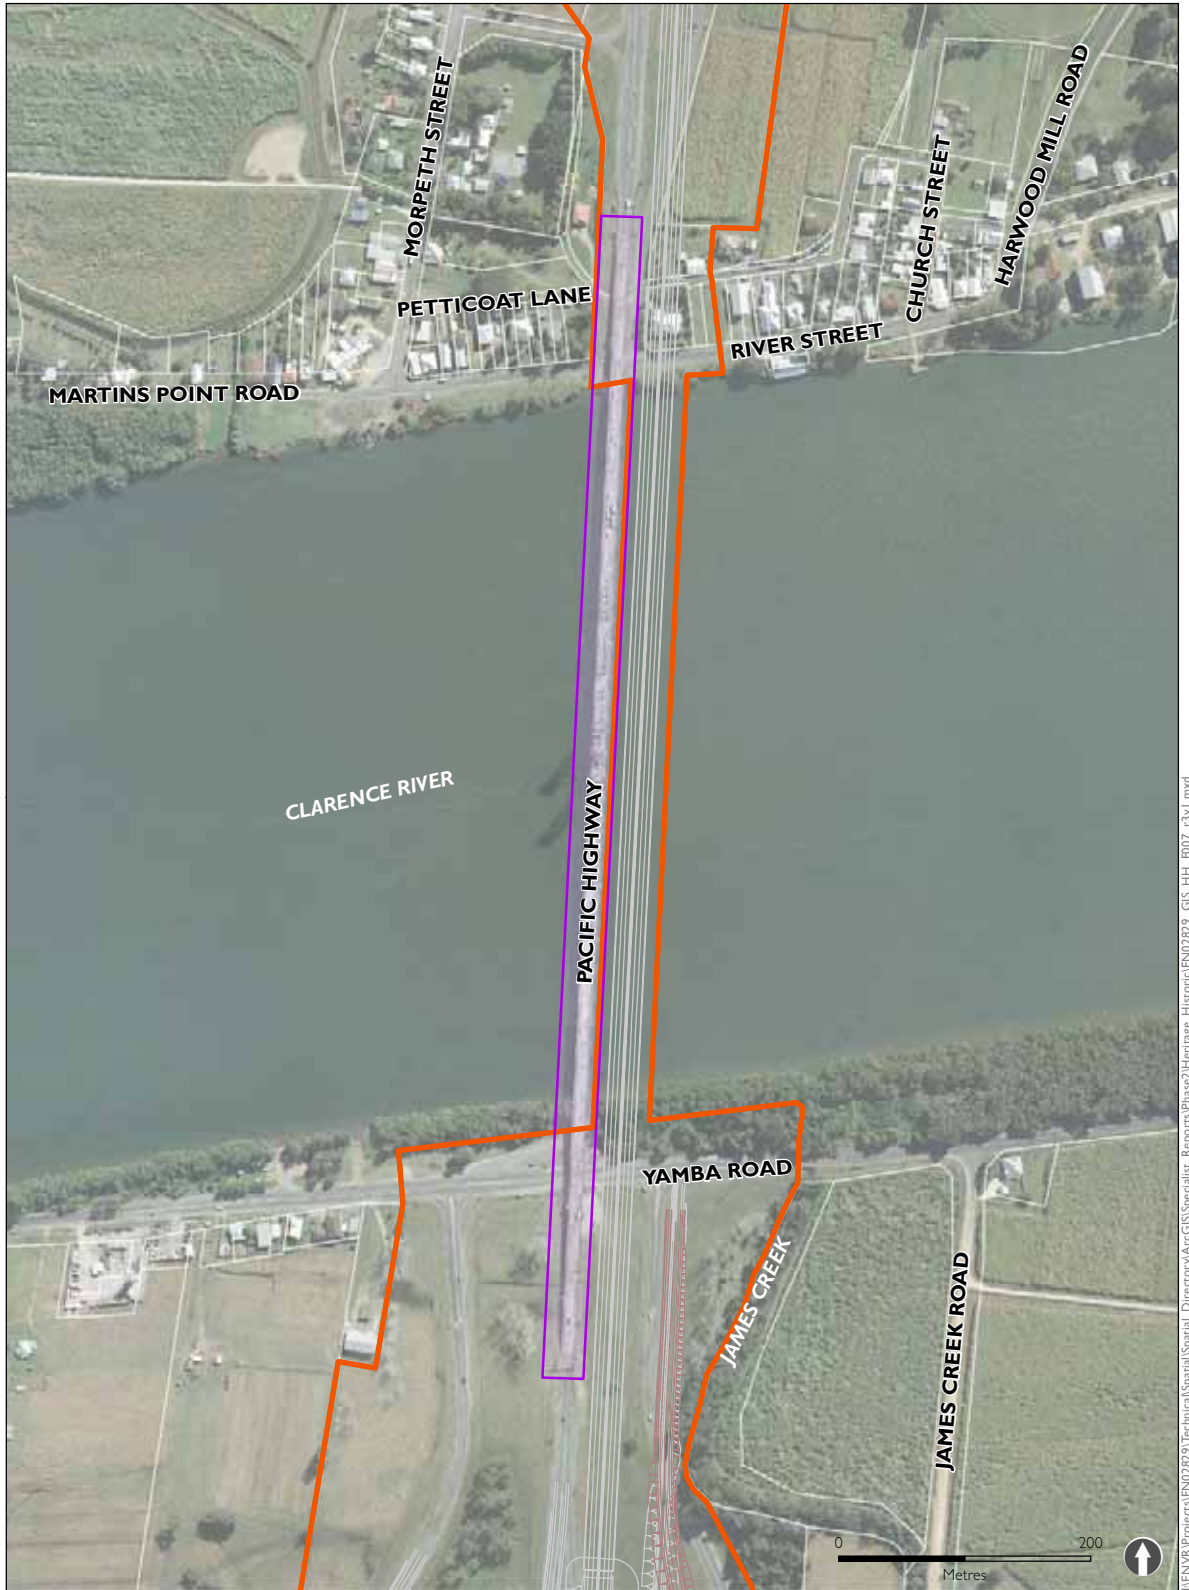
The curtilage of the site has been recorded as the entire extent of the bridge over the Clarence River at Harwood, including footings and abutments and is defined in Figure 7-56.

Figure 7-56 Curtilage of heritage item number 20, Harwood Bridge

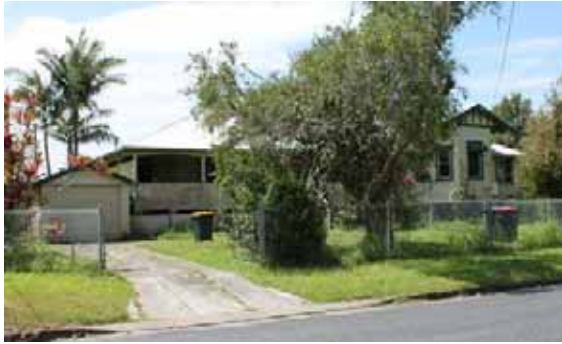
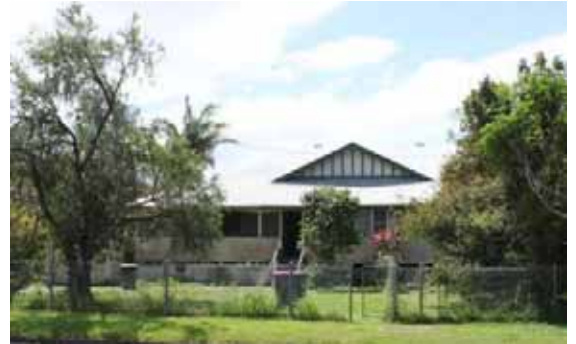
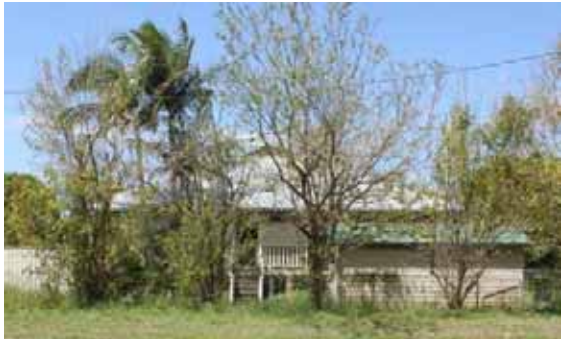
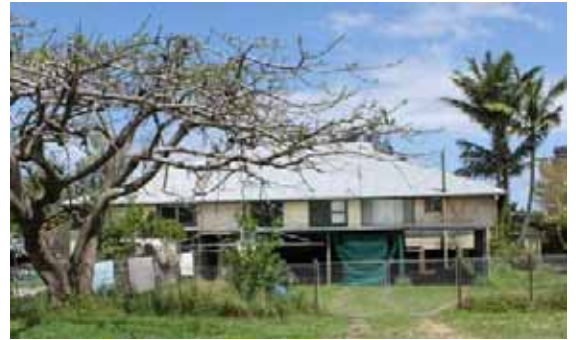
The Convent building is currently divided into two flats with its original size indicating a building larger than a standard residence of the time (Figure 7-57 to Figure 7-60). It is constructed of horizontal weatherboard with a corrugated iron Dutch gable roof. It has a partly enclosed verandah along the front as well as a gabled bay window on the eastern end of the frontage. There also appears to be an enclosed side verandah on the eastern end of the building. There is an open side verandah on the western end of the building. At the rear of the building the external walls are constructed with vertical boards on the eastern end of the wall perhaps indicating a later addition or enclosure to the original building. The building stands on brick stumps with a set of concrete and decorative better block steps at the front entrance. There are also concrete steps on both the east and west side of the building. The entire property is surrounded by a square-mesh metal fence with a dividing fence between the yards of the separate flats at the front and rear. Each flat has an associated single car garage at the front of the property. The garages are constructed of stamped

The interior of the building was not inspected, however based upon an assessment of the exterior and the obvious modifications of the original building into two separate dwellings, the original form and layout of the 1928 Convent building is likely to be much changed.

Figure 7-57: Front of convent building, facing north-east, photo taken by Rachael Loizou on 31 October 2011.

Figure 7-58: Front of convent building, facing north, photo taken by Rachael Loizou on 31 October 2011.

Figure 7-59: West side of convent building, facing east, photo taken by Rachael Loizou on 31 October 2011.

Figure 7-60: Rear of convent building, facing south, photo taken by Rachael Loizou on 31 October 2011.

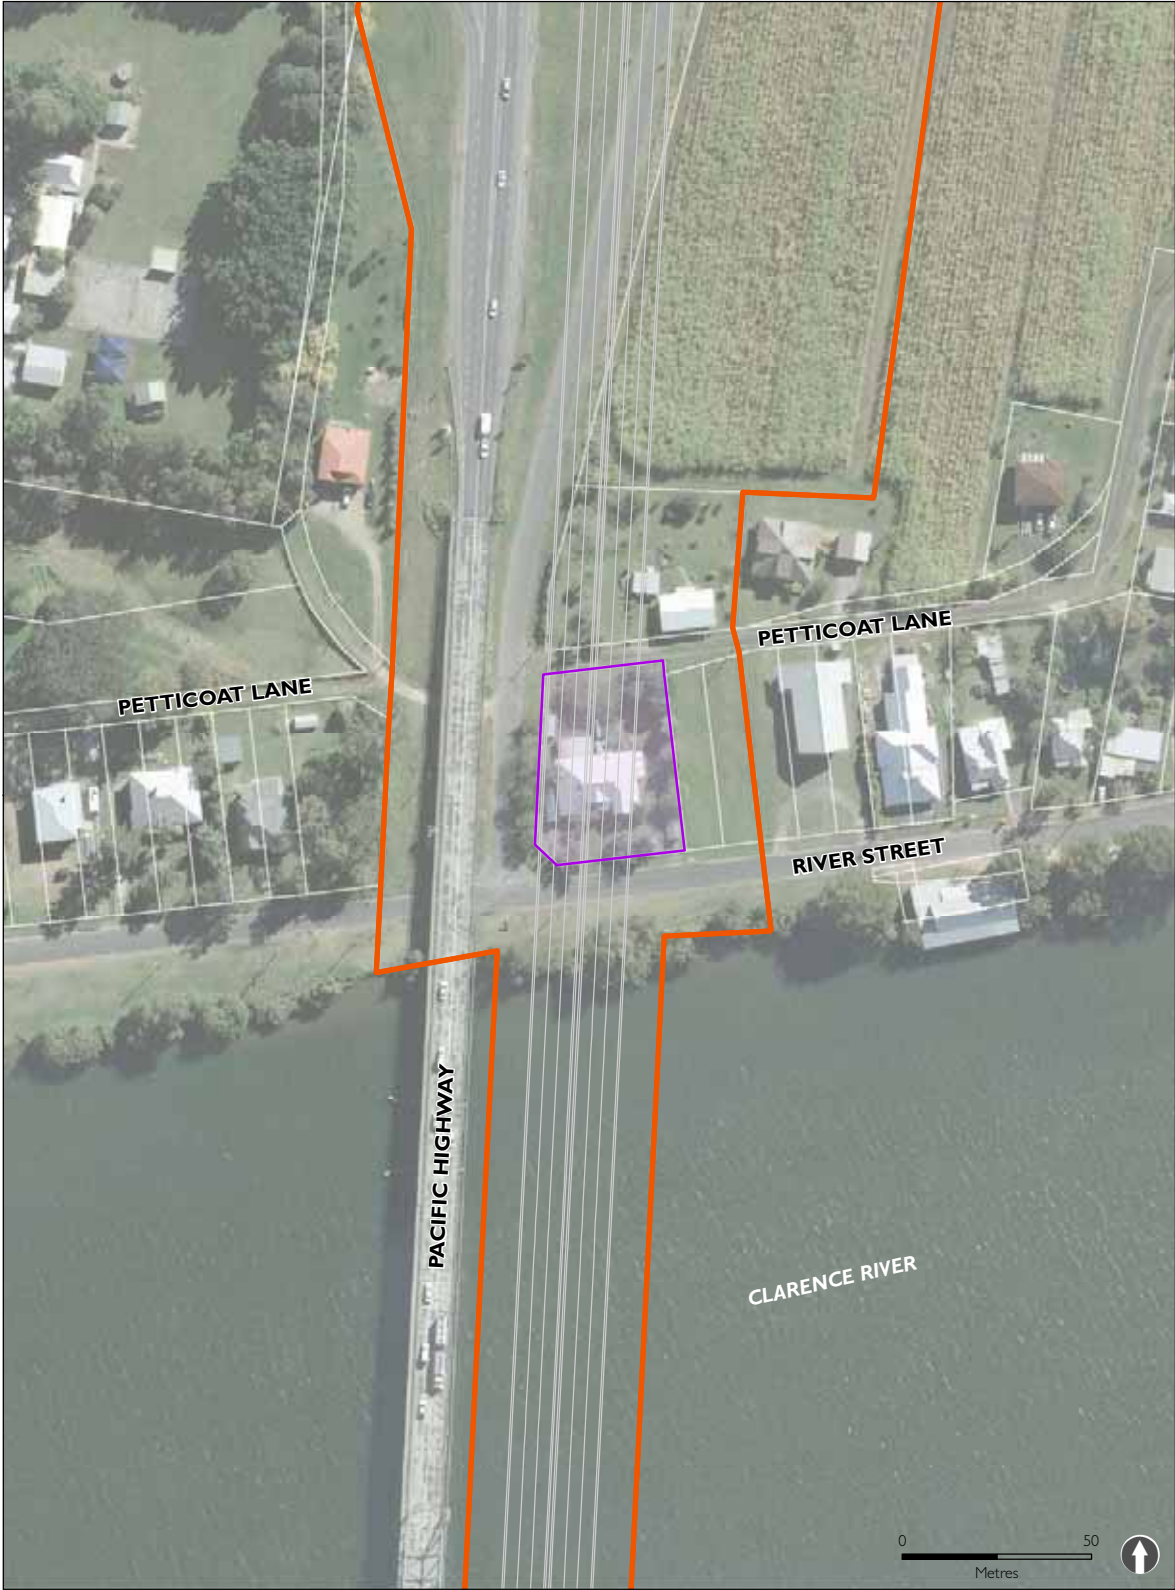
The curtilage of the site should be recorded as the entire property at Lot 1 DP230181 (Figure 7-61).

Figure 7-61 Curtilage of heritage item number 21, Convent, Harwood
