Appendix A **Site descriptions and significance assessments**

Upgrading the Pacific Highway – Woolgoolga to Ballina Upgrade

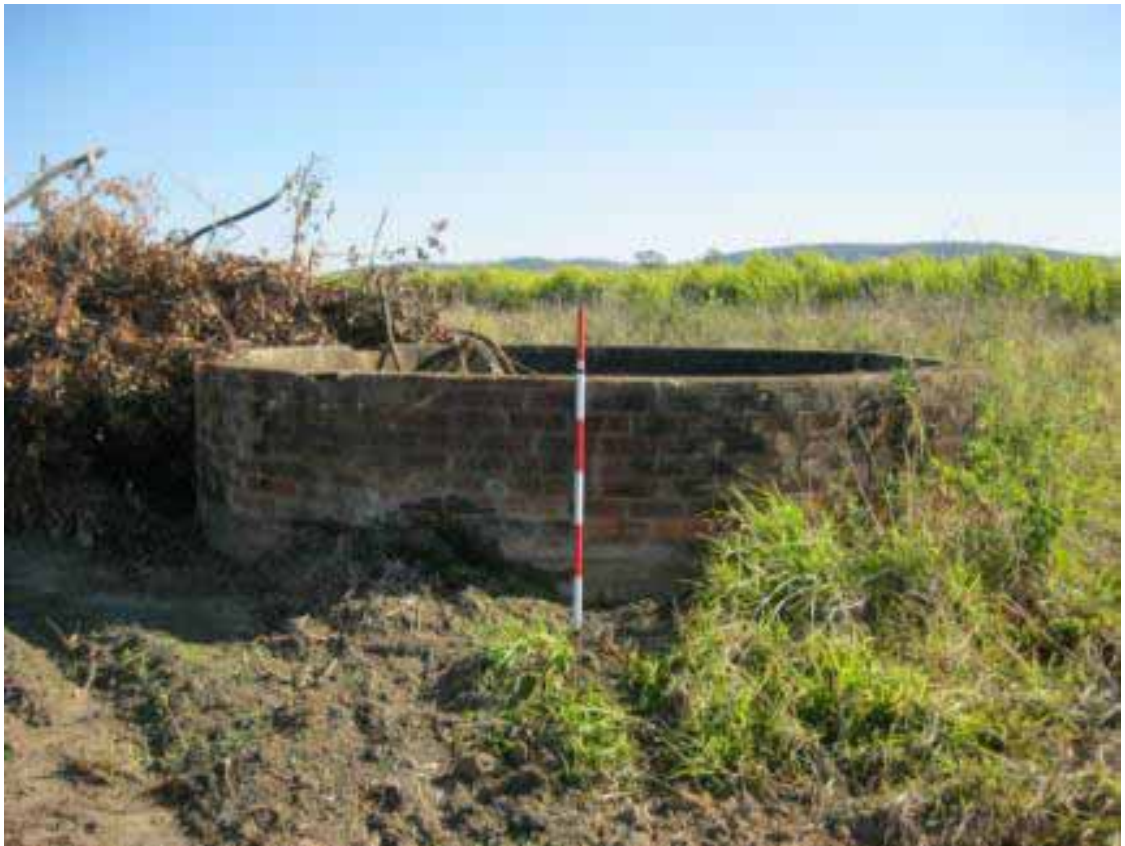
Figure 7-62: Concrete-lined brick well at property 315, photo taken by Vanessa Edmonds in August 2010.

This site was identified during historical heritage field survey in 2010. The site consists of a concrete-lined brick well (Figure 7-62) and concrete slab foundation for a former house. Slab has remnants of bathroom tiles. The house and well are estimated to date to the 1940s to 1950s.

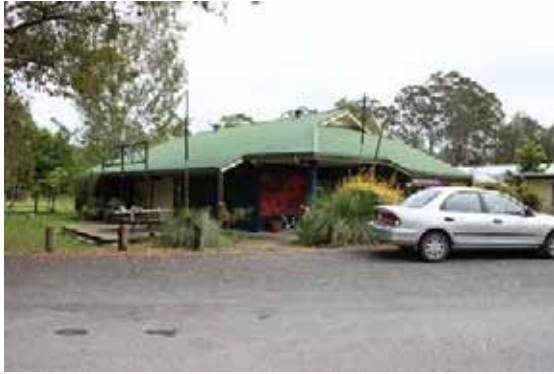
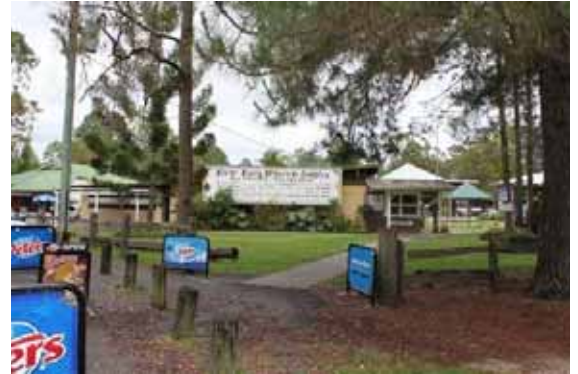
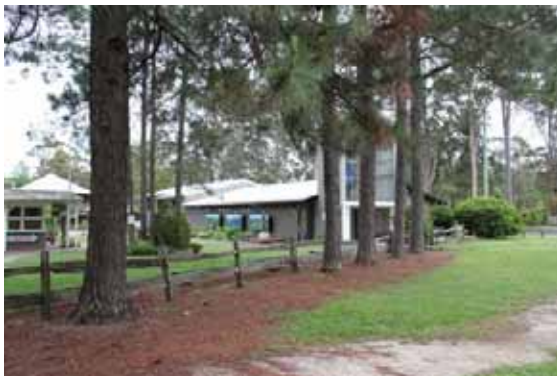
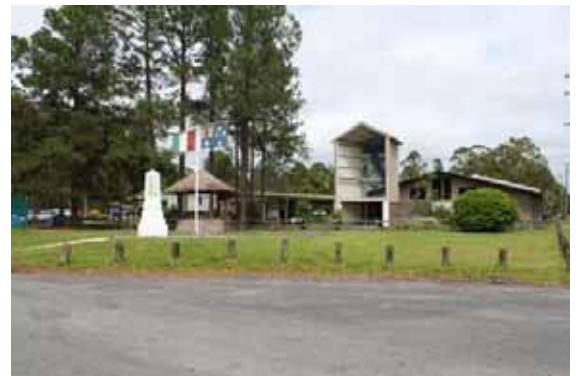
The New Italy Museum and Park of Peace site is located at the junction of the Pacific Highway and the Swan Bay-New Italy Road (Figure 7-63 to Figure 7-66). A parking area is parallel to the highway. The site contains a pavilion next to the Swan Bay-New Italy Road housing a display on 200 years of Italian immigrants in Australia. Directly opposite is a mud brick display hall which houses a collection of artefacts relating to the New Italy families and a cafeteria. Grape vines grow on the outside of the building. A restaurant and bar is situated to the north-west of the Pavilion. These three buildings form a courtyard which contains several copies of well known statuary as well as the 'Pioneer and his Dog' monument. Another hall can be found behind the restaurant. In the north-west corner of the site is the new Park of Peace containing trees planted by various dignitaries commemorating significant events and celebrations. The SHR also includes the site of the New Italy school situated at the junction of New Italy–Swan Bay Road and Moonem Road. Physical condition is fair to good. Archaeological potential of the school site together with the surrounding New Italy landscape is high. Further details on the individual items within the Settlement are available on the SHR site card.

Figure 7-63: New Italy Museum Complex, art gallery, facing west-north-west, photo taken by Rachael Loizou on 26 October 2011.

Figure 7-64: New Italy Museum Complex, art gallery at left, cafe/museum at centre, facing west, photo taken by Rachael Loizou on 26 October 2011.

Figure 7-65: New Italy Museum Complex, cafe/museum at left, pavilion at centre, facing north-west, photo taken by Rachael Loizou on 26 October 2011.

Figure 7-66: New Italy Museum Complex, pavilion at left, facing west. Memorial, flagpole and well in foreground are outside SHR boundary. Photo taken by Rachael Loizou on 26 October 2011.

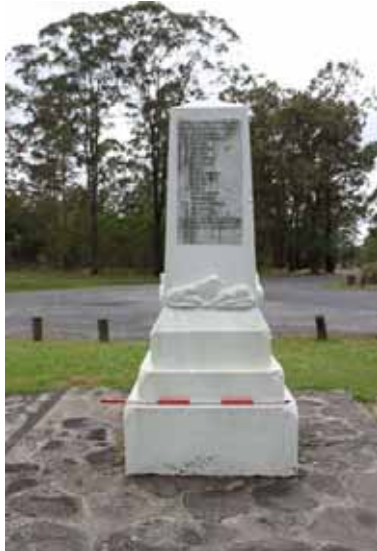
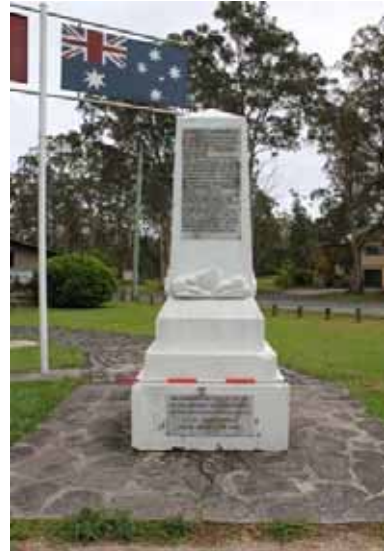
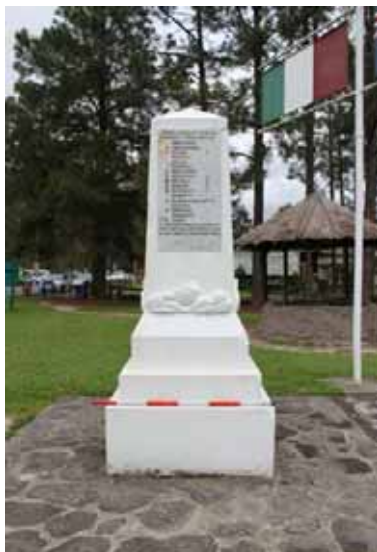
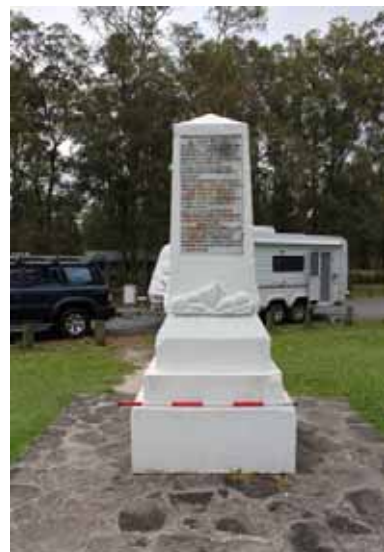
The 1961 Memorial (also known as the Monument to the Pioneers) was designed by Lismore architects Messrs DG Board and Sons. The monument is a concrete obelisk with white Italian marble plaques attached to each of the four sides of the obelisk (Figure 7-67 to Figure 7-70). The story of New Italy is inscribed in English and Italian on the plaques along with the names of the original settlers. The design of the obelisk also incorporates moulded decoration of a boat and ocean waves representing the story of the immigrants' arrival. Adjacent to the west of the memorial is a metal flagpole with two metal hand-painted flags attached to the top – the Italian flag to the south side and the Australian flag to the north. The flagpole was installed at some time after the memorial. Oral history indicates that this area is the site of a former mud brick house belonging to the original settlement. There was no evidence of subsurface historical archaeological deposits identified on the property.

Figure 7-67: New Italy Memorial, facing north-east, photo taken by Rachael Loizou on 26 October 2011.

Figure 7-68: New Italy Memorial, facing north-west, photo taken by Rachael Loizou on 26 October 2011.

Figure 7-69: New Italy Memorial, facing south-west, photo taken by Rachael Loizou on 26 October 2011.

Figure 7-70: New Italy Memorial, facing south-east, photo taken by Rachael Loizou on 26 October 2011.

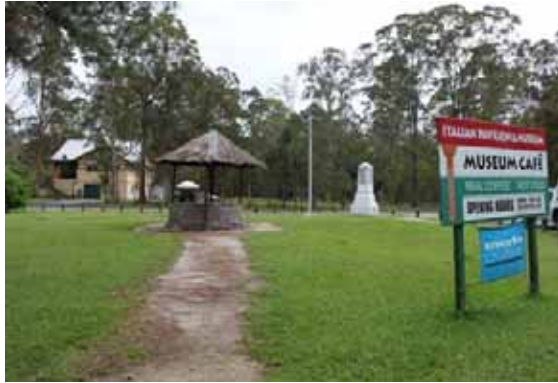
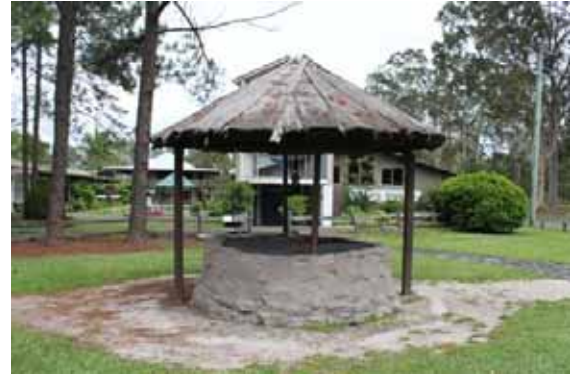
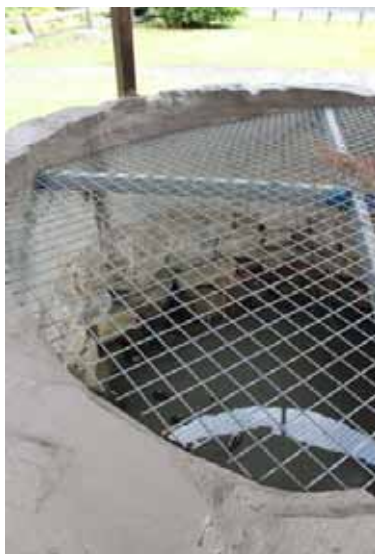
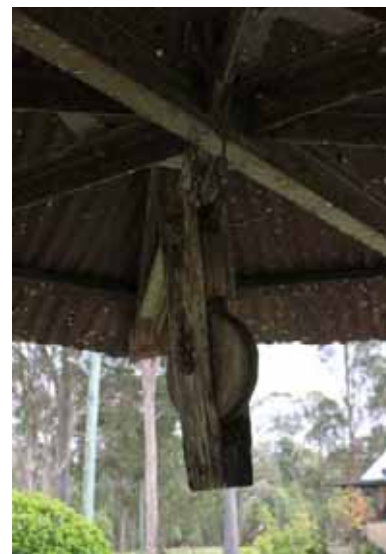
A stone-lined well (2.35 metres interior diameter) is situated south-west of the memorial and is considered to be an original in situ well (Figure 7-71 to Figure 7-74). During a site visit in October 2011 the water level in the well was at around 500 millimetres below the ground surface. Rough undressed stones are present in the deepest visible part of the well. Three courses of stones have been added above ground level and are topped by concrete which has been rendered and painted. This part of the well extends to a height of 910 millimetres above the ground surface. The opening of the well is covered with square metal mesh. The roofing over the well comprises metal square uprights with metal roof frame, and corrugated iron sheeting covered with a layer of tree bark. A wooden pulley hangs from the centre of the roof above the well. It is unclear from a visual inspection the exact depth of the well, how early the construction is or how much of the

Figure 7-71: Stone-lined well, flagpole and memorial, east of Museum Complex, facing north-east, photo taken by Rachael Loizou on 26 October 2011.

Figure 7-72: Stone-lined well with Museum Complex in background, facing west, photo taken by Rachael Loizou on 26 October 2011.

Figure 7-73: Interior to stone-lined well with metal mesh cover and rendered and painted concrete capping, facing north-north-west, photo taken by Rachael Loizou on 26 October 2011.

Figure 7-74: Wooden pulley above stone-lined well, hanging from roof, facing north-north-west, photo taken by Rachael Loizou on 26 October 2011.

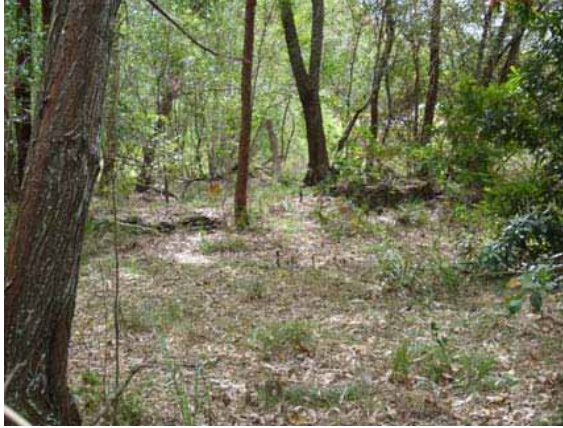
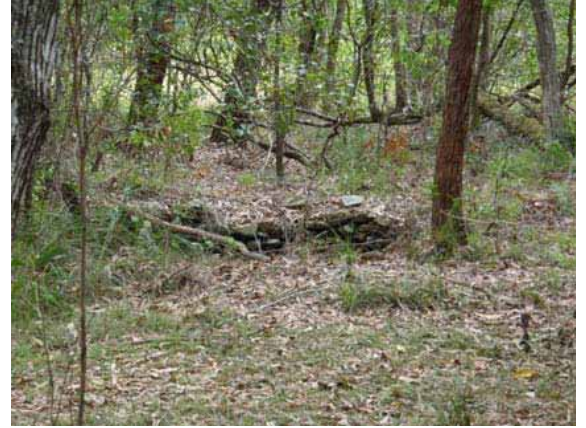
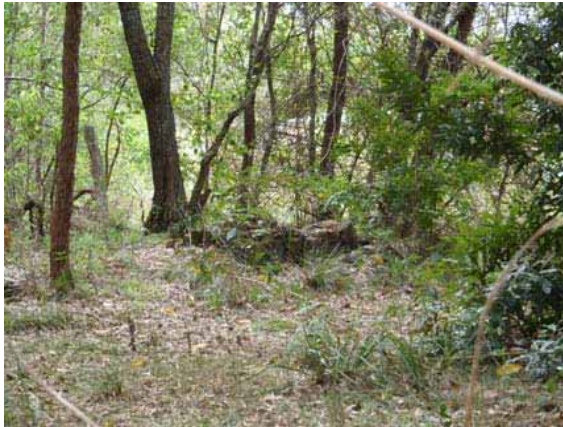
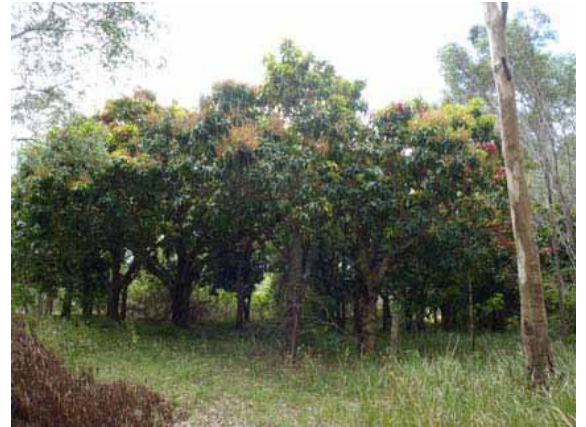
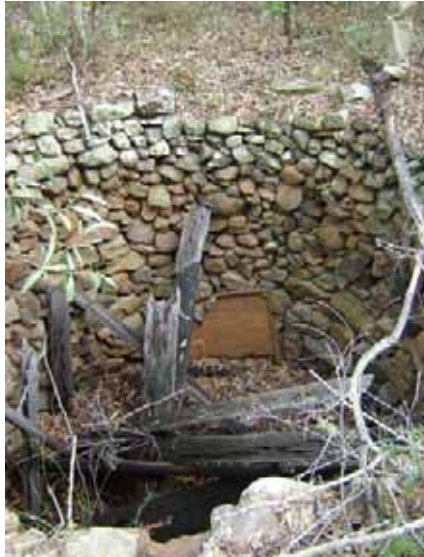
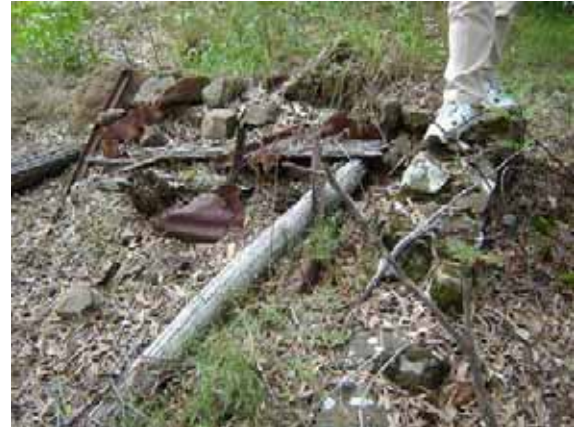
The well is round (around 2.5 metres diameter) and lined with irregular sandstone cobbles to a depth of at least 2.4 metres (2001) (Figure 7-75 to Figure 7-80). The actual depth of the well was unclear due to being partially filled with rubbish. The well was not capped but did contain logs which may have previously been used for capping or for a support for water haulage from the well. Adjacent to the north-east of the well is a low sandstone cobble wall, L-shaped and standing four cobblestones high, and is indicative of the remains of the corner of a building. An orchard of old mango trees is located to the north of the well along the easterly perimeter fence of the property. This general description (apart from the contents of the well) was confirmed during a site inspection undertaken from outside the property perimeter in October 2011.

Figure 7-75: Roder's stone-lined well at left and stone wall at right, facing north-west, photo taken by Rachael Loizou on 26 October 2010.

Figure 7-76: Roder's stone-lined well, facing north-west, photo taken by Rachael Loizou on 26 October 2010.

Figure 7-77: Stone wall, adjacent to Roder's stone-lined well, facing north-west, photo taken by Rachael Loizou on 26 October 2010.

Figure 7-78: Roder's mango orchard, facing north-west, photo taken by Rachael Loizou on 26 October 2010.

Figure 7-79: Roder's stone-lined well, photo courtesy of Richmond Valley Council, taken 2005.

Figure 7-80: Stone wall adjacent to Roder's stone-lined well, photo courtesy of Richmond Valley Council, taken 2005.

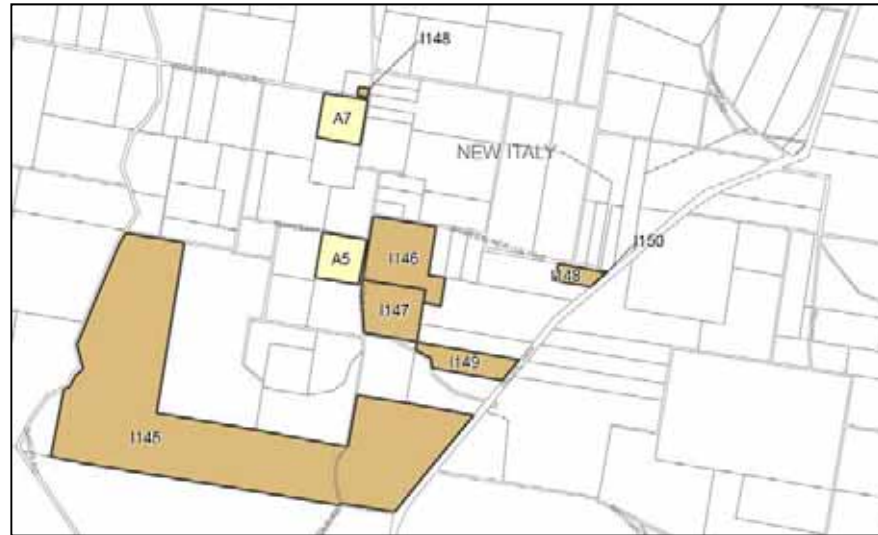
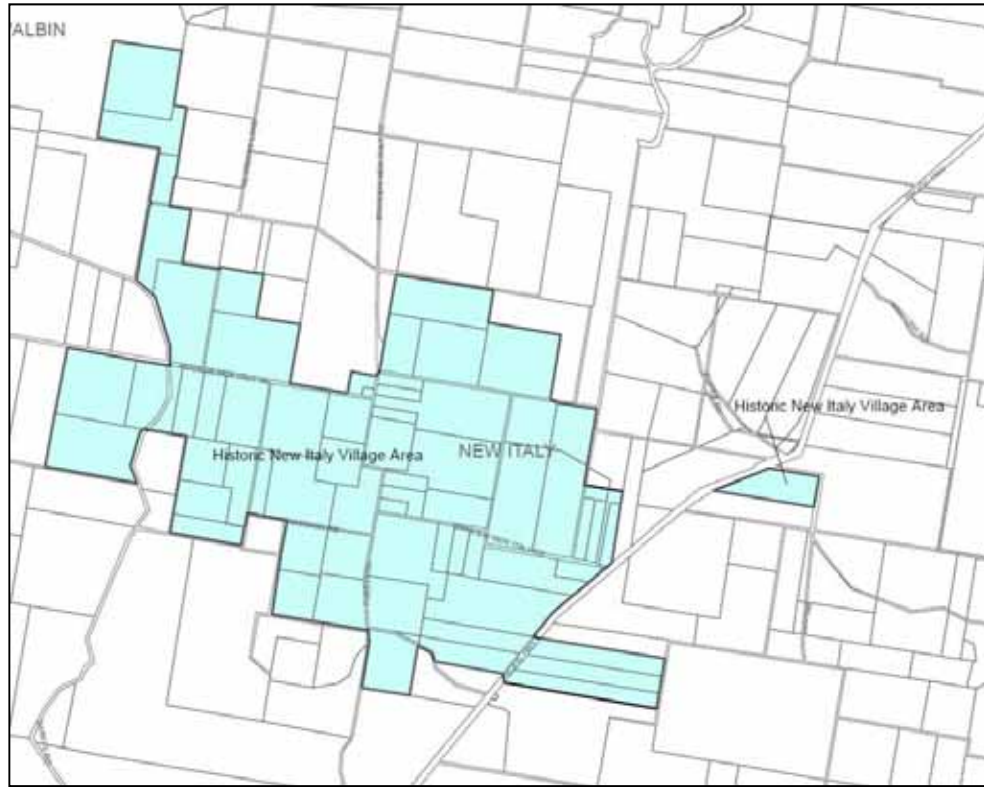
The curtilage of the various site components is listed in Table 7-1. Figure 7-81 details the location and extent of the SHR curtilage for this site, while Figure 7-82 details the curtilage for the individual sites (I145 to I150, A5, A7) included as part of the Richmond Valley LEP 2012. The curtilage of the Historic New Italy Village Area from the Richmond Valley LEP is shown in Figure 7-83.

Figure 7-81: Extent of SHR curtilage for the New Italy Settlement (SHR 2010).

Figure 7-82: Extent of curtilage for the New Italy sites listed on the Richmond Valley LEP 2012.

Figure 7-83: Extent of curtilage for Historic New Italy Village Area, section 6.4, Richmond Valley LEP 2012.

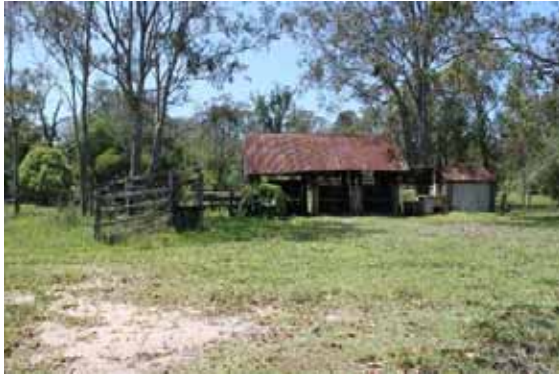
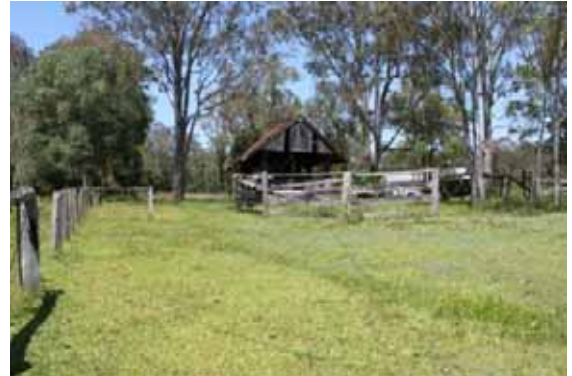
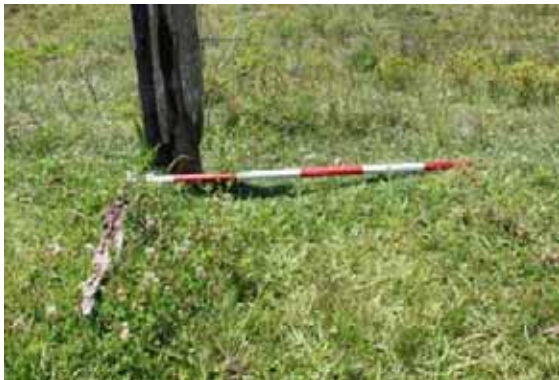
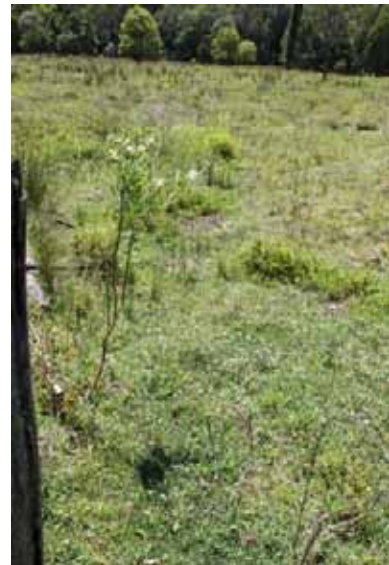
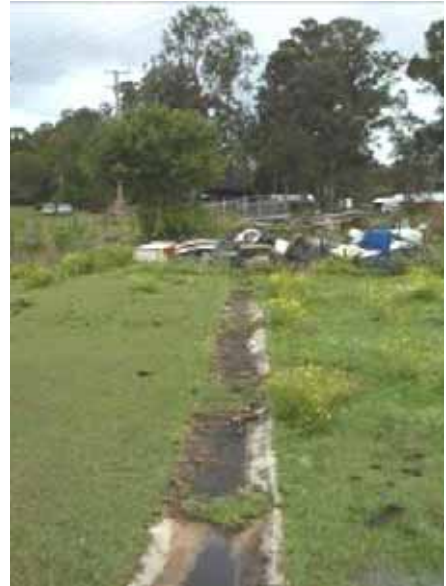
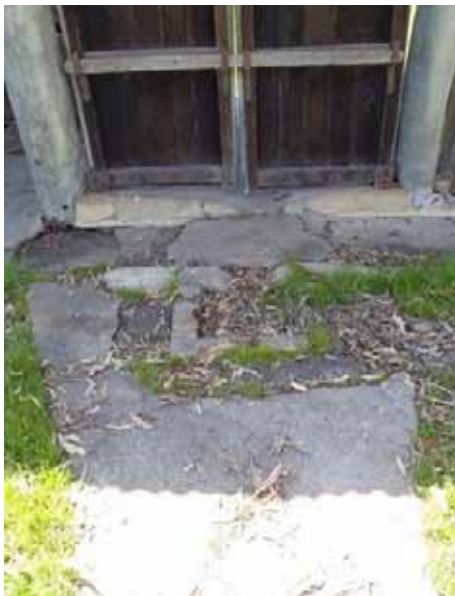
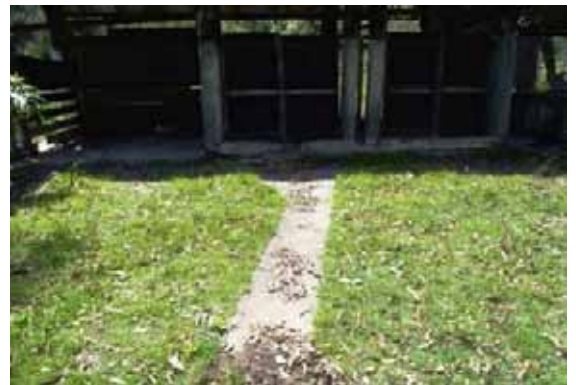
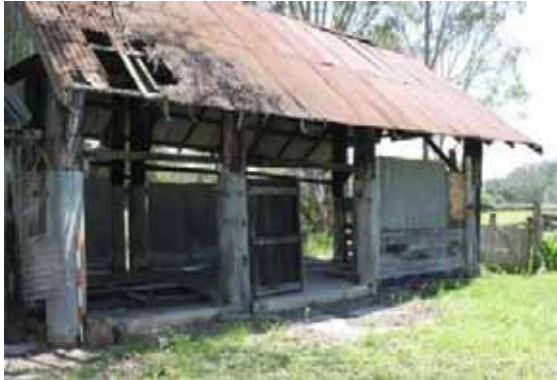
The copper abuts a third structure with a corrugated iron gabled roof. The eastern side of the building has also been intentionally left open with all other sides being enclosed. The western and southern walls are covered with modern zinc aluminium with square corrugations whereas the northern wall is covered with old corrugated iron. This structure may have been utilised for hanging animal carcasses. Immediately south of this structure is a chopping block consisting of a tree stump and post which may have been utilised during the slaughter process ie cattle may have been secured to the post before being killed by having their necks slit or by decapitation.

Around 30 metres north of the main structure is a rectangular concrete pond with a concrete apron which is the possible remains of either a detention basin or foundation for a tallow works, historically common in the area (Heritage Concepts 2007).

Figure 7-85: Woodburn slaughterhouse and adjacent structures, facing east, photo taken by Rachael Loizou on 25 October 2011.

Figure 7-86: Woodburn slaughterhouse and potential discharge drain, facing south, photo taken by Rachael Loizou on 25 October 2011.

Figure 7-87: Discharge drain termination, facing east, photo taken by Rachael Loizou on 25 October 2011.

Figure 7-88: Natural low depression, facing north-east, photo taken by Rachael Loizou on 25 October 2011.

Figure 7-90: Discharge drain located north of rectangular concrete pond, facing south (Heritage Concepts 2007).

Figure 7-91: Discharge drain to west of main structure, facing east, photo taken by Rachael Loizou on 25 October 2011.

Figure 7-92: Western exterior side of main structure, facing east, photo taken by Rachael Loizou on 25 October 2011.

Figure 7-93: Woodburn slaughterhouse, facing west north-west, photo taken by Rachael Loizou on 25 October 2011.

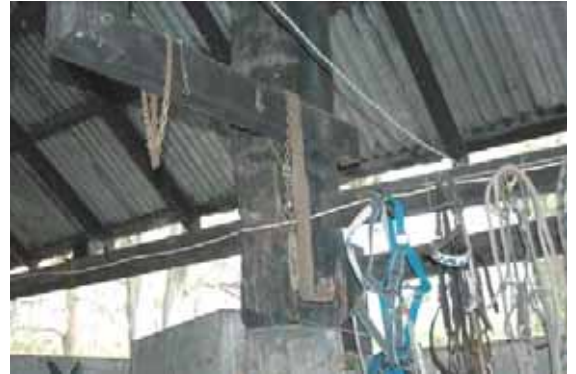
Figure 7-94: Hand forged iron hooks which have been removed, facing south-west (Heritage Concepts 2007).

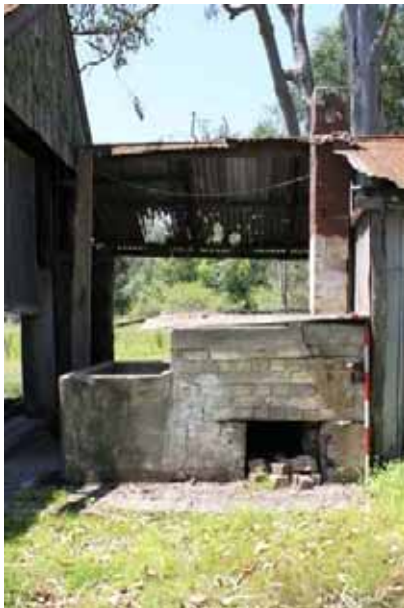
Figure 7-95: Copper, fuel box, chimney and trough, facing east, photo taken by Rachael Loizou on 25 October 2011.

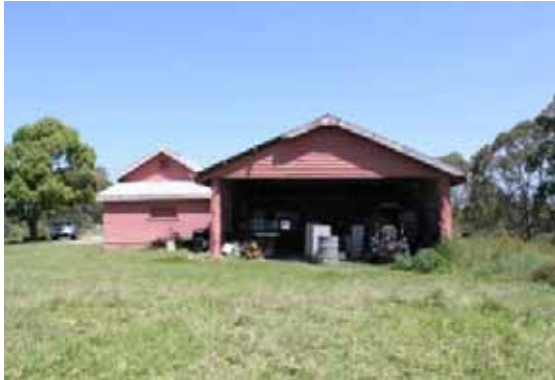
Figure 7-100: Dairy with open timber barn at right and enclosed timber barn section at left, facing south, photo taken by Rachael Loizou on 31 October 2011.

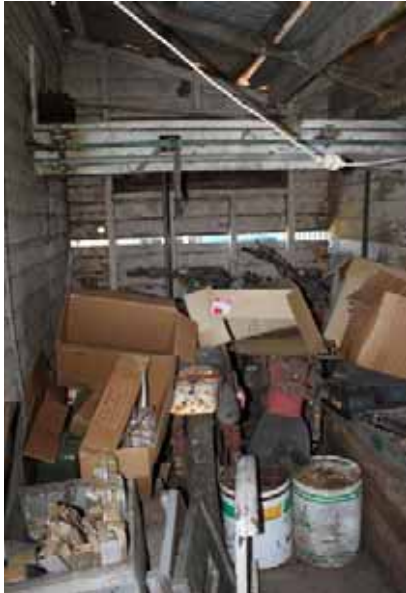
Figure 7-104: Interior of enclosed barn section of dairy showing milk pipeline, facing south, photo taken by Rachael Loizou on 31 October 2011.

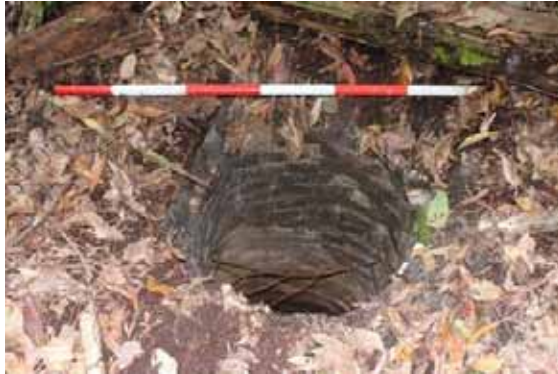
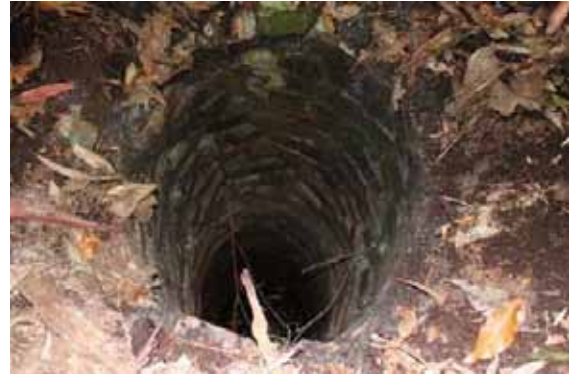
The brick-lined well (Figure 7-119, Figure 7-120) was covered with timber slabs and branches in order to reduce its obtrusiveness to trespassers. The well is a variable ovoid shape ranging in diameter from 610 to 640 millimetres. The depth of the well to the water surface in November 2011 was 3.1 metres from the top course of bricks. The well comprises mainly brick courses, with some

Figure 7-119: Brick lined well, facing south, photo taken by Rachael Loizou on 1 November 2011.

Figure 7-120: Brick lined well, facing south, photo taken by Rachael Loizou on 1 November 2011.

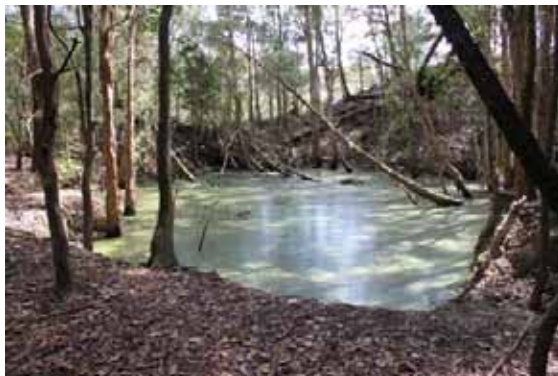
Located west of the well, a large excavated area (>10 metres diameter) now filled with water was identified as a clay pit that provided the raw material for the on-site production of bricks (Figure 7-121). Narrow channels leading downhill from the main pit into other smaller depressions may be related to the required drainage of the clay pit for use following rain, or other aspects of the brick production process. The channels were filled with grasses and leaf litter. A second area to the east of the clay pit has also been excavated into the bank, possibly also related to the accessing of clay material for the manufacture of bricks (Figure 7-122).

Figure 7-121: Clay pit filled with water, facing north-west, photo taken by Rachael Loizou on 1 November 2011.

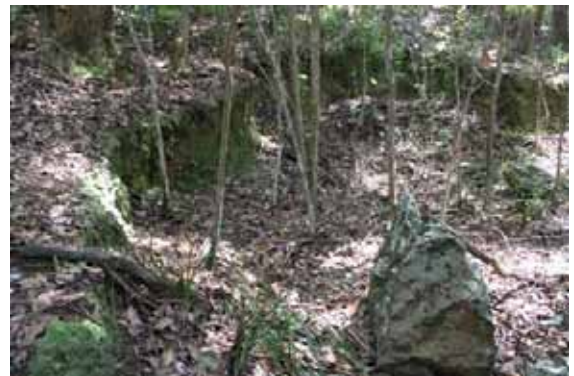
Figure 7-122: Secondary clay pit, facing north-east, photo taken by Rachael Loizou on 1 November 2011.

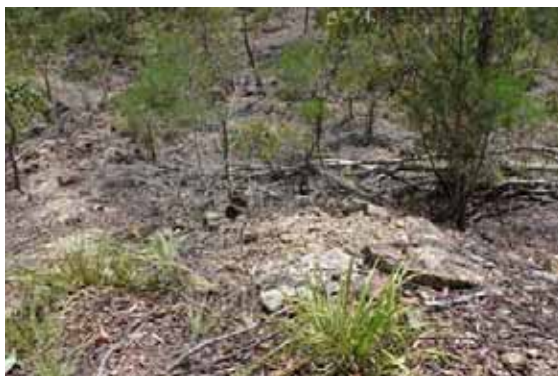
A large quarry area (Figure 7-123) is situated immediately to the north of the clay pit and well on the other side of a stone ridge, with the quarrying area measuring some 80 metres x 100 metres in size. There is extensive evidence of the removal of stone from the quarry over time. The quarry area also contains a number of other items including:

Figure 7-123: Section of stone quarry viewed from ridge, facing north-east, photo taken by Rachael Loizou on 1 November 2011.

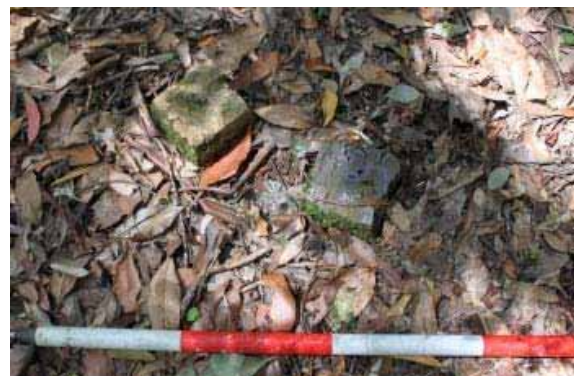
Metal, brick, ceramic and glass artefacts are visible on the surface throughout the southern section of the forested area (Figure 7-124).

Figure 7-124: Example of bricks on ground surface found across site, facing east, photo taken by Rachael Loizou on 1 November 2011.

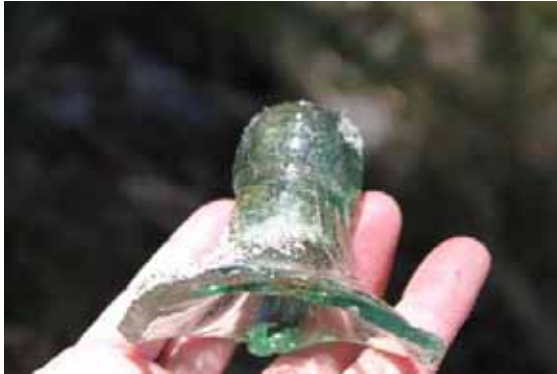
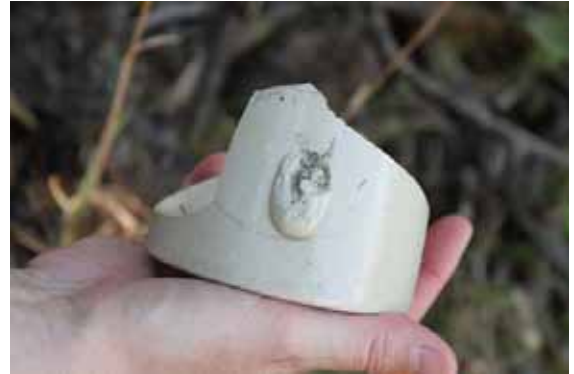
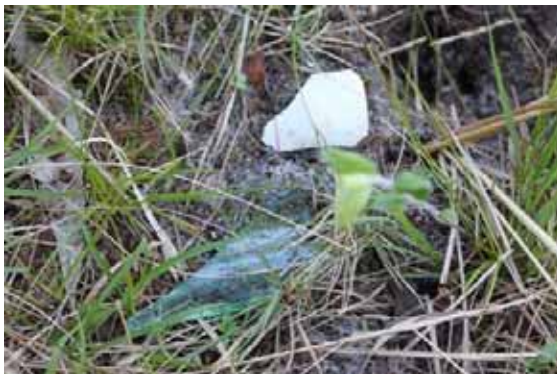
Concentrated evidence of glass bottles and ceramic vessels including white ceramic tableware, stoneware ginger beer bottles, dark green alcohol bottles, and clear/light green condiment and cordial bottles and medicine bottles are situated in the south-east corner of the site (Figure 7-125 to Figure 7-127). This area appeared to be have been excavated by hand, possibly to retrieve bottles. Mark Byrne indicated that the artefacts were found sub-surface by himself and his brother. Other surface artefacts were difficult to see due to the high level of leaf litter covering the ground surface. On walking tracks through the area where ground surface visibility was high, fragments of glass, ceramic, brick and shell were found eroding from below the ground surface (Figure 7-128). The presence of artefacts in these two instances indicates the high likelihood of more artefacts below the ground surface.

Figure 7-125: Example of glass bottle fragment found in south-east corner of site, photo taken by Rachael Loizou on 1 November 2011.

Figure 7-126: Example of ceramic fragment found in south-east corner of site, photo taken by Rachael Loizou on 1 November 2011.

Figure 7-127: Example of artefact scatter in south-east corner of site, photo taken by Rachael Loizou on 1 November 2011.

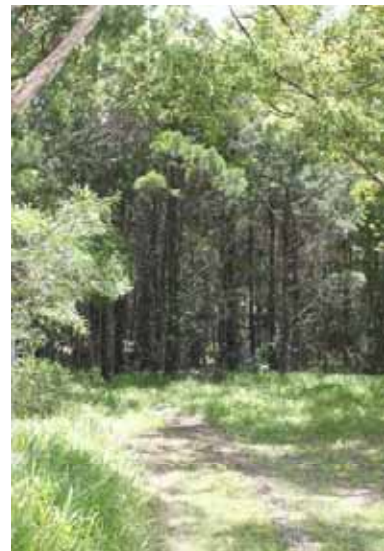
Figure 7-128: Walking track with artefacts eroding from below ground surface, facing east, photo taken by Rachael Loizou on 1 November 2011.

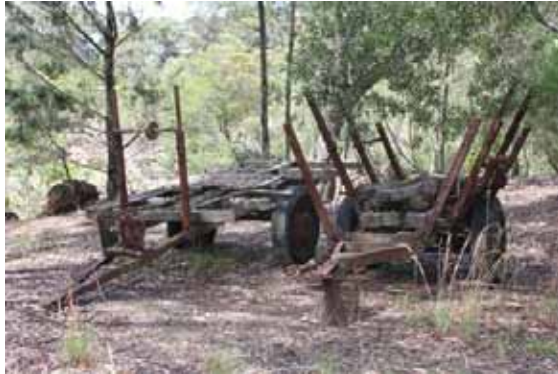
- Two trailers (Figure 7-129), one used for the transport of cane to the river, the other for transporting the cane cutters around the property.
- An old plough/harrow.
- A collapsed timber hut (used in recent years by sons of the property owners).
- Several old cars bodies.
- Metal pipes and other metal pieces.

Figure 7-129: Trailers situated within stone quarry area, facing south, photo taken by Rachael Loizou on 1 November 2011.

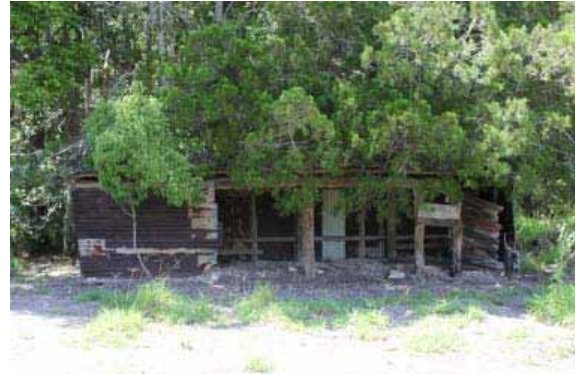
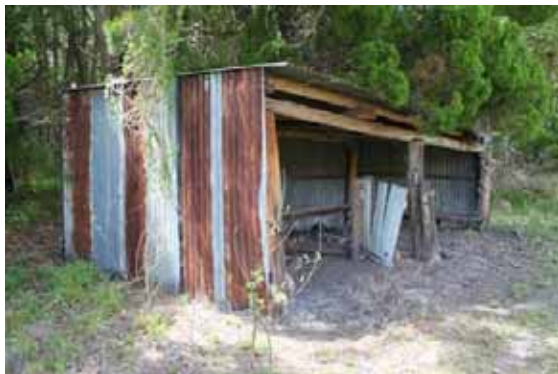
Two structures formerly used as pig-sties are situated on the western margin of the forested area (Figure 7-130, Figure 7-131). Both are rectangular structures constructed with a timber frame of local undressed timber logs and walls and roofing of corrugated iron sheeting. Both are open along one side of the structure and are no longer used for housing pigs.

Figure 7-130: Pig-sty 1 at edge of forested area, facing south-east, photo taken by Rachael Loizou on 1 November 2011.

Figure 7-131: Pig-sty 2 at edge of forested area, facing south, photo taken by Rachael Loizou on 1 November 2011.

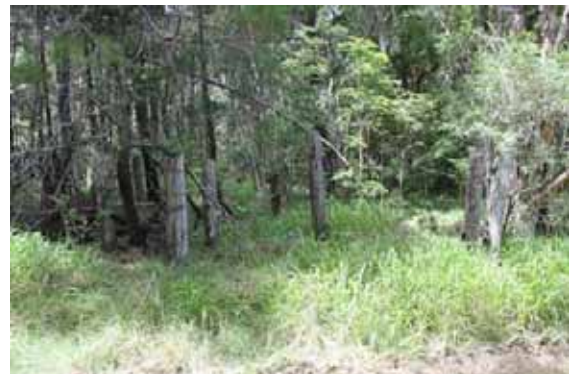
The remains of a stockyard or animal pen are situated in south-west corner of the forested area (Figure 7-132). The pens are in disrepair with the remains of several large timber posts, barbed wire and one timber rail remaining.

Figure 7-132: Stockyard/pens, facing south-east, photo taken by Rachael Loizou on 1 November 2011.

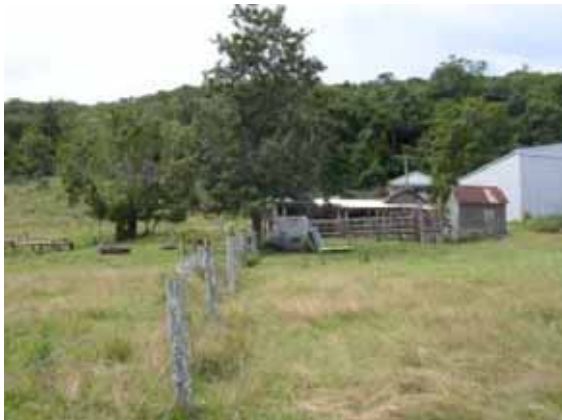
The property maintained its own dairy until 1973, when de-regulation of that industry forced a shift to sugar cane cultivation. The original dairy buildings and yards are still extant, clearly indicating early construction techniques and original materials (Figure 7-137). Old machinery associated with this activity is deposited towards the rear of the buildings. A new workshop was recently erected on the site of a 1900s building that collapsed.

Figure 7-137: Original dairy buildings (Heritage Concepts 2005).

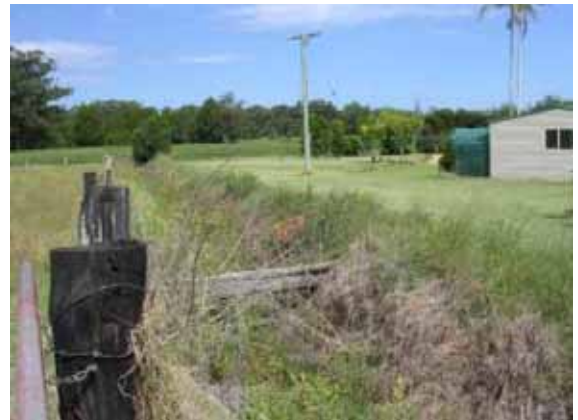
Between the house and the work buildings is an old partially overgrown drainage channel, constructed during the early 1910s (Figure 7-138). According to the owner all drainage channels in the area were constructed under the auspices of a local drainage union early in the 19th century.

Figure 7-138: Drainage Union drainage channel (Heritage Concepts 2005).

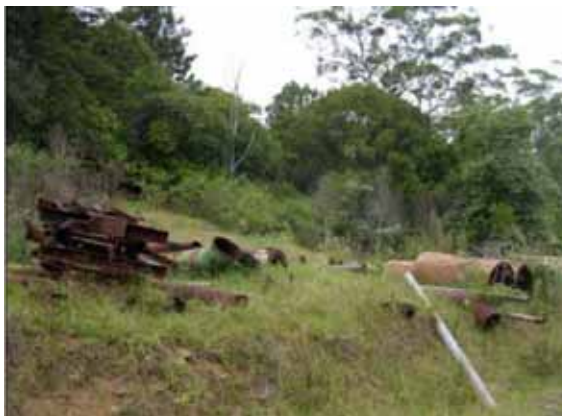
Figure 7-139: Farm equipment and artefacts (Heritage Concepts 2005).

The property contains numerous built and moveable items of heritage value and also serves as an indicator of the types of relics and structures that could be located on other properties (Figure 7-139). These relate to early farming activity, such as sheds, yards and derelict equipment, or regional engineering projects such as the construction of drainage channels. The latter also reflect local social and economic organisation.

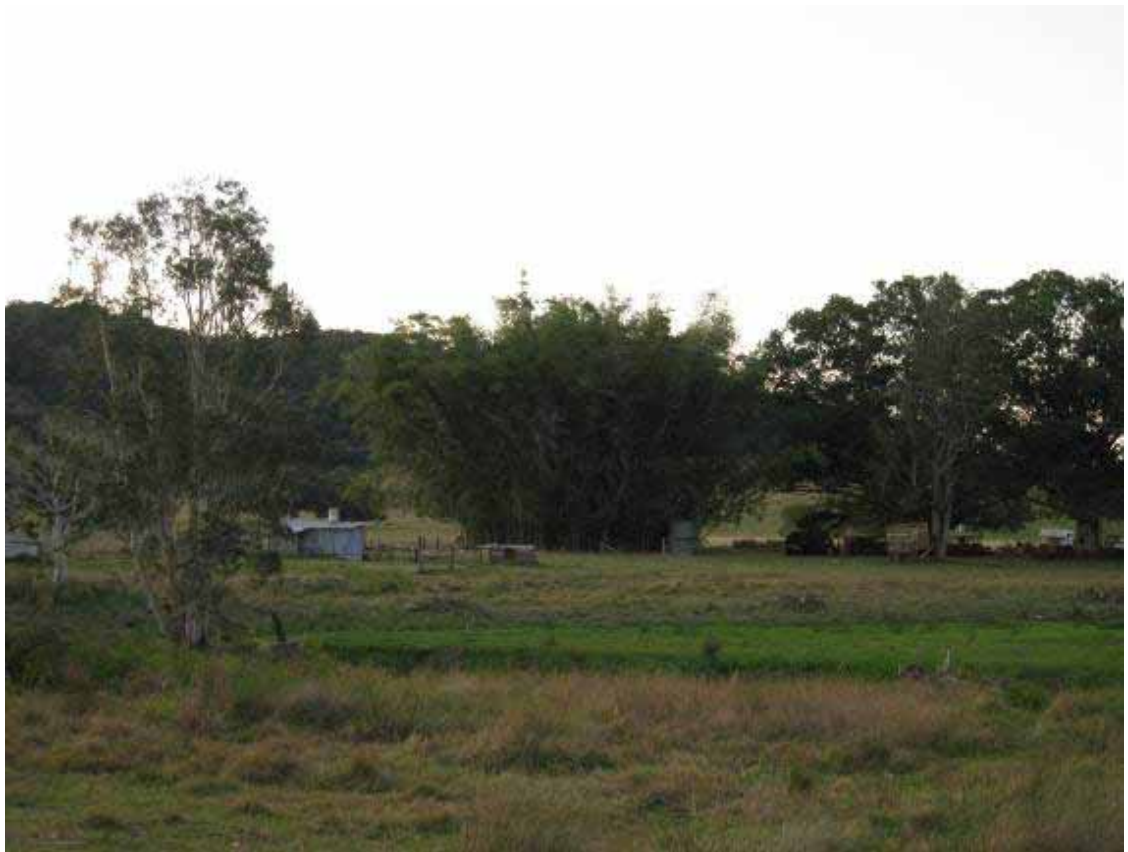
These sites consist of two mature stands of bamboo, around 30 metres x 30 metres, on the edge of property 725 and in the centre of property 723. Property 725 is located to the north of the intersection of Thurgates Lane and Wardell Road, Wardell. Property 723 is located to the west of the southern end of Thurgates Lane.

Figure 7-141: View of mature bamboo stand at property 723, off Thurgates Lane, Wardell, photo taken by Rani Atwood on 27 August 2010.

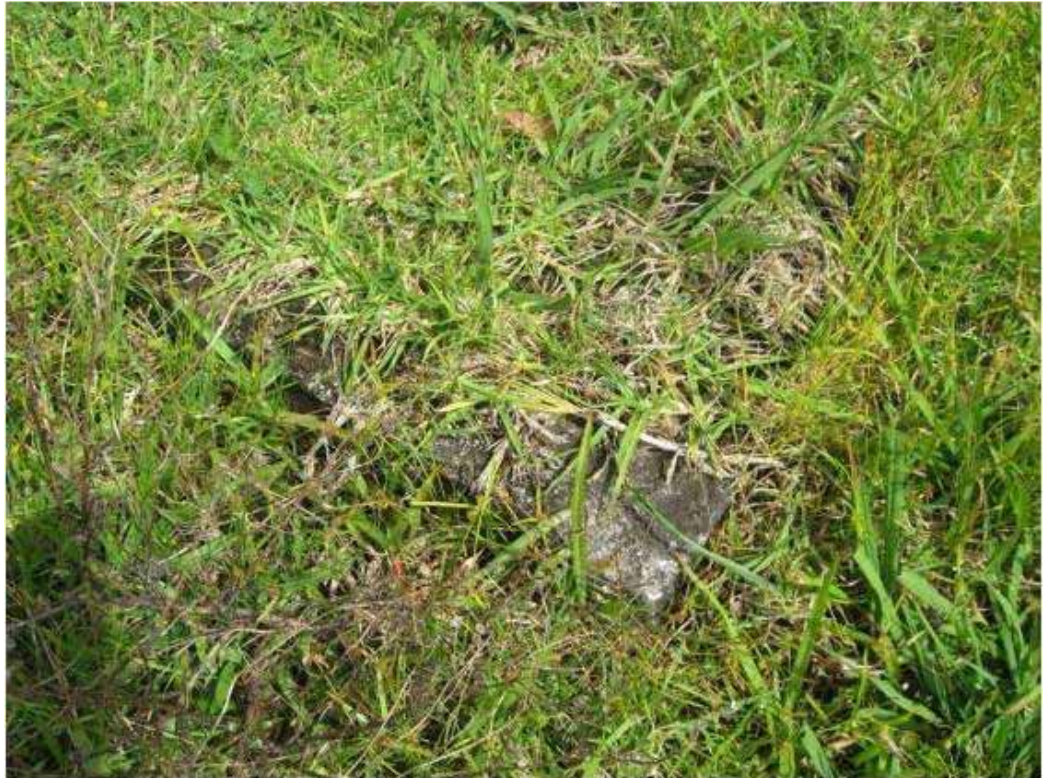
- A rectangular concrete building foundation, possibly a house or shed (Figure 7-142).
- A circular water tank with corrugated iron on the outside and concrete lining inside.
- A small series of furrowed earth mounds, possibly evidence of a small market garden or potato field.

Figure 7-142: Rectangular concrete building foundations, photo taken by Joseph Brooke in November 2010.

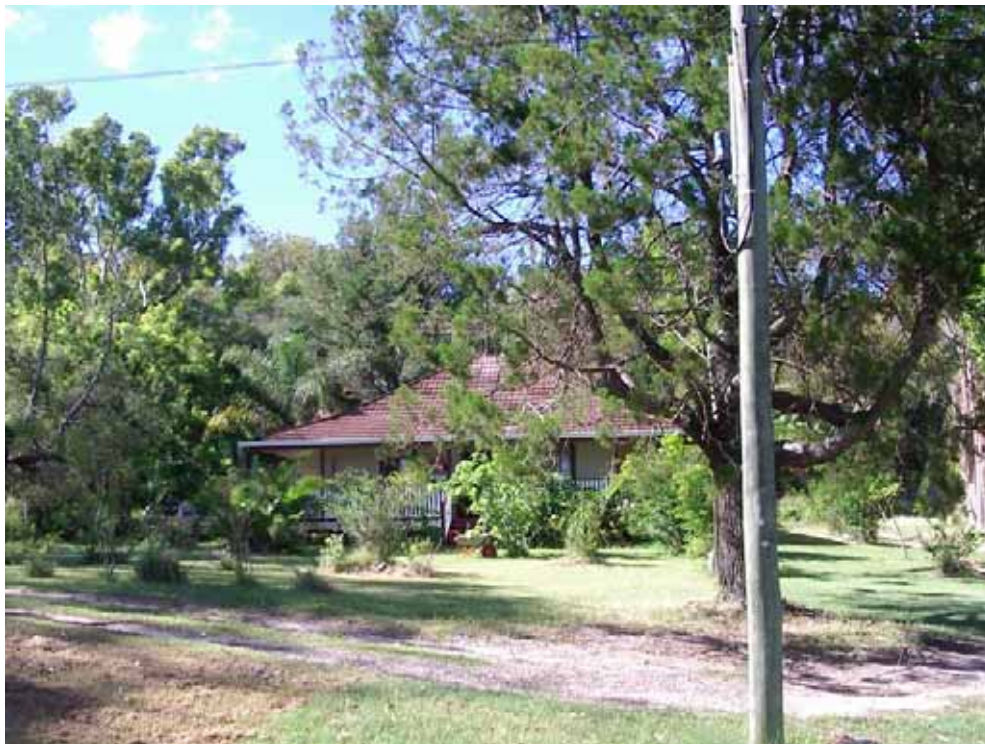
The description of the residence was originally noted by Tim Shellshear in the Maclean Heritage Study undertaken in 1989. The residence was noted as a charming small cottage of elegant architectural simplicity having double pitched roof extending smoothly over encircling verandahs. Verandahs supported on simple timber posts with striking fish scale style valance all round. Weatherboard walls set between exposed studies with twelve pane windows similarly set between. Description of the residence in 2006 indicates that it does not exactly match that given by Shellshear and indicates the property has been modified.

The fish scale valance had been removed. Unsympathetic alterations such as imitation roof tiles, aluminium guttering, boarding to verandah faces and enclosure of side verandah. Comments made in the SHI listing indicate that the integrity of the house is spoiled by these modifications and that renovations undertaken have taken little consideration of its heritage charm.

Figure 7-145: Townsend residence (Source: NSW State Heritage Inventory).

The significance of this cottage lies in its early original c1870s and architectural simplicity having double pitched roof extending smoothly over encircling verandahs. However it has been substantially modified.

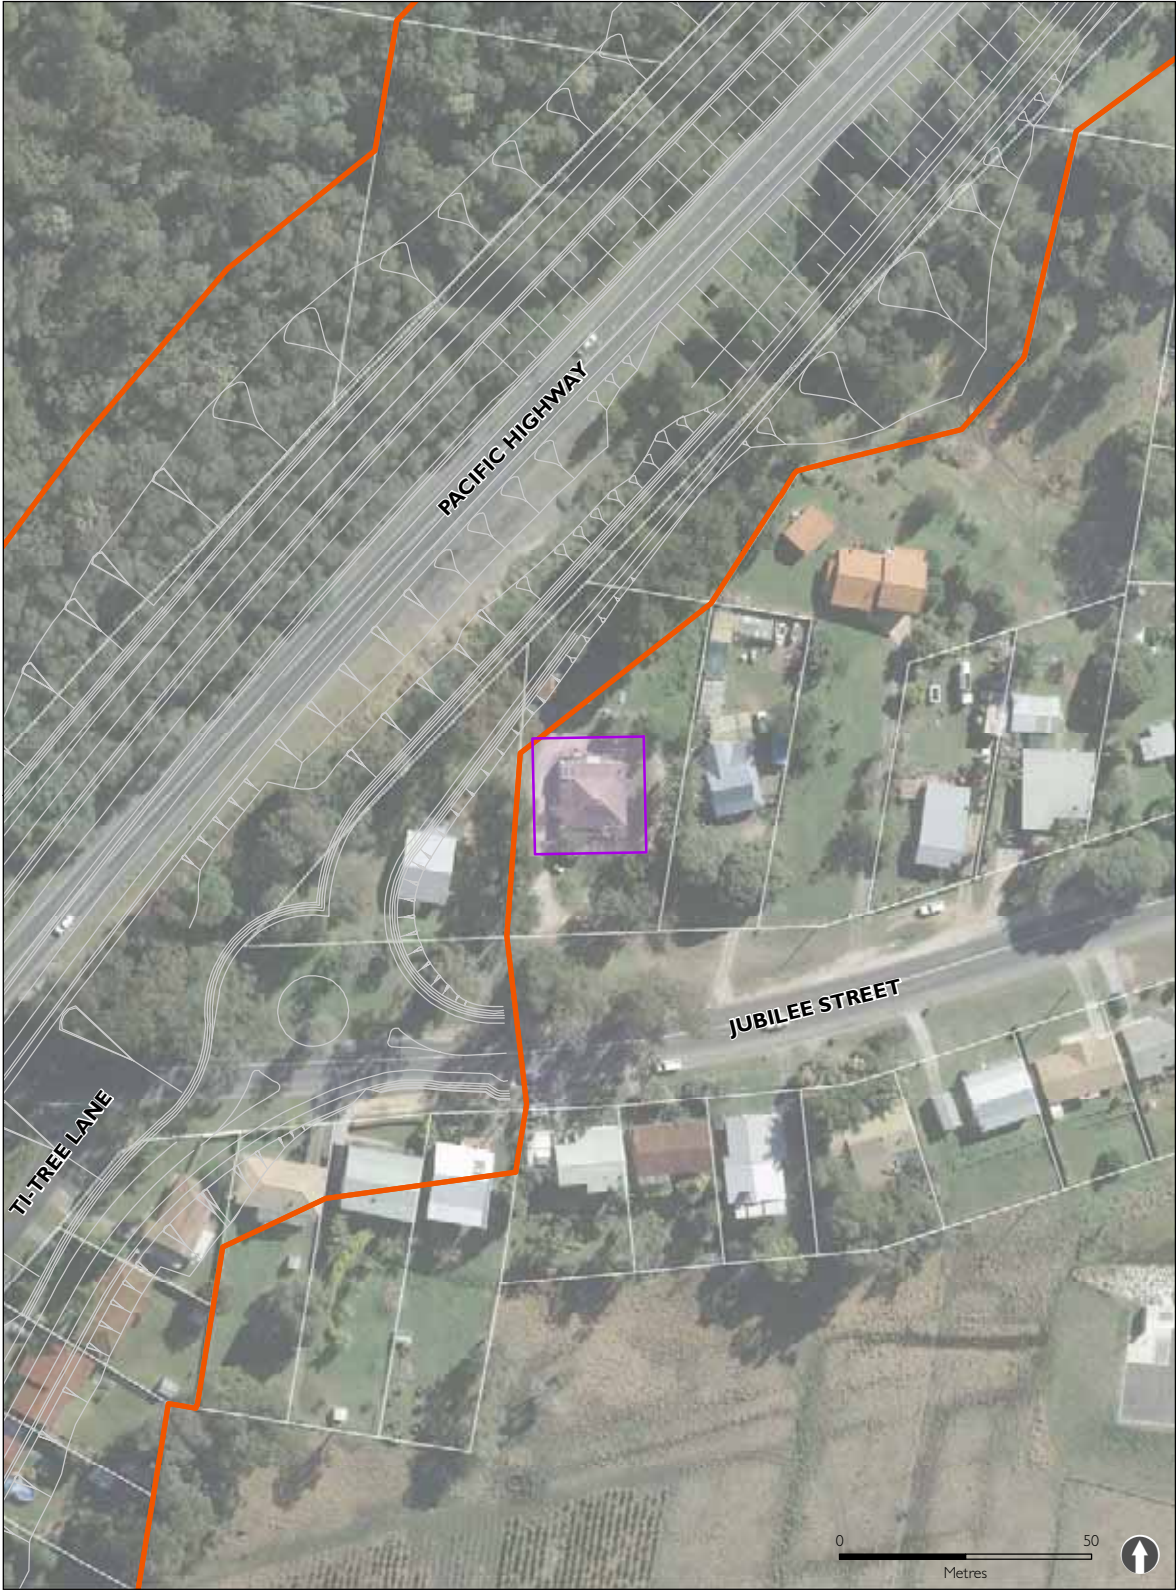
Figure 7-146 Curtilage of heritage item number 34, Townsend Residence, Townsend

The entire allotment at 3 Jubilee Street, Townsend (Lot 1 DP501255) is listed on the Clarence Valley LEP (2011). Based on information from the SHI and analysis of aerial imagery the curtilage of the site is recommended to include the main dwelling as shown in Figure 7-146.
