Appendix A **Site descriptions and significance assessments**

Upgrading the Pacific Highway – Woolgoolga to Ballina Upgrade

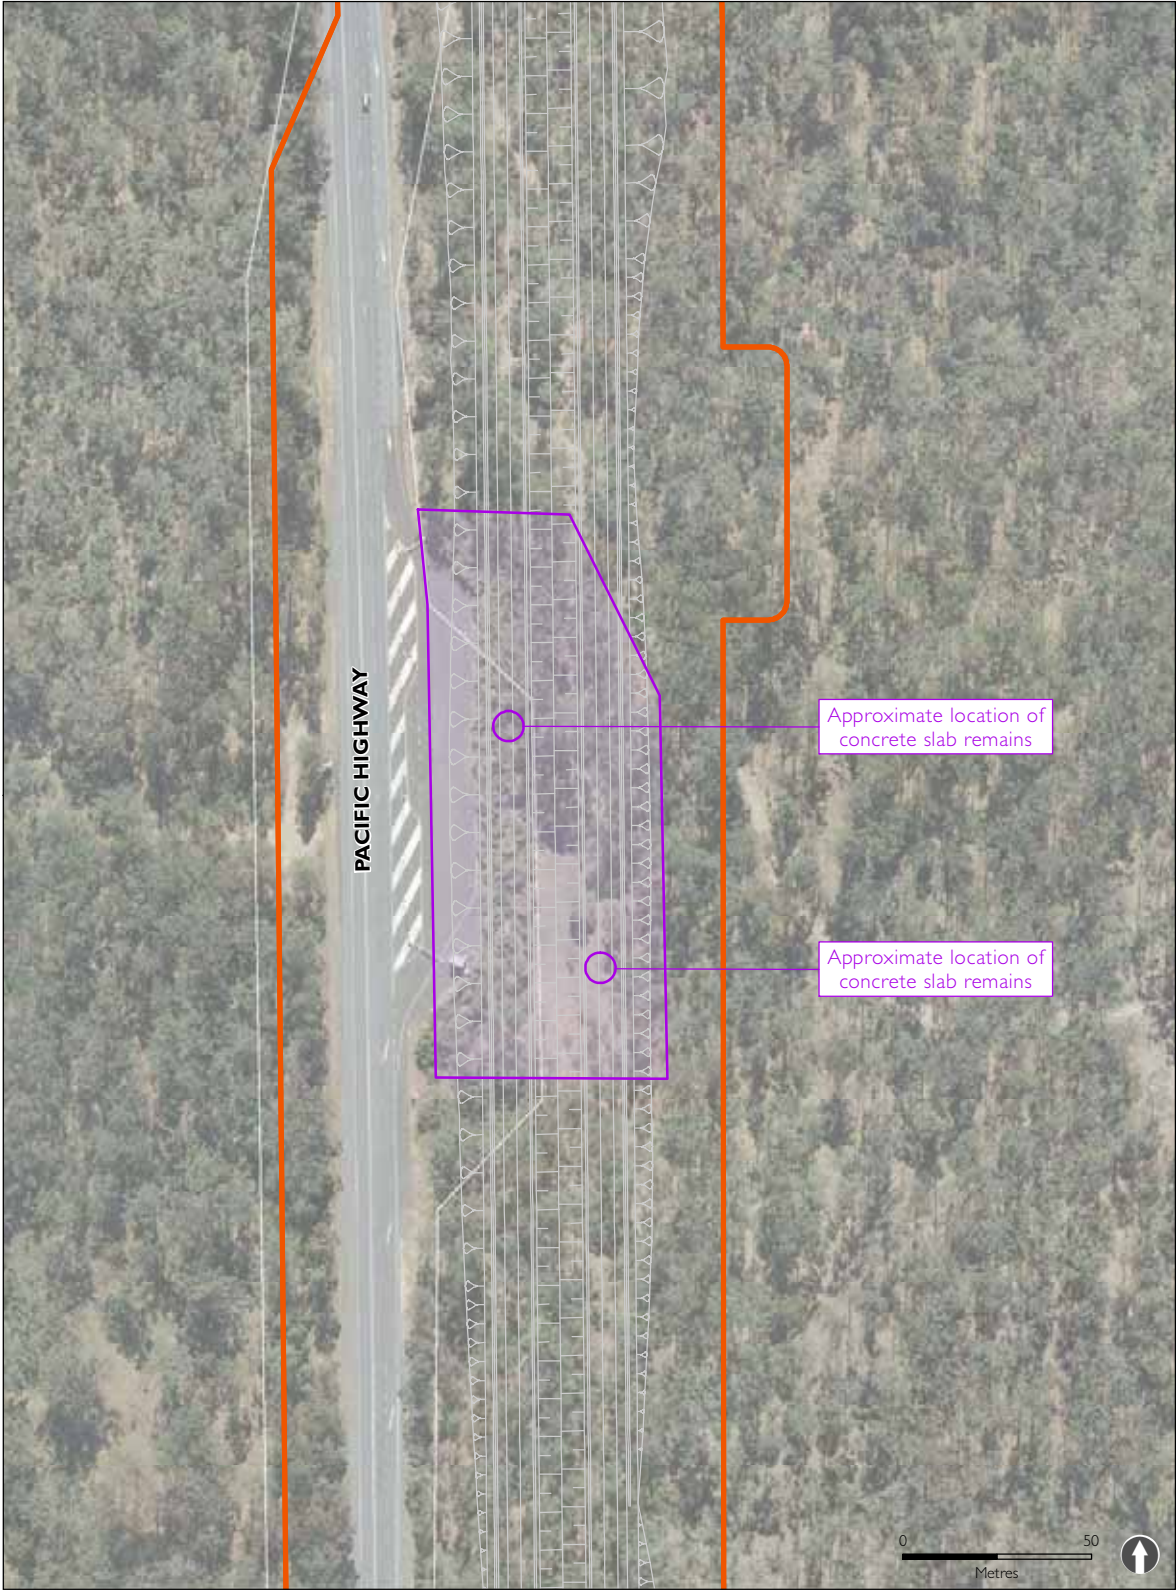
Figure 7-147 Original curtilage of heritage item number 35, Six Mile Tick Gate Remains, Glenugie

The original curtilage of the Six Mile Tick Gate Remains identified in 2007 included all physical evidence described above and is shown on Figure 7-147. The remains still in existence on the site are situated in the eastern half of the curtilage, east of the paved vehicle inspection area and associated planting.

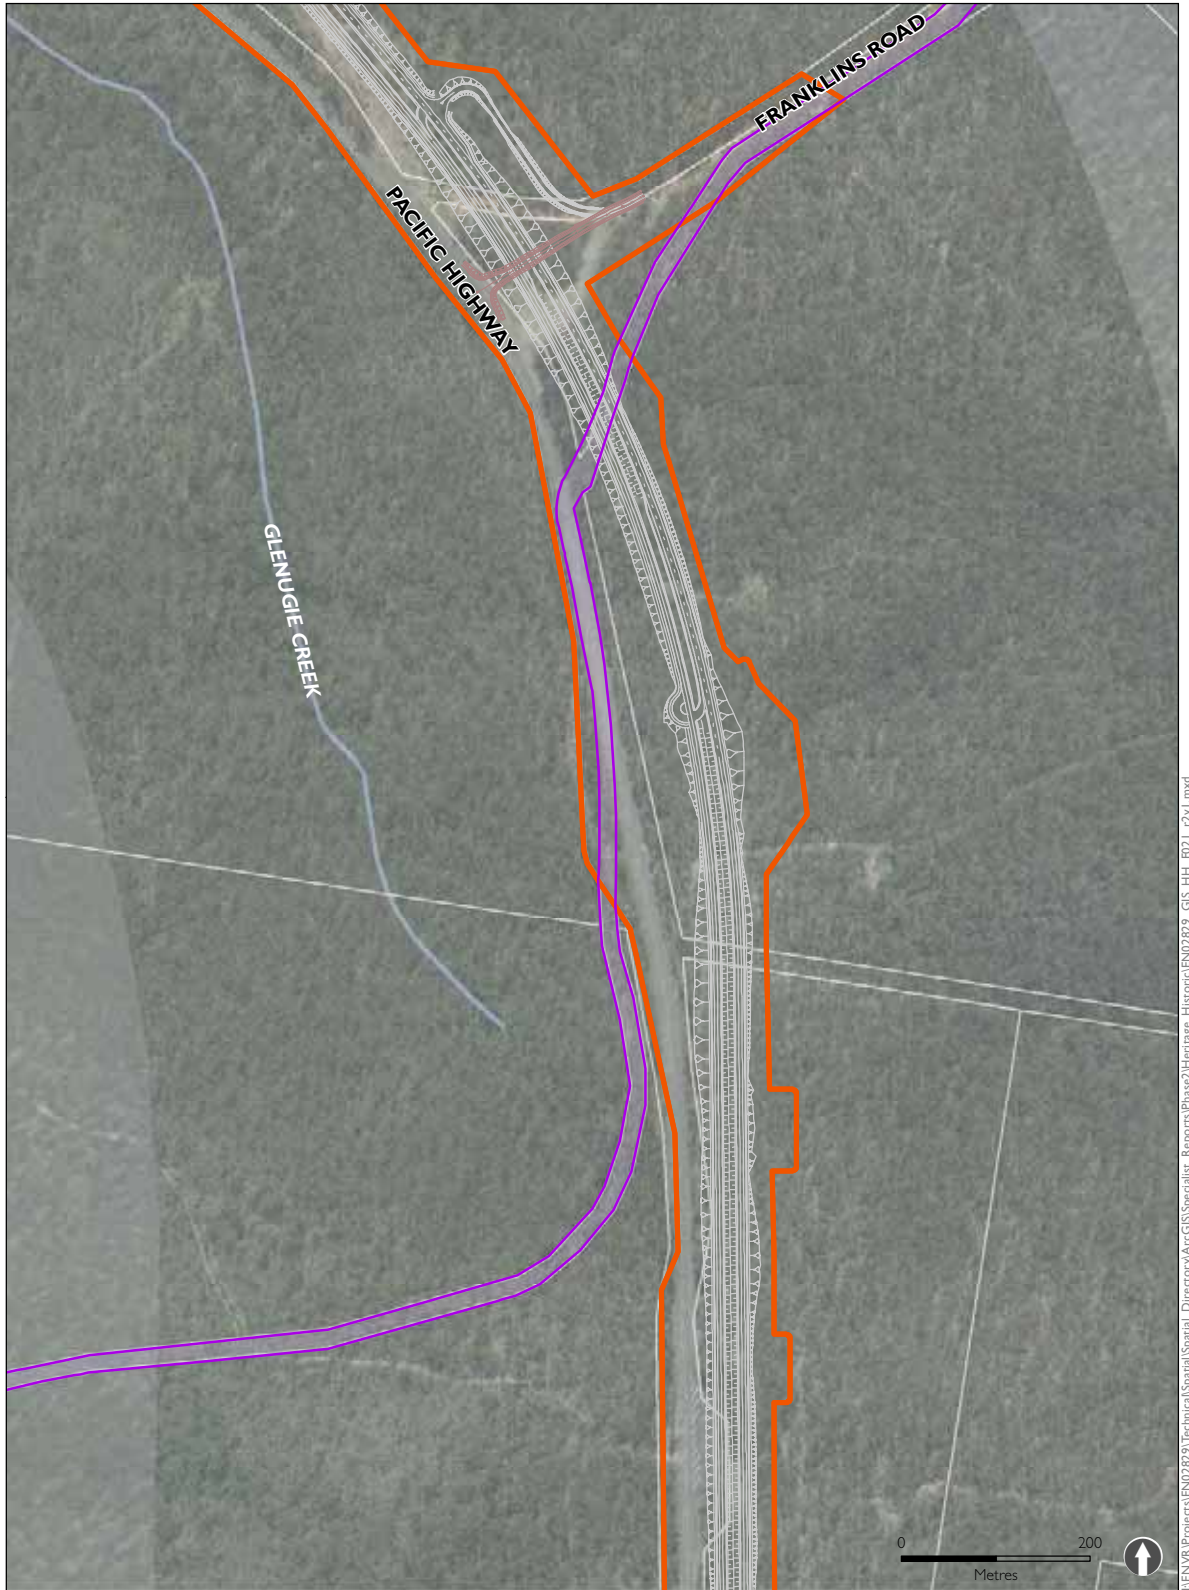
Figure 7-151 Curtilage of heritage item number 36, North Coast Railway Branch Tramway, Glenugie

The curtilage of the North Coast Railway Branch Tramway is the entire alignment from Glenugie Peak to the North Coast Railway line (Figure 7-148). Detail of the curtilage in relation to the Woolgoolga to Ballina Pacific Highway Upgrade Project is shown in Figure 7-151.
