4.10. Mororo Creek

4.10.2. Existing flooding behaviour

4.10.3. Geomorphic characteristics

Upgrading the Pacific Highway - Woolgoolga to Ballina Upgrade

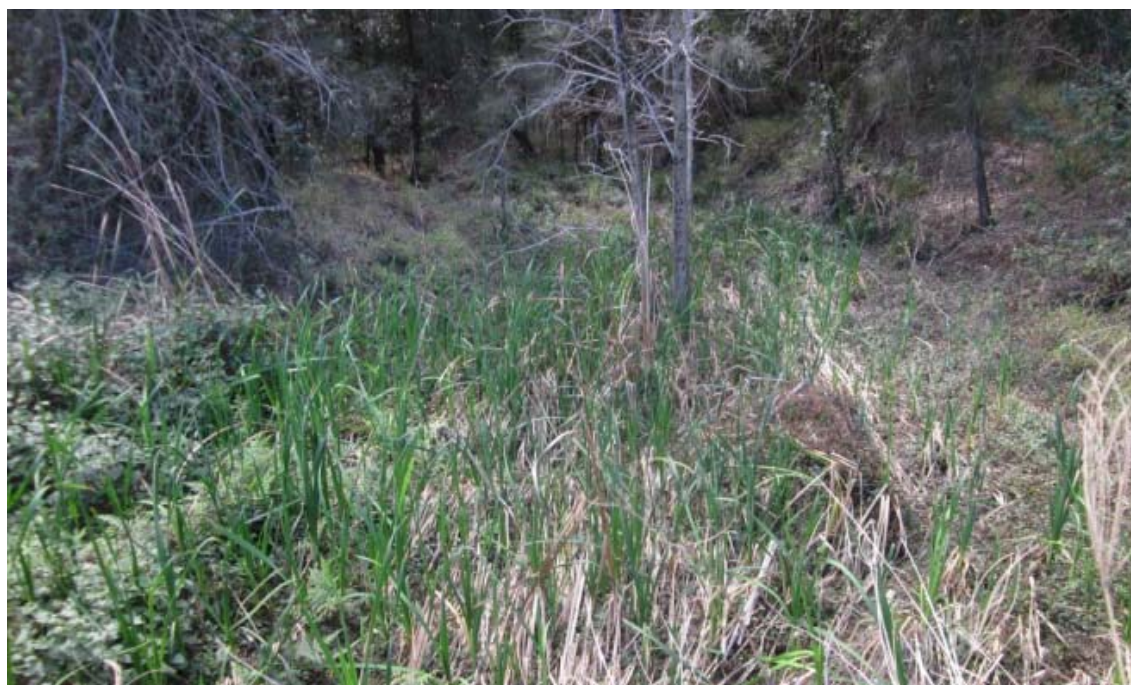
Plate 4-18 Mororo Creek tributary looking upstream

Two of these tributaries are assessed and defined as drainage lines or depressions with stable and well-vegetated banks. The tributaries are shallow, ephemeral and consist of unconnected pools of water.

Plate 4-18 shows a photograph of one of the Mororo Creek tributaries within 100 metres of the project crossing.

- Bank slumping due to floodplain saturation may occur in all flood events
- For flood events greater than two year ARI, localised channel erosion and slumping may occur
- For events greater than 20 year ARI bank erosion causing channel change is possible.

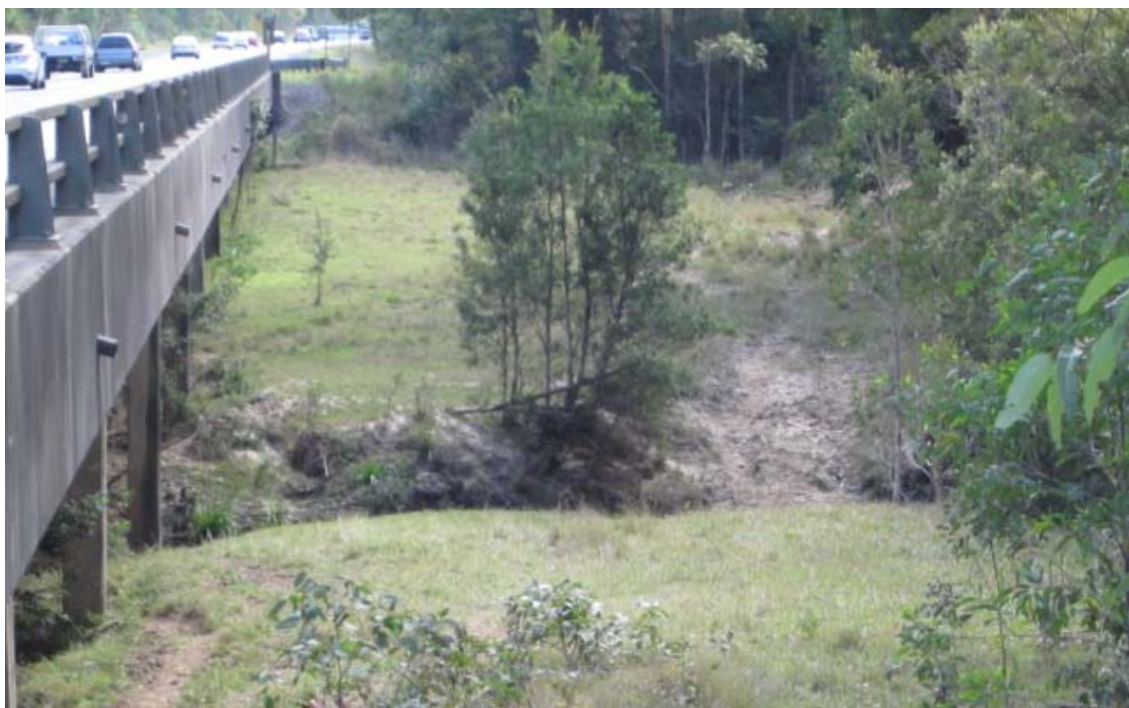
Plate 4-19 Tabbimoble Creek at the existing Pacific Highway looking downstream (left to right)

Tabbimoble Creek may be defined as a partially confined creek. These waterways are relatively stable and likely to be stabilised by rock bars and valley margins. These are assisting in providing a stable stream environment. The adjacent land generally comprises forested valley floors and flats, and alluvial flood plain. These waterways tend to have deeper channels and higher banks, and tend to be confined due to geological features such as bedrock and less erodible banks.

Plate 4-19 shows Tabbimoble Creek within 100 metres of the project crossing.

These streams are well-vegetated and it is unlikely bed deepening will occur. Localised bank erosion may occur in events of the order two year ARI or greater. During events greater than 20 year ARI bank erosion causing channel change is possible.

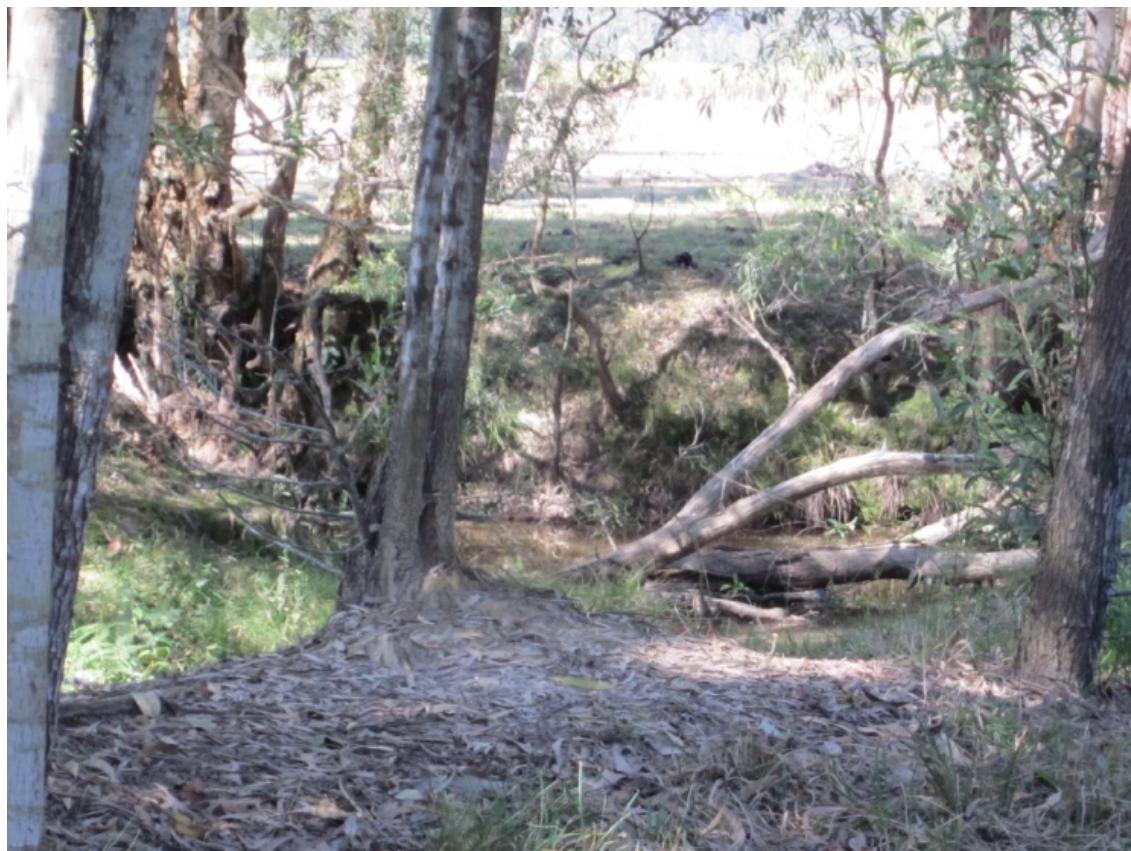
Plate 4-20 Tabbimoble overflow looking downstream (right to left)

The overflow channel of Tabbimoble Creek may be defined as a minor waterway. Erosion tends to be prevalent in minor waterways due to their deeper and narrower channels, which have resulted from bed and bank erosion or slumping at this location. This debris may reinforce the stability of the channel.

Plate 4-20 shows Tabbimoble overflow within 100 metres of the project crossing.

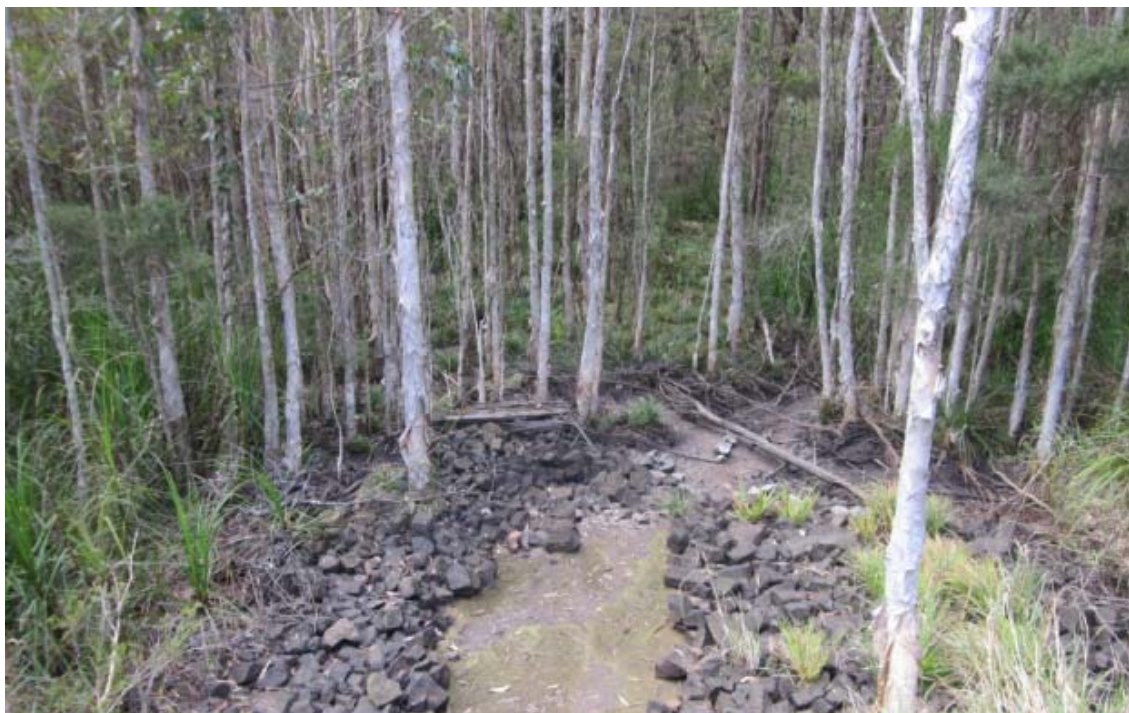
Plate 4-21 Photograph of Tabbimoble Creek tributary looking downstream

The tributary of Tabbimoble Creek appears to be a culvert outlet. It appears that there has been past erosion issues at this site due to the presence of dumped rock near the culvert apron. During the site visit there was evidence of the build up of silt at the culvert apron.

Plate 4-21 shows Tabbimoble Creek tributary within 100 metres of the project crossing.

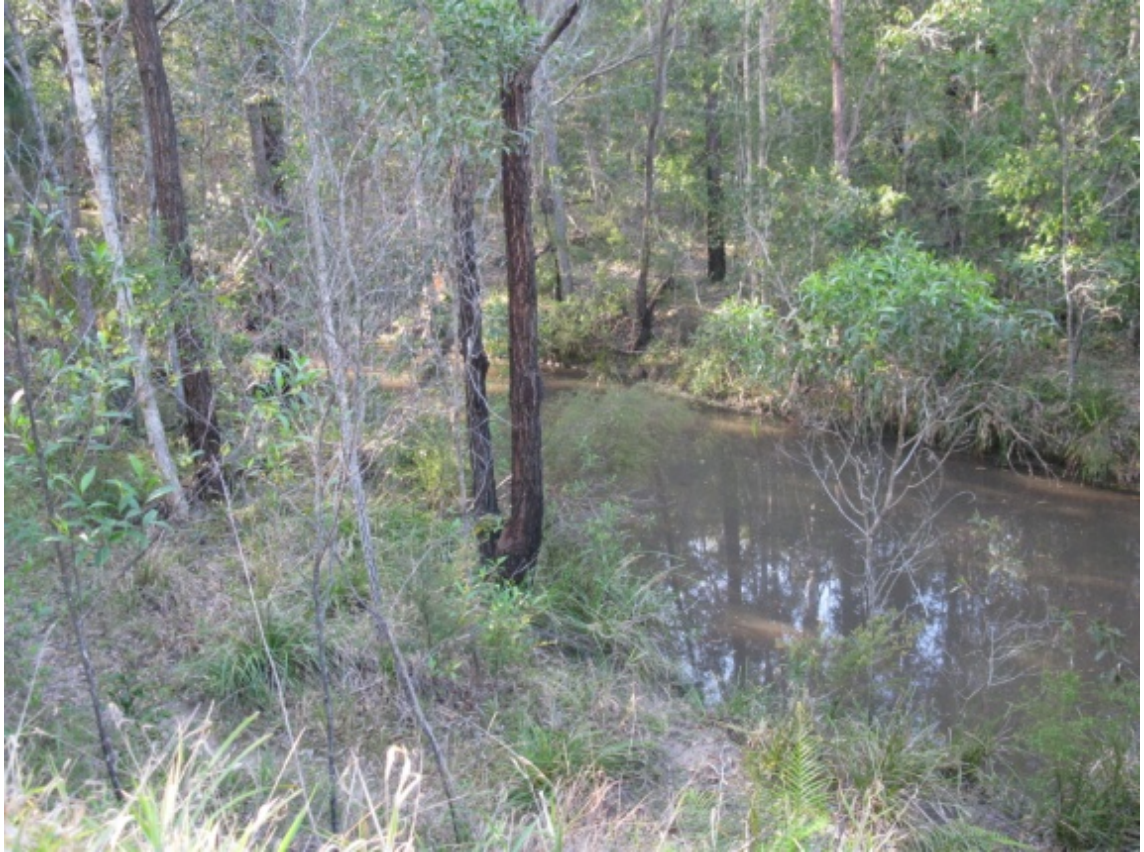
Plate 4-22 Tabbimoble Floodway No. 1

Tabbimoble Floodway No. 1 is defined as an unconfined minor gully. Based on Plate 4-22, the banks of the floodway appear stable.

Plate 4-22 shows Tabbimoble Floodway No. 1 within 100 metres of the project crossing.

- Bank slumping due to floodplain saturation may occur in all flood events
- For flood events greater than two year ARI, localised channel erosion and slumping may occur
- For events greater than 20 year ARI bank erosion causing channel change is possible.

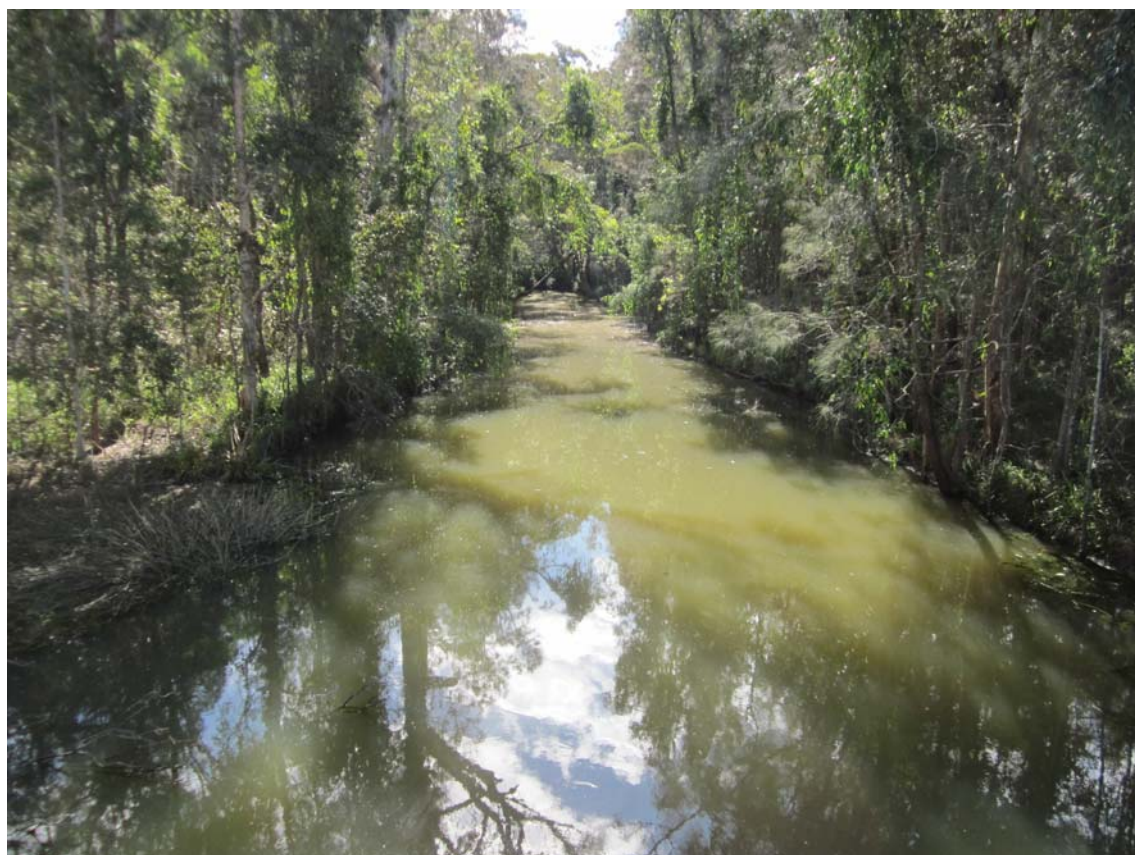
Plate 4-23 Oakey Creek looking downstream

The main crossing of Oakey Creek is a densely forested alluvial stream. The forested waterway is well vegetated with good cover of native trees and shrubs. Oakey Creek is shown in Plate 4-23, within 100 metres of the project crossing.

- Bank slumping due to floodplain saturation may occur in all flood events
- For flood events greater than two year ARI (minor drainage paths) or five year ARI (Oakey Creek), localised channel erosion and slumping may occur
- For events greater than 20 year ARI bank erosion causing channel change is possible.

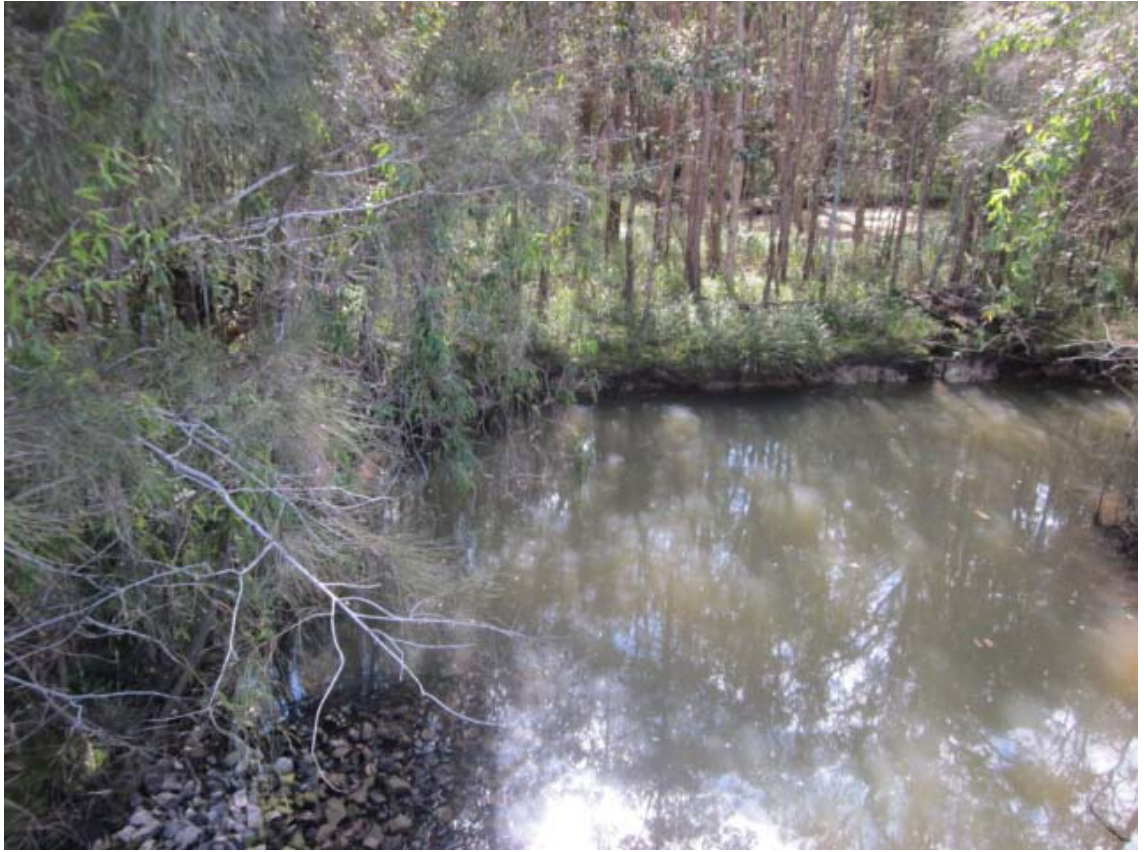
Plate 4-24 Oakey Creek Tributary 1 looking downstream

The two tributaries of Oakey Creek (Plate 4-24 and Plate 4-25) show minor drainage paths. Minor drainage paths are typically situated within both public and private lands. The adjacent land is often roadside or drainage lines through agricultural lands. These waterways tend to have vegetated banks, often with a high weed component. However, one of the tributaries has steep, incised banks with little underlying vegetation.

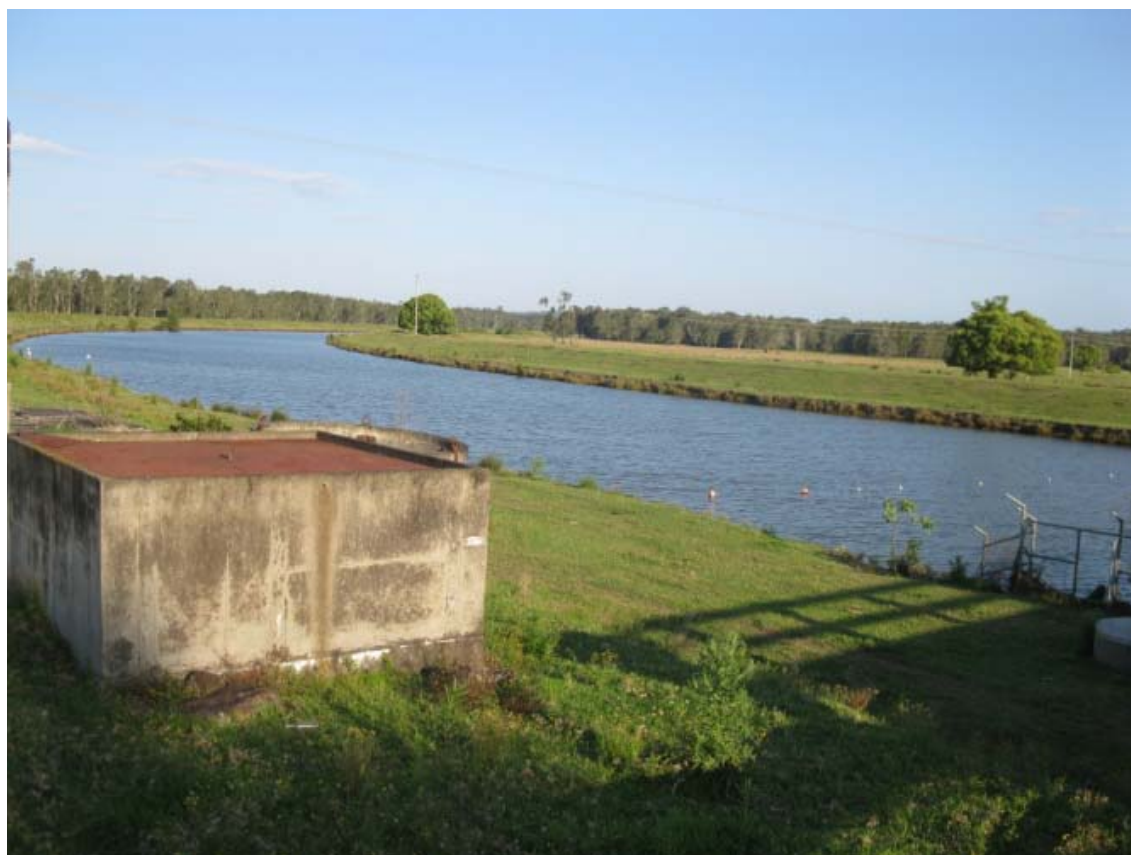
Plate 4-26 Tuckombil Canal looking downstream

This waterway tends to be very sparsely vegetated, comprising mainly grasses and weeds, with very little overstorey growth. The channel has been heavily modified to improve drainage.

Plate 4-27 shows Tuckombil Canal looking downstream at the project crossing. There is a concrete weir immediately (five metres) downstream of the existing Pacific Highway bridge, which is unable to be seen in this photograph. The weir prevents saltwater intrusion for agricultural extractions from the waterway.

Erosion could occur on the canal when saturation of the floodplain causes slumping.

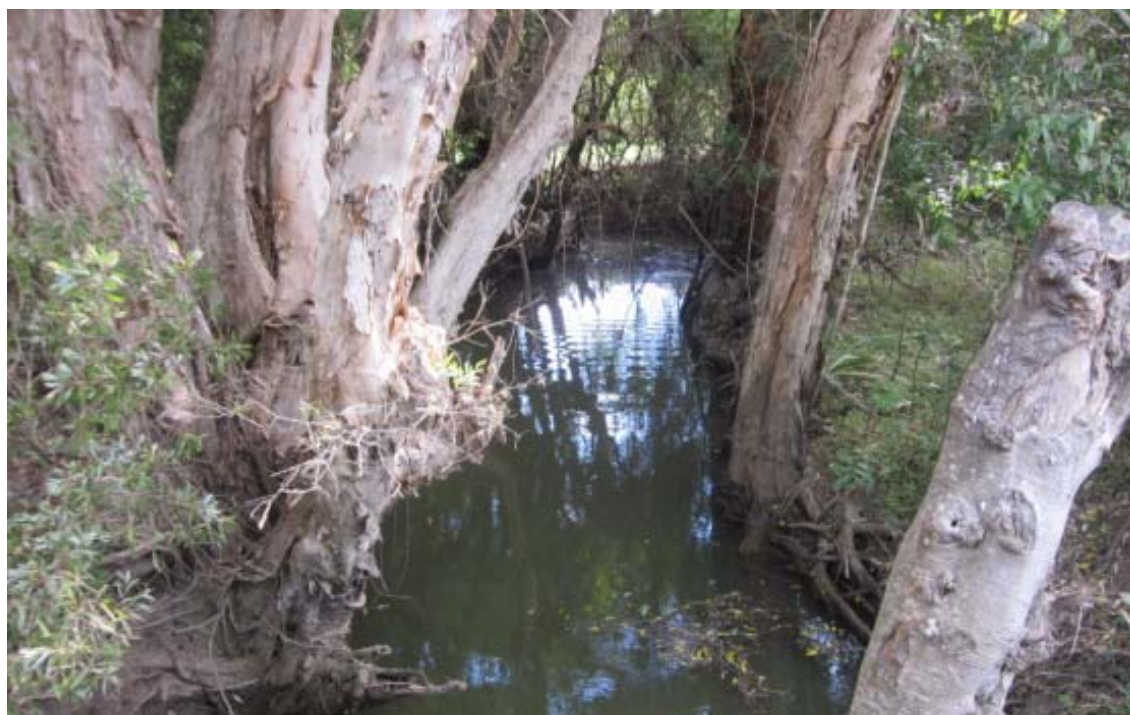
Plate 4-27 McDonalds Creek looking upstream

The creek is well-vegetated with good stands of native trees and shrubs growing along the edges and vicinity, which contributes to river health and the stability of banks.

Plate 4-27 shows McDonalds Creek near the existing Pacific Highway crossing, about one kilometre south-west of the project crossing.

This creek is likely to engage with the floodplain in relatively small flow events. To instigate a change in channel form or for considerable erosion to occur, McDonalds Creek would need to experience flooding of the order two year ARI or greater.

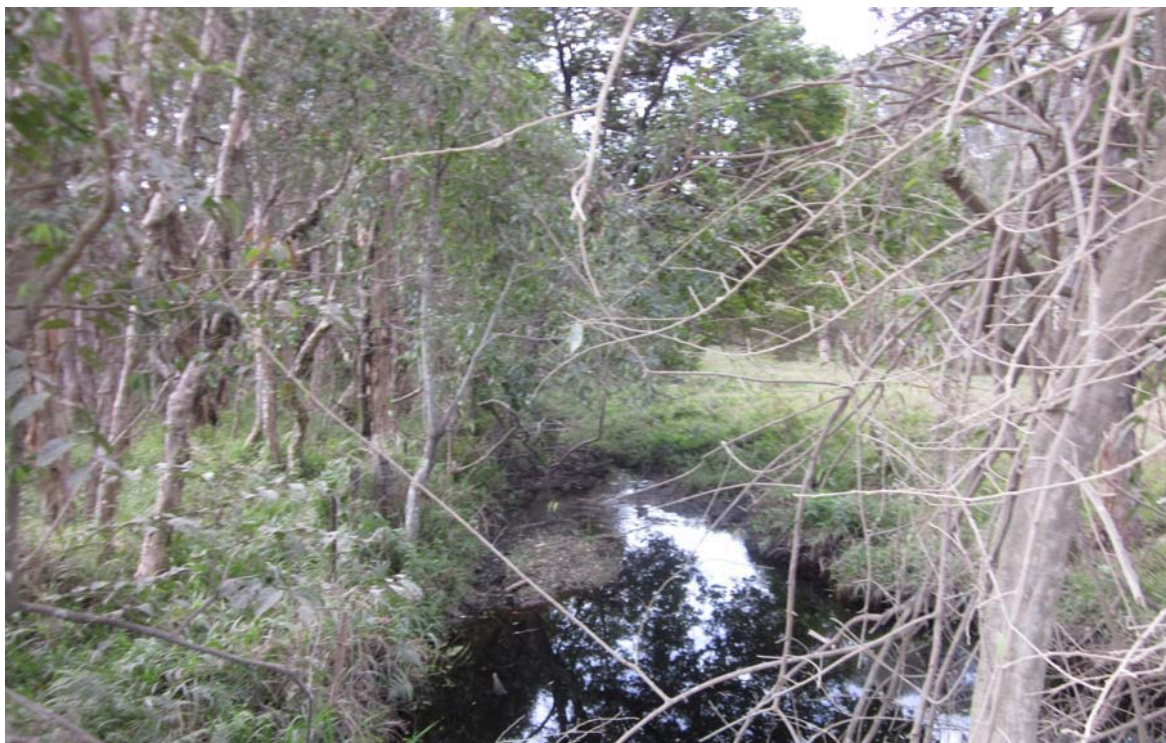
Plate 4-28 Eversons Creek looking downstream

The creek is well-vegetated with good stands of native trees and shrubs growing along the edges and vicinity, which contributes to river health and the stability of banks.

The project embankment does not cross Eversons Creek, but does encroach significantly on the waterway. Plate 4-28 shows Eversons Creek about 100 metres south of where the creek enters the project boundary.

This creek is likely to engage with the floodplain in relatively small flow events. To instigate a change in channel form or for considerable erosion to occur, Eversons Creek would need to experience flooding of the order two year ARI or greater.

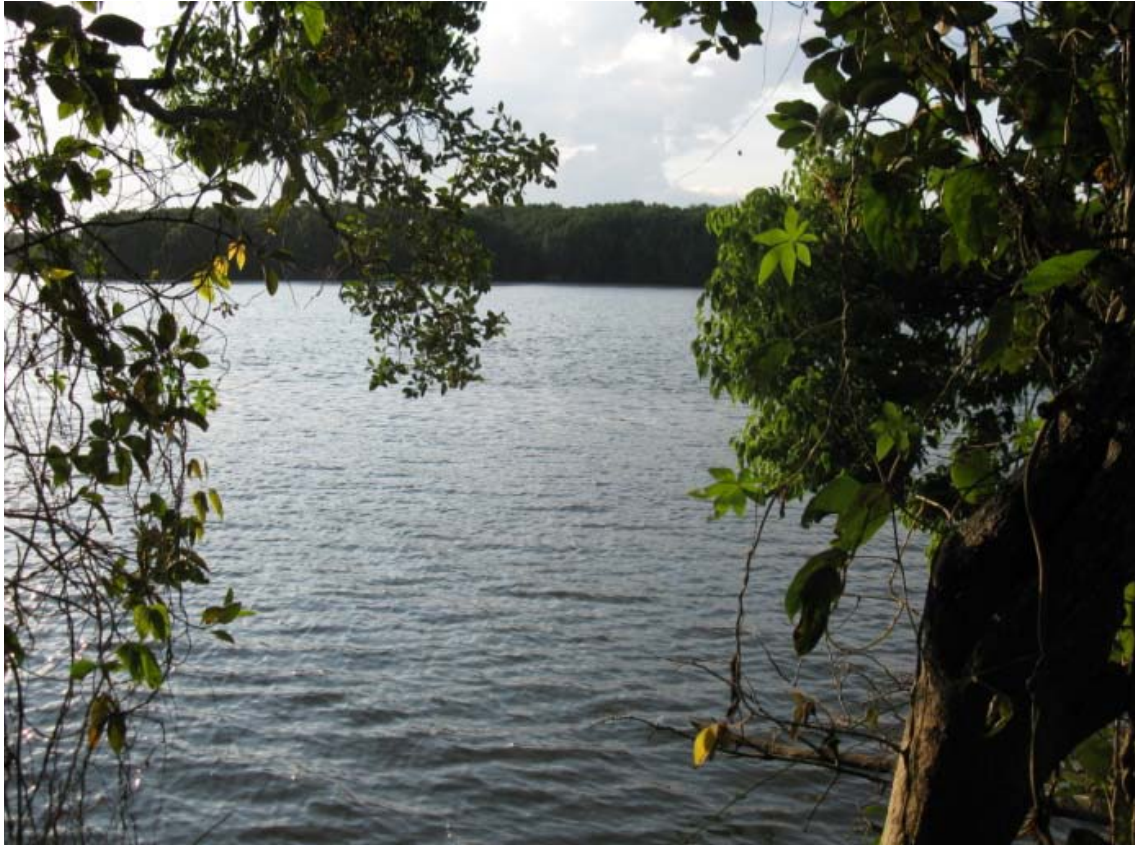
Plate 4-29 Mid Richmond River near Broadwater

The waterway appears stable, however may have the potential for later erosion or potentially slumping. There are generally narrow strips and pockets of native vegetation along the edges of the waterway which contribute to river health and the stability of banks.

Plate 4-29 shows the Richmond River near Broadwater, about 1.5 kilometres upstream of the project crossing.

- Bank slumping due to floodplain saturation may occur in all flood events
- For flood events greater than five year ARI, localised channel erosion and slumping may occur
- For events greater than 20 year ARI bank erosion causing channel change is possible.
