Oxley Highway to Kempsey

EPBC 2012/6518

Condition 8 Annual Report 2019

Roads and Maritime Services | October 2019

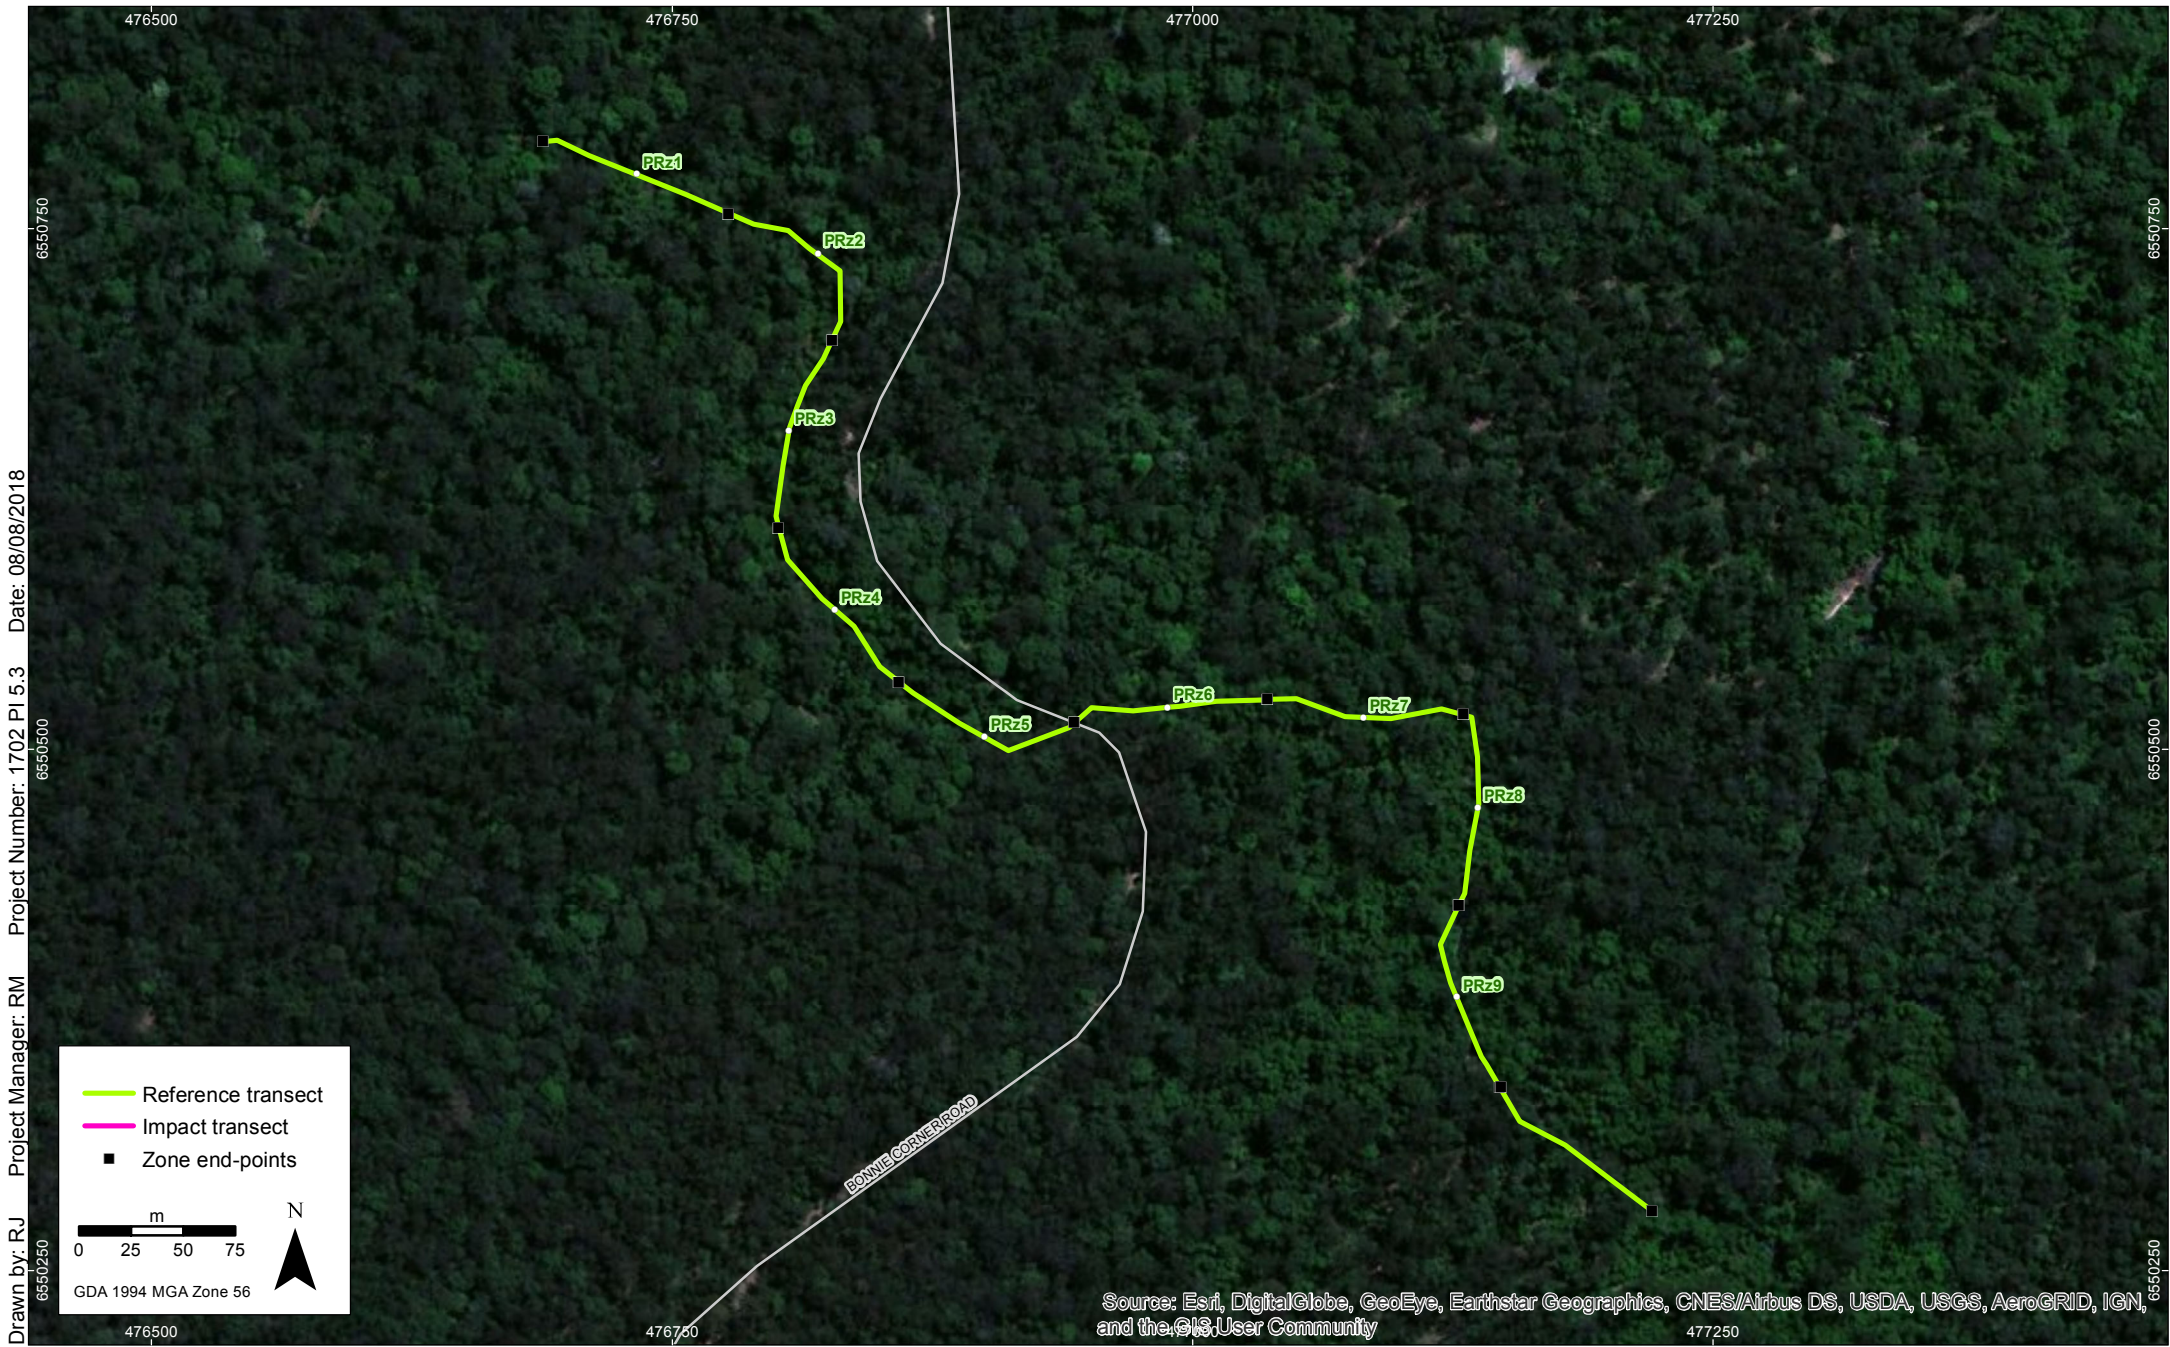
Giant Barred Frog monitoring: Pipers Creek reference site
Pacific Highway Upgrade - Oxley Highway to Kempsey

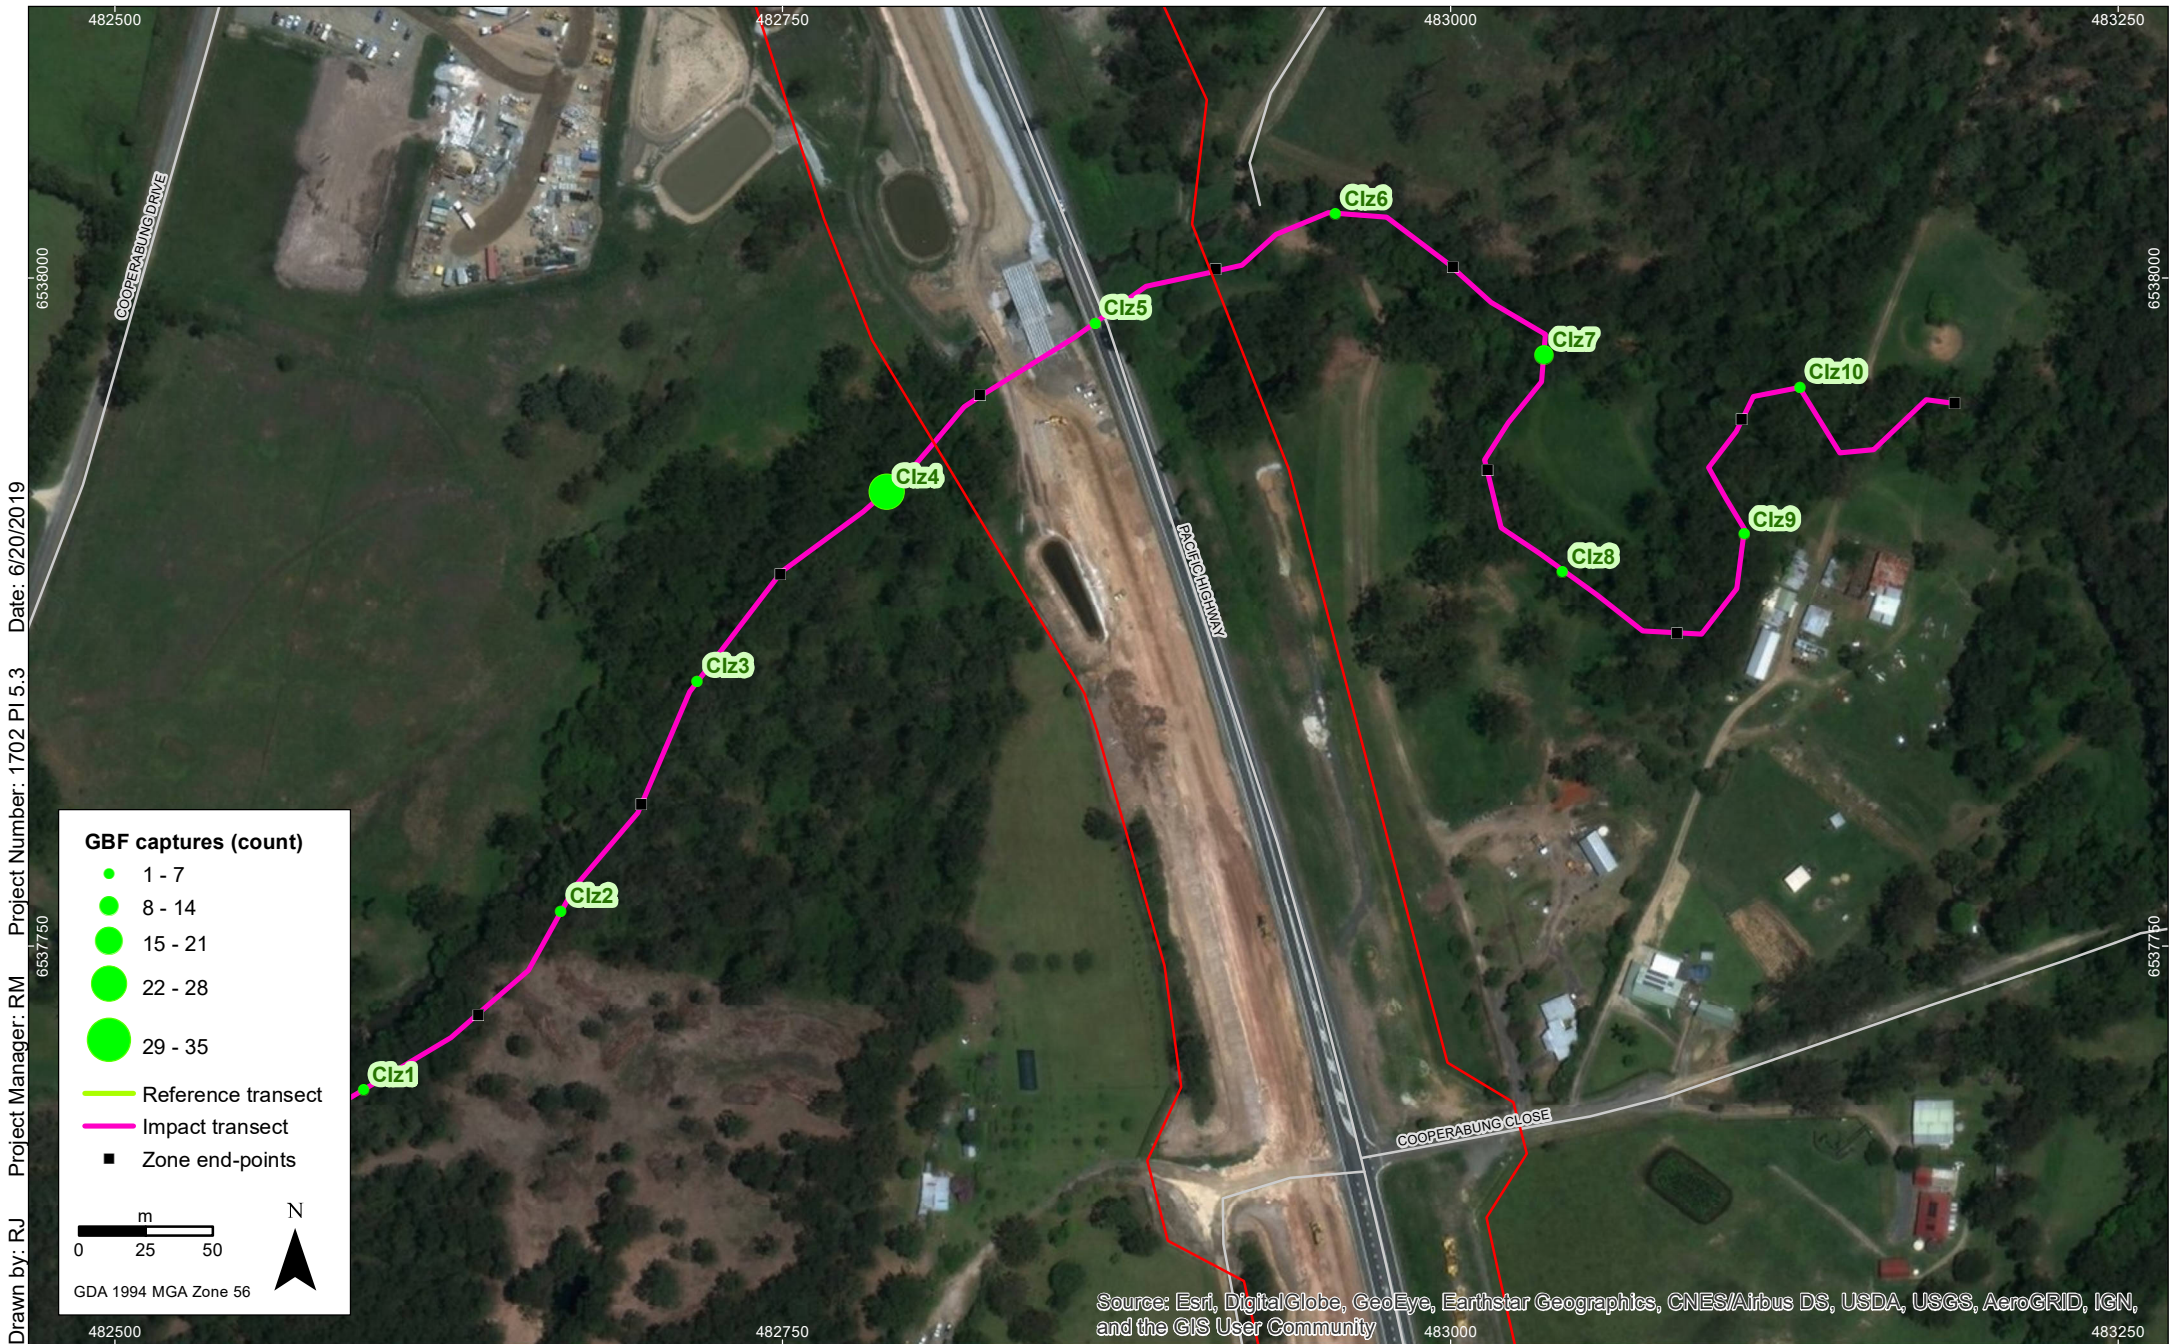
Figure 8 - Figure 13 show all capture records (i.e. cumulative records), whereby capture records (including recaptures) are shown as count ranges, where larger circles indicate larger frog counts. While density data indicates that frog distribution along the transects varies from year to year, when considering all years, frogs mostly appear to be using the entire length of the transect and there is no evidence of frogs being recorded only in one particular zone. In addition, there is no evidence of frogs being absent from zones 5 and 6. While capture frequencies within zones directly under the carriageway consistently fall into the lower range category (1-7 frogs), the low capture frequency range occurs regularly along the transects and at all sites.
