Annual Ecological Monitoring Report

**2015/2016 – Oxley Highway to Kempsey, Pacific Highway
Upgrade**

Prepared for Roads and Maritime Services

December 2016

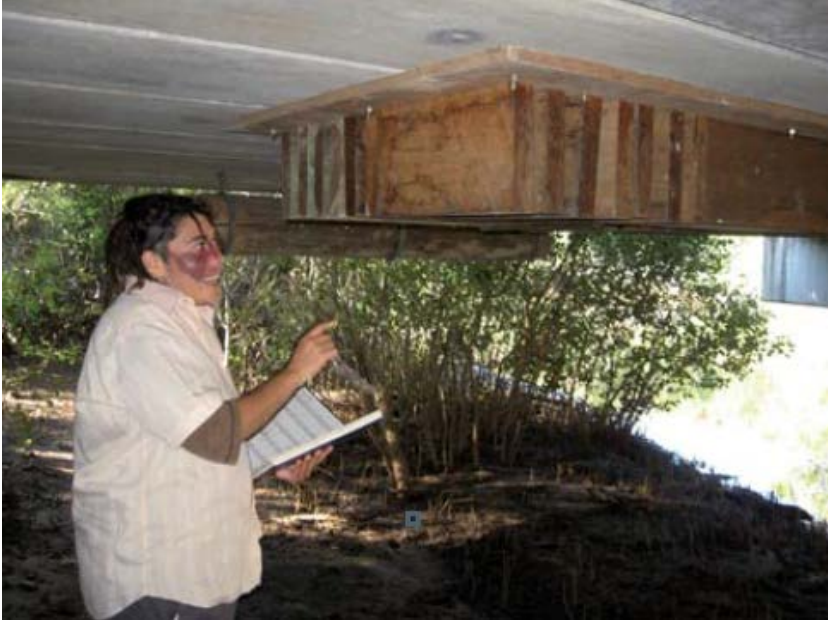
Plate 1: Artificial roost for *Myotis macropus* under bridge at Kioloa Beach NSW. Photo from Marshall (2011).

A comprehensive literature review revealed that Southern Myotis (*Myotis macropus*) have been recorded in timber roost boxes previously, but only if located directly above a water body. The Little Bent-wing Bat (*Miniopterus australis*), Eastern Bent-wing Bat (*Miniopterus schreibersii oceanensis*) and Eastern Horseshoe Bat (*Rhinolophus megaphyllus*) are all cave dwelling bat species. In particular, the Little Bent-wing Bat and Eastern Bent-wing Bat have been found roosting in structures such as caves, tunnels, culverts and bridges, but never in timber boxes (Rueeger 2016, Rhodes and Darry 2011, Van Dyck and Strahan 2008, and Churchill 2008). Based on this information, it is unlikely that the target species will utilise the current roost boxes installed.

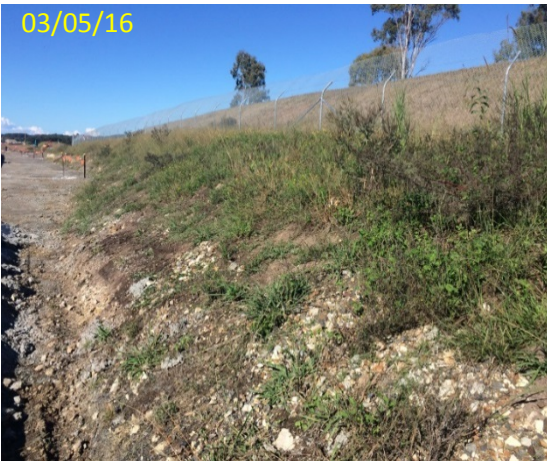
Cut 6	SB	Native Grasses	Hydromulch Woodfibre	Jul-2015	Poor	Poor cover crop, occasional native	Poor, occasional native	Weed treatment, retopsoil and re spray following verge placement.

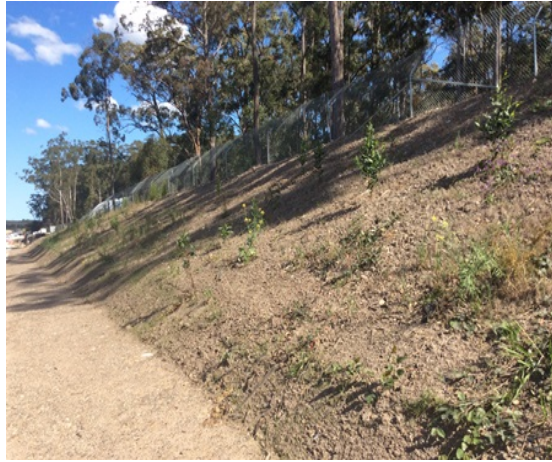
General Location	Specific Location	Vegetation Community Type	Treatment	Date of Sowing	Cover crop Strike at time of sowing.	Revegetation Performance After 2 Months of Sowing	Native Seed Strike	Actions to Reach Performance Criteria	Photograph
Fill 6	NB	Frangible Shrubs/Native Grasses	Hydromulch Woodfibre	Jul-2015	Good	Good cover crop. Some emerging natives.	NA - good natives at base but restart 8 month period due to extensive rework post verge placement.		
Fill 6	SB	Native Grasses	Hydromulch Woodfibre	Jul-2015/Aug-2016	Good	Good cover crop. No natives as yet - Jul 15.	NA - good natives at base but restart 8 month period due to extensive rework post verge placement.		
Cut 7	NB	Frangible Shrubs	Hydromulch Woodfibre	Jul-2015	Average	Average cover crop, some natives.	Good in patches, minimal weeds.	Watch and act.

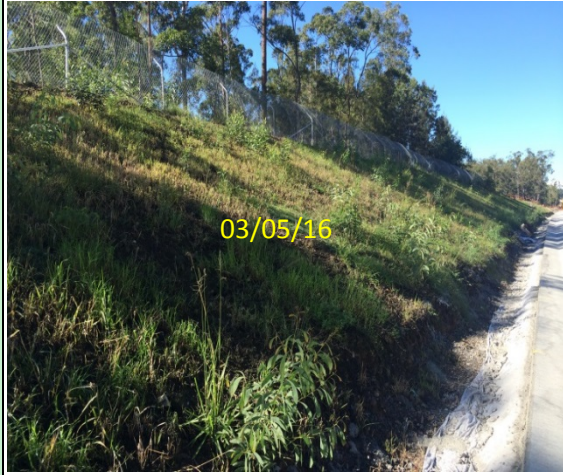
Fill 7	NB	Frangible Shrubs/Native Grasses	Hydromulch Woodfibre	Jul-2015	Average	Poor	Small fill, restart 8 months when verge completed and re topsoiled.

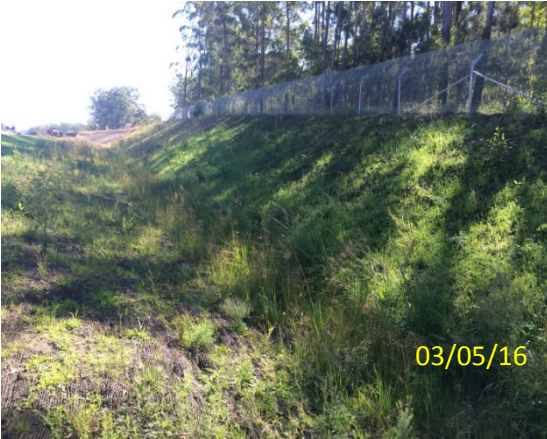
General Location	Specific Location	Vegetation Community Type	Treatment	Date of Sowing	Cover crop Strike at time of sowing.	Revegetation Performance After 2 Months of Sowing	Native Seed Strike	Actions to Reach Performance Criteria	Photograph
Cut 8	SB	Tall shrubs/Fragible Shrubs	Hydromulch Woodfibre	Jul-2015	Patchy	Average cover crop, some natives.	Good native diversity, a few weeds.	Watch and act, may need to spray weeds.

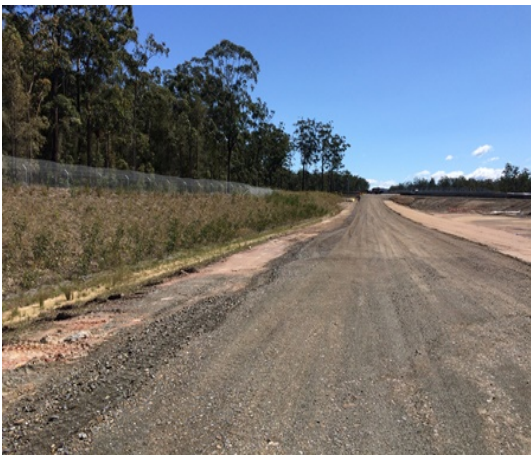
B0778L	NB	Tall Shrubs	Hydromulch Woodfibre	Sep-2015	Good cover	Good cover crop. No natives.	Poor. Scattered natives but dense grass cover.	Watch and act.

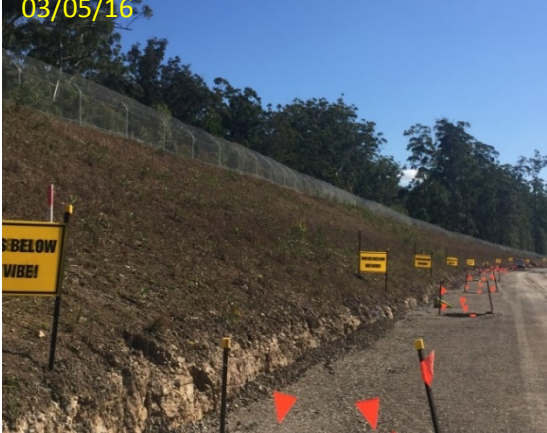
General Location	Specific Location	Vegetation Community Type	Treatment	Date of Sowing	Cover crop Strike at time of sowing.	Revegetation Performance After 2 Months of Sowing	Native Seed Strike	Actions to Reach Performance Criteria	Photograph
Fill 10	SB	Tall shrubs/Native Grasses	Hydromulch Woodfibre	aug-2015	Patchy	Poor		Rework after verge placement.	
Cut 11	NB	Frangible Shrubs	Hydromulch Woodfibre	Nov-2015	Patchy	Patchy cover crop strike. Some native strike.	Good native distribution, should achieve target.	Fix deep scour at southern end, find source.	<p>03/05/16</p>

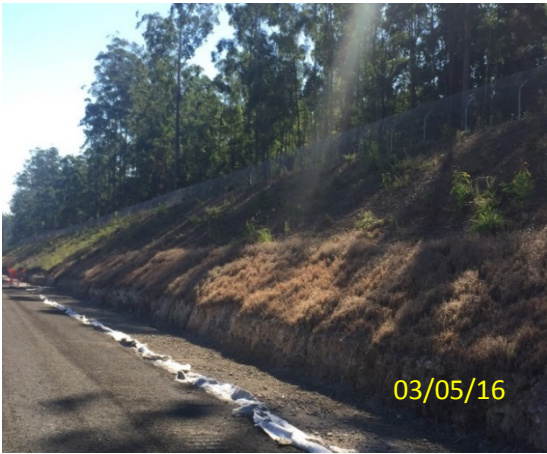
Cut 11	Centre	Tall shrubs/Fragible Shrubs	Hydromulch Woodfibre	sep-2015 (only eastern side, northern most corner)	Good 60%	Good cover crop with some natives.	scattered natives, small section of batter only though. Restart 8 months with remainder.

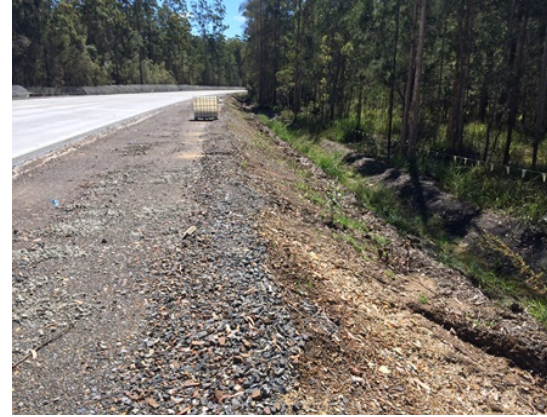
General Location	Specific Location	Vegetation Community Type	Treatment	Date of Sowing	Cover crop Strike at time of sowing.	Revegetation Performance After 2 Months of Sowing	Native Seed Strike	Actions to Reach Performance Criteria	Photograph
Fill 11	NB	Native Grasses	Hydromulch Woodfibre	Nov-2015	Patchy 40%	Poor	Extremely shallow batter.

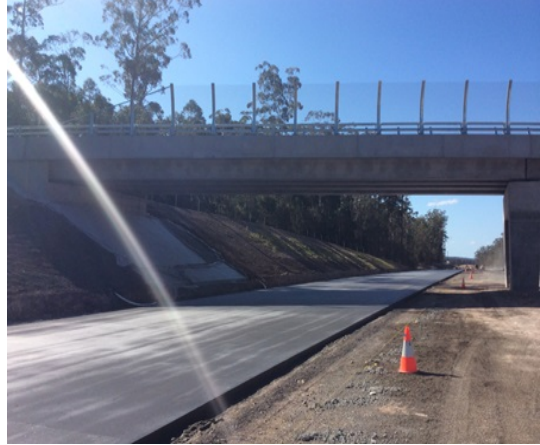
General Location	Specific Location	Vegetation Community Type	Treatment	Date of Sowing	Cover crop Strike at time of sowing.	Revegetation Performance After 2 Months of Sowing	Native Seed Strike	Actions to Reach Performance Criteria	Photograph
Cut 12	NB	Tall shrubs/Frangible Shrubs	Hydromulch Woodfibre	Nov-2015	Good 60-70%	Good cover crop strike. No natives.	Poor native strike to date.	Watch and act. May need patchy respray.

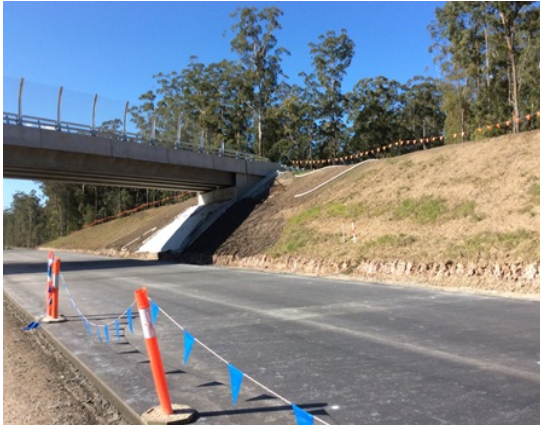
Cut 12	SB	Frangible Shrubs	Hydromulch Woodfibre	Sep-2015	Patchy 30-40%	Patchy cover crop.	scattered natives. Not great diversity.	Watch and act. Potential for re hydro seed with natives and cc only.

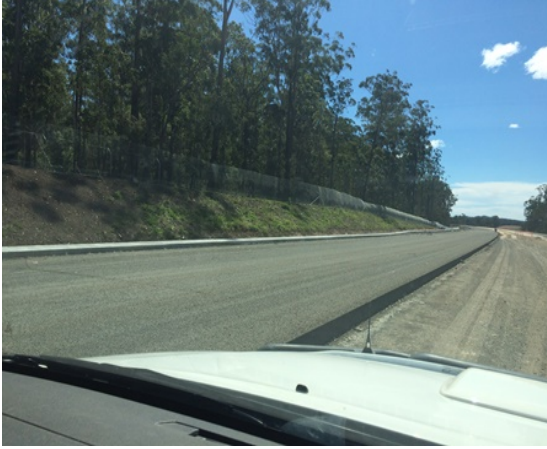
General Location	Specific Location	Vegetation Community Type	Treatment	Date of Sowing	Cover crop Strike at time of sowing.	Revegetation Performance After 2 Months of Sowing	Native Seed Strike	Actions to Reach Performance Criteria	Photograph
Cut 13	NB	Frangible Shrubs	Hydromulch Woodfibre	16 September 2015	Good at north end. South end not yet sprayed.	Good at north end	Good at north end.	Watch and act @ north end. Spray south end.

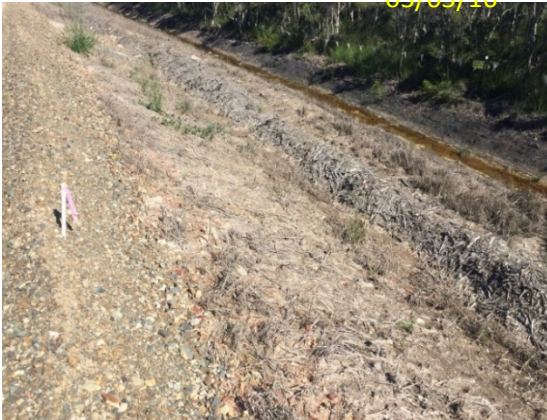
Fill 13	A	Native Grasses	Hydromulch Woodfibre	Sep-2015	Good	Good cover crop. No natives.	NB batter is patchy with poor native diversity. SB very good minimal weeds.	Watch and act.	03/05/16

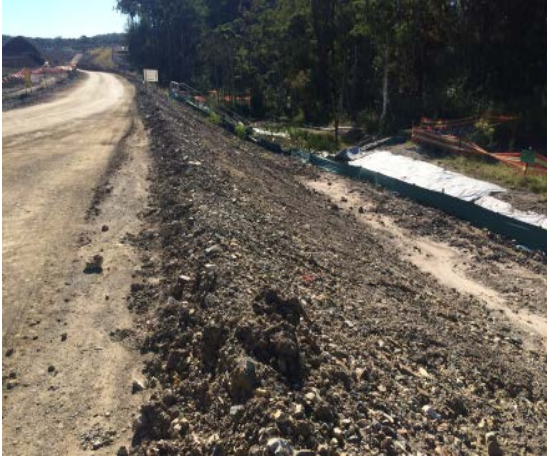
Fill 14	SB	Frangible Shrubs/Native Grasses	Hydromulch Woodfibre	Sep-2015	Poor	Poor	Restart 8 months post re topsoiling etc

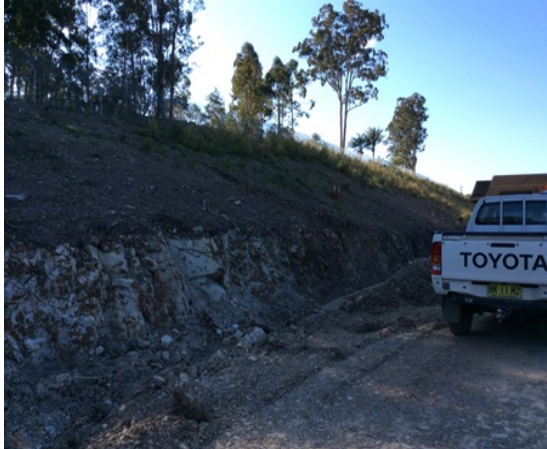
General Location	Specific Location	Vegetation Community Type	Treatment	Date of Sowing	Cover crop Strike at time of sowing.	Revegetation Performance After 2 Months of Sowing	Native Seed Strike	Actions to Reach Performance Criteria	Photograph
Cut 15	NB	Frangible Shrubs	Hydromulch Woodfibre	Nov-2015	50-70%	Reasonable strike with some natives.	Good native diversity in top 3m, stable batter. Lower sections mainly still cover crop and un treated.	Watch and act

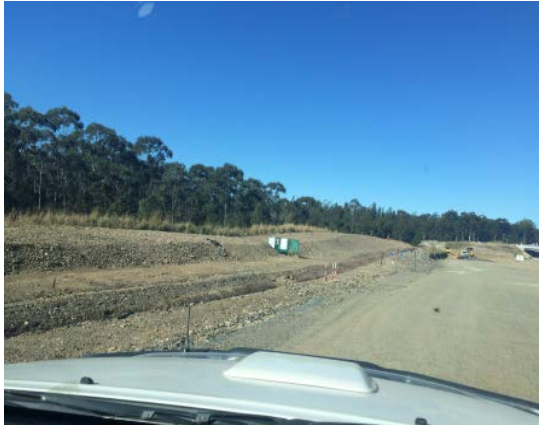
Cut 15	SB	Frangible Shrubs	Hydromulch Woodfibre	Nov-2015		Poor	Restart 8 months when finished.

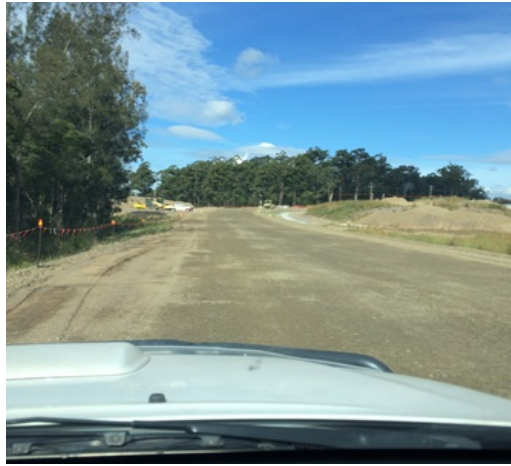
General Location	Specific Location	Vegetation Community Type	Treatment	Date of Sowing	Cover crop Strike at time of sowing.	Revegetation Performance After 2 Months of Sowing	Native Seed Strike	Actions to Reach Performance Criteria	Photograph
Fill 15	NB								
Fill 15	SB								
Haydons Wharf Interchange	East Inside	Frangible Shrubs	Hydromulch Woodfibre	November 2015	Good - 80%	Good cover crop. No natives.	Over grown with pasture grass, no natives visible. No issues with ground cover.	Potentially slash... watch and act

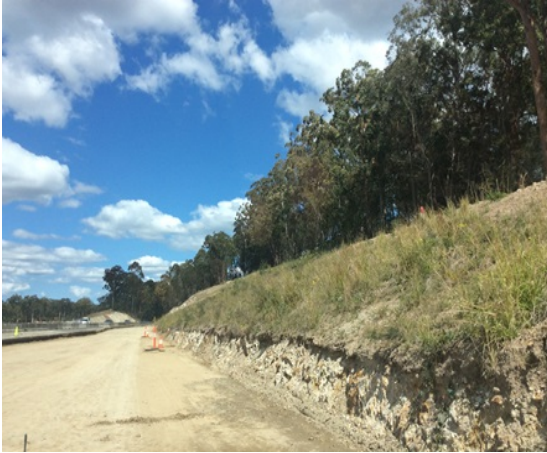
Cut 17	NB	Frangible Shrubs	Hydromulch Woodfibre	Sep-2015	Patchy	Patchy strike with no natives.	Poor native strike, but they are present with minimal weeds	Watch and act

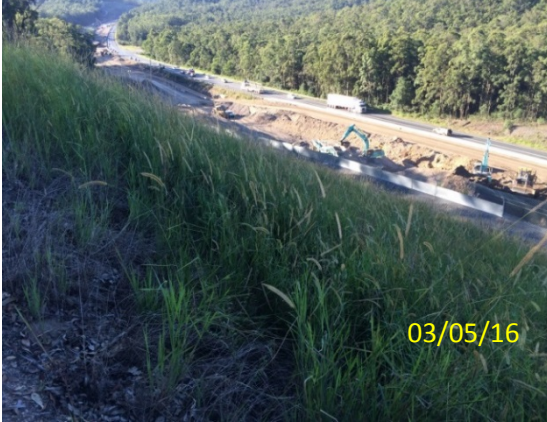
General Location	Specific Location	Vegetation Community Type	Treatment	Date of Sowing	Cover crop Strike at time of sowing.	Revegetation Performance After 2 Months of Sowing	Native Seed Strike	Actions to Reach Performance Criteria	Photograph
Cut 19A	NB	Tall shrubs/Native Grasses	Hydromulch Woodfibre	Jun-2015	Good	Good cover crop. No natives.	Restart monitoring after first inspection due to large stockpile placed against batter		
Cut19B	NB	Tall Shrubs	Hydromulch Woodfibre	Jun-2015, May-02016	Good	Good cover crop. No natives.	Dominated by long grass, scattered natives on edges.	Watch and act

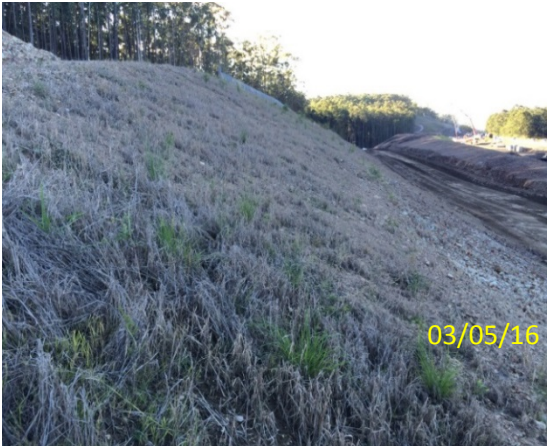
General Location	Specific Location	Vegetation Community Type	Treatment	Date of Sowing	Cover crop Strike at time of sowing.	Revegetation Performance After 2 Months of Sowing	Native Seed Strike	Actions to Reach Performance Criteria	Photograph
Fill 20	NB								
Cut 21	NB	Tall Shrubs	Hydromulch Woodfibre	15/12/2015	Good	Good cover crop. No natives.	Poor		
Fill 21	NB	Tall Shrubs		Not yet sprayed.					
Cut 22	NB	Tall Shrubs	Hydromulch Woodfibre	Sep-2015, May-2016	Poor	Poor cover crop strike. Some natives.	Good native diversity, good density in some areas. Poor ground cover.	Watch and act. Patchy respray over areas that aren't showing growth in 2 months.

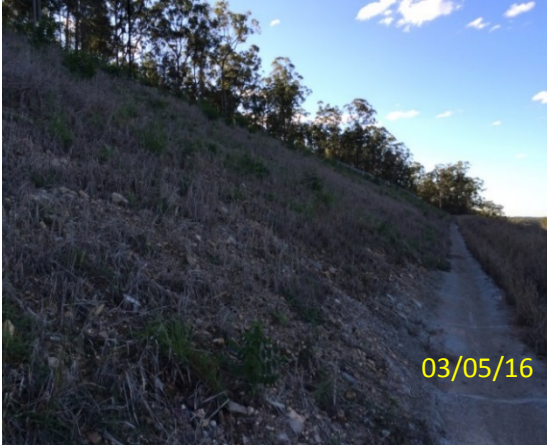
Fill 23	NB	Frangible Shrubs	Hydromulch Woodfibre	29/06/2015	Good 50-70%	Good cover crop. No natives.	Poor	Scarify and respray.

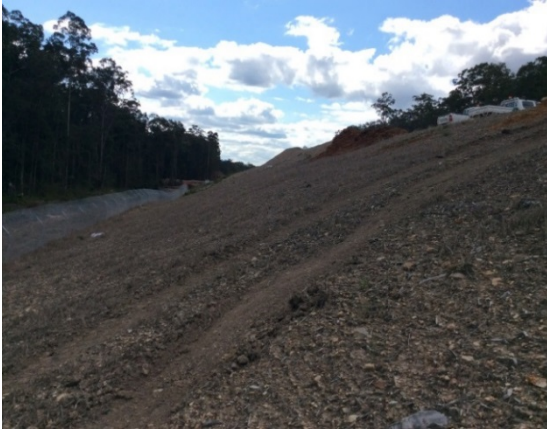
General Location	Specific Location	Vegetation Community Type	Treatment	Date of Sowing	Cover crop Strike at time of sowing.	Revegetation Performance After 2 Months of Sowing	Native Seed Strike	Actions to Reach Performance Criteria	Photograph
Fill 23	SB	Frangible Shrubs	Hydromulch Woodfibre	East (Sep-2015) Resprayed March 2016	Good 50-70%	Good cover crop. No natives.	Restart 8 months following first inspection.		 
Cut 24	SB	Tall shrubs/Frangible Shrubs	Hydromulch Woodfibre	Top (Sep-2015)	Poor - 20-50%	Poor cover crop strike. Some native strike.	Good native strike, weedy patch in lower batter	Watch and act. May need patchy re-spray and weed treatment.

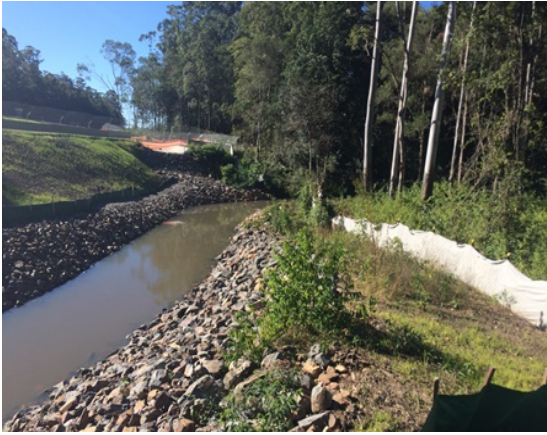
General Location	Specific Location	Vegetation Community Type	Treatment	Date of Sowing	Cover crop Strike at time of sowing.	Revegetation Performance After 2 Months of Sowing	Native Seed Strike	Actions to Reach Performance Criteria	Photograph
Fill 24	SB	Frangible Shrubs	Hydromulch Woodfibre	Sep-2015	Good	Good cover crop. Some native strike.	Some native strike.	Watch and act.

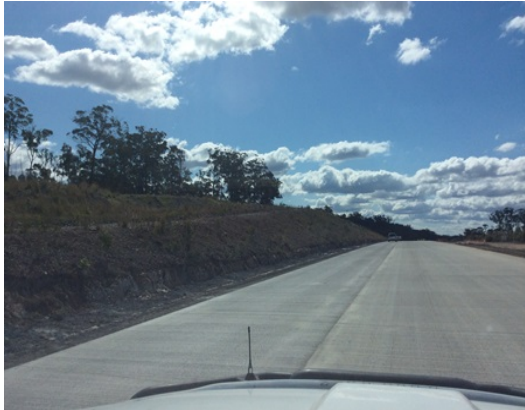
General Location	Specific Location	Vegetation Community Type	Treatment	Date of Sowing	Covercrop Strike at time of sowing	Revegetation Performance After 2 Months of Sowing	Native Seed Strike	Actions to Reach Performance Criteria	Photograph
Fill 3	NB	Native Grasses	Hydromulch Woodfibre	Feb-2016/Ma y16		Good cover crop strike. No native strike.		8 months = Oct 16.	
Cut 4	NB			Not sprayed yet.					
Fill 4	NB	Native Grasses	Hydromulch Woodfibre	Jul-2016	2 mths = good.	Good cover crop strike. No native strike.			
Fill 4	NB (sth of Sancrox Road)			Not yet sprayed.					
Cut 5	NB	Tall shrubs/Frangible Shrubs	Hydromulch Woodfibre	Aug-15 and Sep-15. Following Rework	Poor initially, resprayed and then better.	Good, lots of diversity with average heights of natives between 30-60cm.		NIL

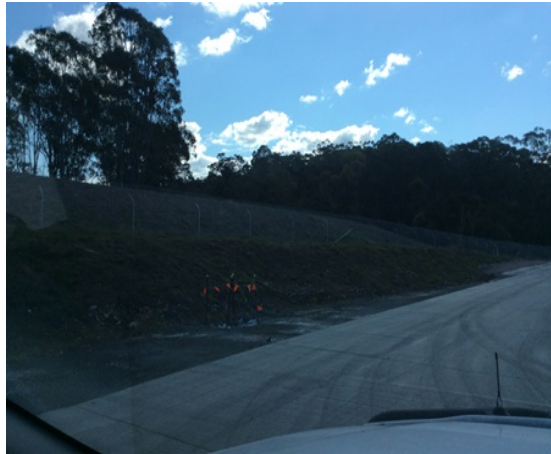
General Location	Specific Location	Vegetation Community Type	Treatment	Date of Sowing	Covercrop Strike at time of sowing	Revegetation Performance After 2 Months of Sowing	Native Seed Strike	Actions to Reach Performance Criteria	Photograph
Fill 5	B	Frangible Shrubs/Native Grasses	Hydromulch Woodfibre	Jul-2016	Not growing yet	Poor		8 mths = Mar 17	
Fill 5	C								
Fill 5	D	Pasture Grasses	Hydromulch Woodfibre	Aug-2016				8 mths = April 17	
Fill 5	E	Pasture Grasses	Hydromulch Woodfibre	Aug-2016				8 mths = April 17	
Cut 6	NB	Native Grasses	Hydromulch Woodfibre	Jul-2015	Poor	Poor cover crop, occasional native	Poor, occasional native	Weed treatment, re-topsoil and respray following verge placement. Investigate substitution of native grasses with an alternative seed mix through RFI.

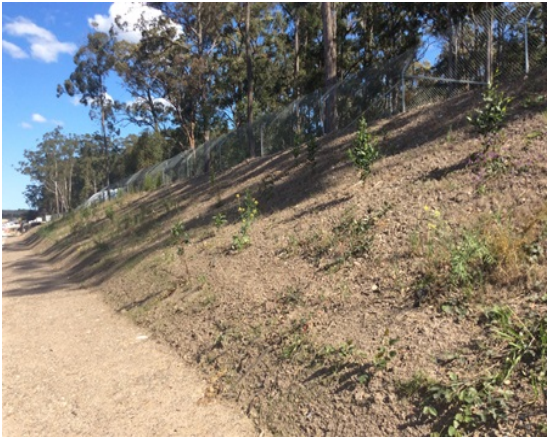
General Location	Specific Location	Vegetation Community Type	Treatment	Date of Sowing	Covercrop Strike at time of sowing	Revegetation Performance After 2 Months of Sowing	Native Seed Strike	Actions to Reach Performance Criteria	Photograph
Cut 6	SB	Native Grasses	Hydromulch Woodfibre	Jul-2015	Poor	Poor cover crop, occasional native	Poor, occasional native	Weed treatment, re-topsoil and re spray following verge placement. Investigate substitution of native grasses with an alternative seed mix through RFI.	
Fill 6	NB	Frangible Shrubs/Native Grasses	Hydromulch Woodfibre	Jul-2015	Good	Good cover crop. Some emerging natives.		Reworked Aug 16. No topsoil or respray as yet.	
Fill 6	SB	Native Grasses	Hydromulch Woodfibre	Jul-2015/Aug-2016	Good	Good cover crop. No natives as of Jul 15.		Reworked Aug 16. No topsoil or respray as yet.	
Cut 7	NB	Frangible Shrubs	Hydromulch Woodfibre	Jul-2015	Average	Average cover crop, some natives.	Good - height 60 - 70cm. Minimal weeds. Good diversity. Meets 12 month requirements.	NIL

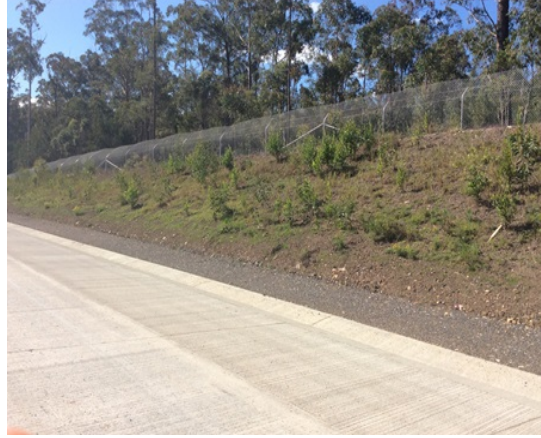
General Location	Specific Location	Vegetation Community Type	Treatment	Date of Sowing	Covercrop Strike at time of sowing	Revegetation Performance After 2 Months of Sowing	Native Seed Strike	Actions to Reach Performance Criteria	Photograph
Cut 7	SB	Frangible Shrubs	Hydromulch Woodfibre	Jul-2015	Average	Average cover crop, some natives.	Good - height 60 - 70cm. Minimal weeds. Good diversity. Meets 12 month requirements.	NIL

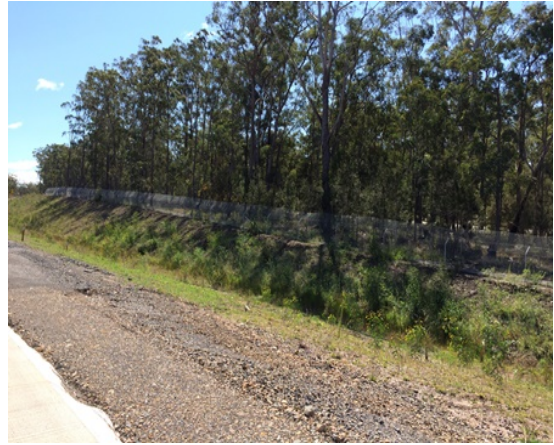
B0778L	NB	Tall Shrubs	Hydromulch Woodfibre	Sep-2015	Good cover	Good cover crop. No natives.	Good native diversity, a few weeds but not too bad.	Meets all 12 month requirements.

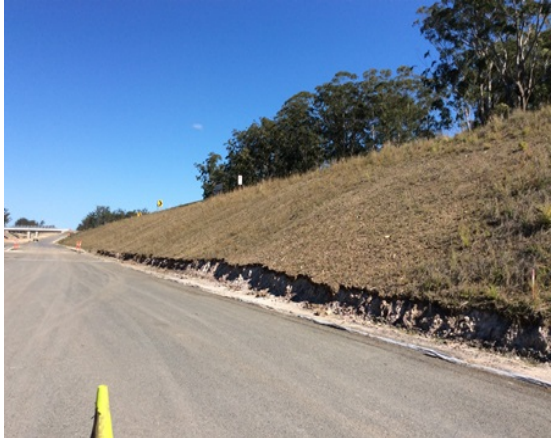
General Location	Specific Location	Vegetation Community Type	Treatment	Date of Sowing	Covercrop Strike at time of sowing	Revegetation Performance After 2 Months of Sowing	Native Seed Strike	Actions to Reach Performance Criteria	Photograph
Cut 9	NB	Frangible Shrubs	Hydromulch Woodfibre	Aug and Sep 2015	Good	Good cover crop. No natives.	No natives but stable batter.	Oversow with frangible shrub hydroseed.

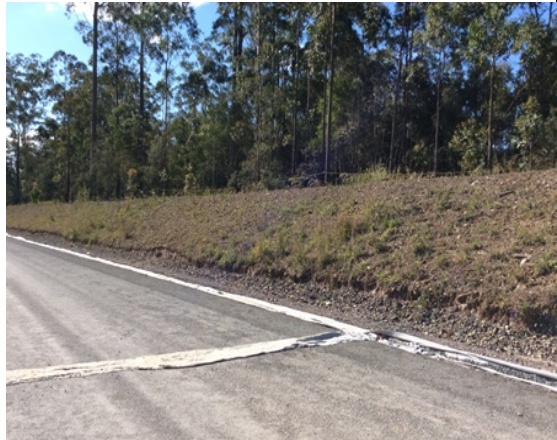
Cut 9	SB	Frangible Shrubs	Hydromulch Woodfibre	Aug and Sep 2015	Average.	Average cover crop, some natives.	Good native diversity with both grasses and shrubs.	Watch and act + oversow with hydroseed at northern end.

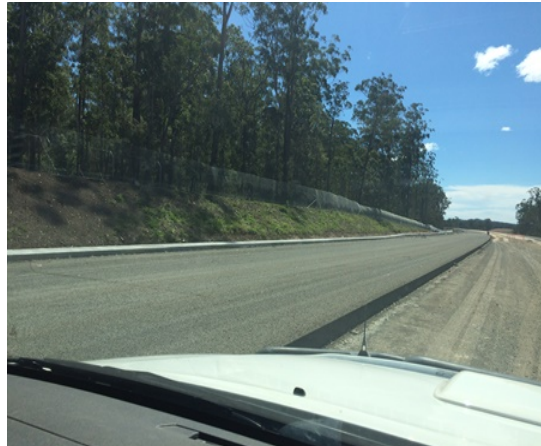
General Location	Specific Location	Vegetation Community Type	Treatment	Date of Sowing	Covercrop Strike at time of sowing	Revegetation Performance After 2 Months of Sowing	Native Seed Strike	Actions to Reach Performance Criteria	Photograph
Fill 12	SB	Frangible Shrubs	Hydromulch Woodfibre	Nov-2015	70% in good areas.	Good cover crop with some natives.	Good native strike in some areas.	Watch and act. Batter chutes and stockpile still need to be sprayed.	 
Cut 13	NB	Frangible Shrubs	Hydromulch Woodfibre	16 September 2015	Good at north end. South end not yet sprayed.	Good at north end	Good at north end.	Watch and act @ north end. Spray south end.

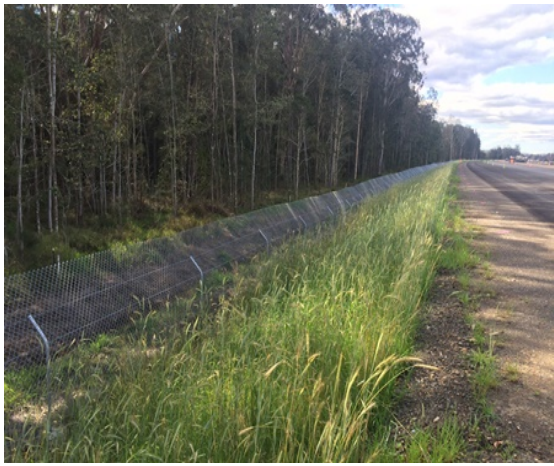
General Location	Specific Location	Vegetation Community Type	Treatment	Date of Sowing	Covercrop Strike at time of sowing	Revegetation Performance After 2 Months of Sowing	Native Seed Strike	Actions to Reach Performance Criteria	Photograph
Fill 13	A	Native Grasses	Hydromulch Woodfibre	Sep-2015	Good	Good cover crop. No natives.	NB batter is patchy with poor native diversity. SB very good minimal weeds.	Both NB and SB patchy (due to native grass mix?). Restart after verge placement.	
Fill 13	B	Native Grasses	Hydromulch Woodfibre	15/12/15	Exemplary	Exemplary	Pasture grass well established.	Nil

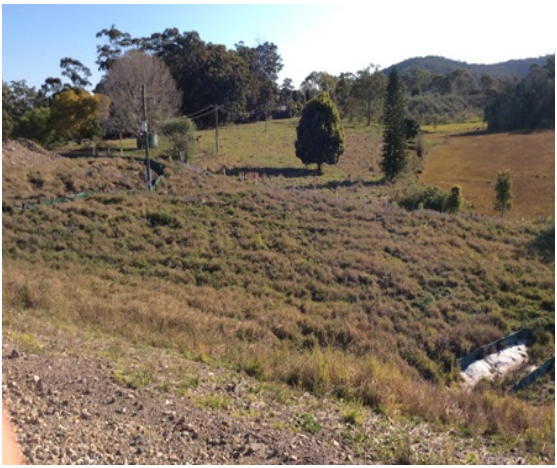
Fill 13	E SB	Tall Shrubs			Good	Good cover crop. Poor native strike.		Stockpile placed on top of revegetation. Restart monitoring once area has been reworked.	
Fill 13	F	Tall shrubs/Fragible Shrubs	Hydromulch Woodfibre	July-Aug 2015	Patchy.	Patchy. No natives.	No native strike.	Whole area has been reworked. Restart monitoring when resprayed.

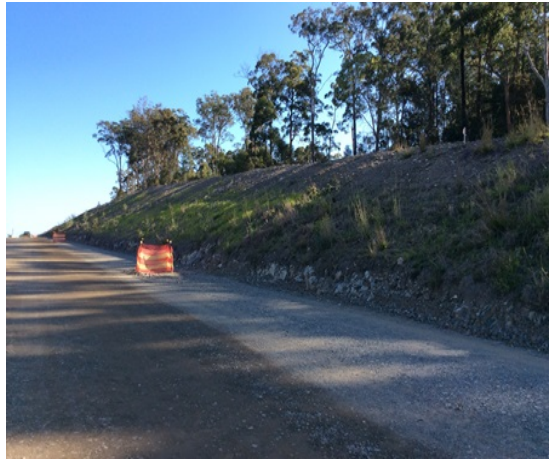
Cut 14	SB	Frangible Shrubs	Hydromulch Woodfibre	Sep-2015	Poor	Poor strike. Some natives.	Scattered natives.	Re-scarify top section.

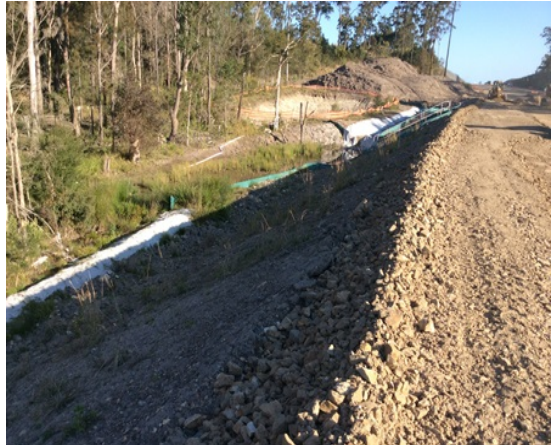
General Location	Specific Location	Vegetation Community Type	Treatment	Date of Sowing	Covercrop Strike at time of sowing	Revegetation Performance After 2 Months of Sowing	Native Seed Strike	Actions to Reach Performance Criteria	Photograph
Fill 14	NB	Frangible Shrubs/Native Grasses	Hydromulch Woodfibre	Sep-2015	Poor	Poor	Poor	Restart 8 months post re-topsoiling

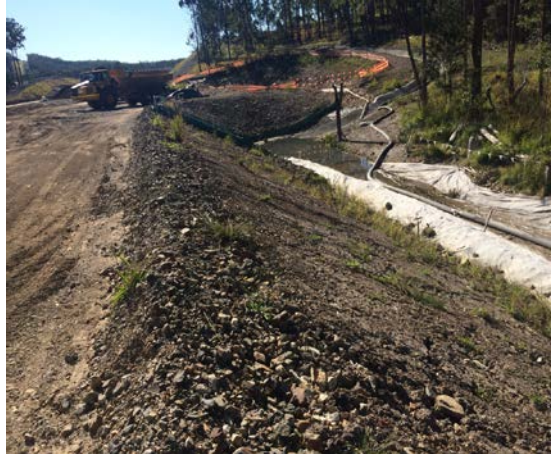
Fill 14	SB	Frangible Shrubs/Native Grasses	Hydromulch Woodfibre	Sep-2015	Poor	Poor	Poor	Restart 8 months post tine and respray.

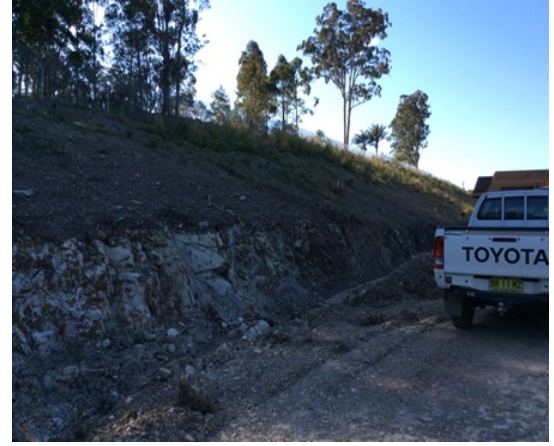
Cut 15	SB	Frangible Shrubs	Hydromulch Woodfibre	Nov-2015		Poor	Restart 8 months when finished.

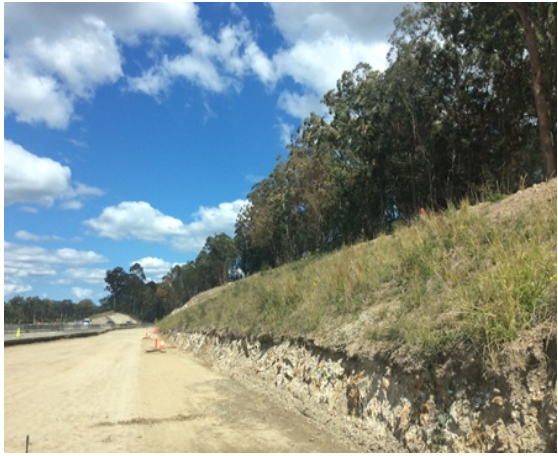
Fill 16	NB	Frangible Shrubs	Hydromulch Woodfibre	Sep-2015	Good 80%	Good cover crop. No natives.	Dominated by pasture grasses, no native visible. Very stable batter.	Watch and act. Need to check with Urban design team in regards to impacts of pasture grass (RFI to leave as is).

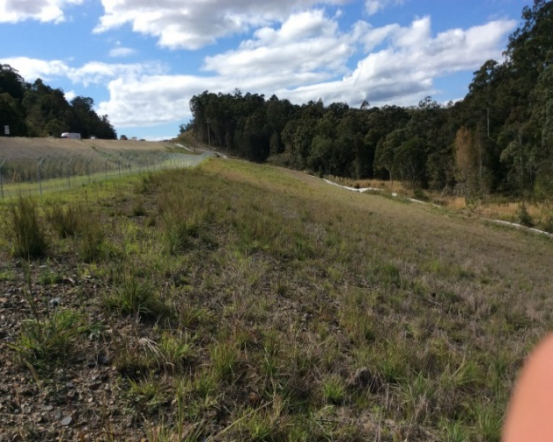
Cut 19A	NB	Frangible Shrubs	Hydromulch Woodfibre	Resprayed on 15 December 2015 following stockpiling against batter.	Good	Good cover crop. No natives.	Good at top and poorer for resprayed area. Some weeds have been sprayed in re-hydromulched section.	Watch and act

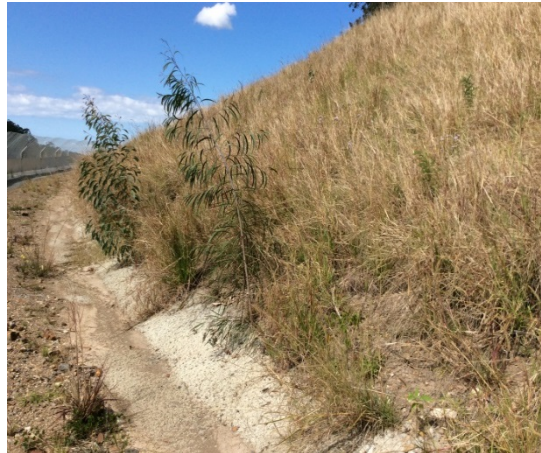
General Location	Specific Location	Vegetation Community Type	Treatment	Date of Sowing	Covercrop Strike at time of sowing	Revegetation Performance After 2 Months of Sowing	Native Seed Strike	Actions to Reach Performance Criteria	Photograph
Cut19B	NB	Tall Shrubs	Hydromulch Woodfibre	Jun-2015, May-02016	Good	Good cover crop. No natives.	Dominated by long grass, scattered natives on edges. Has improved since last inspection with more maturing natives.	Watch and act

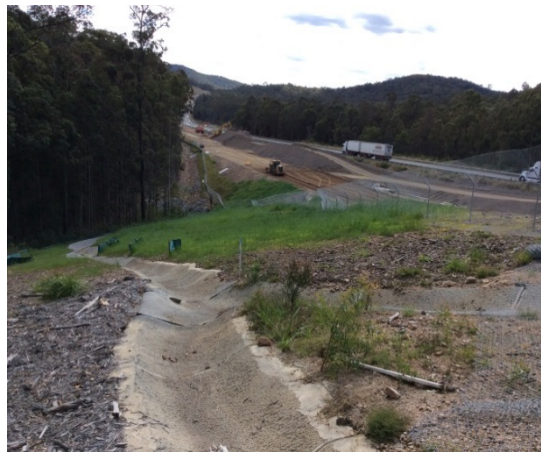
Fill 19	NB	Tall Shrubs	Hydromulch Woodfibre	18/05/2016	Good	Good cover crop with no natives.	None

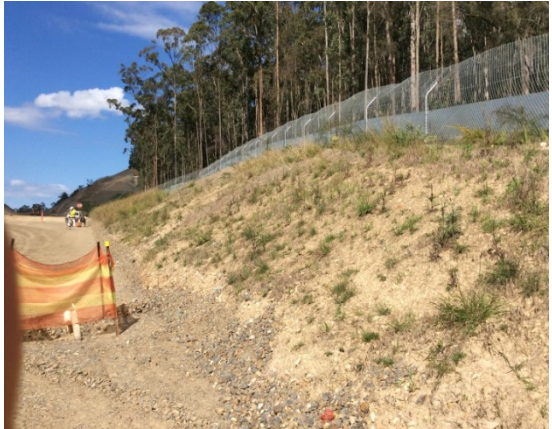
General Location	Specific Location	Vegetation Community Type	Treatment	Date of Sowing	Covercrop Strike at time of sowing	Revegetation Performance After 2 Months of Sowing	Native Seed Strike	Actions to Reach Performance Criteria	Photograph
Cut 20	NB	Tall Shrubs	Hydromulch Woodfibre	15/12/2015	Good strike at top. Poor strike at bottom.	Good strike at top. Poor strike at bottom. No natives.	Poor	Selectively re-scarify and hydromulch lower section where 100% bare. High weeds on bottom of batter but not noxious so no need for spraying.

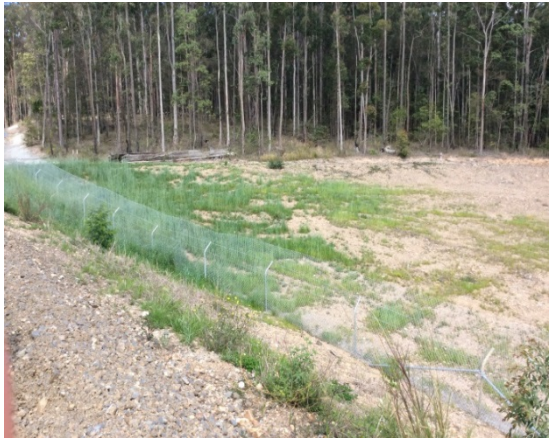
Fill 20	NB	Tall Shrubs	Hydromulch Woodfibre	8/3/2016	Good, except for old basin footprint.	Good cover crop except for old basin footprint. No natives.	One or two natives.	Tyne and respray old basin footprint.

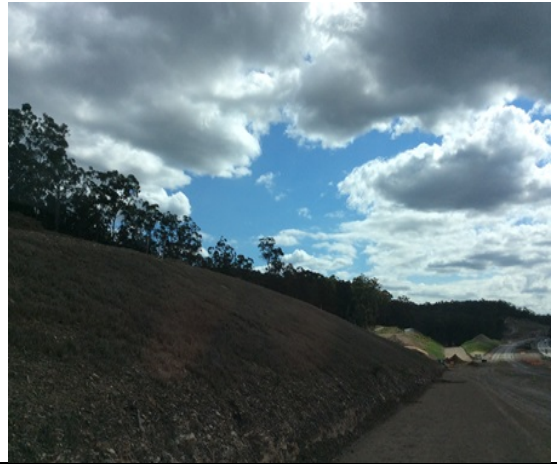
General Location	Specific Location	Vegetation Community Type	Treatment	Date of Sowing	Covercrop Strike at time of sowing	Revegetation Performance After 2 Months of Sowing	Native Seed Strike	Actions to Reach Performance Criteria	Photograph
Cut 21	NB	Tall Shrubs	Hydromulch Woodfibre	15/12/2015	Good	Good cover crop. No natives.	Poor	Watch and act

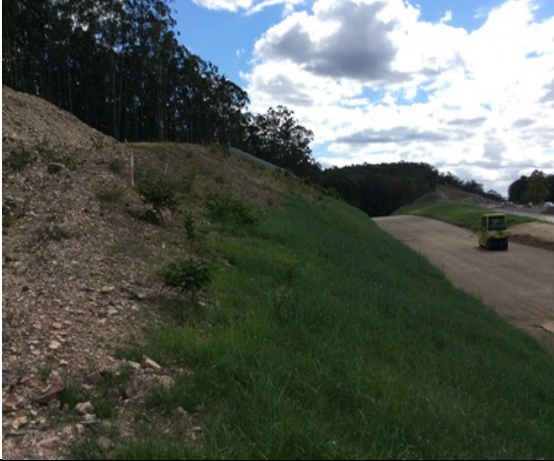
Fill 22	NB	Tall Shrubs	Hydromulch Woodfibre	May-2016/Aug-2016	Good	Good cover crop. Some natives.	Few natives.	8 months = Jan 2017

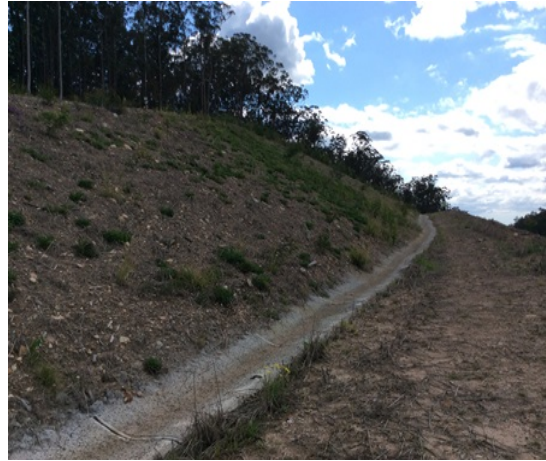
Fill 23	NB	Frangible Shrubs	Hydromulch Woodfibre	29/06/2015	Poor	Poor	Poor	Scarify and respray.

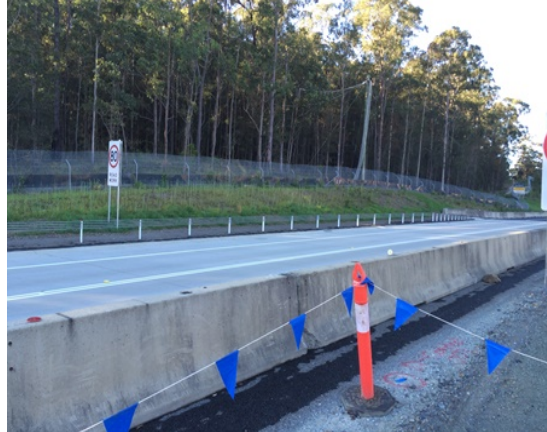
General Location	Specific Location	Vegetation Community Type	Treatment	Date of Sowing	Covercrop Strike at time of sowing	Revegetation Performance After 2 Months of Sowing	Native Seed Strike	Actions to Reach Performance Criteria	Photograph
Cut 23	SB	Frangible Shrubs	Hydromulch Woodfibre	Sep-2015	Good	Good cover crop strike. Some native strike.	Scattered natives emerging	Watch and act.

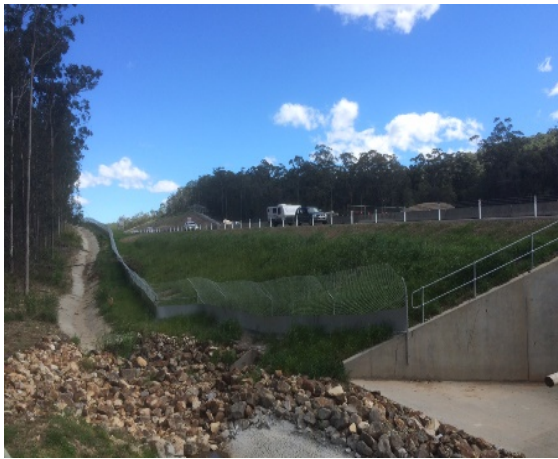
Fill 23	NB	Frangible Shrubs	Hydromulch Woodfibre	East (Sep-2015) Resprayed March 2016	Good 50-70%	Good cover crop. No natives.	Restart 8 months following first inspection.	Watch and act.

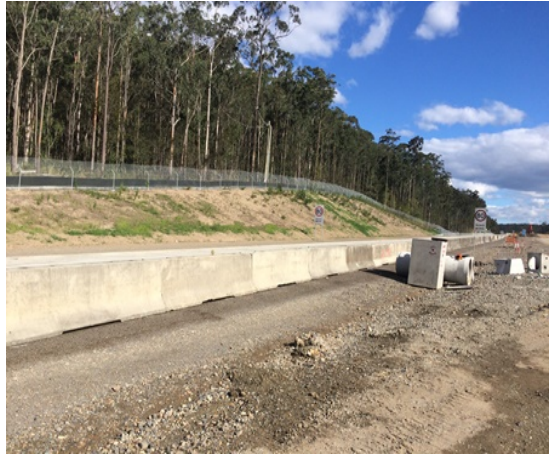
Fill 24	SB	Frangible Shrubs	Hydromulch Woodfibre	Sep-2015	Good	Good cover crop. Some native strike.	Some native strike.	Watch and act.
