# Annual Ecological Monitoring Report 2016/2017

## Oxley Highway to Kempsey, Pacific Highway Upgrade

Prepared for Roads and Maritime Services

December 2017

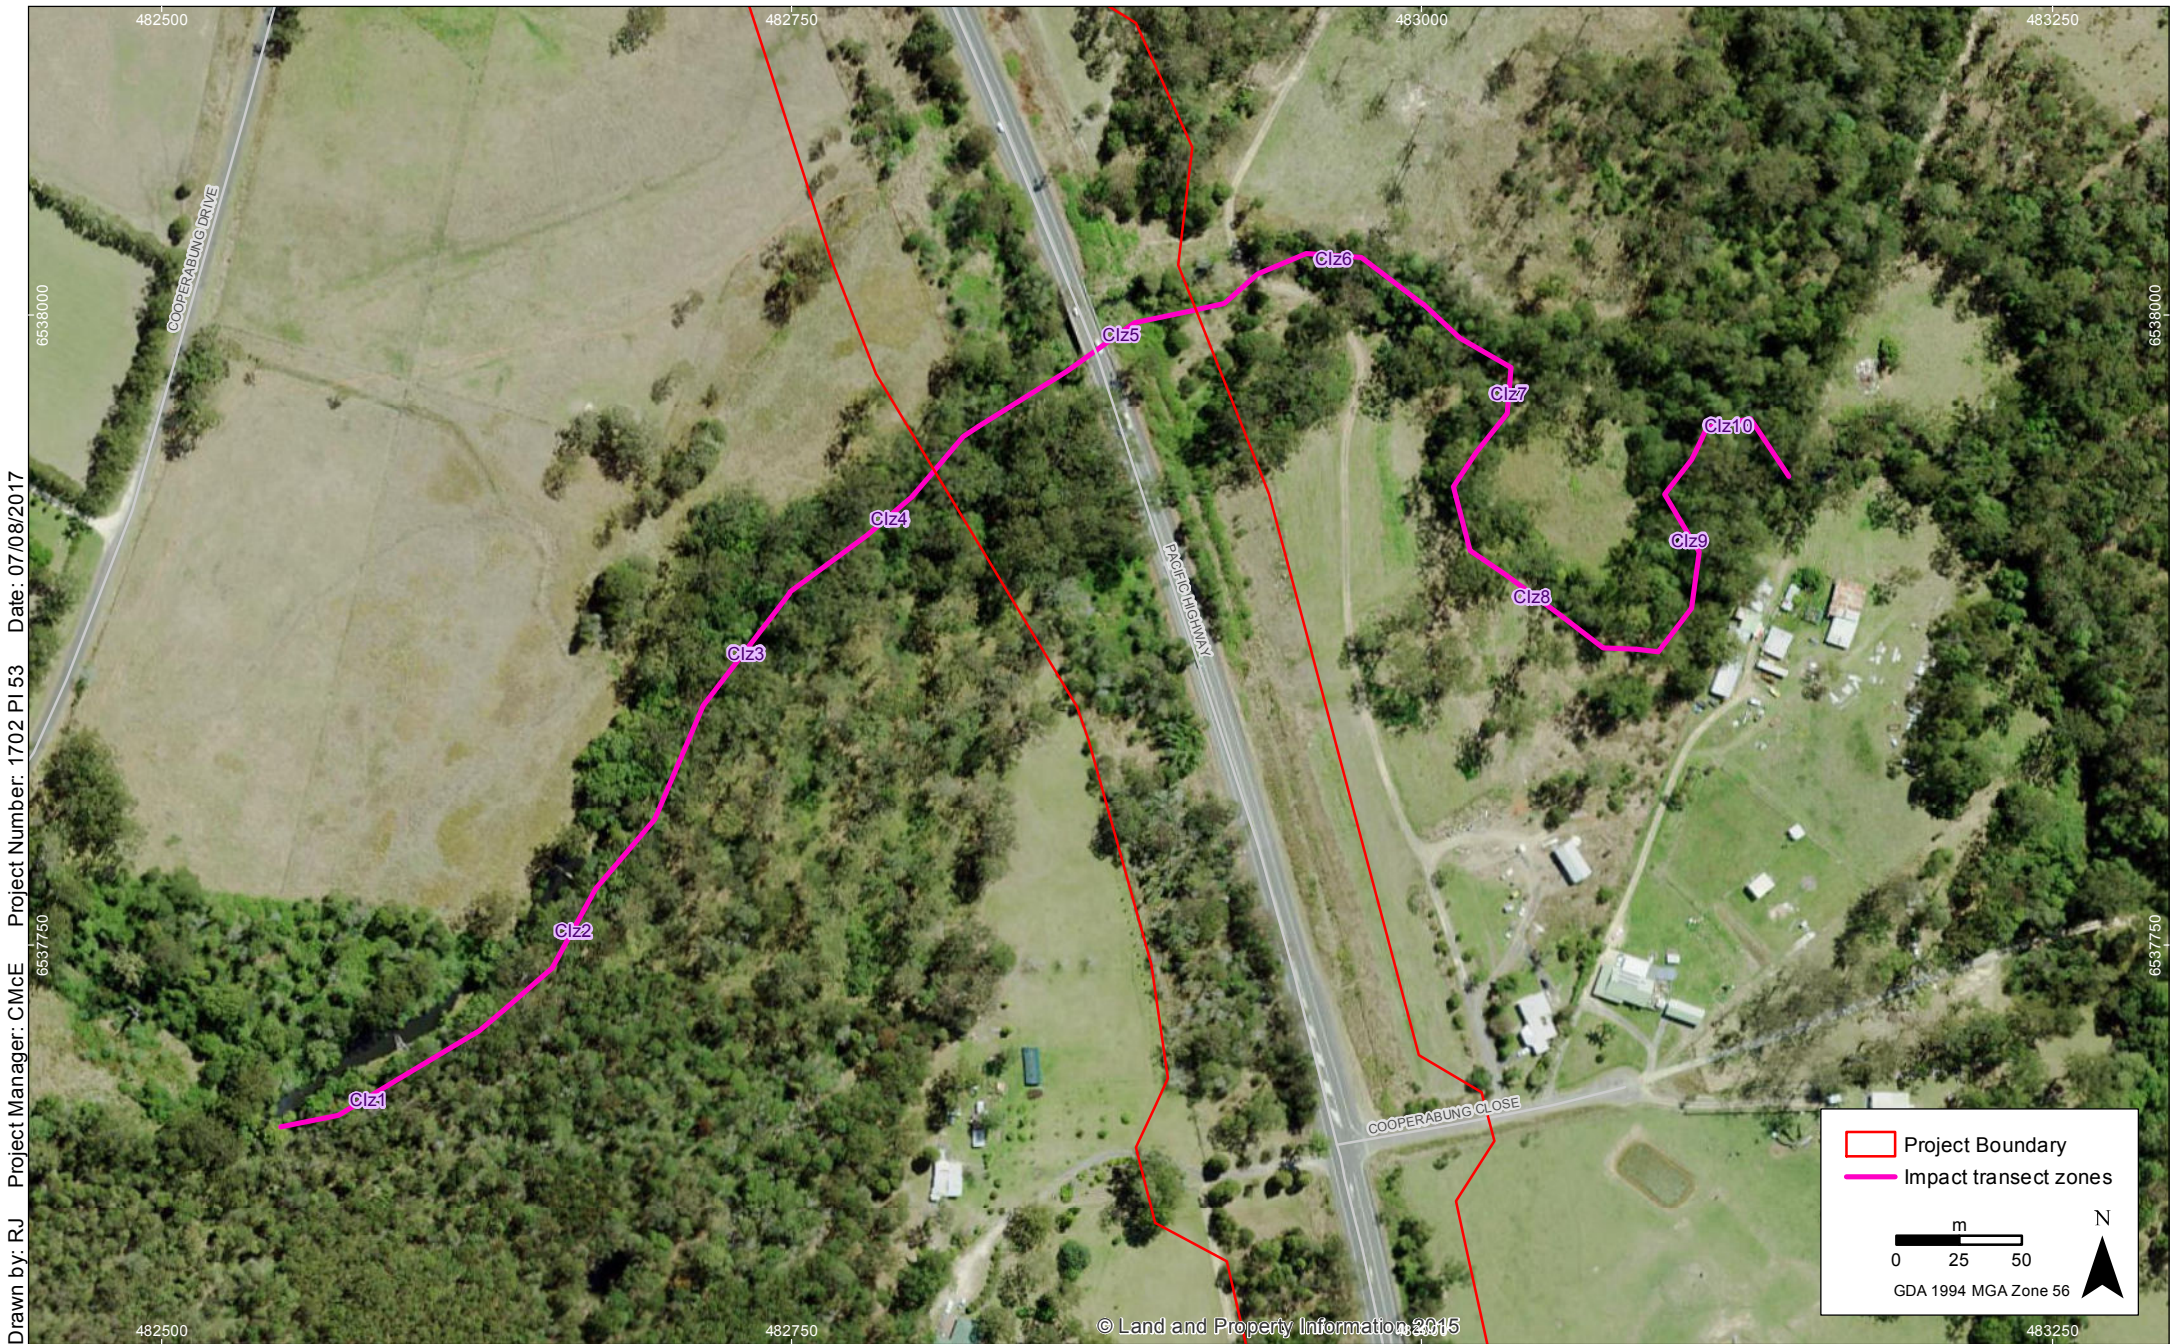
**FIGURE 2**

Giant Barred Frog 2016 - 2017 monitoring: Cooperabung Creek Impact site  
 Pacific Highway Upgrade - Oxley Highway to Kempsey

The locations of all monitoring sites are shown in Figure 1, with detailed locations for each site transect provided in Figure 2 to Figure 7.

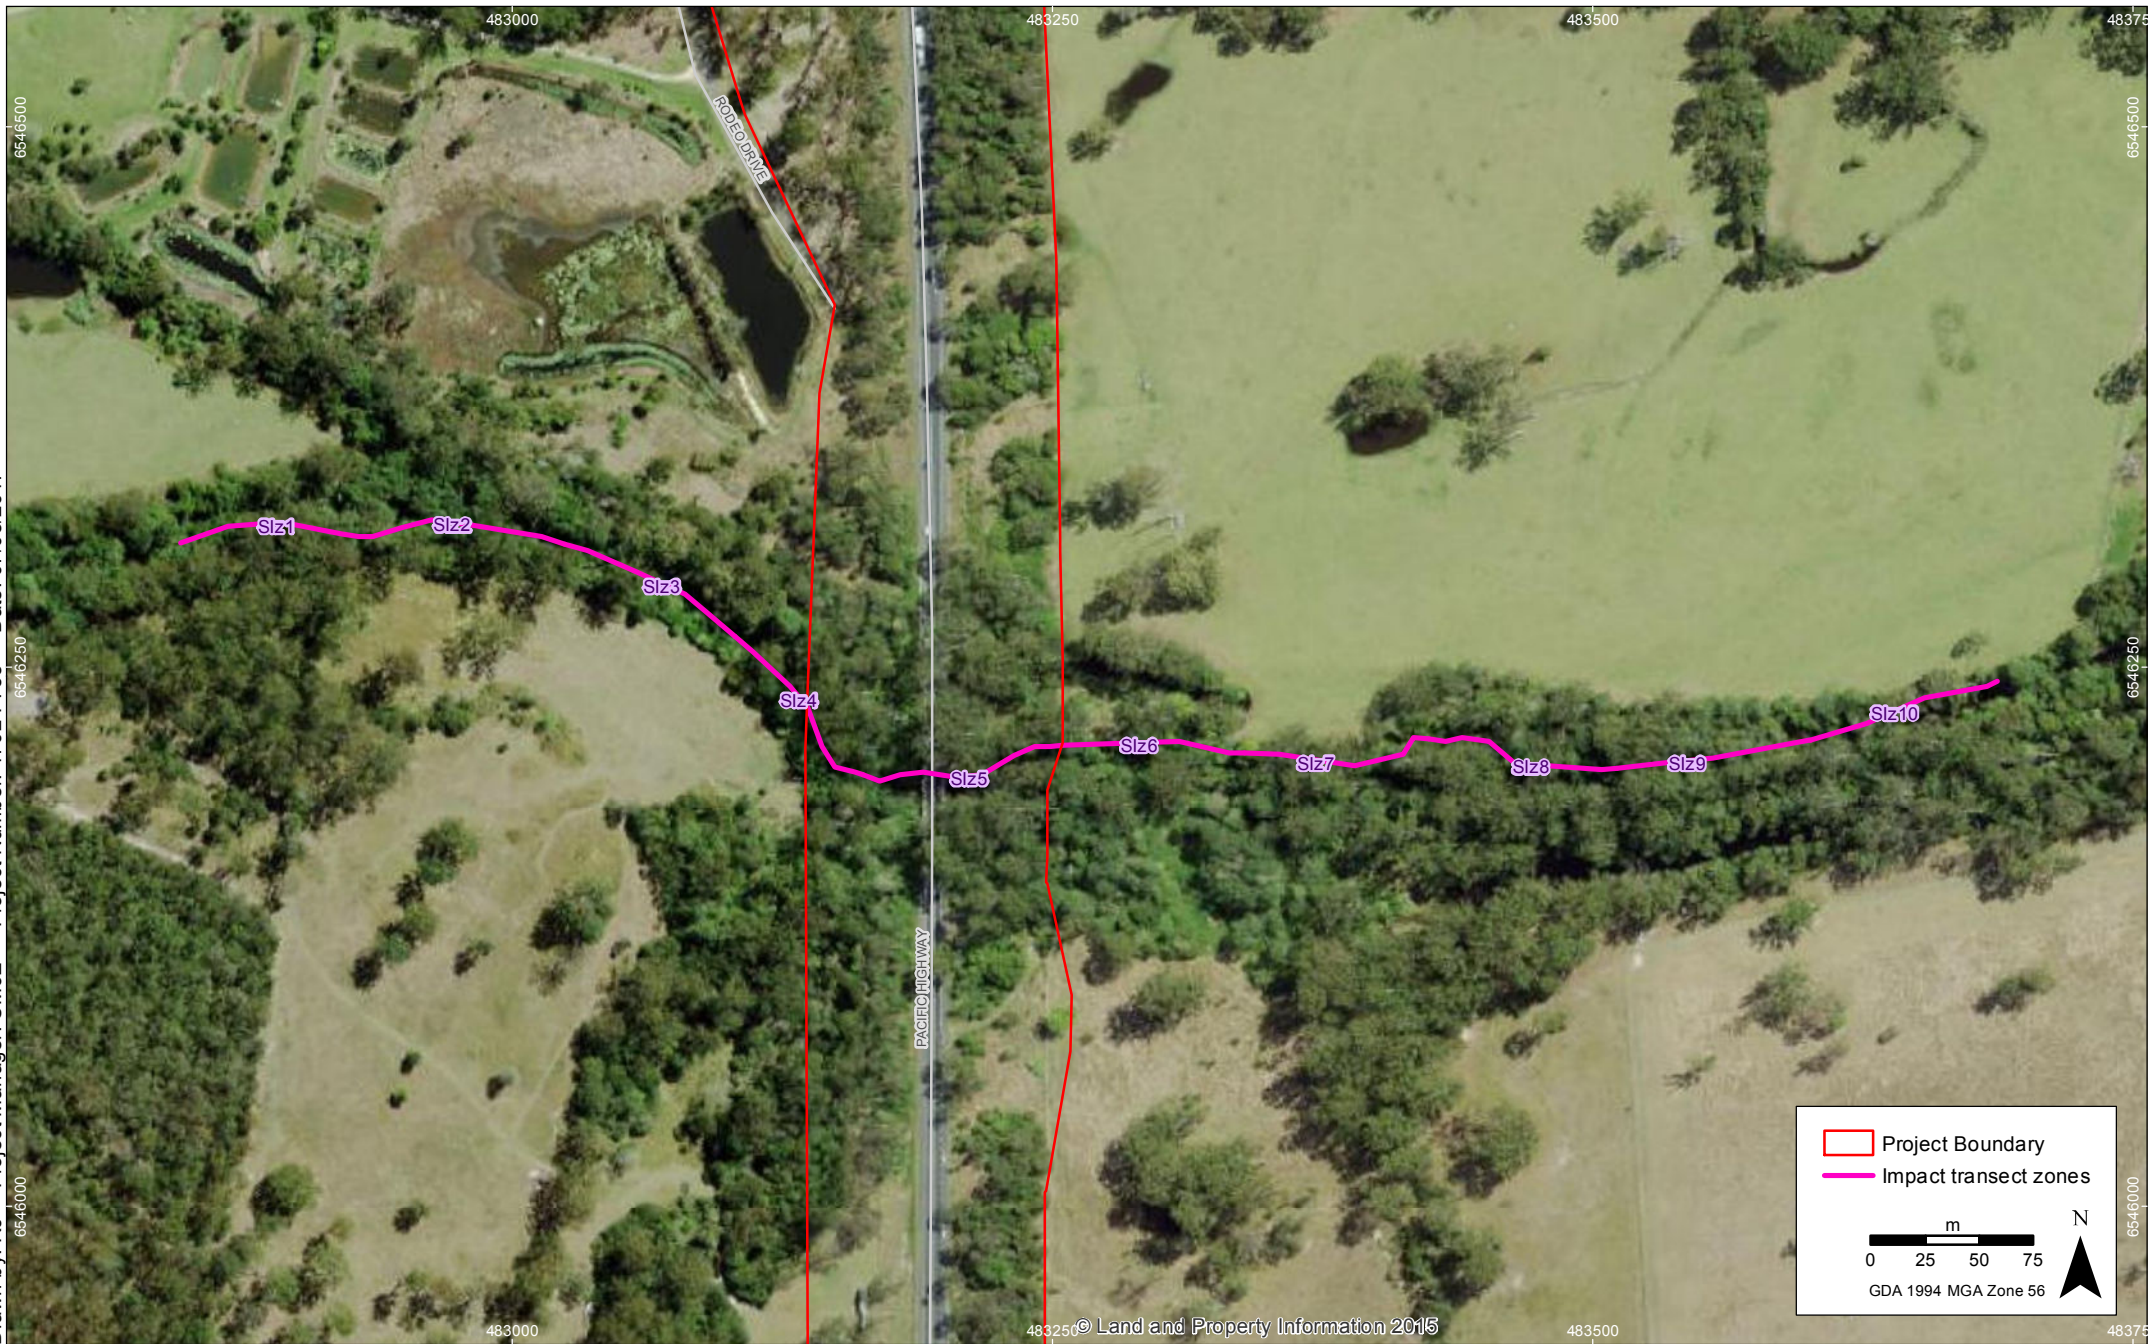
**FIGURE 3**

Giant Barred Frog 2016 - 2017 monitoring: Smiths Creek Impact site  
Pacific Highway Upgrade - Oxley Highway to Kempsey

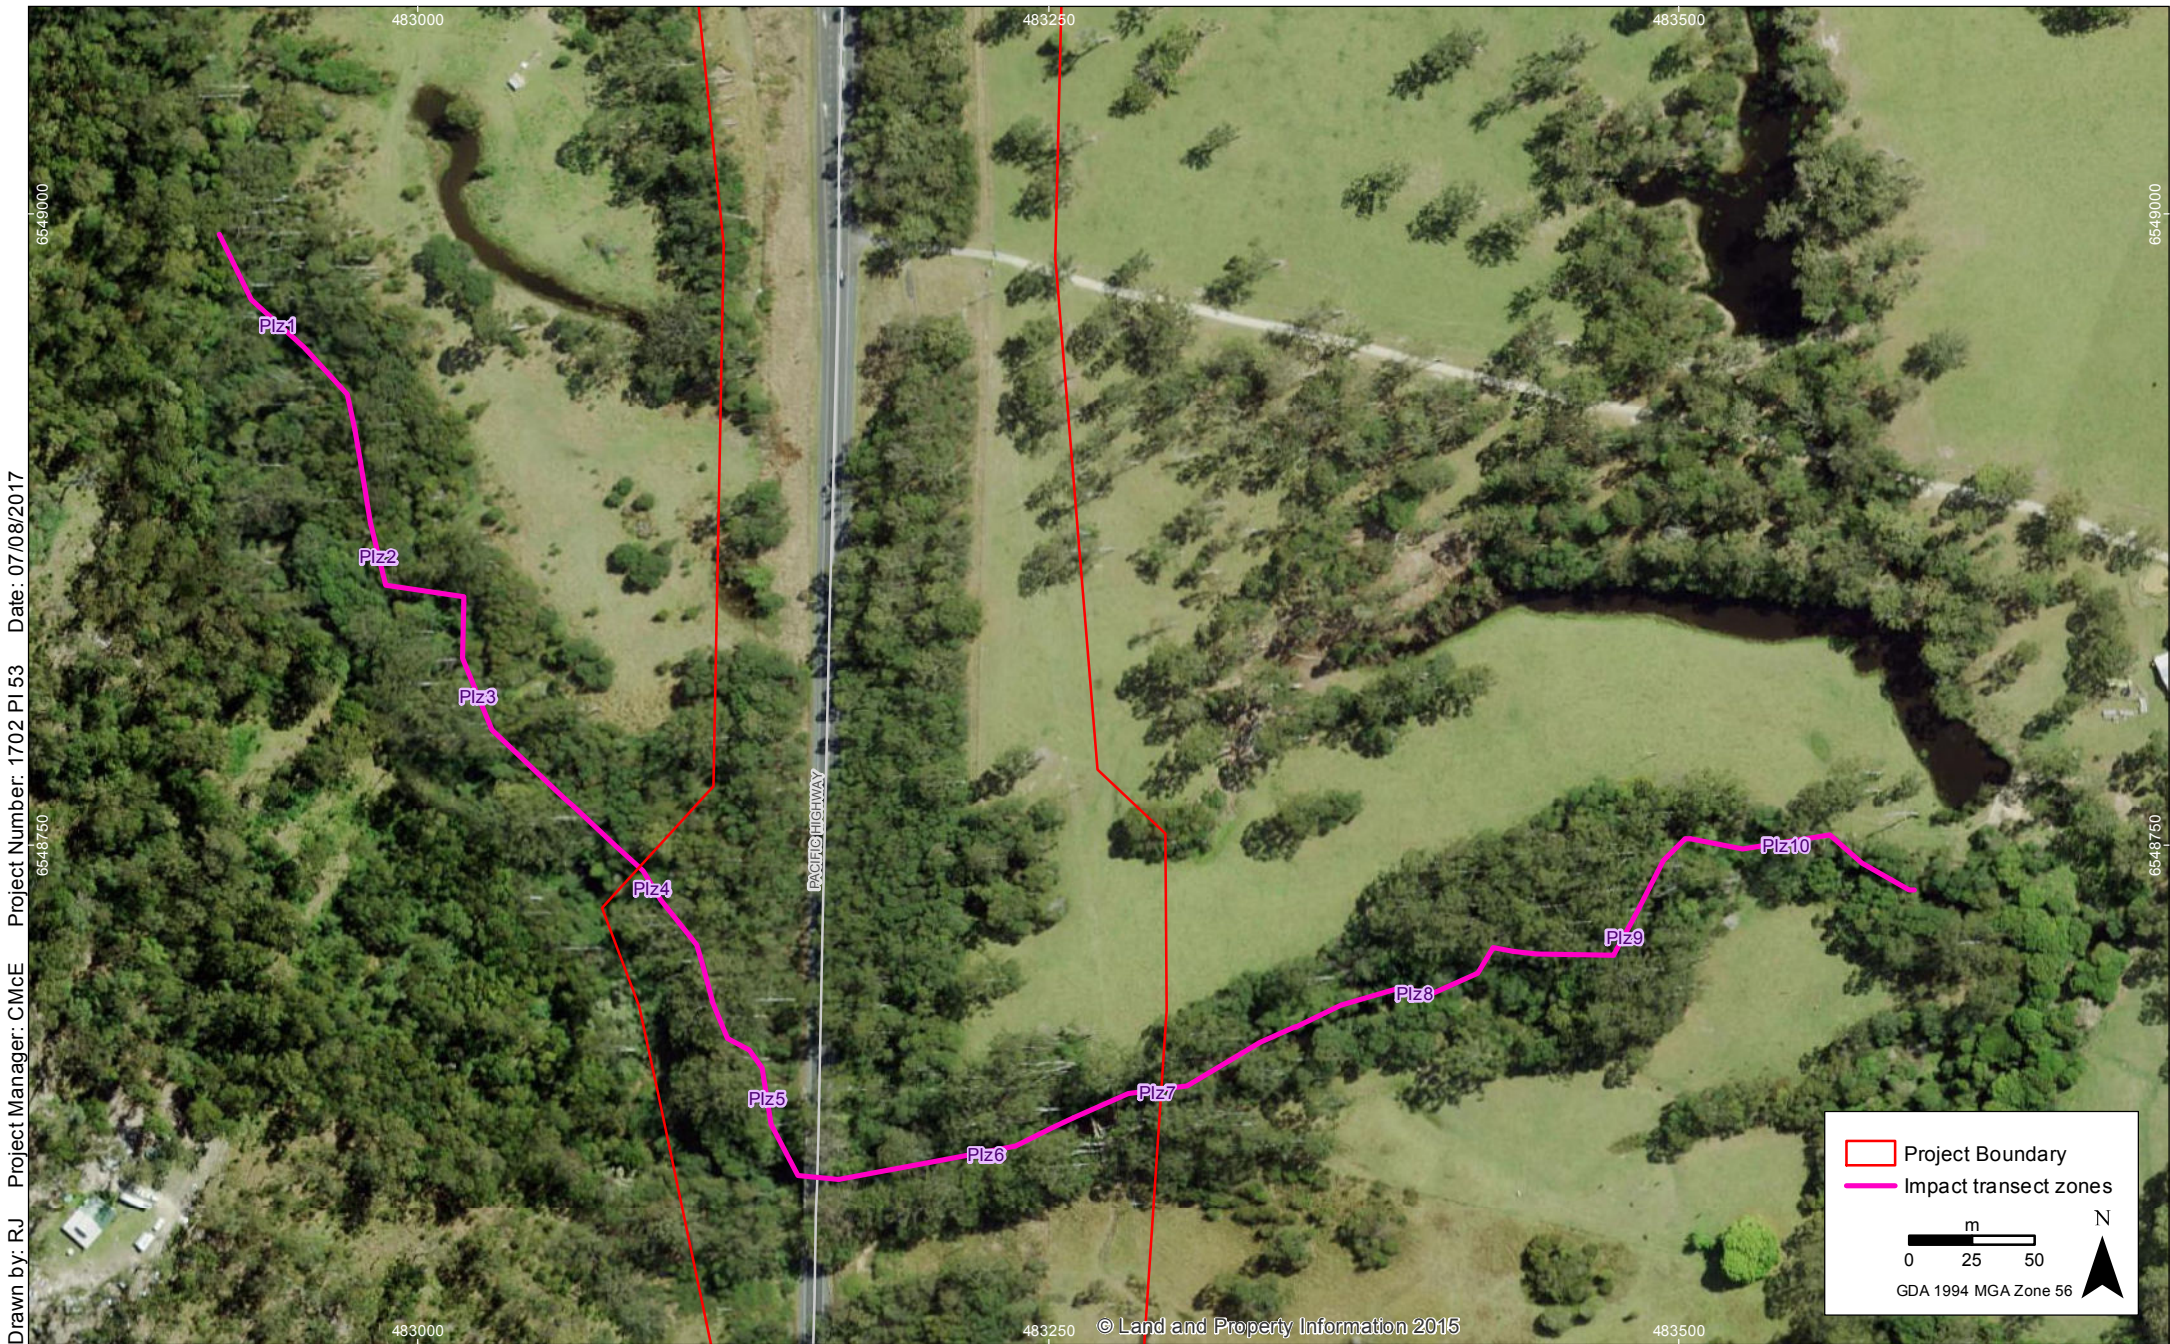
**FIGURE 4**

Giant Barred Frog 2016 - 2017 monitoring: Pipers Creek Impact site  
 Pacific Highway Upgrade - Oxley Highway to Kempsey

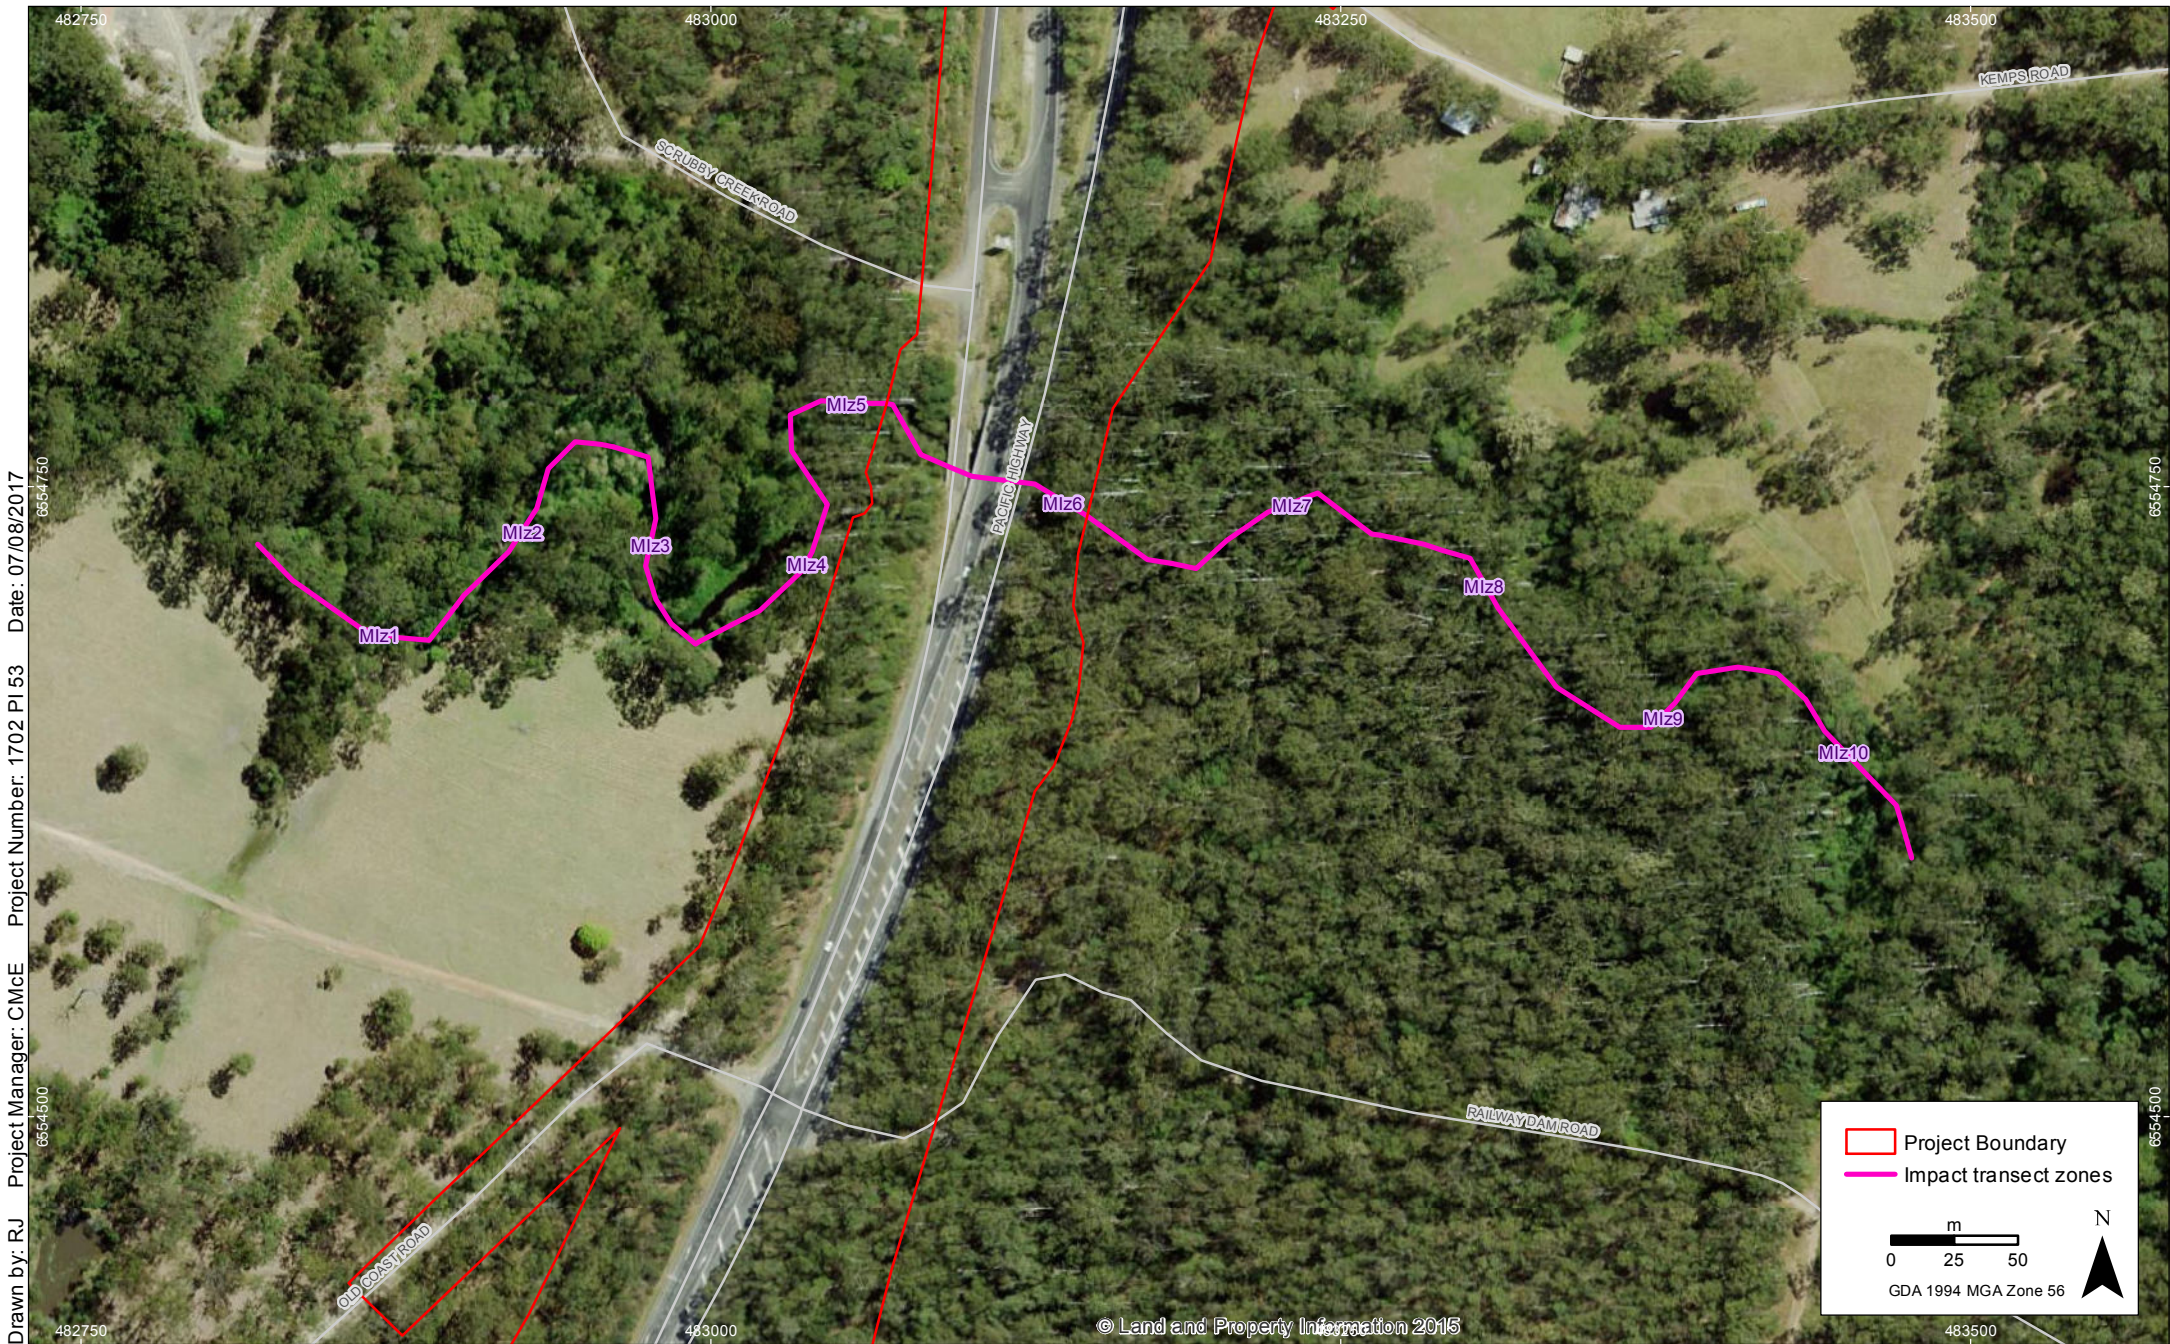
**FIGURE 5**

Giant Barred Frog 2016 - 2017 monitoring: Maria River Impact Site  
 Pacific Highway Upgrade - Oxley Highway to Kempsey

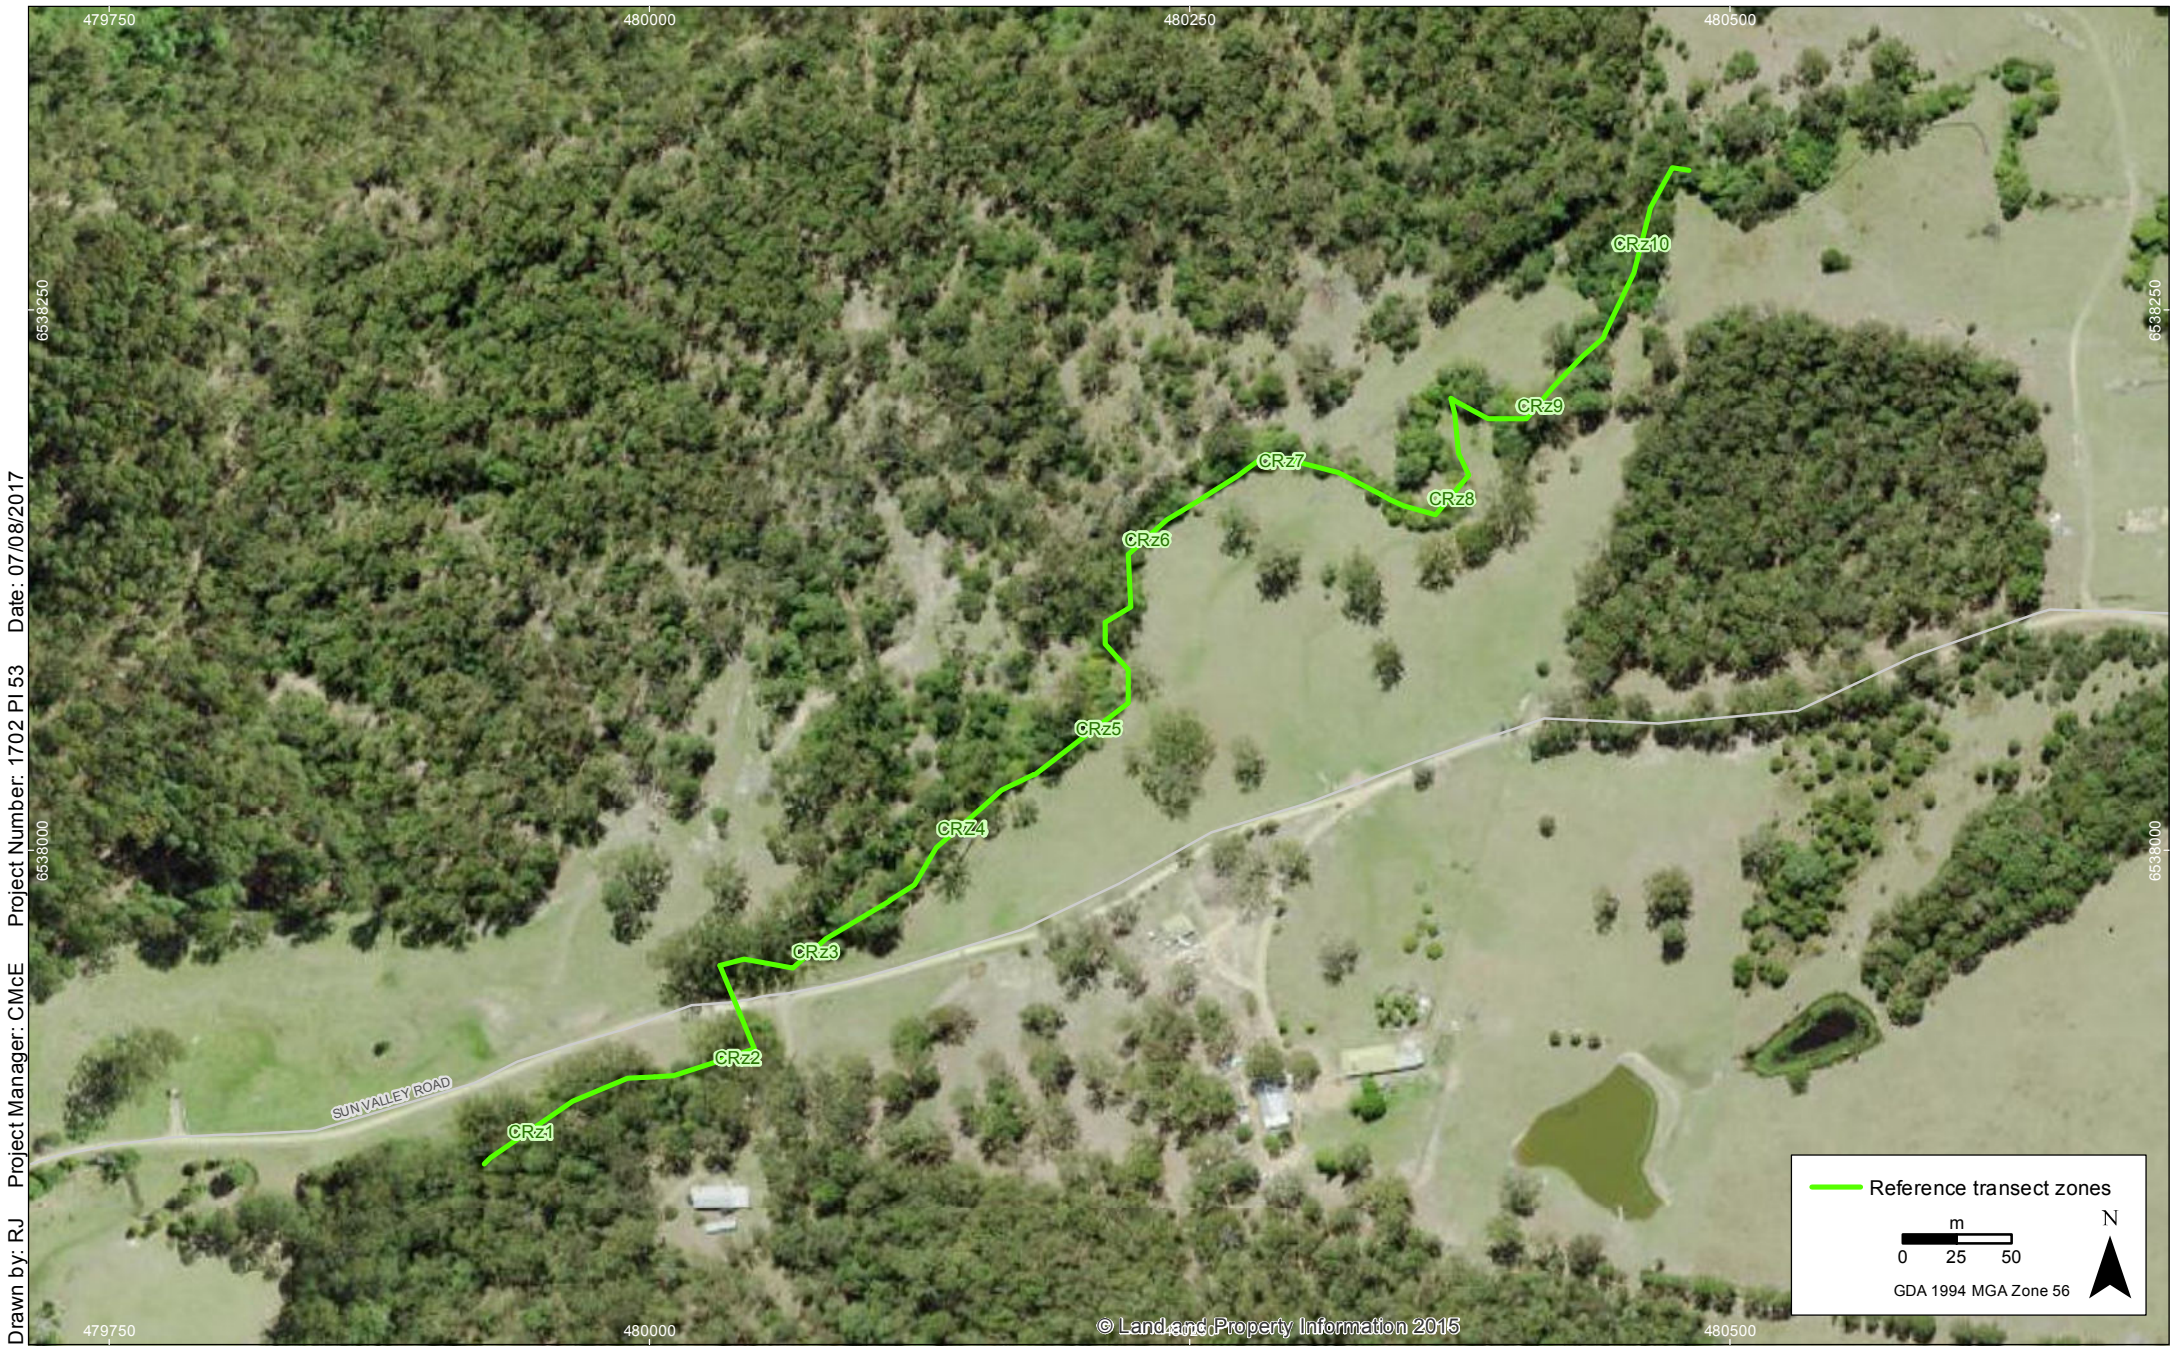
**FIGURE 6**

Giant Barred Frog 2016 - 2017 monitoring: Cooperabung Creek Reference Site  
Pacific Highway Upgrade - Oxley Highway to Kempsey

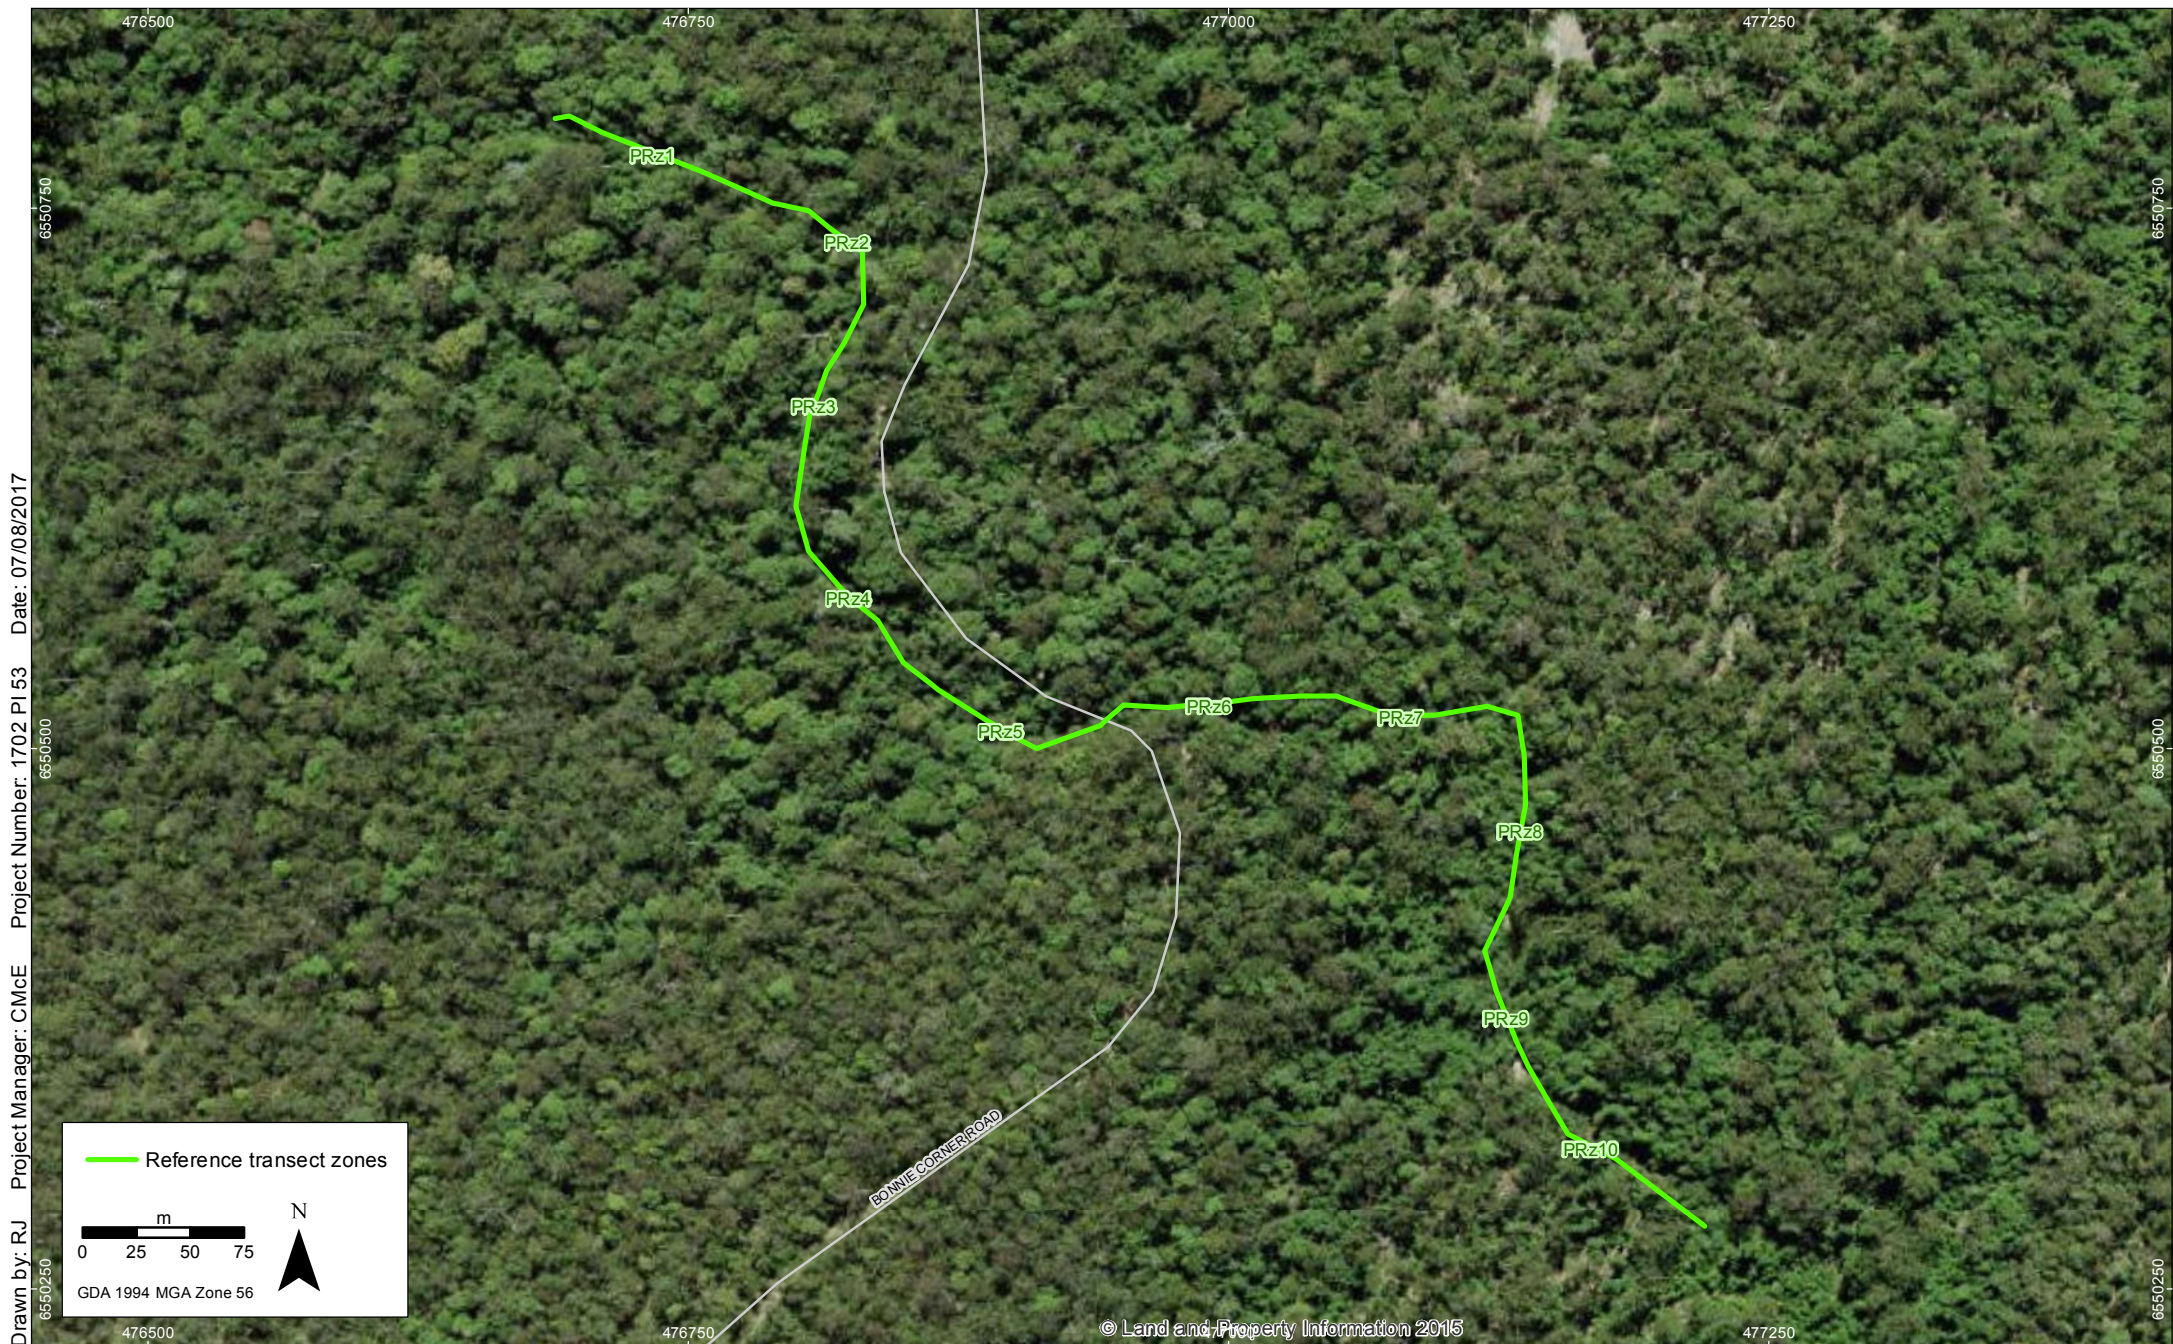
**FIGURE 7**

Giant Barred Frog 2016 - 2017 monitoring: Pipers Creek Reference Site  
Pacific Highway Upgrade - Oxley Highway to Kempsey

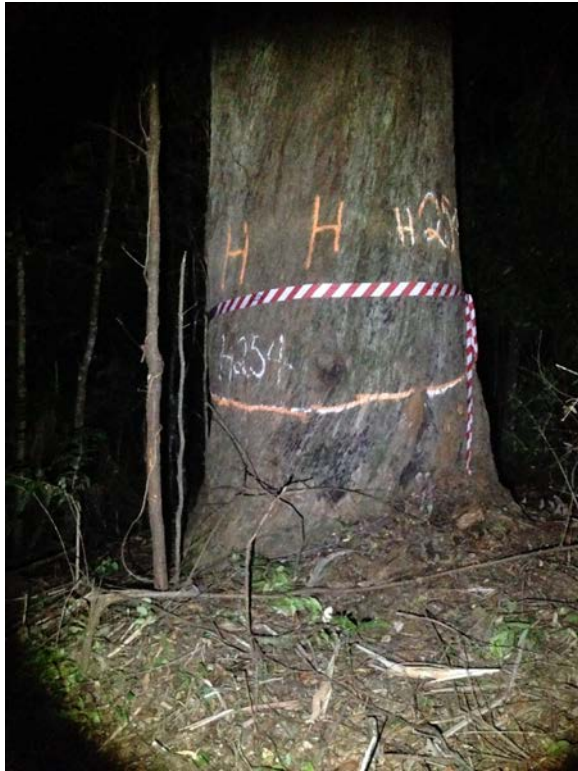
**Plate 1:** HBT's marking protocol – red and white danger tape and painted orange "H".

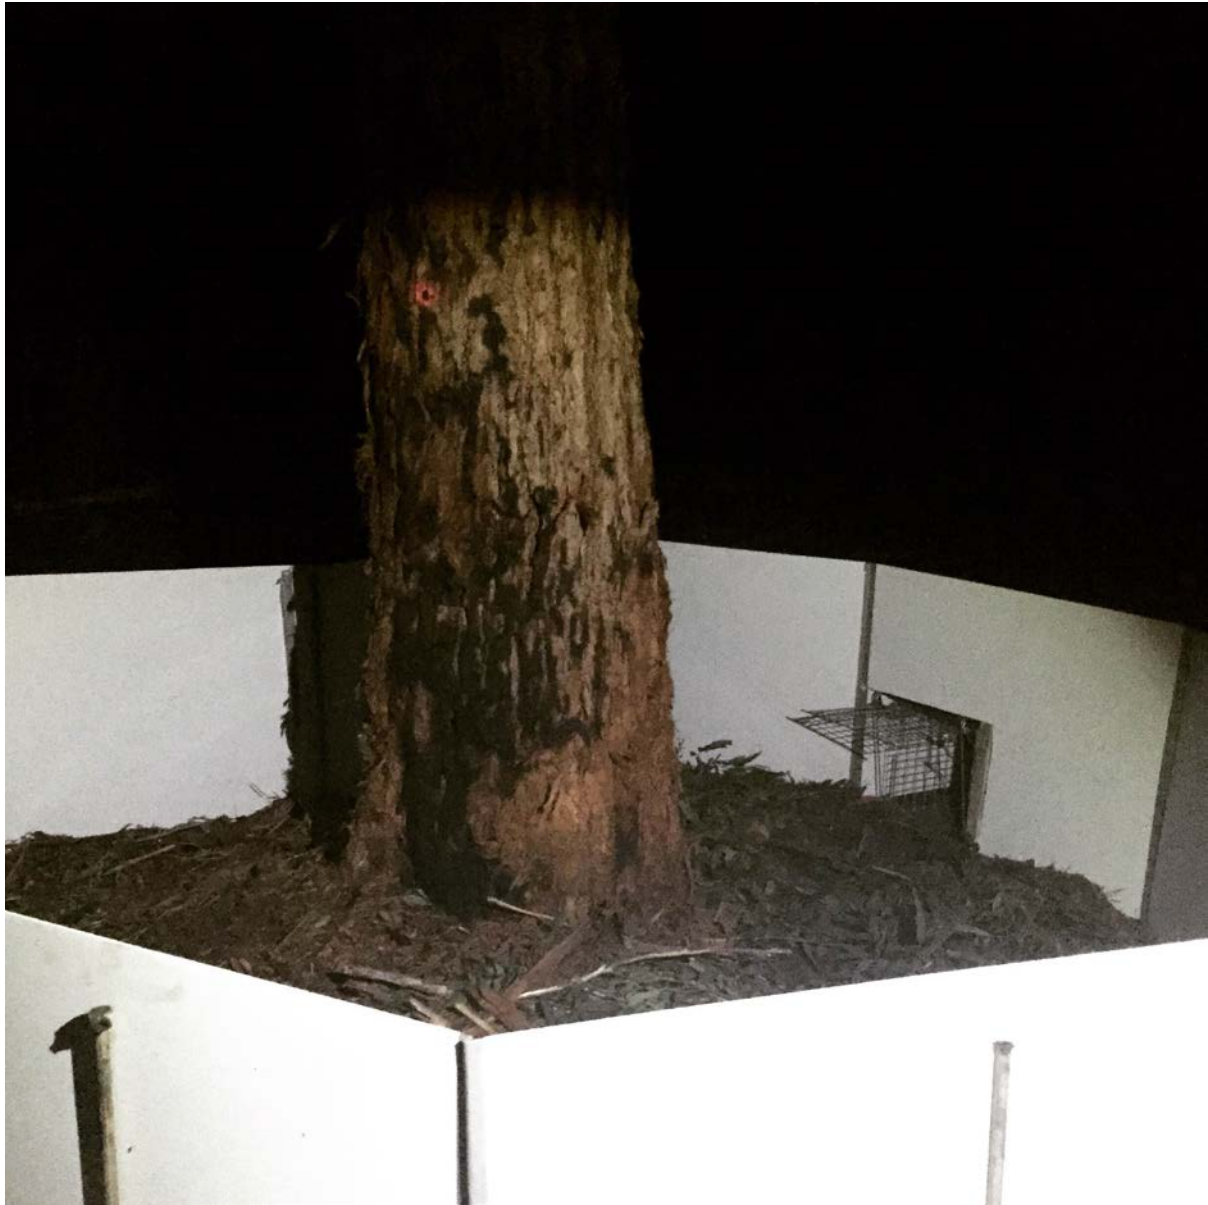
**Plate 3:** Koala trap installed around a tallowwood occupied by a female koala on 19 January 2015.

A koala trap was used as required. The koala trap was based on Phillips (2011) and included a corflute pen positioned around the occupied tree with a large cage trap fitted into a hole in the fence (Plate 3). A protocol was developed to deal with koalas recorded in the clearing area (Appendix A). The adopted protocol differs slightly to the method proposed in the EMP. The main difference was that a pen trap was installed immediately upon identifying a koala during spotlighting rather than leaving the individual to move, potentially to another tree in the clearing limit. This approach was preferred due to concern about relocating the koala the following day. There is a high likelihood that a koala identified at night would move prior to the morning pre-clear survey and relocating that individual in tall forest with a dense shrub layer during daylight would be difficult. Due to concern about an increased risk of mortality if an identified individual was left to move elsewhere within the clearing limit it was decided to control the situation and minimise the risk of mortality. The method proposed in the EMP relies on relocating a koala during the morning pre-clear and installing a 50m buffer around the occupied tree. A pen trap would then be installed if the koala does not vacate the area. The EMP does not specify the time between the initial observation and installation of the pen trap.

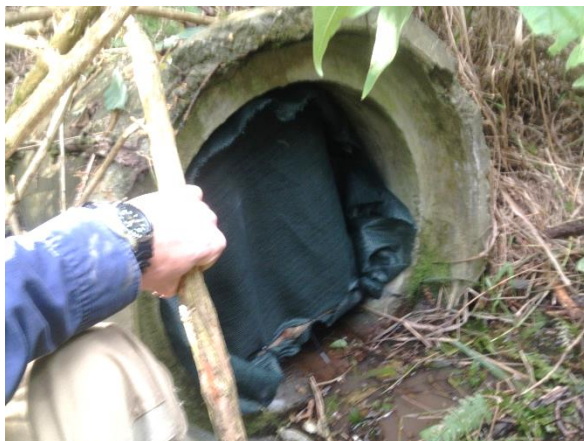
**Plate 3.** RCP 511067 (chainage 1000) was excluded with a nylon curtain after determining microbats were not roosting within the structure. The curtain features a 100mm gap at the base.

The entry/exit to structure RCP 510067 at chainage 1000 was curtained during the September 2014 exclusion process (Plate 3) and further inspection of that site is not required.

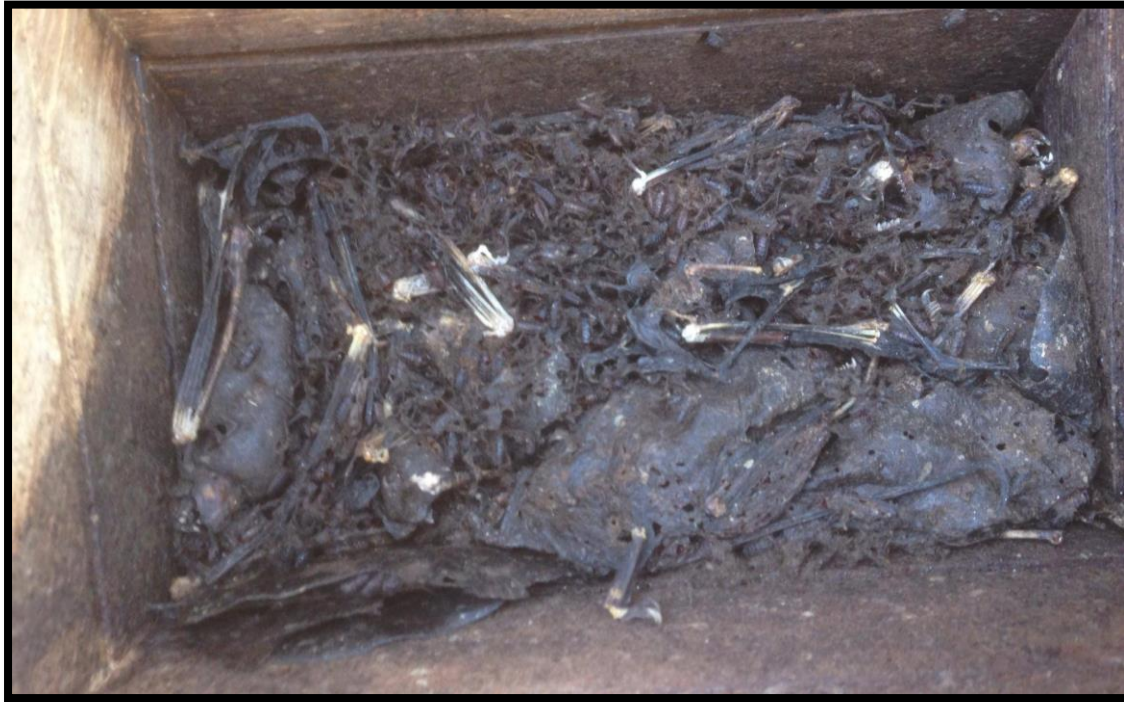
**Plate 3-2.** Chocolate Wattled Bat (*Chalinobus morio*) remains from a wedge shaped bat box in Management Zone V.

The discovery of deceased micro bats from a nest box specifically designed for bats raises some discussion. At the time of monitoring (i.e. 11<sup>th</sup> March), leaves had been constructed at the egress of the box and this would not enable bats to move freely from their roost. The fact that a number of smaller skeletal remains were present in the box indicates that the deaths occurred around the time of breeding (Plate 3-2). With this in mind, it is thought that the hot conditions which regularly exceeded 40°C in January/February may have contributed to this finding. The exposure of nest boxes and how fauna respond requires additional attention as individuals may be subject to greater levels of exposure.

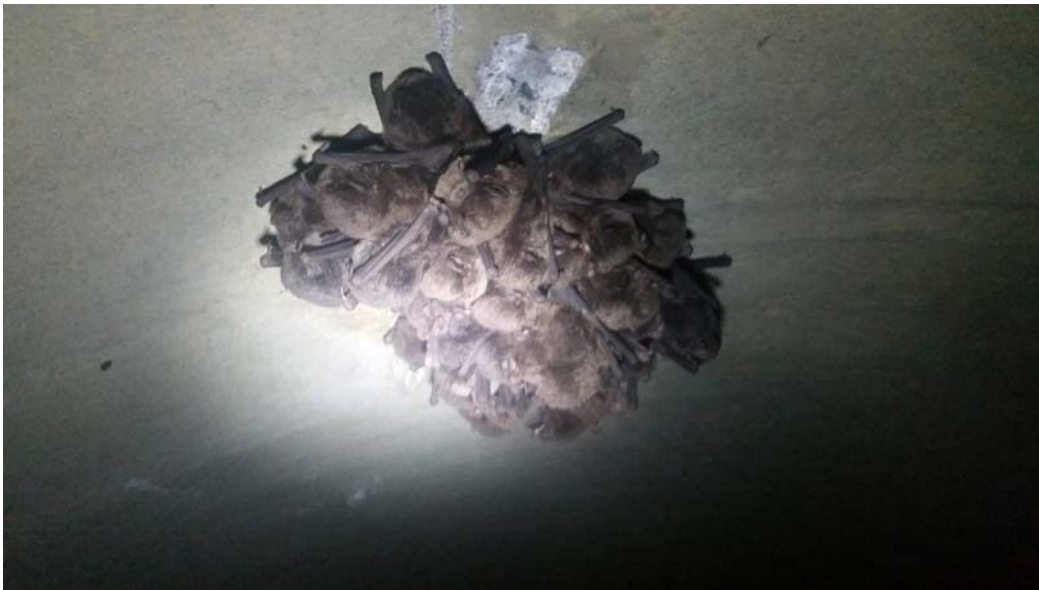
**Plate 1-1.** One of the four main clusters of roosting Little Bent-wing Bat (*Miniopterus australis*) recorded in Culvert 599038.

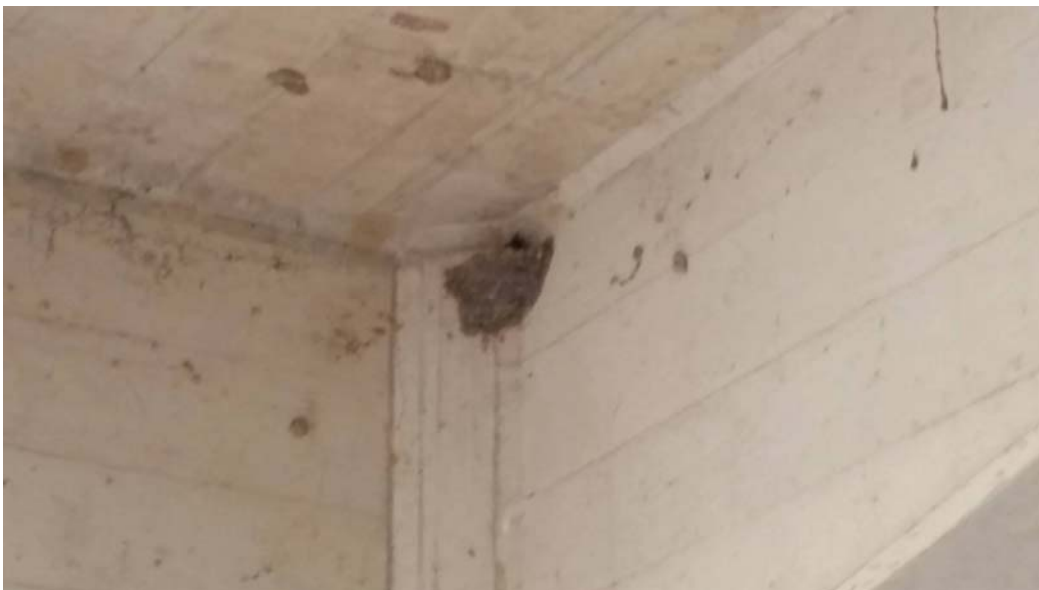
**Plate 1-2.** Micro bat suspected as Southern Myotis (*Myotis macropus*) inhabiting newly constructed swallow nests under the existing Pipers Creek Bridge.
