# Annual Ecological Monitoring Report 2016/2017

## Oxley Highway to Kempsey, Pacific Highway Upgrade

Prepared for Roads and Maritime Services

December 2017

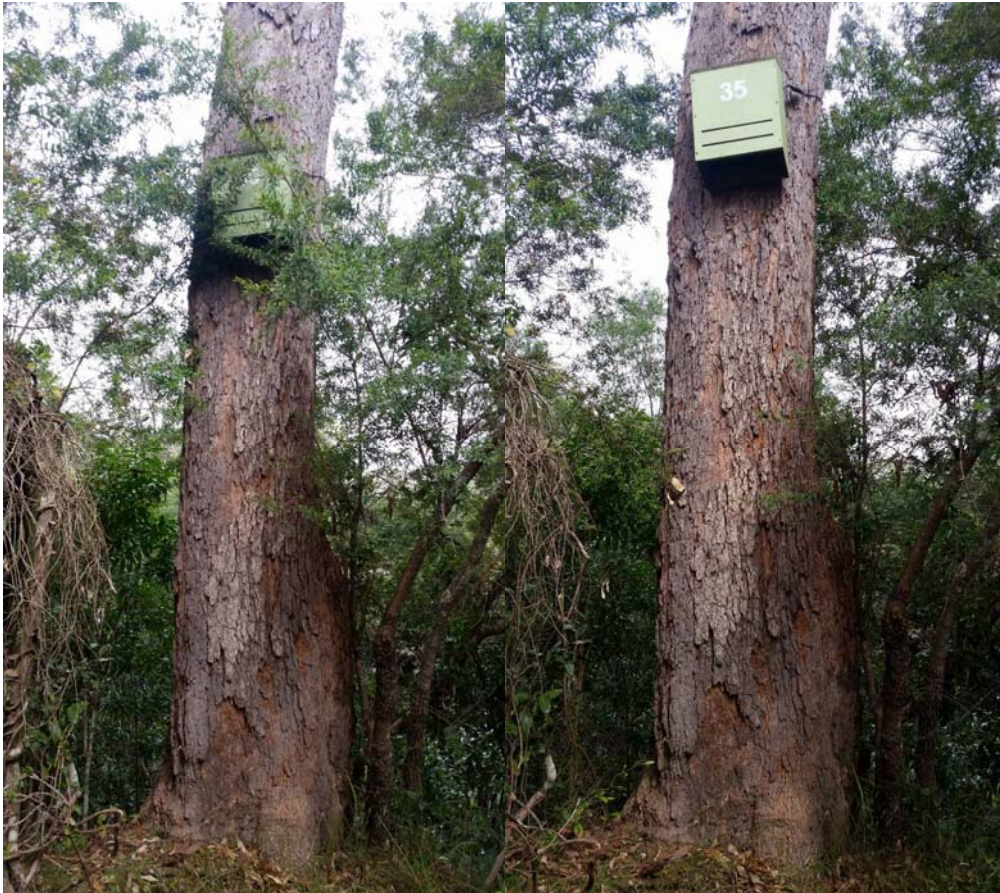
Plate 1-3. Bat Box 35 showing vegetation requiring removal (left) to improve its suitability for micro bats (right).

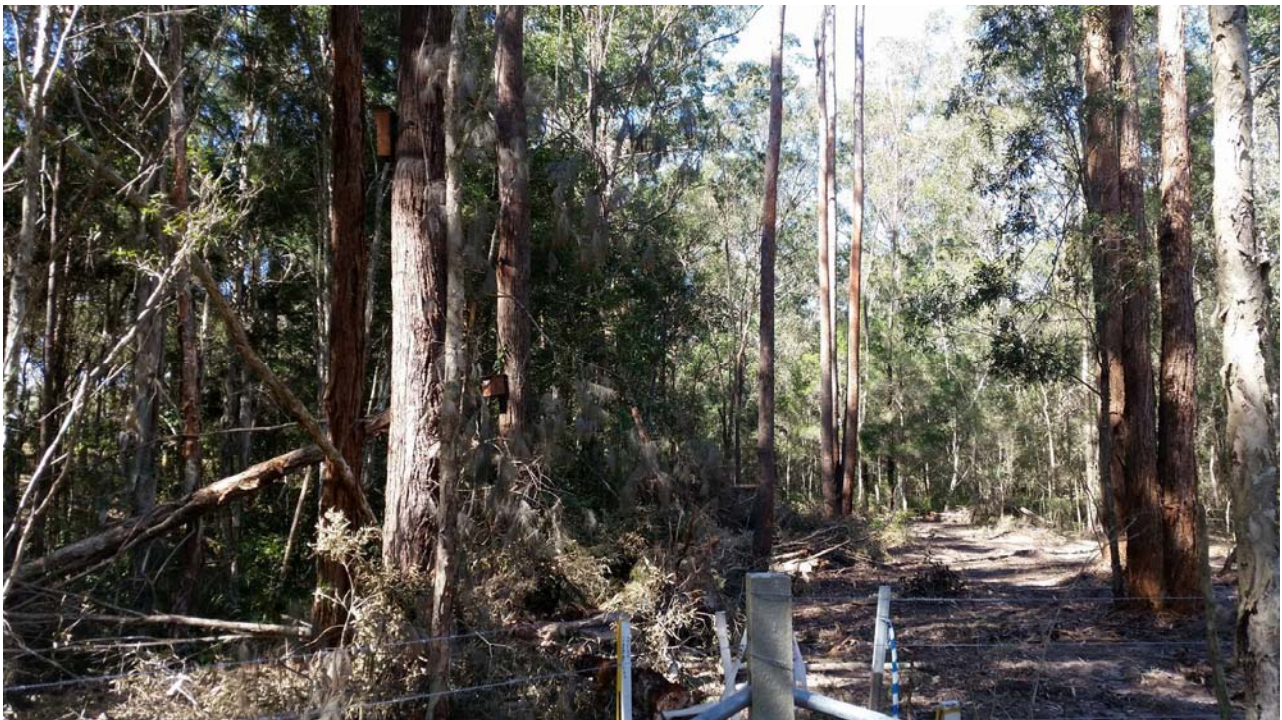
Plate 1-4. Clearing of vegetation around Bat Boxes 139 and 140 adjacent to Mobbs Drive.

With regard to the maintenance of the bat boxes, termites on both box number 54, 56, 68 remain dormant and at present the box shows no obvious structural damage that would limit its functionality. Continual evaluation of this will be required to ensure the boxes remain in a functional state during the remainder of the construction program. At Bat Box 35, vegetation growth was trimmed back to make this box more suitable to micro bats (Plate 1-3). At Bat Box 8, the Monkeys Rope (*Parsonsia straminea*) vines are starting to encapsulate the boxes entrance. Clearing was also reported Boxes 139 and 140 (Plate 1-4).

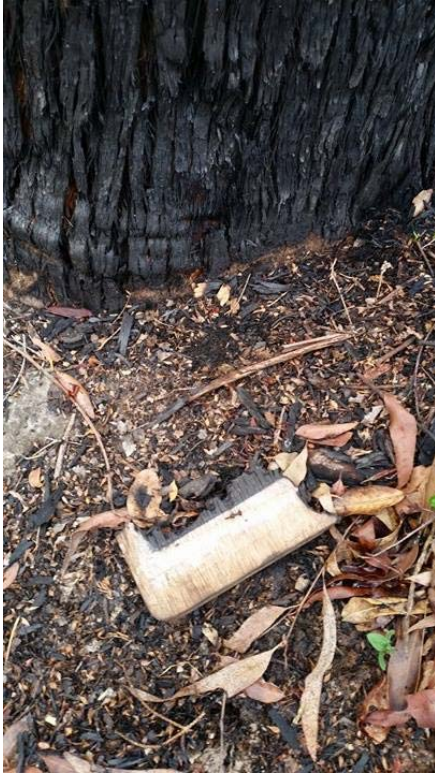
Plate 1-2. Remnants of Bat Box 49 from the southern side of Maria River.

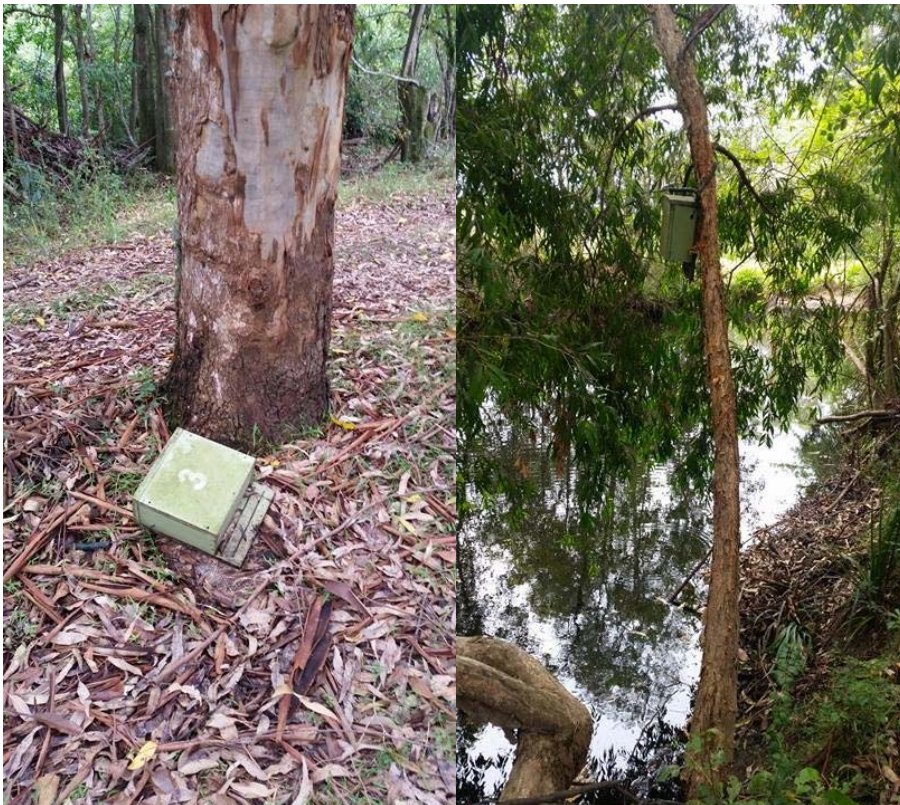
Plate 1-3. Bat Box 3 as located during Episode 10 monitoring (left) which has been subsequently relocated to an over water position 10 m to the north (right).
