Oxley Highway to Kempsey

2017-18 Annual Ecological Monitoring Report

Roads and Maritime Services | November 2018

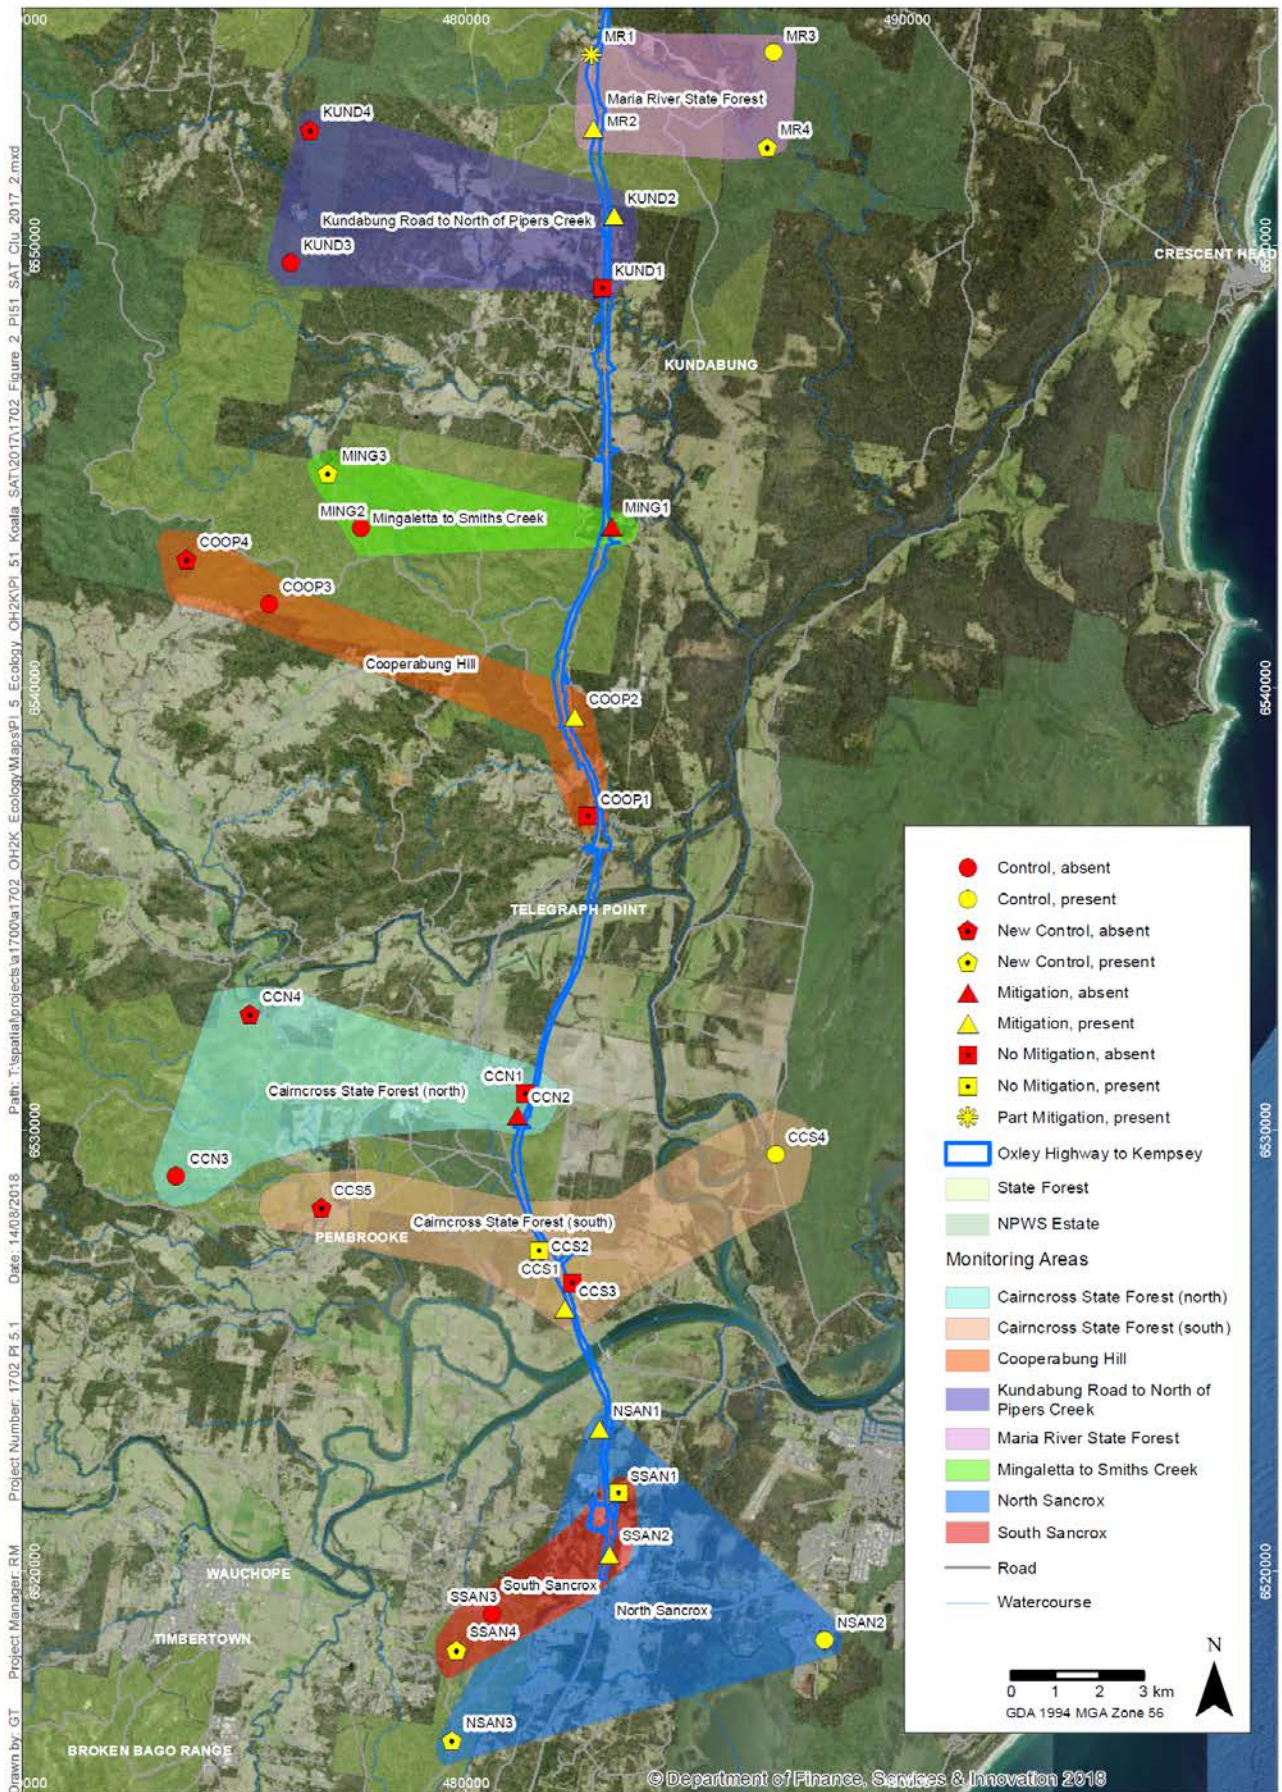
Koala SAT cluster results 2017
Oxley Highway to Kempsey - PI 5.1 Koala report

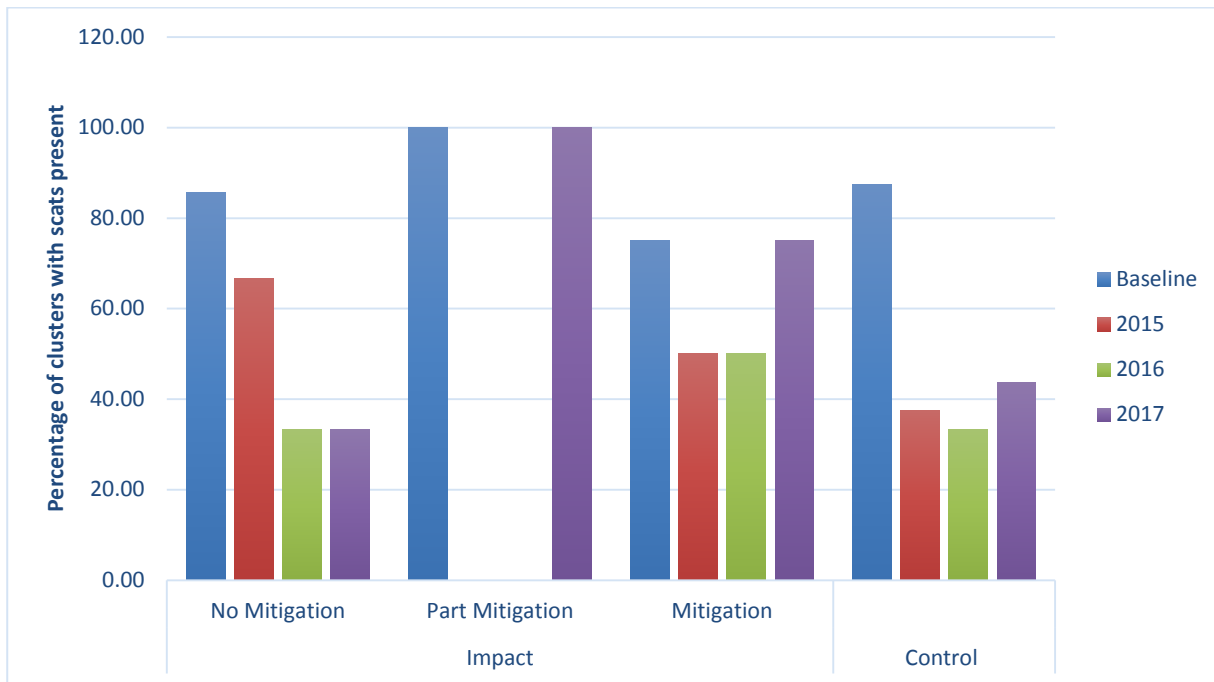
Graph 5: Koala presence and cluster type

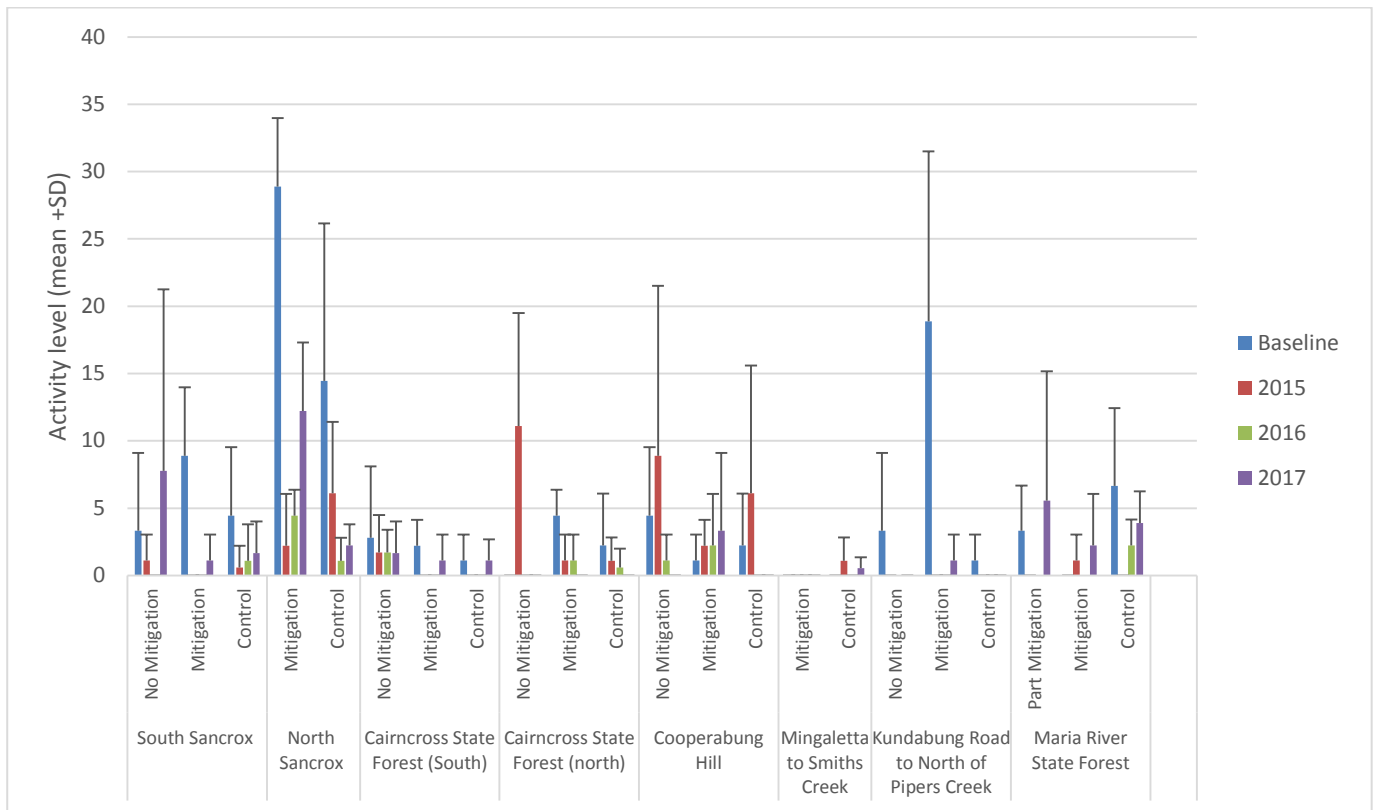
Graph 6. Mean Koala activity for cluster type within areas (mean ± SD)

Koala activity (mean activity of plots) for the cluster types is provided in Table 5 and is shown for each area in Graph 6 (mean activity of all plots within each cluster type for each area). When considering all plots, average activity levels have decreased from baseline levels for all treatments, including control plots. Lewis 2014 recommends that analyses should:

Activity levels for each treatment type have not decreased from the baseline surveys beyond the recommended 10% tolerance level. Nor is there a greater than 10% difference between treatment types.

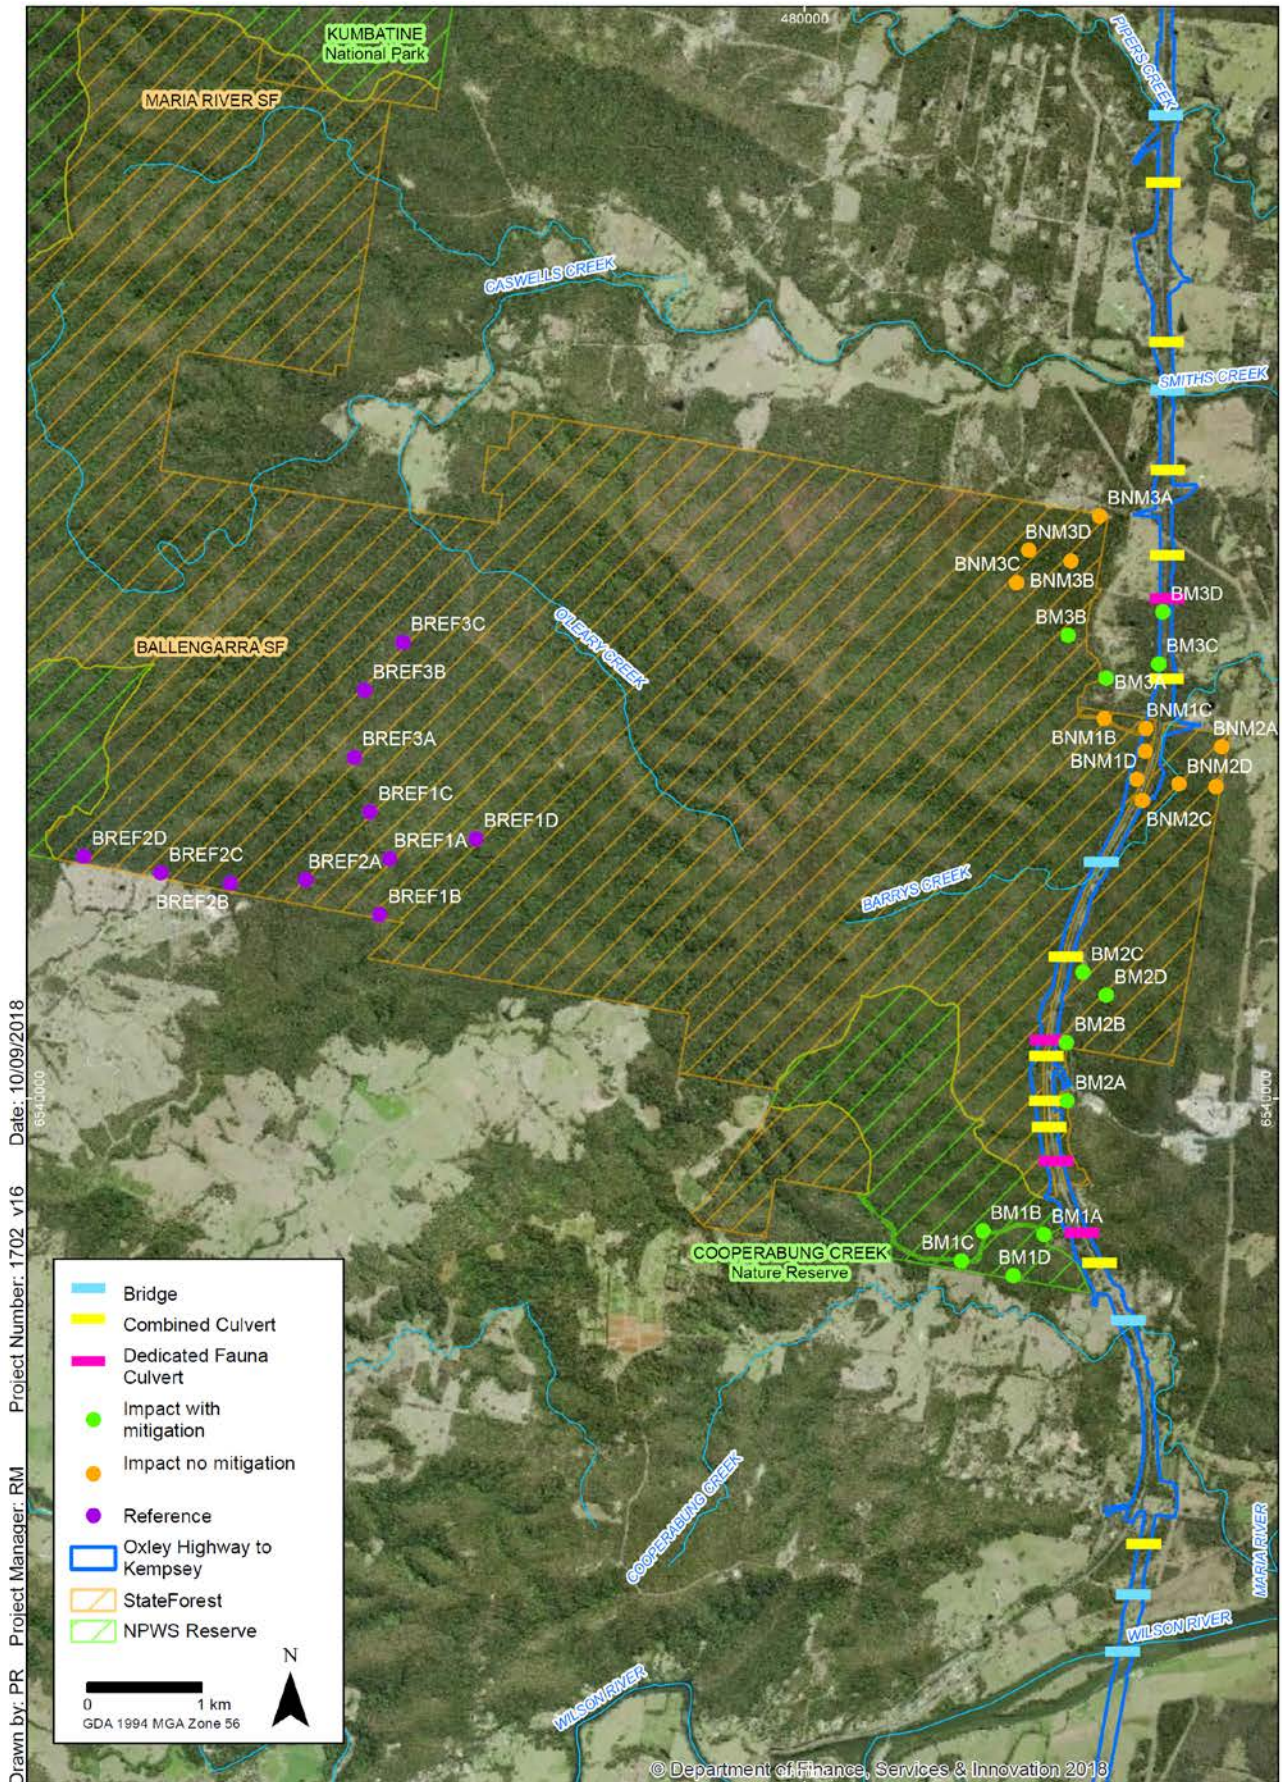
FIGURE 3

Ballengarra State Forest camera locations
Oxley Highway to Kempsey - Spotted-tailed Quoll Monitoring sites

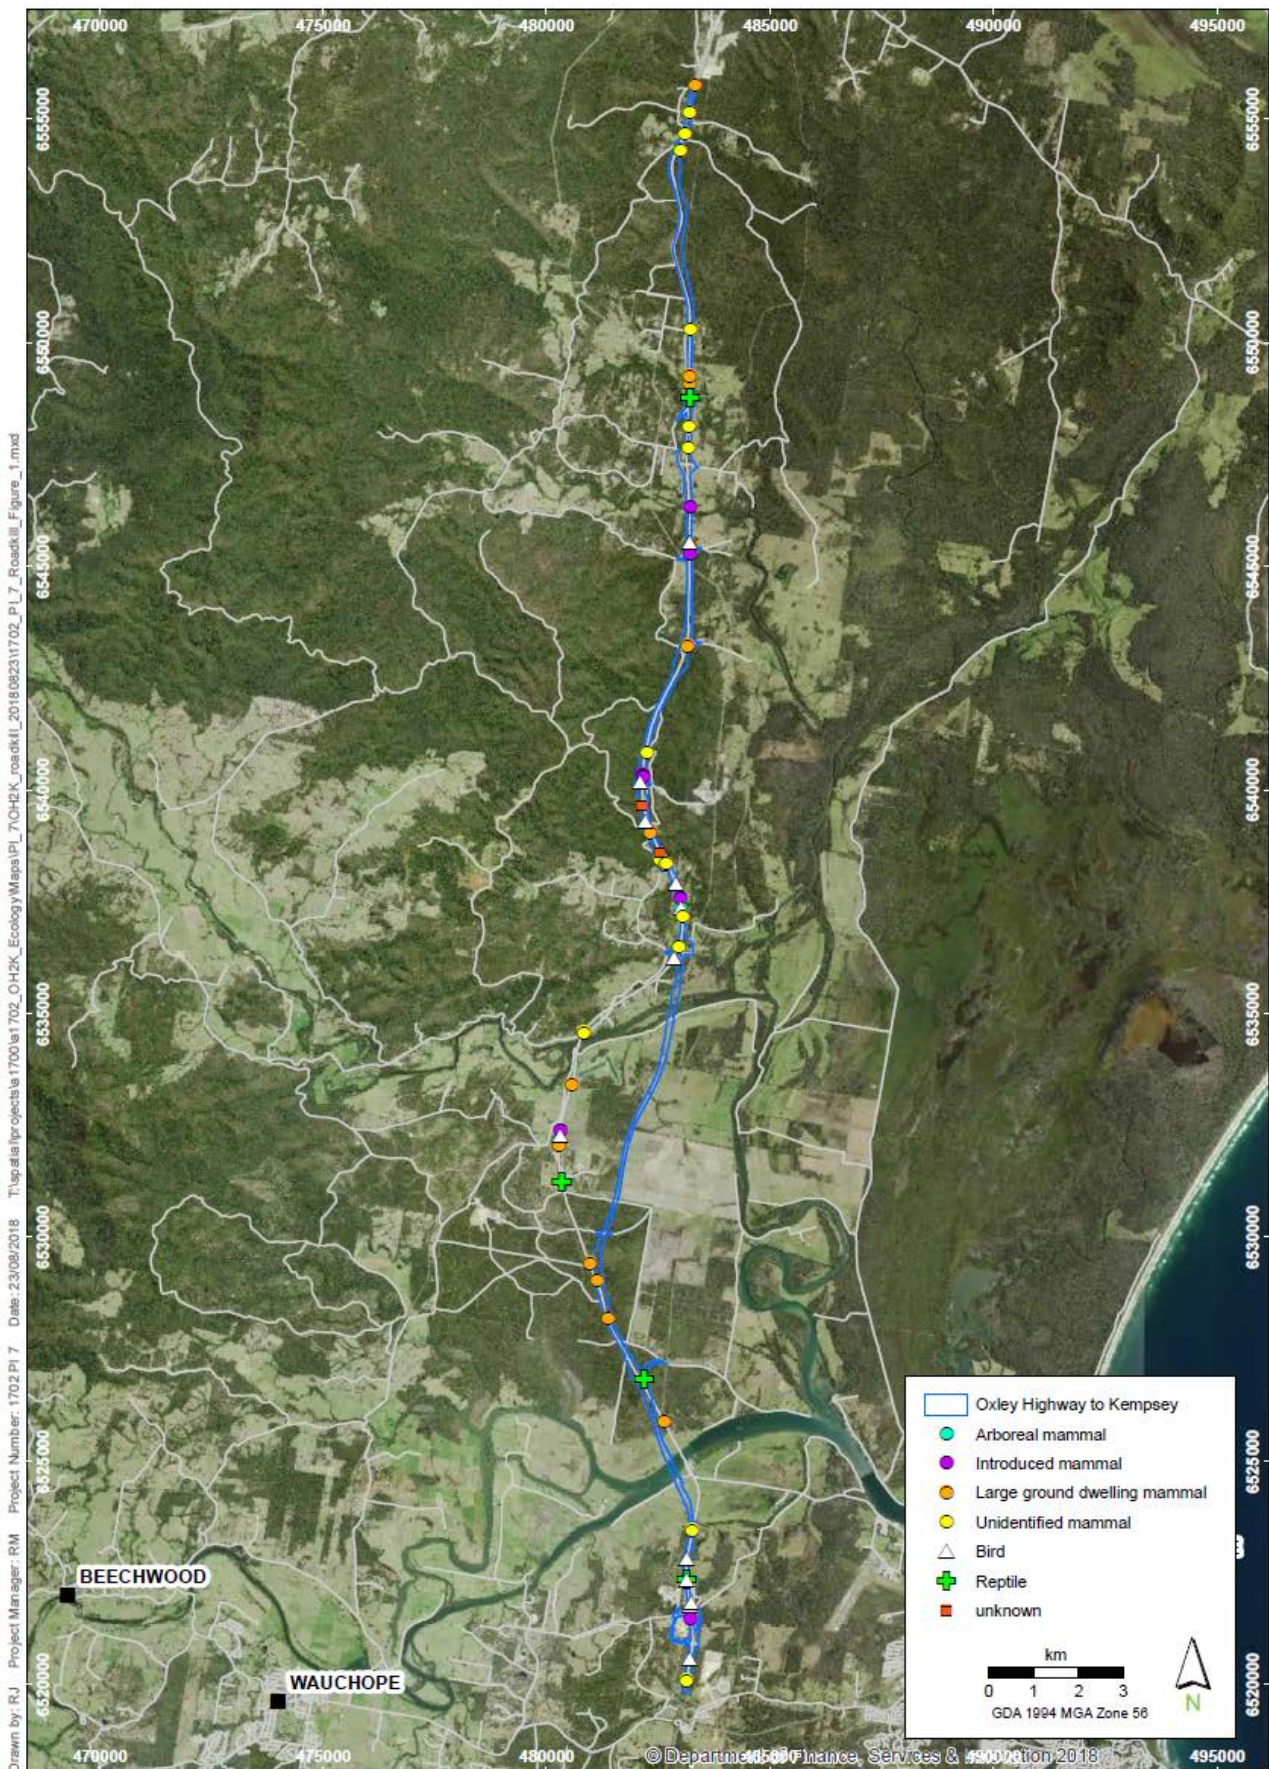
Distribution of road kill records: all construction monitoring 2017/2018

Current trends indicate an overall reduction in road kill incidence during construction activities and immediately after opening of the road to traffic. No threatened species were identified as road kill in the 2017/2018 monitoring period. As such there are no current recommendations based on the outcomes of the 2017/2018 monitoring period. The current results, for the most part, represent monitoring undertaken during the construction and post-construction/early operational phase of the road. It is considered too early at this stage to assess the relationship between mitigation measures (such as fauna underpasses and crossings) and road kill rates or patterns. Operational road kill monitoring is due to commence in spring 2018 and will provide further information as to the effectiveness of these measures.
