Second Annual Report for Post Construction Year 3, 4 and 6 Ecological Monitoring Devils Pulpit Pacific Highway Upgrade

Prepared for: NSW Roads and Maritime Services
© GeoLINK, 2019

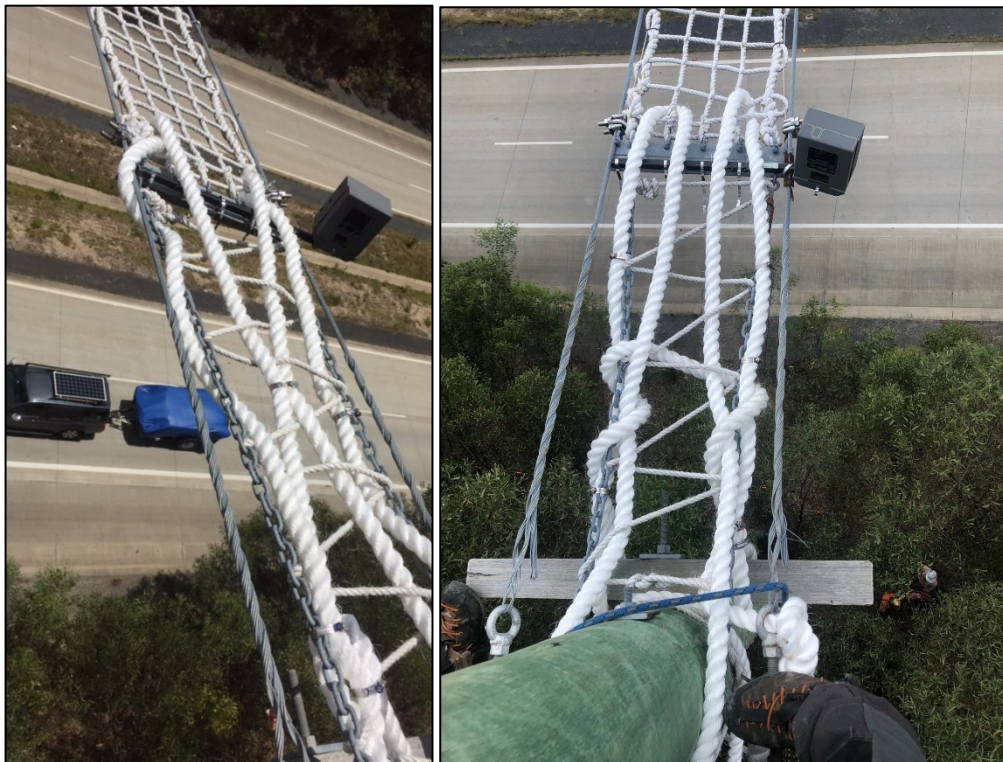
Plate 2.1 Silver rope addition at rope bridge chain on the eastern pole (left) and western pole (right)

- Installation of 30 mm diameter silver rope over the chained section of the rope bridge to provide linear opportunities for fauna movement on non-metal elements (thus reducing the chance of fauna slipping on the metal components when moving along the rope bridge (refer to **Plate 2.1**). This was undertaken at both the east and western poles following observations of fauna slipping on the metal components (refer to **Plate 2.1**).

- Installation of a release (weak) point on the western rope bridge ladder connecting the western pole and a large Pink Bloodwood (*Corymbia intermedia*). The tree has a fire scar and cracking at the base. The tree was identified as a risk of falling away from the highway and damaging the rope bridge structure. Decisions were made to install a release point rather than relocate the rope bridge ladder to a different tree or remove the tree. The release point included a 100 kg strength cable tie and hose clamp attached at the pole end of the ladder. The hose clamp is designed to allow the 30 mm silver rope to slide out upon excess force.

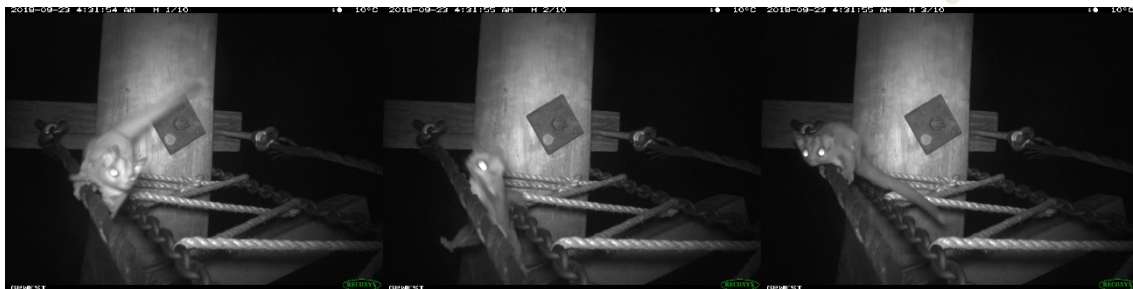
Plate 2.2 Image sequence of a Sugar Glider slipping then recovering on the metal wire component near the western rope bridge pole.

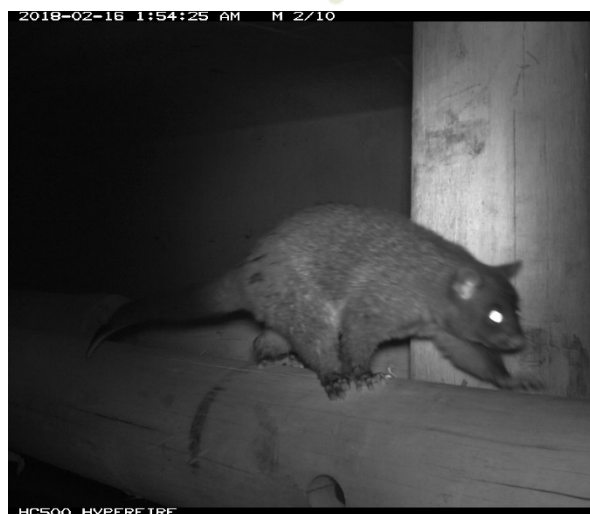
Plate 3.9 Short-eared Possum using fauna furniture at fauna underpass C6.
A complete crossing was recorded.

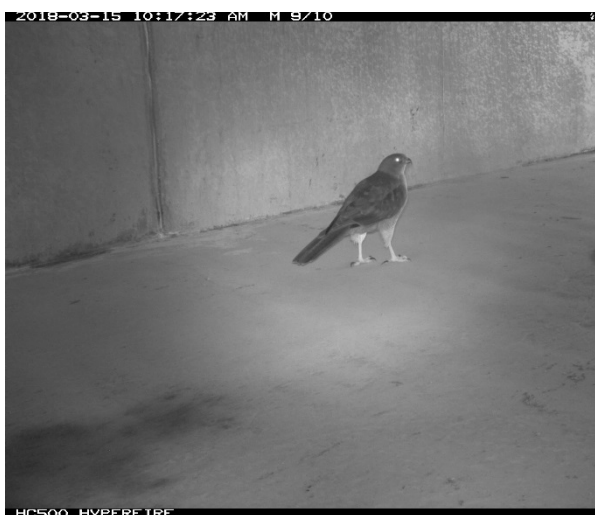
Plate 3.10 Brown Goshawk in the middle of fauna underpass C7.
A complete crossing was recorded. Brown Goshawks were regularly recorded at the underpasses (in particular moving along fauna furniture).

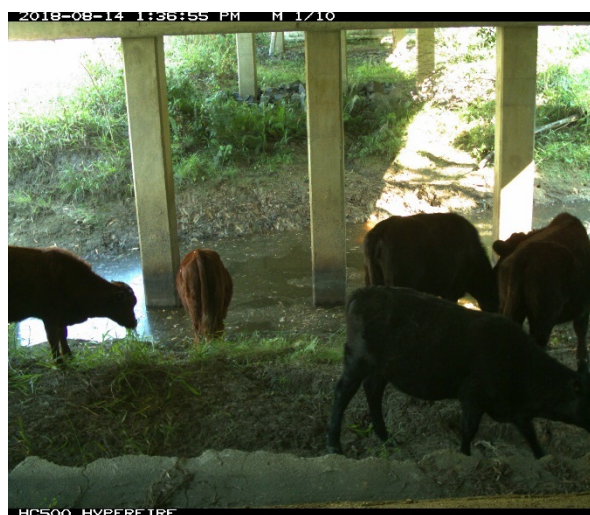
Plate 3.11 Domestic cattle at NBT3.
The cattle were from private land to the east that escaped onto RMS land.

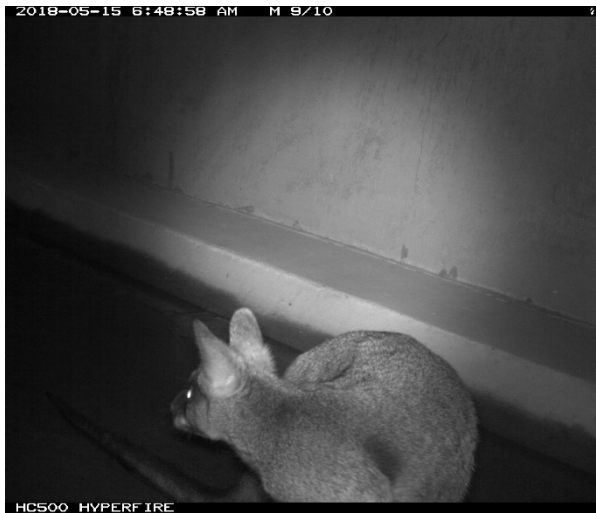
Plate 3.12 A Swamp Wallaby in the middle of fauna underpass C8.
A return was recorded.

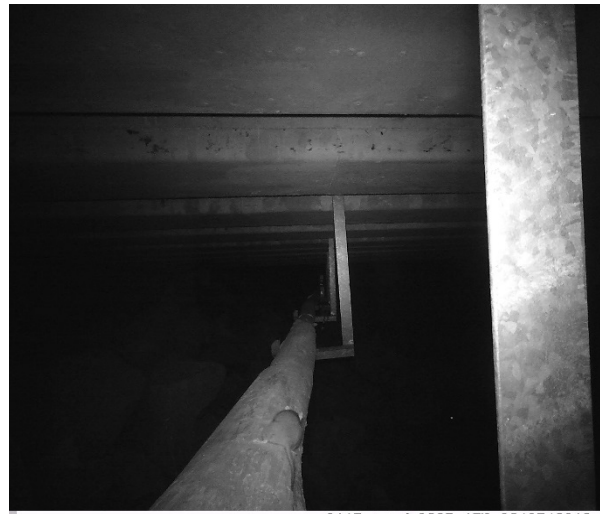
Plate 3.13 A Yellow-footed Antechinus using the fauna furniture at SBT2.
A complete crossing was not recorded.

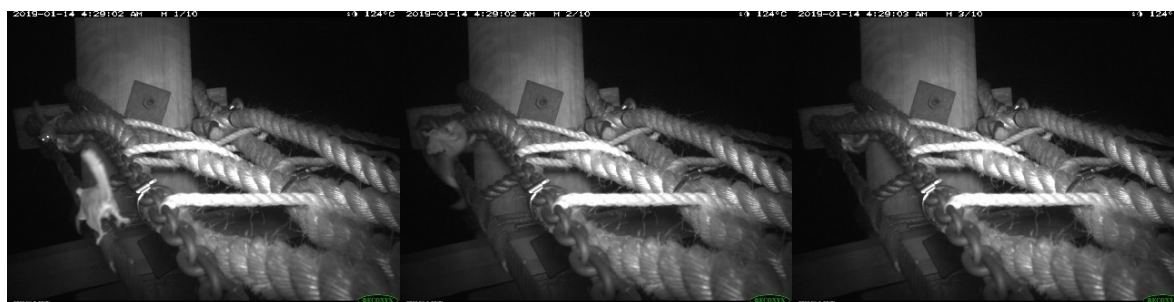
Plate 3.14 Two feathertail Gliders having a territorial dispute at the eastern rope bridge pole.
A likely complete crossing was recorded in this instance.

However directional movements were not consistent at each end of the rope bridge. It is also plausible that gliders were present at each end of the rope bridge on the same night and did not cross. On one occasion, two gliders had a territorial dispute at the eastern rope bridge pole, after one glider approached from the west (this was recorded as a potential complete crossing; refer to **Plate 3.14**).

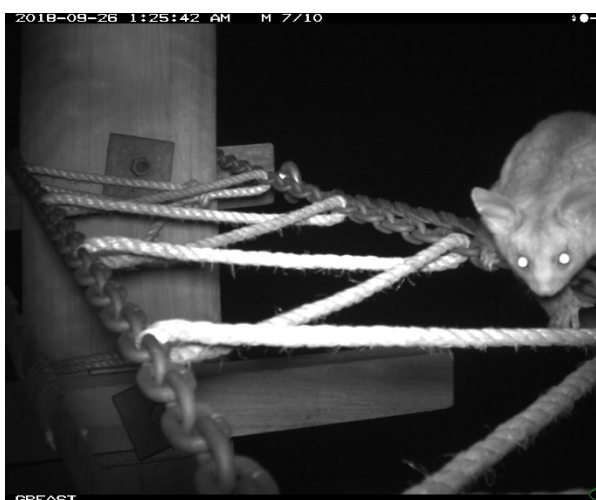
Plate 3.15 Yellow-bellied Glider at the eastern rope bridge pole.
A complete crossing was not recorded in this instance.

The Yellow-bellied Glider record was obtained on the eastern side of the rope bridge moving to the west along the rope bridge (refer to **Plate 3.15** and **Plate 3.16**). The image sequence does not show the animal going completely past the camera, with the last image showing the animal moving backwards slightly. No Yellow-bellied Glider images were recorded at the western side of the rope bridge; therefore a complete crossing was not confirmed.

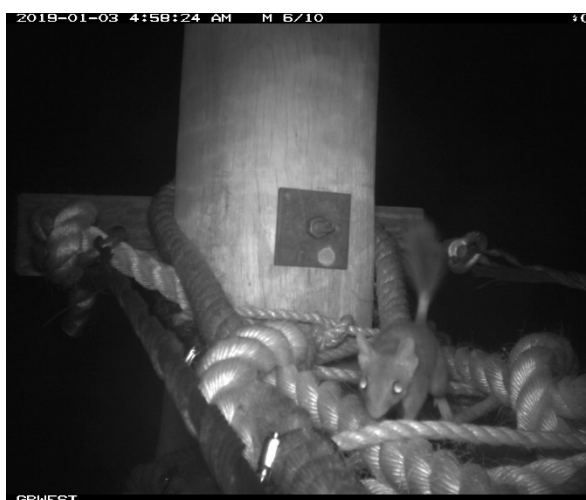
Plate 3.16 Brush-tailed Phascogale on the western rope bridge pole.
The image sequence shows the animal return to the pole.
