Warrell Creek to Nambucca Heads

Grey-headed Flying Fox – Operational Habitat Monitoring

Roads and Maritime Services | 201J

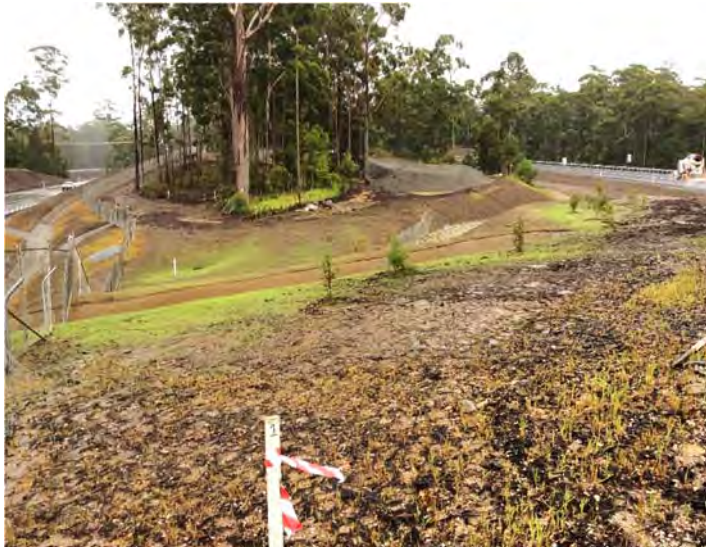
<p>Photo Point RS1 – view to the south</p>

The results of the rehabilitation site monitoring are detailed in Table 5 along with photos from the four photo points that were established. Plantings at these sites are either young or have not been undertaken (in the case of the rehabilitation site at the 15c ancillary compound).

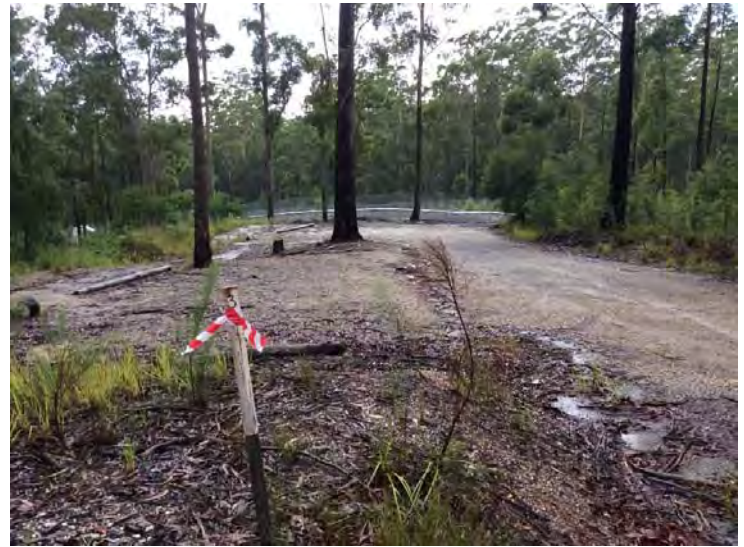
<p>Photo Point RS3 - view to the east, no rehabilitation works started at time of monitoring.</p>

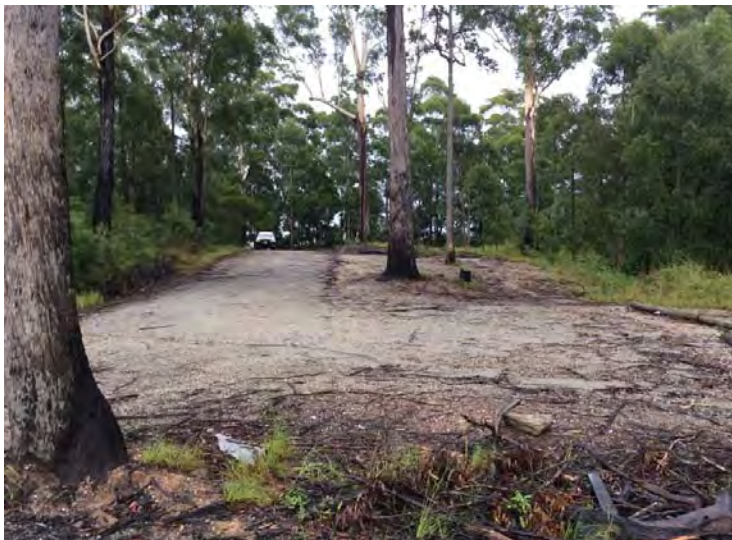
<p>Site reference photo view to the west looking towards Photo Point #3, no rehabilitation works started at time of monitoring.</p>

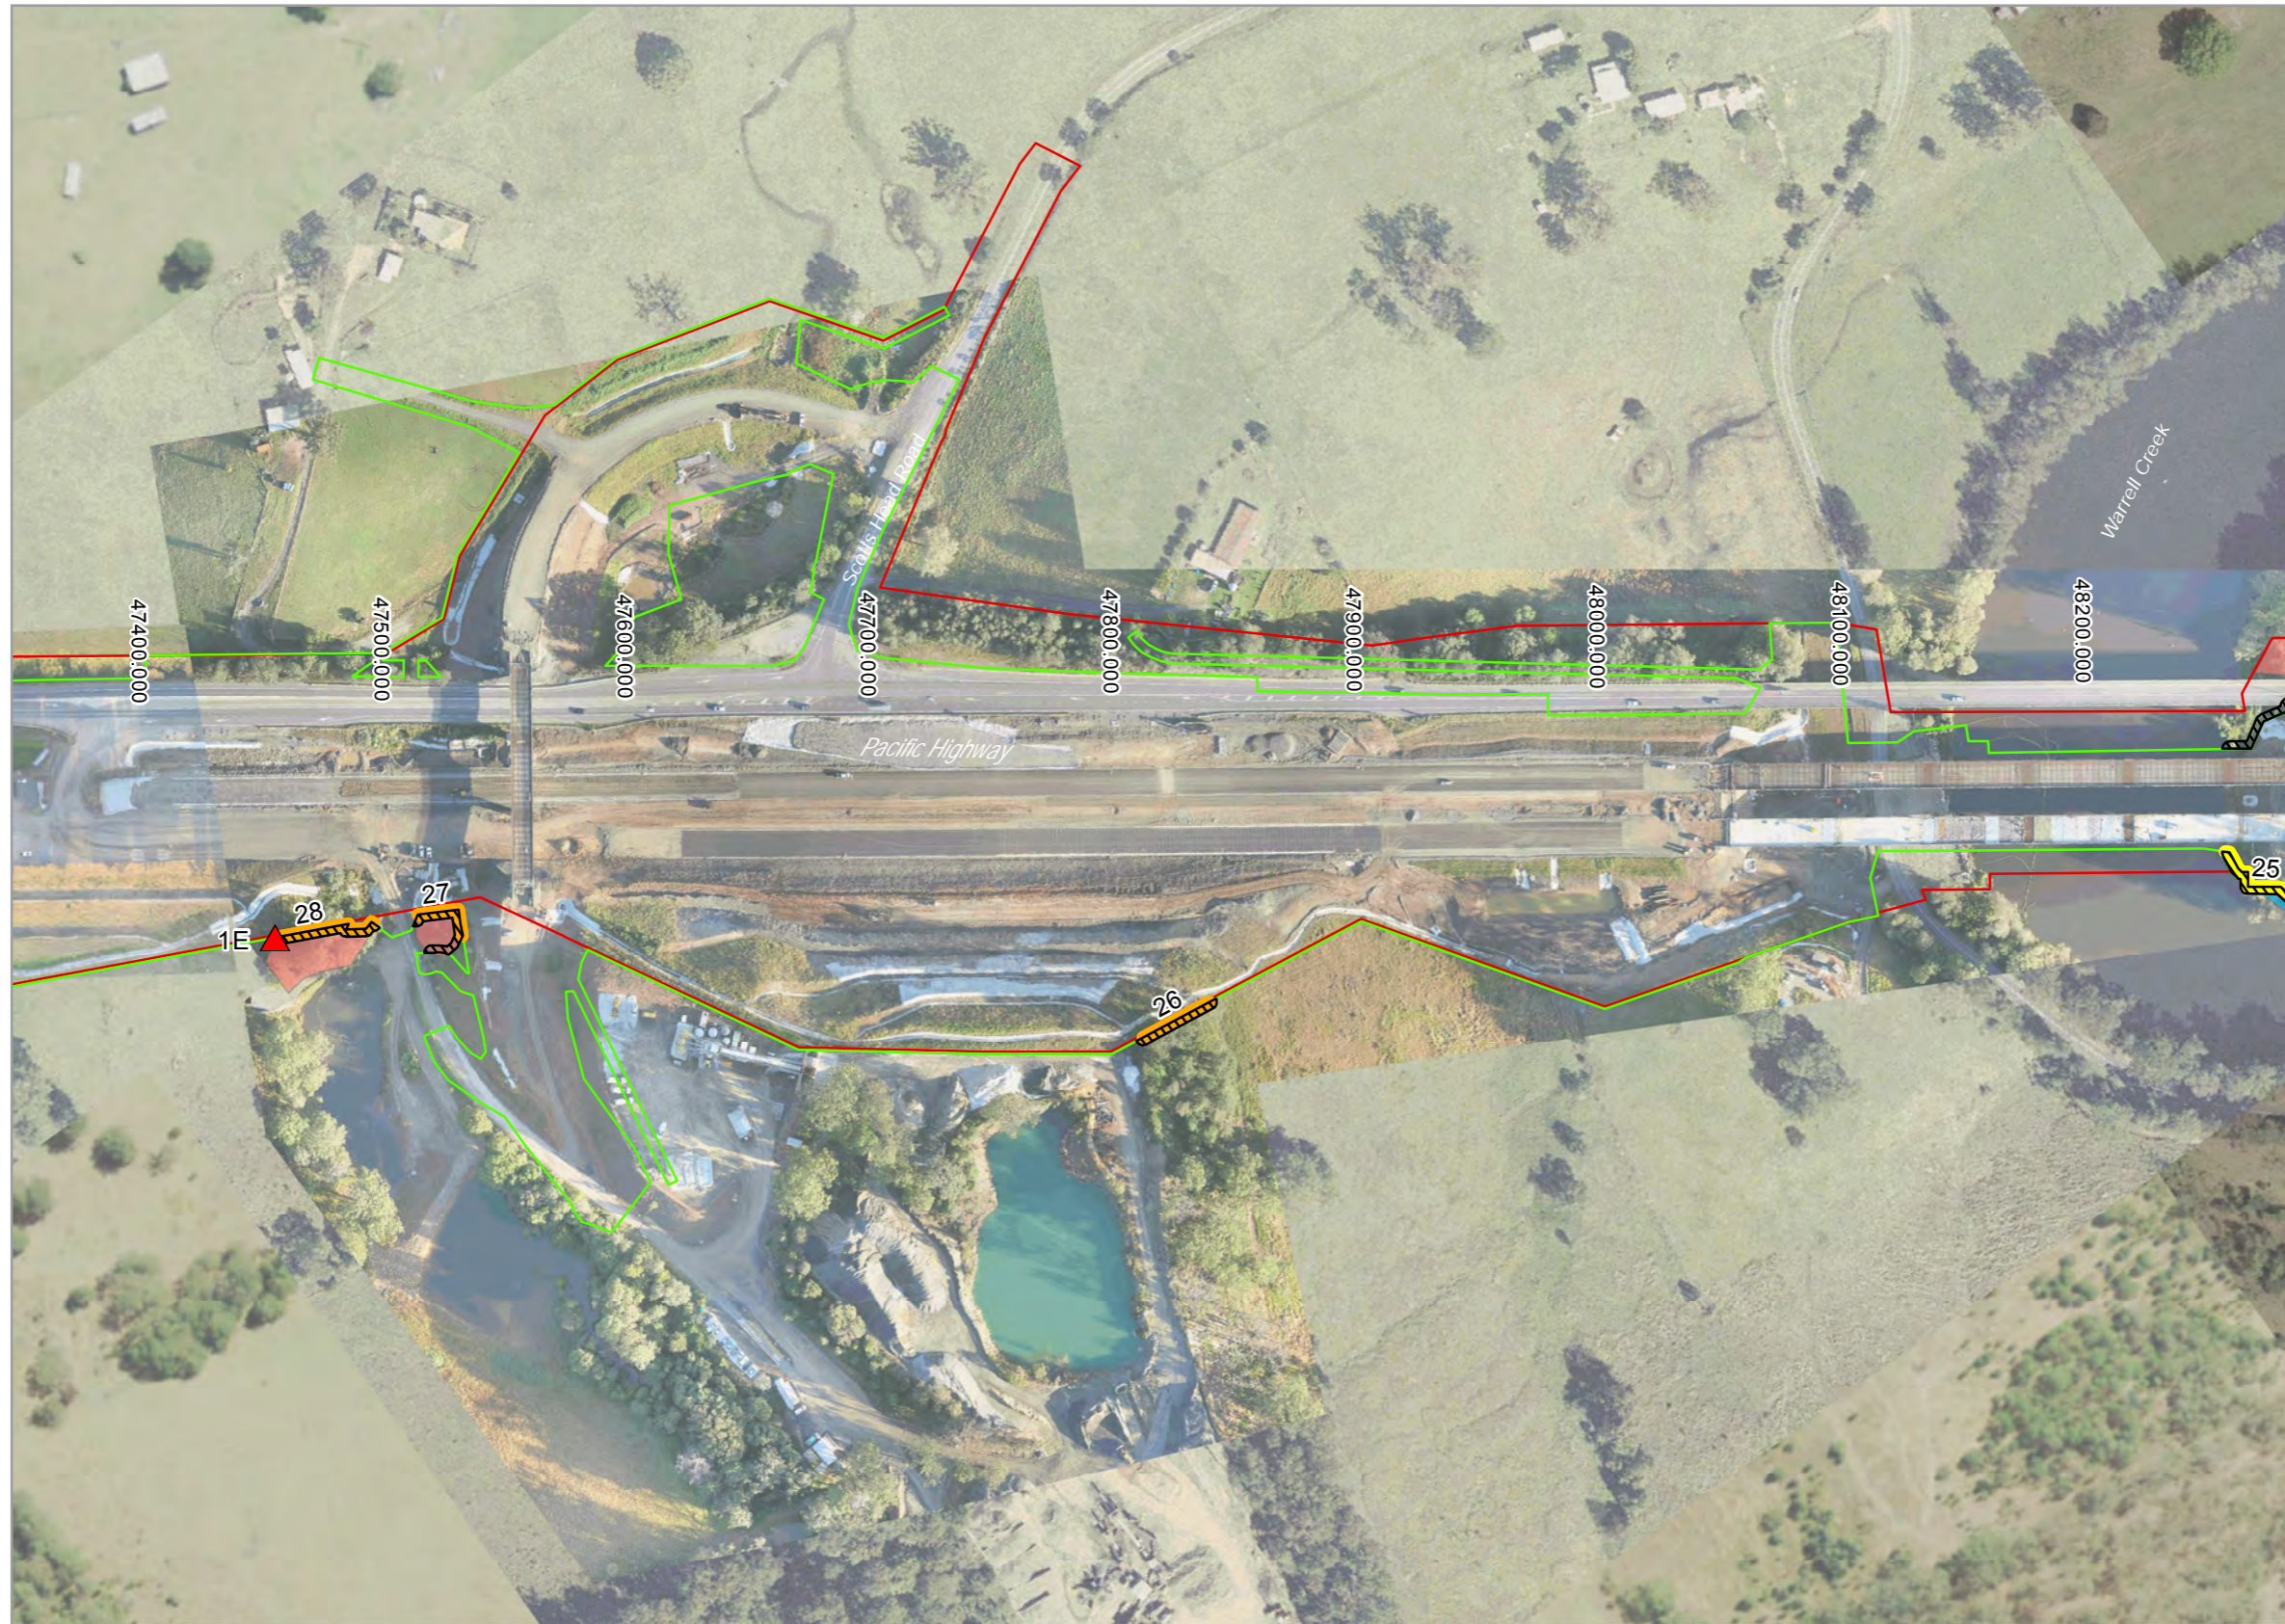
GHFF Weed Survey Areas and Weed Infestation Levels (February 2018)

One weed occurrence area (site 25) was considered to have a high weed management priority and nine areas were considered to have a medium weed management priority (sites 5, 16, 18, 22, 23, 24, 26, 27 and 28). These areas should be targeted during weed management works.

Site 25 comprises an understorey dominated by Lantana. Site 16 encompasses eight discrete small areas of Flooded Gum Moist Open Forest generally in association with small low-lying gullies. In these areas infestations of Lantana are prominent, with some gullies recording densities of >25% to >50% cover. With the potential for Lantana to alter community structure and inhibit regeneration, sites 25 and 16 are important target areas to avoid any degradation to GHFF habitat.

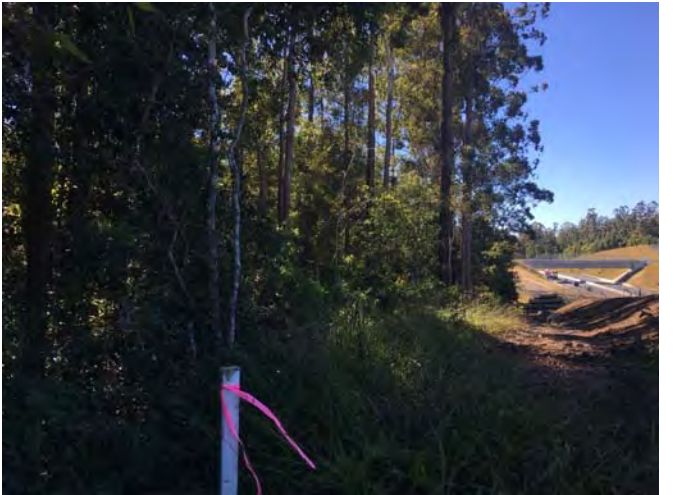
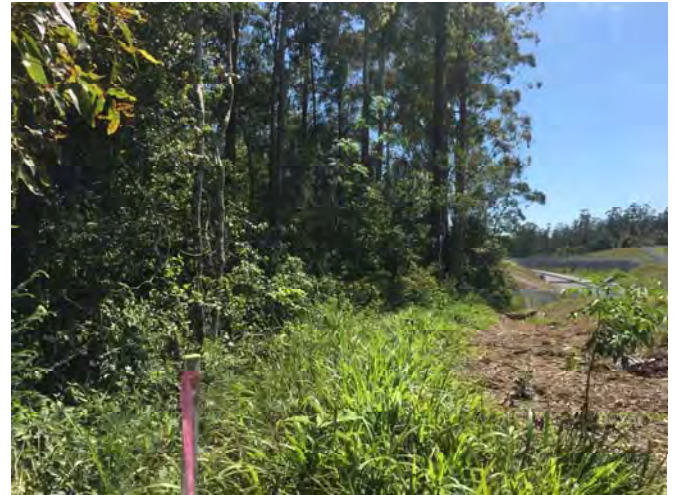
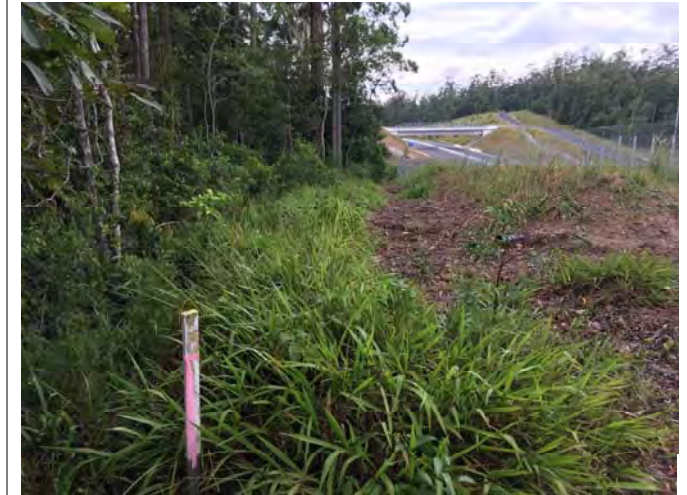
Photo Point ID *	Photo Point GPS Coordinates^	July 2018 photograph	October 2018 photograph	January 2019 photograph
2BW	489407, 6594440

No significant change to the structure or composition of GHFF habitat has been recorded during fixed photo point monitoring. No exotic vines with the potential to inhibit native regeneration and smother the canopy of intact GHFF habitat were observed.
