Frederickton to Eungai

2019 Annual Ecological Monitoring Report

Roads and Maritime Services | February 2020

Hairy Joint Grass Monitoring 2018/2019

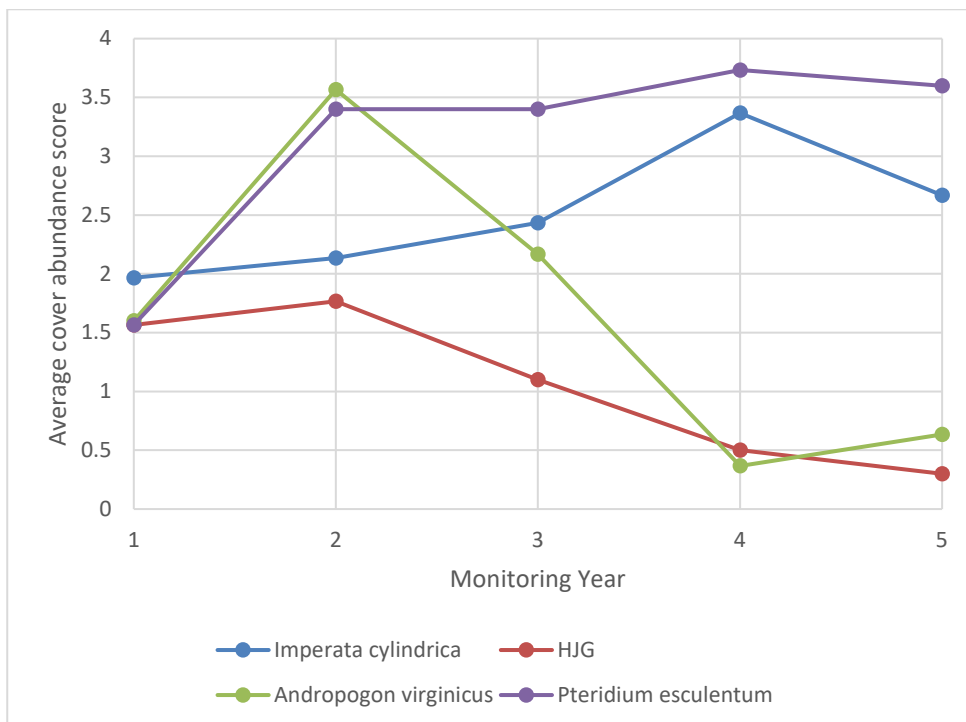
Graph 2: Average annual cover abundance of dominant species at impact site 2HW

A substantial decrease in HJG records and flowering/seeding over successive monitoring events was observed at site 2HW. However this cannot be attributed directly to the Project as the previously identified paired control site could not be accessed subsequent to the first monitoring period.

Flowering/seeding was recorded in autumn only. Recruitment was observed during all surveys in each of the quadrats where the species was recorded. Total quadrats recording flowering/seeding has decreased over all monitoring events: 2014/2015 (n = 8, 27%), 2015/2016 (n = 6, 20%), 2016/2017 (n = 2, 7%), 2017/2018 (n = 1, 3%) and 2018/2019 (n = 1, 3%). **This equates to a substantial decrease (> 15%) in the flowering/seeding records between the 2014/2015 and 2016/2017 and the 2014/2015 and 2018/2019 monitoring events.** Recruitment at this site also decreased between 2015/2016 (n = 10, 33%) and 2016/2017 (n = 4, 13%) but increased in 2017/2018 (n = 6, 20%) and was similar in 2018/2019 (n = 5, 17%). Substantial decreases observed at site 2HW cannot be attributed directly to the Project as the control site is not available for comparison.

Site 2HW has shown progressive substantial reductions in the presence of HJG. However, ongoing monitoring of this site (and others) would be futile given the lack of control sites for comparison. Ongoing monitoring is therefore not recommended for HJG.

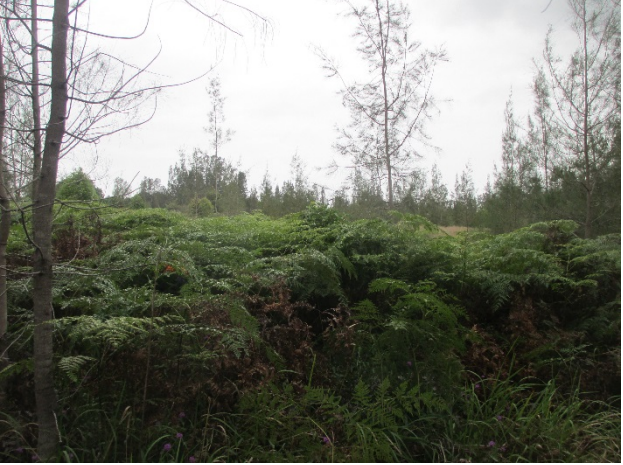
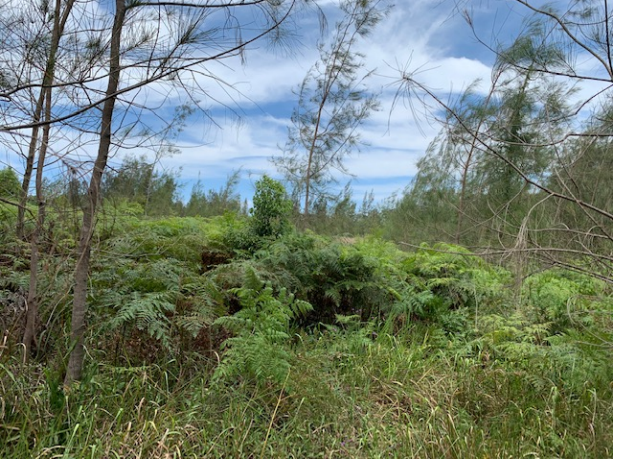
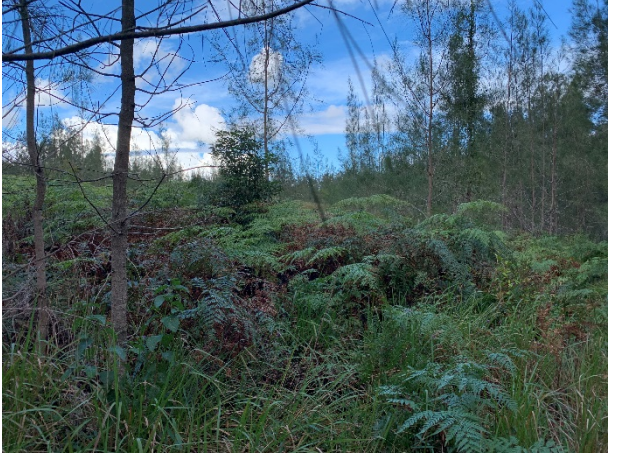
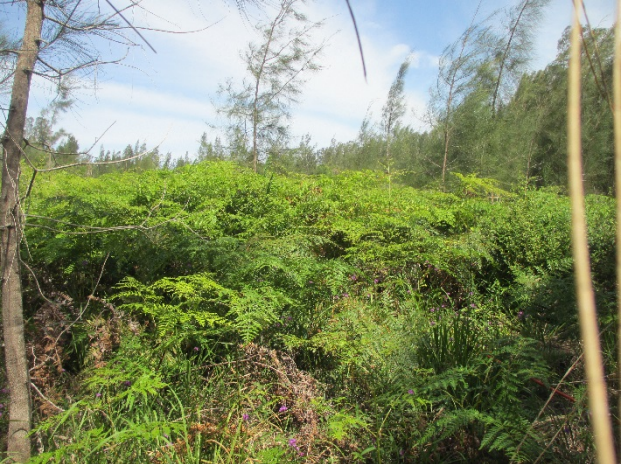
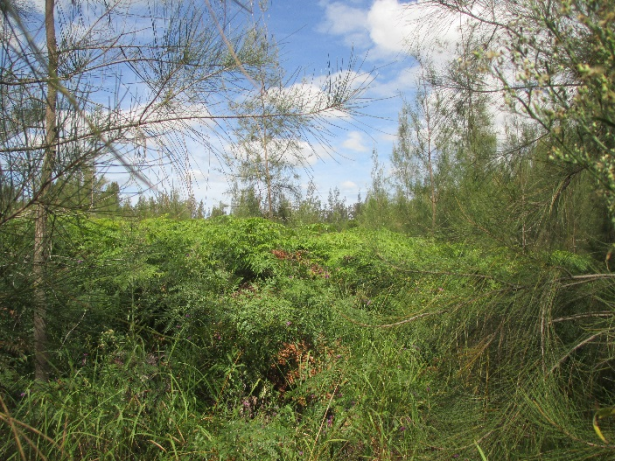
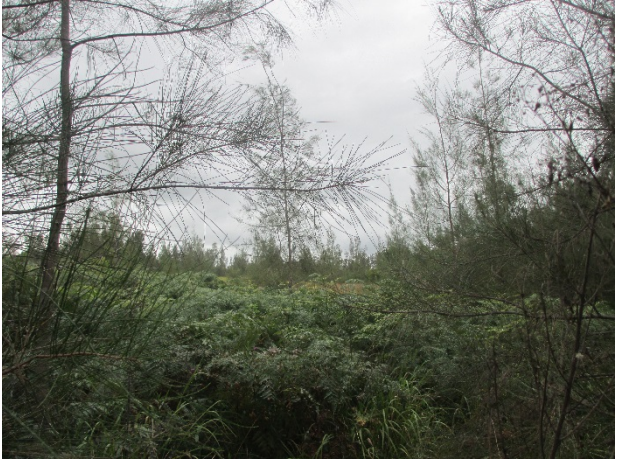
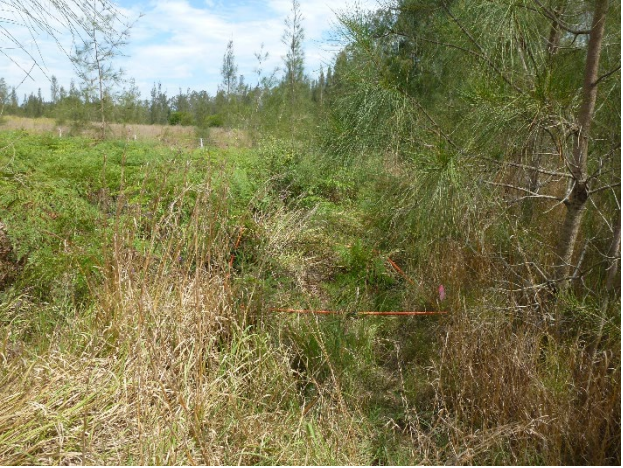
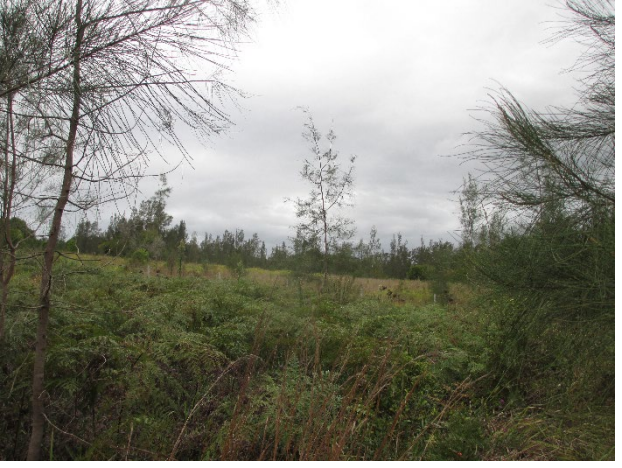
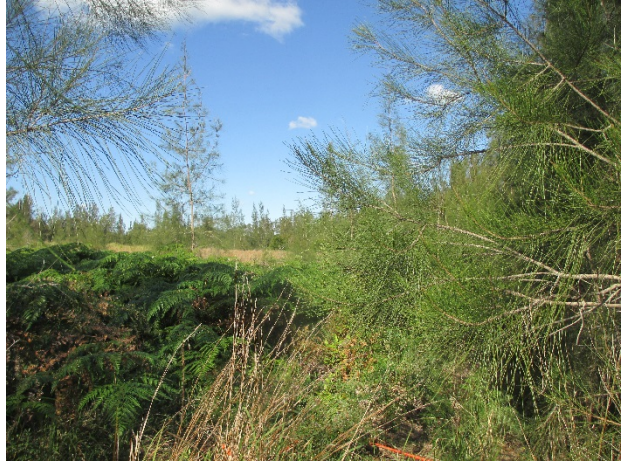
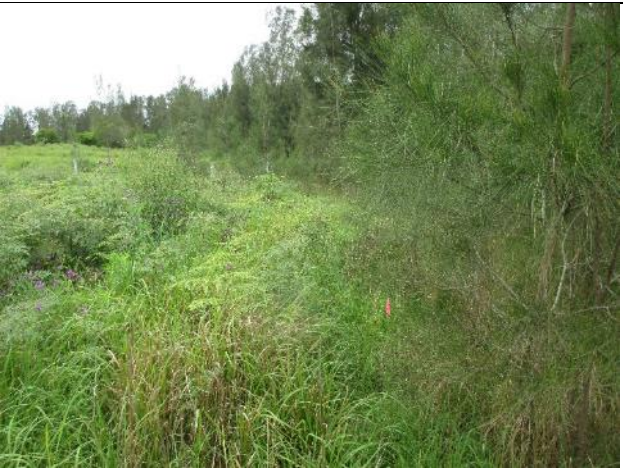
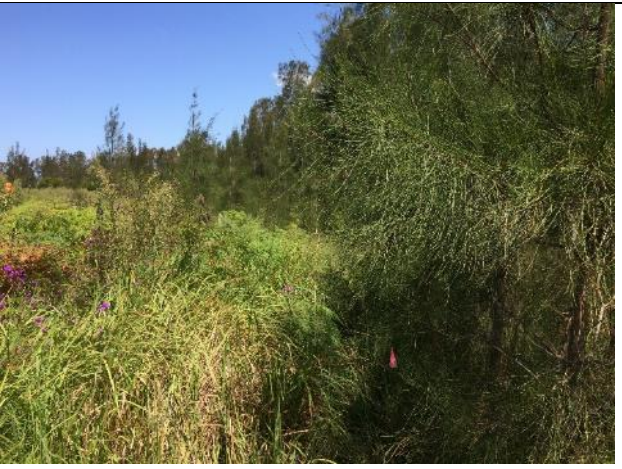
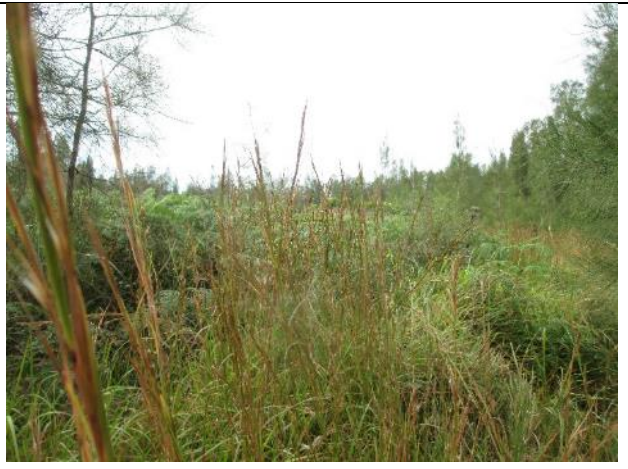
Site 1HE photo monitoring

During the 2018/2019 monitoring period HJG was recorded at two of the impact sites (1HE and 2HW), but was not recorded at 3CN or 3HN. Flowering/seeding and recruitment was observed at both 1HE and 2HW where the species was detected. The species remained absent from impact site 3HN, where it has never been detected, and from control site 3CN where it has not been recorded since 2016/2017.

Ongoing monitoring is not recommended for HJG due to the lack of control sites from which conclusions could be drawn. While it is not possible to directly attribute the reduction in presence and cover abundance of HJG to works associated with the Project due to the absence of control sites, it is considered likely that changes in land use associated with the Project have resulted in changes in species composition, habitat suitability and increased competition for HJG. Given the new and ongoing land use and maintenance regime of impact sites will not change, and that concurrent management of adjacent areas within private land is unlikely to occur, management actions are unlikely to be effective in the long term.

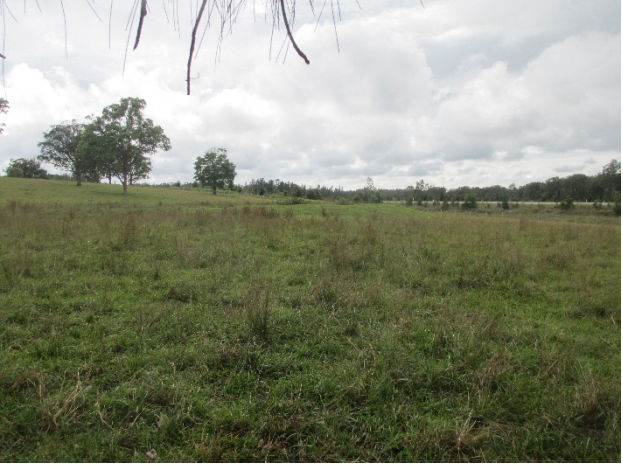
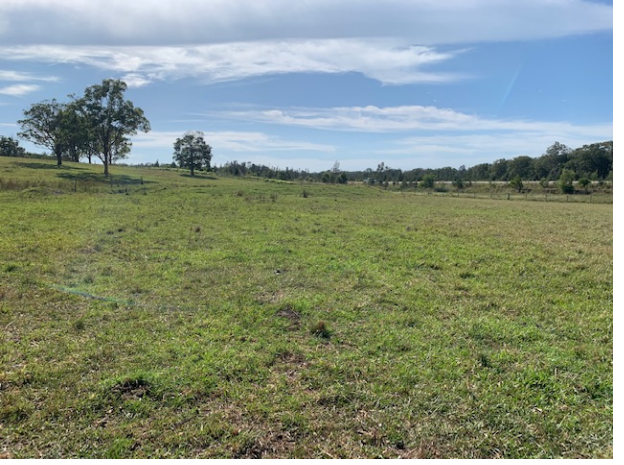
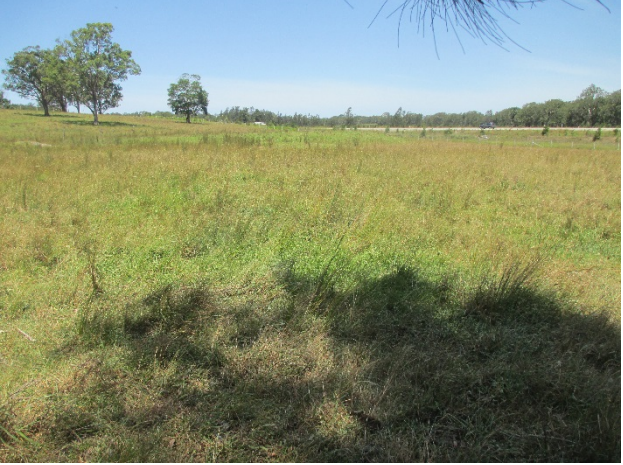
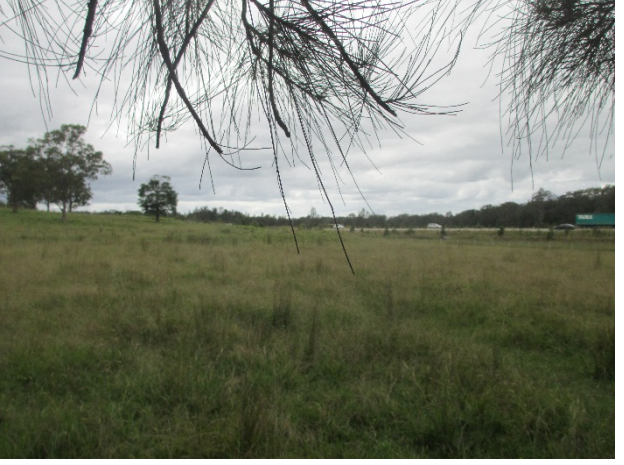
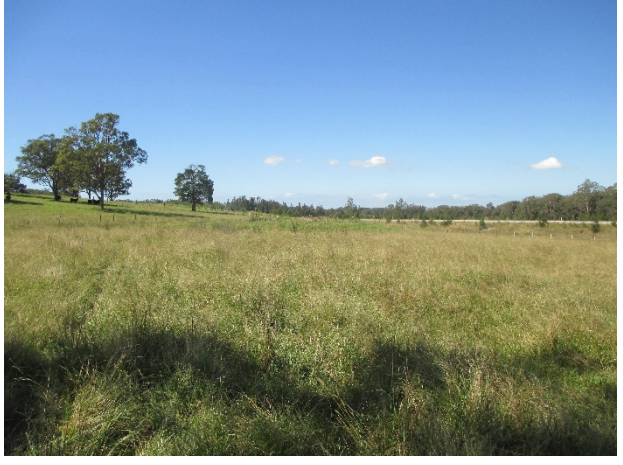
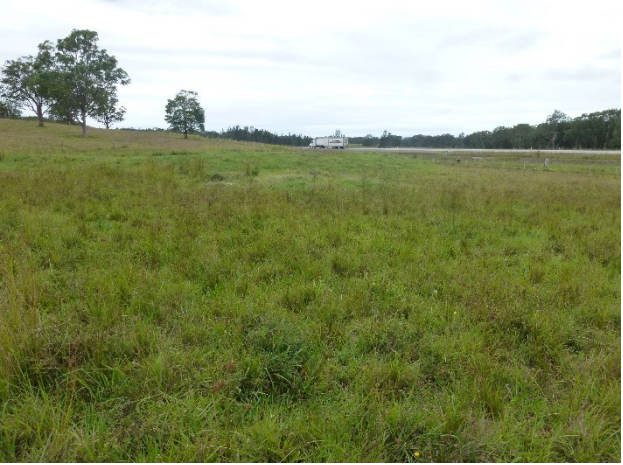
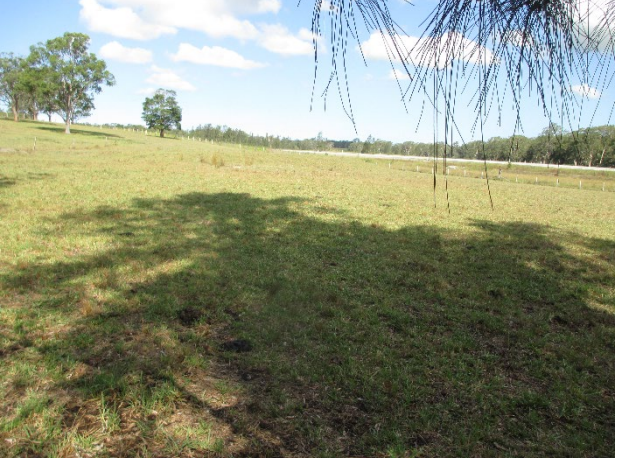
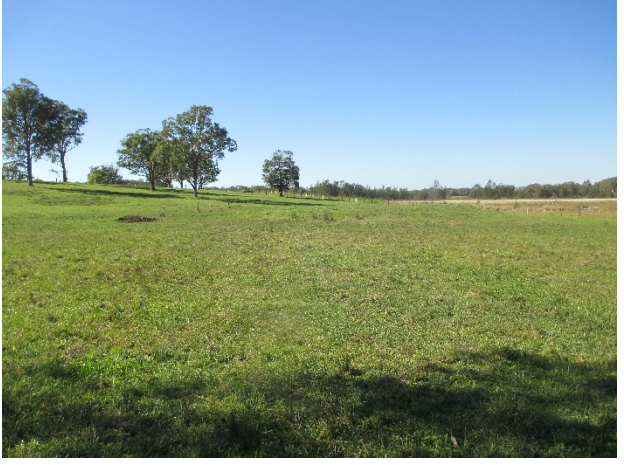
Site 3CN photo monitoring

- The 3CN control site is considered to be unsuitable to be used in statistical comparisons with the other sites due to the difference in the condition treatment of this site (3CN site is grazed) that may itself result in any differences seen.
- Due to the broad cover abundance range within each Braun-Blanquet score, it is not possible to determine whether a substantial difference has occurred between sites where the Braun-Blanquet Scale score of '3' (i.e. 5-25% cover) or above has been applied, as the percent range exceeds the 15% threshold for detecting change. A smaller percent cover score (e.g. 1-5% increments) should be considered for future monitoring to improve the detectability of change.

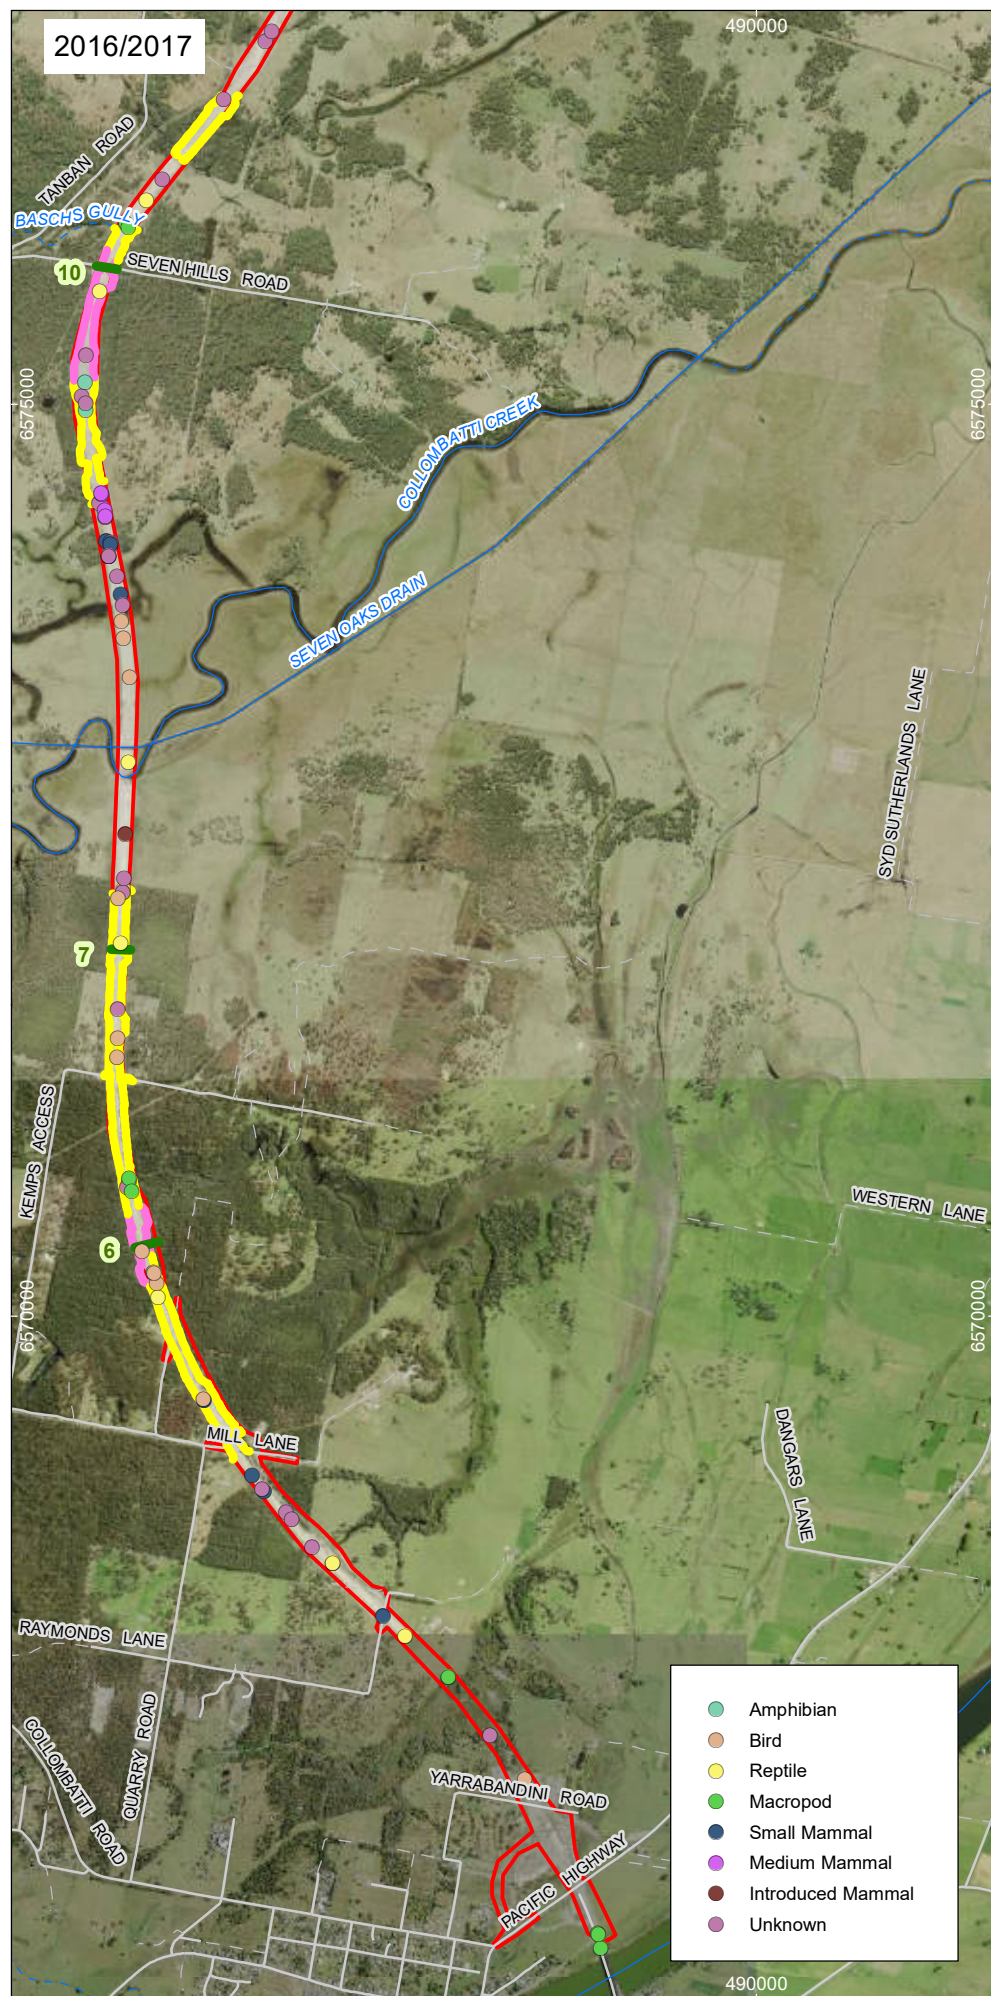
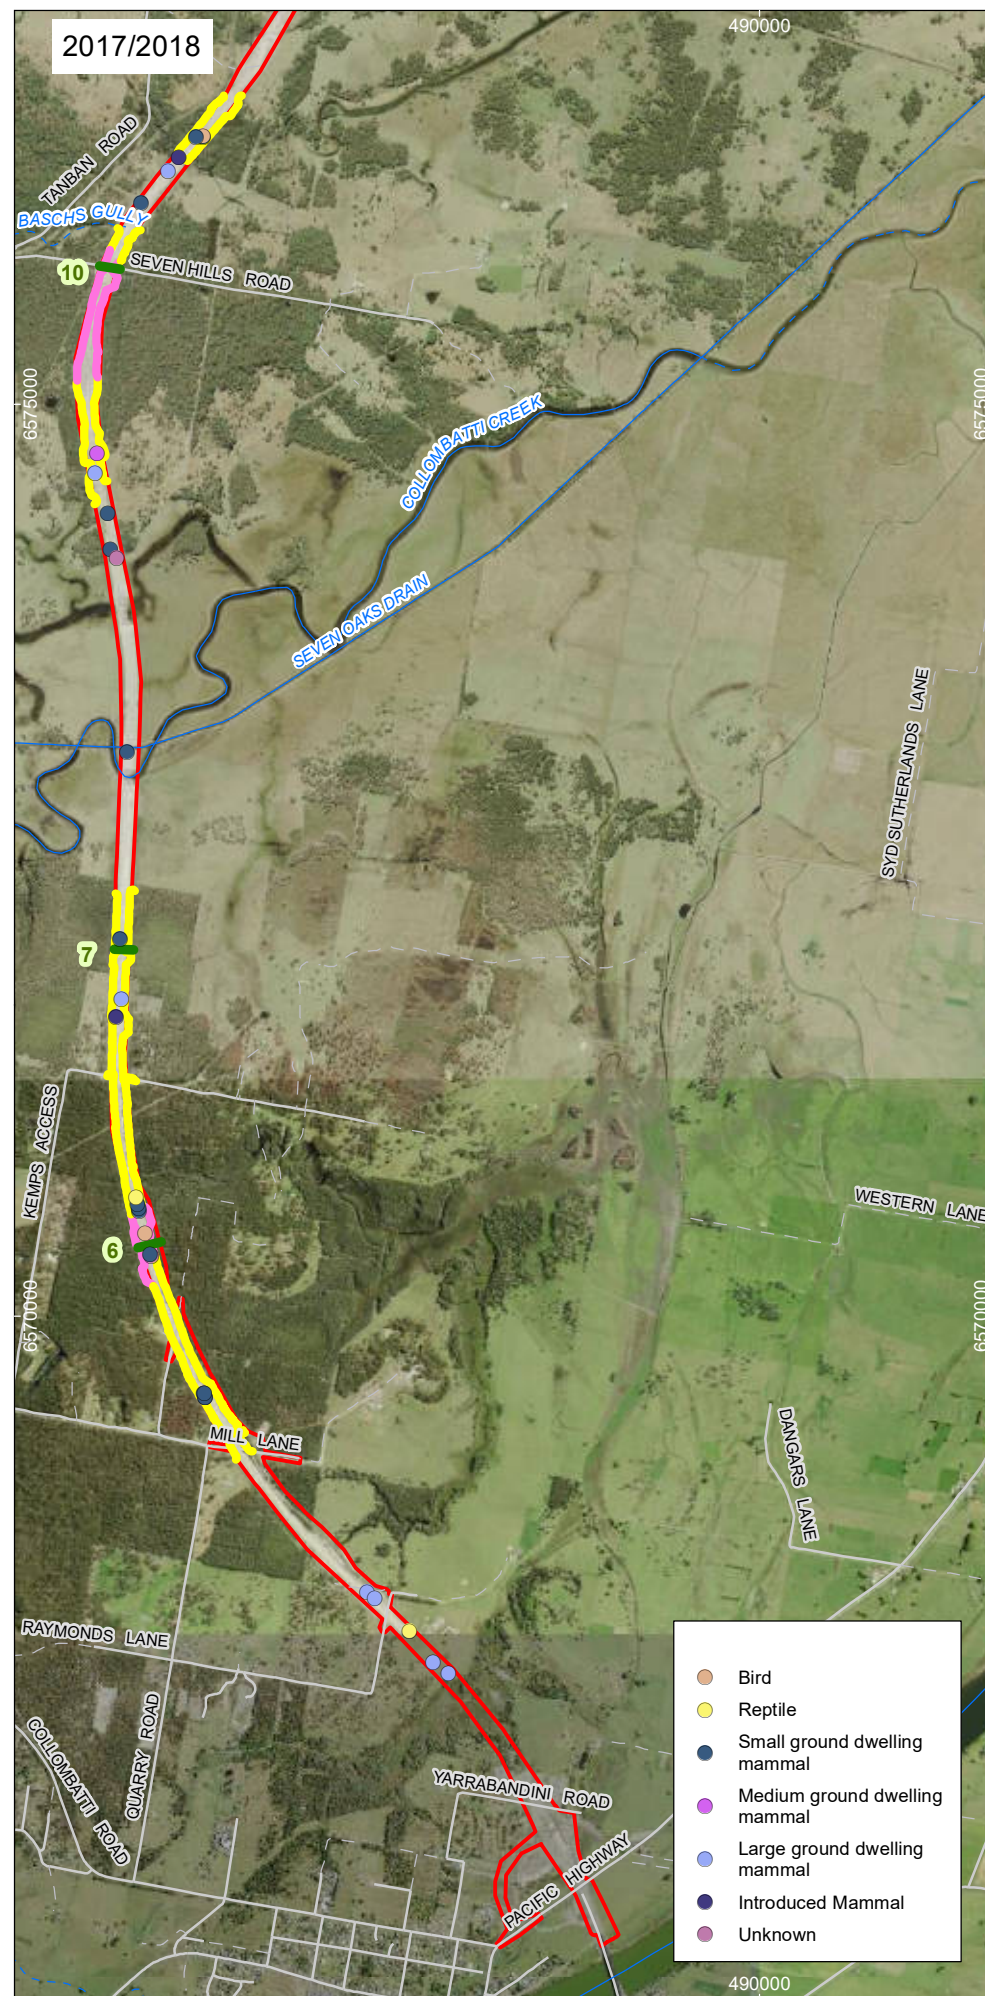
Comparison of 2016/2017, 2017/2018 and 2018/2019 road kill records
Pacific Highway Upgrade - Frederickton to Eungai
