# Aerial Crossing Monitoring 2020

Frederickton to Eungai Pacific Highway Upgrade

Prepared for Transport for NSW September 2020

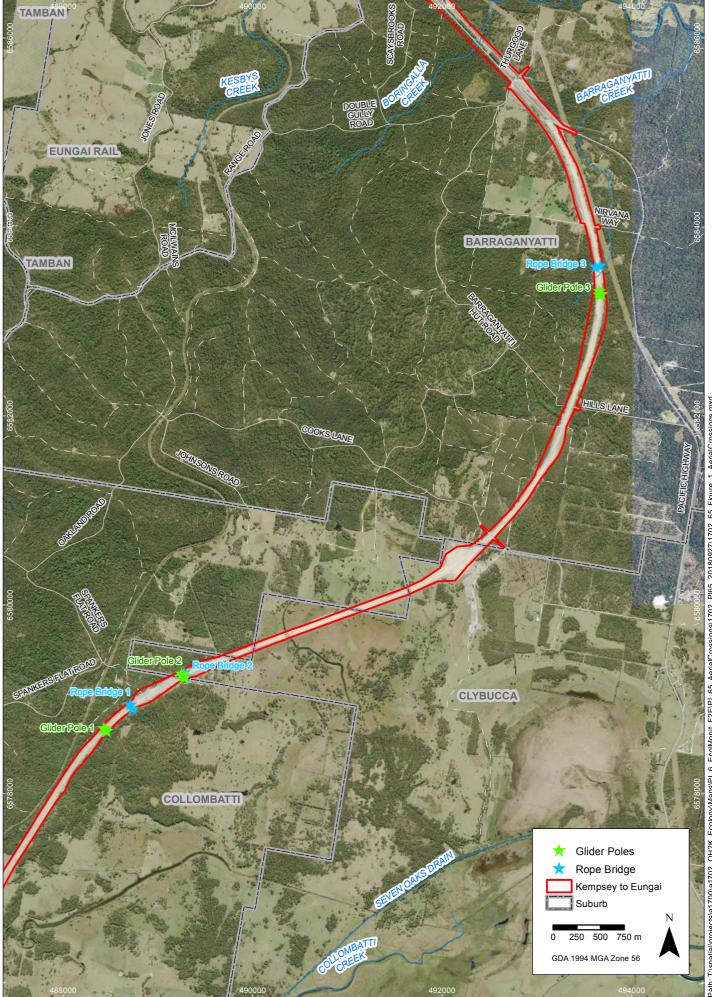
Location of Aerial Crossings Frederickton to Eungai Pacific Highway Upgrade

Three aerial crossing zones (hereafter Sites 1, 2 and 3) are specified in the EMP. Site 1 and 2 each have a single canopy rope bridge and a set of glider poles consisting of a pole on each opposing road verge and a single median pole. Site 3 has a single canopy rope bridge and a single glider pole crossing, consisting of two median poles and one road verge pole (east), due to existing suitable trees to glide from/to on the opposing (western) road verge. The location of each crossing structure is provided in Figure 1.
