# **Commonwealth approval EPBC 2013/6963 conditions compliance tracking and management annual report**

**Nambucca Heads to Urunga Pacific Highway  
Upgrade**

February 2020 – January 2021

## **Threatened Flora Monitoring Annual Report Year 4 – 2020/21**

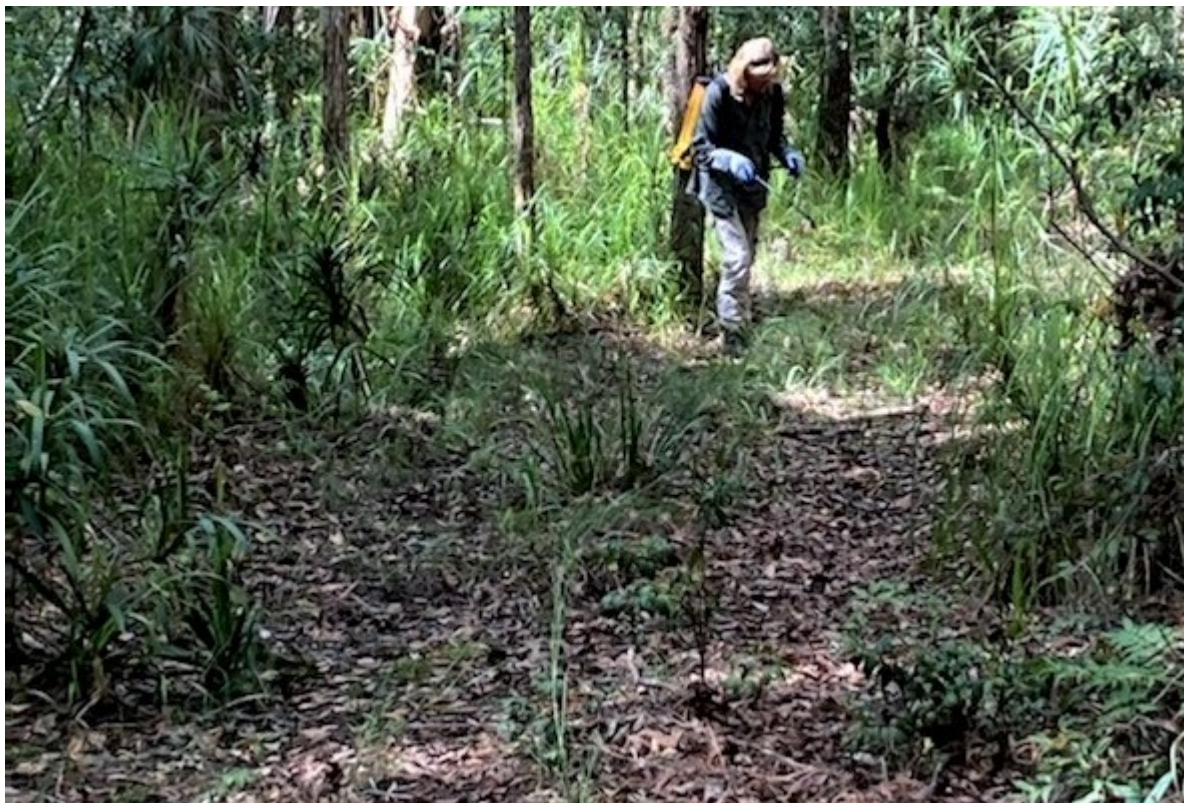
The follow-up weed treatment was undertaken at the site on 22<sup>nd</sup> January 2021, after being delayed by wet weather. Inspection of treated areas at the time of follow-up show complete removal of Lantana from treated areas and almost complete removal of adult and seedling Broad-leaved Paspalum (Figure 7; Figure 8).

Figure 7: Follow-up treatment of seedling Broad-leaved Paspalum 22nd Jan 2021

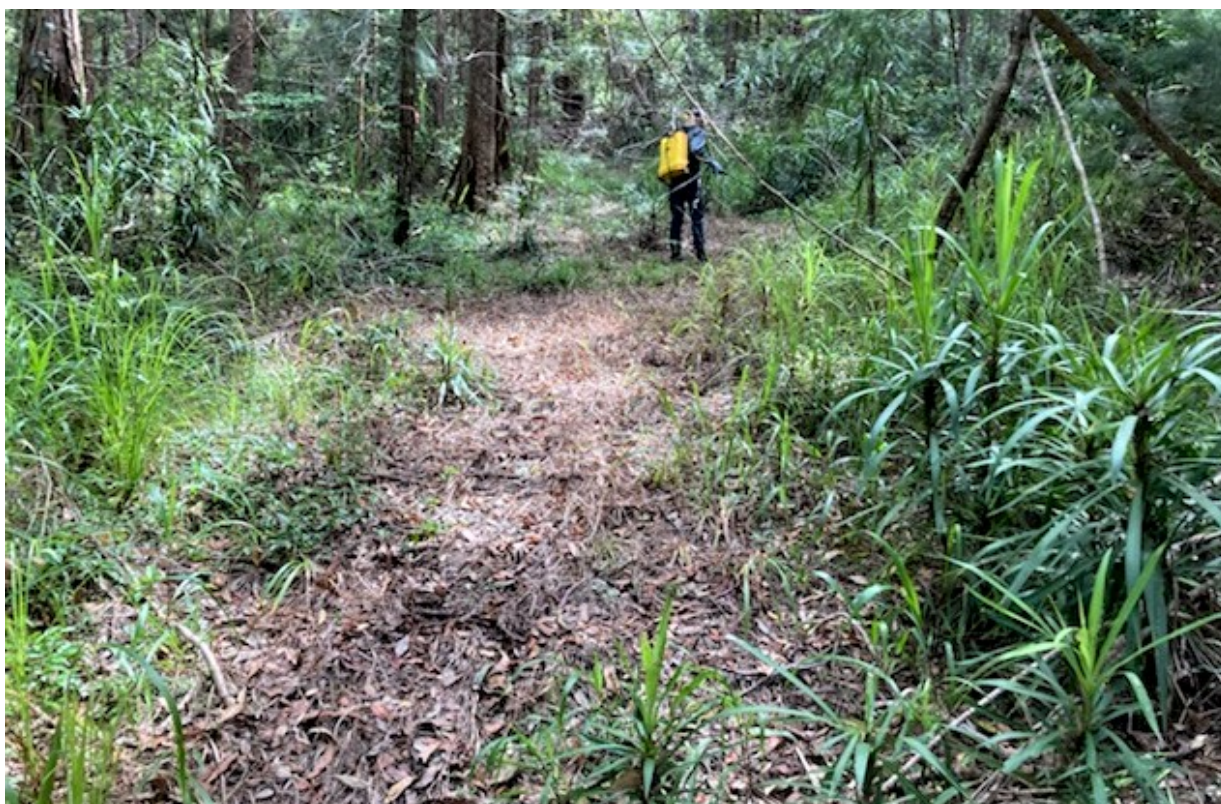
Figure 8: Follow-up weed treatment, TA1, 22nd Jan 2021
