**Transport for
New South Wales**

Coffs Harbour Bypass

Threatened Species Management Plan

Transport for New South Wales | Working Draft | May 2021

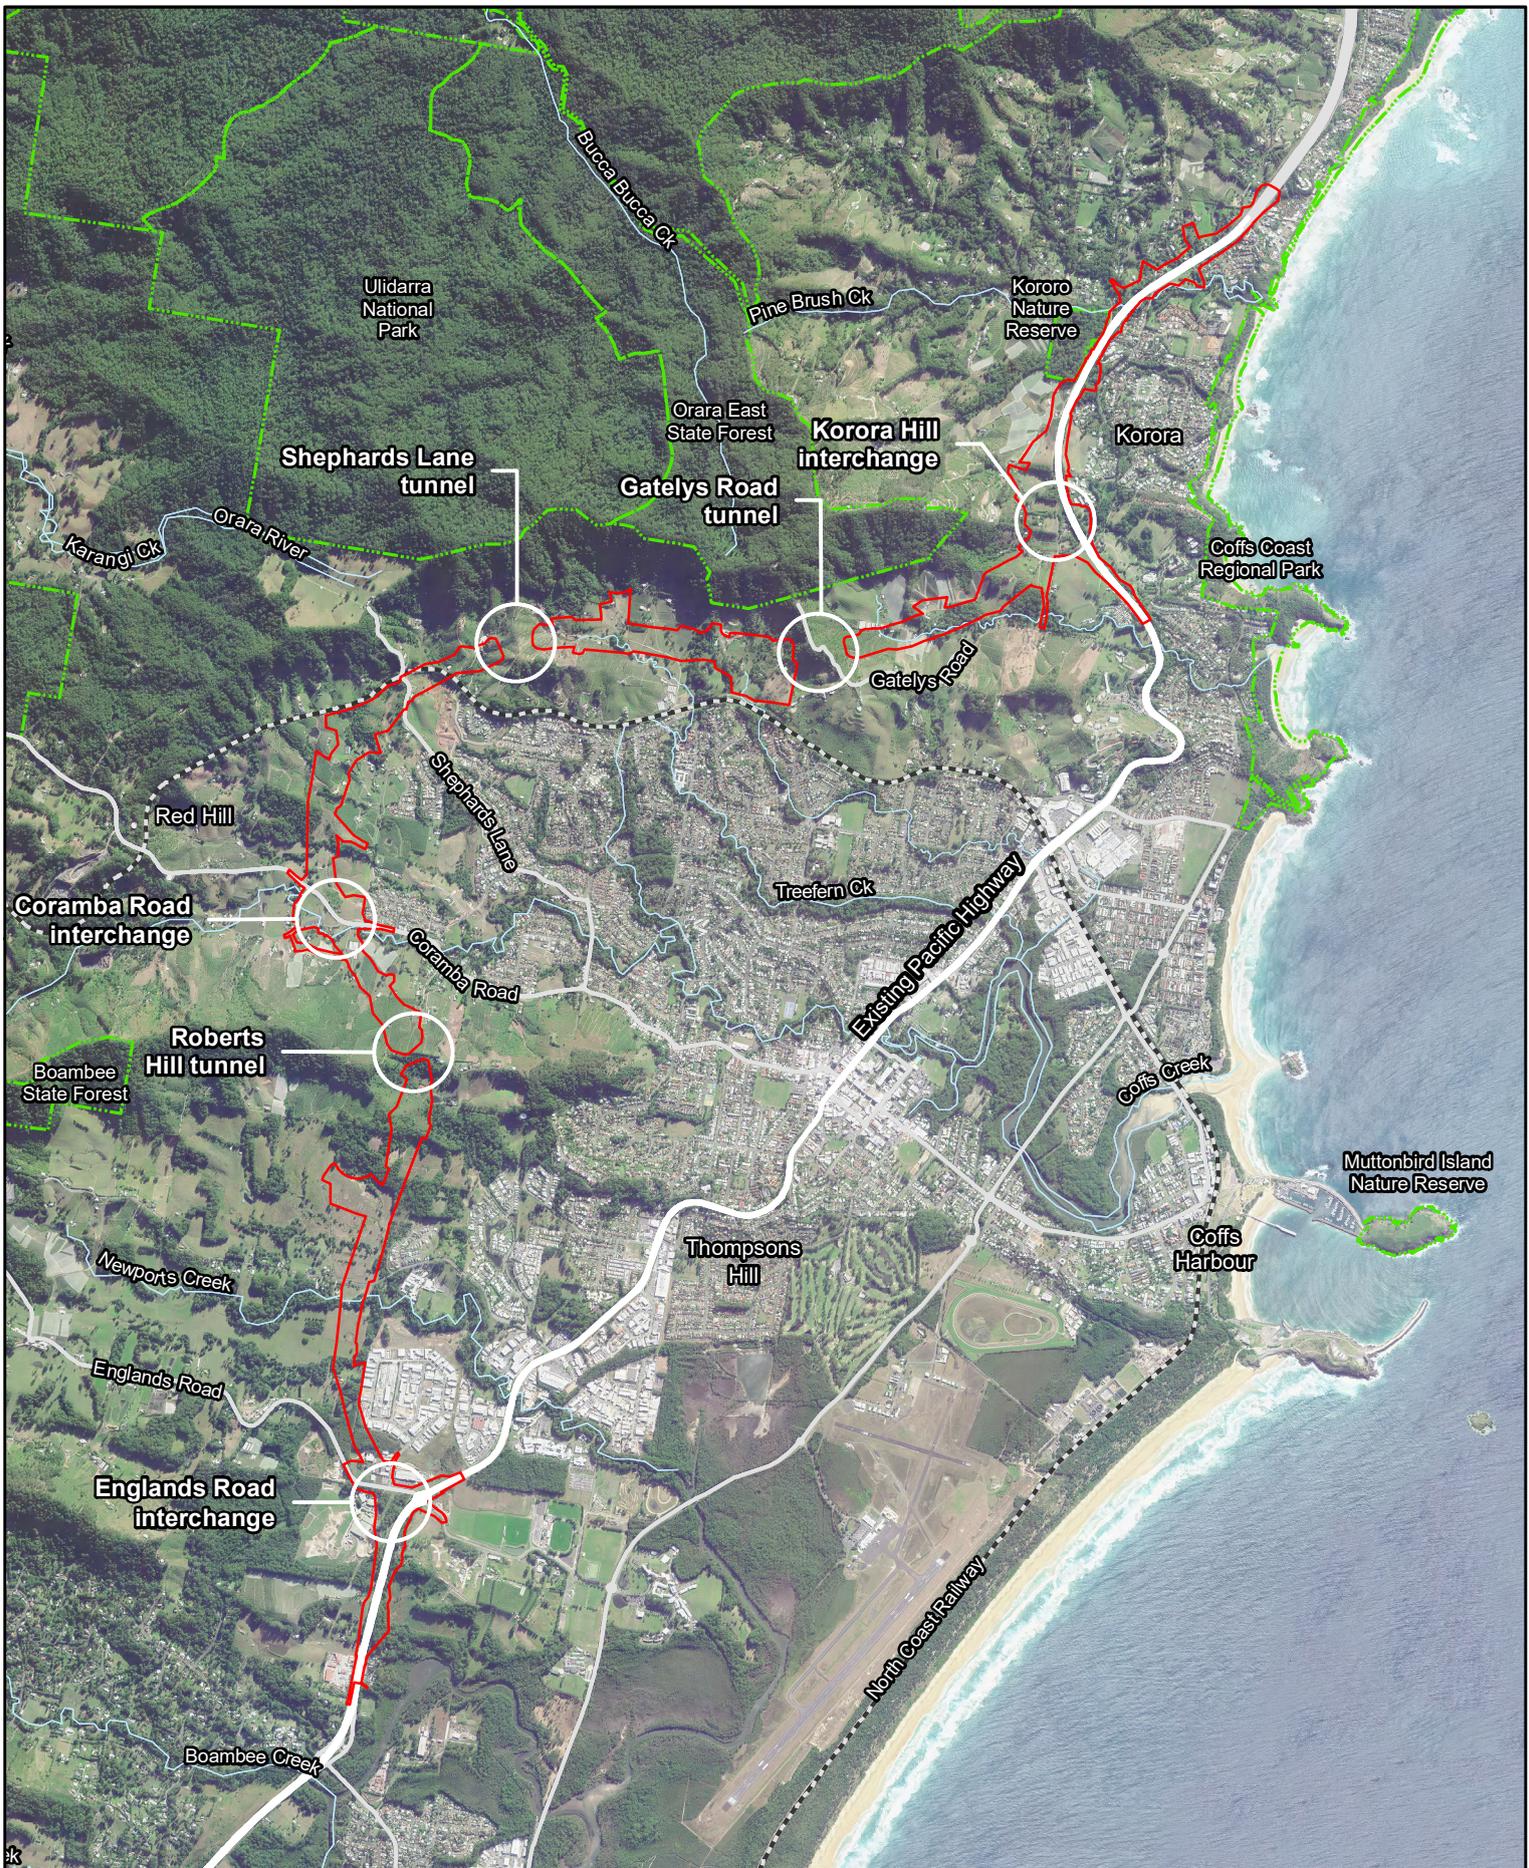
Coffs Harbour Bypass
 Project area
 Figure 1

- Legend**
- Construction footprint
 - North Coast Railway
 - Watercourse
 - Park/Reserve

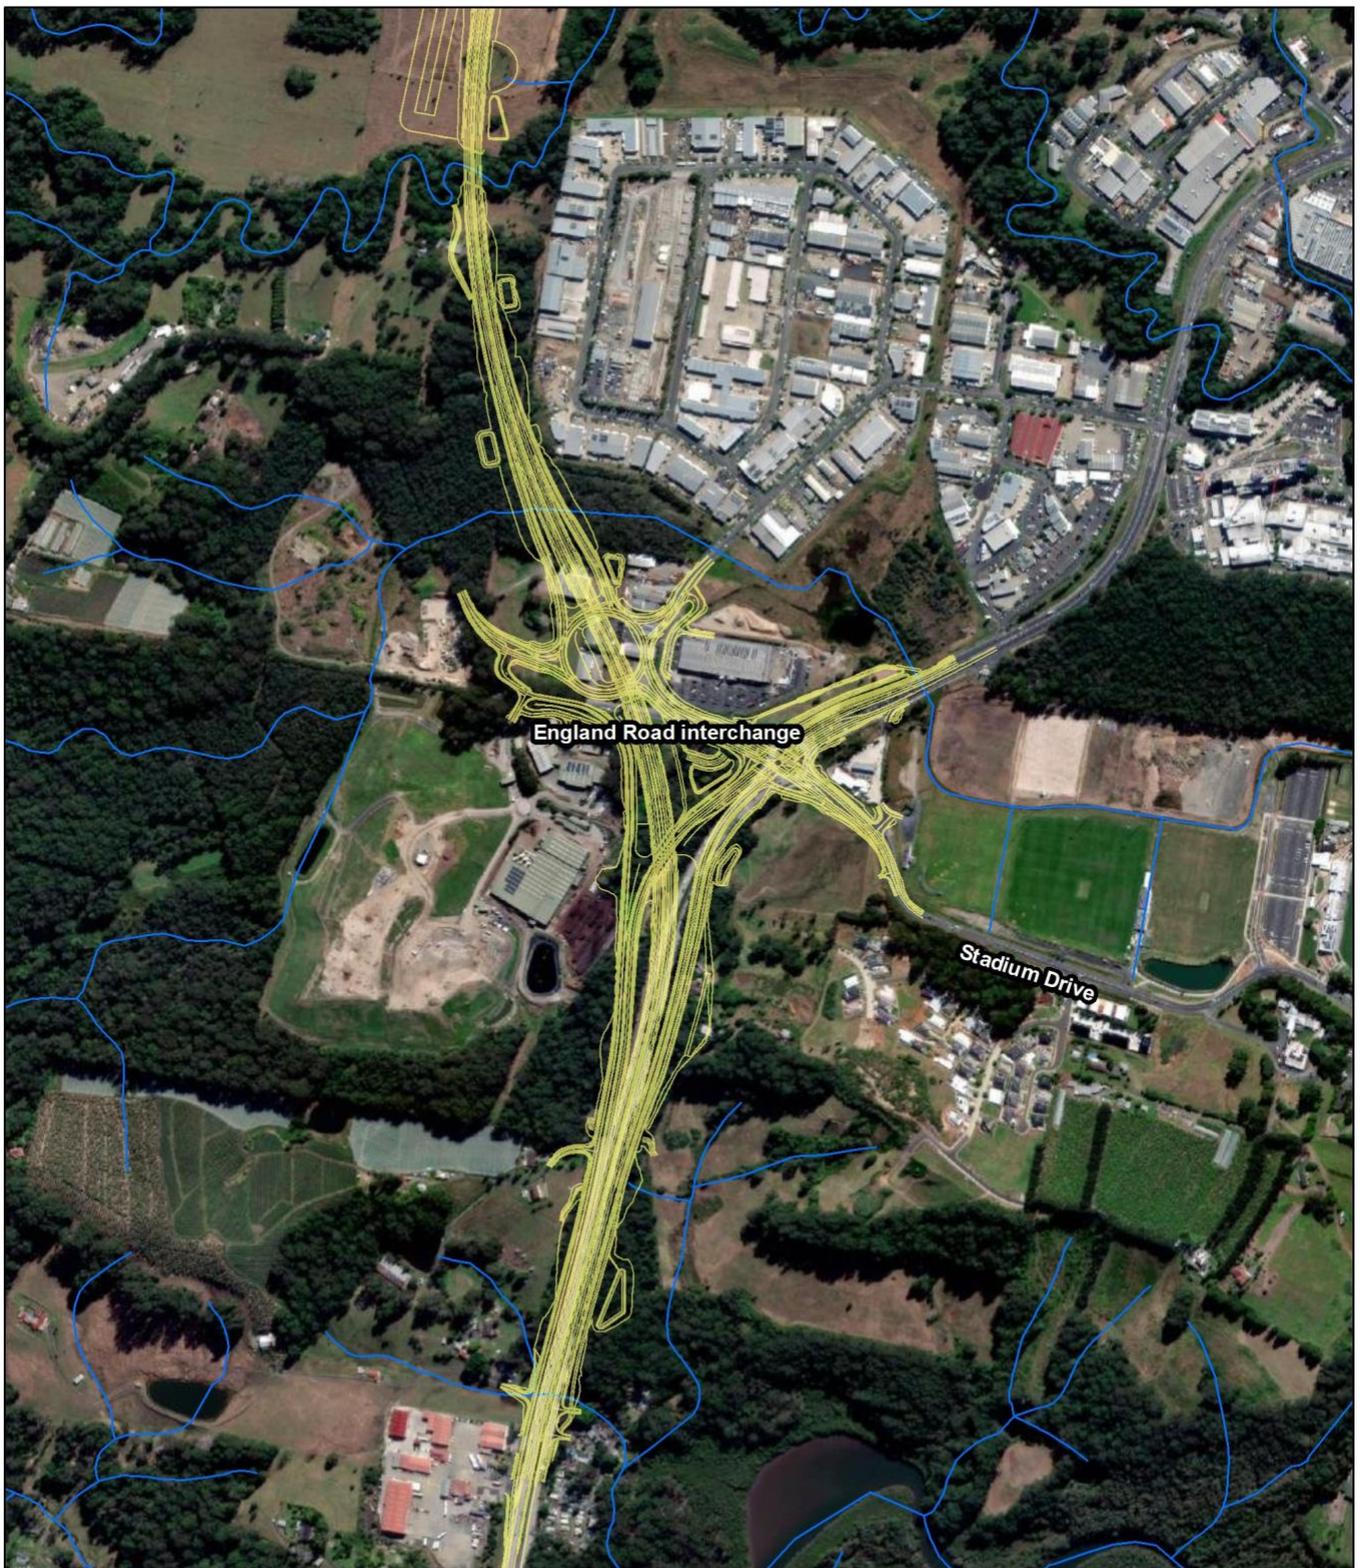
Figure 2-01

- + Niemeyera whitei - rusty plum
- Watercourse
- Alignment

Species	Habitat within project area	Number of records	Species credit polygon (ha)
Rusty plum	<p>Predominantly in the northern extent of the project area in gullies and depressions associated with the riparian corridors of Pine Brush Creek and Jordans Creek. This species occurred across six PCTs including:</p> <ul style="list-style-type: none"> • PCT 670 Black Booyong – Rosewood – Yellow Carabeen subtropical rainforest of the North Coast • PCT 747 Brush Box - Tallowwood - Sydney Blue Gum tall moist forest of the ranges of the central NSW North Coast Bioregion • PCT 692 Blackbutt – Tallowwood moist ferny open forest of the coastal ranges of the North Coast • PCT 695 Blackbutt – Turpentine shrubby open forest of the coastal foothills of the central North Coast • PCT 1285 Turpentine moist open forest of the coastal hills and ranges of the NSW North Coast Bioregion • PCT 1262, Tallowwood - Small-fruited Grey Gum dry grassy open forest of the foothills of the NSW North Coast • PCT 1302 White Booyong – Fig subtropical rainforest of the NSW North Coast 	74	7.95 ha

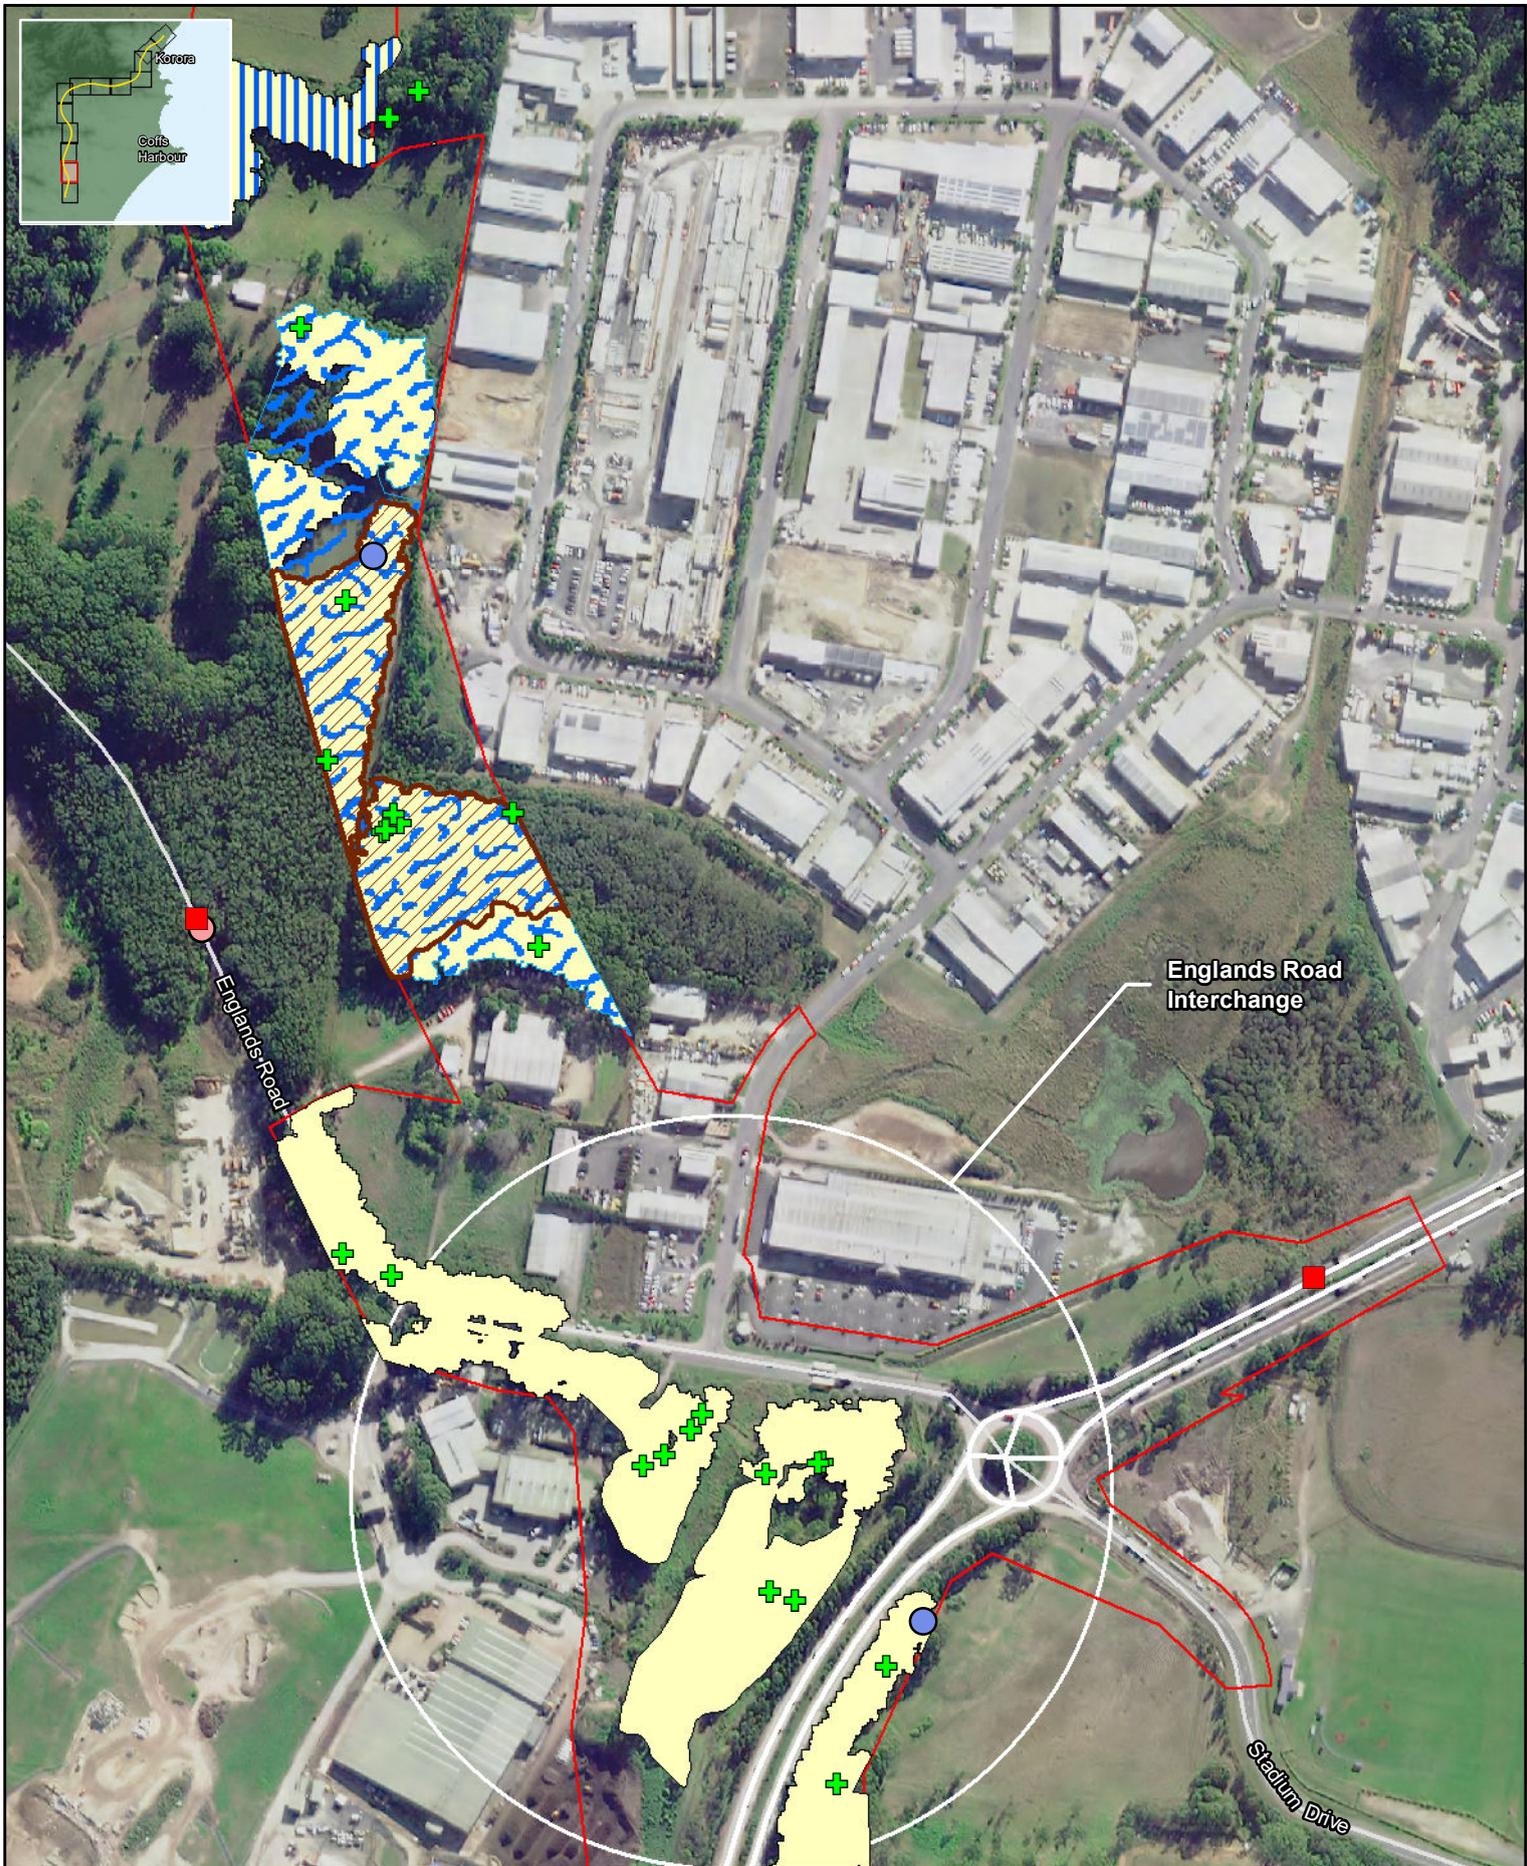
Coffs Harbour Bypass
 Threatened fauna records and species credit habitat polygons
 Figure 3-02

- Legend**
- Construction footprint
 - North Coast Railway
 - Watercourse
 - + Hollow bearing tree
 - Threatened fauna records**
 - Koala
 - Southern myotis
 - Species credit species habitat polygons**
 - Coastal petaltail
 - Giant barred frog
 - Southern myotis
 - Koala
 - Culverts - potential microbat roost**
 - High

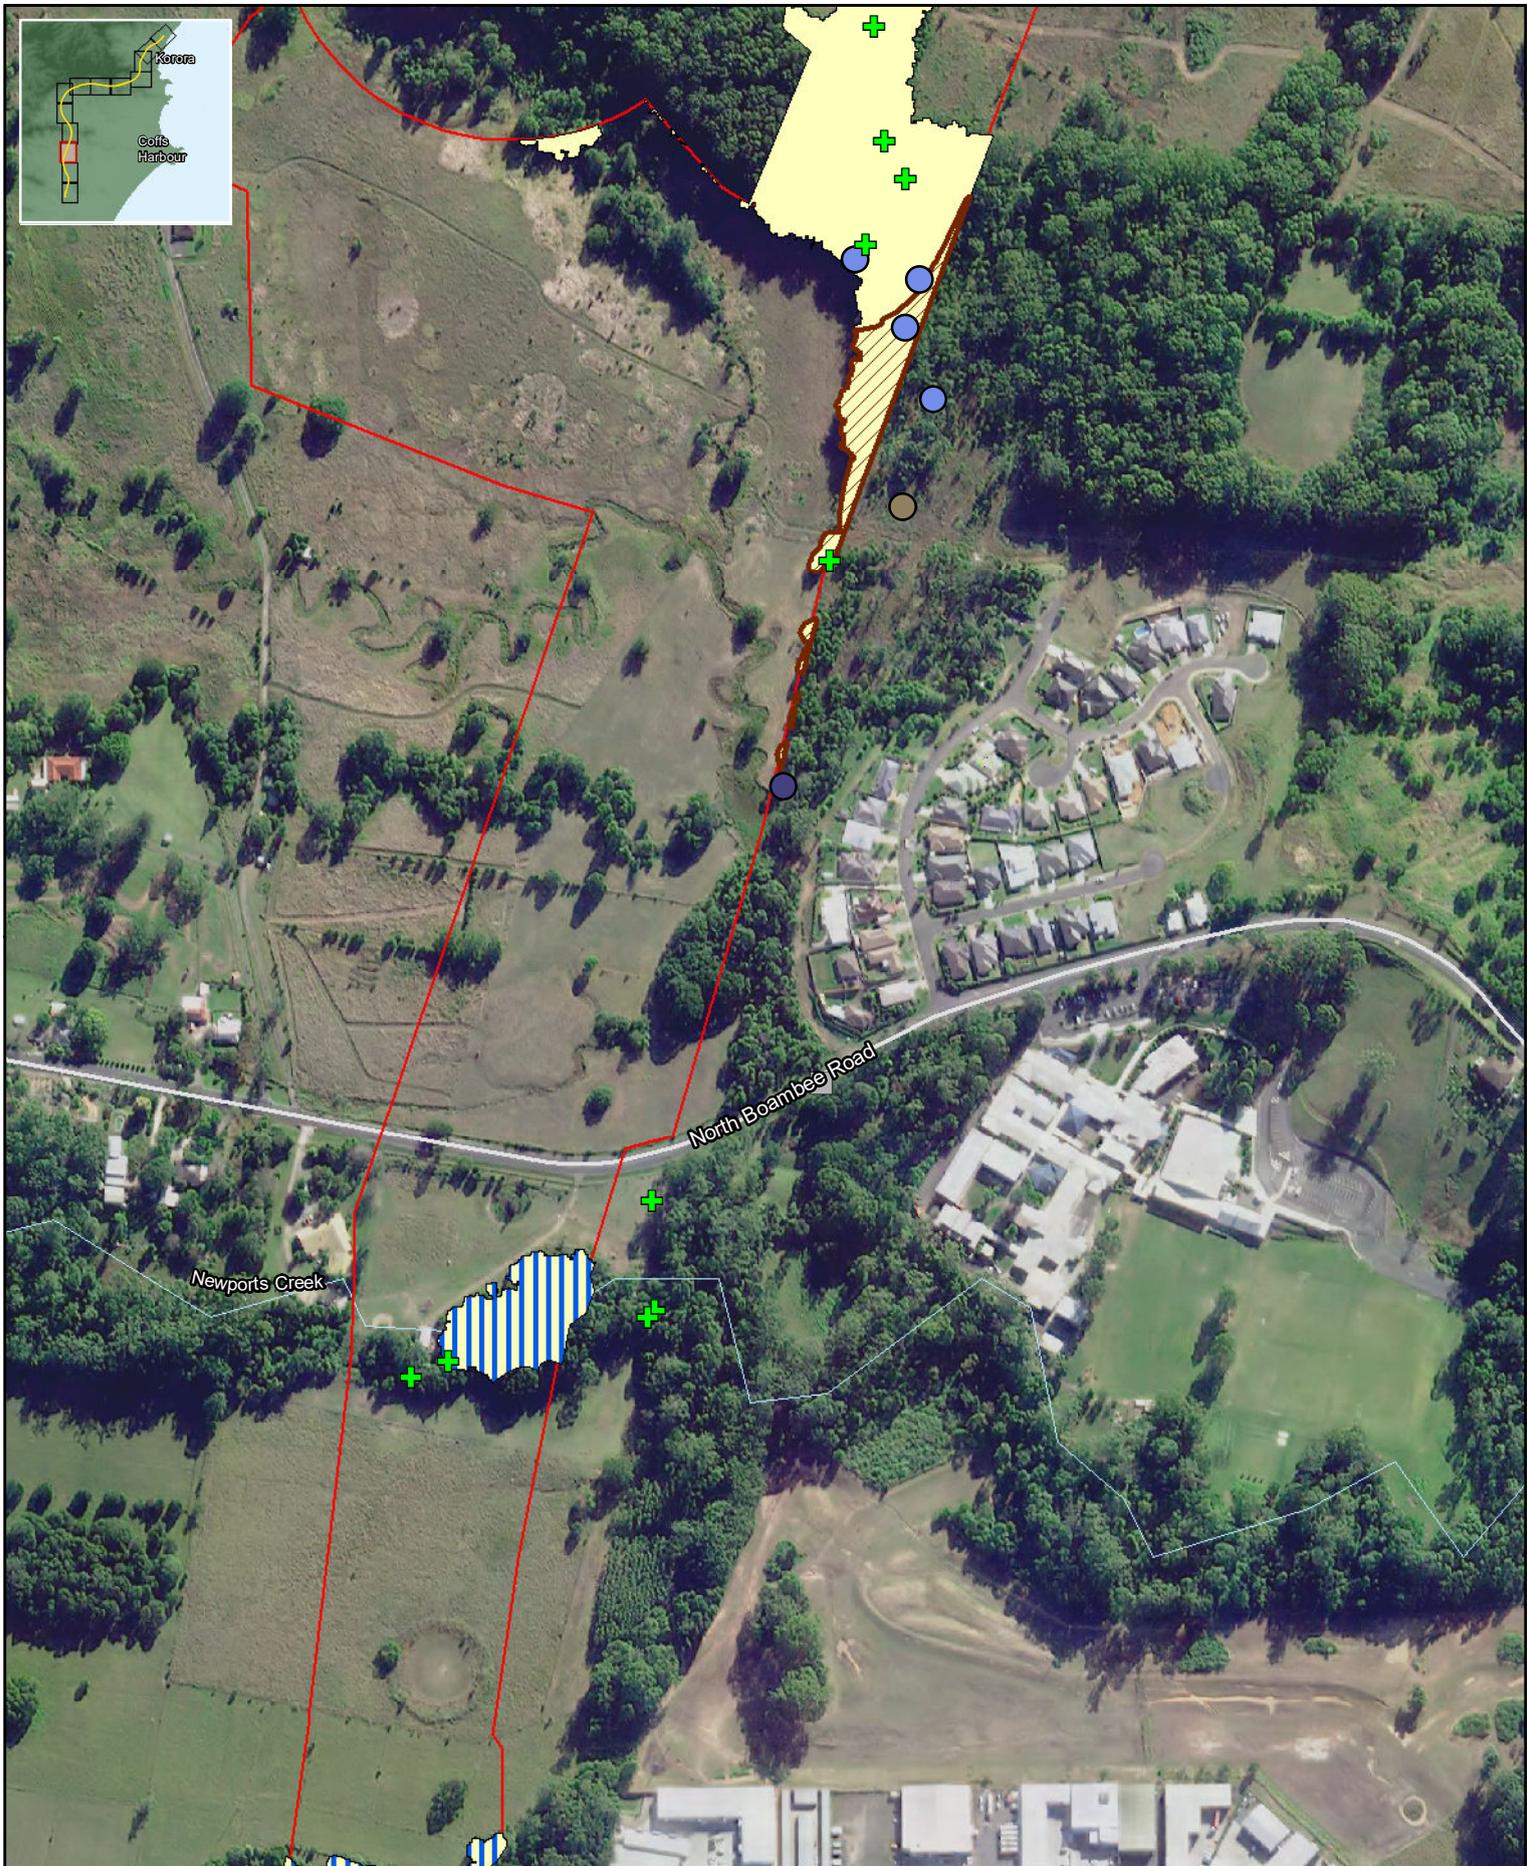
Coffs Harbour Bypass
 Threatened fauna records and species credit habitat polygons
 Figure 3-03

- Legend**
- Construction footprint
 - - - North Coast Railway
 - Watercourse
 - + Hollow bearing tree

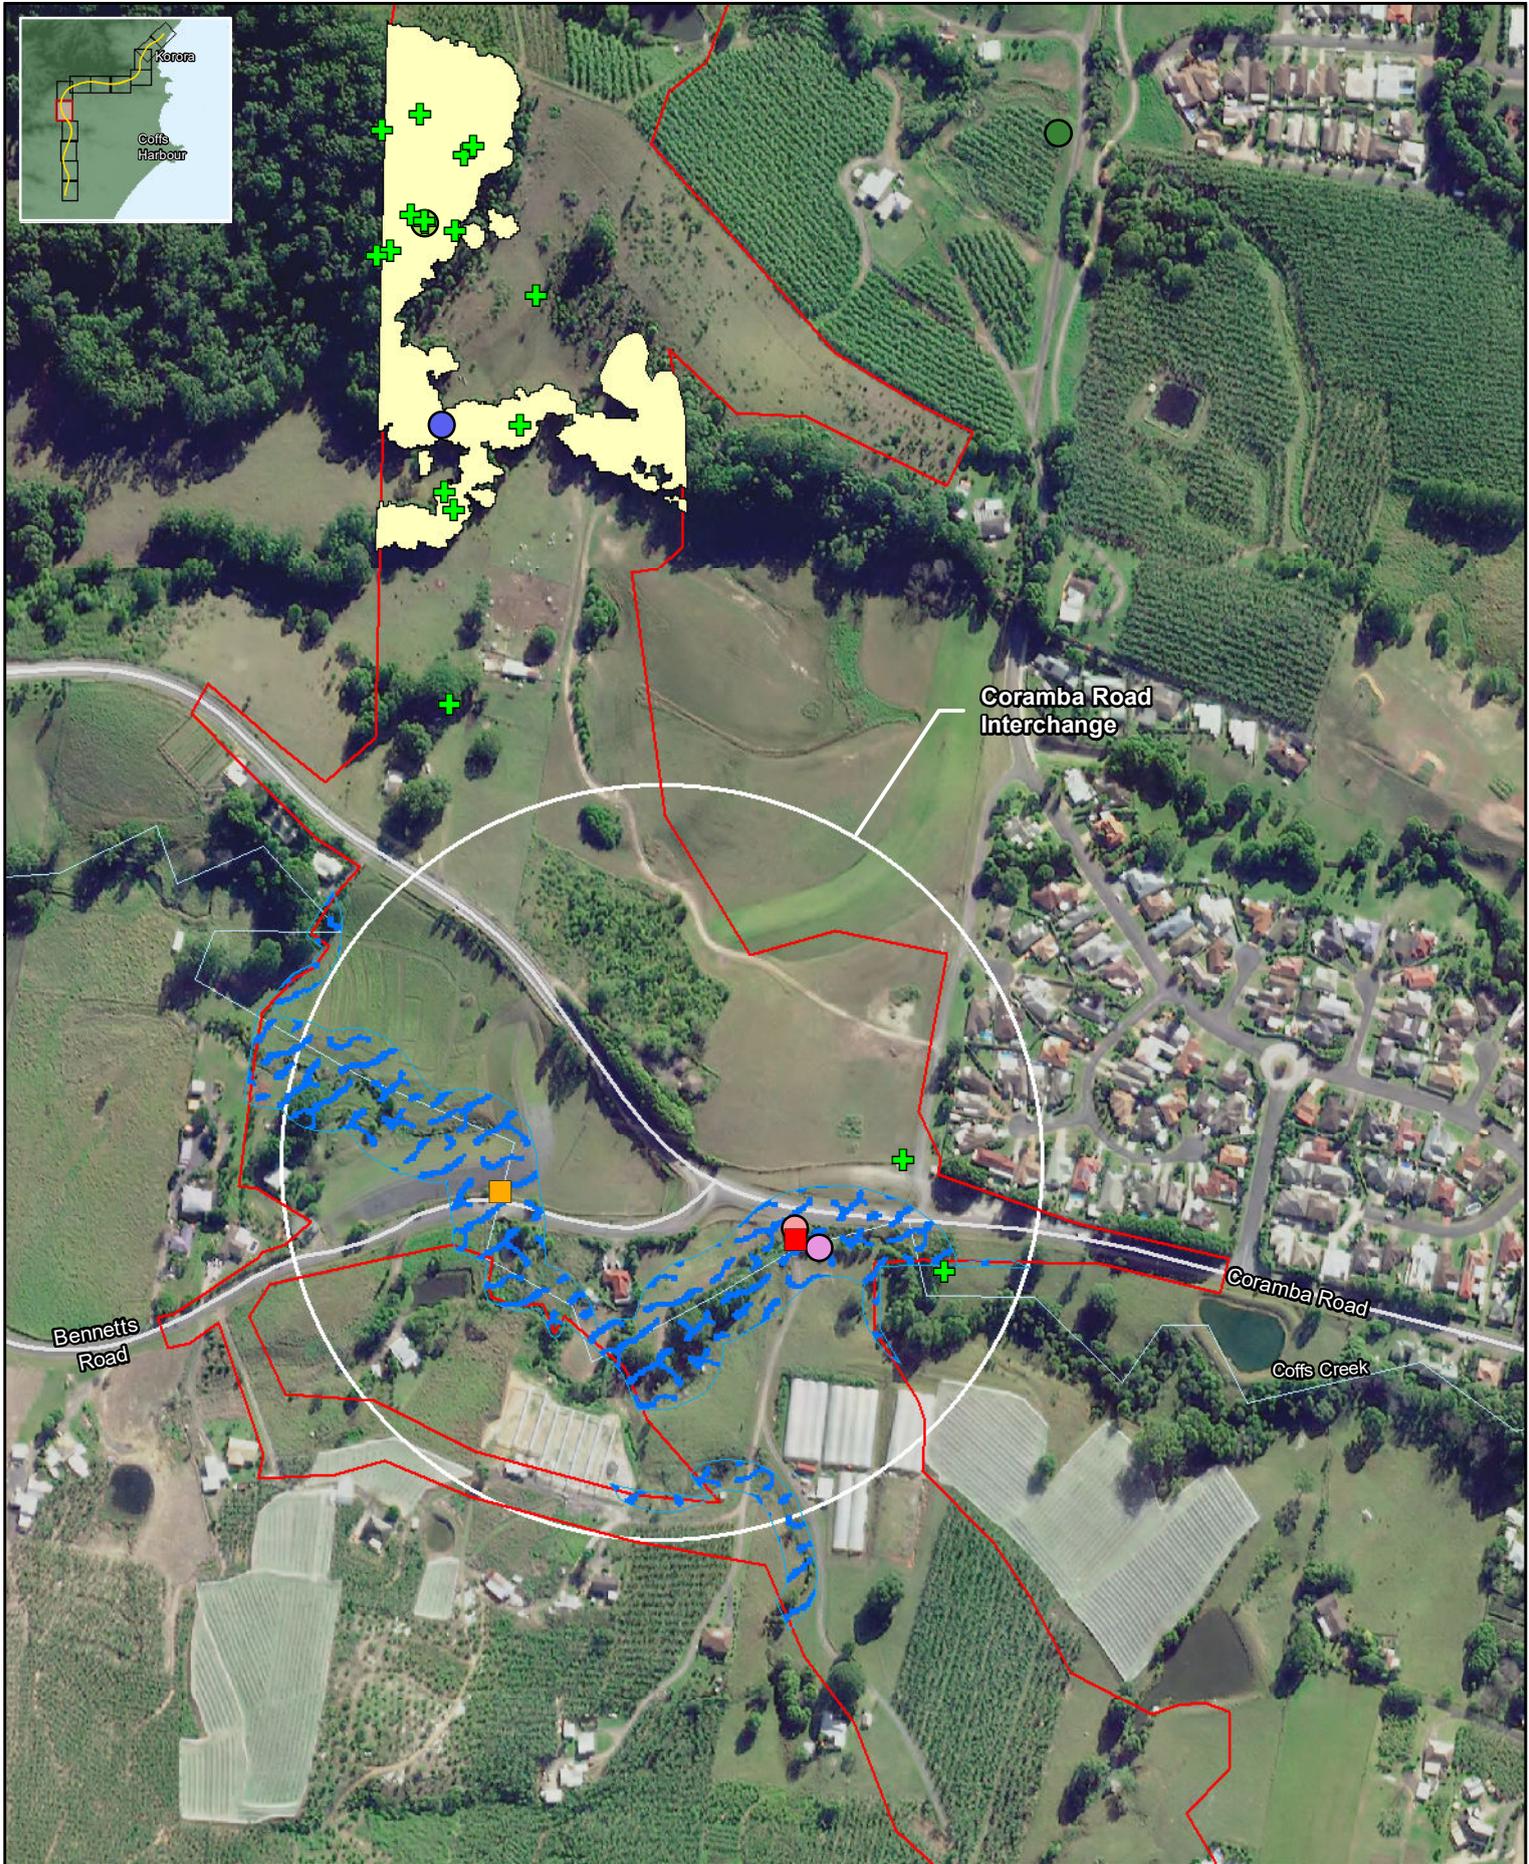
Coffs Harbour Bypass
 Threatened fauna records and species credit habitat polygons
 Figure 3-05

- Legend**
- ▭ Construction footprint
 - - - North Coast Railway
 - Watercourse
 - + Hollow bearing tree
- Threatened fauna records**
- Little bentwing-bat
 - Eastern freetail-bat
 - Southern myotis
 - Olive whistler
 - Square-tailed kite
- Species credit species habitat polygons**
- ▭ Southern myotis
 - ▭ Koala
- Culverts - potential microbat roost**
- ▭ High
 - ▭ Medium

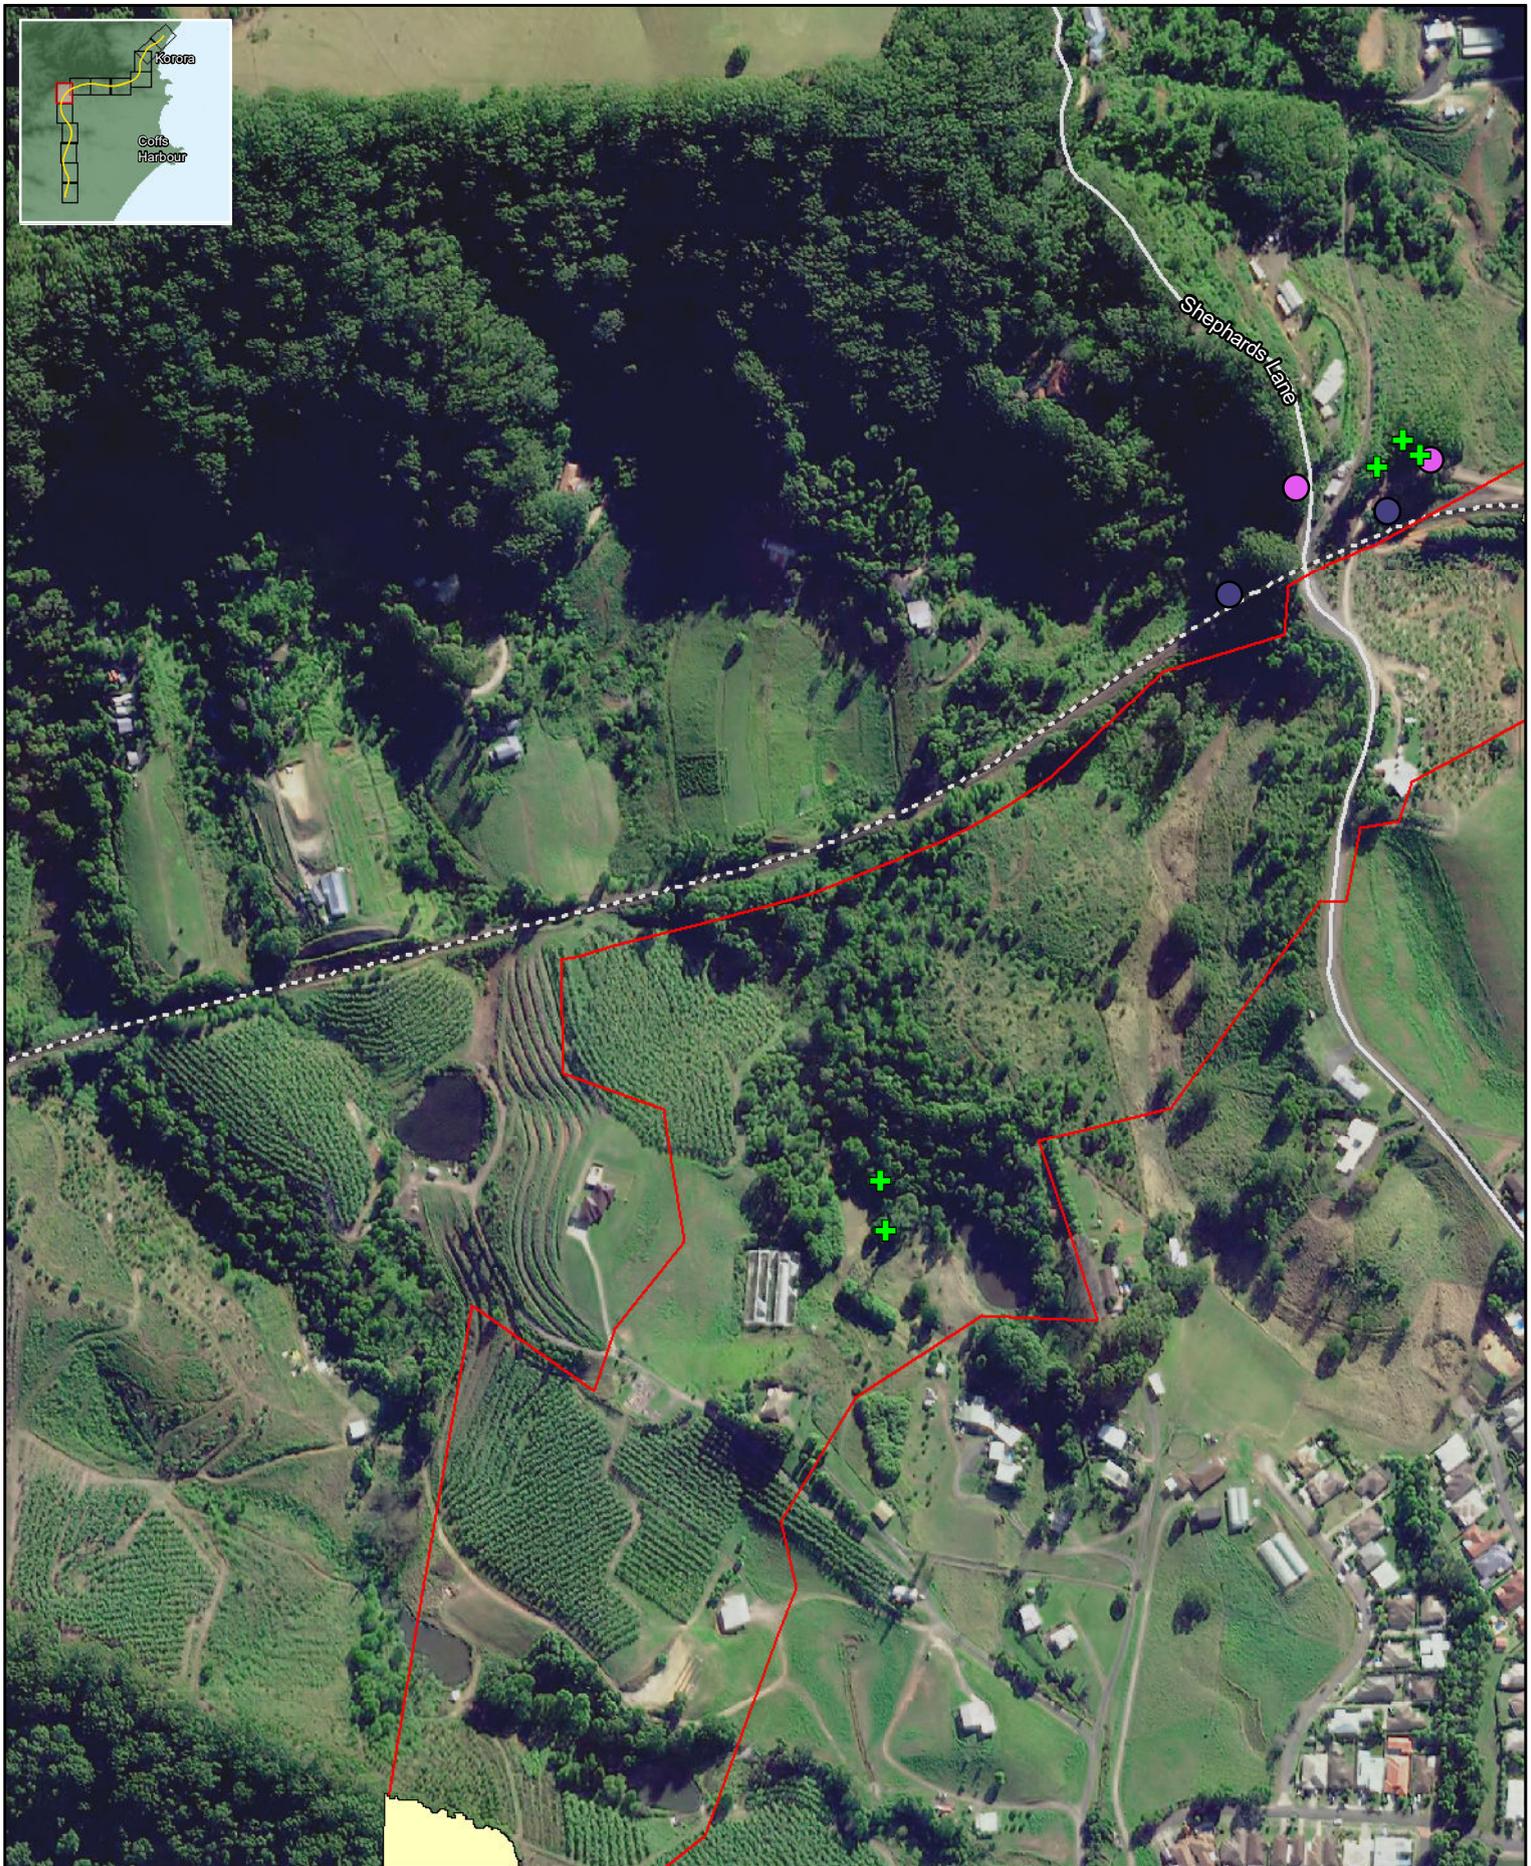
Coffs Harbour Bypass
 Threatened fauna records and species credit habitat polygons
 Figure 3-06

- Legend**
- Construction footprint
 - North Coast Railway
 - Watercourse
 - + Hollow bearing tree
- Threatened fauna records**
- Eastern false pipistrelle
 - Grey-headed flying-fox
- Species credit species habitat polygons**
- Koala

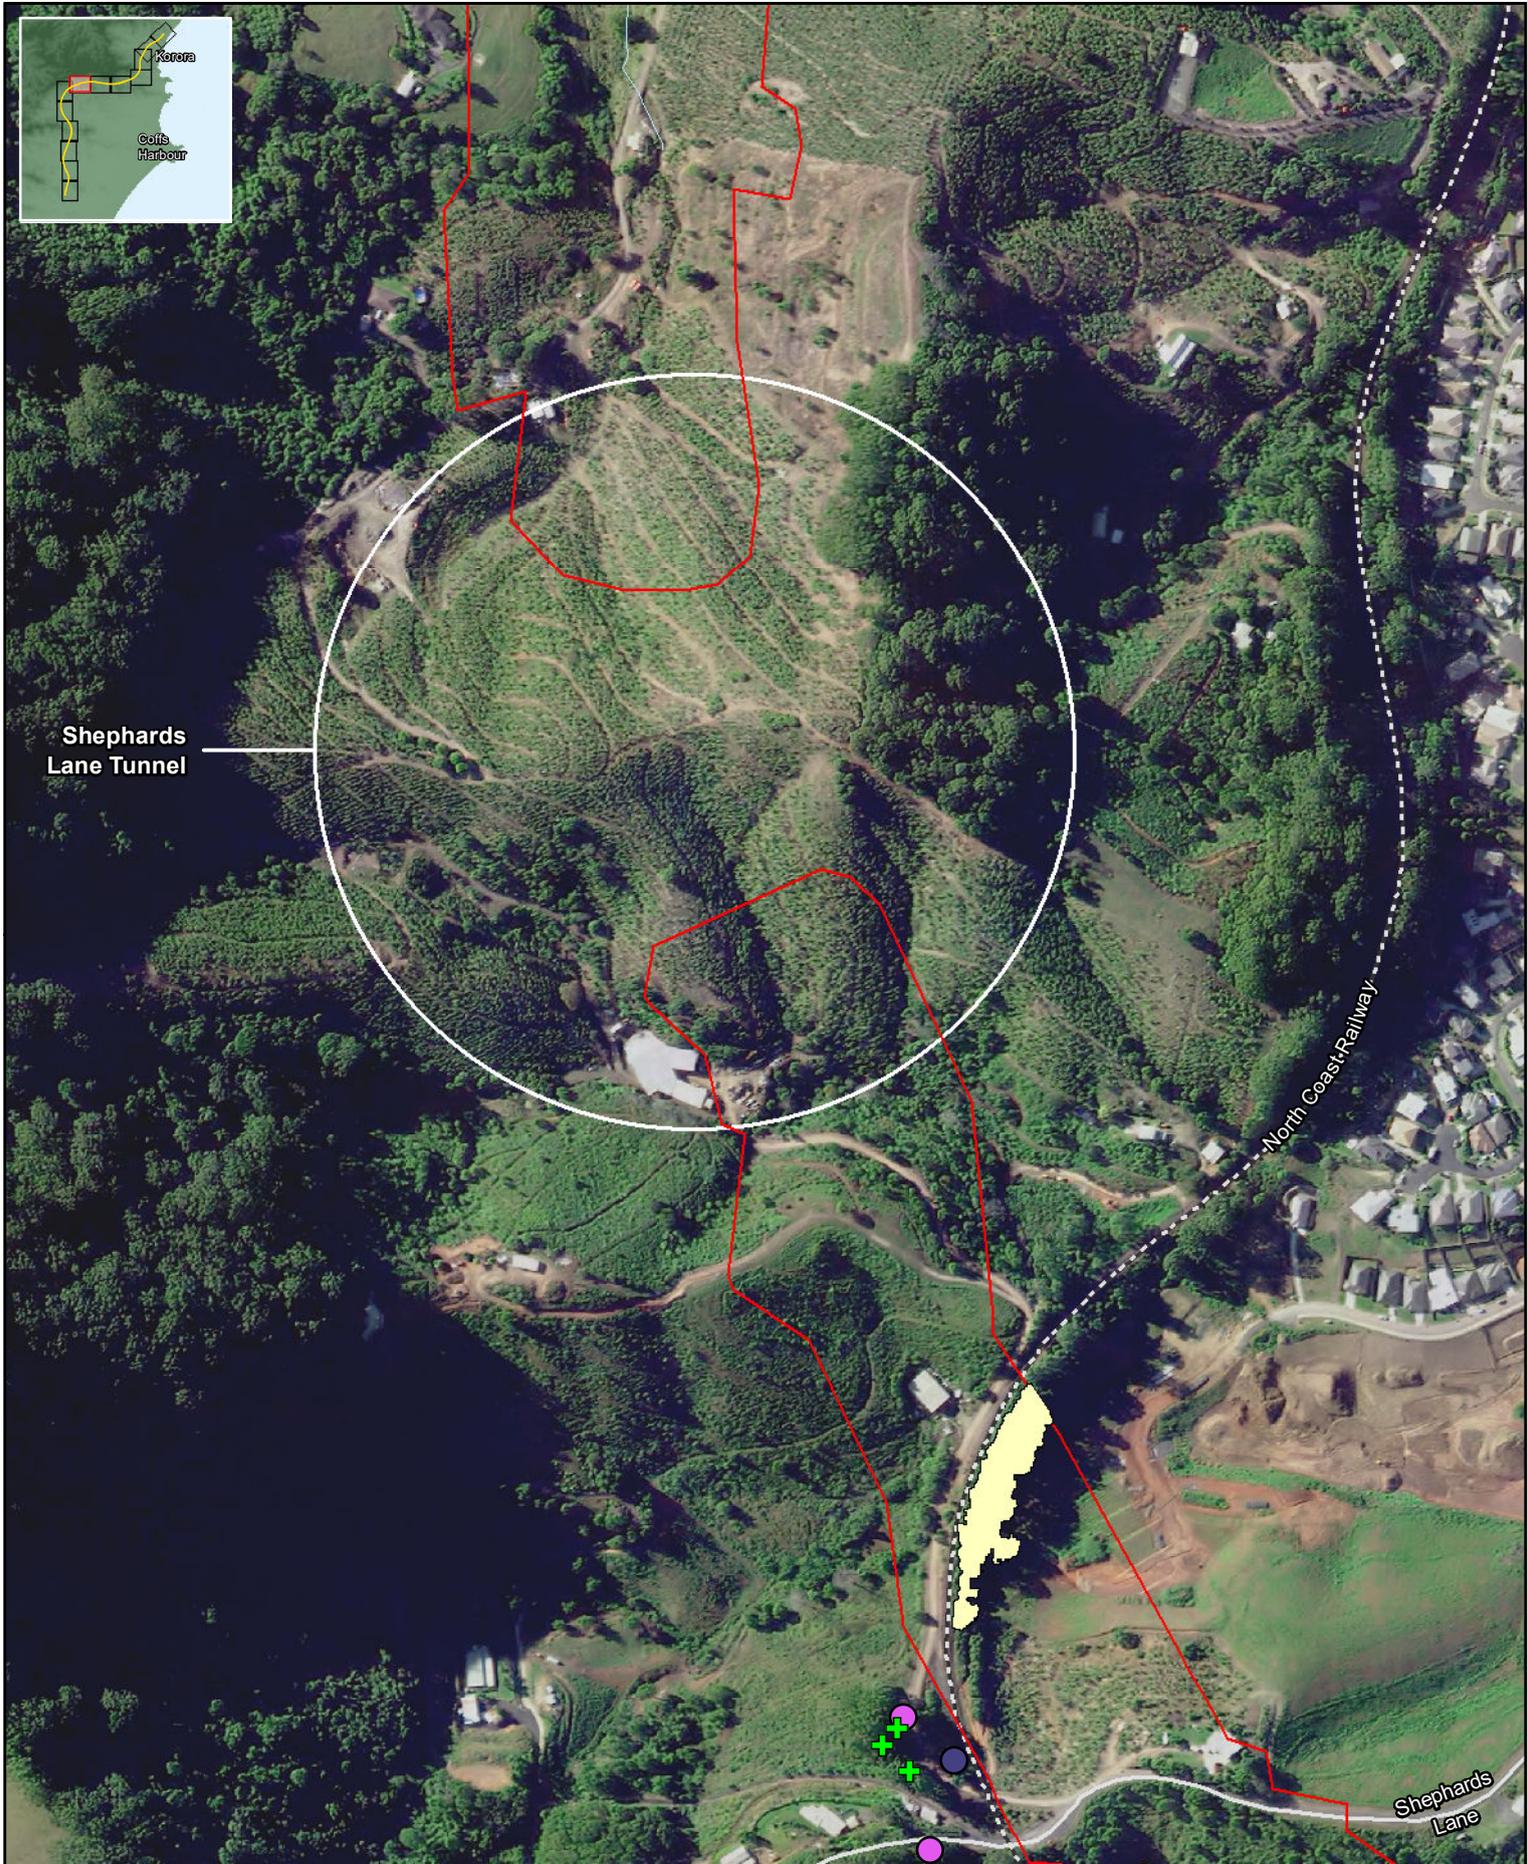
Coffs Harbour Bypass
 Threatened fauna records and species credit habitat polygons
 Figure 3-07

- Legend**
- ▭ Construction footprint
 - - - North Coast Railway
 - Watercourse
 - + Hollow bearing tree
- Threatened fauna records**
- Grey-headed flying-fox
 - Eastern false pipistrelle
- Species credit species habitat polygons**
- ▭ Koala

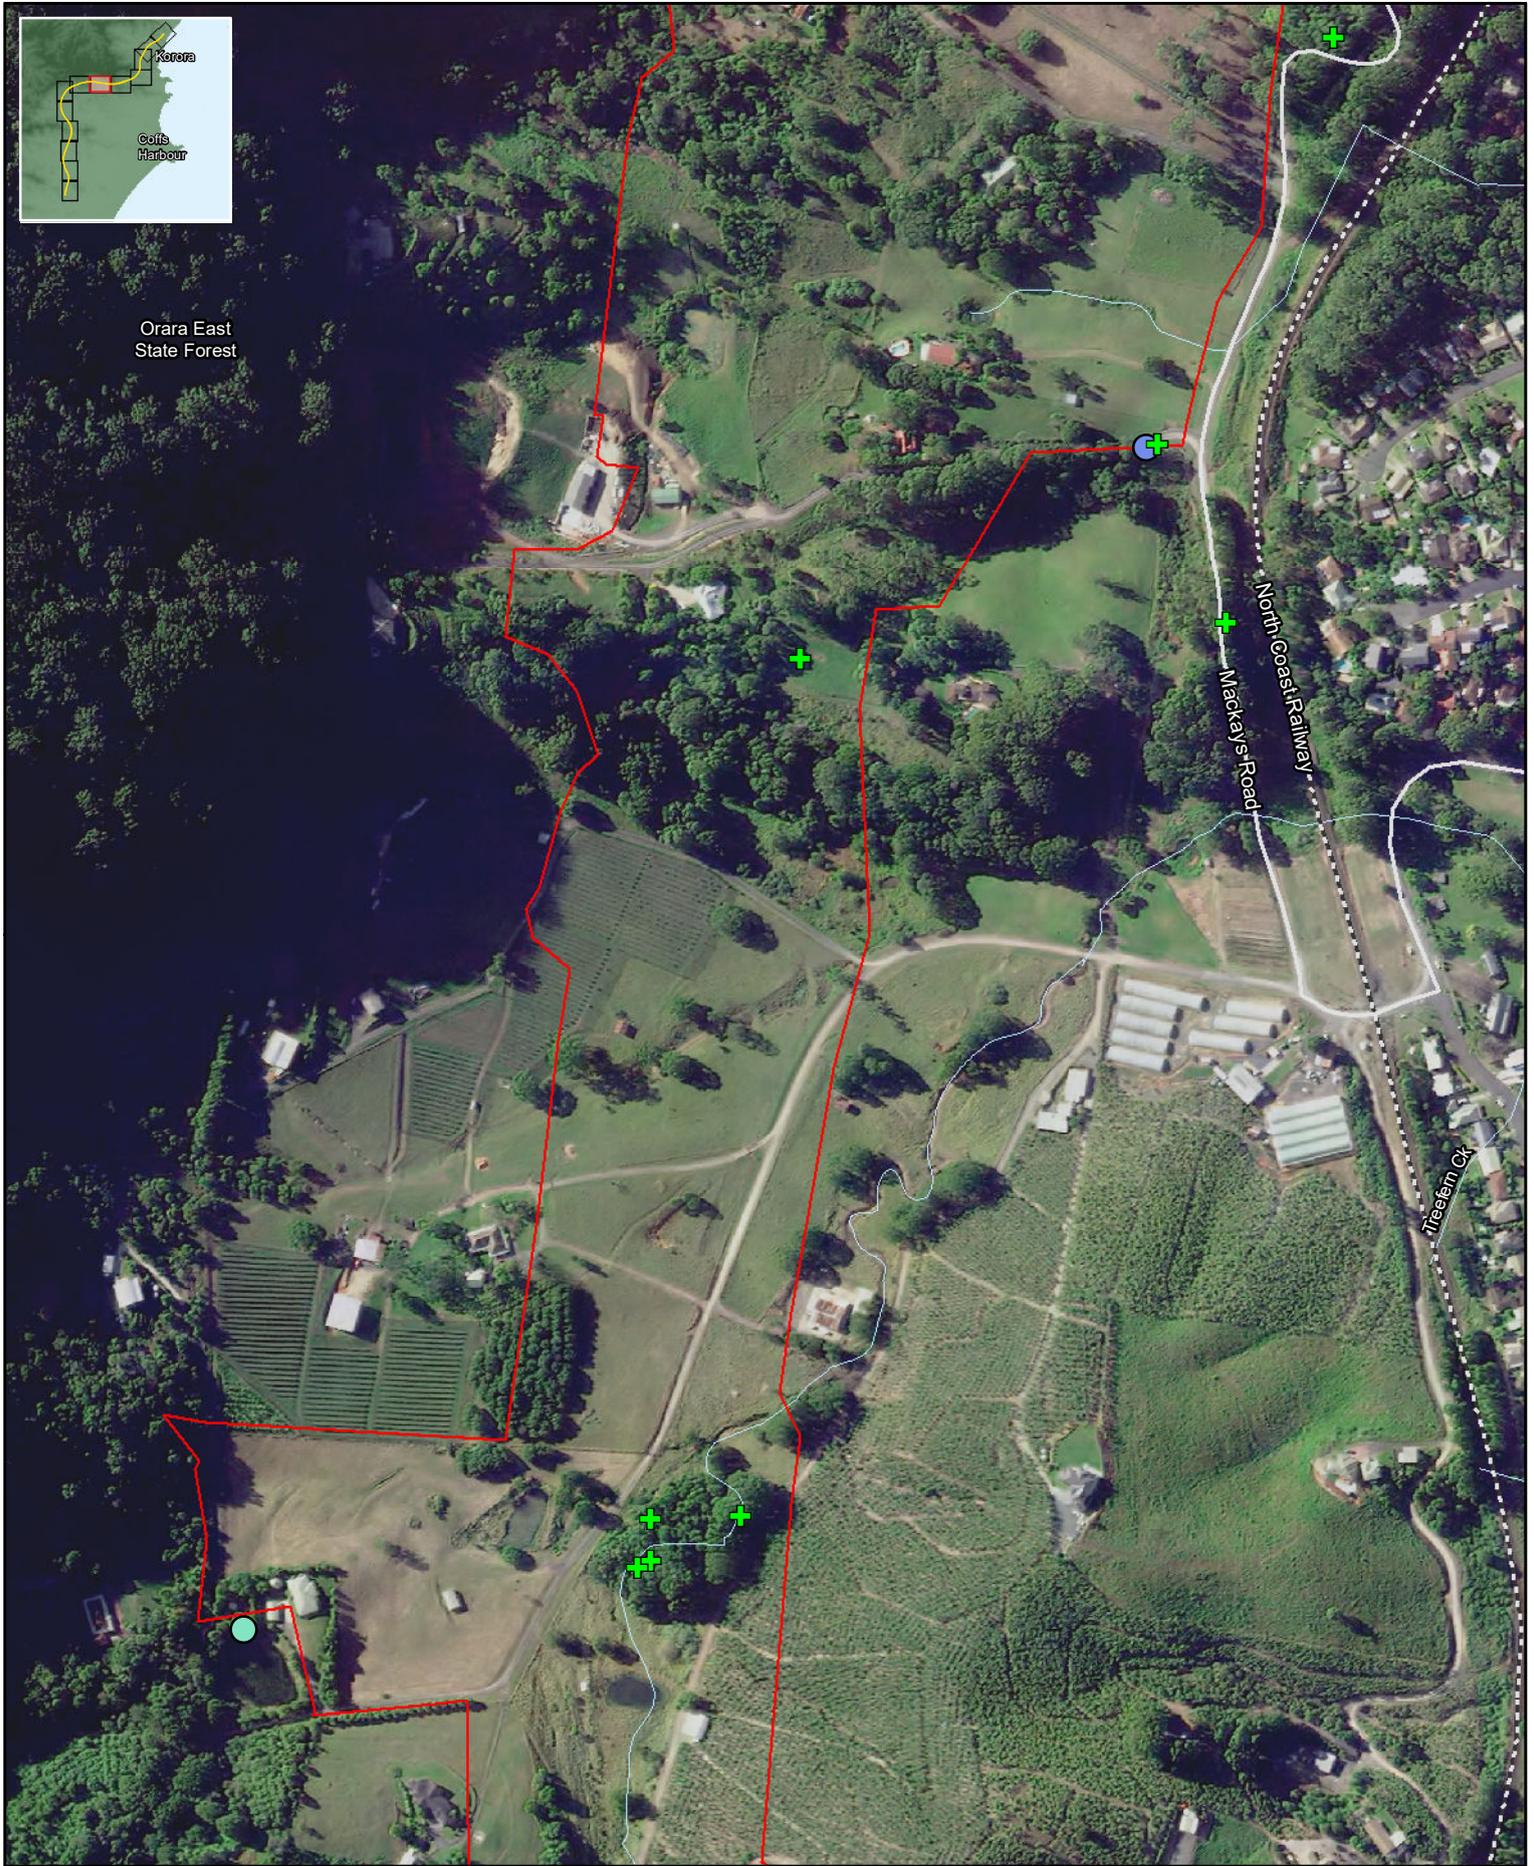
Coffs Harbour Bypass
Threatened fauna records and species credit habitat polygons
Figure 3-08

- Legend**
- ▭ Construction footprint
 - - - North Coast Railway
 - Watercourse
 - + Hollow bearing tree
 - Threatened fauna records**
 - Koala
 - Pale-vented bush-hen
