**Transport for
New South Wales**

Coffs Harbour Bypass

Threatened Species Management Plan

Transport for New South Wales | Working Draft | May 2021

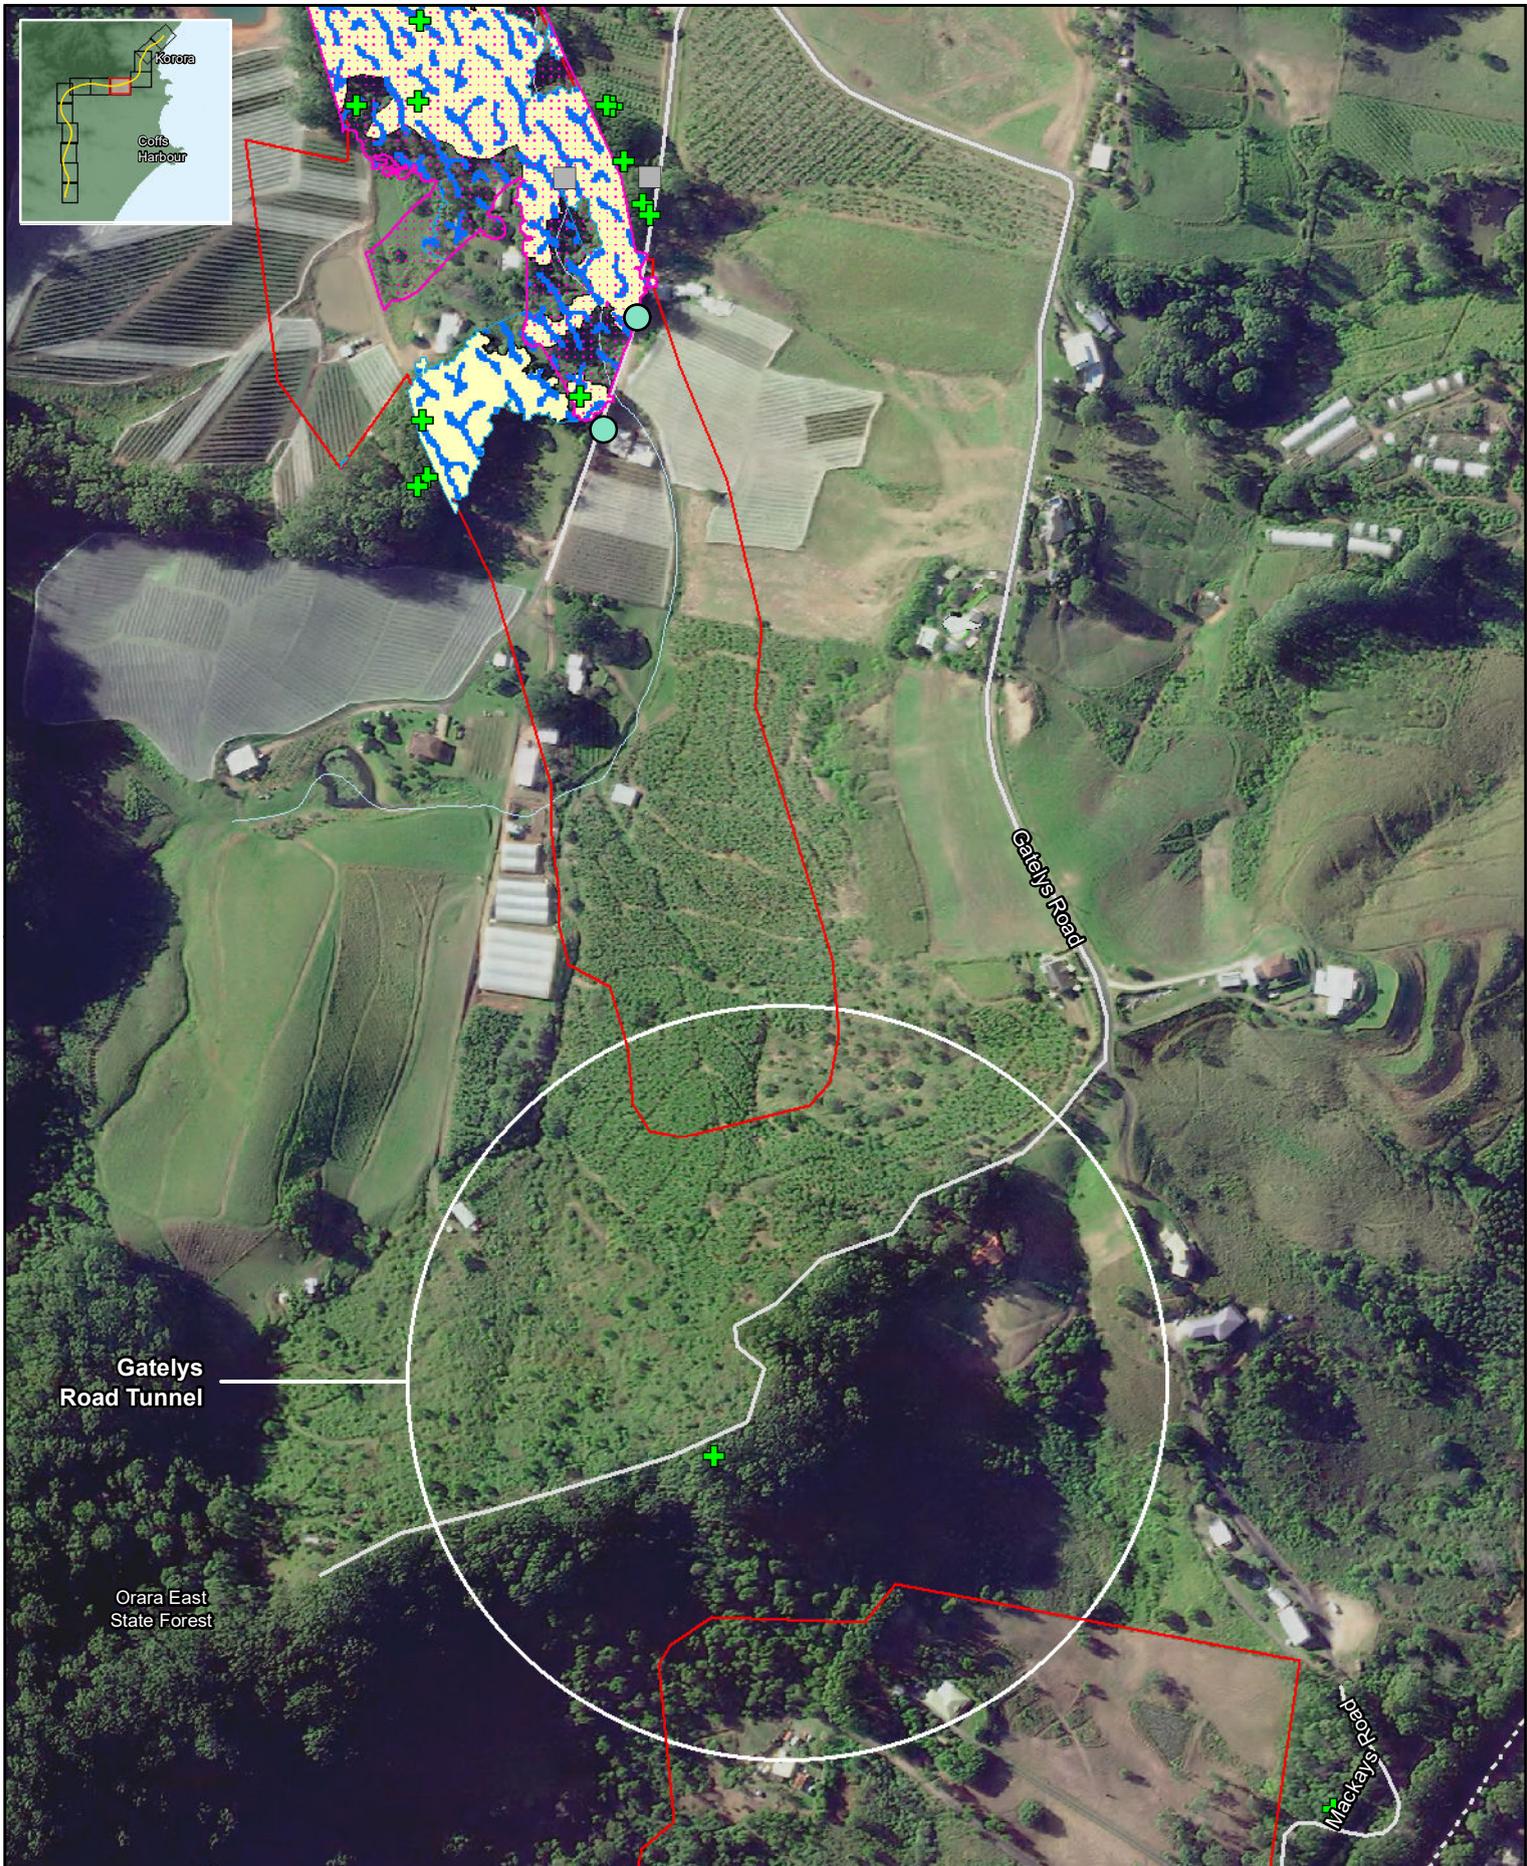
Coffs Harbour Bypass
 Threatened fauna records and species credit habitat polygons
 Figure 3-09

- Legend**
- ▭ Construction footprint
 - - - North Coast Railway
 - Watercourse
 - + Hollow bearing tree
 - Threatened fauna records
 - Pale-vented bush-hen
 - ▭ Species credit species habitat polygons
 - ▭ Pale-vented bush-hen
 - ▭ Southern myotis
 - ▭ Koala
 - ▭ Culverts - potential microbat roost
 - ▭ None

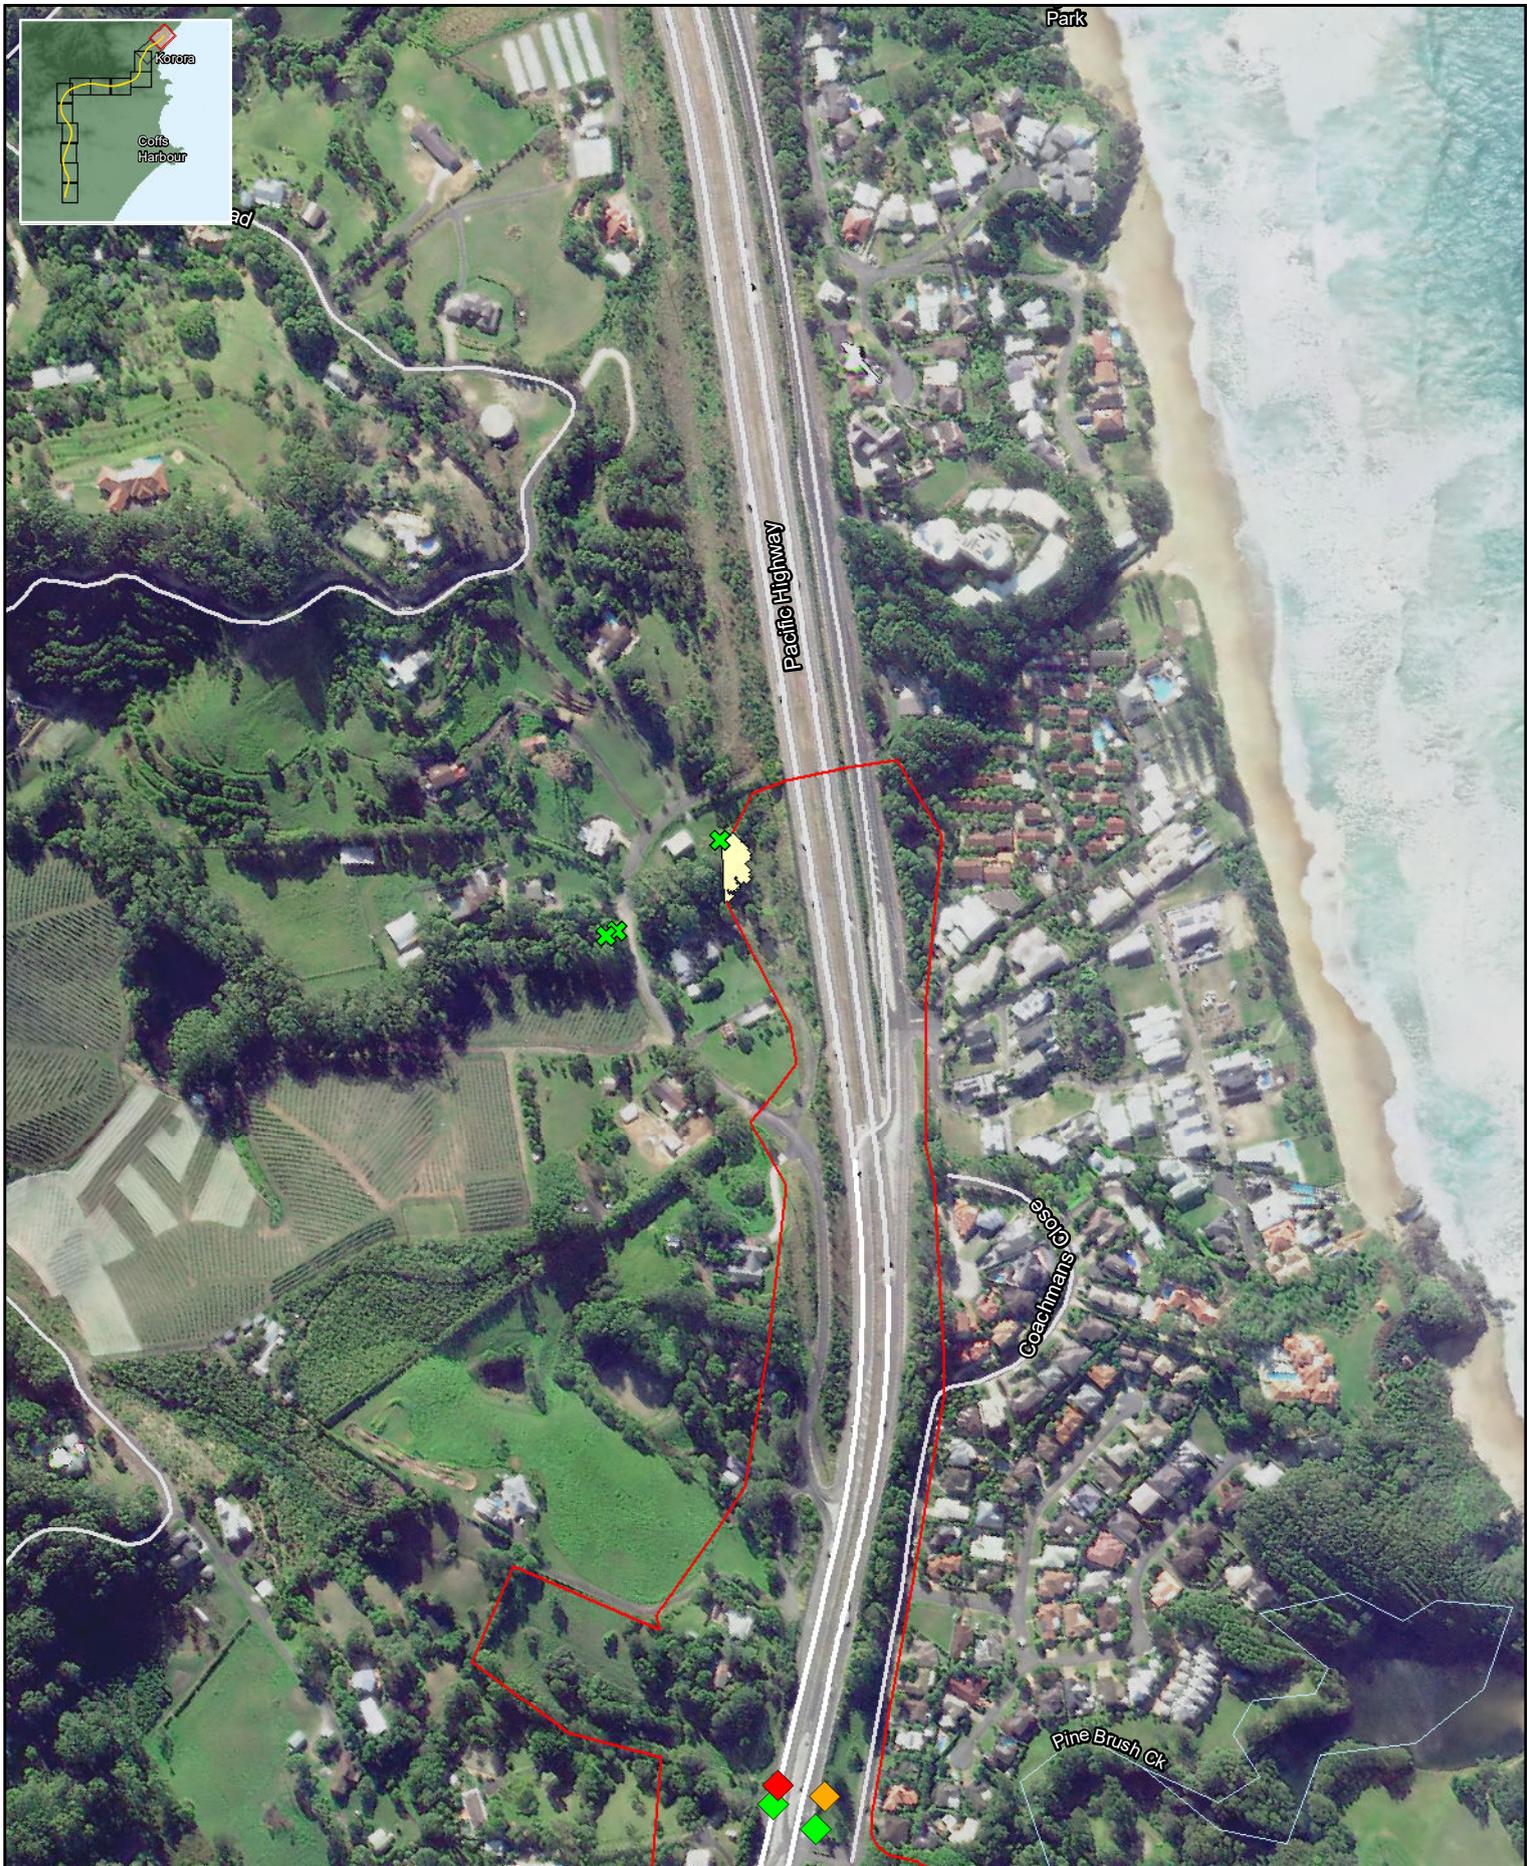
Coffs Harbour Bypass
 Threatened fauna records and species credit habitat polygons
 Figure 3-13

- Legend**
- Construction footprint
 - North Coast Railway
 - Watercourse
 - + Hollow bearing tree
 - Species credit species habitat polygons
 - Koala
 - ◆ Culverts - potential microbat roost
 - ◆ High
 - ◆ Medium
 - ◆ Low

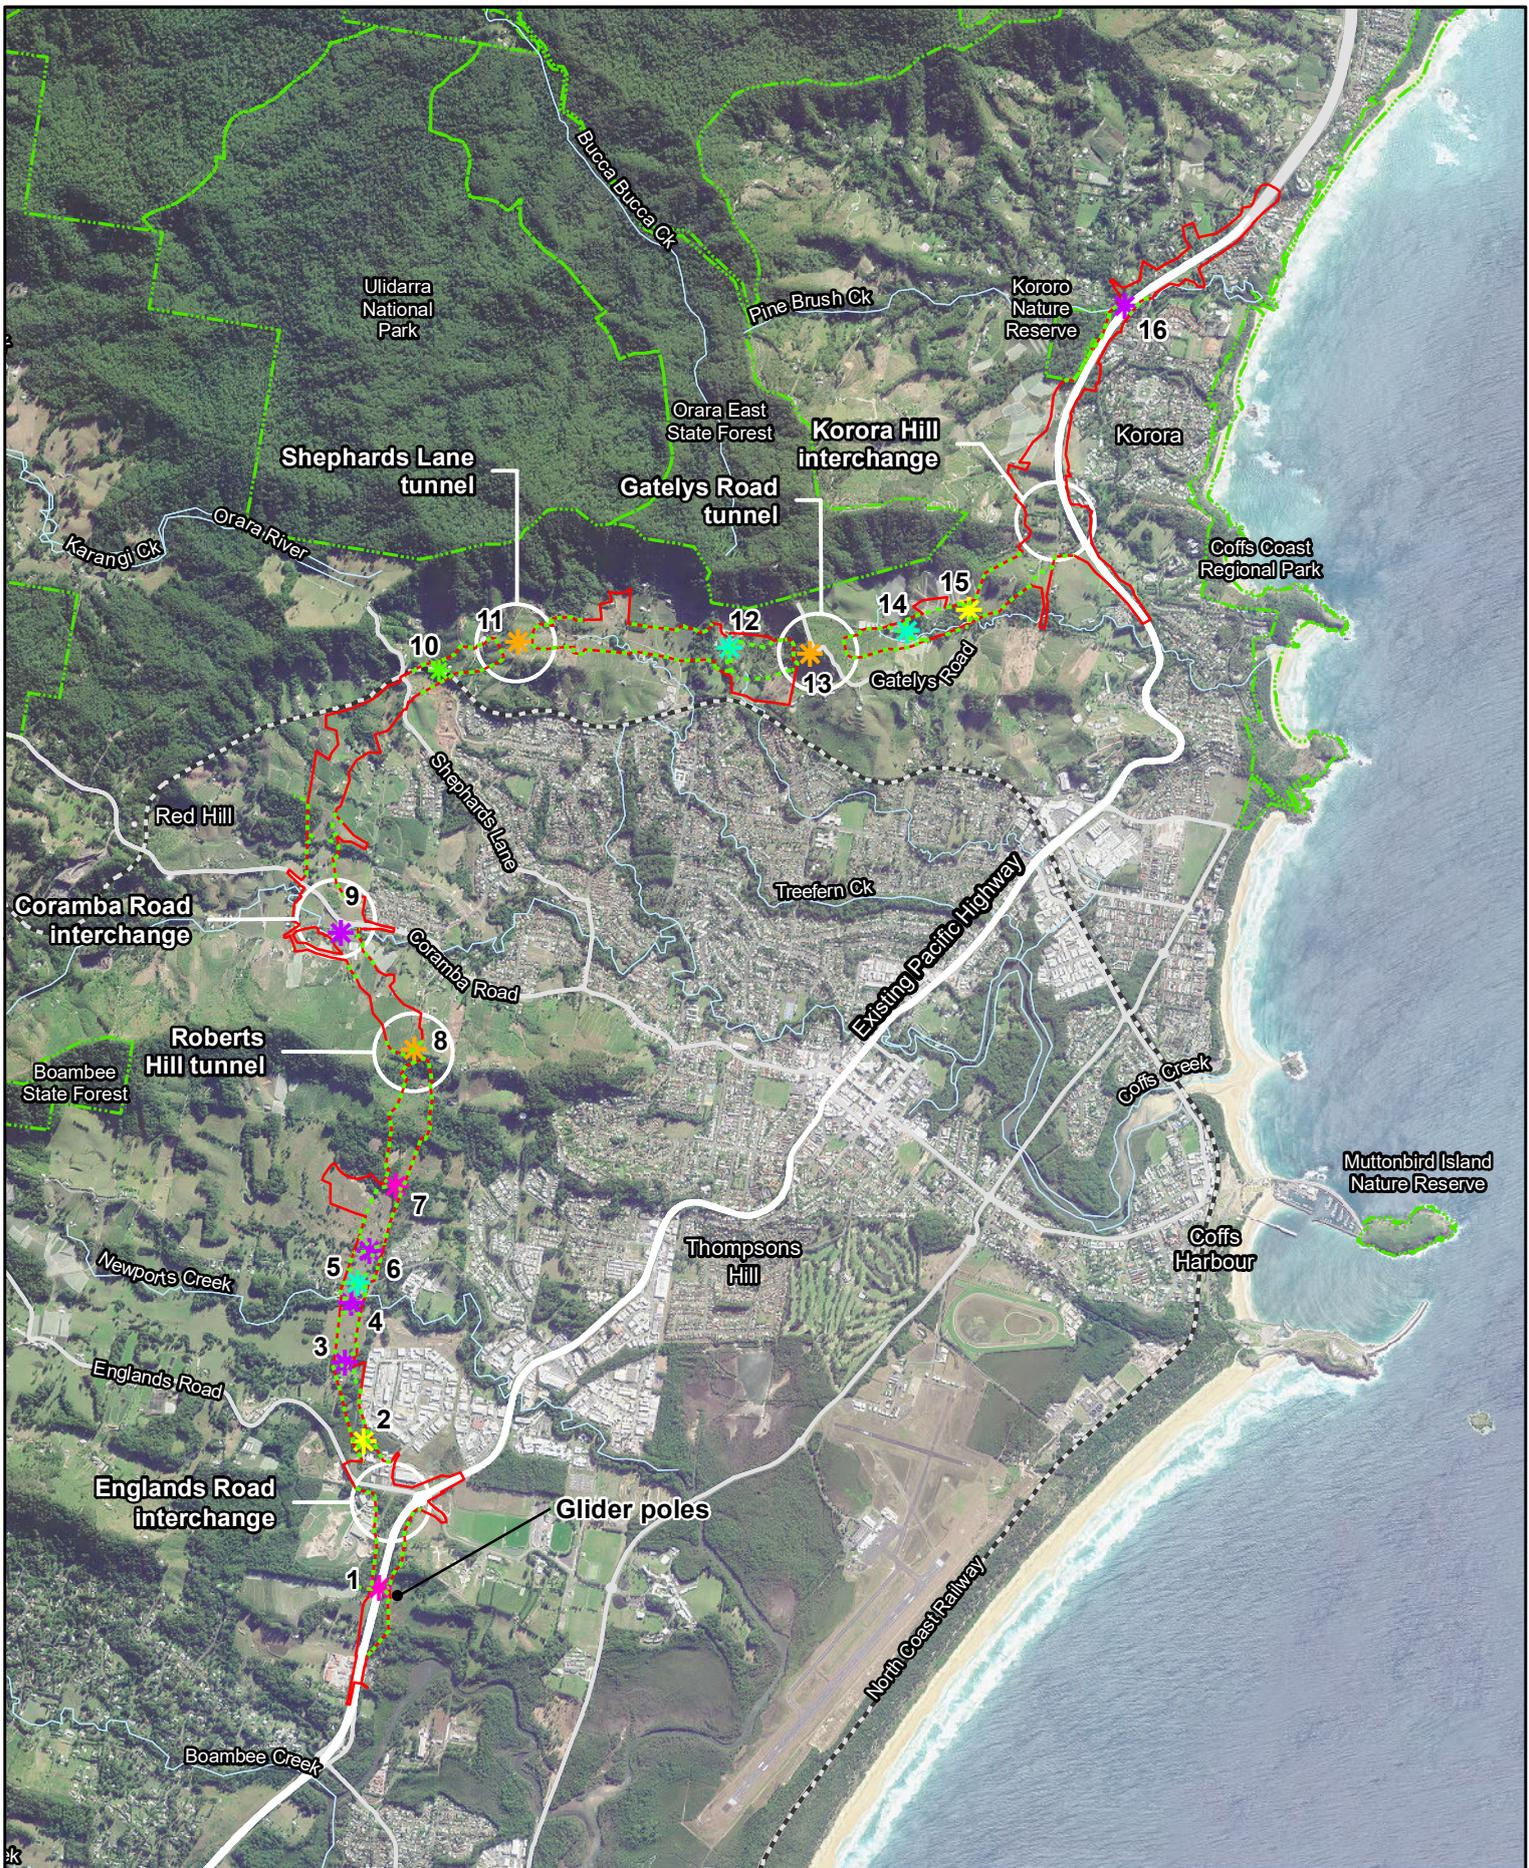
Coffs Harbour Bypass
 Permanent fauna connectivity structures and fencing
 Figure 5

- Legend**
- Construction footprint
 - North Coast Railway
 - Watercourse
 - Park/Reserve
 - Indicative fauna fencing location
- Fauna Structures**
- ✦ Combined fauna and drainage underpass
 - ✦ Combined rail bridge incorporating fauna underpass
 - ✦ Combined road bridge incorporating fauna underpass
 - ✦ Combined waterway bridge incorporating fauna underpass
 - ✦ Dedicated fauna underpass
 - ✦ Retained ridgeline over tunnel overpass

Crossing structures have been proposed based on the requirements of the target species, the alignment and condition of fauna corridors and the design and topographic constraints of the project. Sixteen locations have been identified along the 14 km alignment where connectivity structures can be placed, as identified in **Table 6** and shown in **Figure 5**. The location and final details of these structures will be subject to detailed design.

Fauna exclusion fencing, with appropriate mechanisms to prevent climbing and burrowing animals, is to be installed on both sides of the tunnel approaches, extending above both portals and tying into the fauna fencing along the road corridor. The design of any barriers must not cause a barrier to the movement of any of the target fauna species.

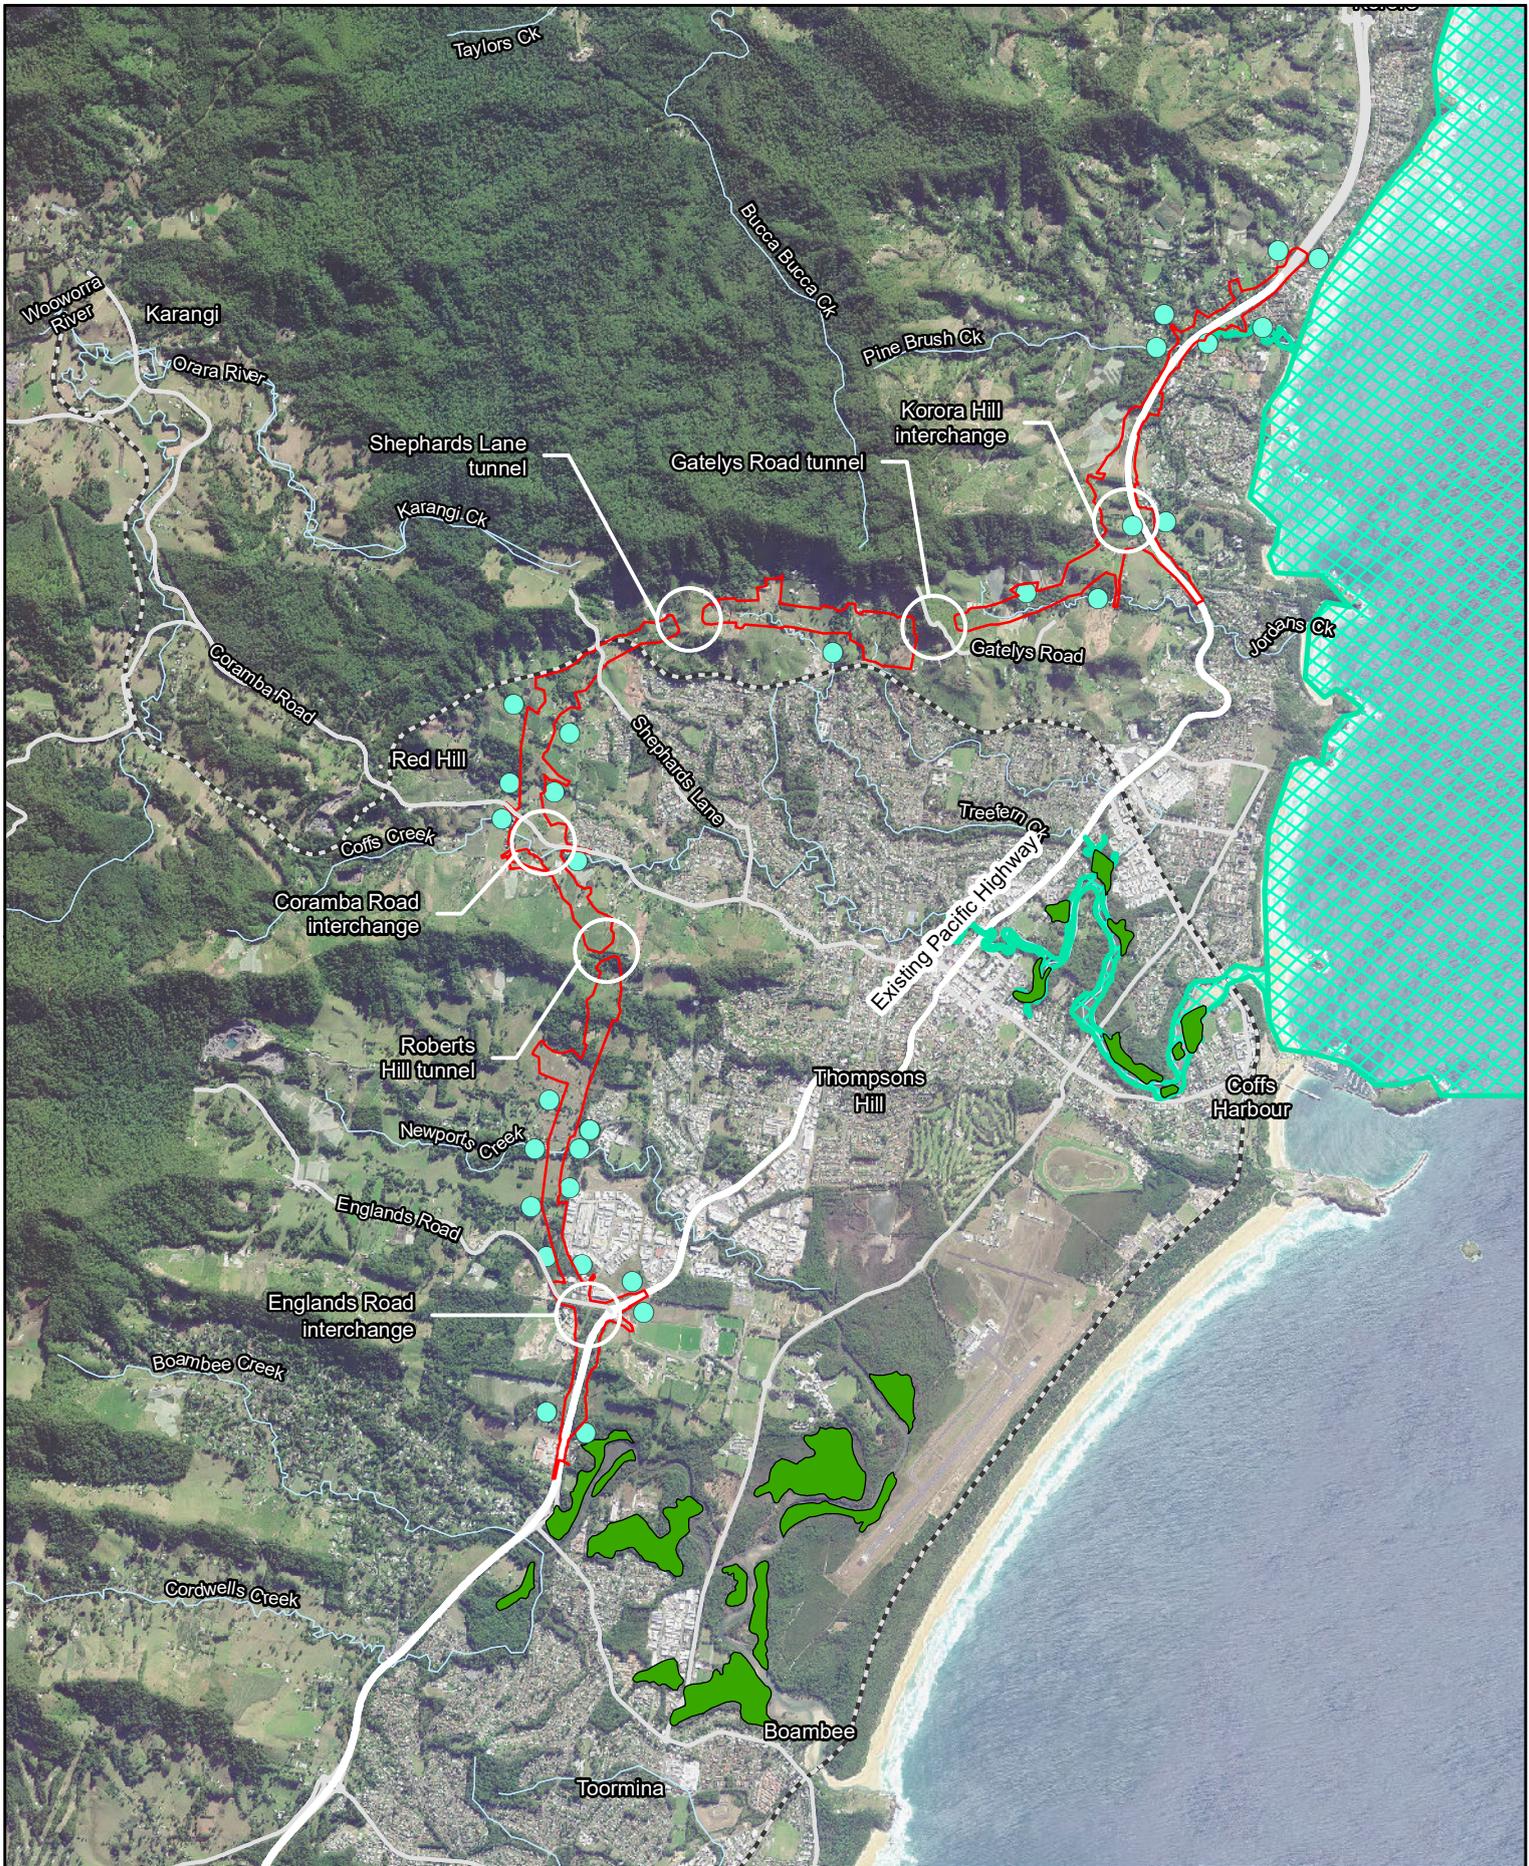
Coffs Harbour Bypass
 Recommended surface water quality sampling locations
 Figure 6

- Legend**
- Construction footprint
 - Indicative Surface Water Quality Sampling Locations
 - North Coast Railway
 - NSW Coastal Management SEPP wetlands
 - Watercourse
 - Solitary Islands Marine Park (NSW)
