Woolgoolga to Glenugie Pacific Highway Upgrade Microbat Management Plan Sections 1 and 2

Prepared for: NSW Roads and Maritime Services
© GeoLINK, 2014

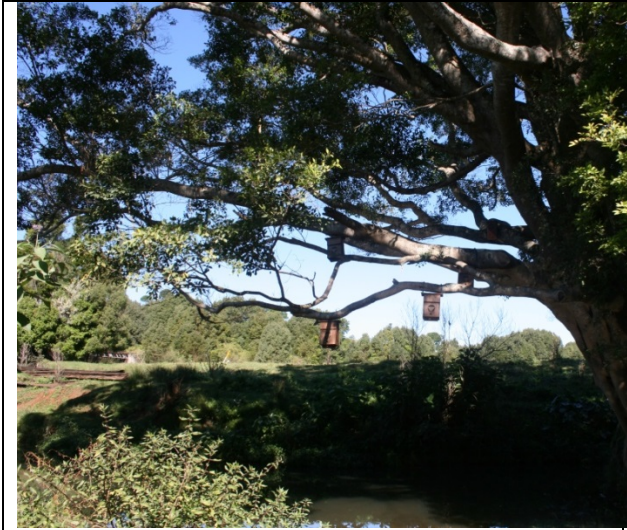
Plate 3.1 Hanging bat boxes over water
(Source: V. Silver)

Where no suitable trees occur in proximity to water, a length of timber or wire/ rope system would be erected between two trees over a waterway (refer to **Plate 3.2**). The bat box can then be attached to hang from this structure.

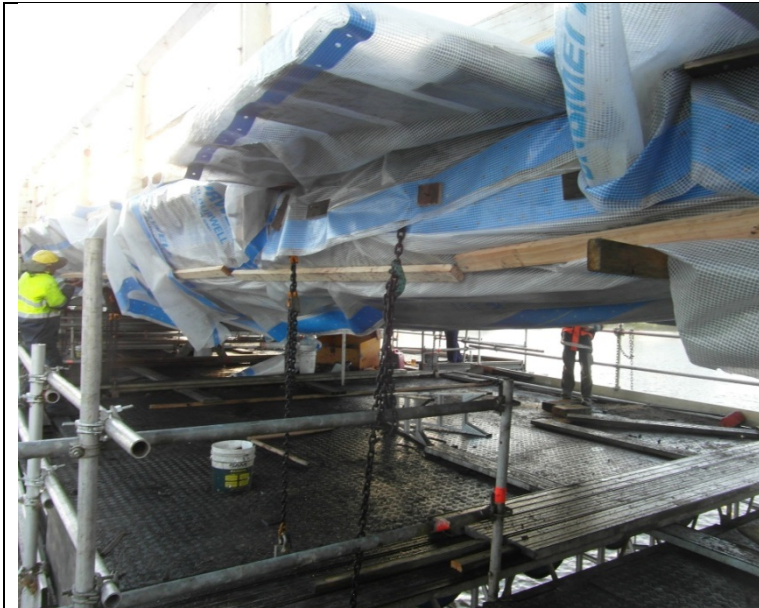
Plate 3.5 Exclusion Option – Plastic wrap bridge
(Source: A. Lloyd)

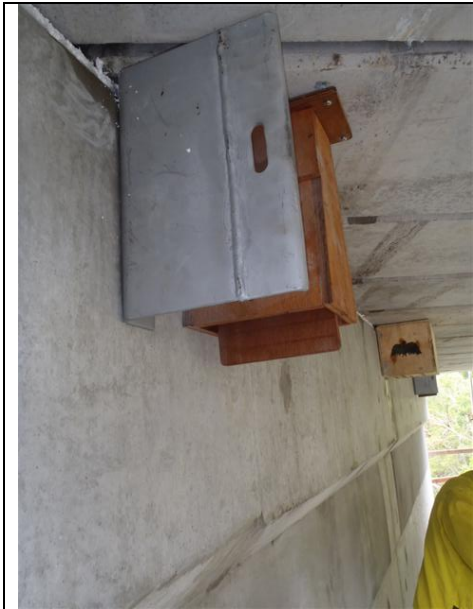
Plate 3.7 Bat boxes with bash plate beneath Myott Bridge (Source: A. Lloyd)

- Hanging four-chambered bat boxes with bash plate to deflect any debris and reduce damage during a flood event (refer to **Plates 3.7 and 3.8**);
- Light weight concrete blocks (Hebel) with holes drilled to create cavities (refer to **Plates 3.9 and 3.10**); and
- Lattice style bat boxes (refer to **Plate 3.11 and 3.12**).

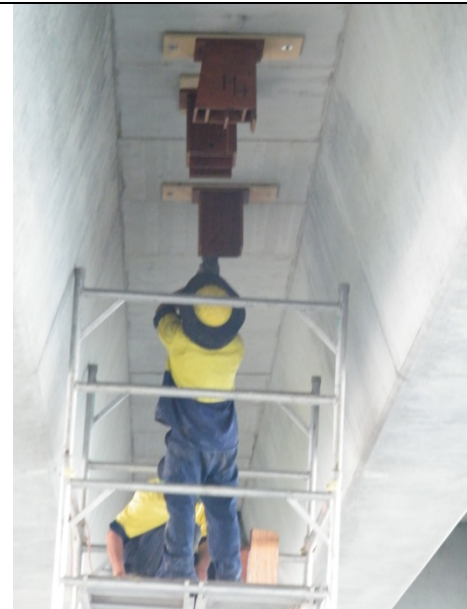
Plate 3.8 Installation of bat boxes beneath Mororo Bridge (Source: D. Andrighetto)

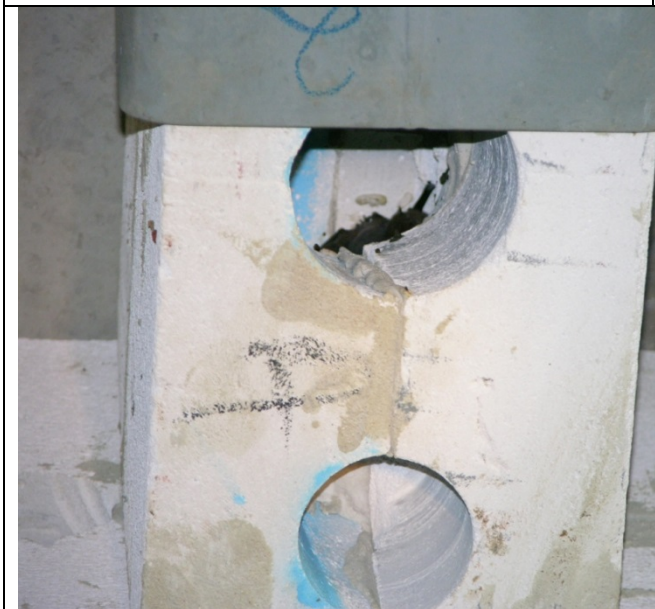
Plate 3.9 Light weight concrete blocks with drill holes, microbat visible in chamber (Source: N. Williams)

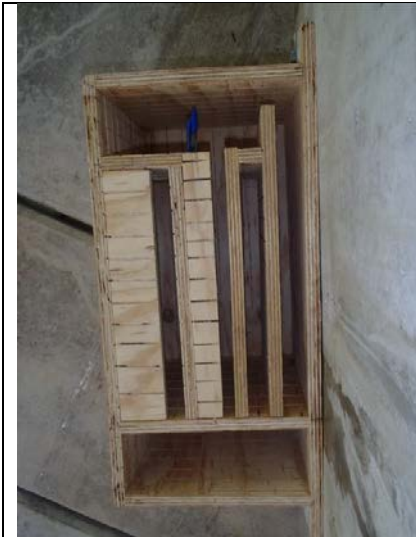
Plate 3.11 Lattice style bat box beneath Myott Bridge (Source: A. Lloyd)

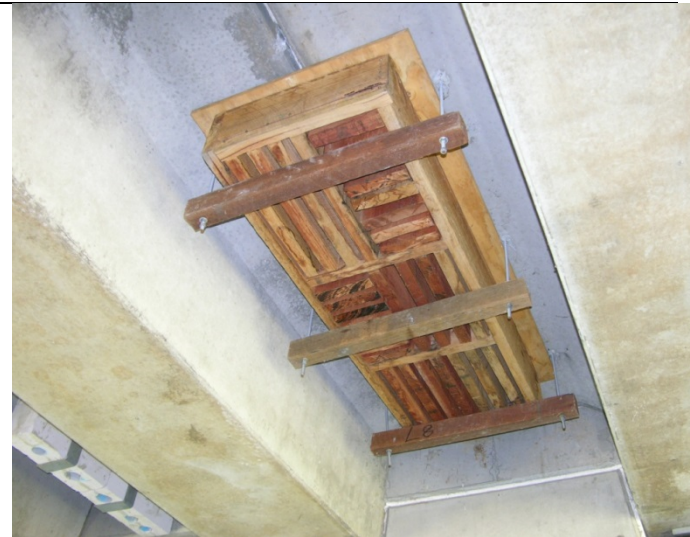
Plate 3.12 Lattice style bat box under bridge (Source: N. Williams)

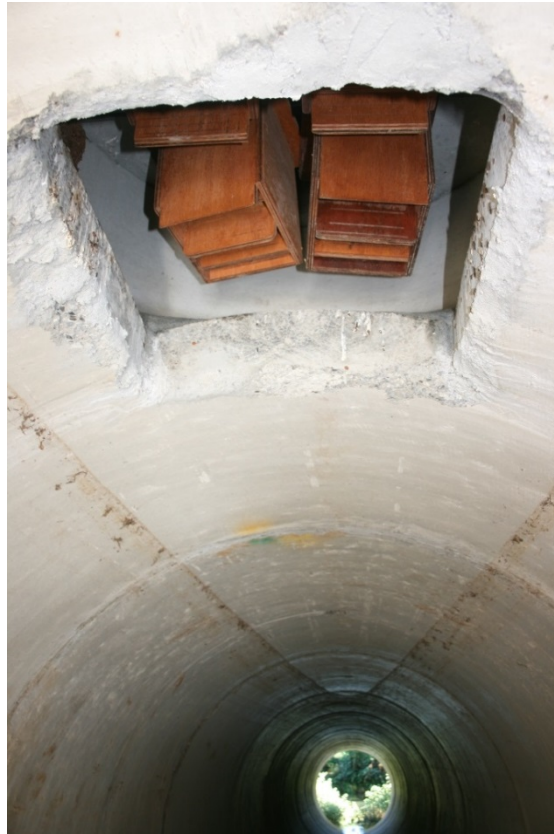
Plate 3.13 Recessed Chamber with Bat Boxes (Source: V. Silver)

A recessed chamber in the form of a manufactured man hole would provide bats with a well-insulated replacement cavity that would provide a safe roosting location. Recessed chambers are only recommended within CPCs, this is due to structural reinforcing being compromised within the obvert of a RCBC. The recessed chamber would be located approximately one third of the way through the culvert at the outlet end (as pools of water are often present at the outlet rather than inlet). The CPC would have a pre-fabricated hole the size of the man hole (chamber) and would be fitted with four-chambered hanging bat boxes (refer to **Plate 3.13**).
