# Warrell Creek to Nambucca Heads Pacific Highway Upgrade

Annual Ecological Monitoring Report

February 2020 - February 2021

Transport for NSW | April 2021

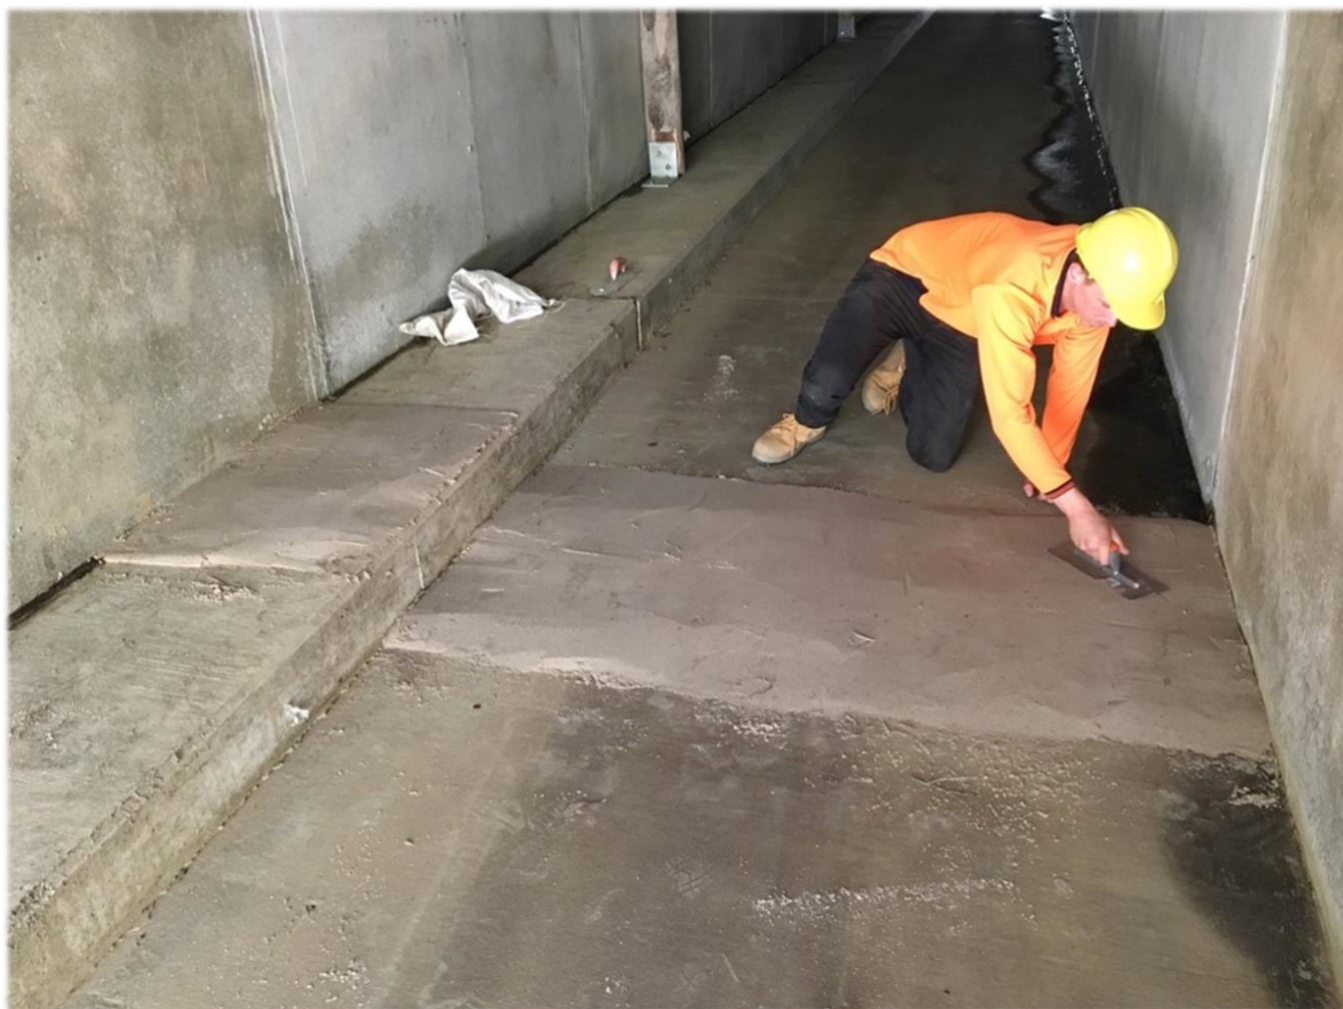
**Plate 1.** Sand pad being installed in a fauna underpass on the WC2NH upgrade.

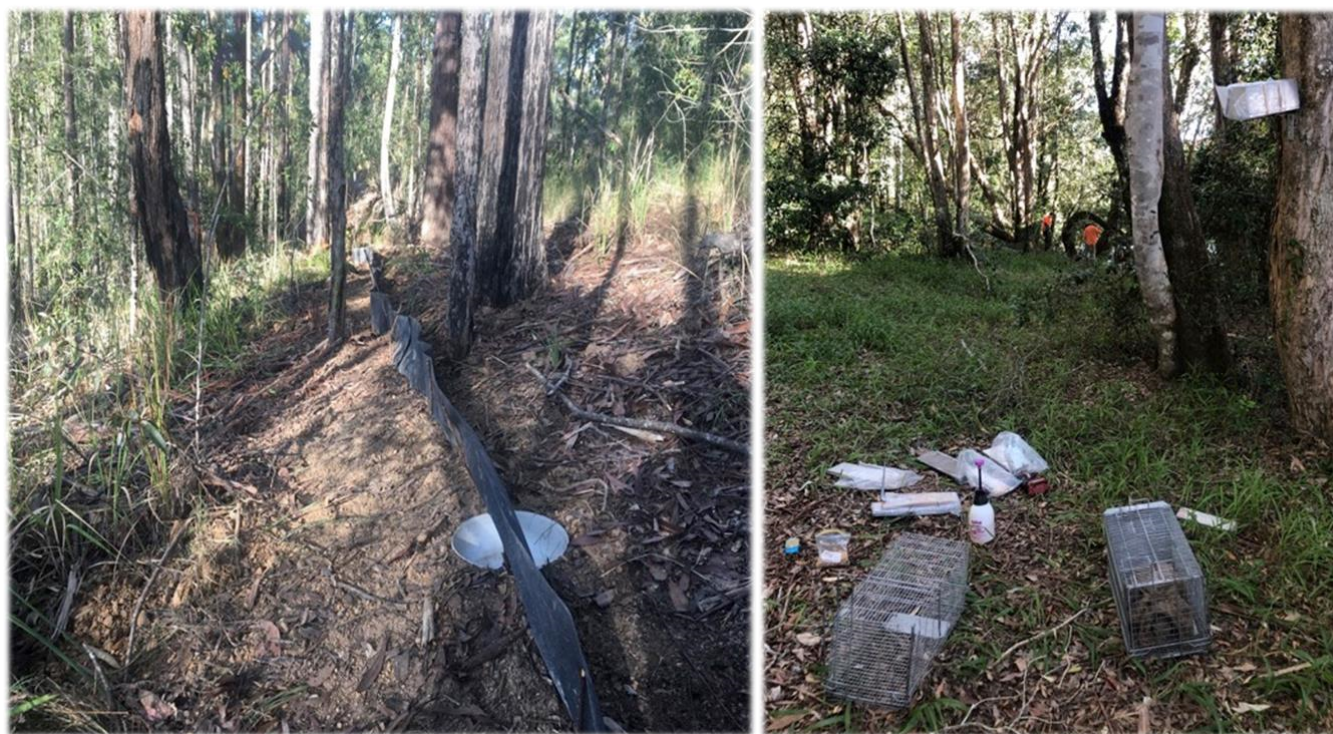
**Plate 2:** Example of a pitfall trap line installed during adjacent habitat surveys (L). Setting up traps in adjacent habitat at site 1 (R).

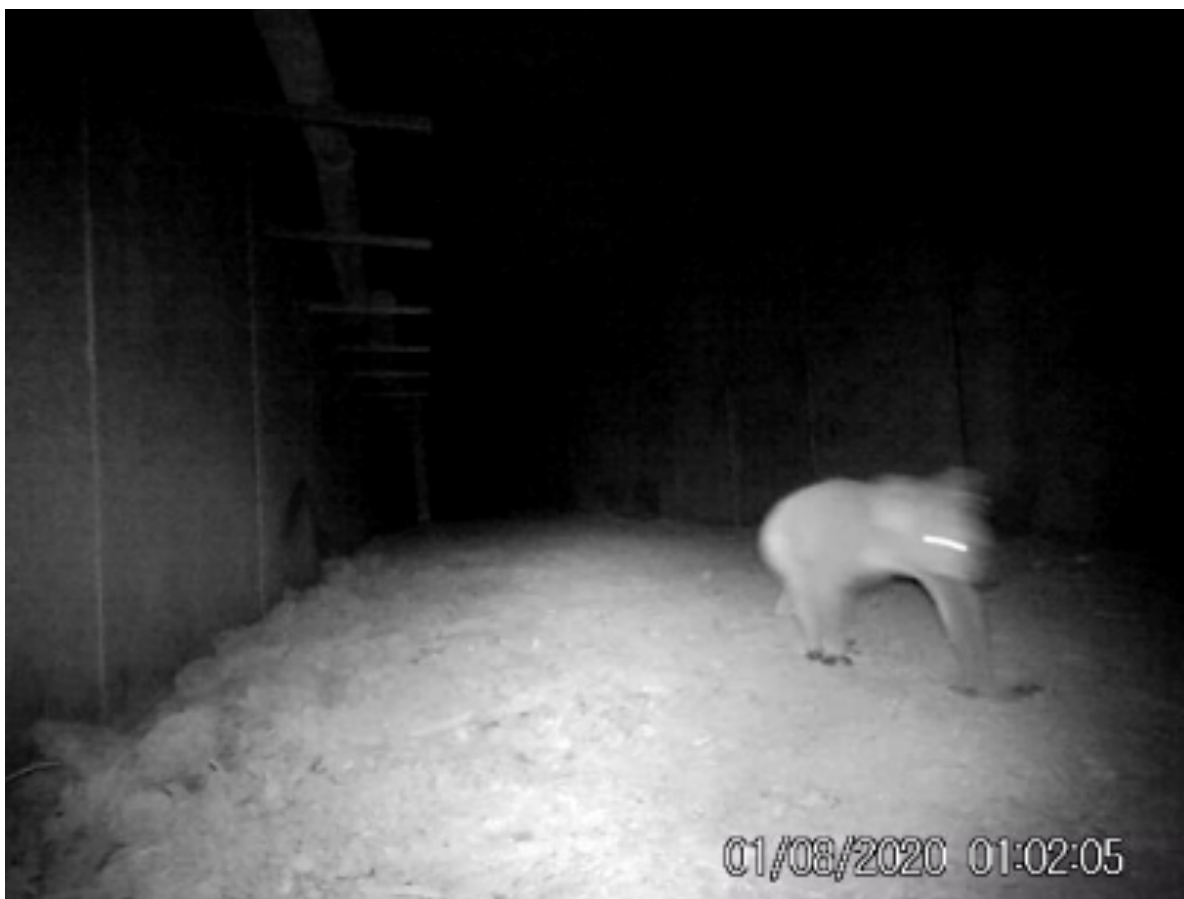
Plate 3: Koala recorded at Site 4, moving west on 1 August 2020.

Koala was the only threatened species recorded, with complete crossings using the culvert floor recorded at sites 4, 9, and 10 (Table 5 and Figure 2). Koala made seven complete crossings (four east, three west) at site 4 during spring/summer and two complete crossings (one east, one west) during winter (Plate 3). An individual was also recorded making a complete crossing (heading west) through 9 and 10 (split median) during spring/summer (Figure 2, see appendix C Table 1)

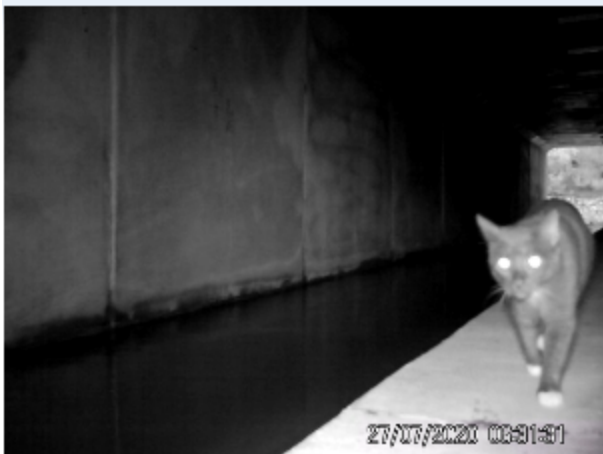
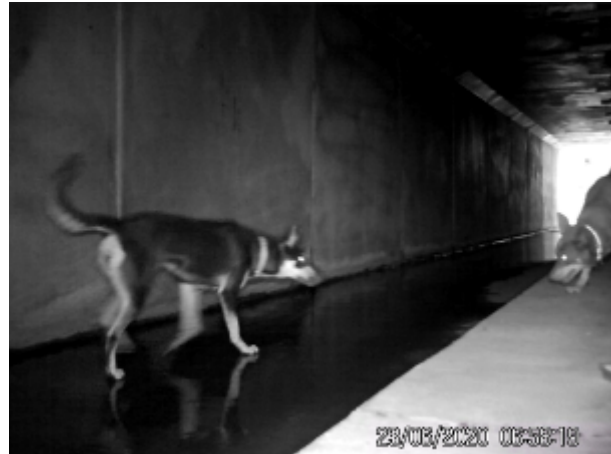
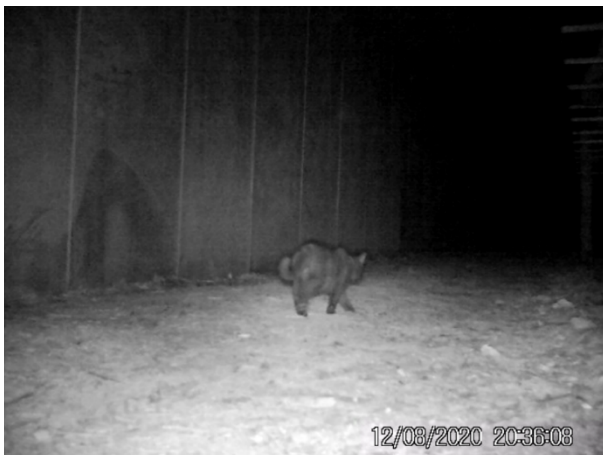
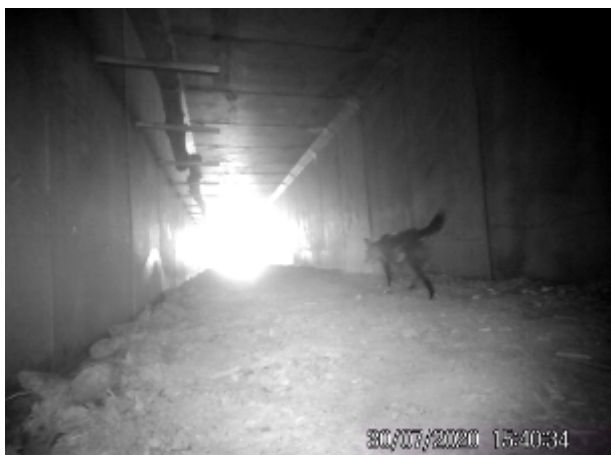
**Plate 4:** Cat individual frequently recorded at site 3 (Top left). Dogs recorded at site 3 (Top right). Feral cat making a complete crossing east at site 7 (Bottom left). Feral dog making a complete crossing east at site 4 (Bottom right).

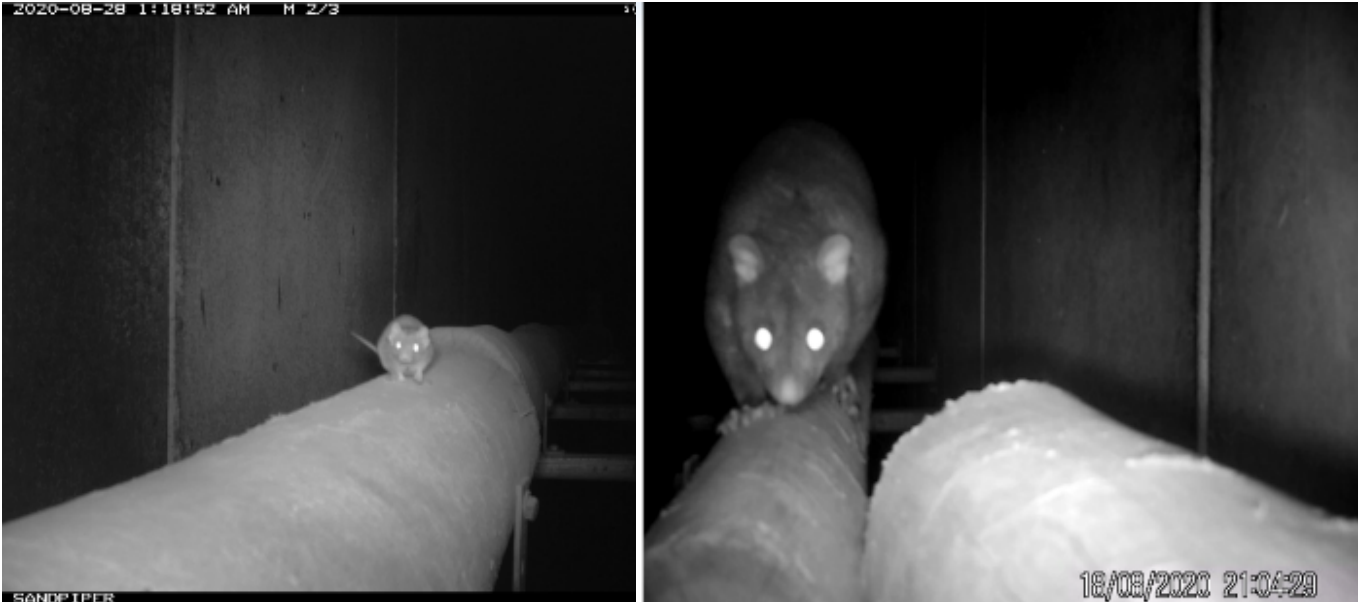
Plate 5: Antechinus making a complete crossing west using the fauna furniture at site 6 (Left). Short-eared brushtail possum utilising the fauna furniture at site 8.

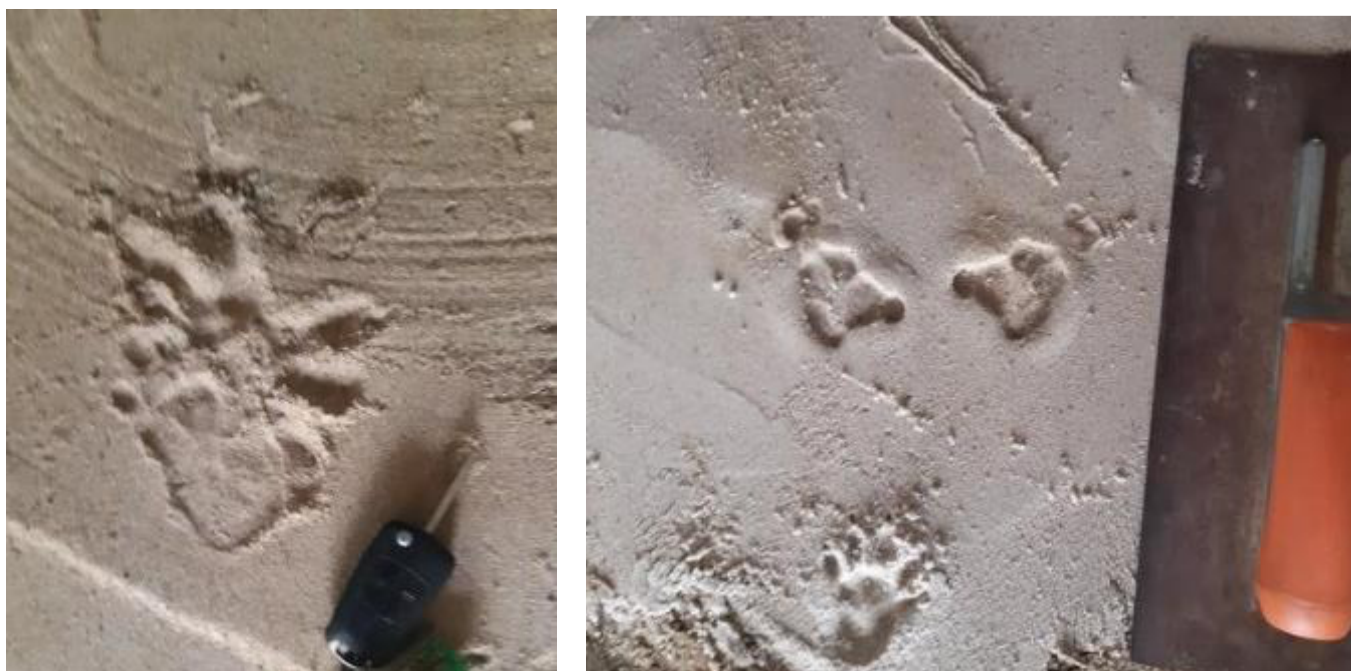
**Plate 6:** Koala tracks (L) recorded on sand pads at Site 4 and Brushtail possum tracks (R) recorded during spring/summer monitoring.

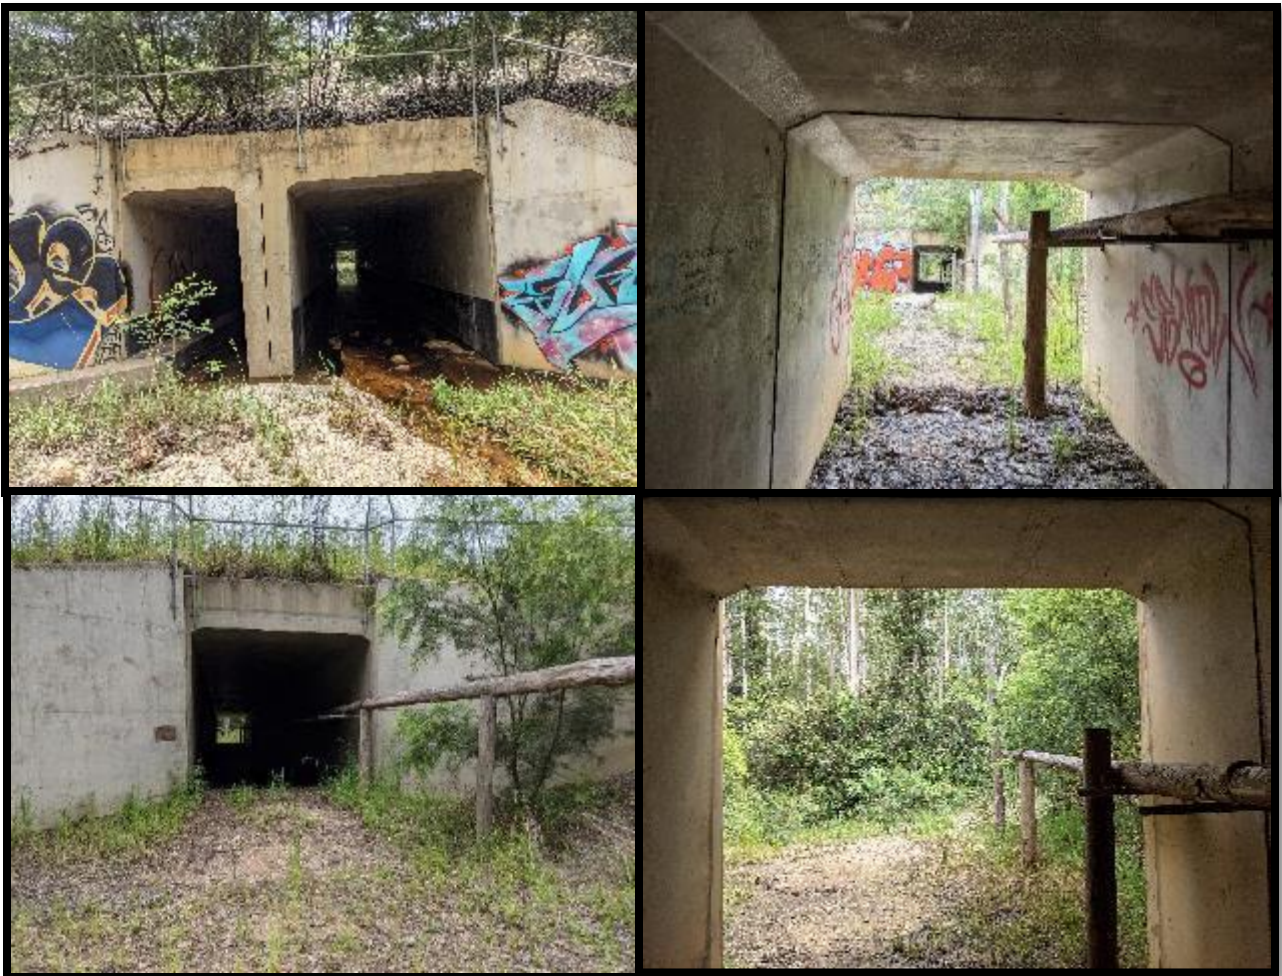
**Plate 1.** Dual box culverts with designated wet passage at site 5 (top left). Split median box culverts at site 9 and 10 (top right). Fauna furniture entering (bottom left) and exiting site 8 (bottom right).

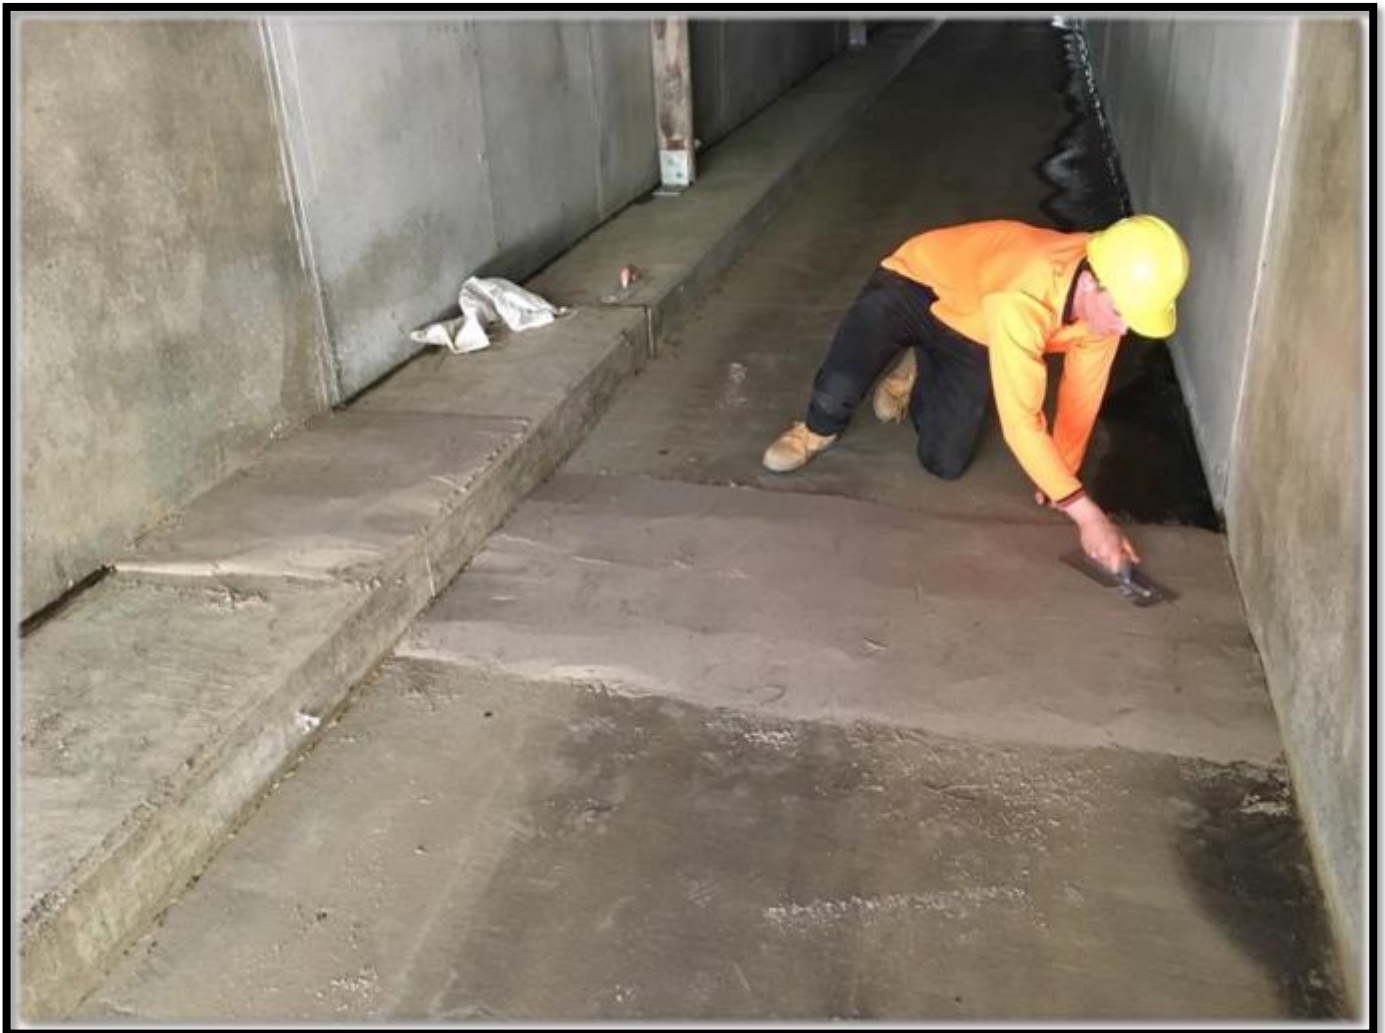
**Plate 2.** Sand pad being installed in a fauna underpass (Site 3) on the WC2NH upgrade.

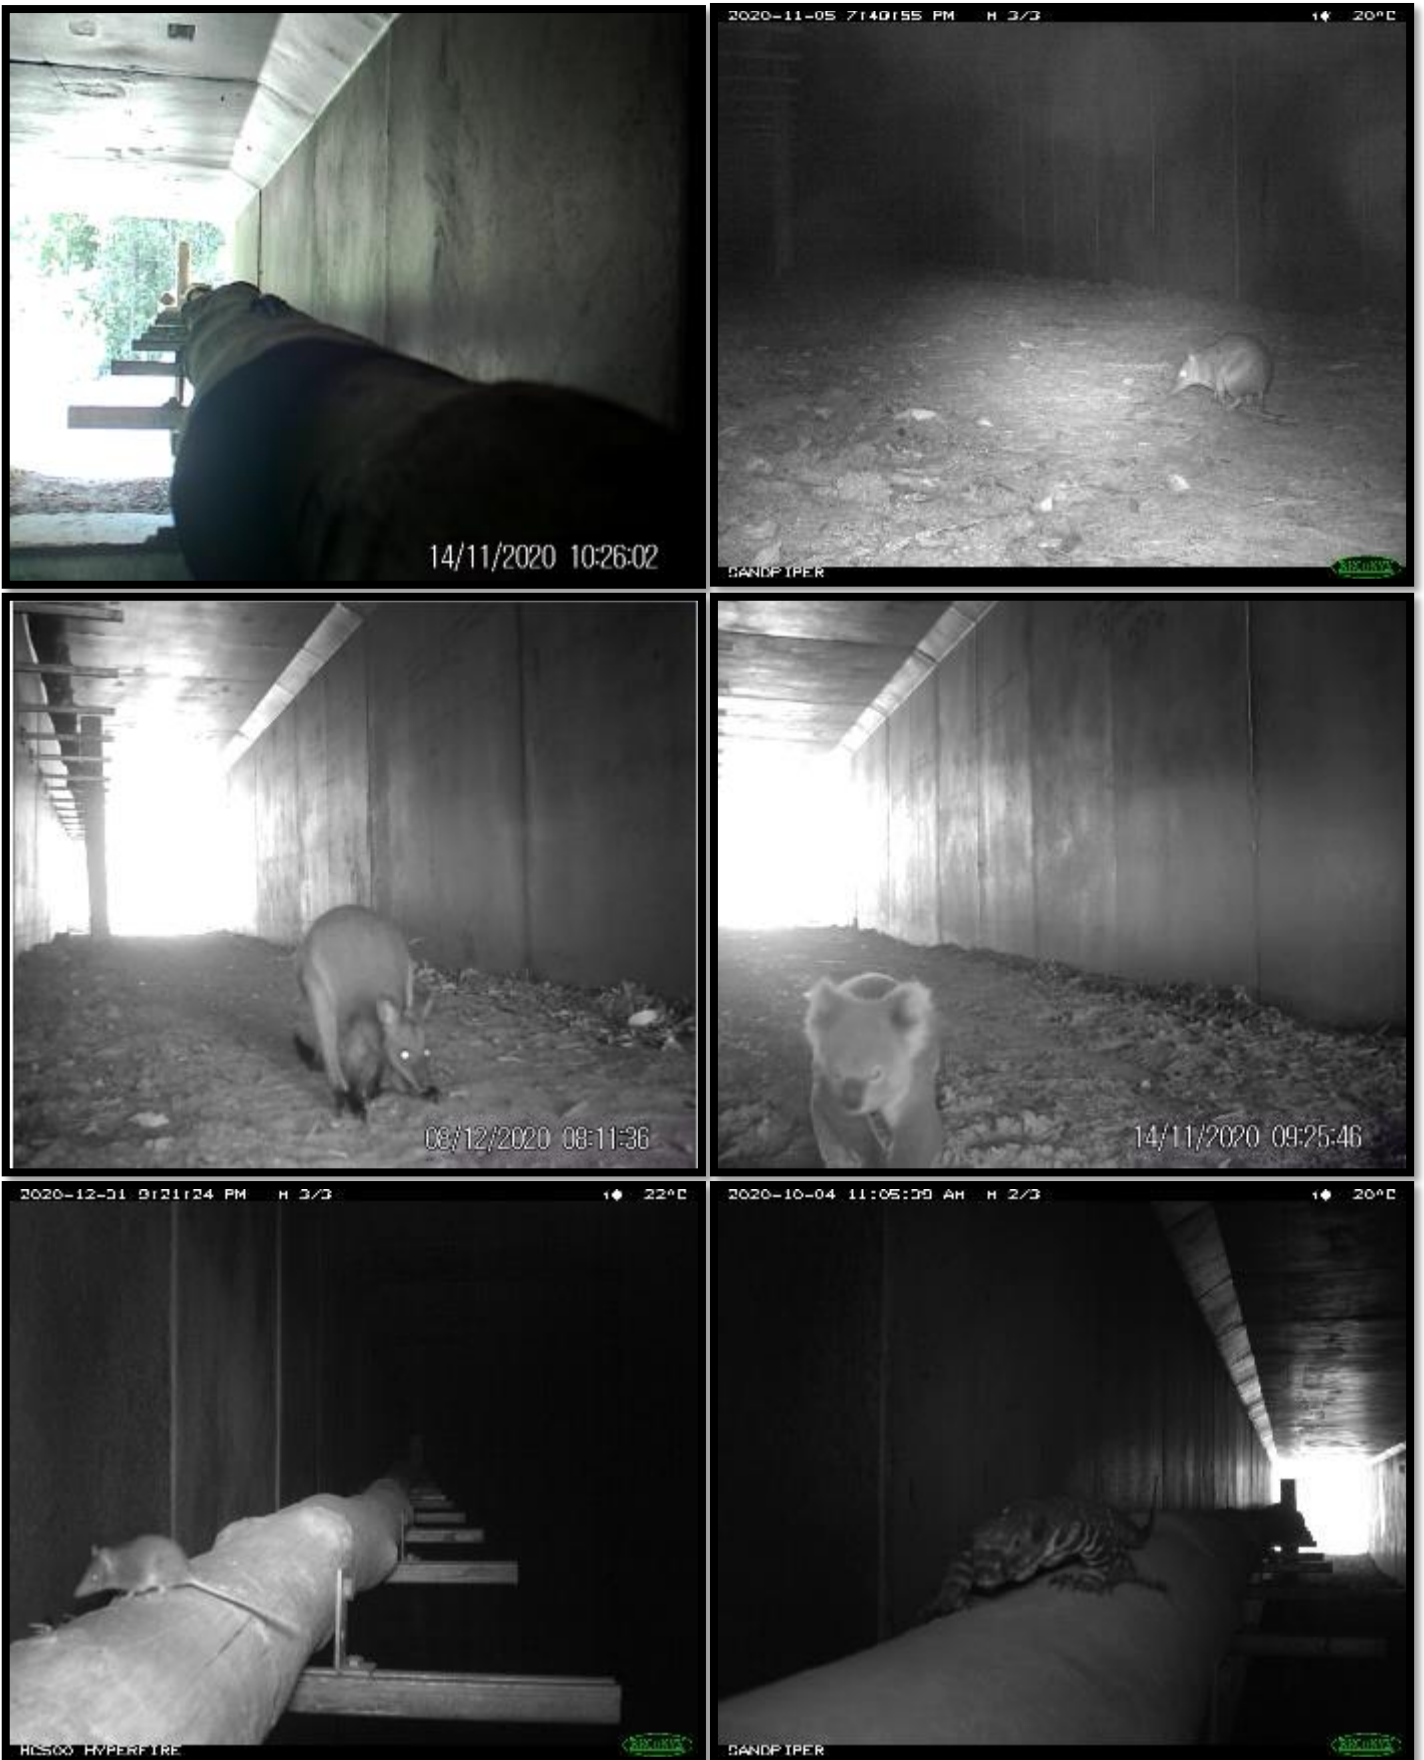
**Plate 4:** *Egernia* spp recorded on furniture at site 9 (Top left). Long-nosed bandicoot heading east at site 6 (Top right). Swamp wallaby travelling west at site 2 (Middle left). Koala recorded making an incomplete crossing at site 10 (Middle right). *Antechinus* spp recorded on fauna furniture at site 2 (Bottom left). Lace monitor recorded on fauna furniture at site 6 (Bottom right).

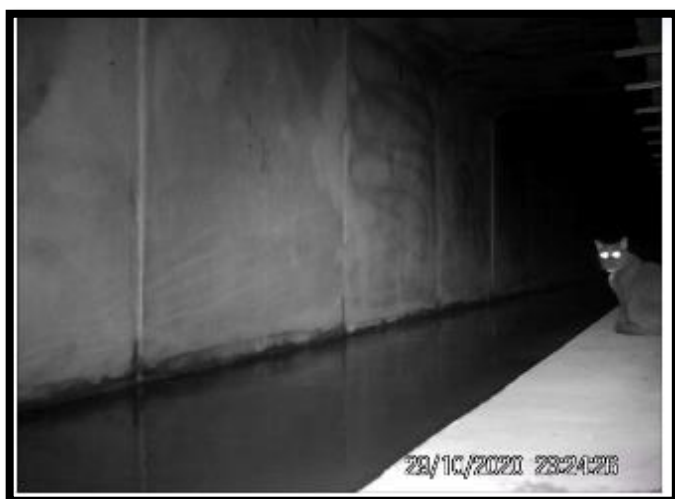
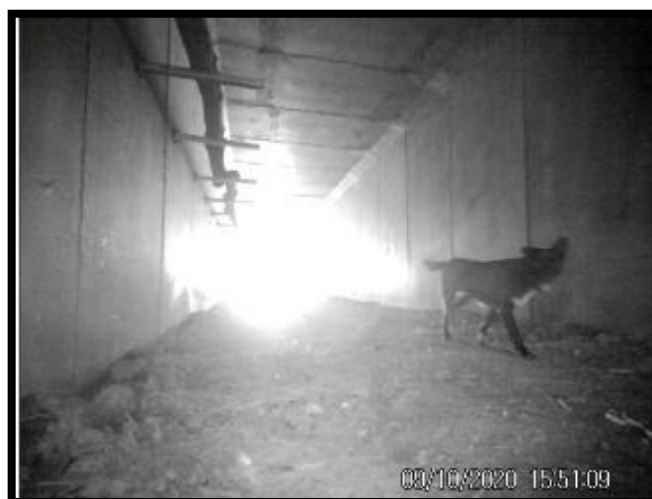
**Plate 5:** Cat frequently recorded at site 3 (Left) and dog frequently recorded at sites 4, 9,10,11,12 (Right).

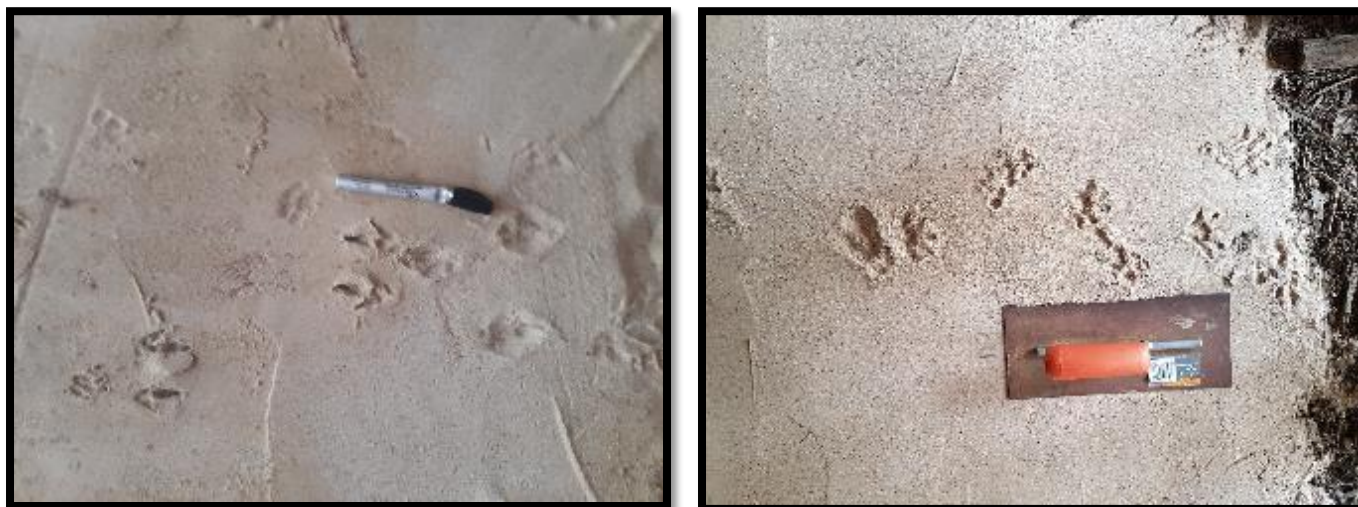
**Plate 6:** Bandicoot tracks recorded alongside cat tracks at site 8 during spring/summer monitoring. *Trichosurus* spp heading east at site 4 (right)

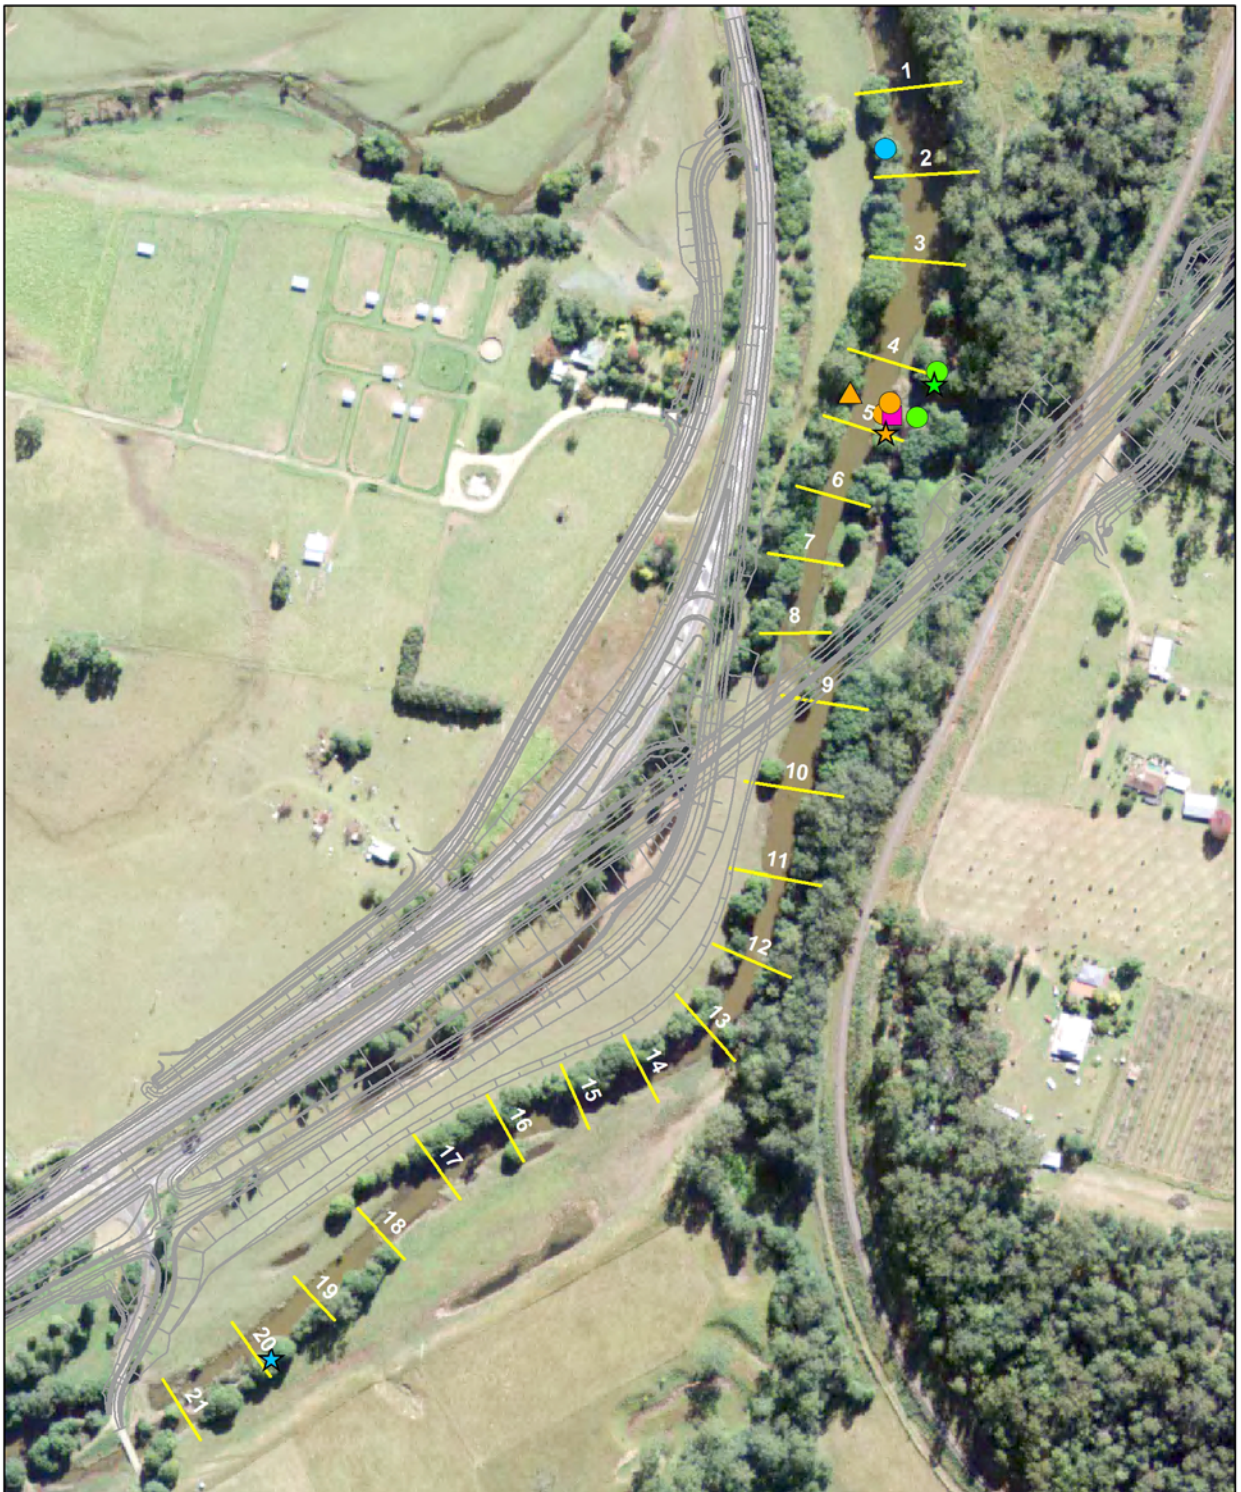
**Figure 3:** Location of frogs captured during the spring 2020 giant barred frog survey and all previous capture locations for these individuals at Upper Warrell Creek.

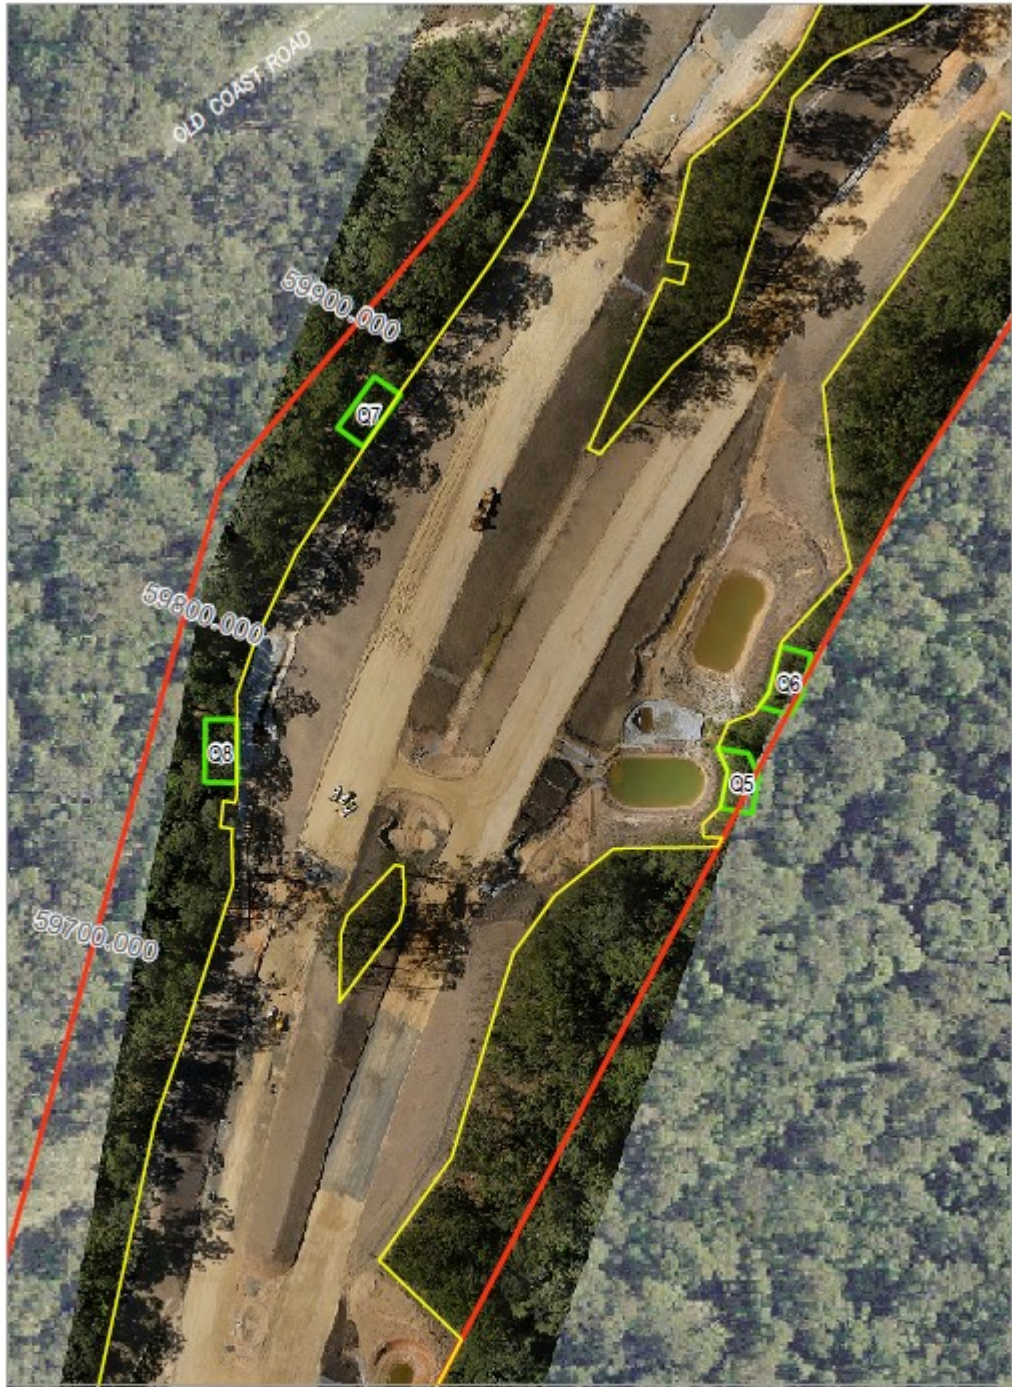
**Figure 10:** Slender Marsdenia and Woolls' Tylophora Habitat monitoring quadrats 5, 6, 7 and 8, WC2NH. Map sourced from GeoLINK (2017).

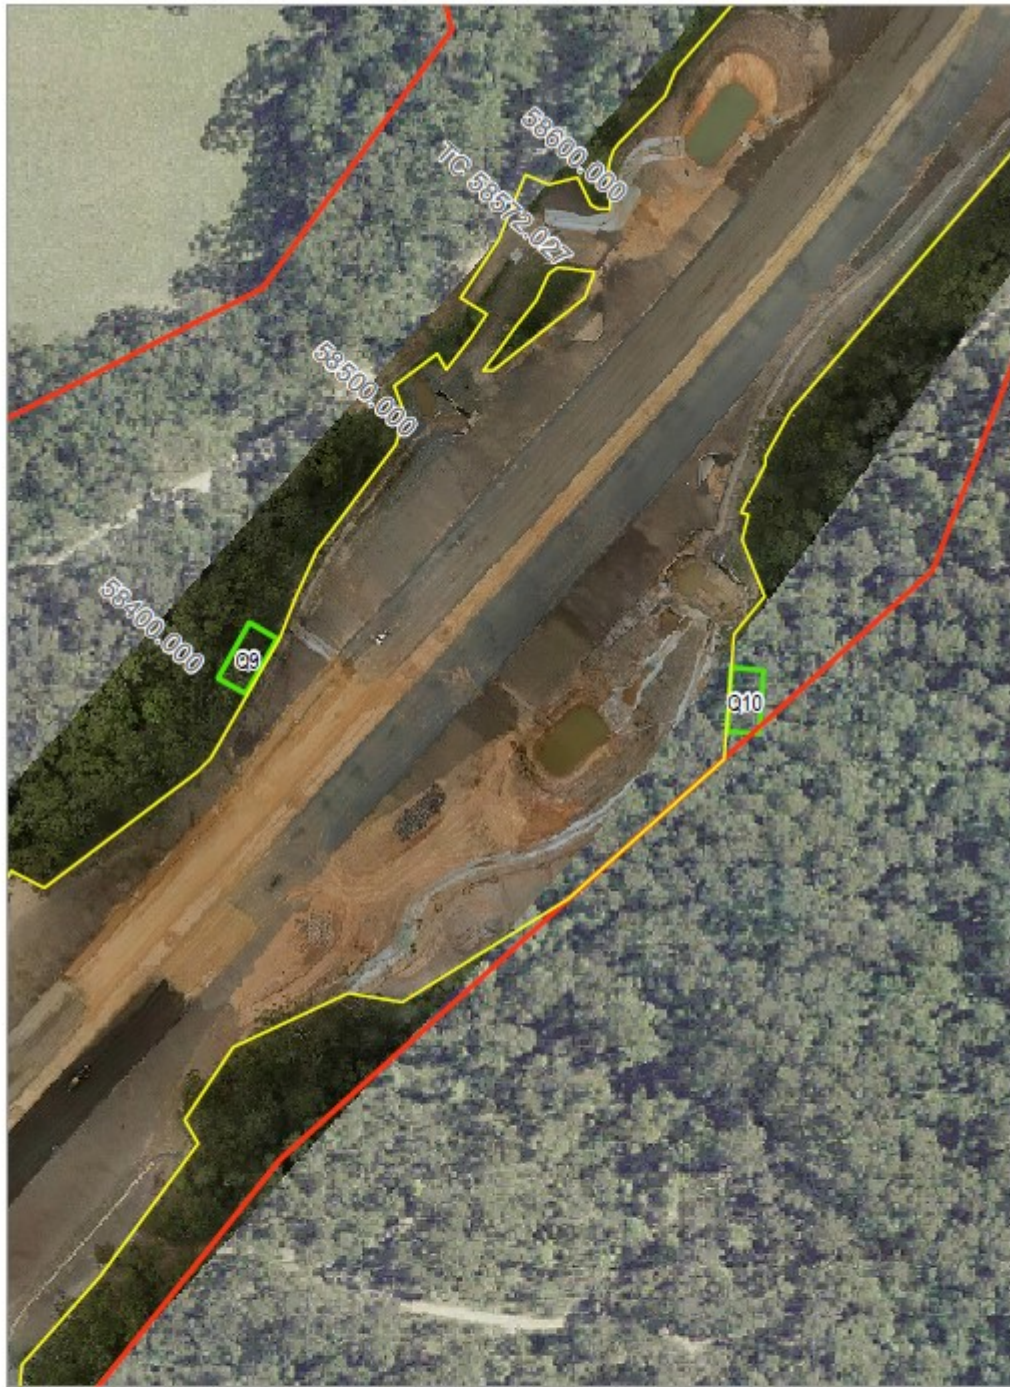
**Figure 11:** Slender Marsdenia and Woolls' Tylophora Habitat monitoring quadrats 9 and 10, WC2NH. Map sourced from GeoLINK (2017).

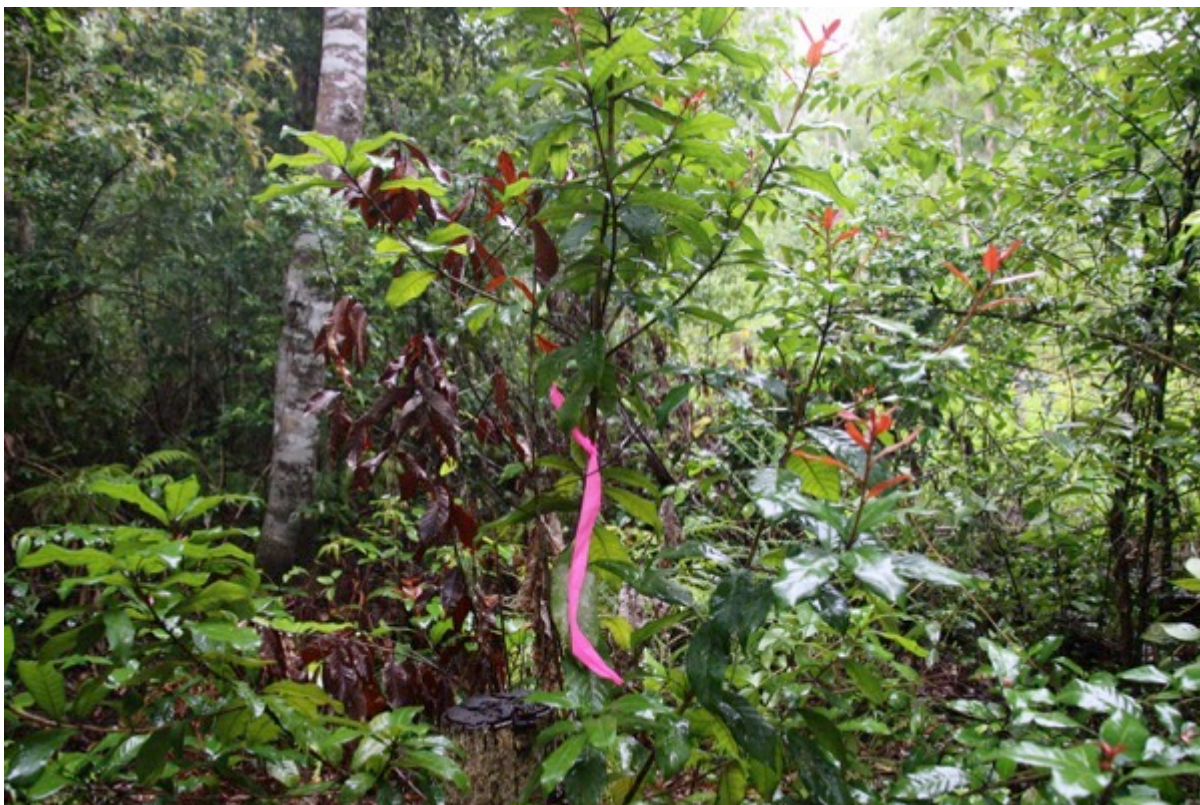
**Plate 1:** Transplanted Rusty Plum no. 1 at Receival Site 1 Cockburns Lane showing one dead branch and new tip growth. Nov/2020.

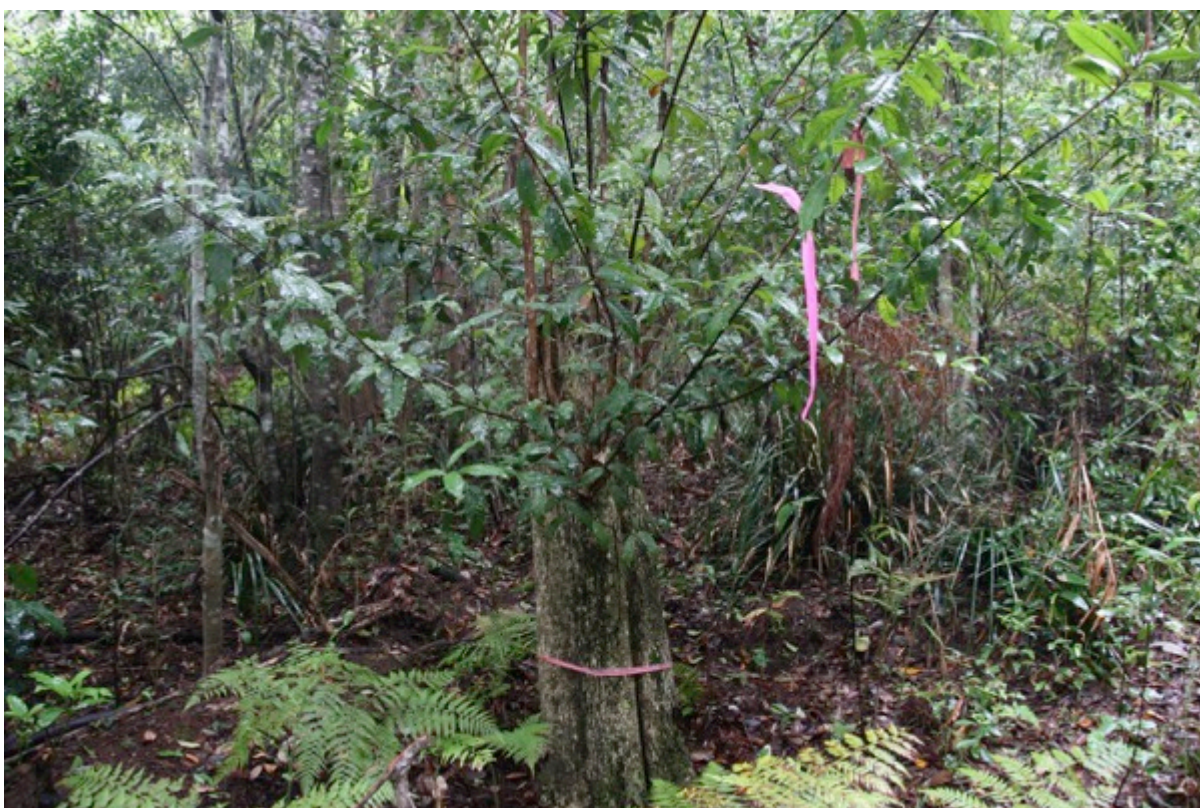
**Plate 2:** Transplanted Rusty Plum no. 2 at Receival Site 1 Cockburns Lane, 4.1 metres high after 6 years. Original height approx. 8 m with a dbh of 30 cm. New stems and branches resprouted from trunk cut off about 1 m above ground. Nov/2020.

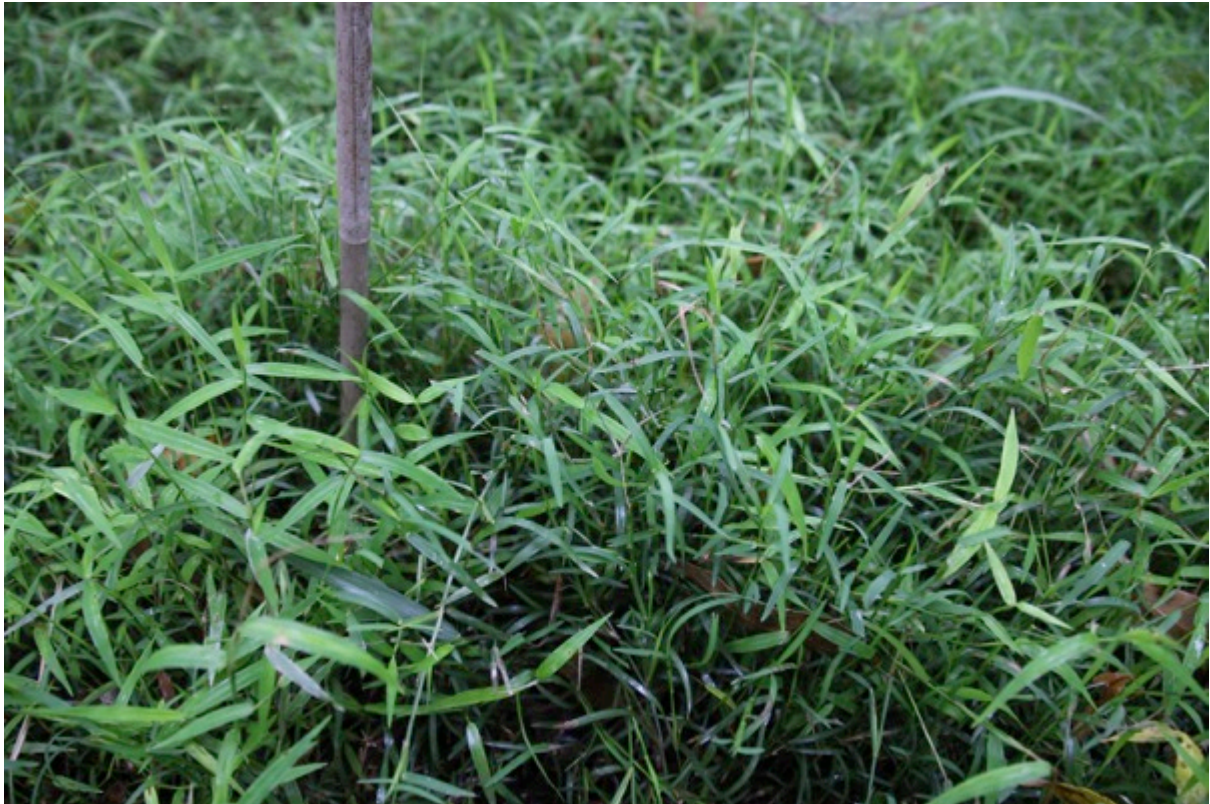
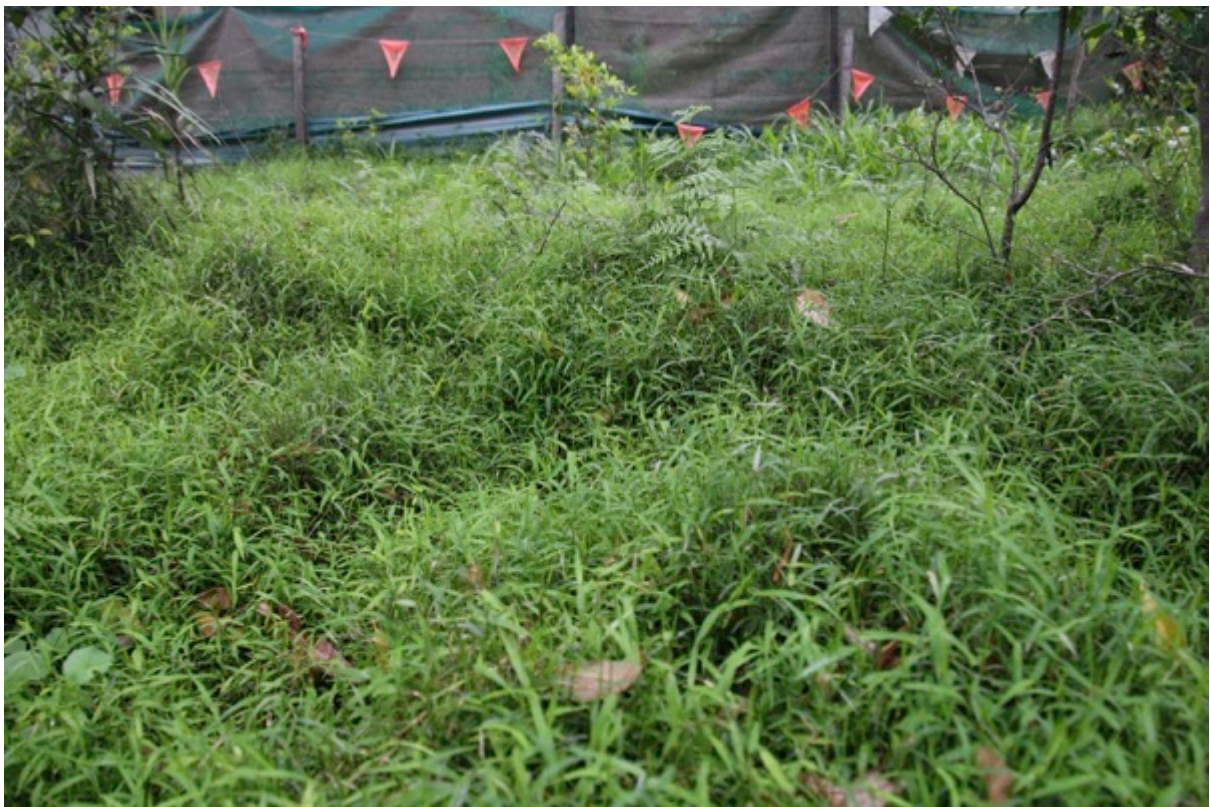
**Plates 6 and 7:** Floyd's Grass translocation area – Receiving Site 9, Area 1. Close-up of Floyd's Grass and Ottochloa growing together and mounds with Floyd's Grass underneath Ottochloa growing on top. Nov/2020.

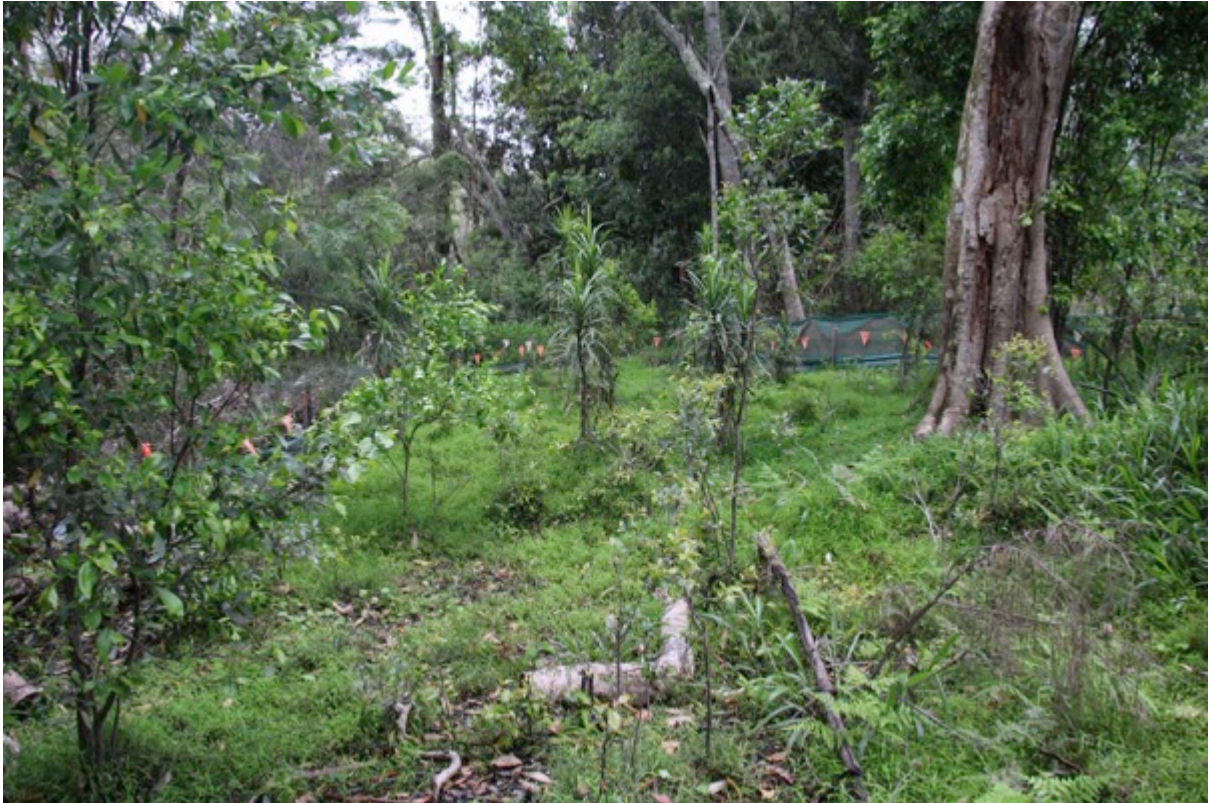
**Plate 8.** Floyds Grass translocation area – Receiving Site 9, Area 1. Warrell Creek on the left hand side.
