# Warrell Creek to Nambucca Heads Pacific Highway Upgrade

Annual Ecological Monitoring Report

February 2020 - February 2021

Transport for NSW | April 2021

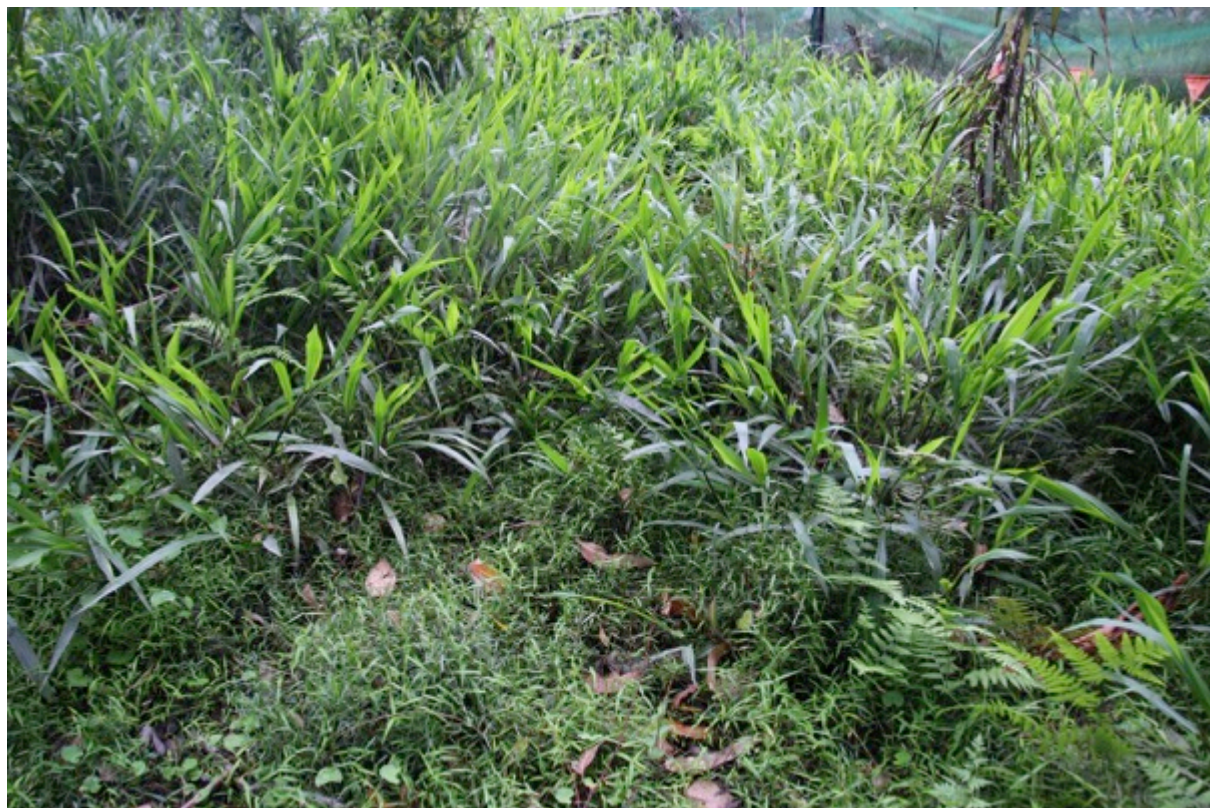
**Plate 9.** Floyds Grass translocation area – Receiving Site 9, Area 1. Floyds Grass in the foreground and encroaching Broad-leaved Paspalum. Nov/2020.

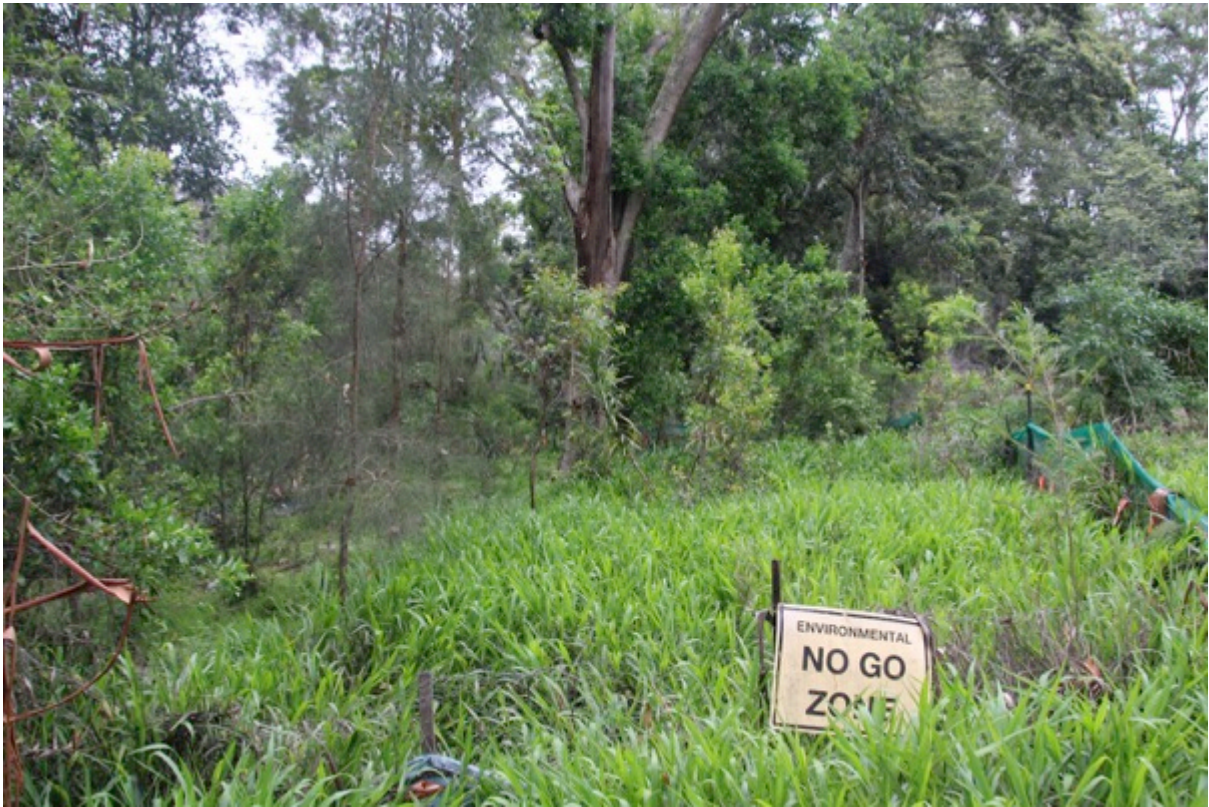
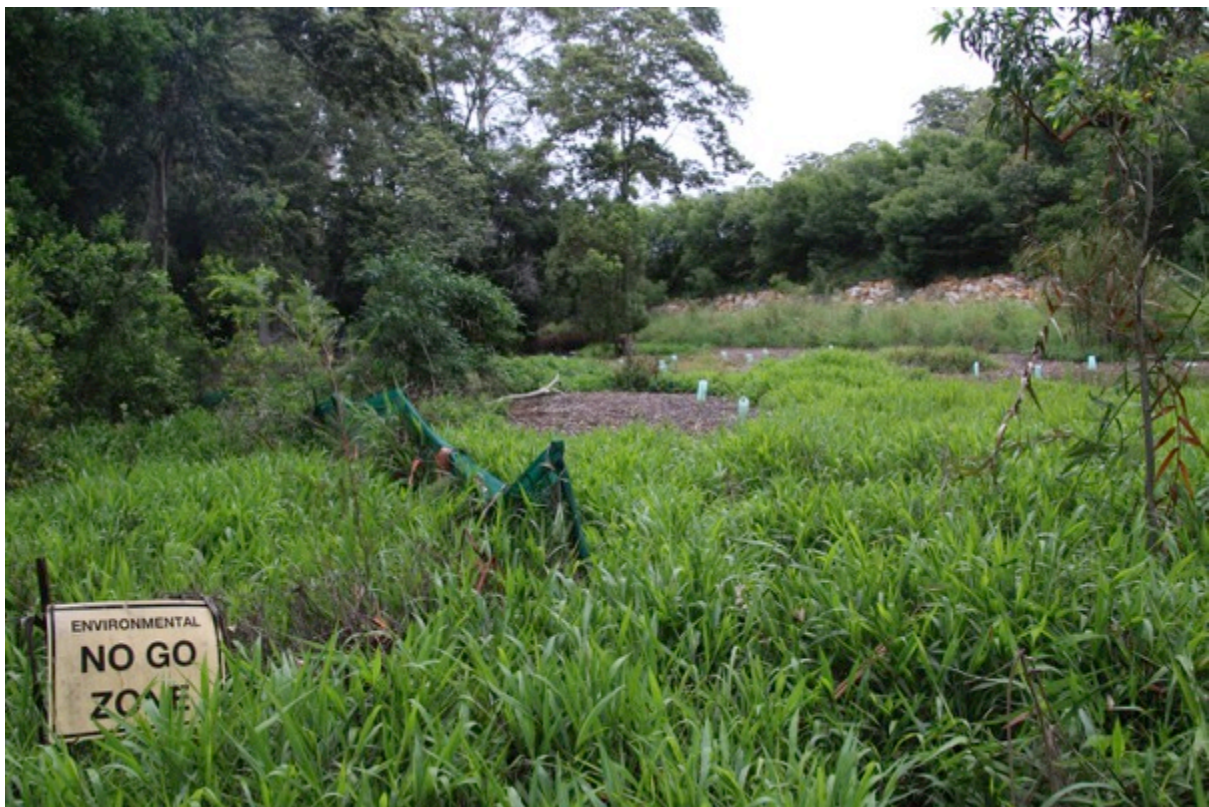
**Plates 10 and 11.** Floyds Grass Receival Site 9, Area 1 showing dense Broad-leaved Paspalum surrounding the translocation area, and wood chipped patches in the background (attempt at habitat restoration).

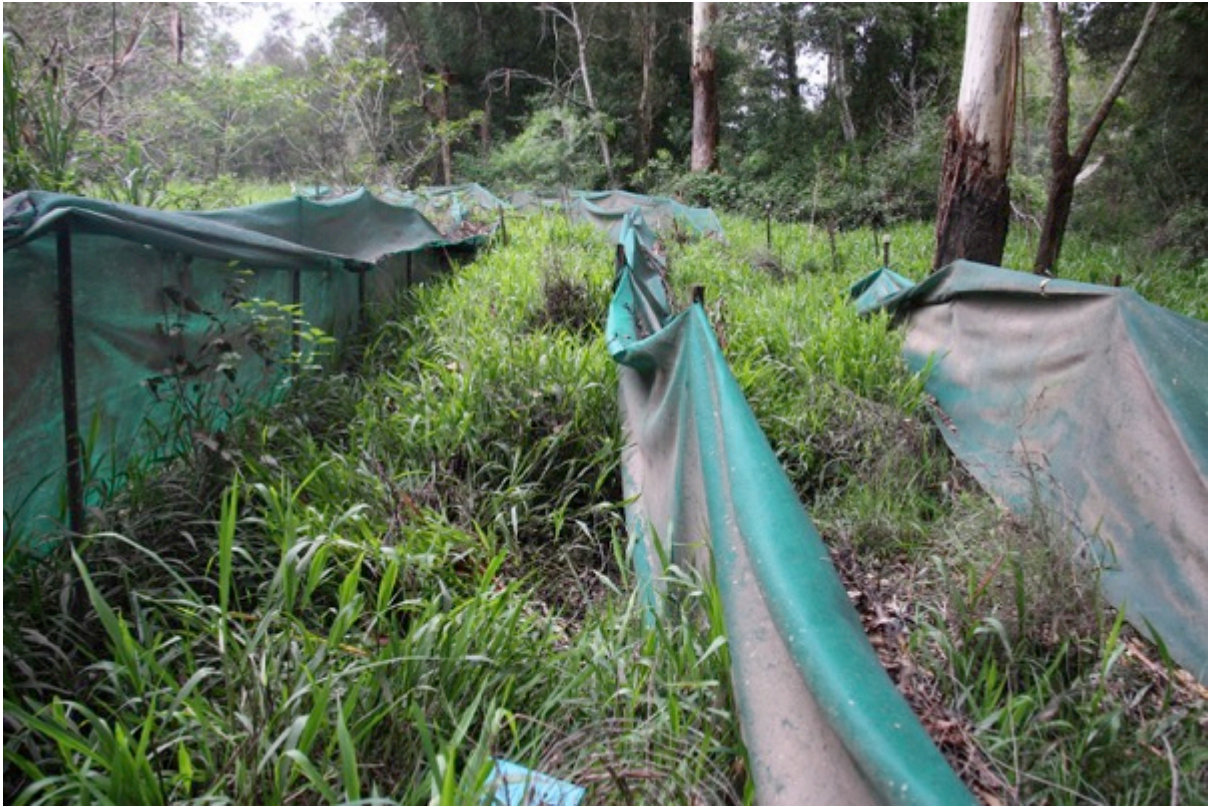
**Plate 12.** Floyds Grass Receival Site 9, Area 2 showing dense Broad-leaved Paspalum within the translocation area.

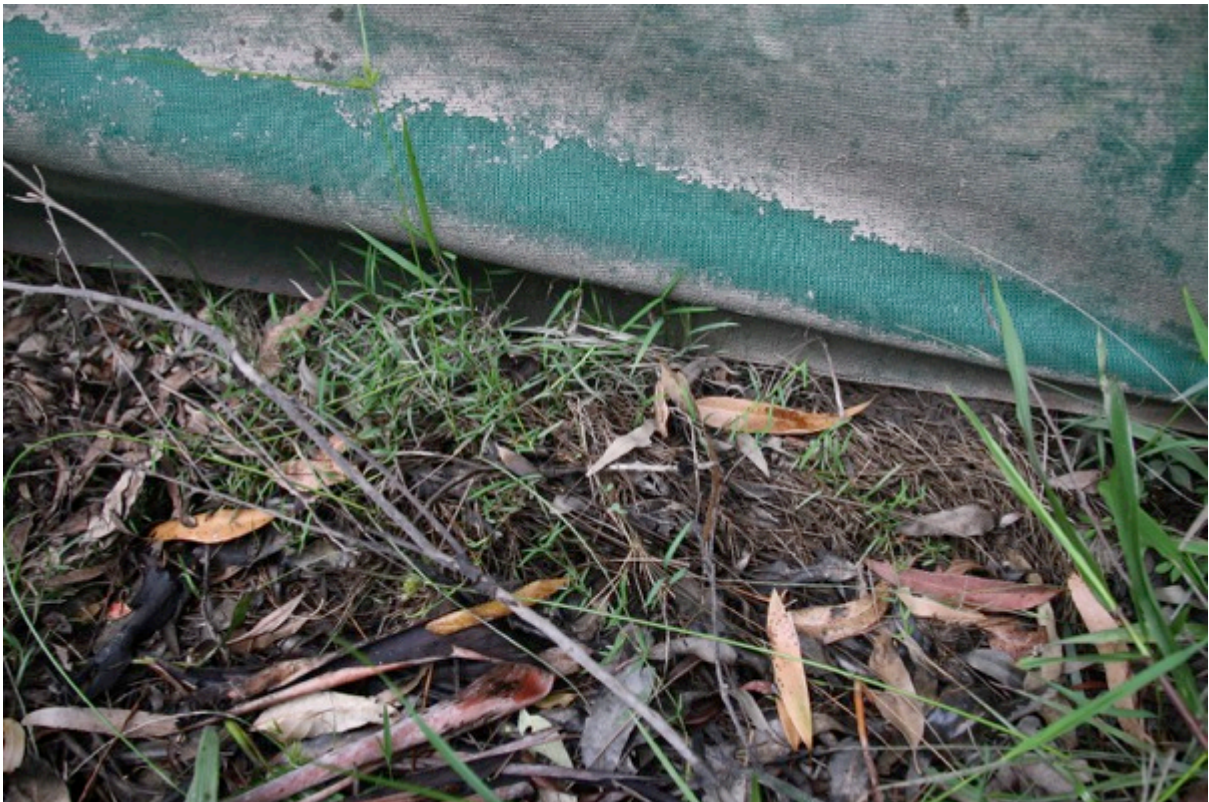
**Plate 13.** Floyds Grass Receival Site 9, Area 2. There is still a reasonable amount of Floyds Grass growing amongst Broad-leaved Paspalum which would have a much better chance of survival if the site had more maintenance, which it missed out on during the construction period.

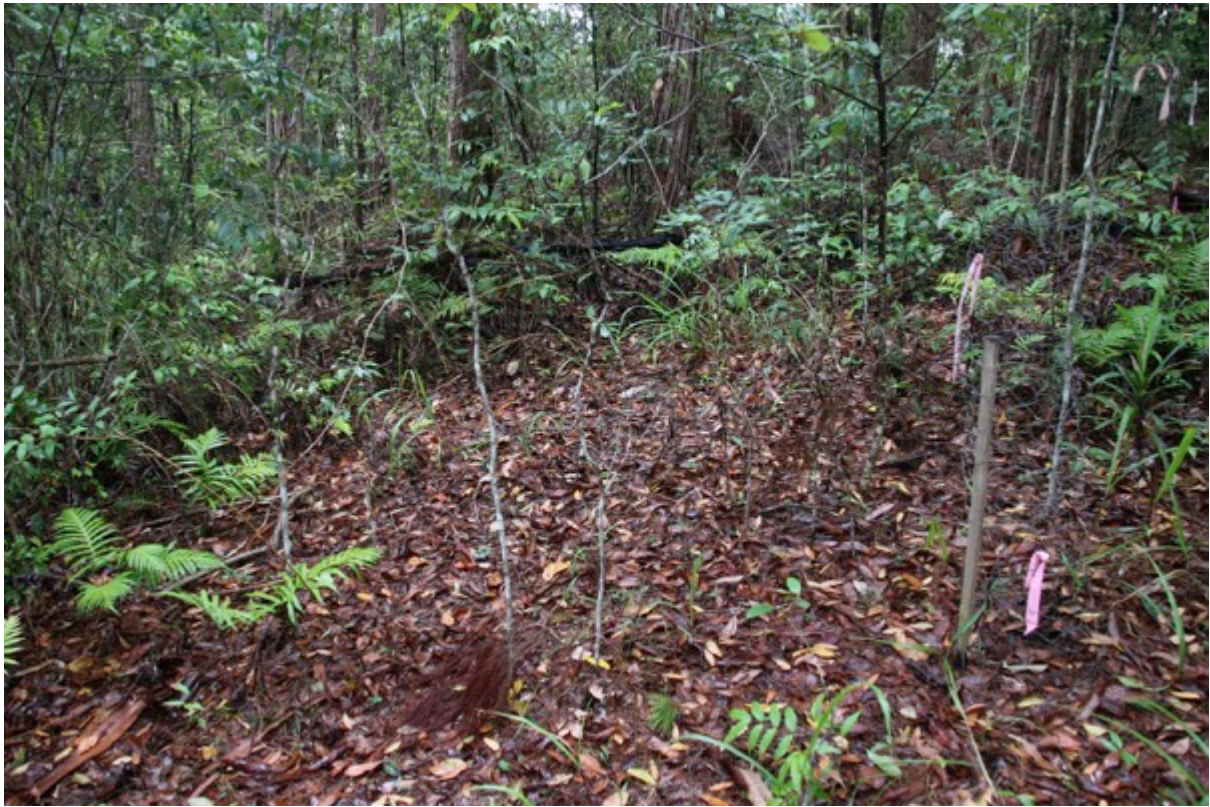
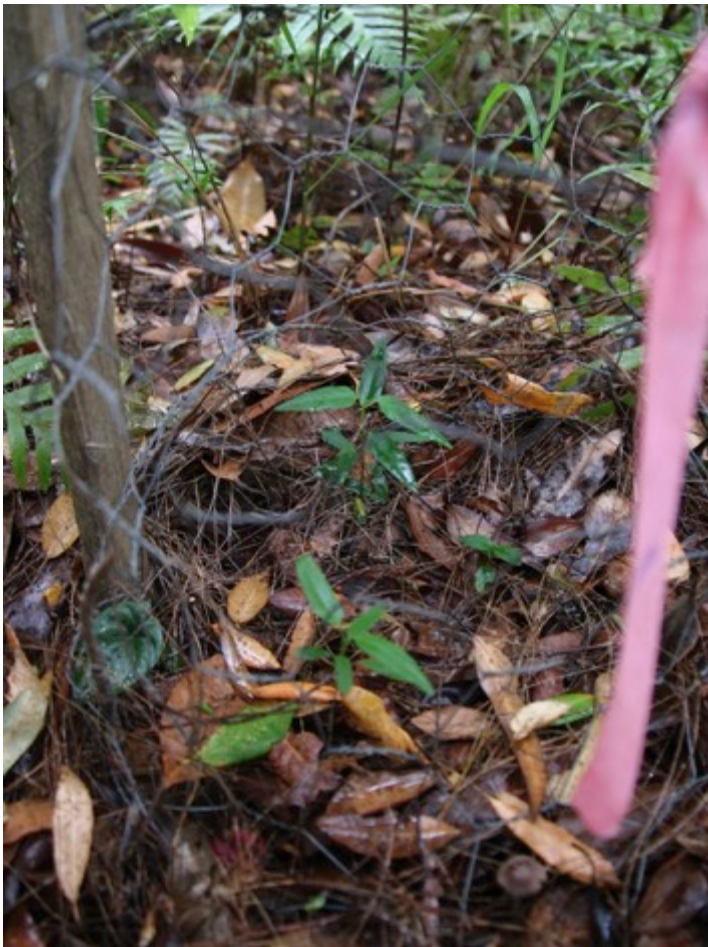
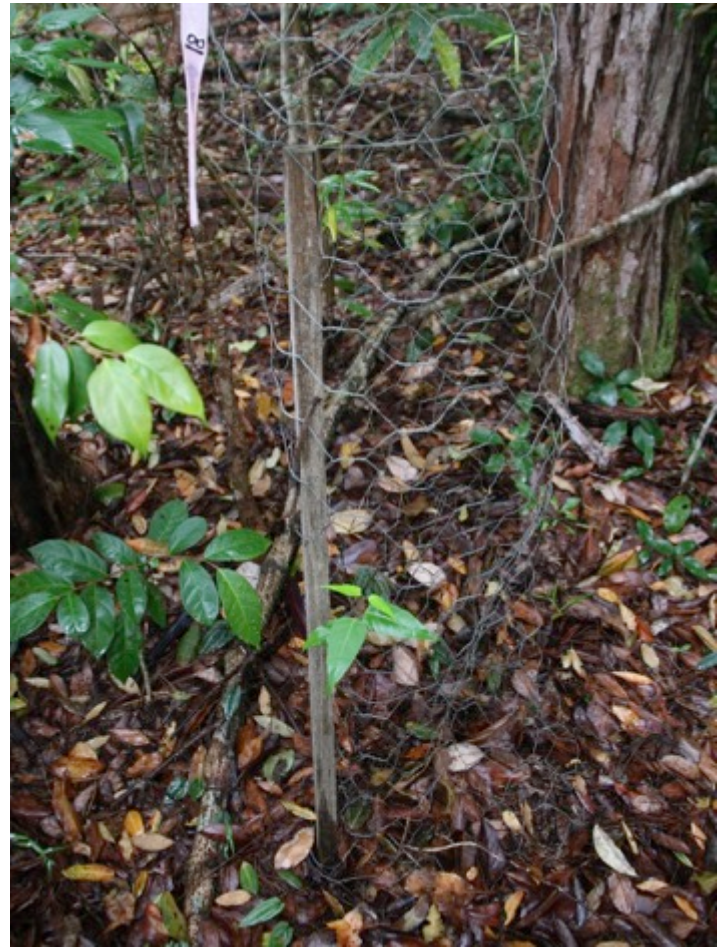
**Plates 14-16:** Receival Site 1 Cockburns Lane. Upper – habitat with in situ and transplanted Slender Marsdenia; Lower – transplanted Slender Marsdenia's no. 1 and 18. Nov 2020.

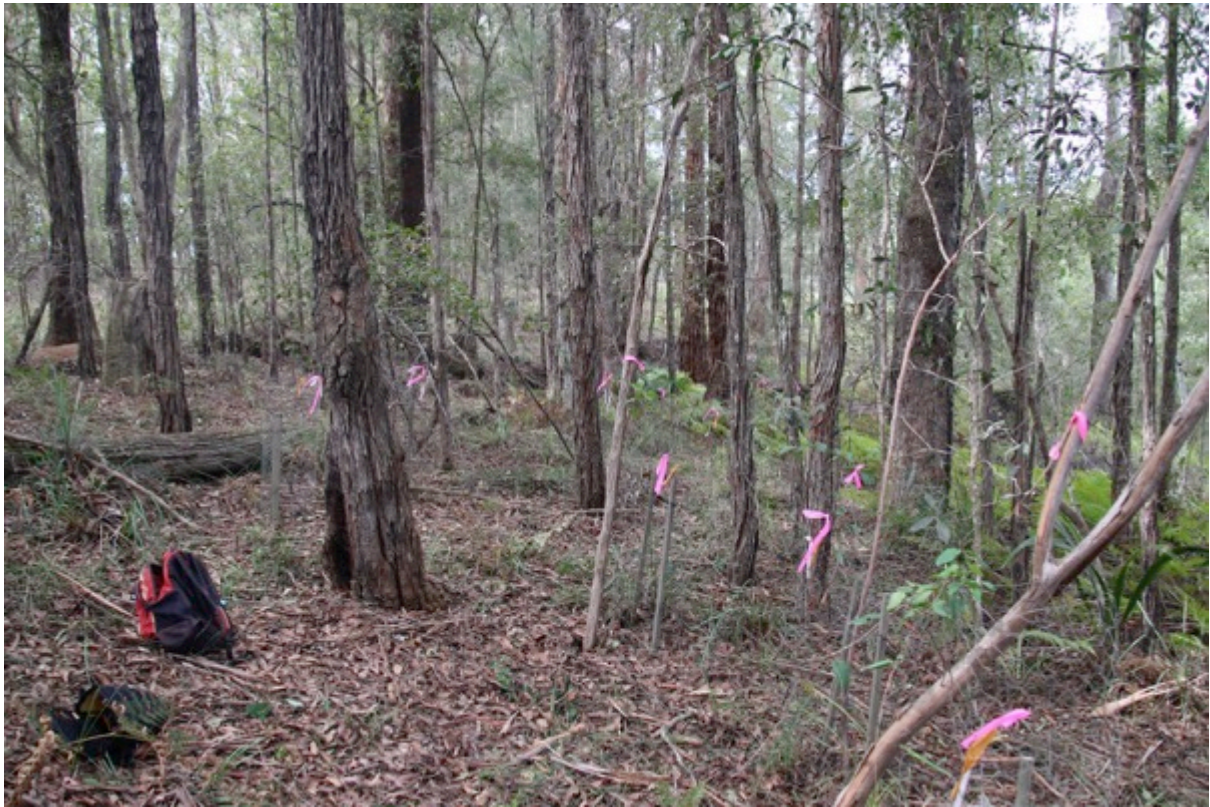
**Plate 17:** Receival Site 3. This site was relatively open and unshaded, and usually had a SE breeze blowing through it. Slender Marsdenia transplanted to the site had a high survival rate and high mean height.

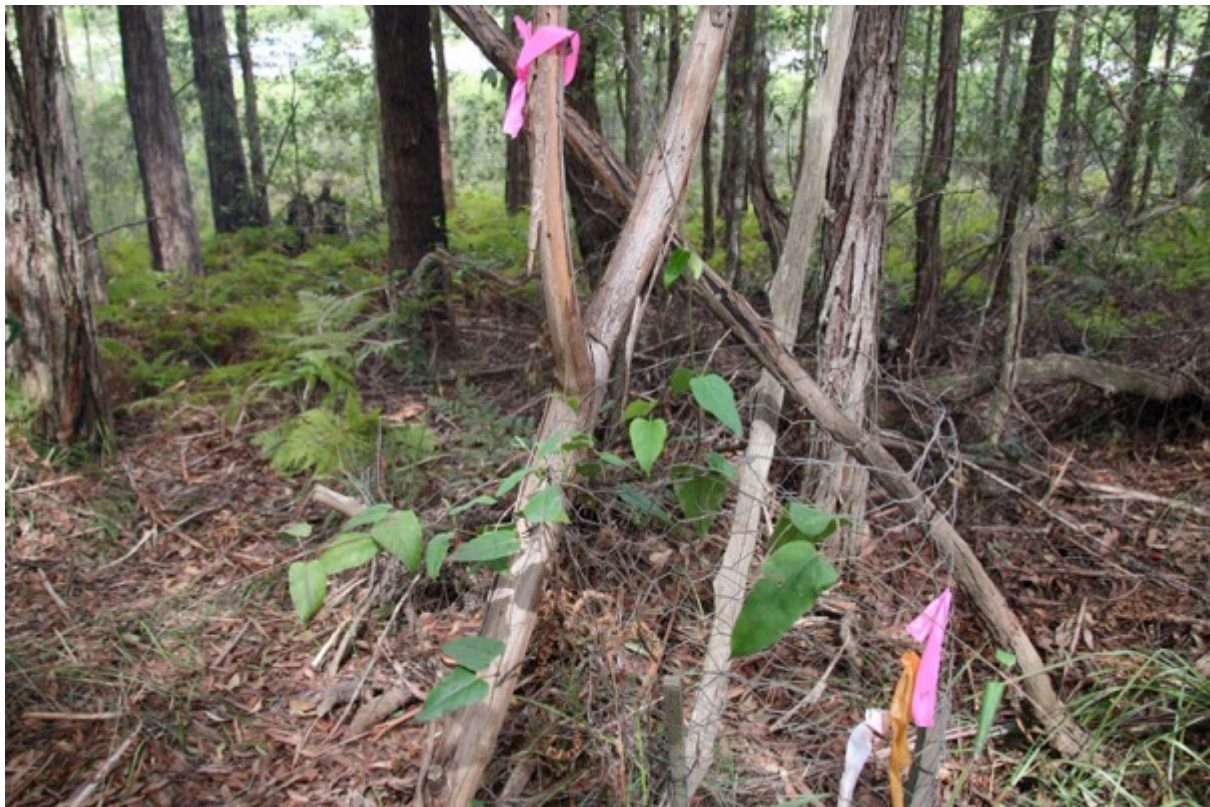
**Plate 18:** Receival Site 3, Slender Marsdenia no. 5. This plant flowered in Nov 2020 and the year before, the only one recorded flowering out of 164 transplanted.

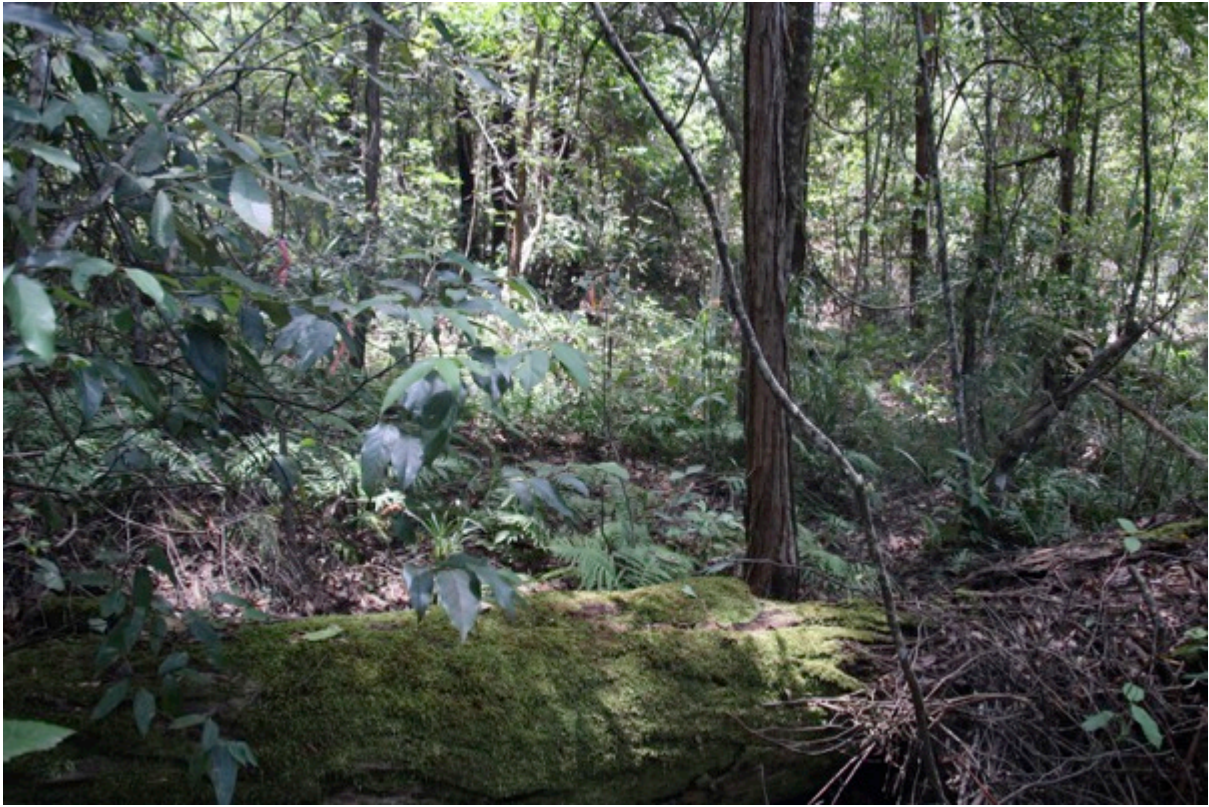
**Plate 19:** Receival Site 5a. This receival site had a denser 'rainforest' understory and deeper shade.

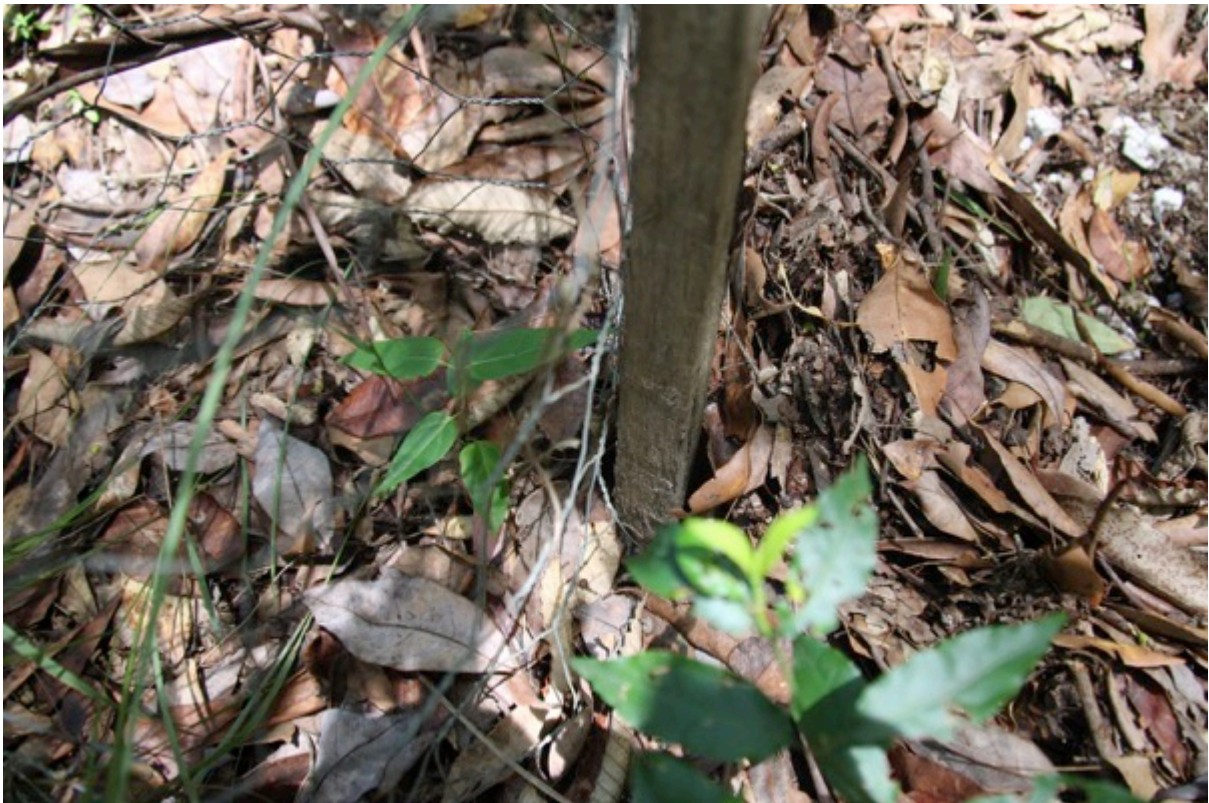
**Plate 20:** Small Slender Marsdenia in Receival Site 5a

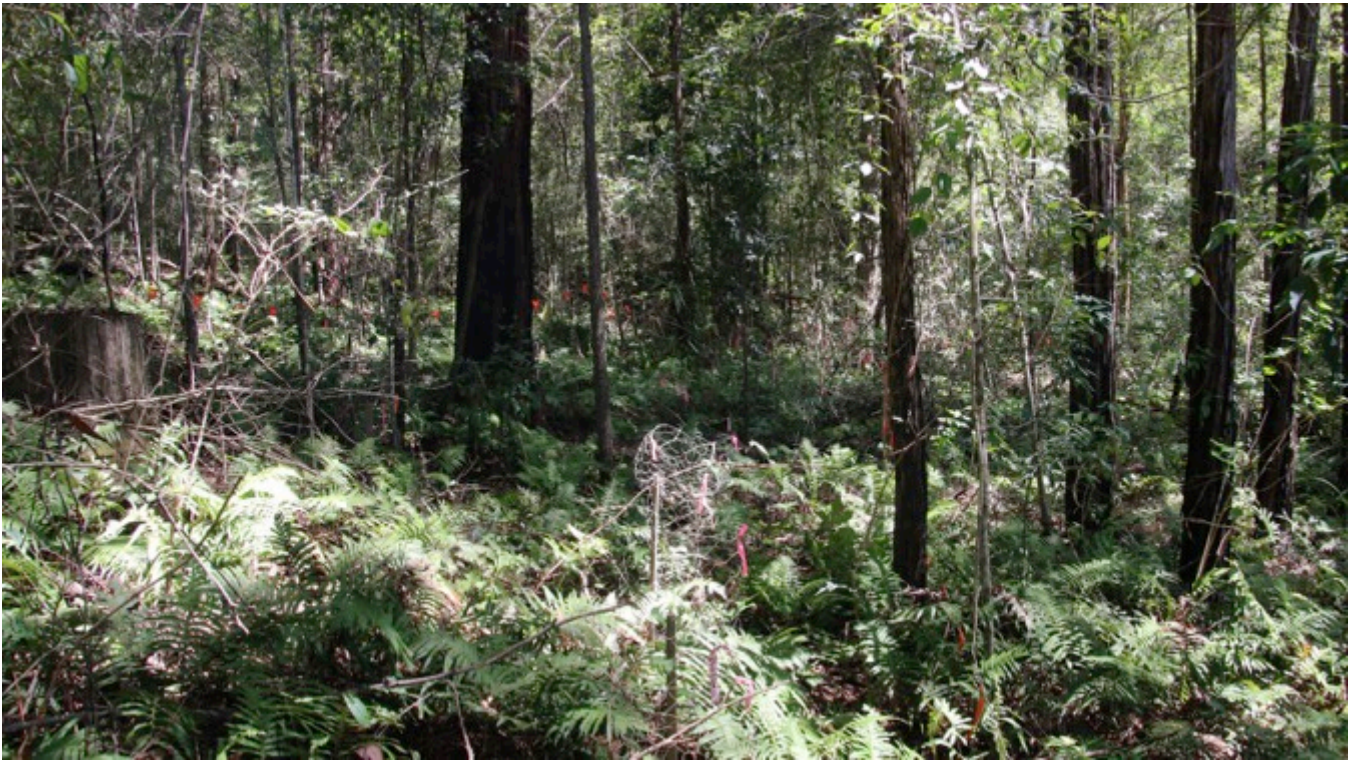
**Plate 21:** Receival Site 7a. The survival rate and mean height of Slender Marsdenia at this site were relatively low . The habitat has a denser understory and deeper shade compared to other sites.

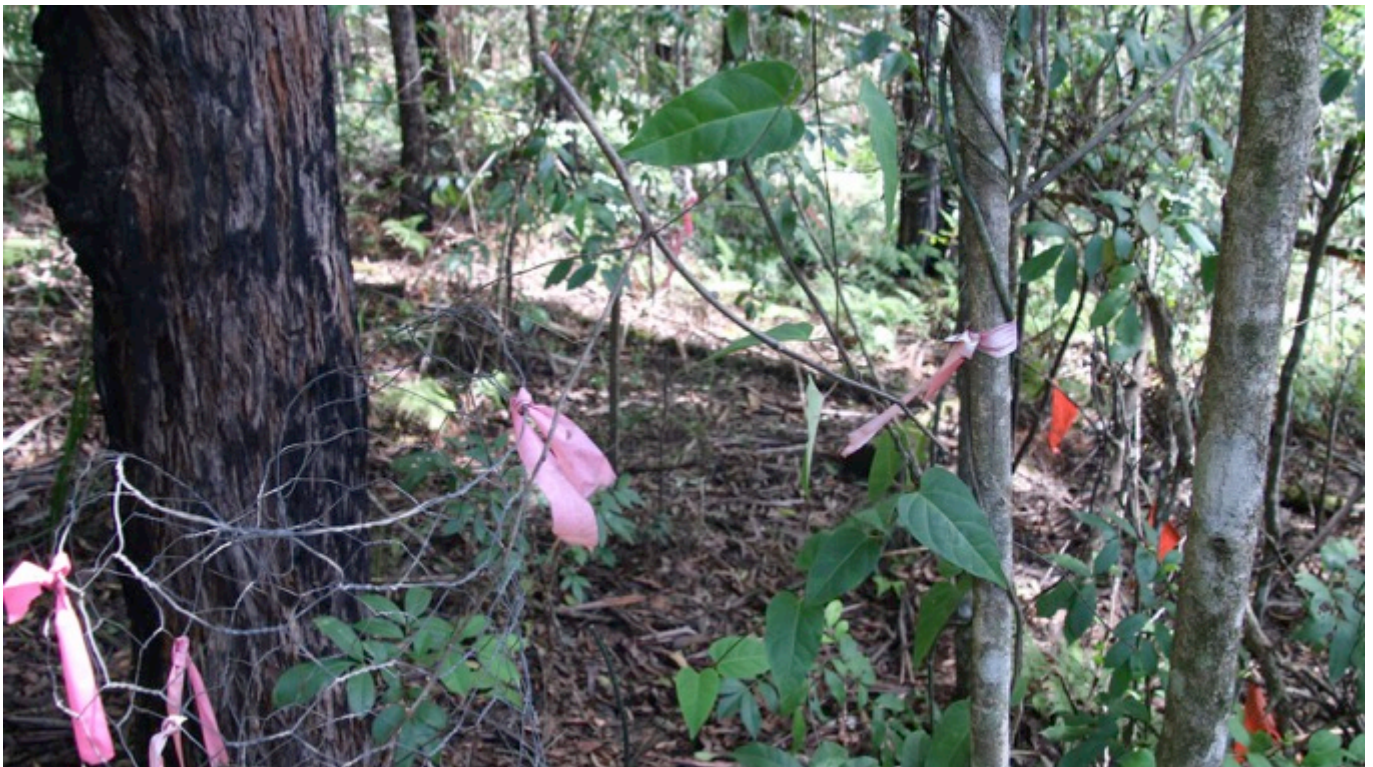
**Plate 22:** Transplanted Slender Marsdenia in Receival Site 7a. This one has left the wire cylinder and has climbed a small tree.

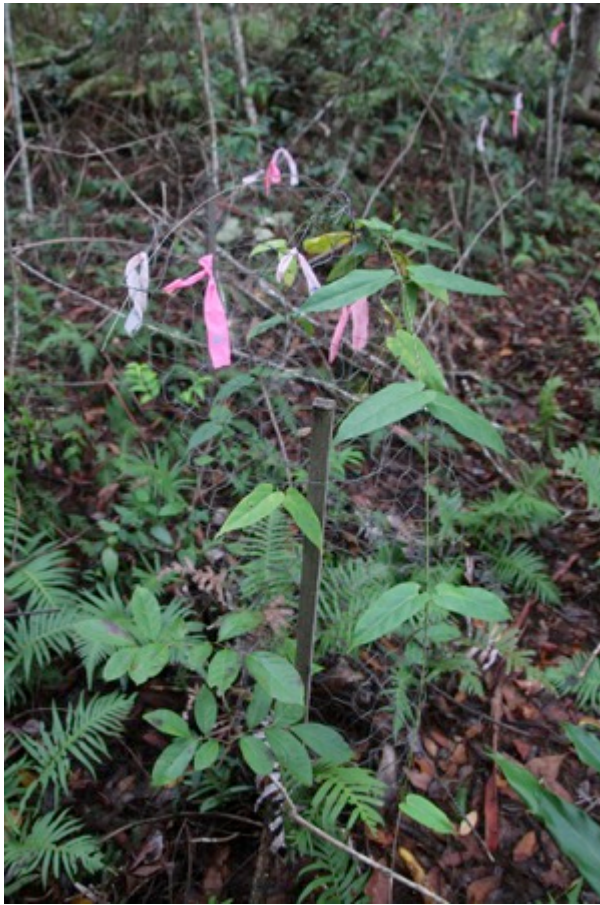
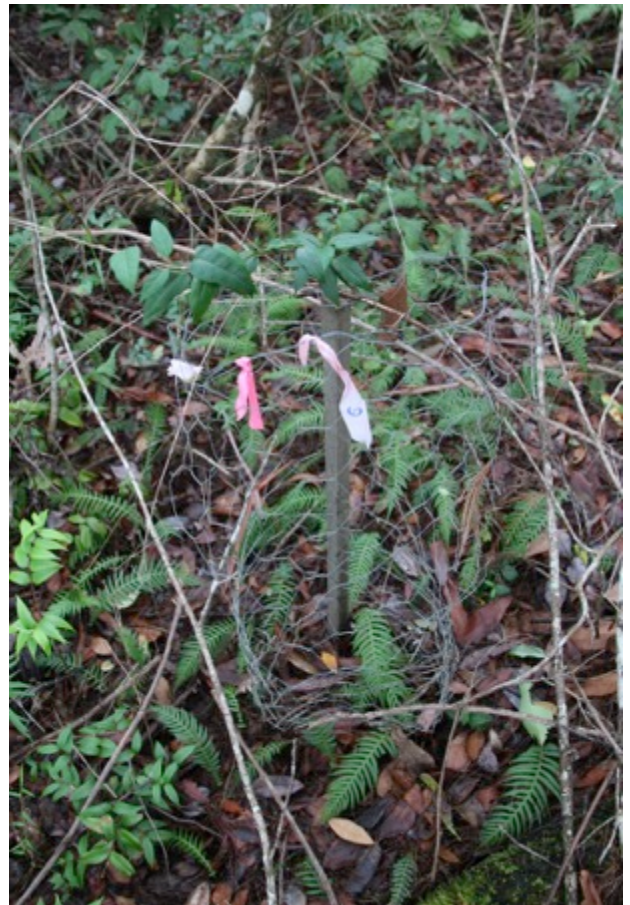
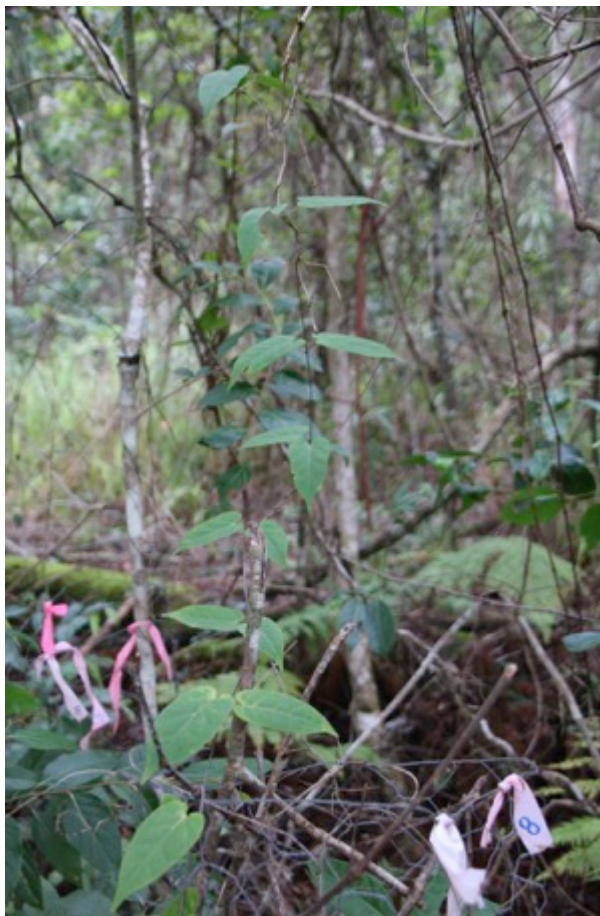
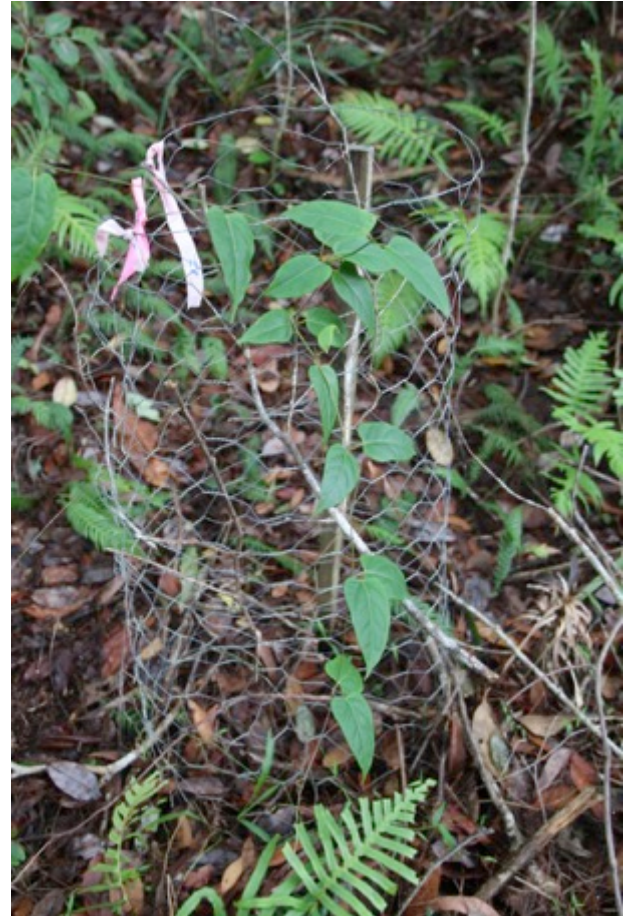
**Plate 25: Receiving Site 8a.** From top left, Slender Marsdenia nos. 3, 6, 8 and 12. This receiving site is relatively open on the edge of clearing and a track. Survival rate and mean height are high.

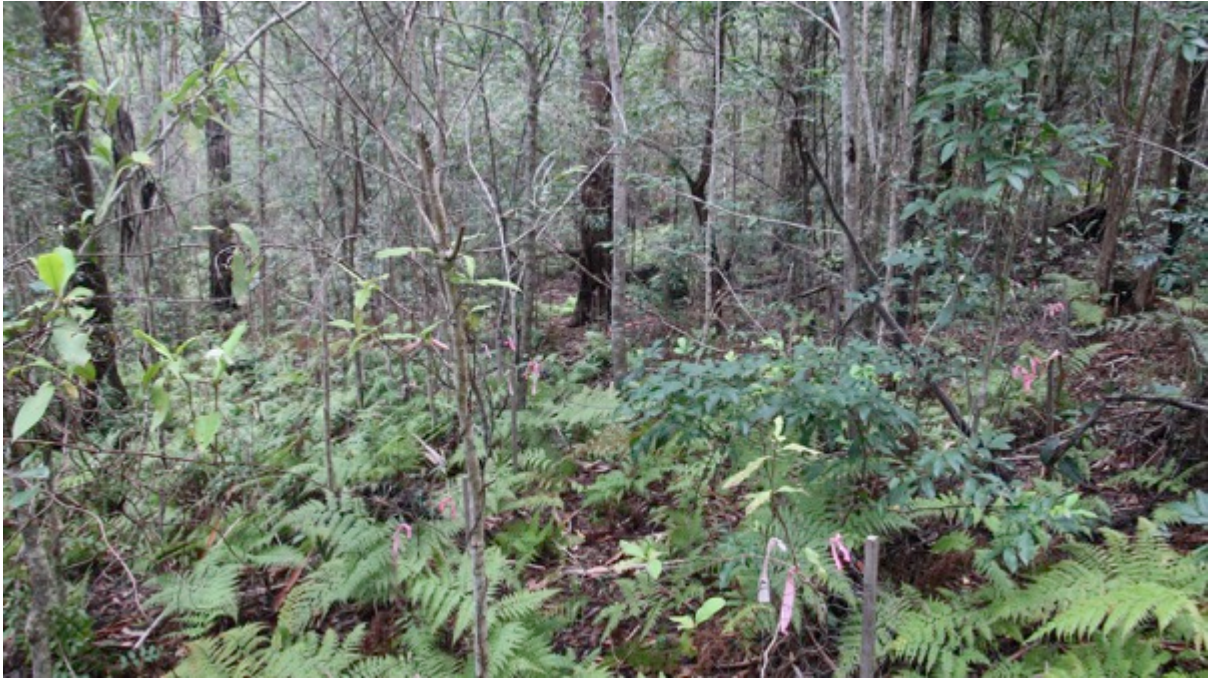
**Plate 26:** Receival Site 8c. This receival site was relative open and unshaded. Survival and growth rates of transplanted Slender Marsdenia were relatively high compared to other receival sites.

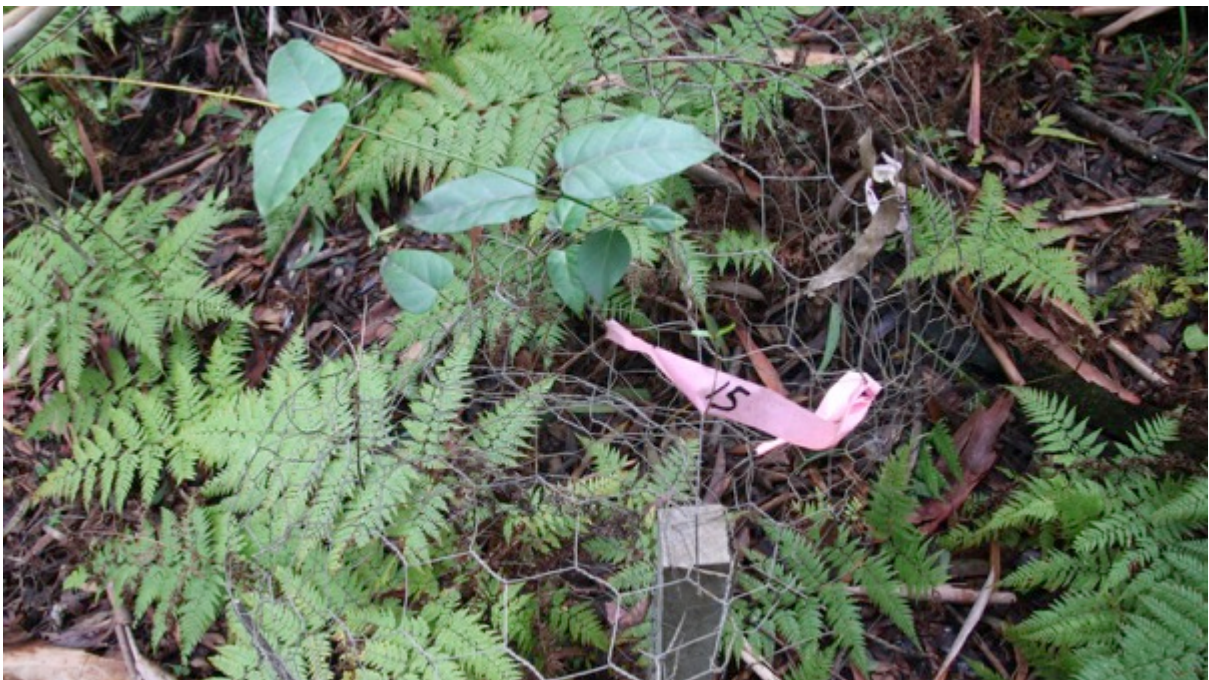
**Plate 27:** Receival Site 8c. Slender Marsdenia no. 15. Nov 2020.

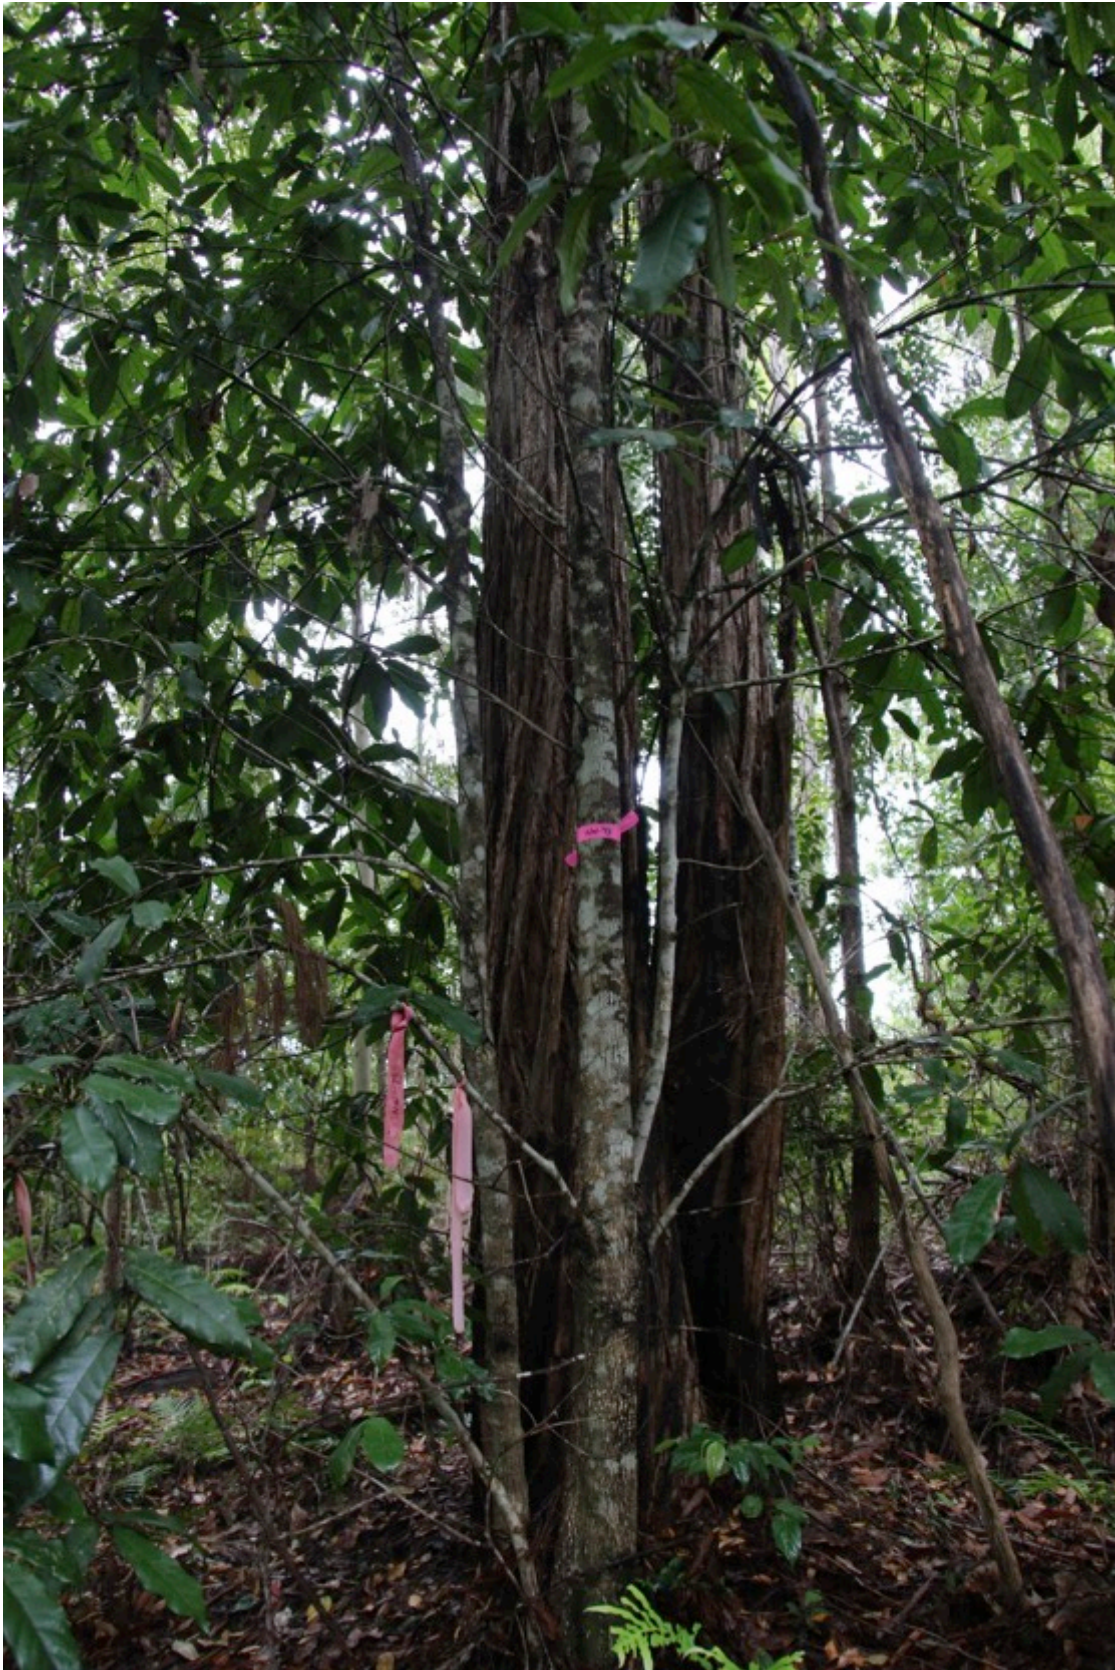
**Plate 28:** In situ Rusty Plum NW 73 at Cockburns Lane, growing hard against the trunk of a Flooded Gum but in good condition. Nov 2020.

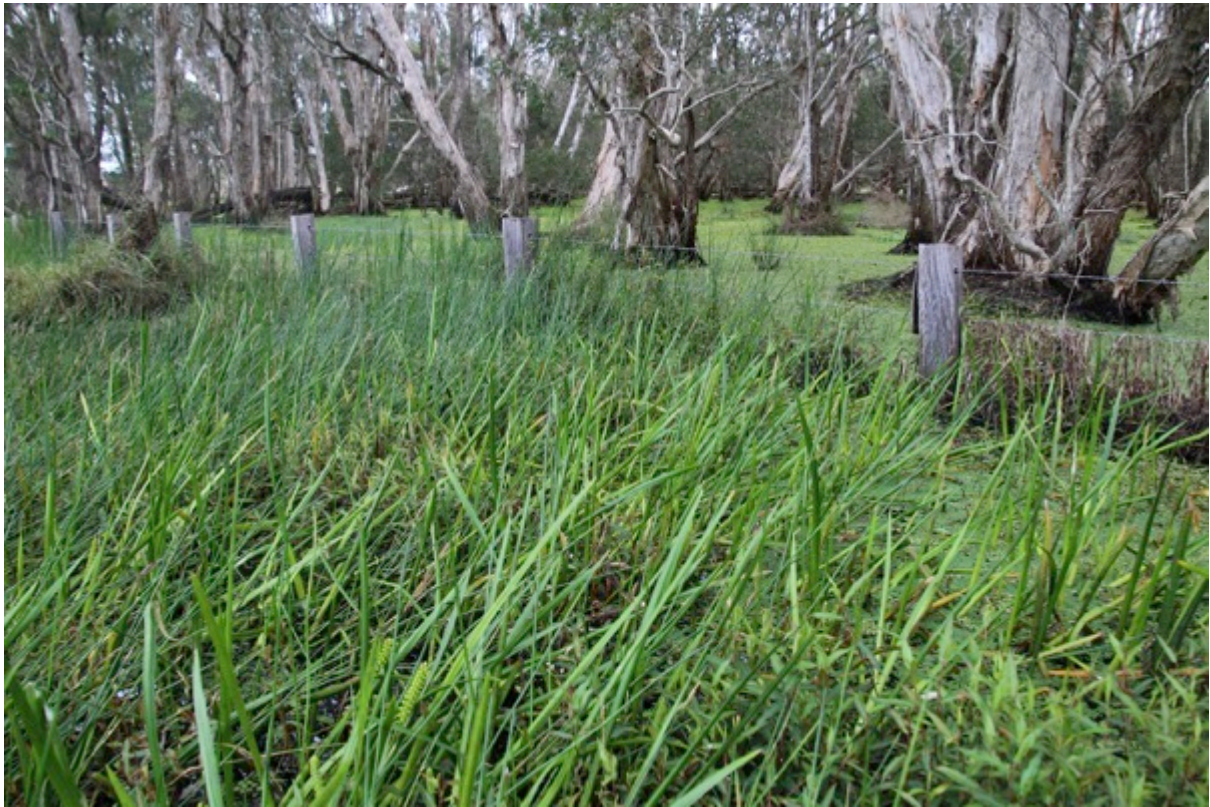
**Plate 29:** *Maundia triglochinos* with the sword shaped leaves at in situ monitoring site on the Nambucca River floodplain. Water in swamp 0.5 m of water after 2019 drought. Nov 2020.

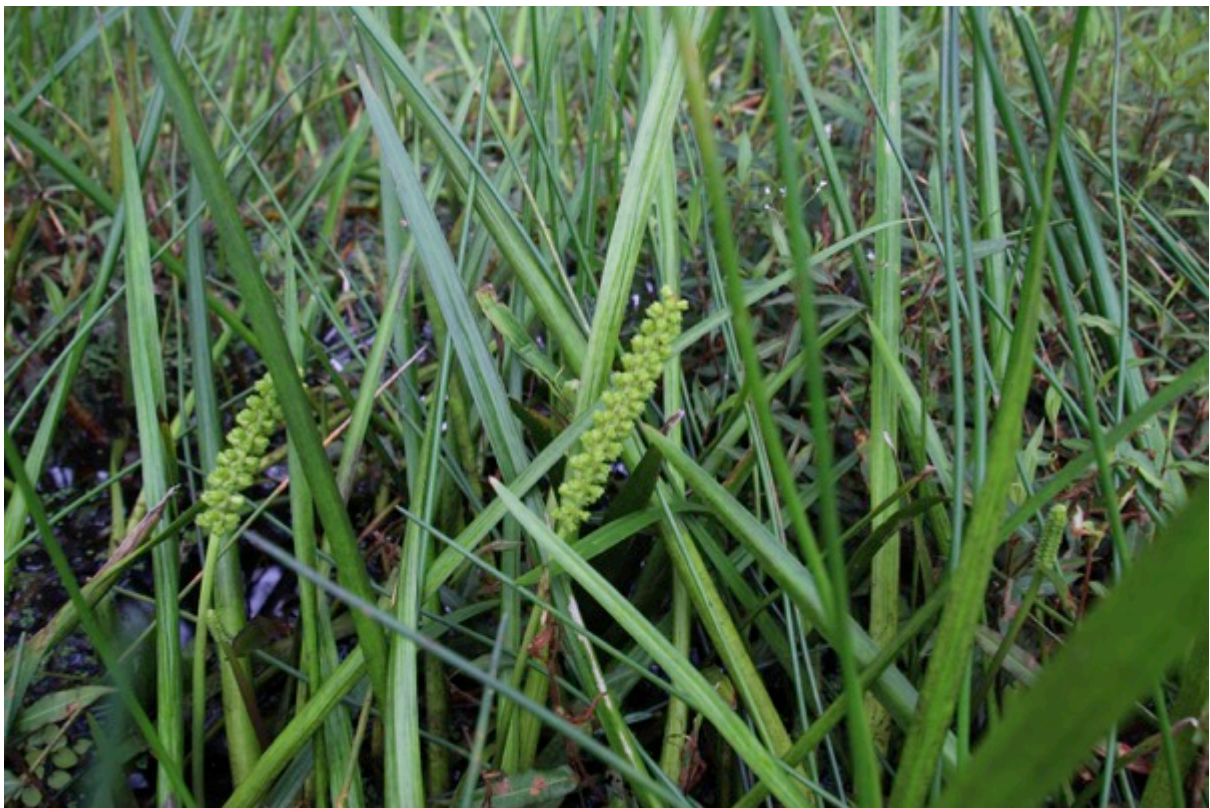
**Plate 30:** After declining from 40% to <1% crown cover in the 2019 drought (crown cover <1%), *Maundia* recovered quickly in 2020, which had above average rainfall, refilling the swamp at the monitoring site alongside the new highway. Photo shows *Maundia* flowering, Nov 2020.

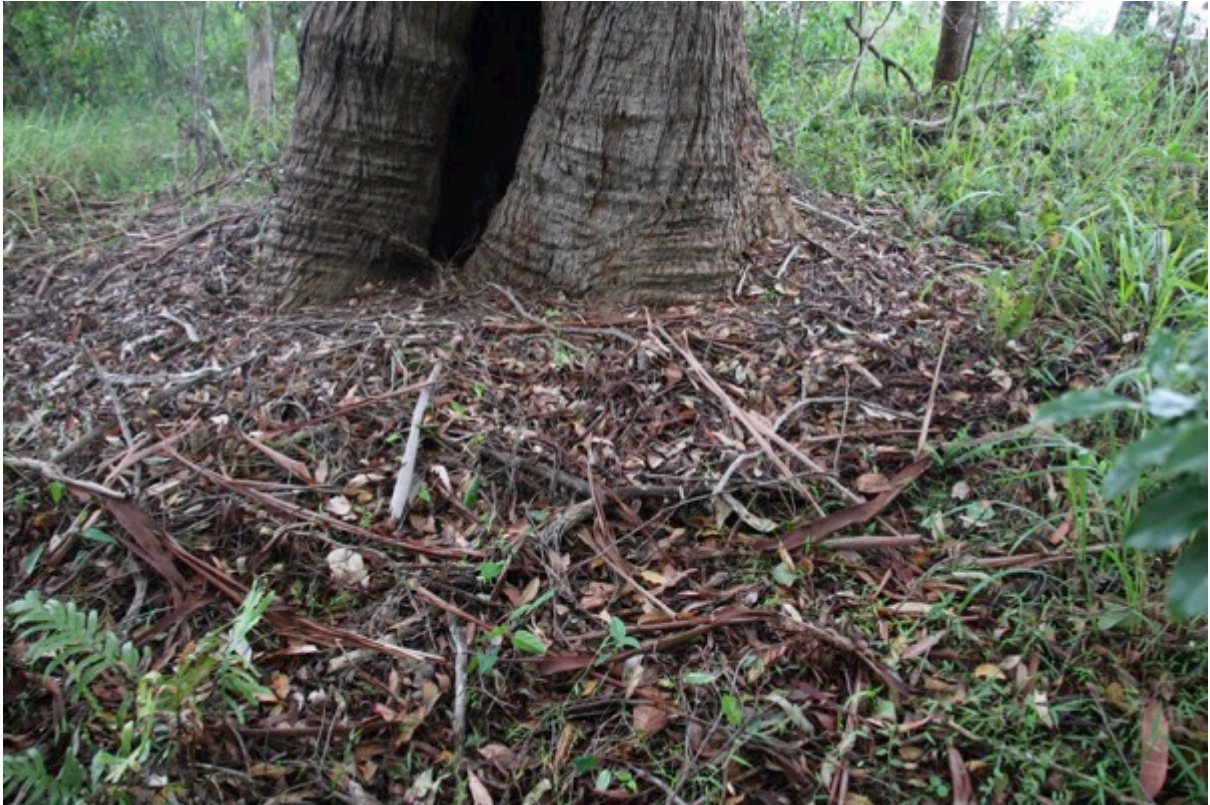
**Plate 31:** In Situ Slender Marsdenia ML-93, Old Coast Road. Slender Marsdenia growing in a litter mound at the base of a large Tallowwood tree with stem-individuals also extending to the right into the road reserve up to edge of road.
