# Warrell Creek to Nambucca Heads Pacific Highway Upgrade

Annual Ecological Monitoring Report

February 2020 - February 2021

Transport for NSW | April 2021

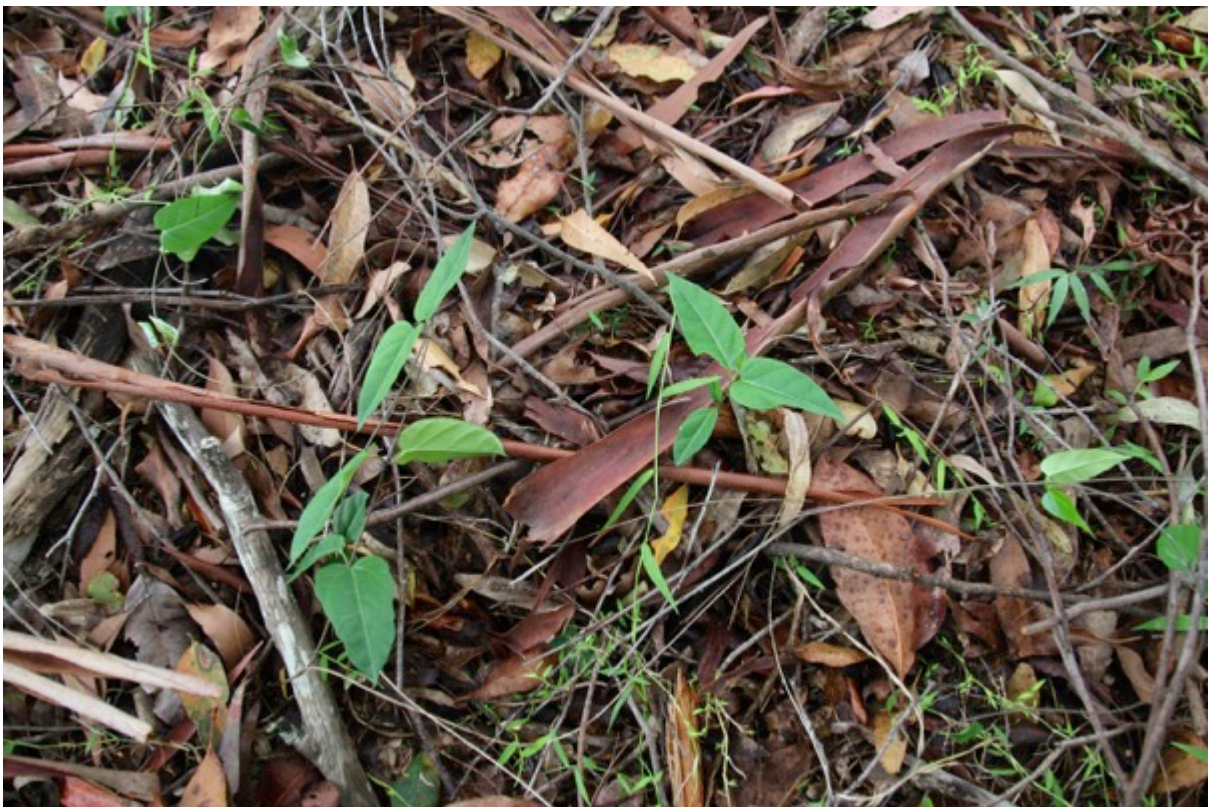
**Plate32:** Close up of small Slender Marsdenia stem-individuals in photo above.

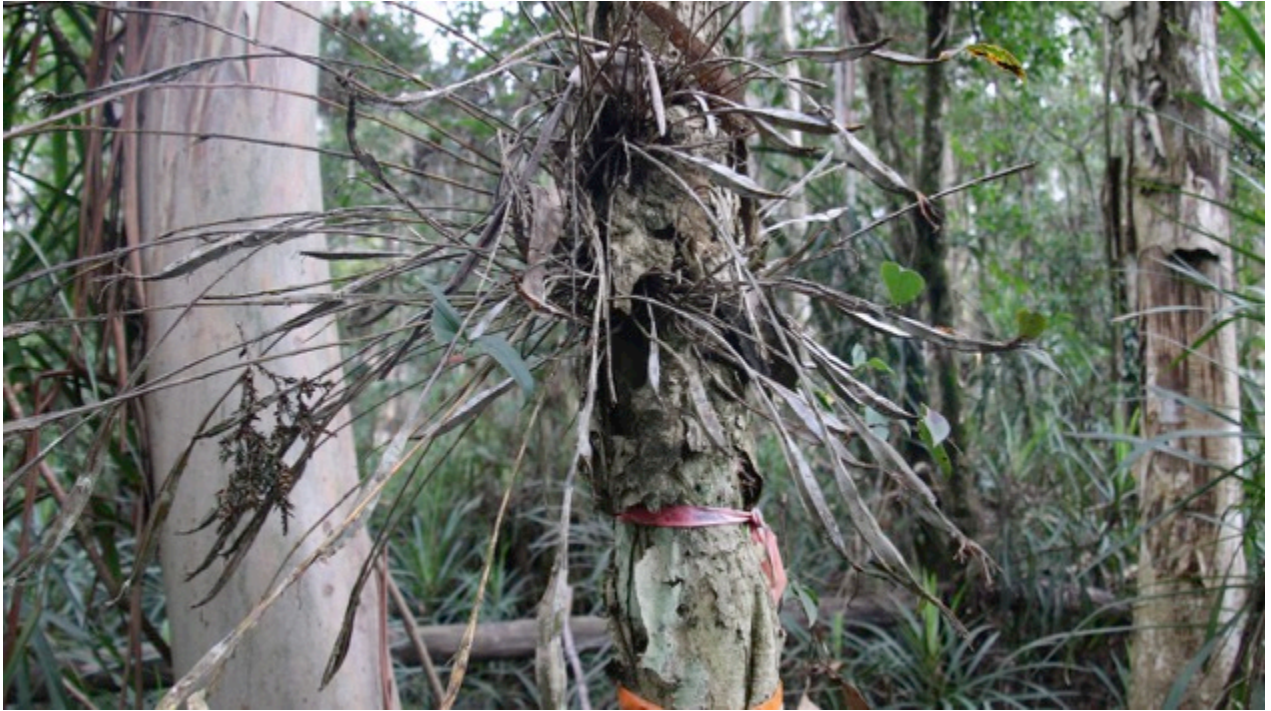
**Plate 33:** In Situ Spider Orchid in swampy wet sclerophyll forest on Old Coast Road. The plant had decline since last year, possibly an effect of the 2019 drought. The pseudobulbs were in poor condition. Many were discoloured, partly hollow, possibly grazed by something. Most had flowered in spring. Nov 2020.

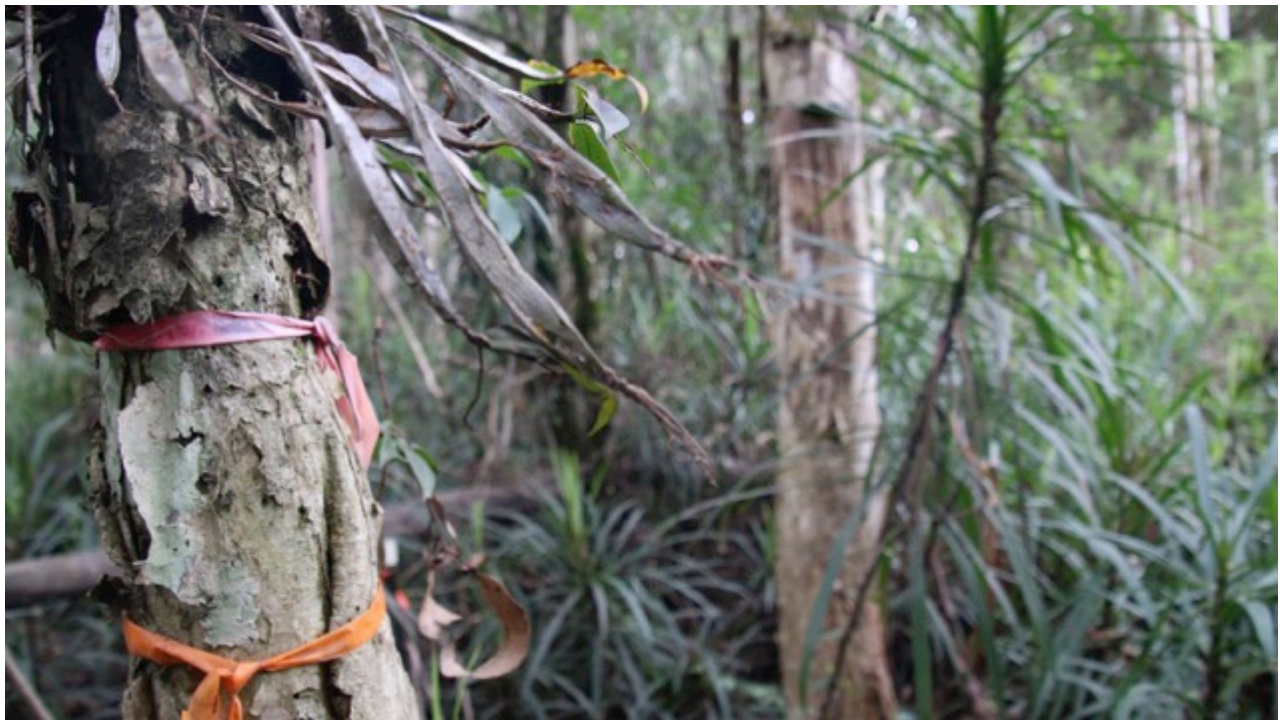
**Plate 34:** In Situ Spider Orchid. Close up of above showing remains of terminal flower racemes.

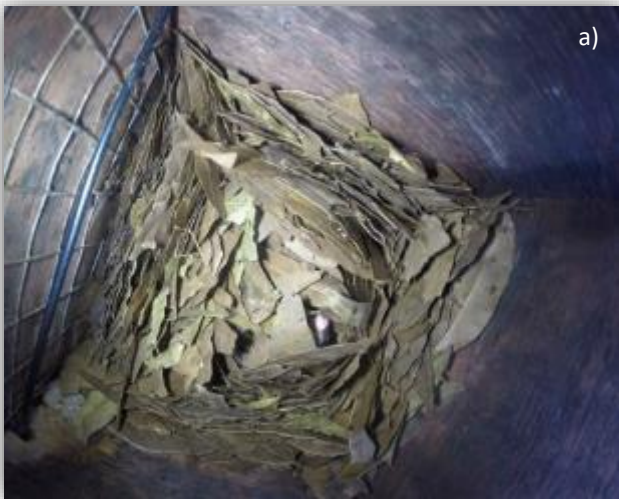
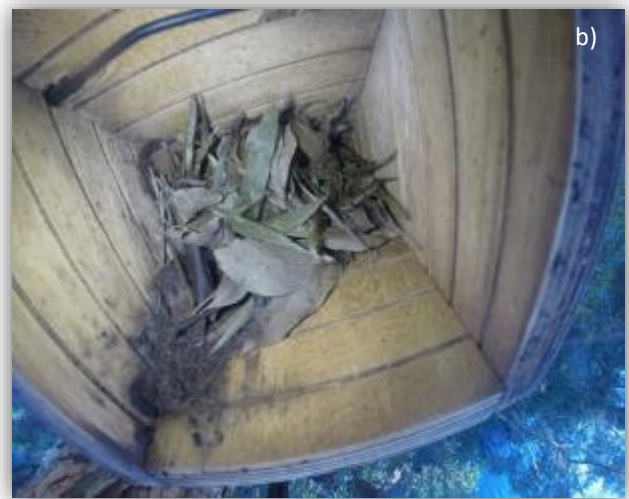
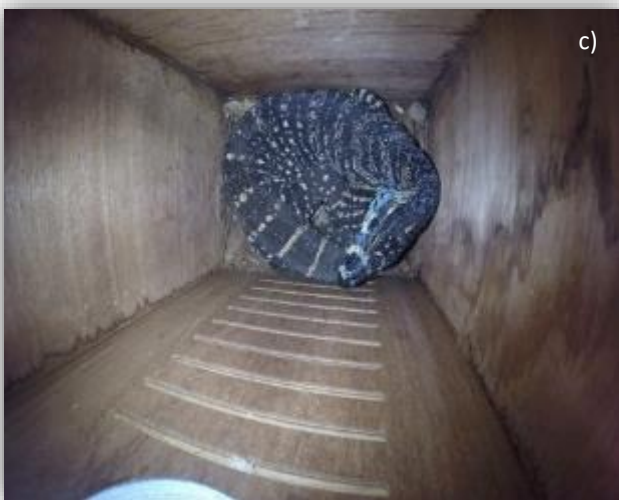
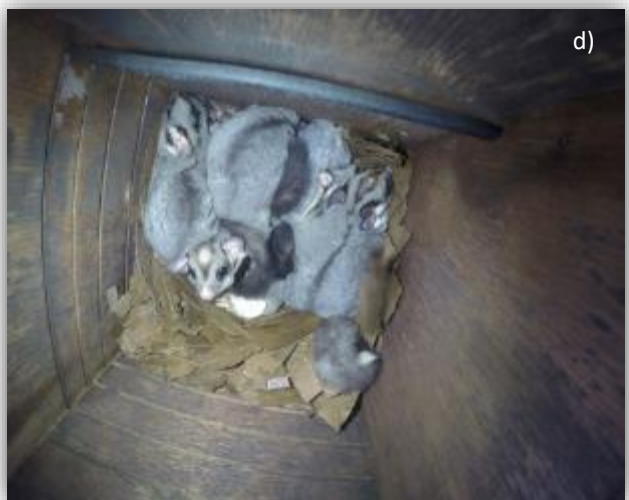
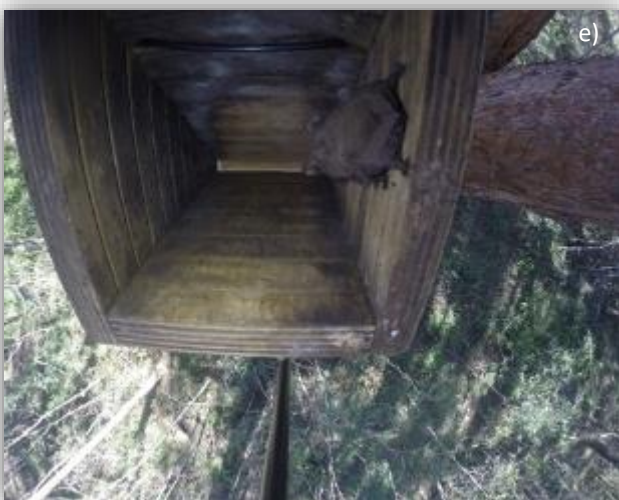
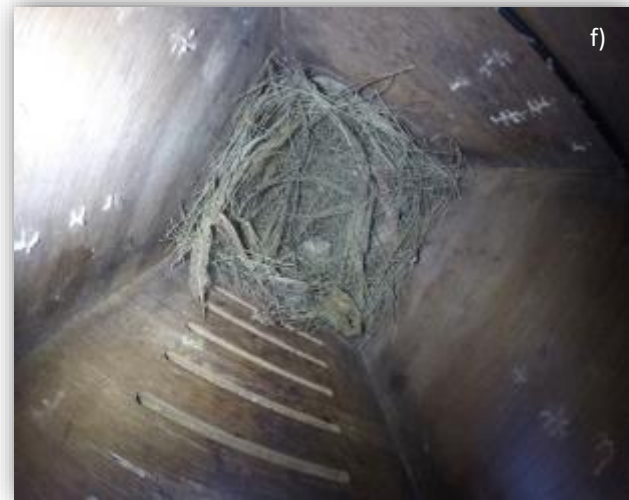
**Plate 1.** (a) Sugar glider in a typical bowl-shaped nest observed in a scansorial mammal box. (b) *Antechinus* spp. nest with latrine deposited in corner of microbat box. (c) Lace monitor in a parrot/lorikeet box. (d) Sugar glider x 4 recorded in a small glider nest box. (e) *Nyctophilus* spp. recorded roosting in a microbat box. (f) Probable white-throated tree creeper nest indicated by layered foliage.

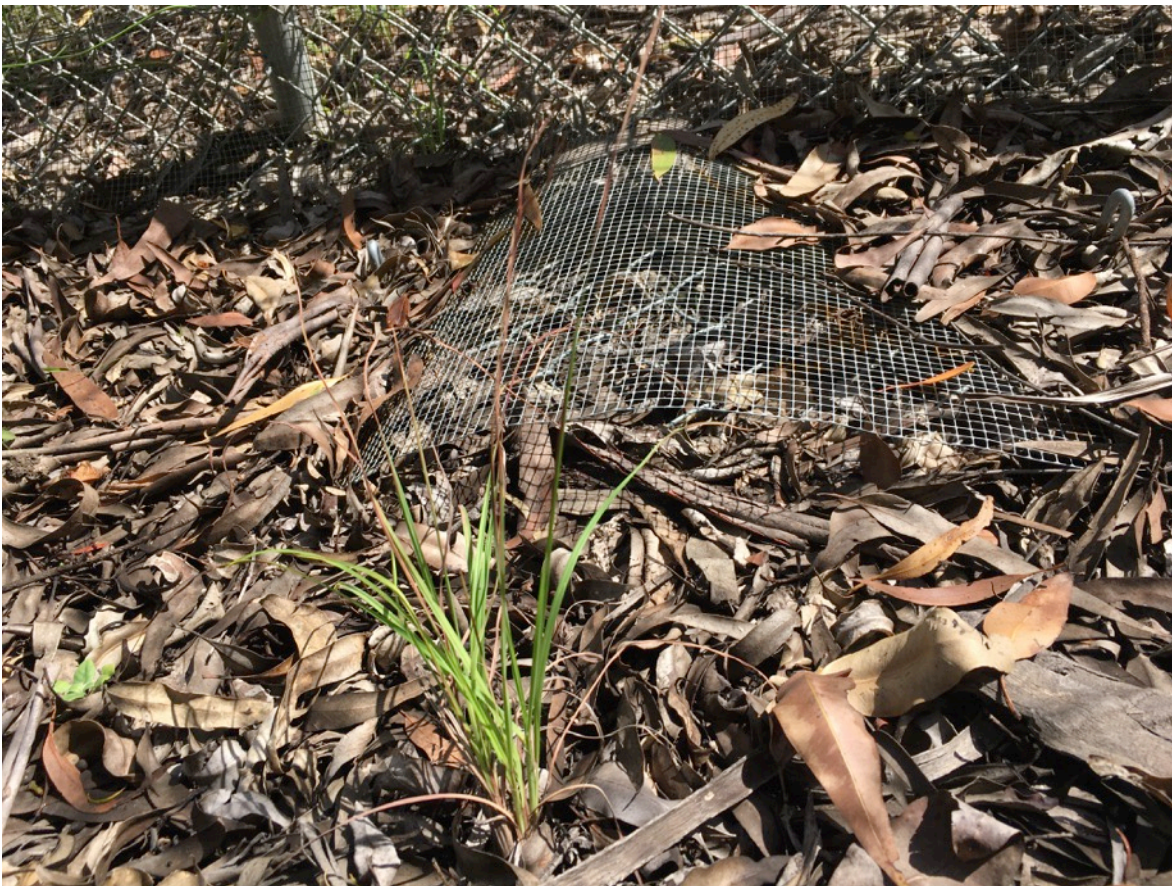
**Plate 2:** Lifting of fine mesh exclusion.

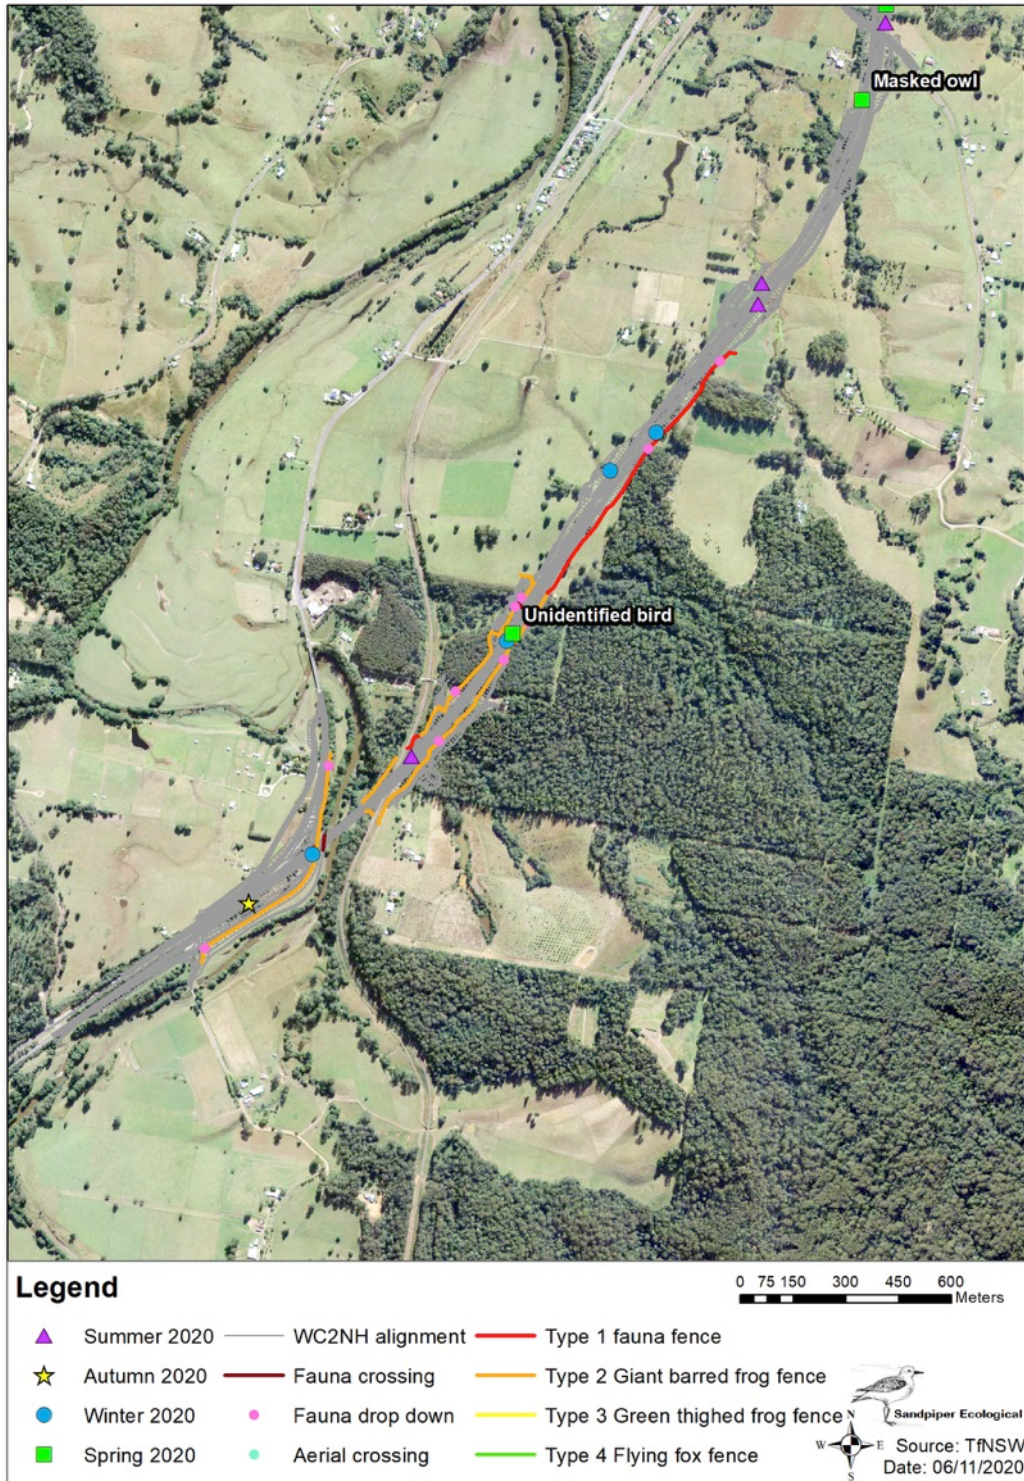
**Figure 4:** Location of road-killed fauna recorded in 2020. Note: only October 2020 records are labeled.

In October 2020, road-killed fauna was recorded over the entire WC2NH alignment (Figure 4-8), although the majority of records (68%) occurred south of Mattick Road. Of the eight road-kills recorded north of Mattick Road, 50% were birds. Despite the broad distribution of road-kill a distinct cluster was evident between the Nambucca River and Mattick Road (Five individuals; 2.5 ind/km). Four of the five individuals were wallabies with one bird (domestic goose) recorded (Figure 6 & 7). Clusters of two or more individuals were also recorded to the south of Lower Warrell Creek Bridge and around Nambucca Floodplain Bridge 1 (Figure 5 & 6).

In October 2020, 14 road-kills were recorded in areas with exclusion fence, and 11 were recorded in areas without exclusion fence (Figures 4-8). Road-kills in areas with exclusion fence on one side of the carriageway were classed as fence absent. Five records (or 36%) in sections with fence were species that should have been blocked by the fence (i.e. medium and large mammals and reptiles). In contrast, eight individuals (or 72%) of road-kills in sections without fence were of species that should be blocked by a fence.

Road-killed fauna have been recorded over the entire study area (Figures 4-8). There were substantially fewer road-kills in areas with continuous fauna fence north of Mattick Road and the southern extent to just north of Rosewood Road. Road-kill density between the southern extent and just north of Rosewood Road was 3.3 ind/km, which is similar to the 3.57 ind/km recorded north of Mattick Road, but less than the 9.18 ind/km recorded between Warrell Creek and Nambucca river (inc. Gumma floodplain) and 26.7 ind/km on the Nambucca Bridge. Notable road-kill hotspots include:

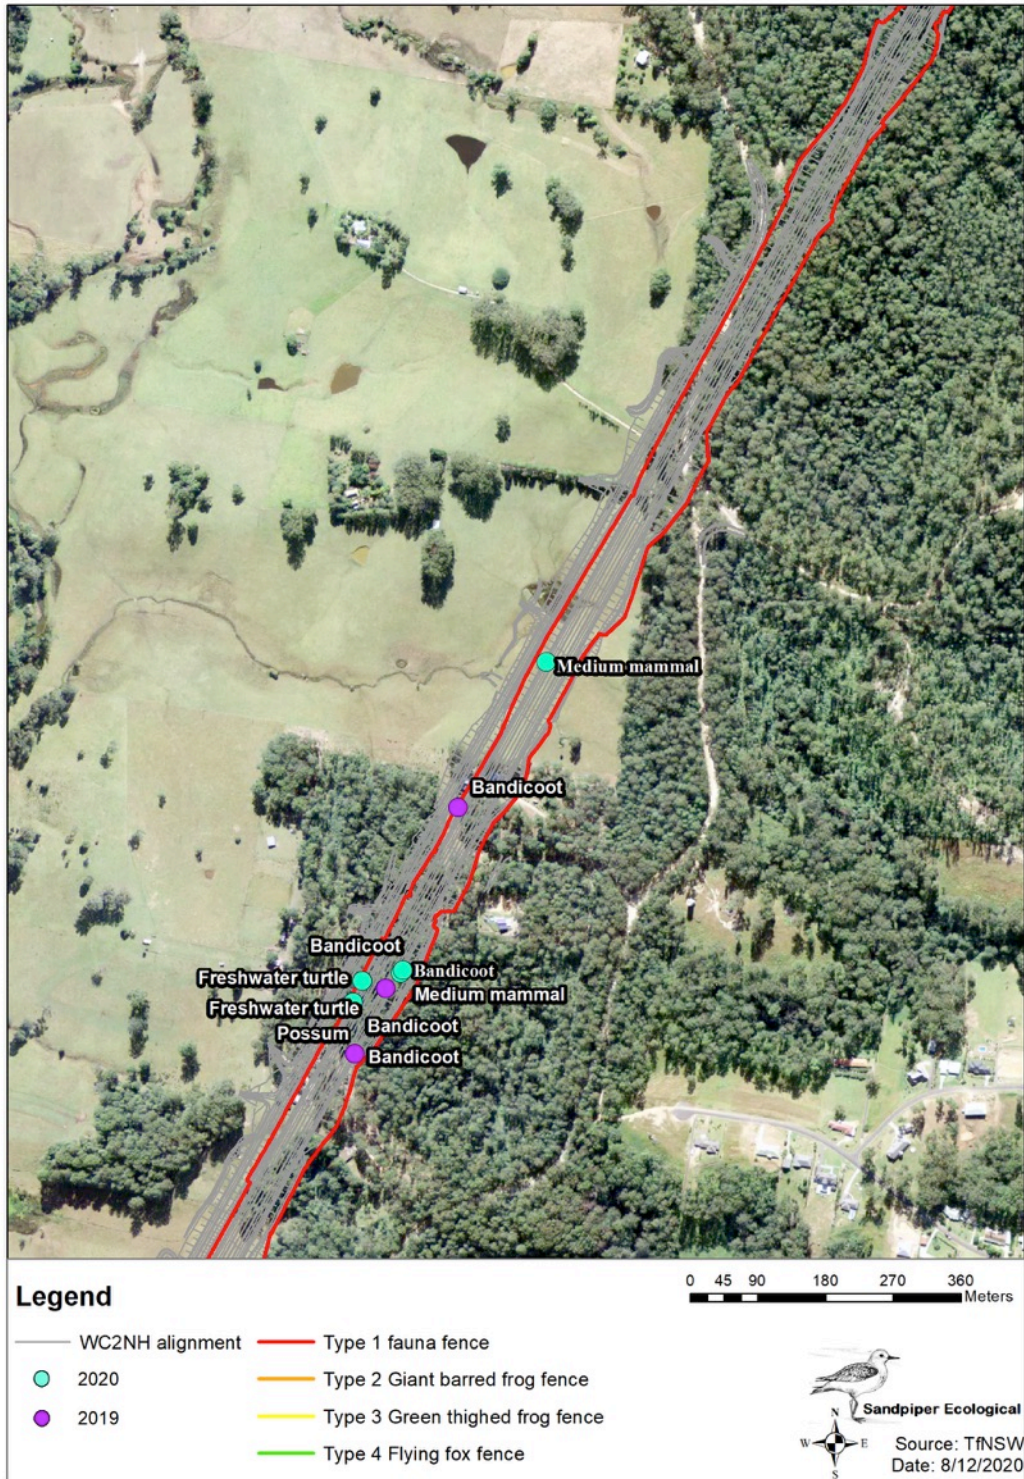
**Figure 14:** Distribution of fauna groups recorded in 2019 and 2020 that should be blocked by exclusion fence.

In both 2019 and 2020 the number of road-kills of species that should be blocked by exclusion fence varied between sections of alignment with or without fauna exclusion fence (Figure 12). The number of road-kill was higher in sections where exclusion fence was absent and lower along fenced areas of the alignment (Figure 12). The distribution of species recorded in 2019 and 2020 that should be blocked by the fence is shown on Figures 13 to 20. These figures highlight the clustering of records in areas without fence such as south of Mattick Road (Figure 15), north and south of Bald Hill Road (Figure 17), and between Upper Warrell creek and Warrell creek (Figures 18 & 19).

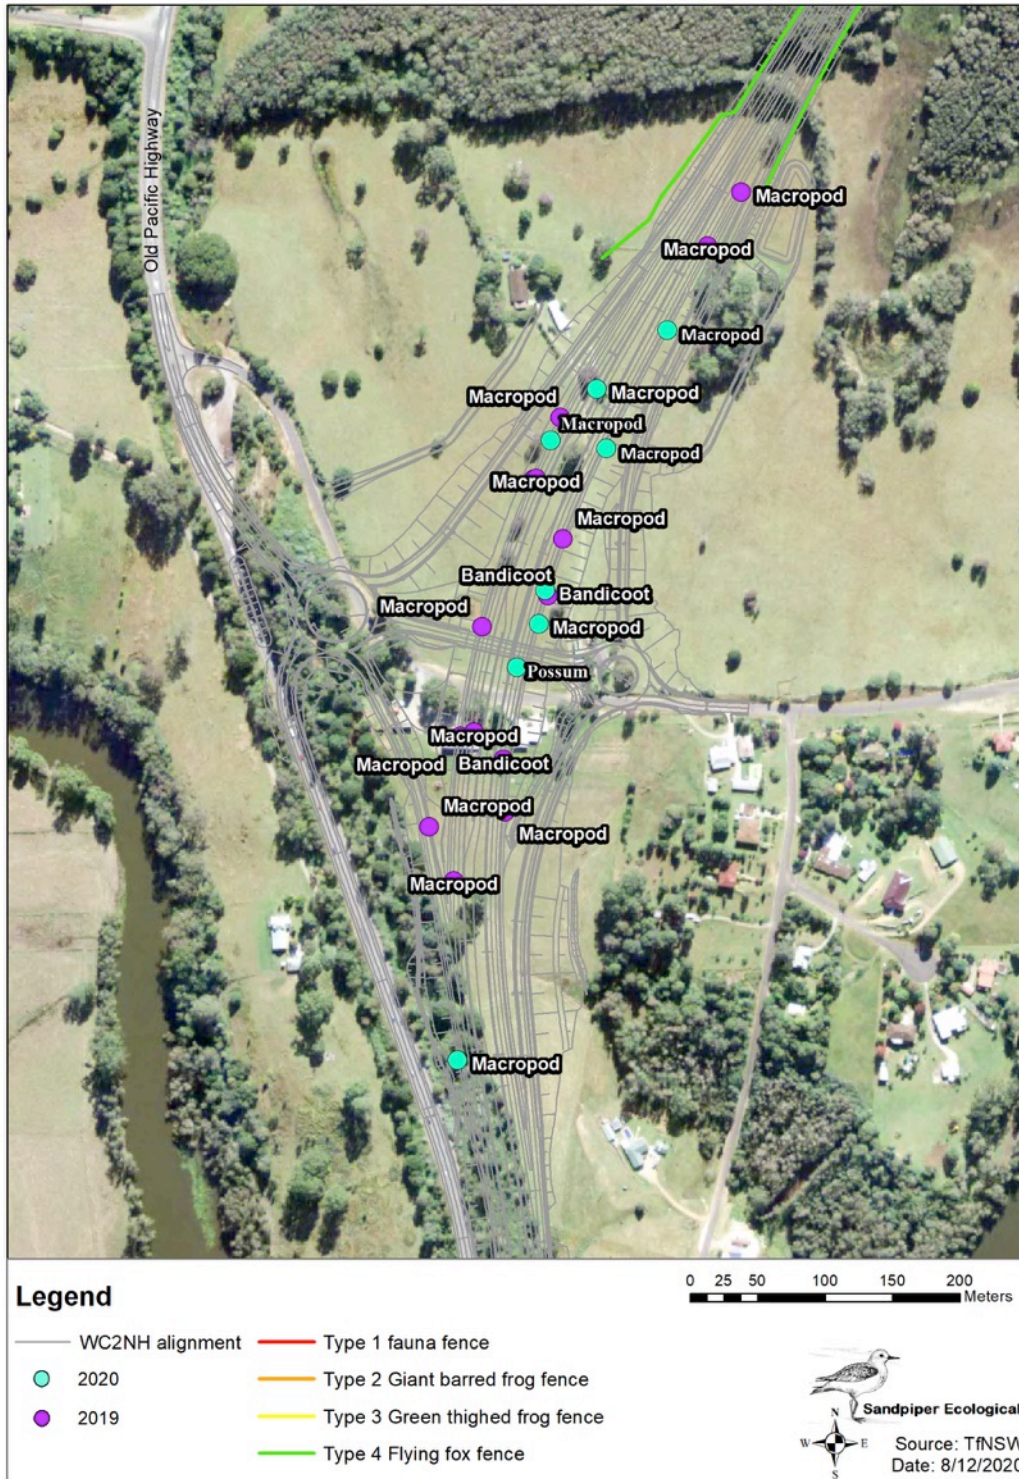
**Figure 17:** Distribution of fauna groups recorded in 2019 and 2020 that should be blocked by exclusion fence.

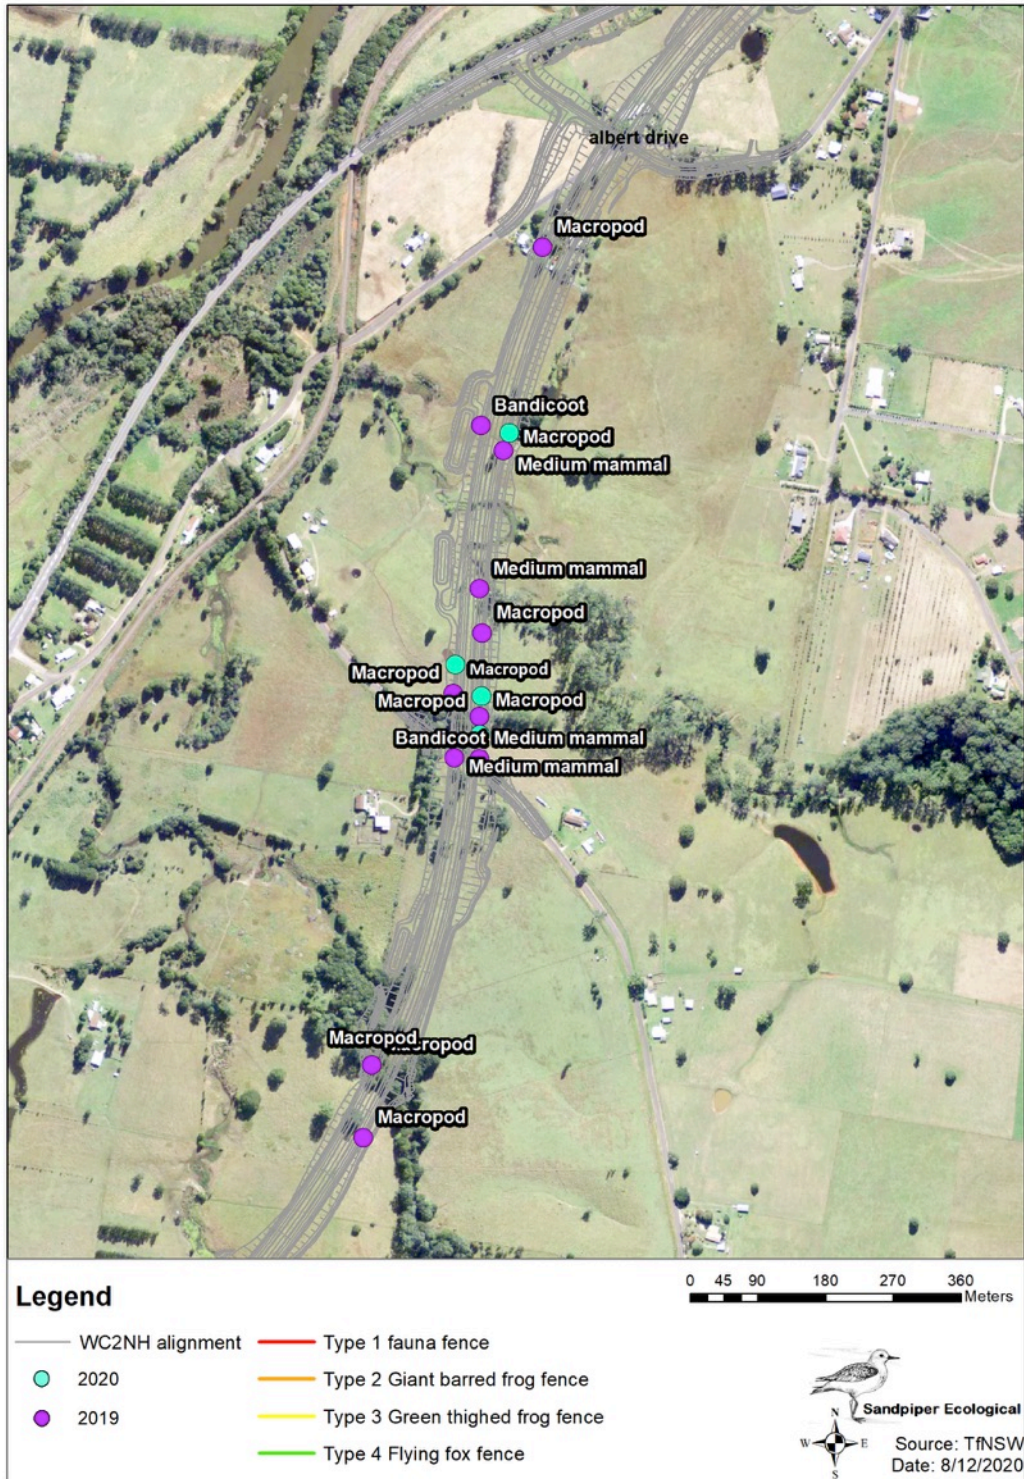
**Figure 19:** Distribution of fauna groups recorded in 2019 and 2020 that should be blocked by exclusion fence.

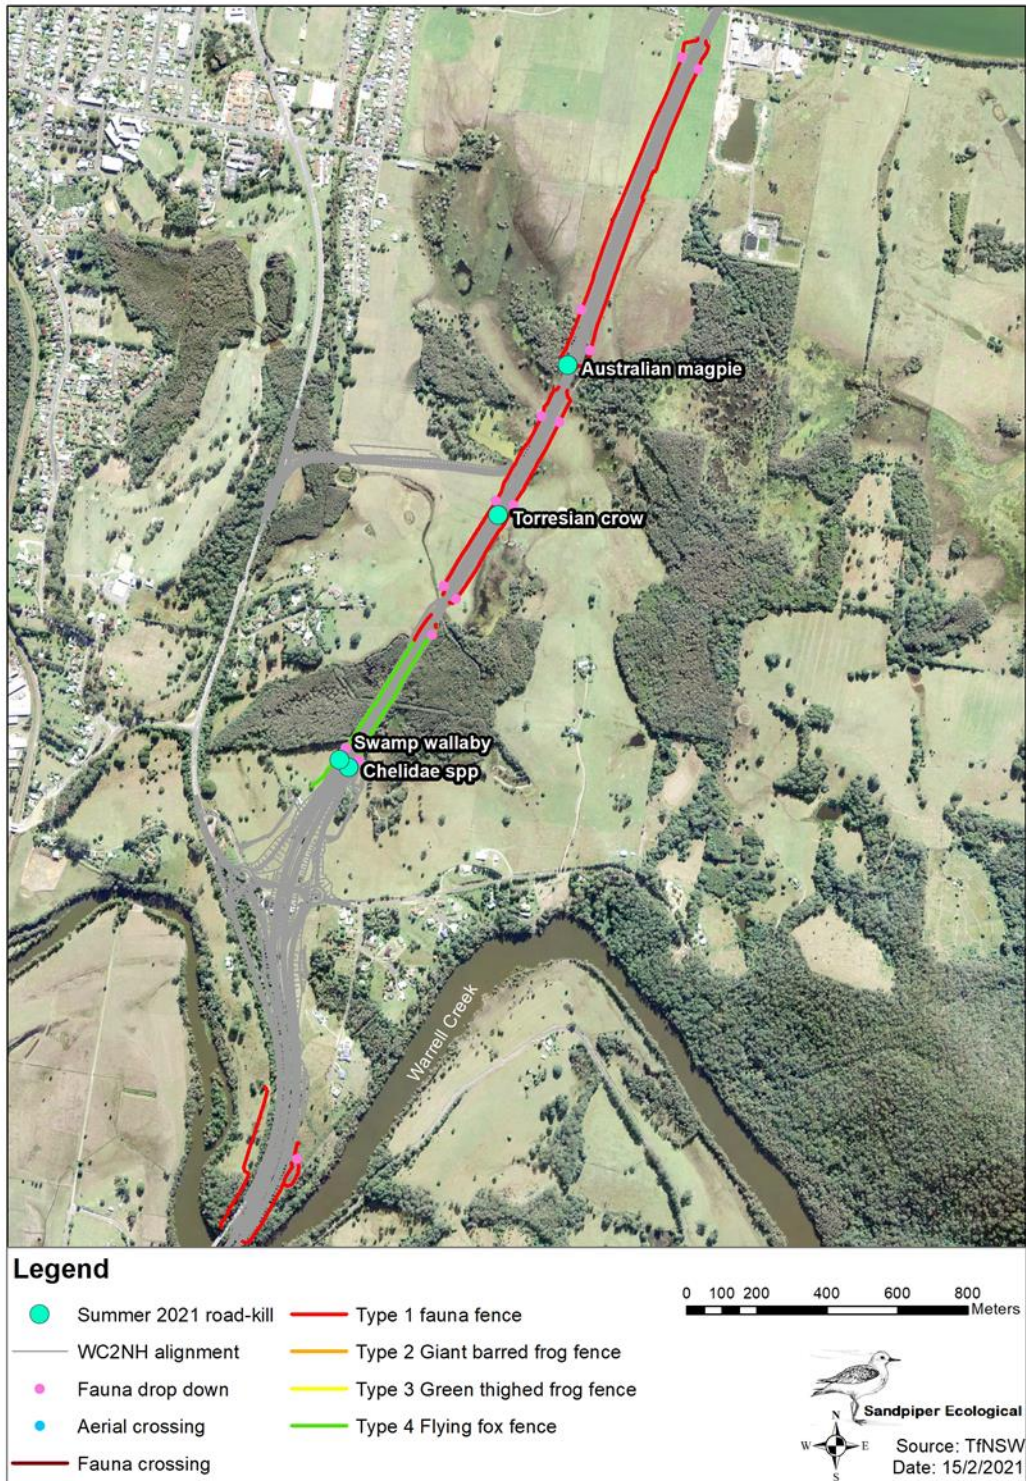
Figure 7: Location of road-killed fauna recorded in summer 2021.
