Warrell Creek to Nambucca Heads Pacific Highway Upgrade Koala Monitoring

Annual report 2020-21 (Year 3)

Transport for NSW | November 2021

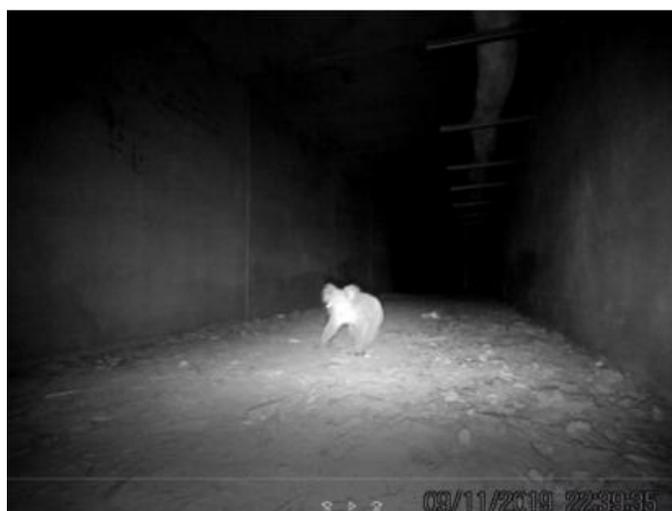
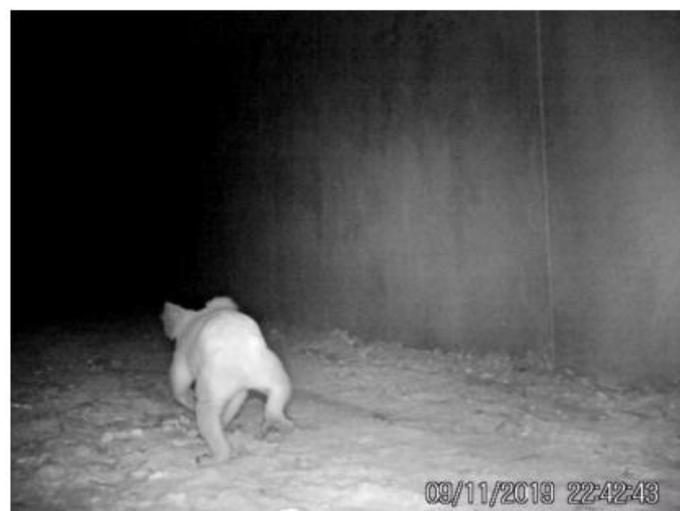
Plate 1: Koala recorded moving east through site 9 (L) and 10 (R) on 9 September during spring/summer monitoring 2019/20.

Koalas were recorded using underpasses to make complete crossings beneath the highway in both years two and three. In year two, koalas were recorded at three underpasses (sites 4, 9 and 10), with detections made by passive infra-red cameras, sand pads, scat/track surveys, adjacent habitat active searches and spotlighting. Two complete crossings were recorded on sand pads at site 4, and further evidence of crossings were recorded during scat/track searches at sites 4, 9 and 10 (Table 3). Camera monitoring detected koalas at site 4 on seven occasions and at sites 9 and 10 on one occasion each (Plate 1). All camera records were classed as complete crossings. Spotlighting of adjacent habitat detected koala on the eastern side of site 4 (Table 3). In year three, koalas were recorded making complete crossings at sites 4 and 8 and incomplete crossings at sites 10 and 12. Koala scats were also recorded on the west side of the alignment at site 4 in winter 2021 (Table 3).

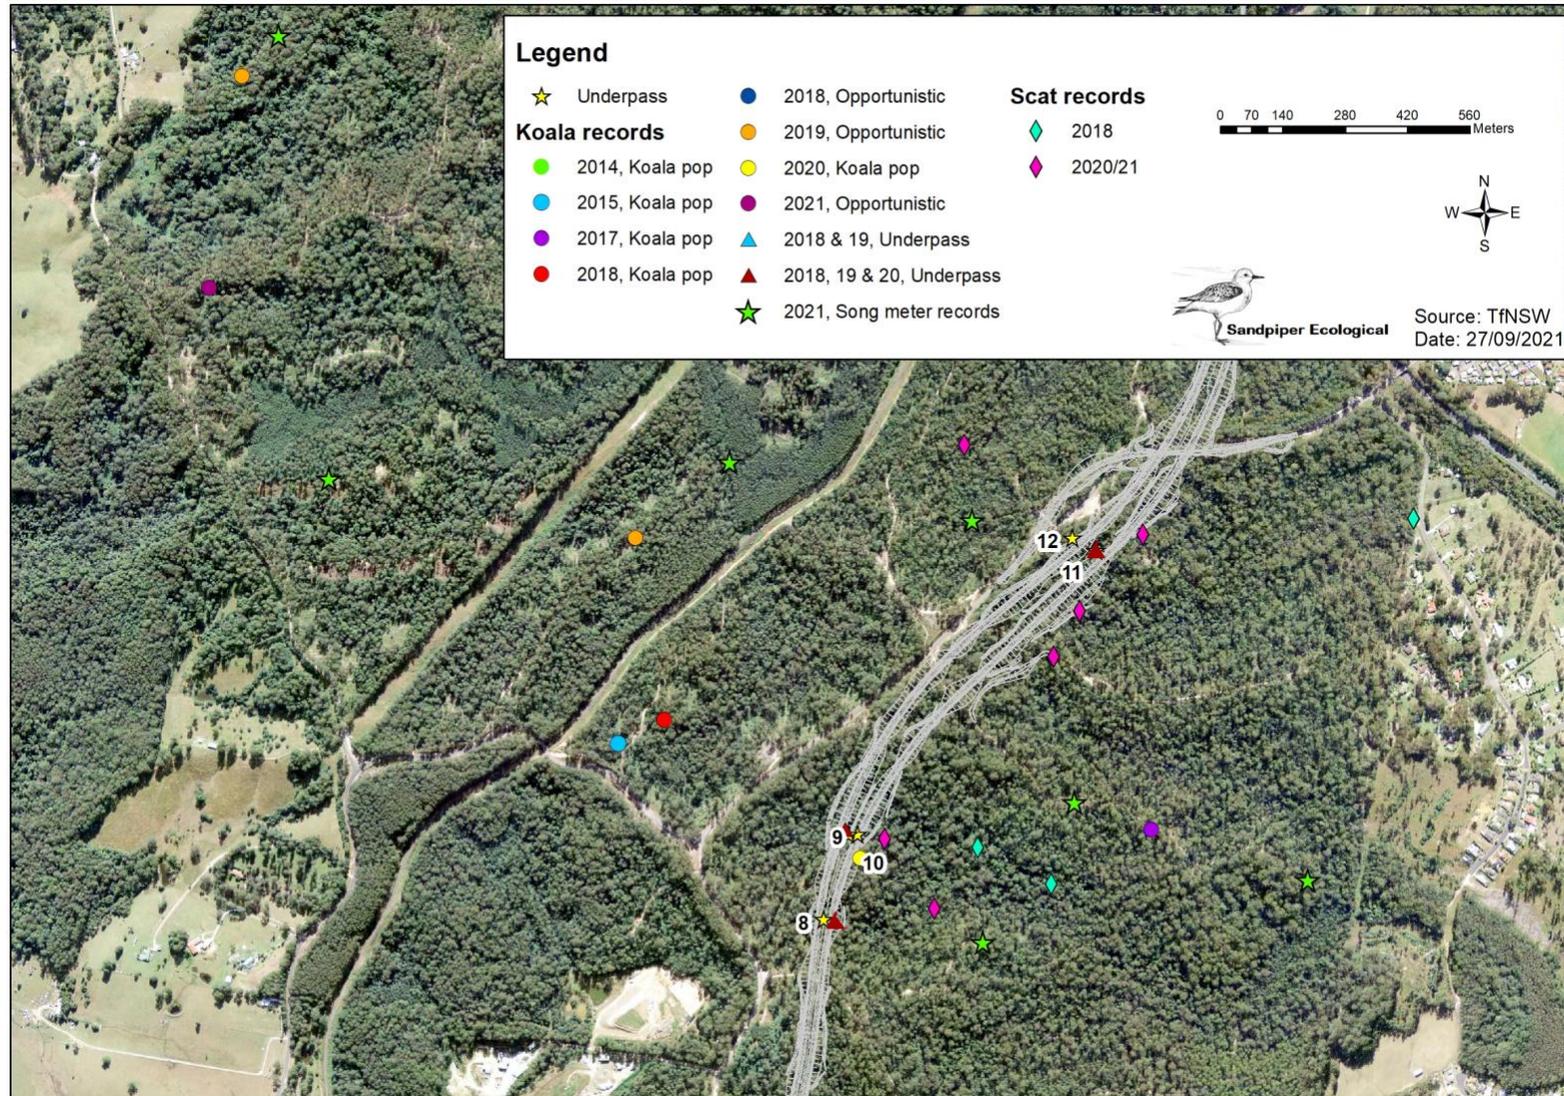
Figure 2: Location of koala records obtained between 2014 and 2021 during surveys for the WC2NH Pacific Highway Upgrade

No koalas were recorded while completing transect surveys during the spring 2020 sample event. Koala scats were recorded beneath tallowwood trees (*Eucalyptus microcorys*) on transects E7, E11, E13, E22, W5, and W16 (Figures 2 & 3). The location of transects is shown on Figure 4.

One koala was observed inside (i.e. within road corridor) the exclusion fence near E11 during spotlight surveys of tracks and easements on 8/9/2020 (Table 1; Figure 2). The individual was captured and relocated to forest habitat adjacent E11 (i.e. outside the road corridor). The male koala was a healthy sub-adult in good condition with no signs of disease. It is likely the individual breached the exclusion fencing via a nearby gate that featured a ~200mm gap between the gate bottom and the ground. The gap was remedied after relocating the individual to the adjoining forest.

Opportunistic records of koalas were collected whilst conducting spotlight surveys and song meter surveys for yellow-bellied glider in year three (i.e. 2020/21) and year four (i.e. September 2021). Song-meters detected koala at nine sites during 2020/21 (S1, 2 & 3, S7 to 12) (Figure 2), with a total of 28 recordings across all sites. Calls were recorded on both sides of the highway and extended from song meter #7 near Old Coast Road/Nambucca Community Recycling Centre and song meter #12 off Bellwood Road in the south to song meter #9 near Gordons Knob Road in the north (Figure 2). Three koalas were recorded during spotlight surveys including two adults and one back young. A mother and joey were recorded on 13/9/2021 on Gordons Knob Road (E495177, N6610623) west of the highway, and one adult (sex undetermined) was recorded on 13/9/2021 approximately 220m east of underpass #4 (Figures 2 & 3).

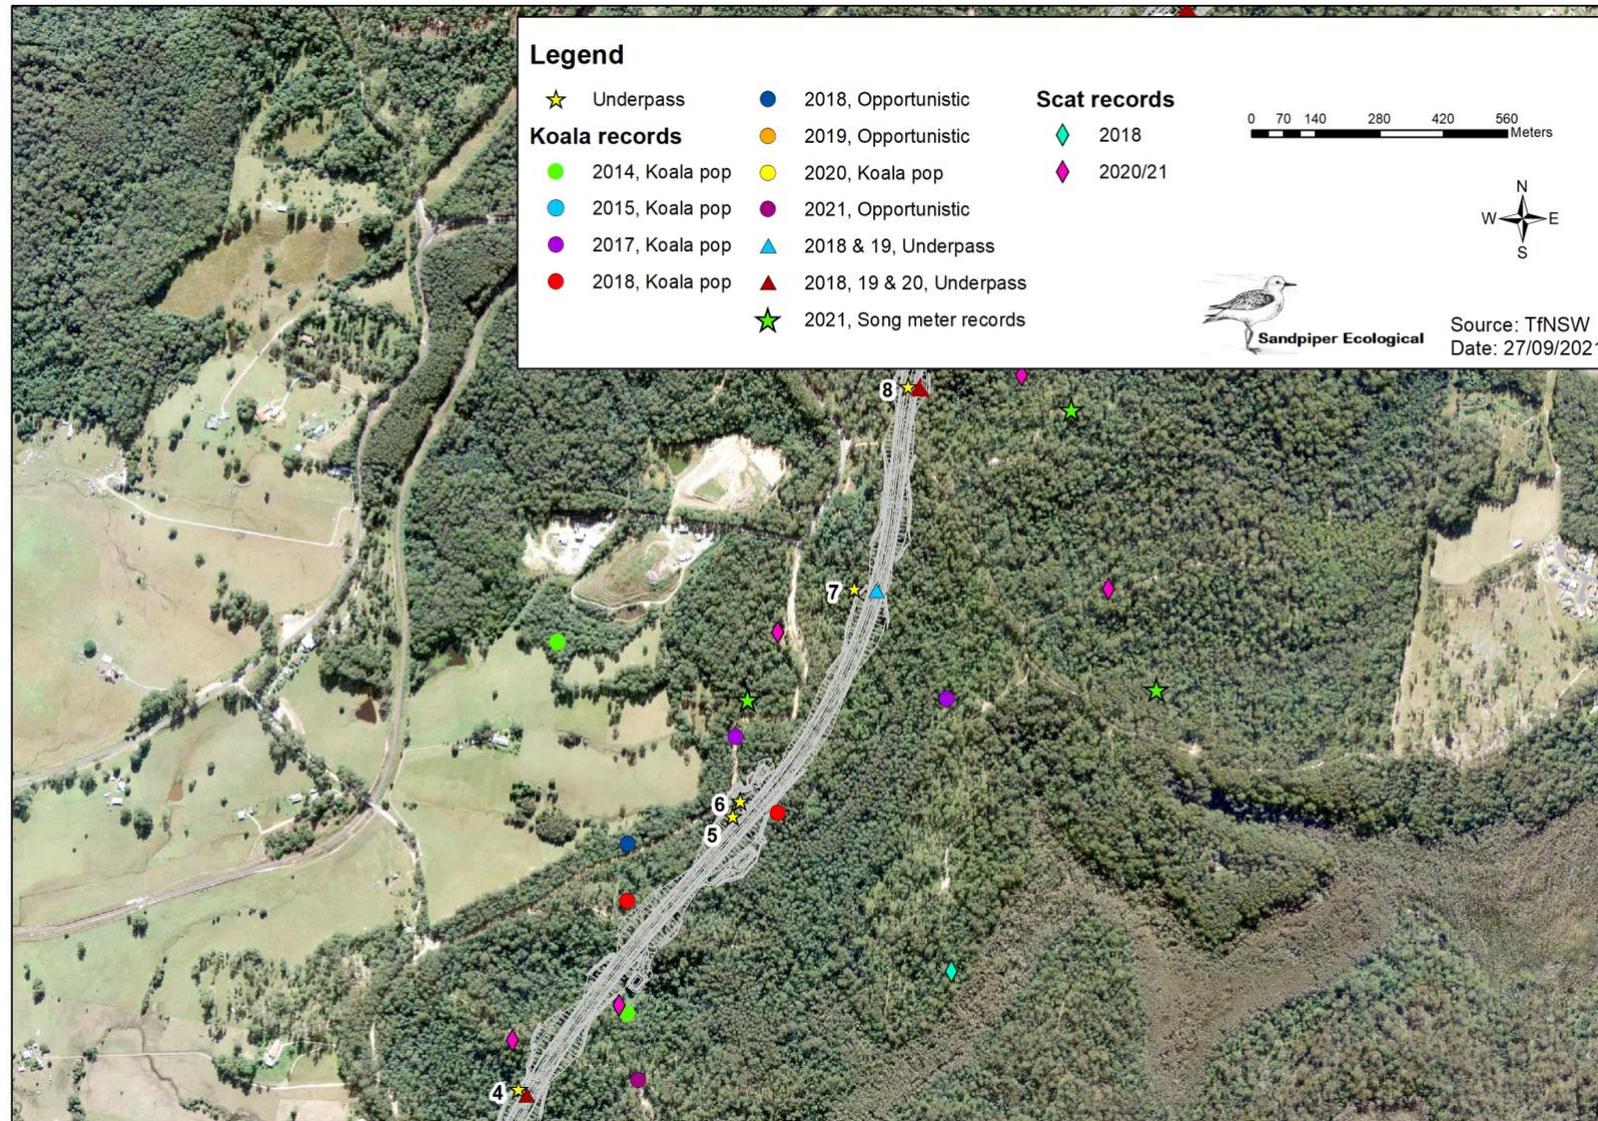
Figure 3: Location of koala records obtained between 2014 and 2021 during surveys for the WC2NH Pacific Highway Upgrade

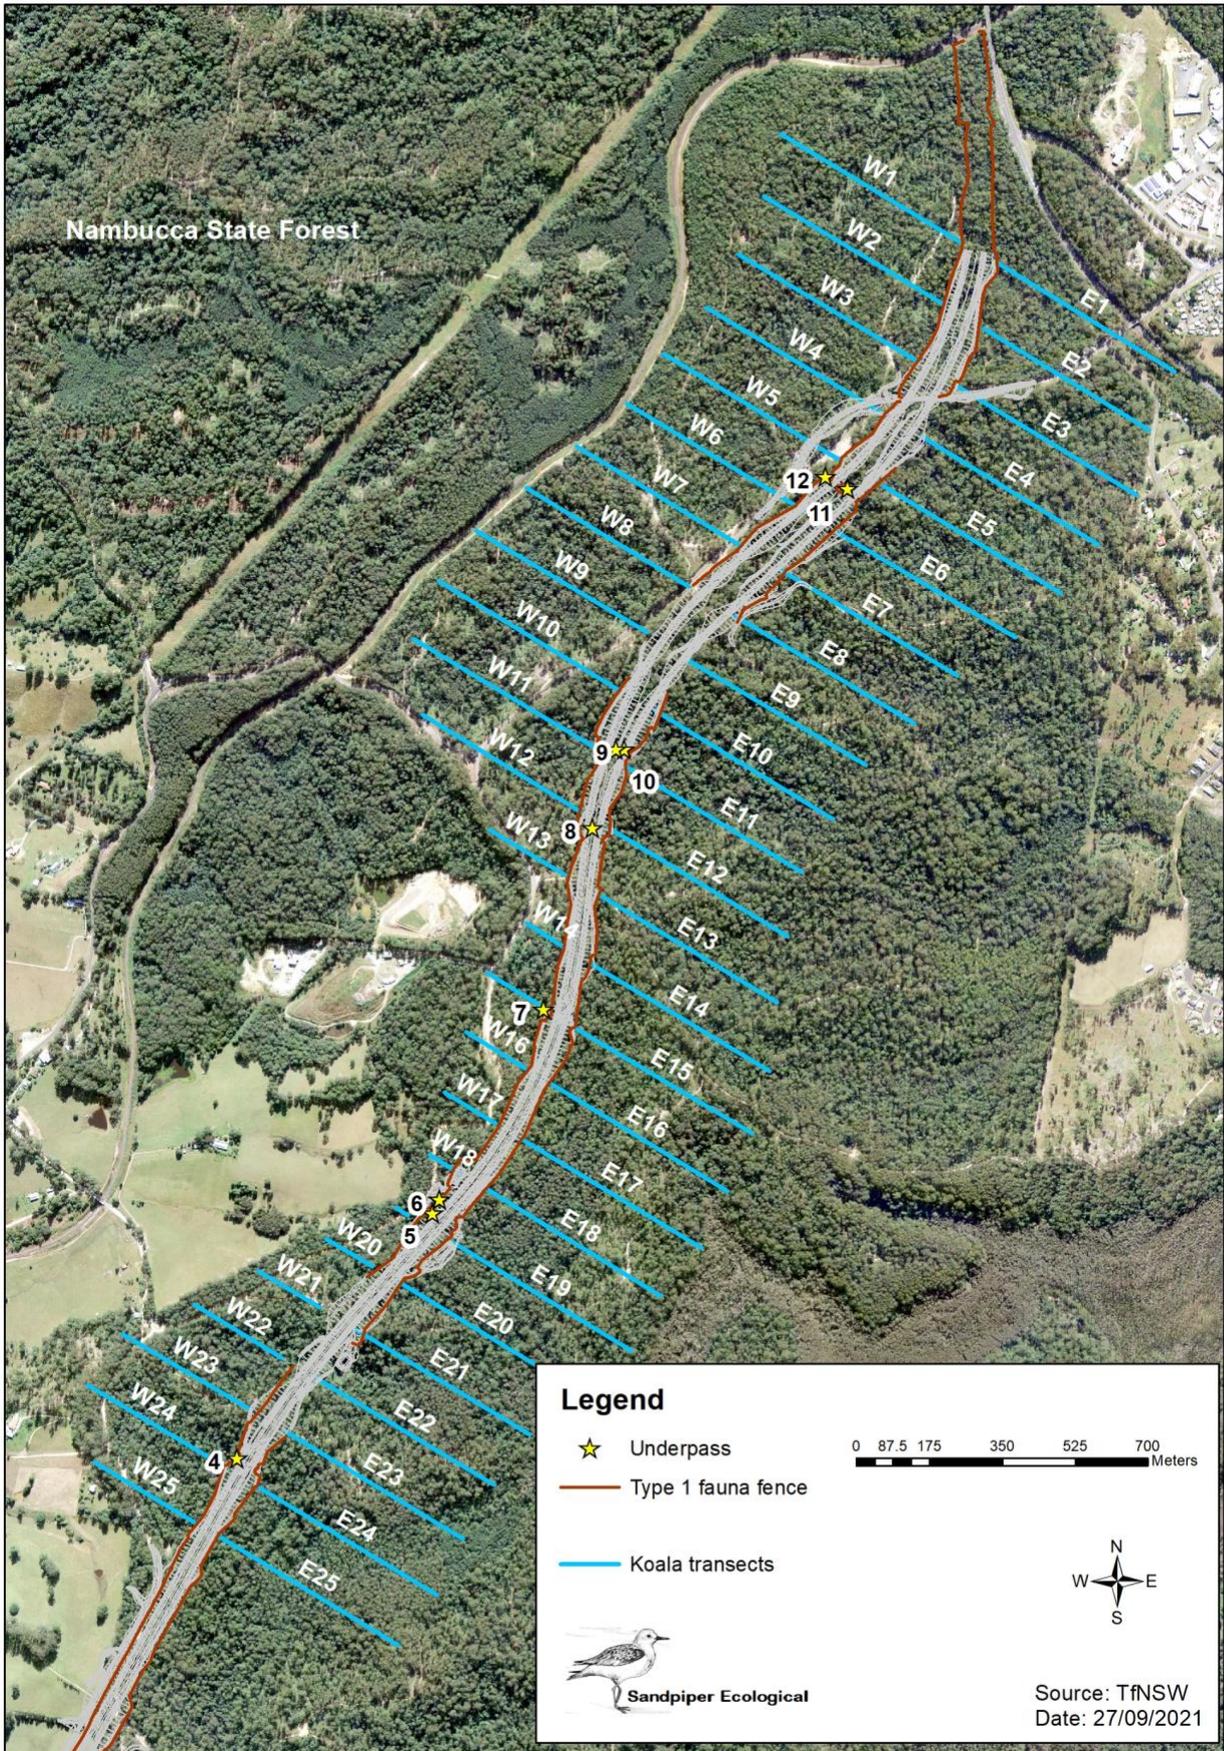
Figure 4: Location of transects sampled during the year three operational phase koala population surveys.
