## Coffs Harbour Bypass

### Pittosporum sp. Coffs Harbour & Jordans Creek Exclusion Zone Management Plan

281967-0-DC-EN-MPL-0001

Issue 4 | 26 May 2022

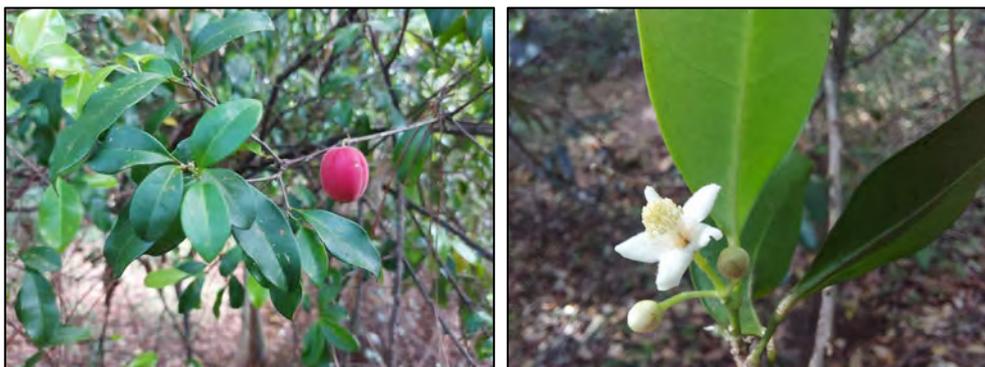
Photograph 1 Fruit and leaves of *Fontainea* sp. Coffs Harbour at Kororo Hill and flower at Jordans Creek

- *Fontainea* sp. Coffs Harbour (A.S. Benwell 341, NSW1102027) (Photograph 1)
- *Pittosporum* sp. Coffs Harbour (A.S. Benwell 342, NSW1102028) (Photograph 2)

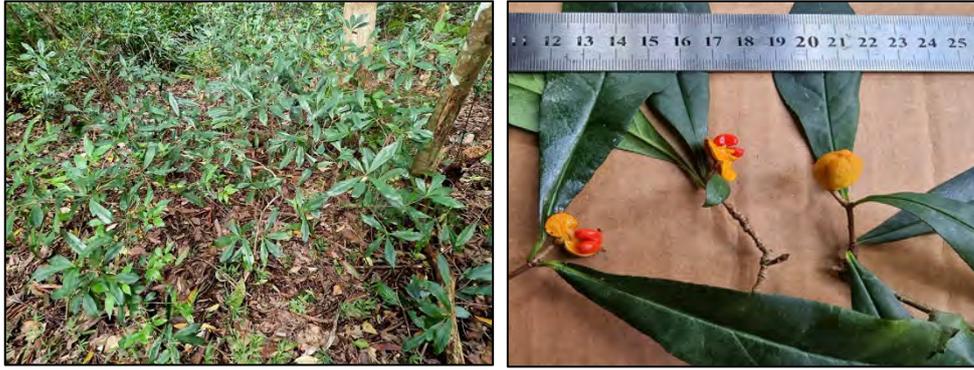
Photograph 2 *Pittosporum* sp. Coffs Harbour patch of stems (left) and leaves, fruits and seeds (right)

*Pittosporum* sp. Coffs Harbour was observed to generally occur in patches of stems, that grow as suckers from the root system (which is a form of vegetative reproduction). Several stems were excavated and found to be growing from horizontal, rhizome-like roots 5 – 10 cm underground. The patches of stems appear to be clones and may be genetically identical. A few single, isolated plants were recorded which may represent recruitment from dispersed seed, although observations over the course of 2021 indicate that very few fruits and seeds are produced, despite reasonable numbers of flowers. Fruit have only been recorded in one small area within the [Redacted].
