Devils Pulpit Pacific Highway Upgrade

Compliance Report

Transport for NSW | March 2021 to February 2022

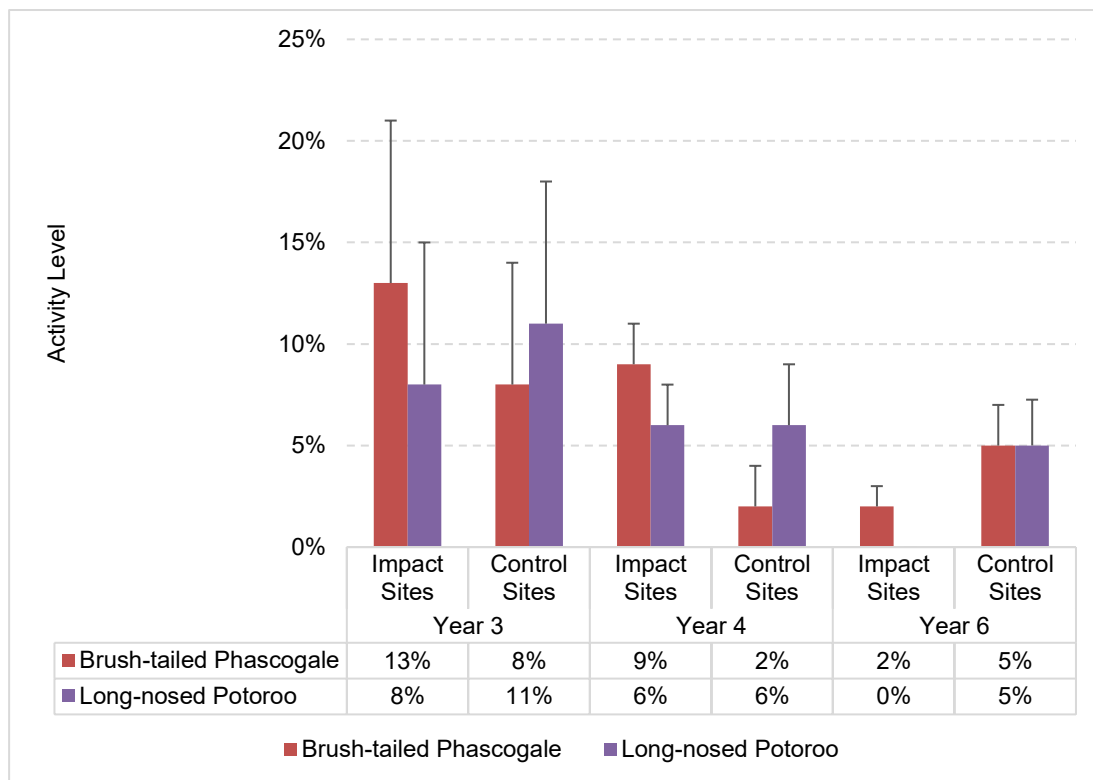
Figure 3.1 Average Activity Levels of Brush-tailed Phascogale and Long-nosed Potoroo at Impact and Control Sites During Year 3, Year 4 and Year 6.

- activity levels decreased at both impact and control sites between each monitoring period
- activity levels were lower at impact sites compared with control sites during Year 3 and Year 6 and equal in Year 4.

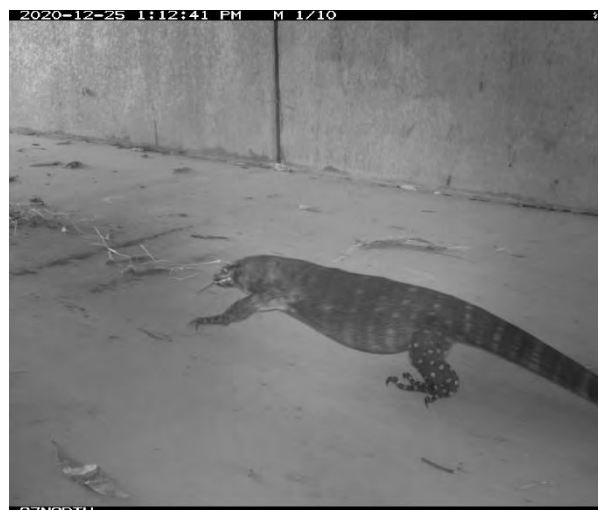
Plate 3.7 Lace Monitor moving east-west at fauna underpass C7.
A complete crossing was recorded.

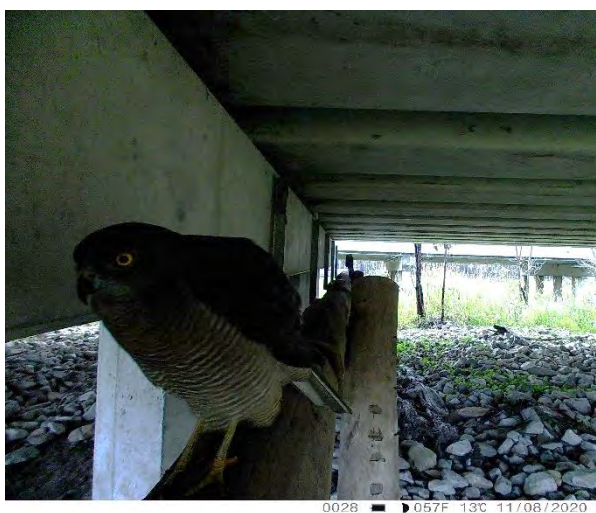
Plate 3.10 Brown Goshawk using fauna furniture at SBT3.
This was a regular observation, mainly at underpasses with fauna furniture.

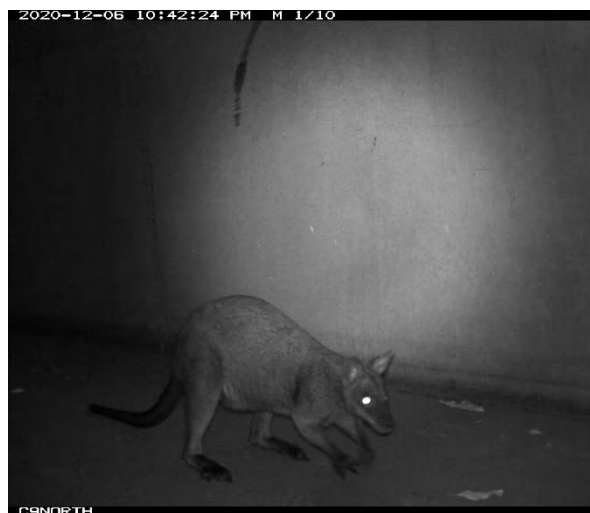
Plate 3.11 Swamp Wallaby moving west-east at fauna underpass C9.
A complete crossing was not recorded on this occasion.

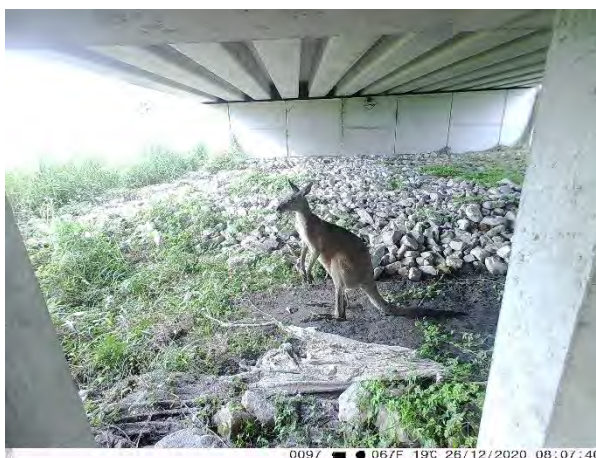
Plate 3.12 Eastern Grey Kangaroo crossing west-east at SBT3 (southern span)

A complete crossing was recorded. Note that the animal is crossing in an area with no rock. Macropods were frequently observed to avoid the irregular rock when crossing.

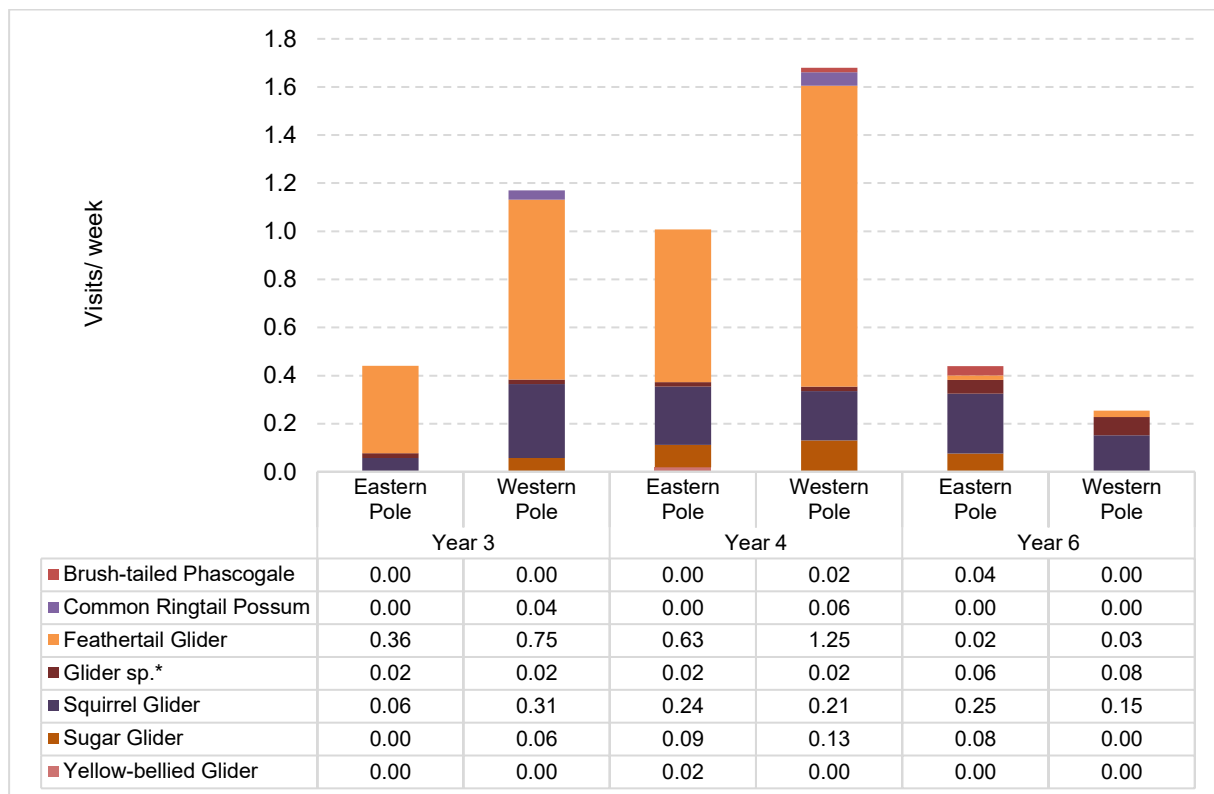
Figure 3.9 Visitation rates (visits/ week) of target species at each rope bridge pole during Year 3, Year 4 and Year 6 monitoring

- overall visitation rates (combined species) increased during Year 3 and Year 4, however decline during Year 6
- overall visitation rates were higher at the western pole compared with the eastern pole in Years 3 and 4, however during Year 6 visitation at the western pole decreased to lower levels than at the eastern pole
- during Year 3 and Year 4 Feathertail Gliders had the highest visitation rates, followed by Squirrel Gliders. During Year 6 Feathertail Glider visitation dropped significantly, which was the main contributor to the decrease in overall visitation in Year 6. In contrast, Squirrel Glider visitation remained relatively constant.

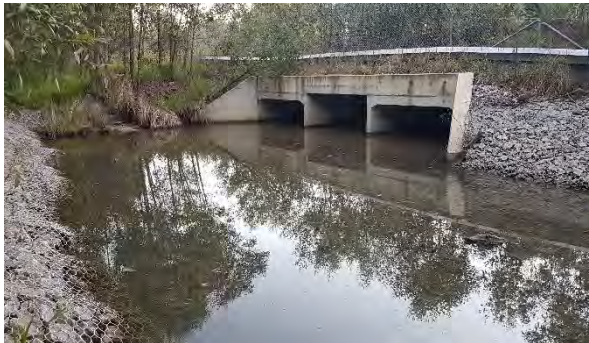
Plate 4.1 Typical water height at the outlet of C3.

This damage has affected fauna underpass usage which is demonstrated during the Year 6 reporting period by the substantially greater number of unique fauna crossings at structures without pooled water at the entrance compared to structures with pooled water (refer to **Section 3.6.1**). Transport are currently investigating repair works for these structures.

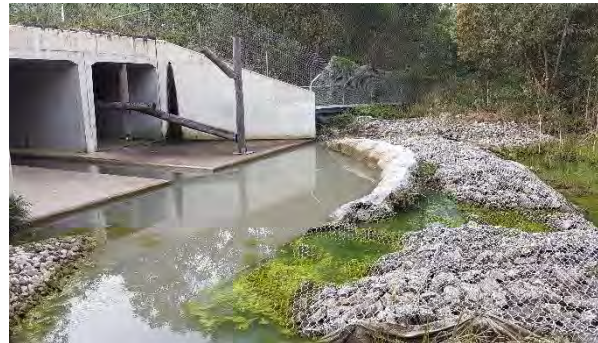
- Scouring at the inlet and/ or outlet of five culvert structures (C3, C6, C8, C9 and C10; refer to **Plate 4.1** and **4.2**), causing pooling of water within or at the entrance to the subject culverts. C6 has since been upgraded (refer to **Section 1.1.2**), although pools of water remain across most of the entrances and dense aquatic vegetation (Bulrush, *Typha sp.*) occurs at the inlet.
- Damage to the fauna furniture.

Plate 4.2 Scouring and pooled water at the outlet of C8.

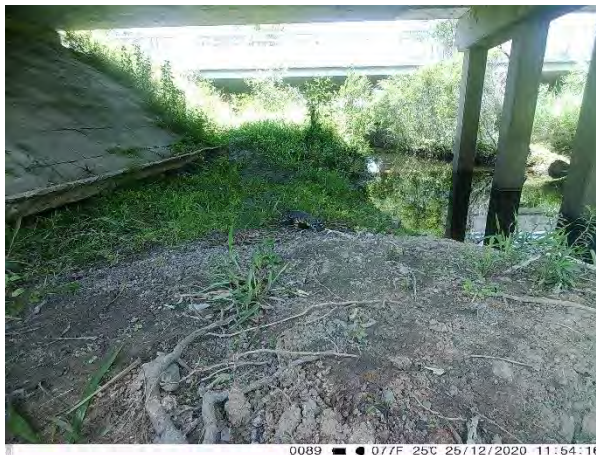
The bridge underpass monitoring results suggest that fauna are more likely to use bridge underpasses with an obvious passage for fauna to traverse, compared to those with less defined or irregular (rocky) routes. For example, the absence of a clear passage at SBT2 (refer to **Plates 4.3** and **4.4**) is likely to have reduced the number of fauna records and complete crossings recorded for this structure and the adjoining NBT2. In contrast, the Tabbimoble Floodway No.3 bridges have defined passages (refer to **Plates 4.5** and **4.6**) and recorded higher numbers of fauna records and complete crossings.

Plate 4.5 Northern bank at NBT3 showing obvious passage for crossing fauna (flat regular ground).

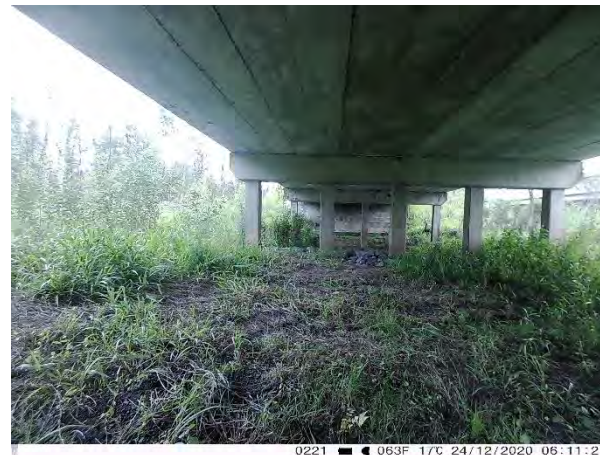
Plate 4.6 Southern bank at NBT3.
The vegetation has been trimmed in this photo to prevent obstruction of camera traps. The image shows that the passage for crossing fauna consists of regular flat ground.

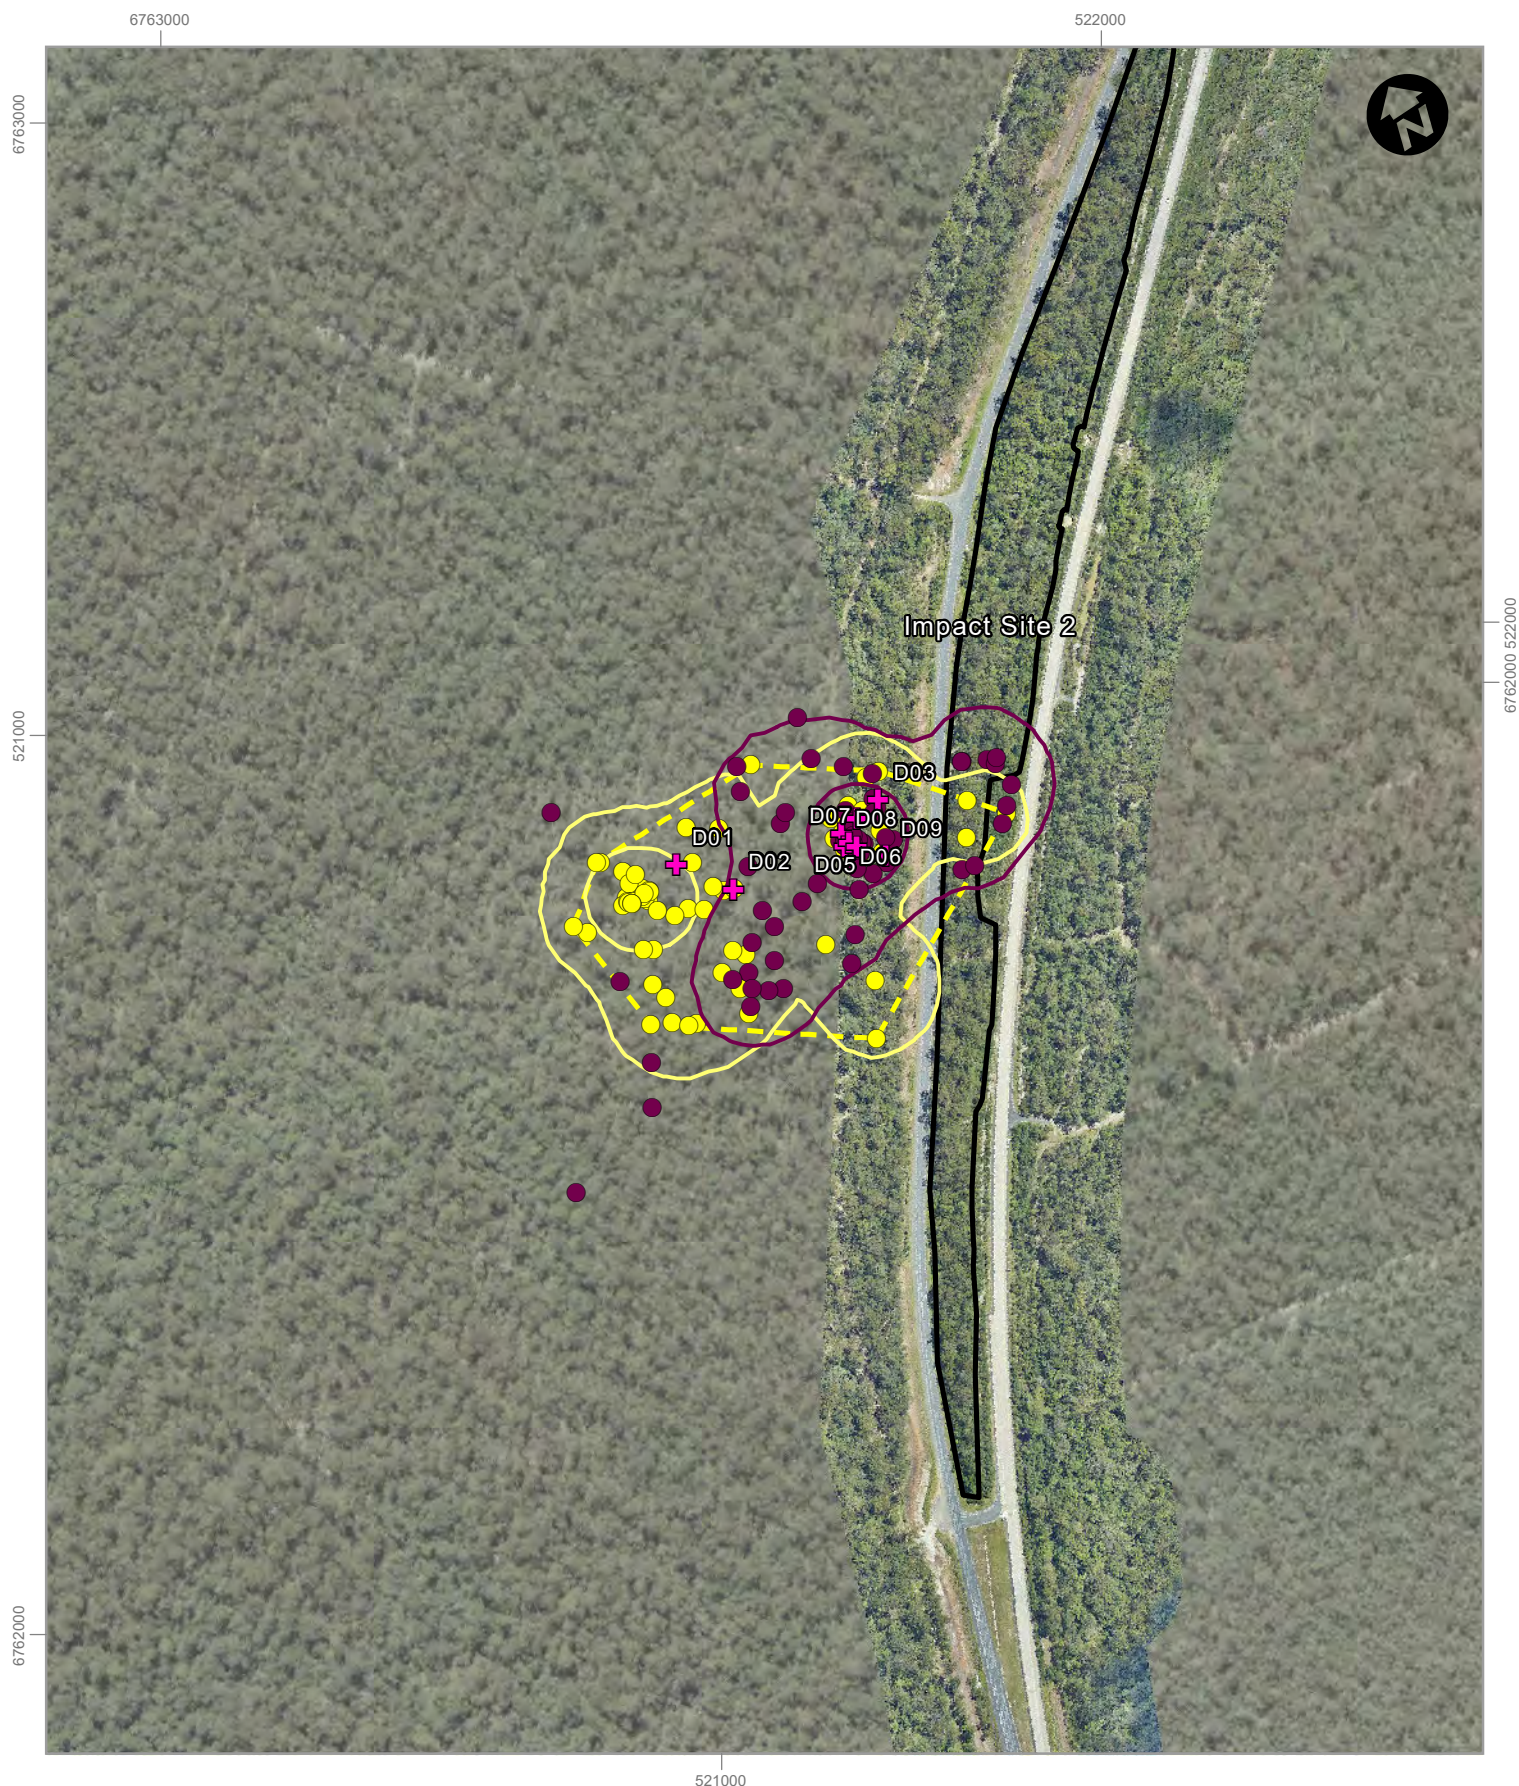
Impact Site 2 (median)
 Den tree

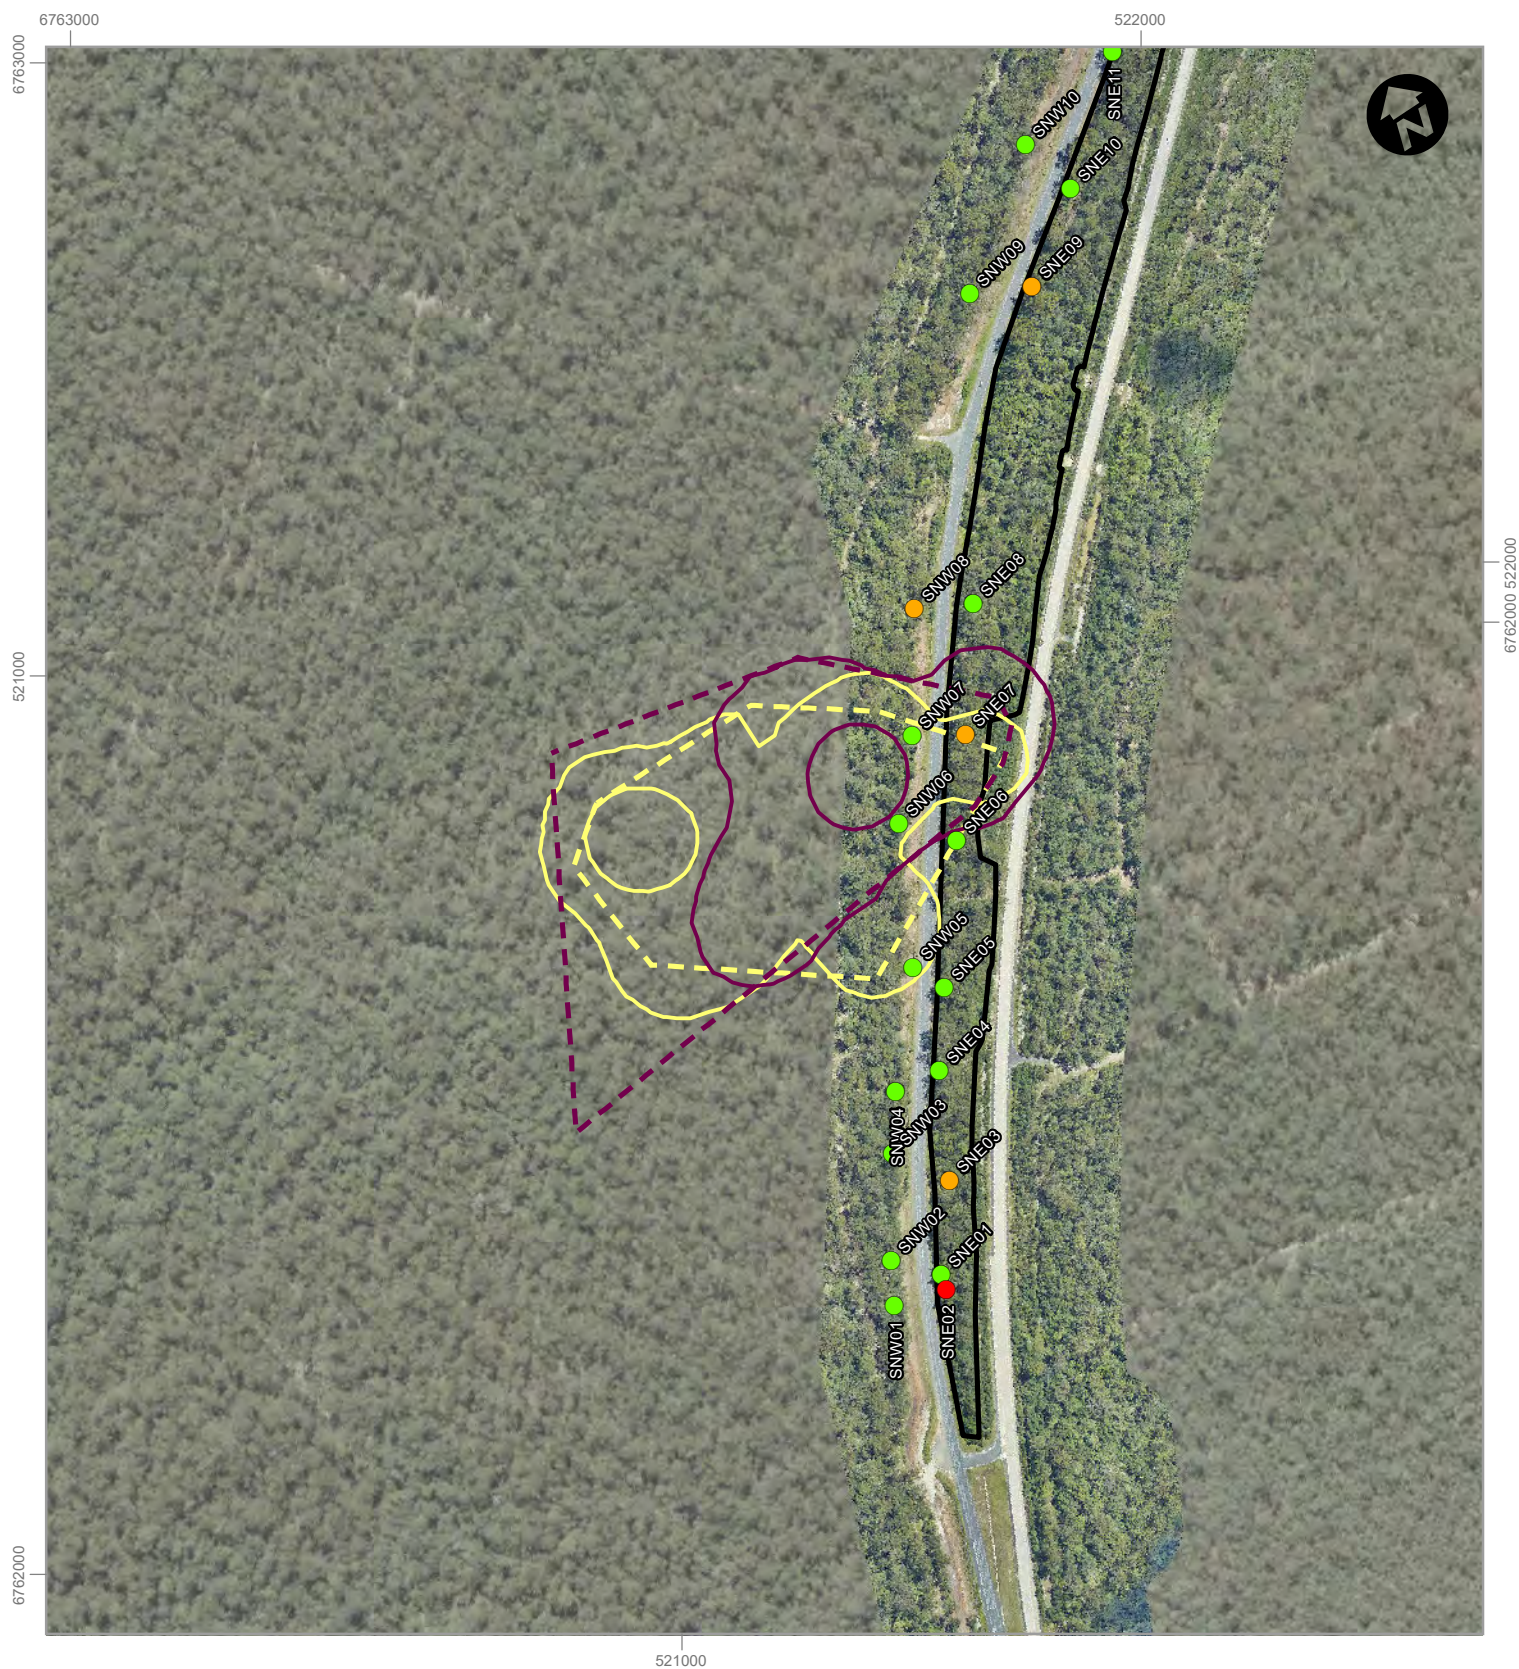
- Impact Site 2 (median)
- F7 FK home range estimate
- F7 MCP home range estimate
- M9 FK home range estimate
- M9 MCP home range estimate
