Third (Final) Annual Report for Post Construction Year 3, 4 and 6 Ecological Monitoring Devils Pulpit Pacific Highway Upgrade

Prepared for: NSW Transport for NSW
© GeoLINK, 2021

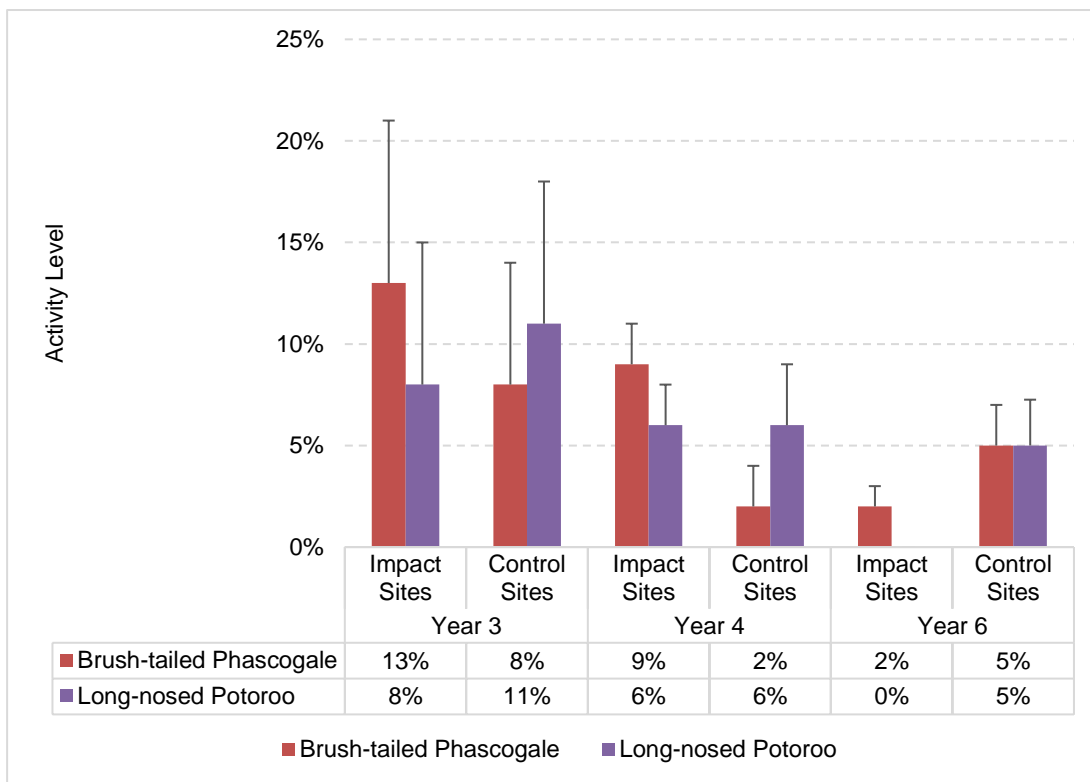
Figure 3.1 Average Activity Levels of Brush-tailed Phascogale and Long-nosed Potoroo at Impact and Control Sites During Year 3, Year 4 and Year 6.

A comparison of the activity level of target species at impact and control sites for Year 3, Year 4 and Year 6 monitoring is provided in **Figure 3.1**. The following trends can be observed:

- activity levels decreased at both impact and control sites between each monitoring period
- activity levels were lower at impact sites compared with control sites during Year 3 and Year 6 and equal in Year 4.

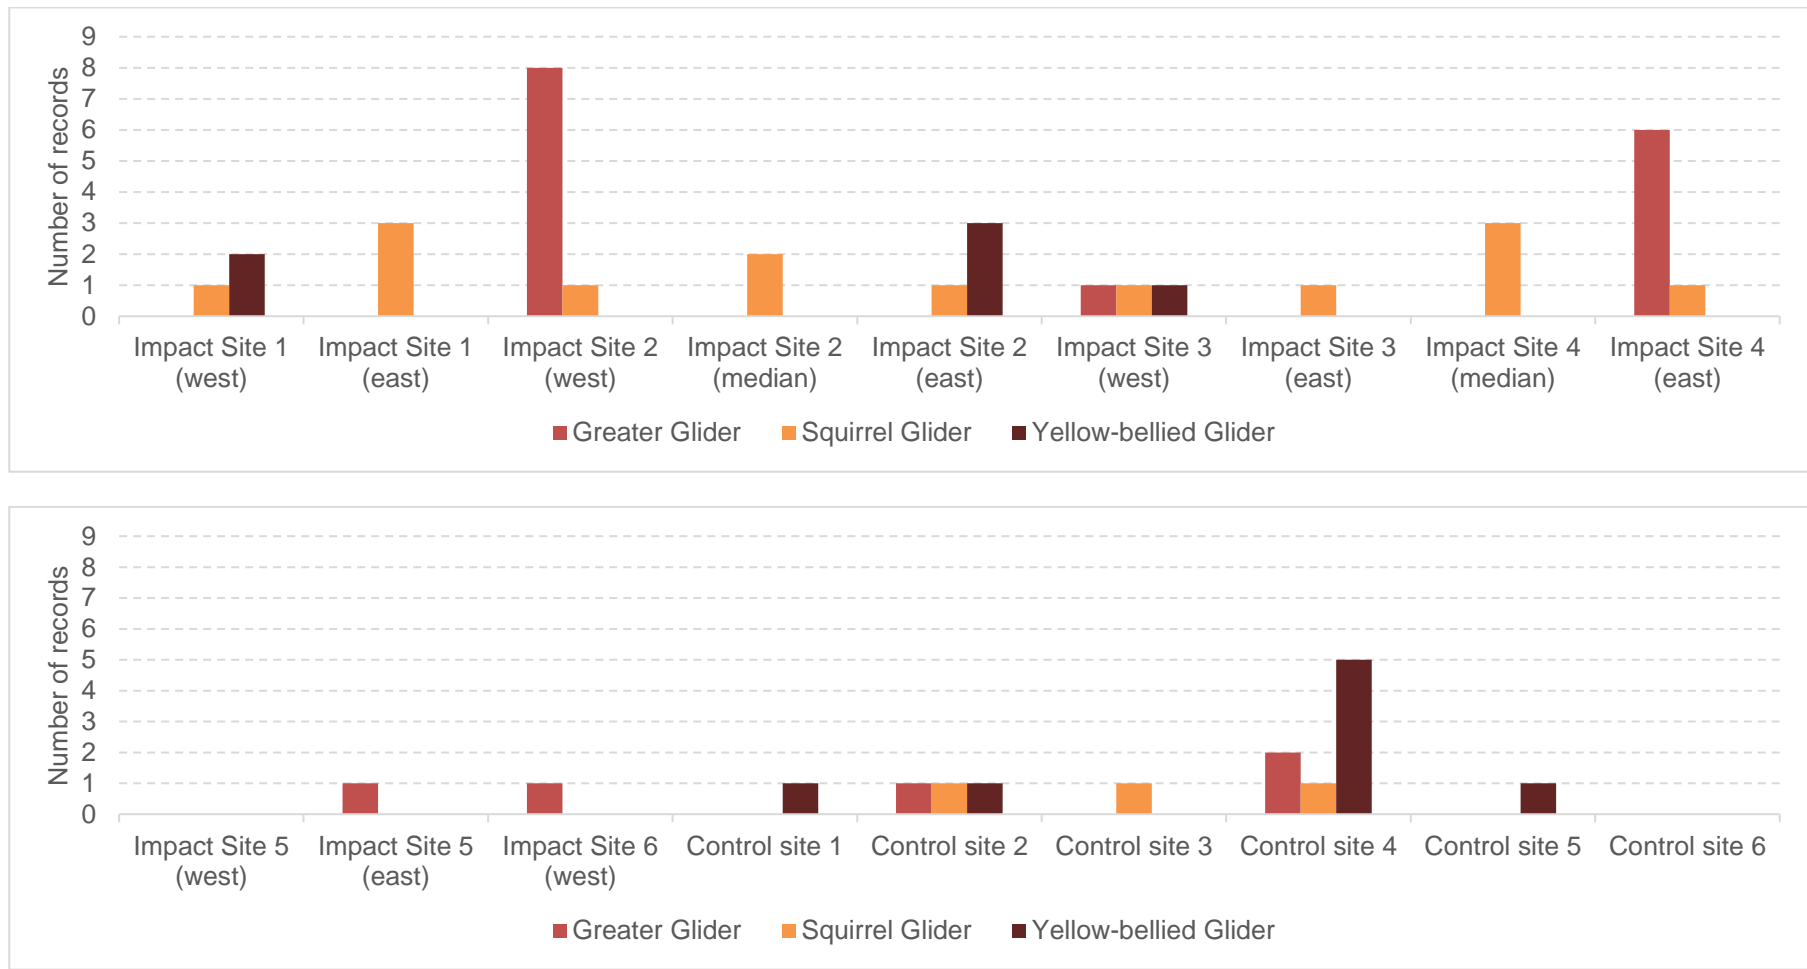
Figure 3.2 Number of Target Species Recorded via Spotlighting/ Call Playback during Year 6 Monitoring

Note: Spotlighting transects are 1 km long at Impact Site 2 (median) and Impact Site 4 (median); and 500 m long at all other sites.

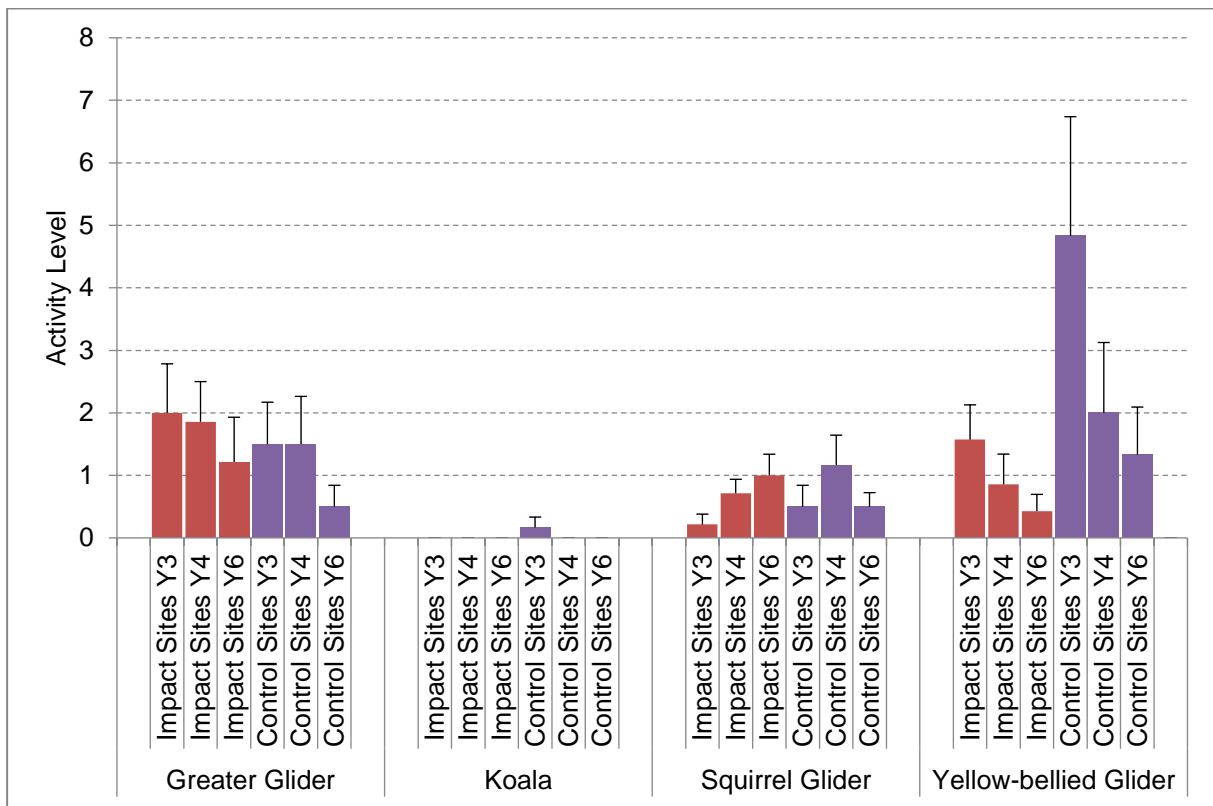
Figure 3.3 Mean Activity Levels of Target Species Recorded via Spotlighting/ Call Playback Survey during Year 3, Year 4 and 6 Monitoring

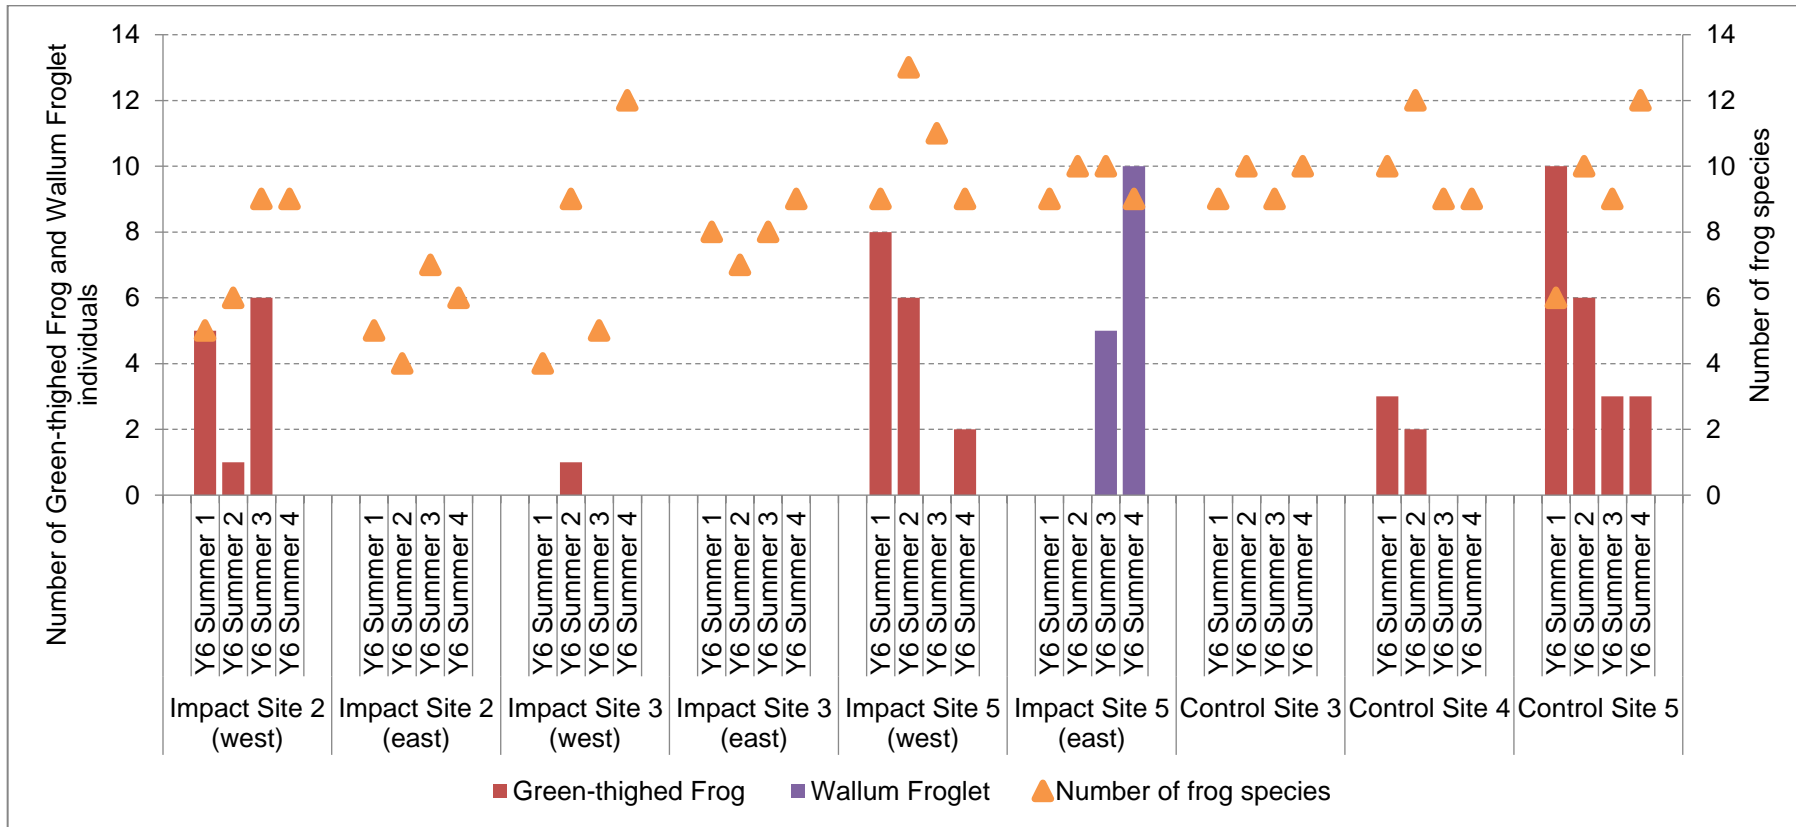
Figure 3.4 Threatened Frog Survey Results During Year 6 Monitoring

The number of individuals and location of threatened frog species recorded during each survey event is provided in **Figure 3.4**. Green-thighed Frog numbers ranged from 0-10 (mean: 1.6; SD: 2.66). Wallum Froglet numbers also ranged from 0-10 (mean: 0.4; SD: 1.84).

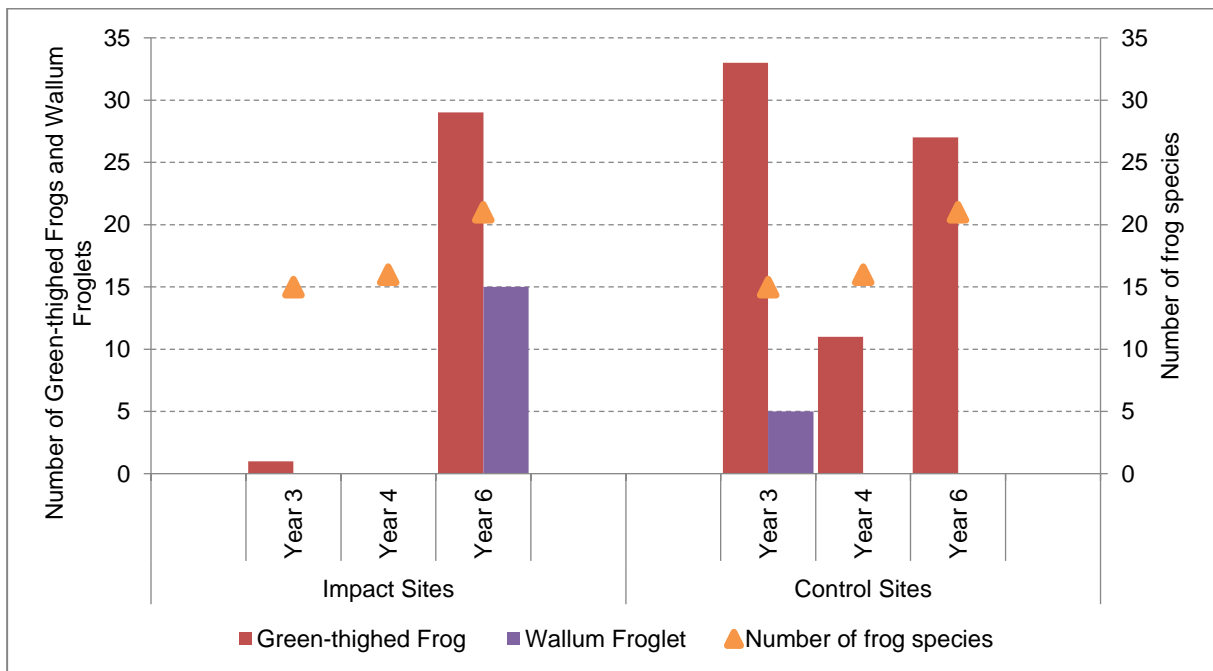
Figure 3.5 Threatened Frog Survey Results During Year 3, Year 4 and Year 6 Monitoring

Figure 3.5 shows a comparison between the number of target threatened frog species individuals and the number of frog species recorded at impact and control sites in Year 3, Year 4 and Year 6 monitoring. Higher species diversity (number of species) was recorded at both impact and control sites in Year 6 compared to Years 3 and 4. Higher numbers of threatened frogs were recorded at impact sites in Year 6 compared to Years 3 and 4; while numbers were variable at control sites between years.

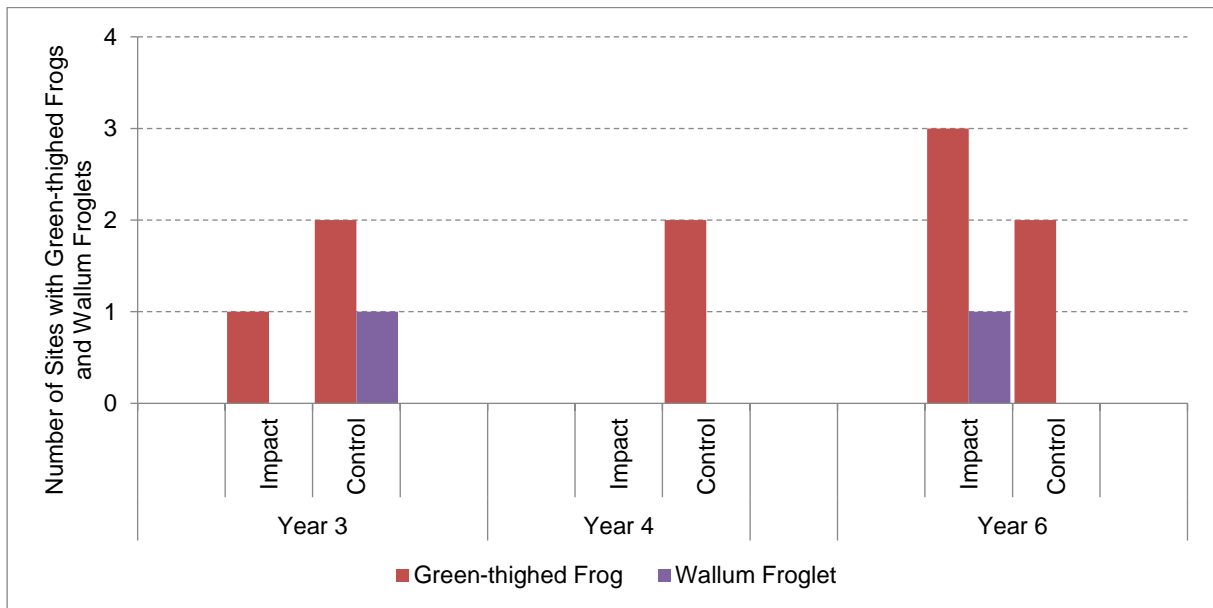
Figure 3.6 Number of Sites With Threatened Frogs During Year 3, Year 4 and Year 6 Monitoring

Figure 3.6 shows a comparison between the number of sites where threatened frog species were recorded in Year 3, Year 4 and Year 6 monitoring. Green-thighed Frogs were recorded at more impact sites in Year 6 compared to Years 3 and 4, and the same number of control sites each year. Wallum Froglets were not frequently recorded and detected only at one impact site in Year 6 and one control site in Year 3.

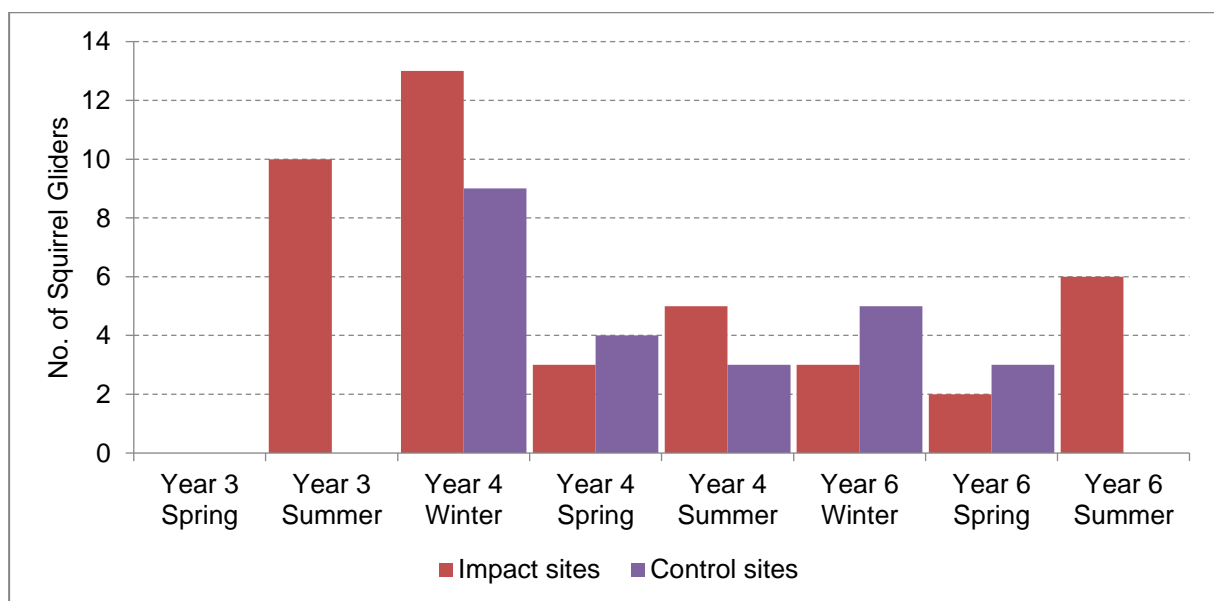
Figure 3.7 Squirrel Glider Results During Year 3, Year 4 and Year 6 Monitoring

Figure 3.7 shows the number of Squirrel Glider individuals recorded over time at the site while **Figure 3.8** shows nest box occupancy rates. The nest box monitoring observed a peak in Squirrel Glider numbers in Year 4 winter (22). Five to eight Squirrel Gliders were recorded during the five subsequent monitoring events, despite a 30-31 % reduction in nest box numbers monitored during the three Year 6 monitoring events (refer to **Section 2.1.7**). The proportion of gliders at impact and control sites has fluctuated. The number of nest boxes showing evidence of glider occupancy has increased overtime.

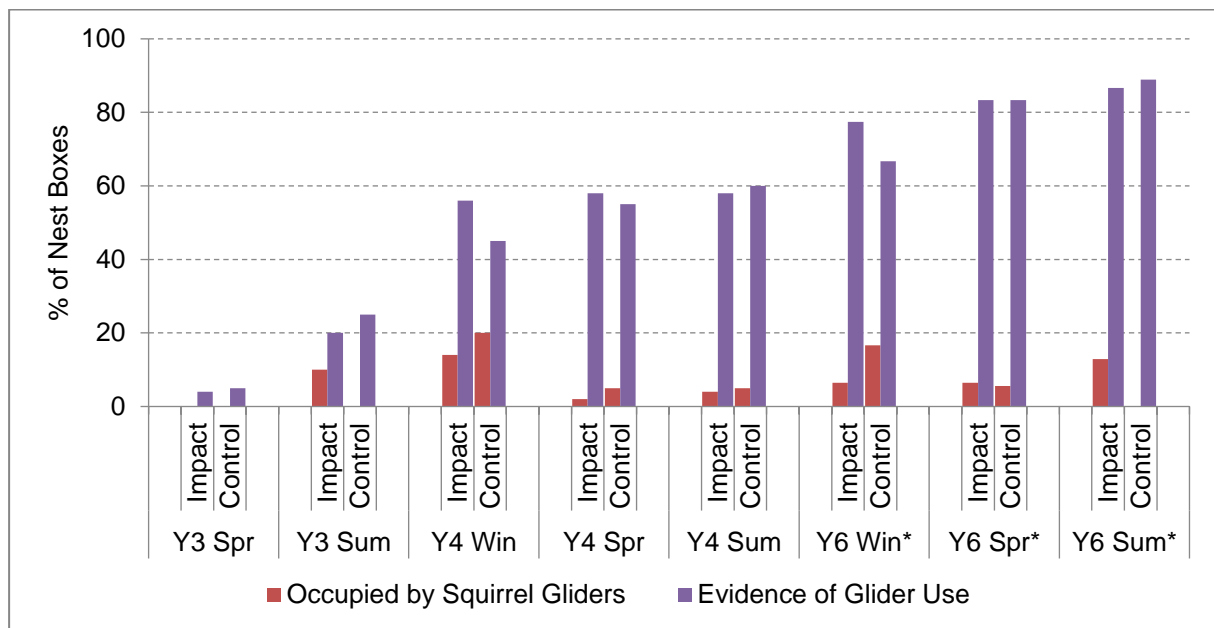
Figure 3.8 Nest Box Occupancy Rates During Year 3, Year 4 and Year 6 Monitoring

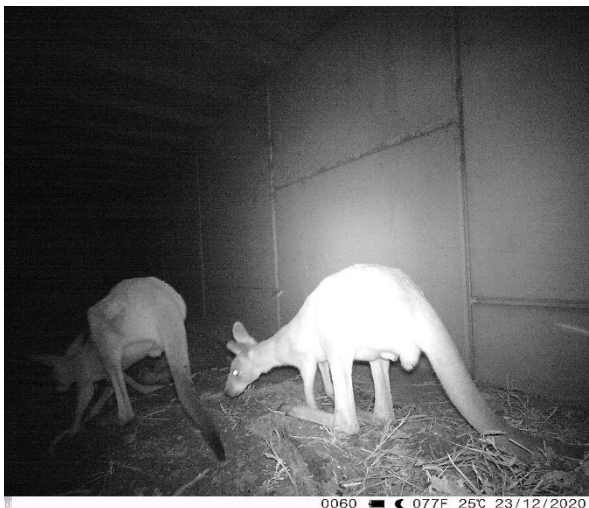
Plate 3.6 Eastern Grey Kangaroos grazing while moving west (northern bank) at SBT3. A complete crossing was recorded.

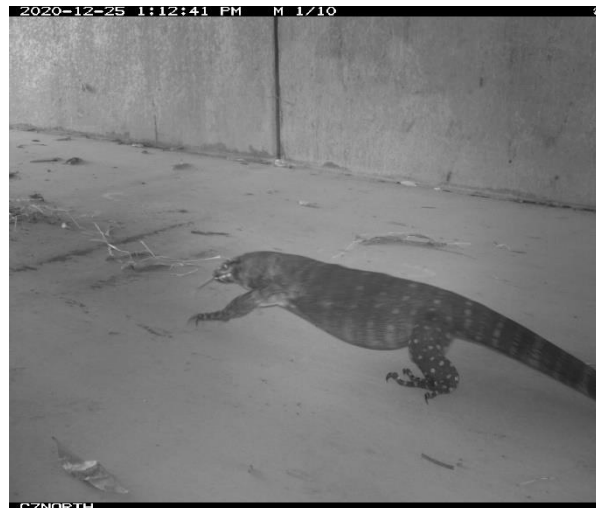
Plate 3.7 Lace Monitor moving east-west at fauna underpass C7. A complete crossing was recorded.

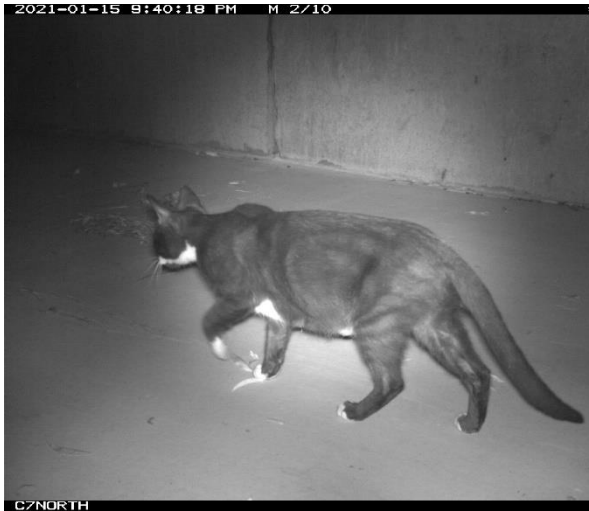
Plate 3.8 Feral cat moving east-west at fauna underpass C7.
A complete crossing was recorded

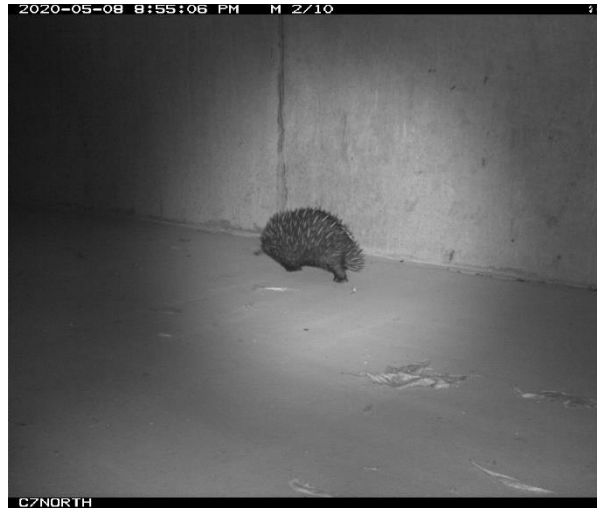
Plate 3.9 Short-beaked Echidna moving east-west at fauna underpass C7.
A complete crossing was recorded.

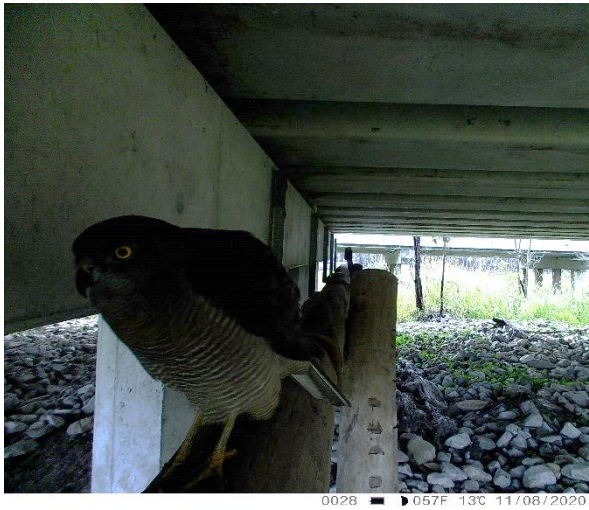
Plate 3.10 Brown Goshawk using fauna furniture at SBT3.
This was a regular observation, mainly at underpasses with fauna furniture.

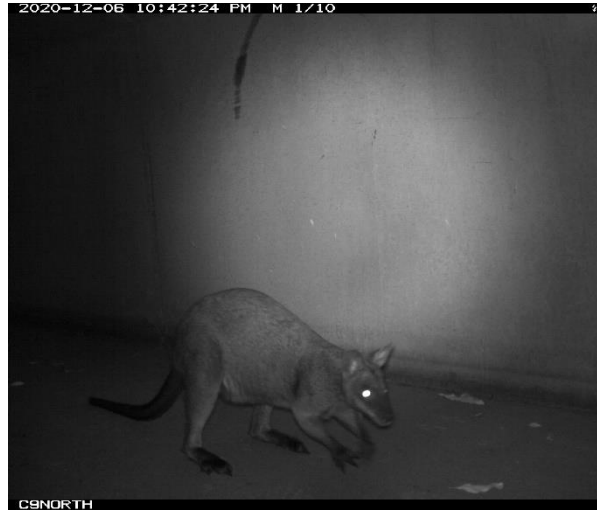
Plate 3.11 Swamp Wallaby moving west-east at fauna underpass C9.
A complete crossing was not recorded on this occasion.

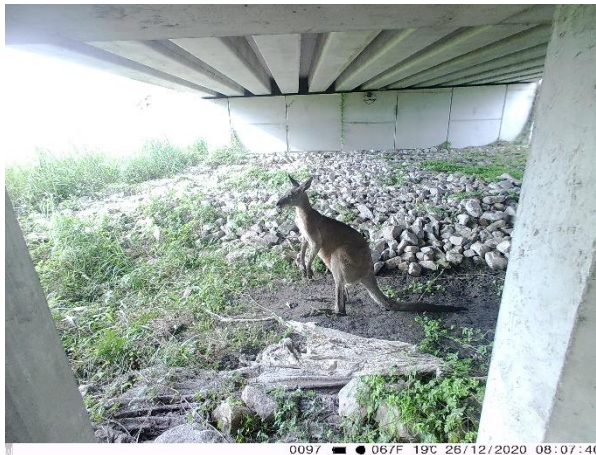
Plate 3.12 Eastern Grey Kangaroo crossing west-east at SBT3 (southern span)

A complete crossing was recorded. Note that the animal is crossing in an area with no rock. Macropods were frequently observed to avoid the irregular rock when crossing.

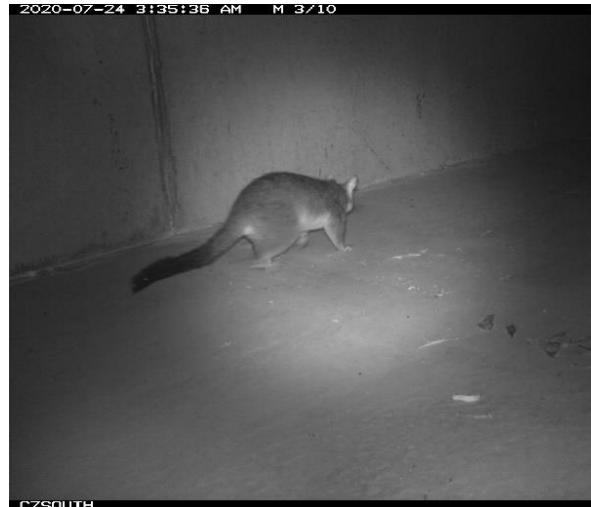
Plate 3.13 Common Brushtail Possum crossing west-east at fauna underpass C7.

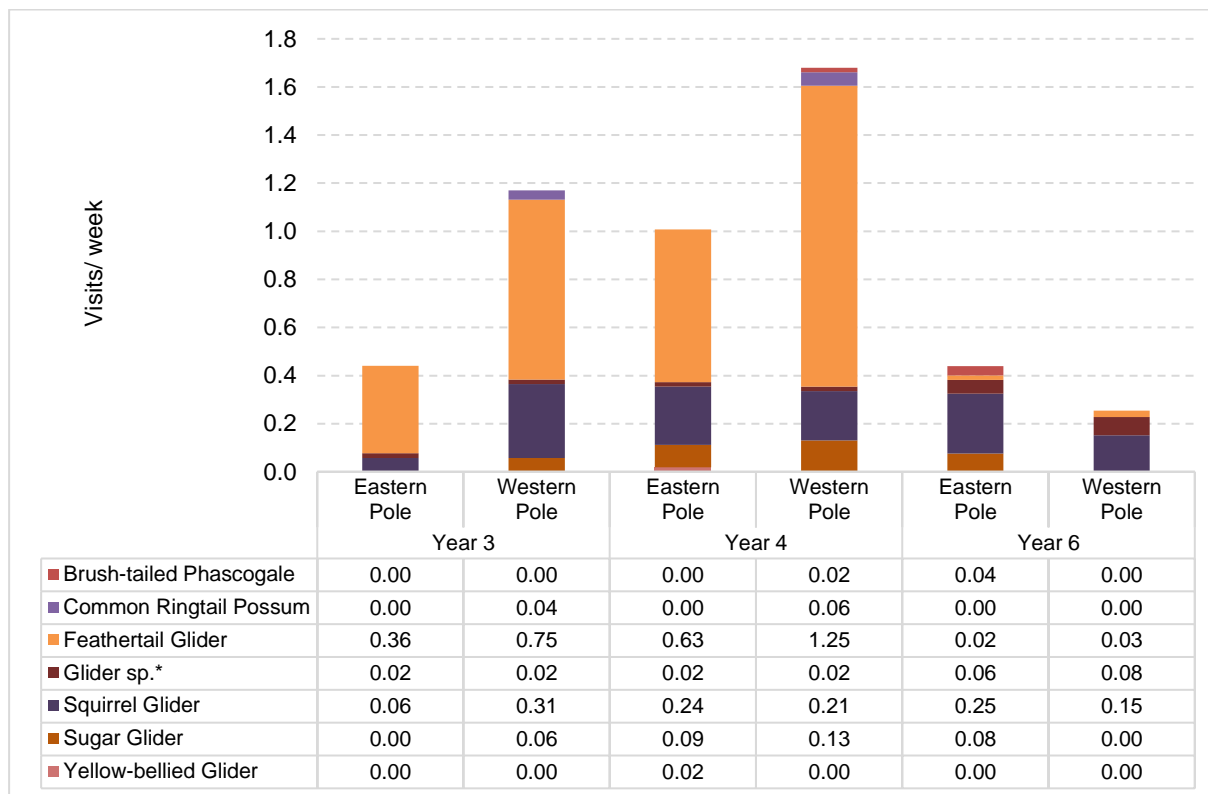
Figure 3.9 Visitation rates (visits/ week) of target species at each rope bridge pole during Year 3, Year 4 and Year 6 monitoring

- overall visitation rates (combined species) increased during Year 3 and Year 4, however decline during Year 6
- overall visitation rates were higher at the western pole compared with the eastern pole in Years 3 and 4, however during Year 6 visitation at the western pole decreased to lower levels than at the eastern pole
- during Year 3 and Year 4 Feathertail Gliders had the highest visitation rates, followed by Squirrel Gliders. During Year 6 Feathertail Glider visitation dropped significantly, which was the main contributor to the decrease in overall visitation in Year 6. In contrast, Squirrel Glider visitation remained relatively constant.

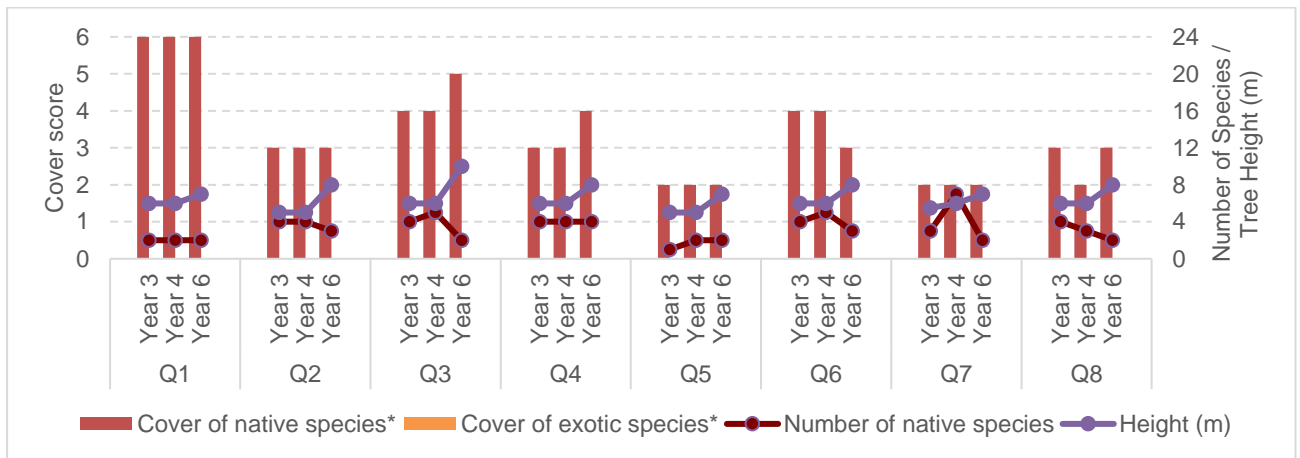
Figure 3.10 Cover of native and exotic species, number of native species and mean height of tree (T1) layer – Year 3, Year 4 and Year 6 monitoring

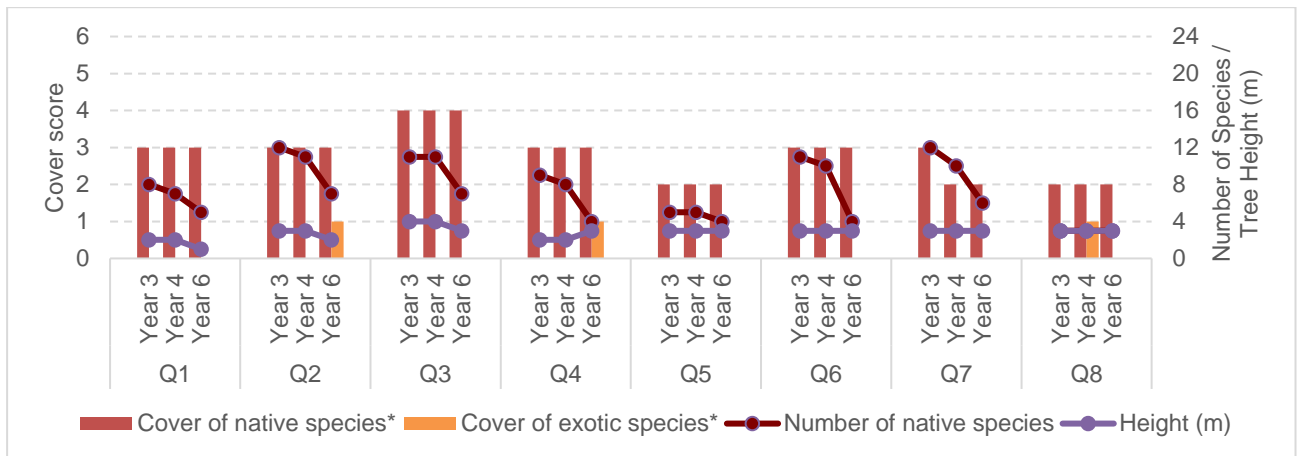
Figure 3.11 Cover of native and exotic species, number of native species and mean height of shrub (T2) layer – Year 3, Year 4 and Year 6 monitoring

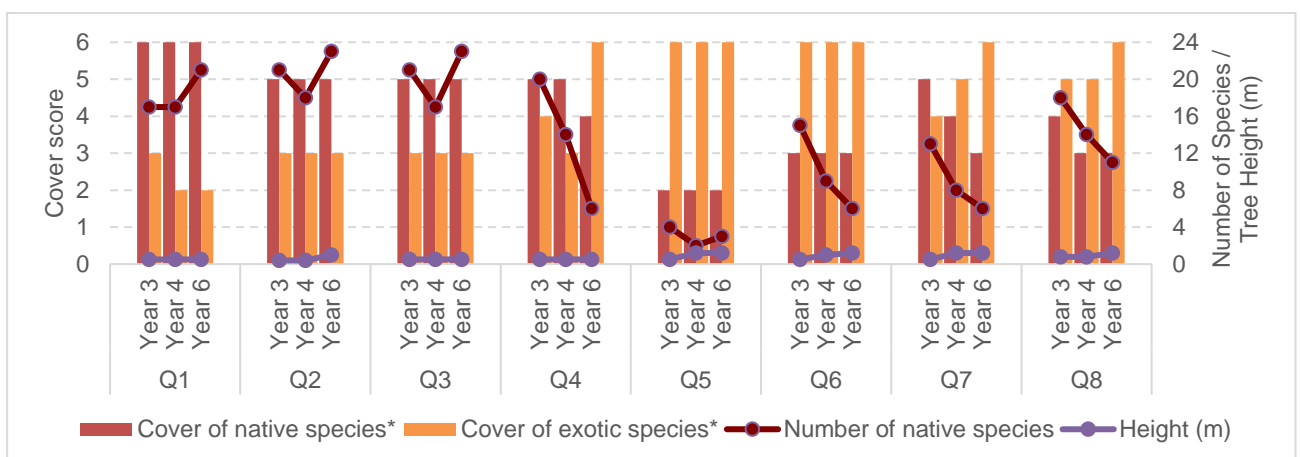
Figure 3.12 Cover of native and exotic species, number of native species and mean height of groundcover (G) layer – Year 3, Year 4 and Year 6 monitoring

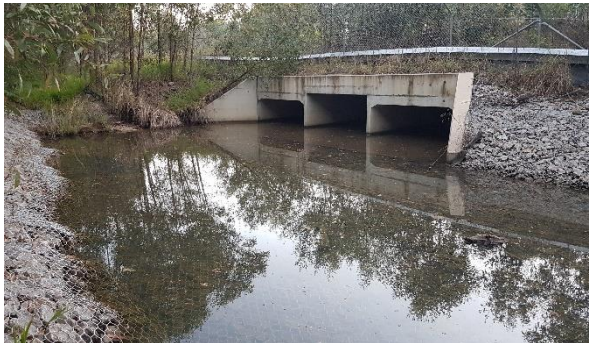
Plate 4.1 Typical water height at the outlet of C3.

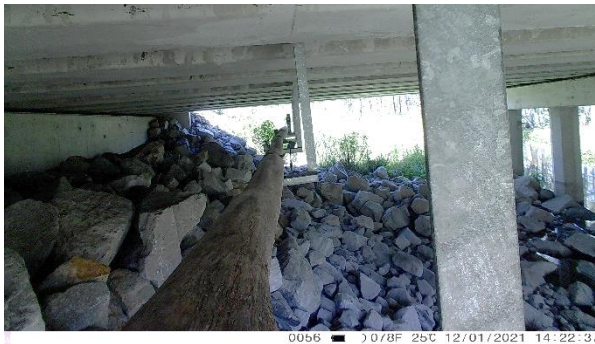
Plate 4.3 Northern bank at SBT2 with rock scour protection that crossing fauna need to navigate.
