# **Commonwealth approval EPBC 2013/6963 conditions compliance tracking and management annual report**

**Nambucca Heads to Urunga Pacific Highway  
Upgrade**

February 2021 – January 2022

## **Threatened Flora Monitoring Annual Report Year 5 – 2021/22**

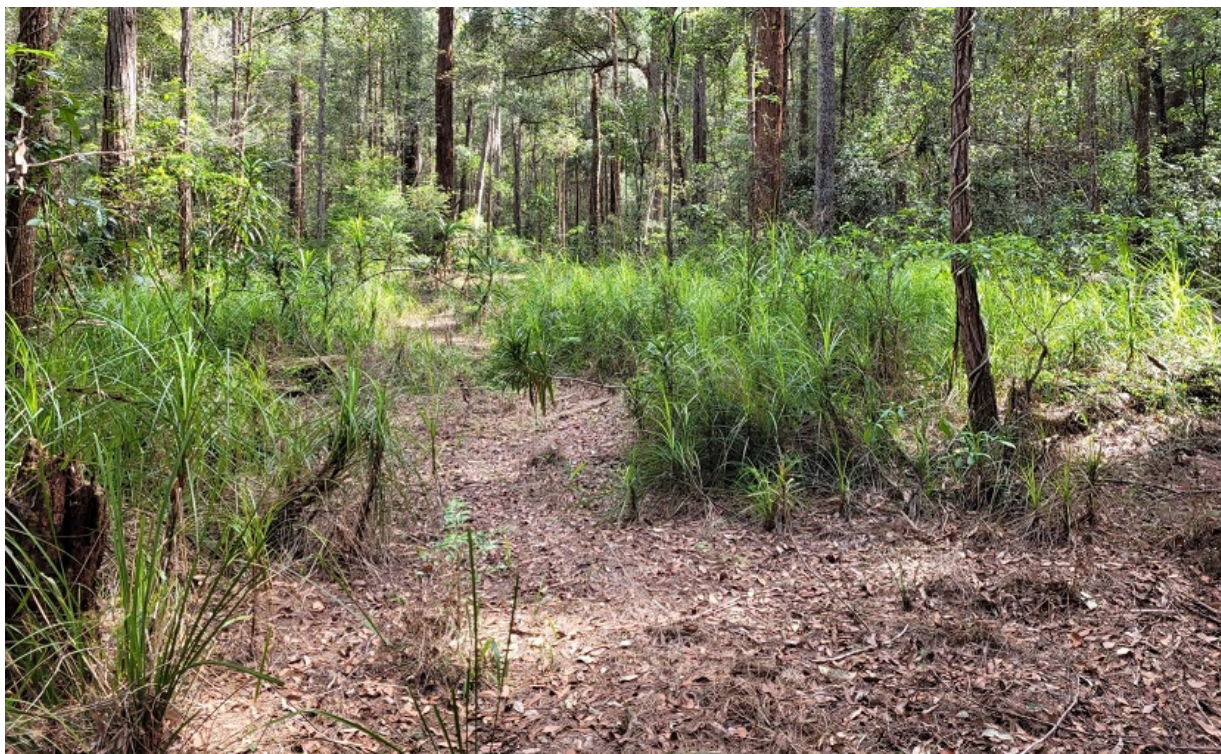
The areas treated for Broad-leaved Paspalum and Lantana in November 2020 and January 2021 were inspected in November and December 2021. The areas were in excellent condition, with both weed species almost completely absent from the treated sites (Figure 4, Figure 5). It is considered that these weed species currently pose no threat to any translocated plants, and that follow-up treatment is not necessary.

Figure 4: Area treated for Broad-leaved Paspalum infestation, November 2021.

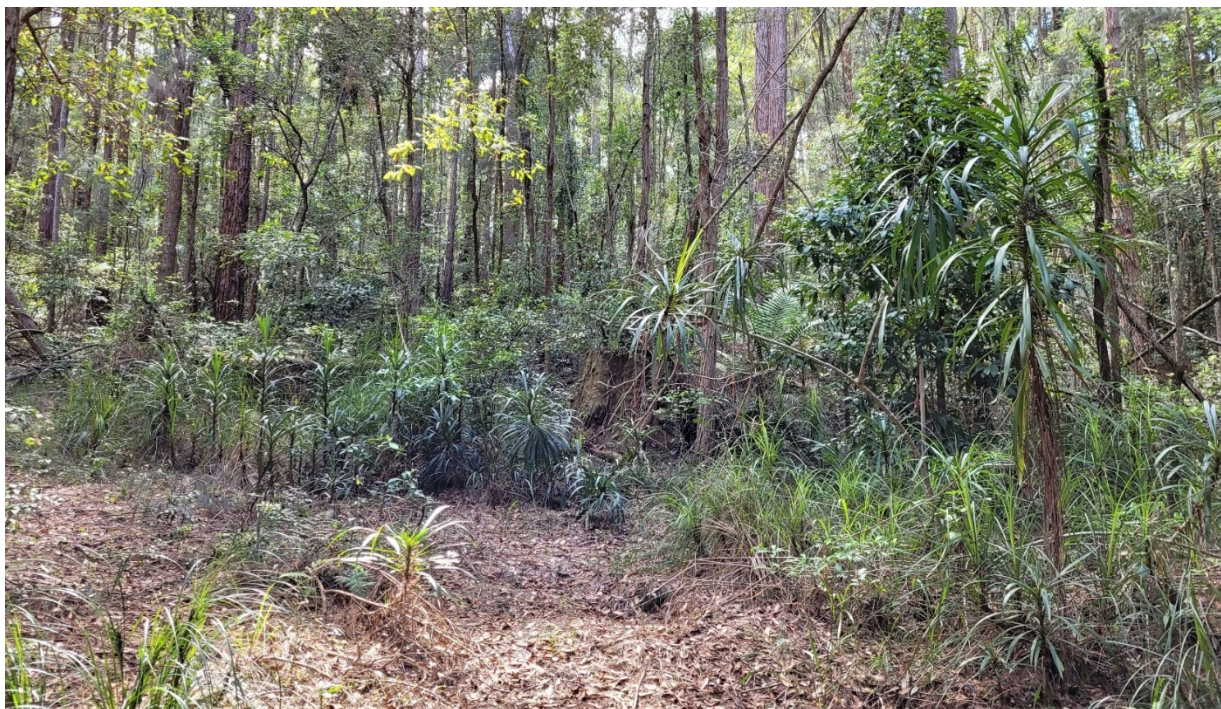
Figure 5: Area treated for Lantana infestation, November 2021. Note translocated Rusty Plum in right hand background.

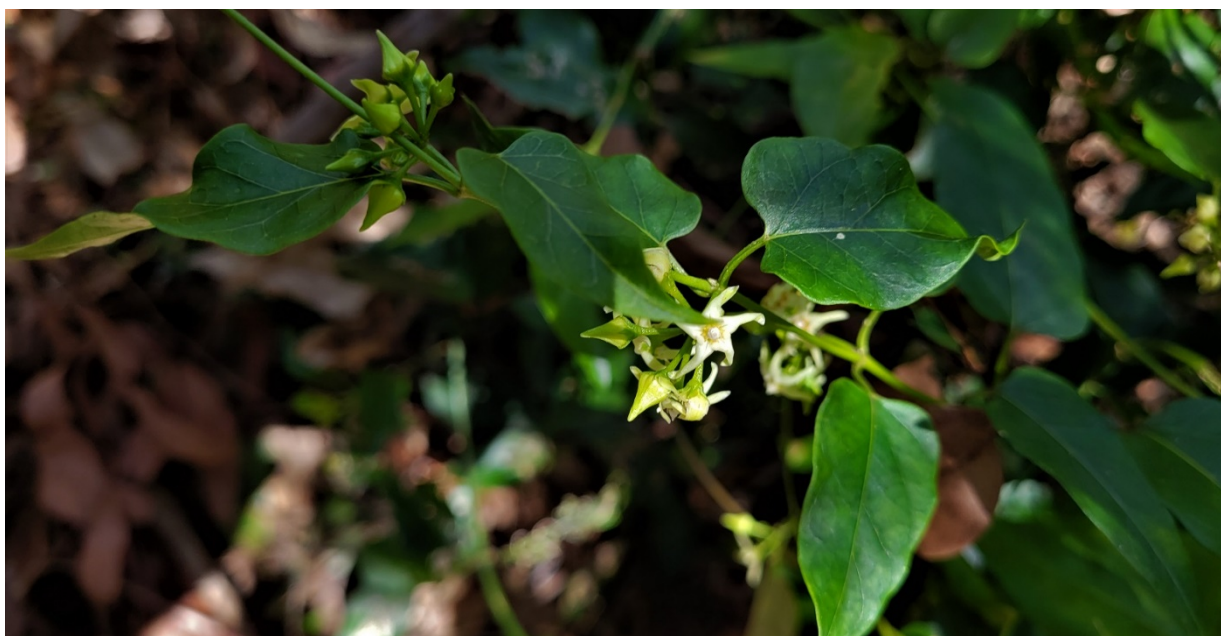
Figure 6: Slender Marsdenia transplant in flower, TA1 Sector A, December 2021.

After eight years the 'thrival rate' of Slender Marsdenia in Sector A was 27.3% (29 plants out of 106 with a Condition Class score of 3, 4 or 5), a slight decrease from the previous survey rate of 28.3%. Five plants were in flower at the time of survey (Figure 6).

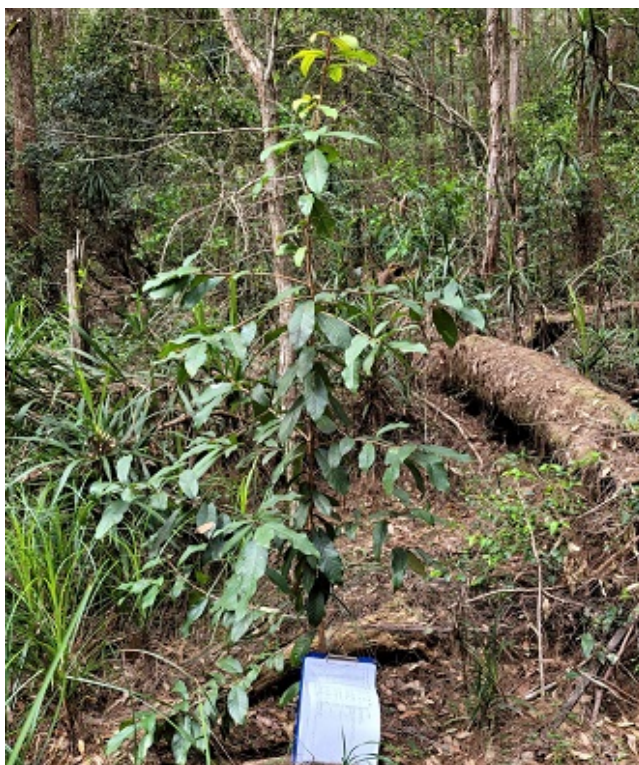
Two small Rusty Plum trees (4-8m high) were transplanted into Sector E in TA1. One tree had split and was separated into two pieces (plants 1 and 2) before planting. The other tree (plant 3) was pruned back to remove most of the branch system before being transplanted. Plant 2 died in 2017. The current survey revealed no losses since the previous survey, with a survival rate of 67%. Plant 1 bore a healthy, basal stem shoot which had grown significantly since the previous survey and was starting to produce major lateral branches (Figure 7). Plant 3 was in excellent health (Figure 5).

Figure 7: Rusty Plum transplanted tree No. 1 in excellent health with new growth and lateral branching.

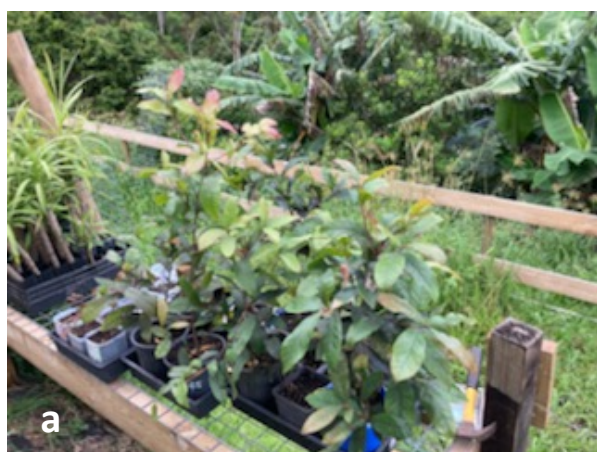
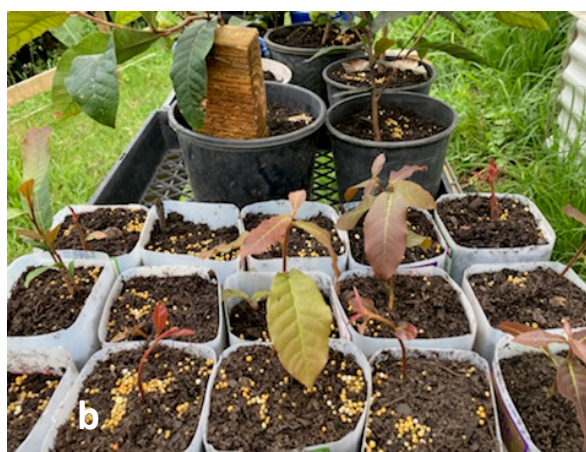
Rusty Plum fruits were collected and potted up in spring 2020. Of those potted seeds, 12 successfully germinated. The remainder either germinated then died or failed to germinate. Brent Hely (New Earth Regeneration) collected and potted fresh seed in spring 2021. As of January 2022, the original 12 plants had attained 50cm height (Figure 8a) and are ready for transplanting, and 30 seeds had germinated and grown up to 15cm high (Figure 8b, estimated 4 weeks until ready for planting). The current La Niña climatic conditions with above-average rainfall provides the ideal opportunity to transplant the plants into TA1 in February 2022 (see below for details in 12 month work plan recommendations).

Figure 8: Germinated Rusty Plum seeds (a) >50cm high; (b) up to 15cm high.

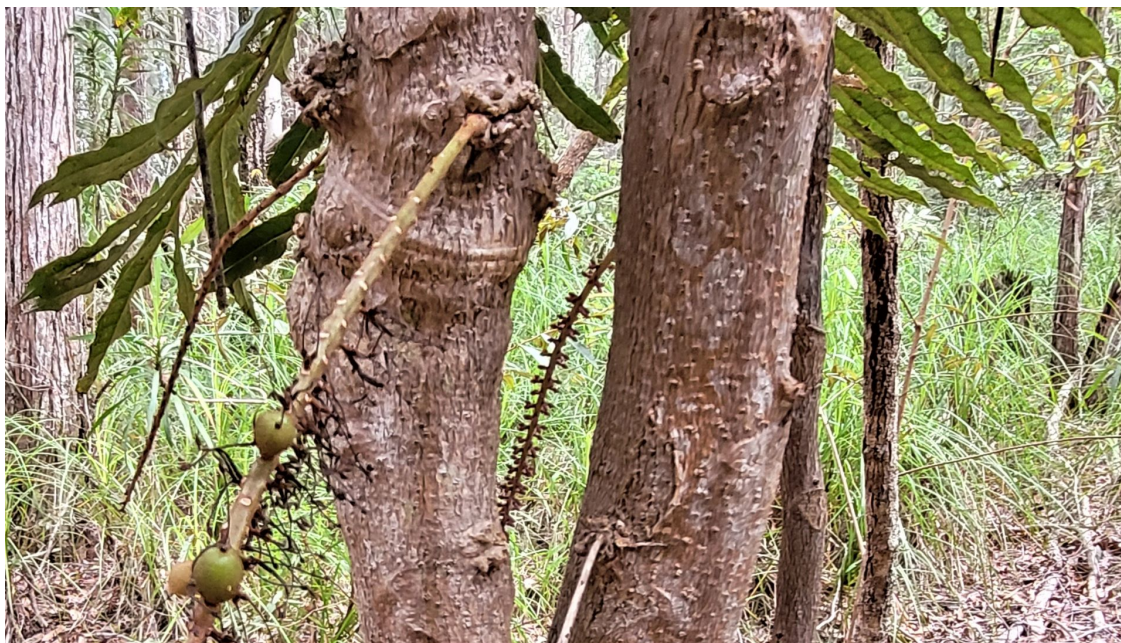
A single Red Bopple Nut tree was transplanted to Sector H in TA1. The tree was recorded in excellent condition during the current survey. Flowering had occurred, with several developing fruits observed (Figure 9) as well as new inflorescences.

Figure 9: Immature fruits and fresh inflorescence observed on Red Bopple Nut transplant in TA1 Nov 2021

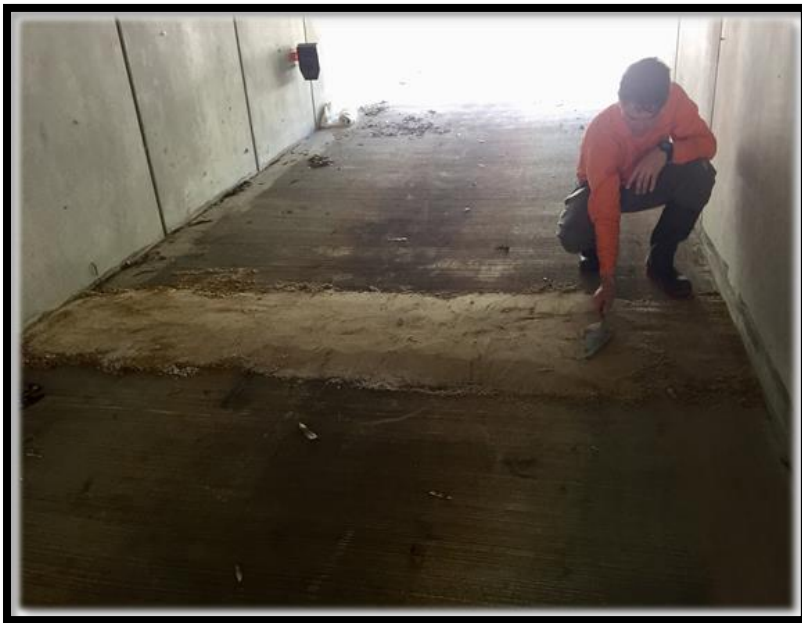
To complement camera monitoring, sand pads were installed in the centre of each cell at each site. Sand pads were installed using a 1:1 mix of brickie's sand and beach sand and smoothed out with a cement trowel at the start of monitoring and after each inspection (Plate 2). Pads were approximately 1m wide and 50mm deep. A small channel (200mm wide) was left in the centre of pads in combined structures to allow for drainage. Sand pads were monitored for a minimum of four consecutive days during each monitoring period. The change in method from previous years (when pads were checked weekly) was to align sampling with the method used on the Warrell Creek to Nambucca Heads (WC2NH) project and reduce the loss of data from washouts.

**Plate 2:** Sand pad installation at Tyson's underpass.

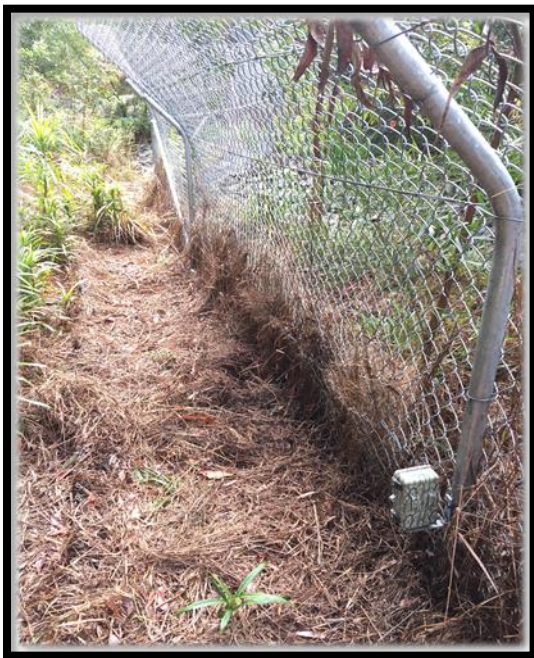
Fence cameras were installed at all sites except McGraths. The setup involved installation of a camera on each side of each culvert entrance (total of 28 cameras). Cameras were attached to a bracket fixed to a fence post at approximately 400mm above ground and orientated along the fence towards the underpass entrance (Plate 3). Distance from the culvert entrance ranged from 10m to 60m and depended on obtaining a reasonable line of sight. Ground vegetation was trimmed at all sites in autumn to improve visibility and reduce the incidence of false triggers. Scoutguard KG680V cameras were used at all sites except Burke's west where Reconyx HC500 cameras were installed. Scoutguard cameras were scheduled to arm at 4pm and disarm at 9am. Cameras were set to take a series of three photos with a ten second delay between activation. Exclusion fence camera monitoring effort is described in Table 3 (see full details in Appendix B, Table B11).

**Plate 3:** Typical exclusion fence camera set up. It shows a Scoutguard KG680V camera attached to a steel bracket fixed to a fence post.

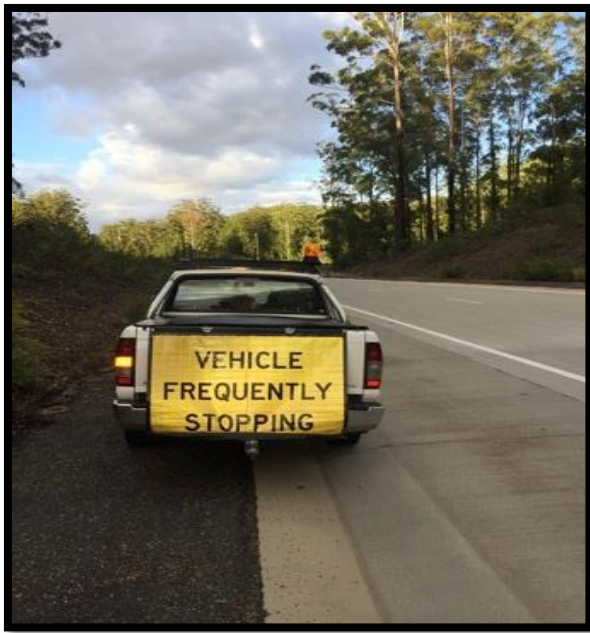
**Plate 4:** Work vehicle with signage, flashing amber light and indicators

Surveys were conducted by a two-person team from a constantly moving vehicle driven at 80-90km/hr in the left lane. The vehicle was equipped with an amber (flashing) light and warning sign (Plate 4). The team consisted of a driver and an ecologist passenger with experience identifying road-killed fauna. The entire NH2U alignment was surveyed twice during each seasonal sample period, with surveys commencing within three-four hours of sunrise. During each survey the ecologist scanned the road surface and road shoulder for fauna. When road-kill fauna were detected the species or fauna group was recorded into an audio recorder with the record number, and a "drop pin" showing the site location was placed on an iPad running Motion-X. Fauna records considered likely to be an unidentified target species (i.e. spotted-tailed quoll, koala, grey-headed flying-fox, giant

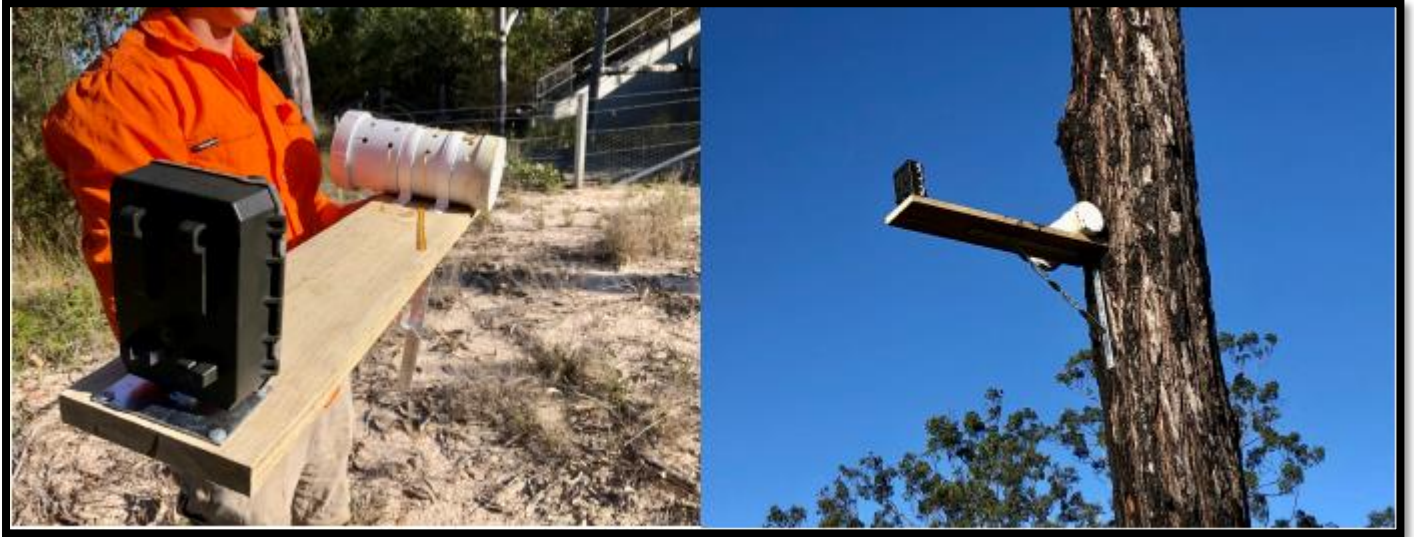
Monitoring of vegetated medians at NH2U has previously been conducted through spotlighting and arboreal hair funnel surveys (Sandpiper Ecological 2020). After completing the 2019 sample, approval was attained from TFNSW and the EPA to amend the survey method to align with the method adopted for the Woolgoolga to Ballina and Warrell Creek to Nambucca Heads highway upgrades. The new method involved installation of baited camera traps at approximately 5m above ground near potential crossing points (Plate 5). Each trap consisted of one Swift Enduro passive infrared camera and a bait station (100mm diameter PVC pipe) installed at opposite ends of a 500 mm long platform (Plate 5). Traps were baited with a 50/50 honey/water solution and left insitu for the 2021 autumn and spring sample period (March-November). The honey water solution and SD cards were periodically replaced approximately eight week intervals. Four camera traps were installed in both the Dalhousie and Tyson's vegetated median between 29 and 30 March and collected on 26 November (Table 3).

**Plate 5:** Arboreal camera trap used to monitor glider presence in vegetated medians along the Pacific Highway.

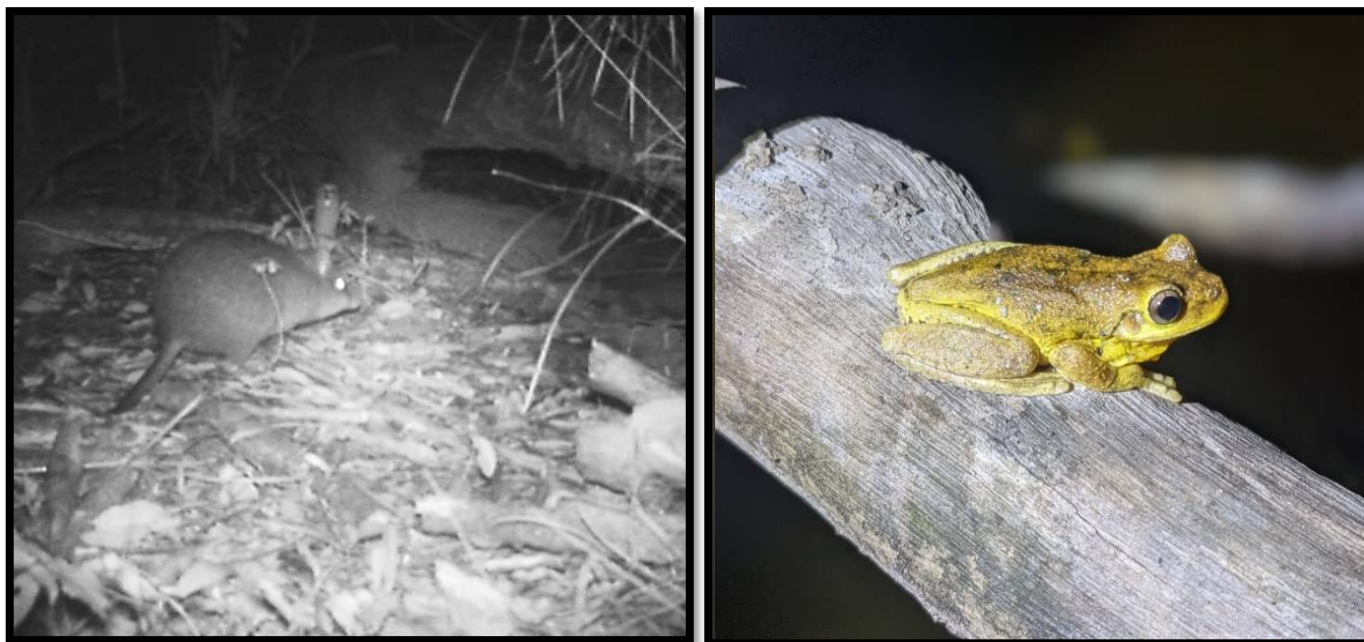
**Plate 6** Long-nosed potoroo detected in habitat to the west of Martells north (L) and a Tyler's tree frog detected in adjacent habitat at Martells south (R)

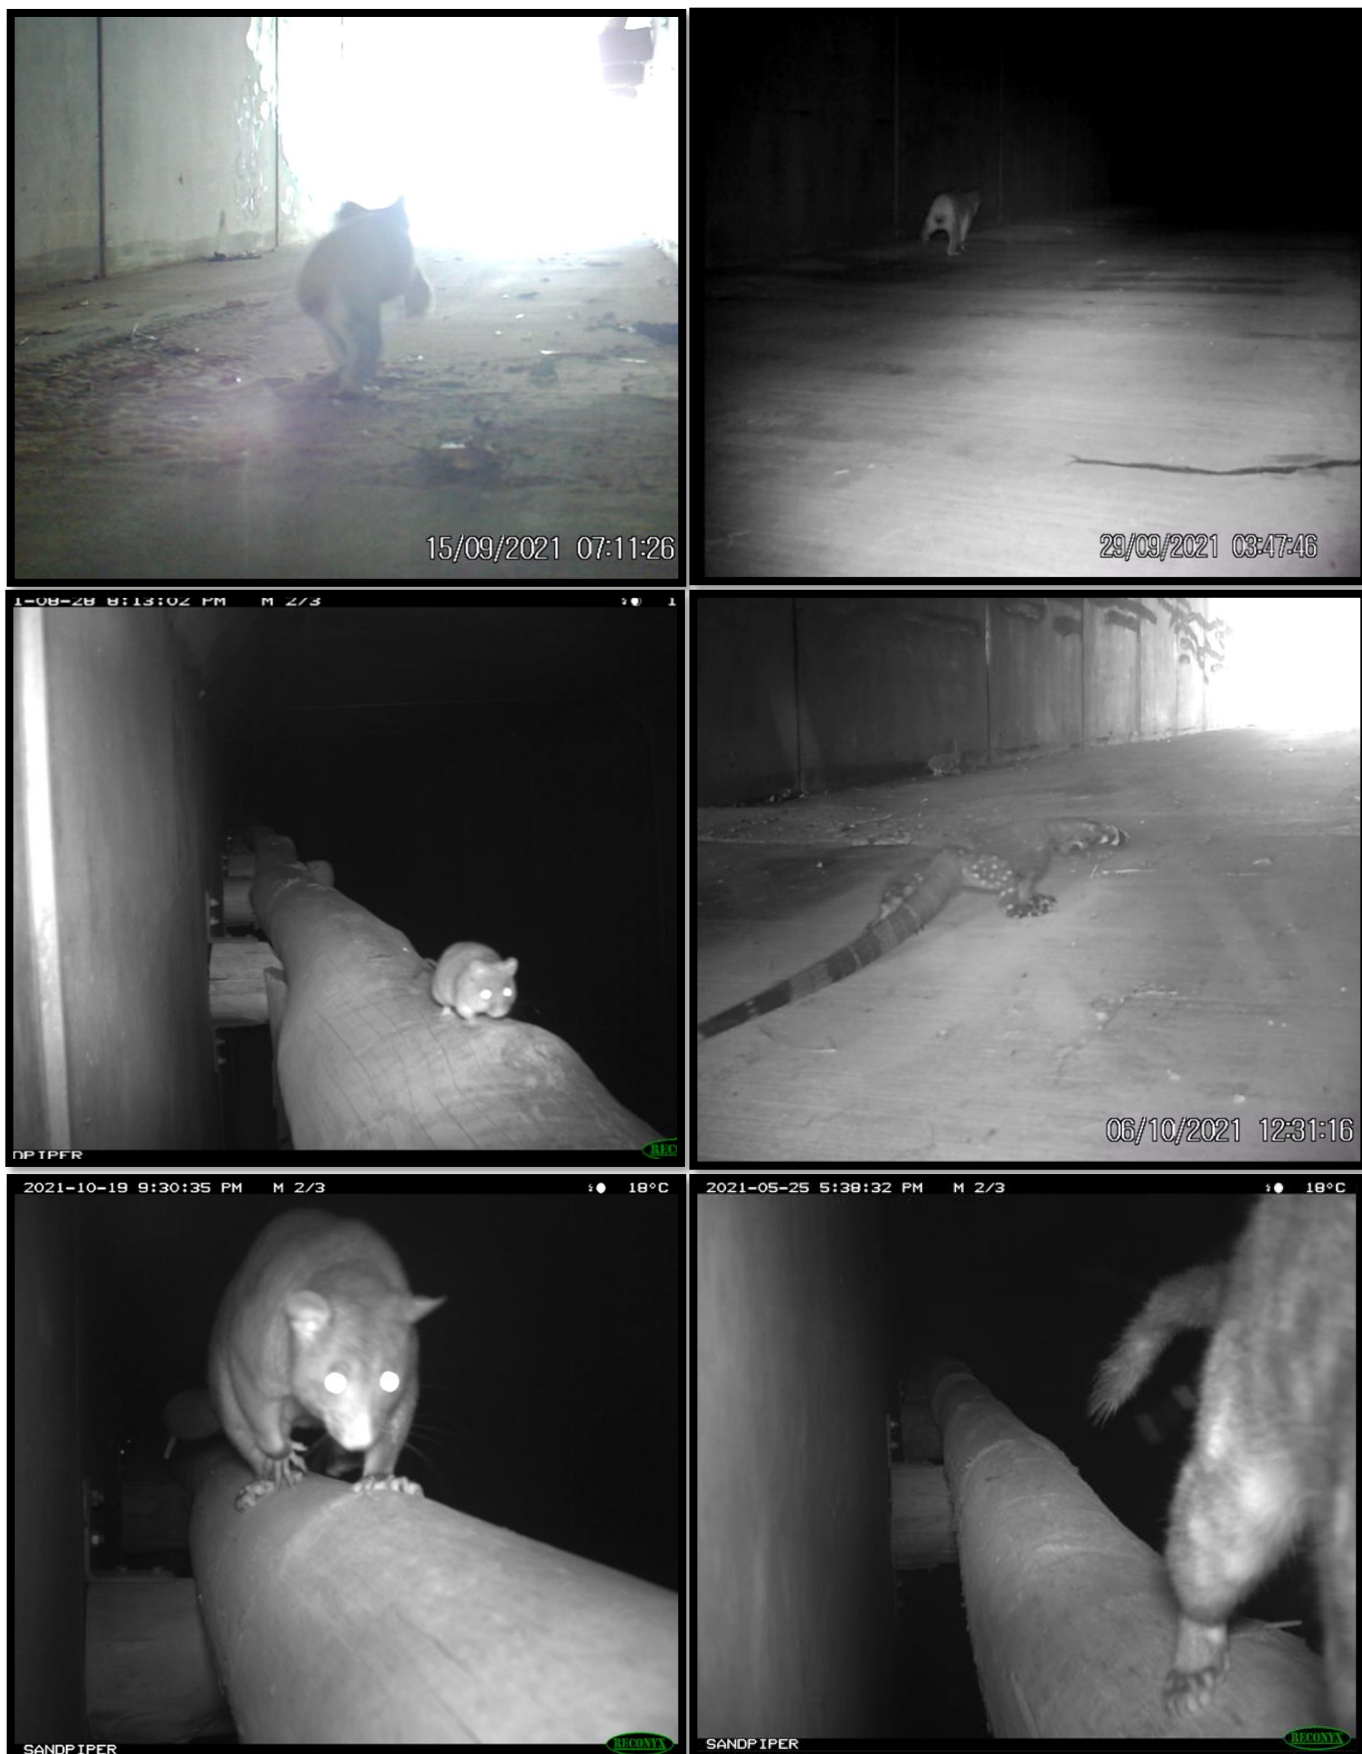
**Plate 7:** Koala recorded travelling east at Dalhousie during spring (Top left). Koala using the culvert floor to travel east at Martell's North during spring (Top right). Fawn-footed melomys travelling west on furniture at Dalhousie (Middle left). Lace monitor travelling east along the culvert floor at Access G (Middle right). Short-eared brushtail possum recorded on fauna furniture at Tyson's underpass (Bottom left). Spotted-tailed quoll travelling west on fauna furniture at Martell's South during spring (Bottom right).

Fauna was recorded using both the culvert floor and furniture during year five operational phase monitoring (Table 5). Furniture use accounted for a majority (52.1%) of complete crossings by native fauna, attributed mainly to high preferential use by brushtail possums (combined short-eared brushtail possum, common brushtail possum and *Trichosurus* spp.) and *Antechinus* spp. (Table 5). Introduced rodents (67% of crossings) and feral predators (100% of crossings) used the underpass floor more frequently than furniture (Table 5). Of the threatened fauna, koalas were recorded using the floor only with the spotted-tailed quoll recorded on furniture (Table 5; Plate 7).
