Pacific Highway Upgrade Woolgoolga to Ballina

Threatened Gliders Monitoring Program, Year
Five (2021)

Transport for New South Wales | July 2022 | Final Report

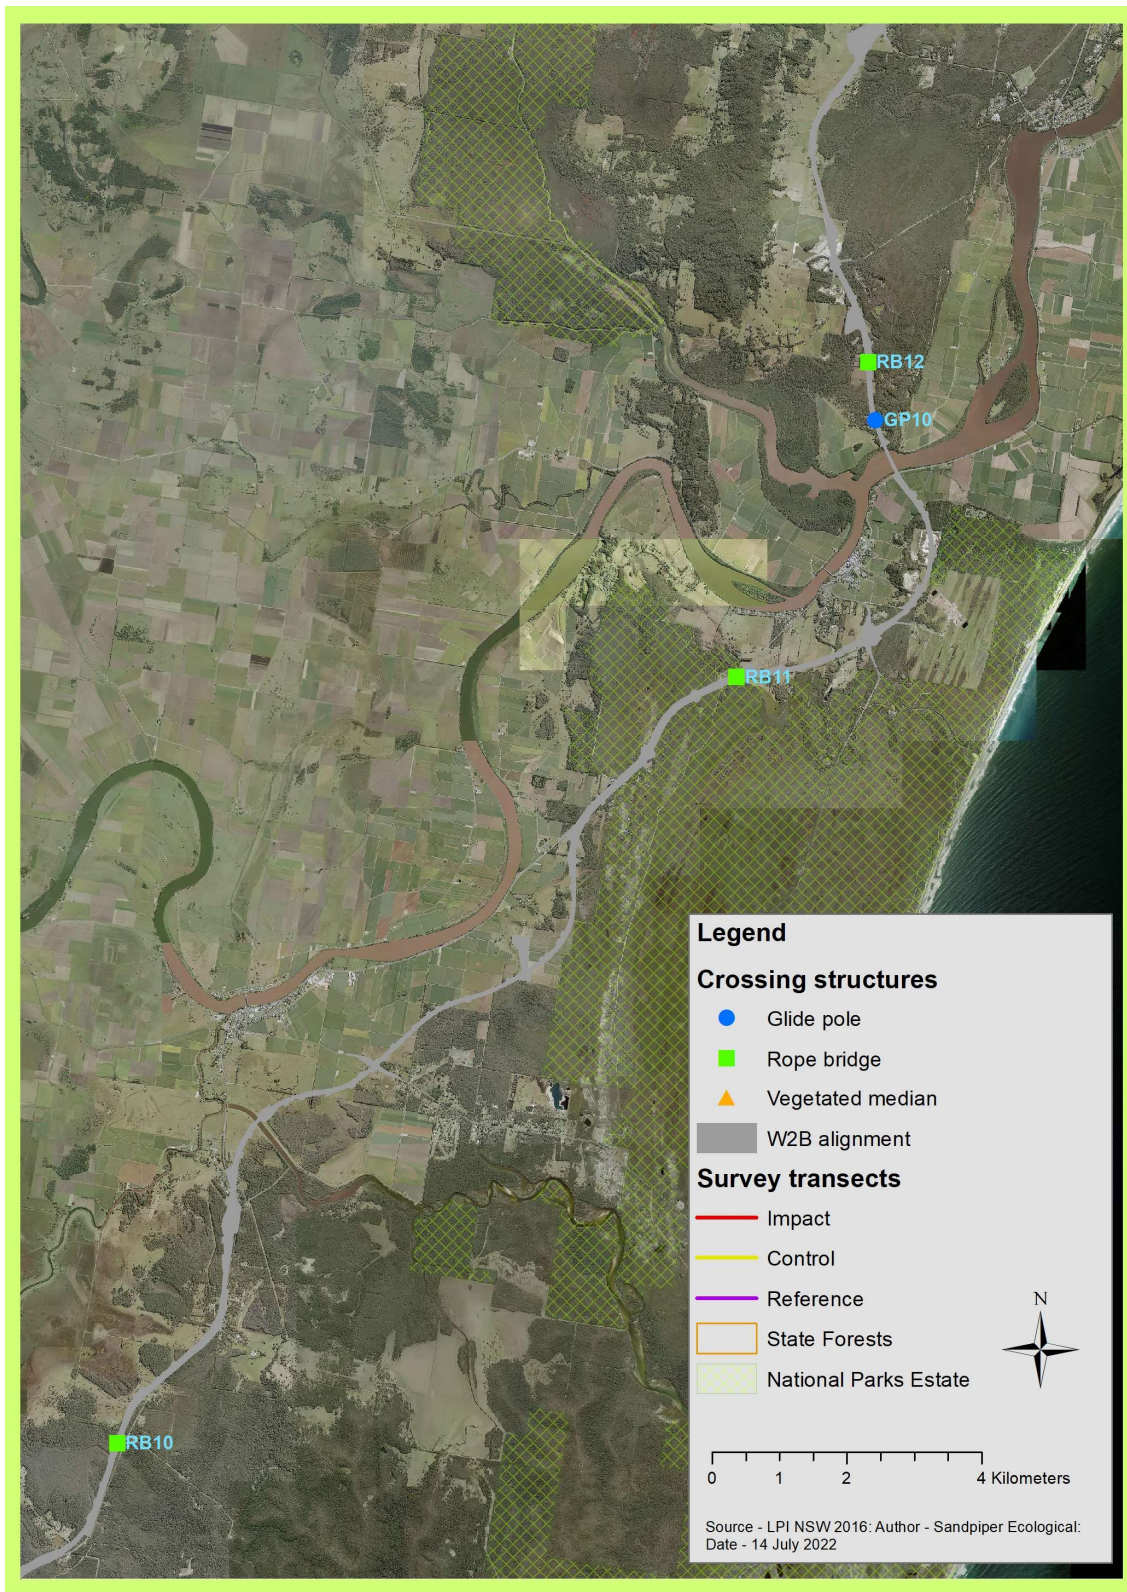
Figure 6: Location of aerial crossing structures within sections 3-11 of the W2B alignment.

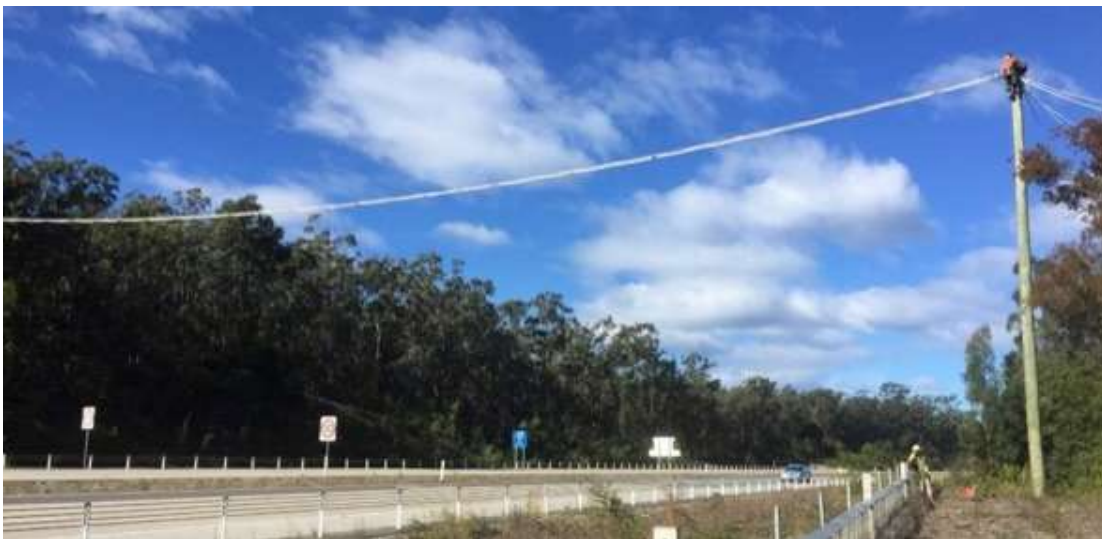
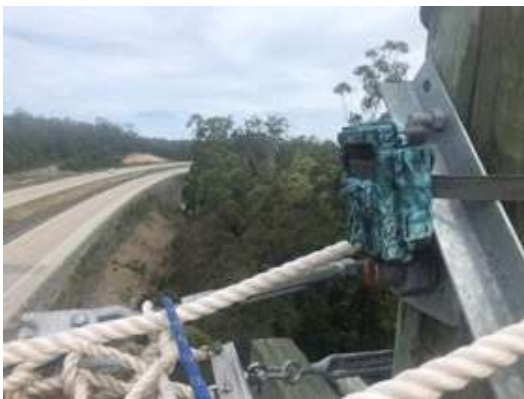
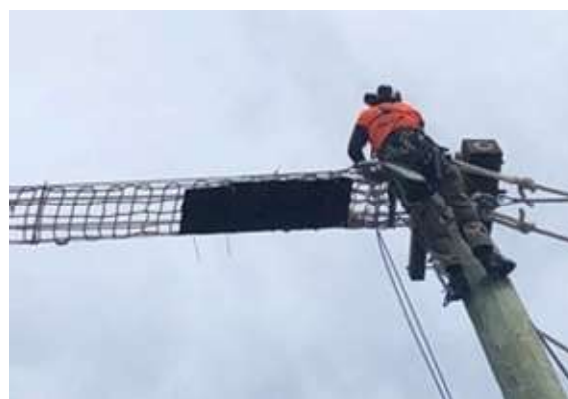
Plate 1: Rope bridges were suspended >10m above the road deck (upper) and supported by poles adjacent to the forest edge. A camera was strapped to the bulkhead at each end of the bridge (lower left). Black core-flute was cable tied to the underside of the rope ladder at each end during year 1 to reduce the incidence of false-triggering caused by traffic (lower right).

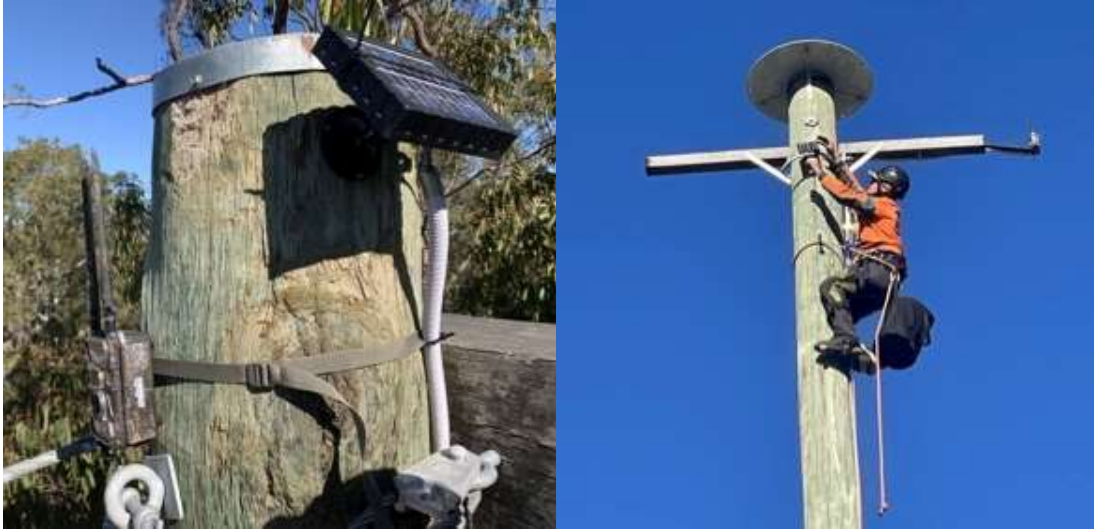
Plate 2: Location of camera attachment on rope bridges (left) and glide poles (right) in S3-11. Each structure contained a wireless 4G Enduro camera with a small solar panel.

An arborist installed wireless 4G Swift Enduro cameras on rope bridges in sections 3-11 between 26 May and 7 July 2021 (Plate 2). Wireless cameras were installed to minimise the number of aerial climbs required to download and maintain cameras, thereby improving safety. Wireless cameras were equipped with a 16 or 32GB SD card. A small solar panel with inbuilt battery was attached to each camera, and all cameras were fitted with 12 NiMH rechargeable batteries as a back-up during cloudy conditions. Cameras were active from 1700-0500hrs EST from 26 May to 30 November and from 2000-0500hrs EST from 1 November to 31 December 2021. Cameras were set at low sensitivity to reduce the incidence of false triggering caused by passing traffic and upon activation each camera sent a series of three photographs to a central email address, with no delay between triggers. Video was not used on wireless cameras due to concern about signal strength and battery capacity. Images from the previous night were reviewed daily, false triggers discarded immediately and active images saved for further review. Consequently, the number of images taken was not recorded for cameras in S3-11.

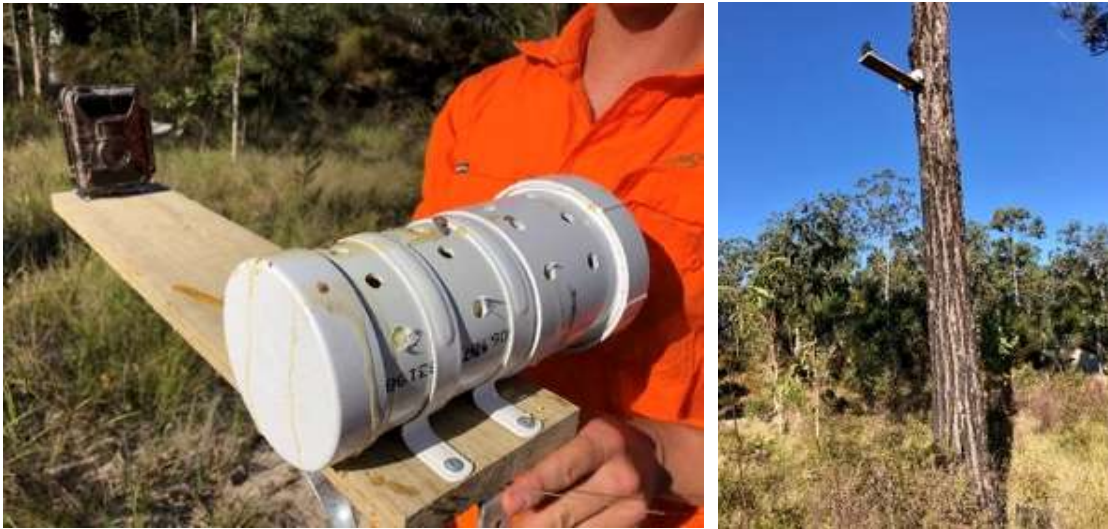
Plate 3: Vegetated median camera trap set up.

a metal bracket and mounted to subject trees at approximately 6m above ground level (Plate 3). A dilute mixture of honey and water was sprayed up the trunk of the tree above the camera trap to act as extra attractant.

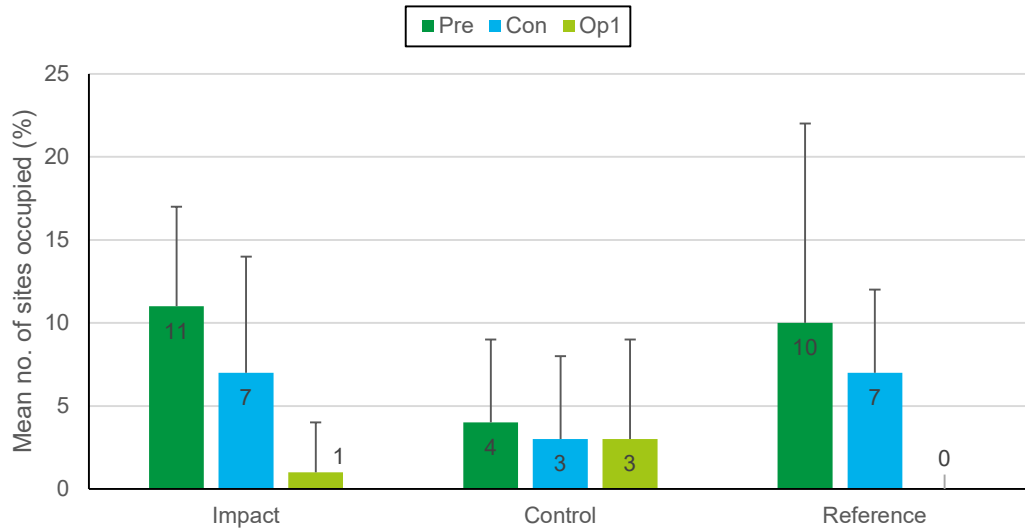
Figure 7: Mean ± SD occupation rates for yellow-bellied glider at impact, control and reference sites in sections 3-11 during pre-construction, construction and year one operation phase. Pre = pre-construction; Con = construction; Op1 = operation year 1.

With the inclusion of 2021 data, the mean yellow-bellied glider occupation rate in sections 3-11 continued to show a decline from pre-construction levels at impact and reference sites (Figure 8). Occupation rate at control sites has remained stable. The scale of the decline between construction phase and year one operation was substantially greater than recorded between pre-construction and construction phases. The change in occupation rate from pre-construction to construction ranged from 25% at control sites to 36.4% at impact sites, whilst the change from construction to year one operation was 85.7% at impact sites and nil at control sites. A similar downward trend was evident at reference sites where occupancy has declined from 10% in pre-construction to nil in year one operation (Figure 8). No yellow-bellied gliders were recorded in the first quarter of year two (i.e. Q4 2021) operational phase monitoring.

Results of the Fisher’s Exact Test suggest that impact site occupation levels differed significantly for yellow-bellied glider between pre-construction and operation year 1 ($P = 0.018$). The cumulative tally of sites with yellow-bellied gliders in pre-construction was nine compared to one in year one of operation.

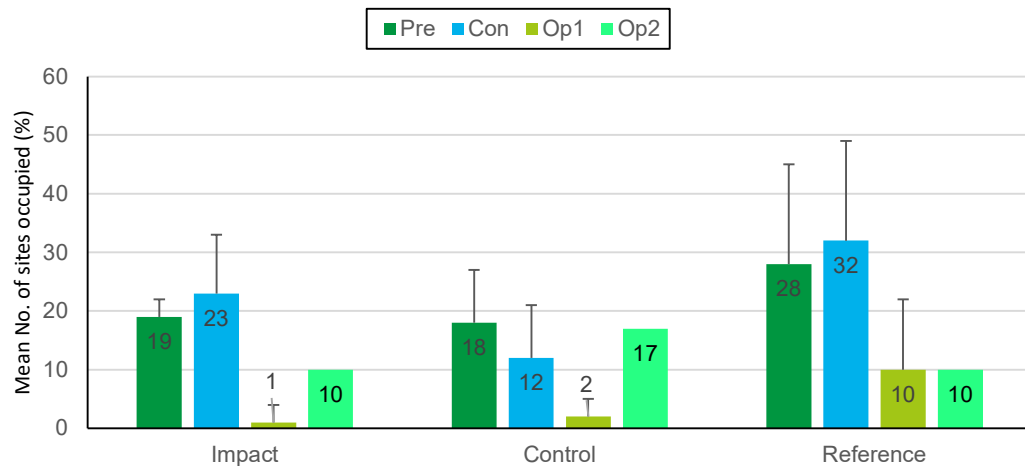
Figure 8: Mean ± SD occupation rates for squirrel glider at impact, control and reference sites in sections 3-11 during pre-construction, construction, year one operation phase and one quarter of year two operation phase (i.e., Q4 of 2021). Pre = pre-construction; Con = construction; Op1 = operation year 1.

The trend in occupation rate across treatments was mixed for squirrel glider (Figure 9). With the inclusion of year one operational phase data (i.e. Q4 2020 & Q1-3 2021), mean squirrel glider occupation rates were between 68.7 and 95.7% lower than construction levels across all treatments. Inclusion of data from one sample in year two operational phase (i.e. Q4 2021) shows some evidence of increasing occupancy at impact and control sites, with occupancy remaining stable at reference sites (Figure 9). Results of the Fisher’s Exact Test suggest that impact site occupation rates differed significantly for squirrel glider between pre-construction and operation year 1 ($P = 0.000$). The cumulative tally of sites with squirrel gliders during the baseline was 15 compared to one in year one of operation.

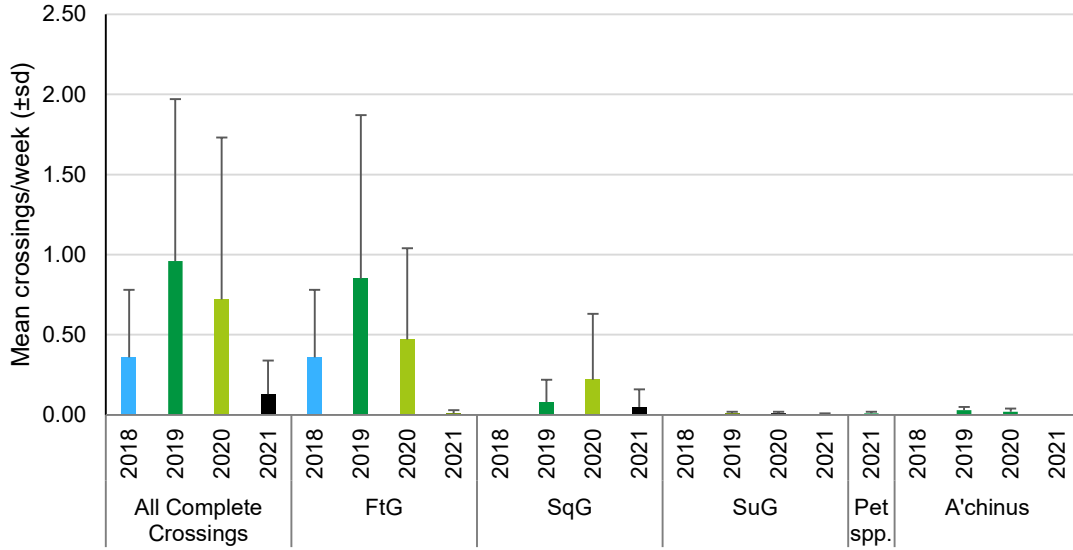
Figure 9: Comparison of mean \pm SD weekly rope bridge complete crossings for 2018, 2019, 2020 and 2021. FtG = feathertail glider; SqG = squirrel glider; SuG = sugar glider; Pet spp. = Petaurus species; A'chinus = *Antechinus* spp.

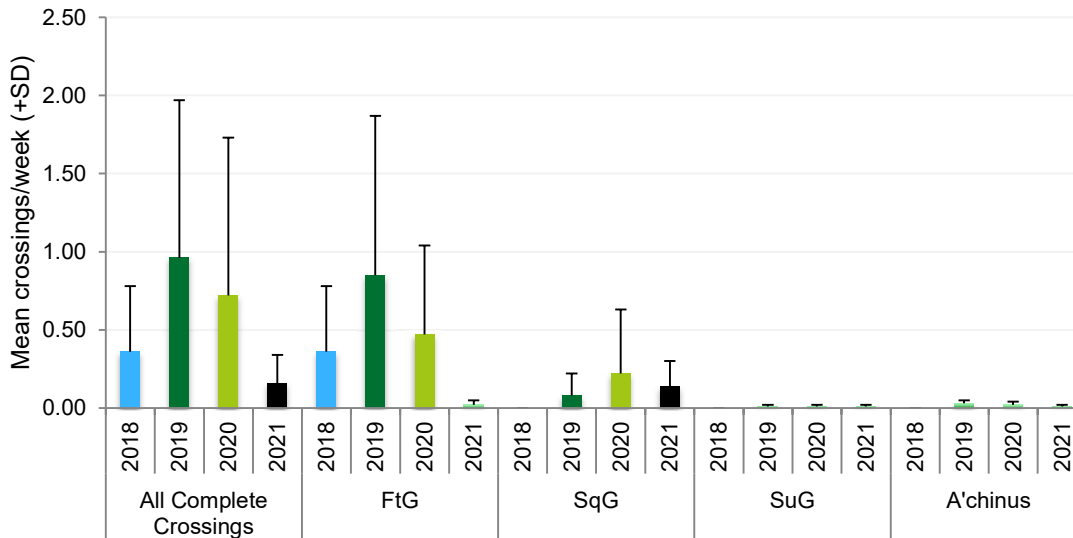
Figure 10: Comparison of mean \pm SD weekly rope bridge complete crossings for 2018, 2019, 2020 and 2021 in sections 1 and 2. FtG = feathertail glider; SqG = squirrel glider; SuG = sugar glider; Pet spp. = Petaurus species; A'chinus = *Antechinus* spp.

Comparison of mean weekly rope bridge complete crossings in sections 1 and 2 from 2018 to 2021 highlights the substantial decline in 2021 for complete crossings by feathertail glider and squirrel glider (Figure 11). This suggests that the low numbers recorded in sections 3-11 in 2021 may not be solely due to camera issues.

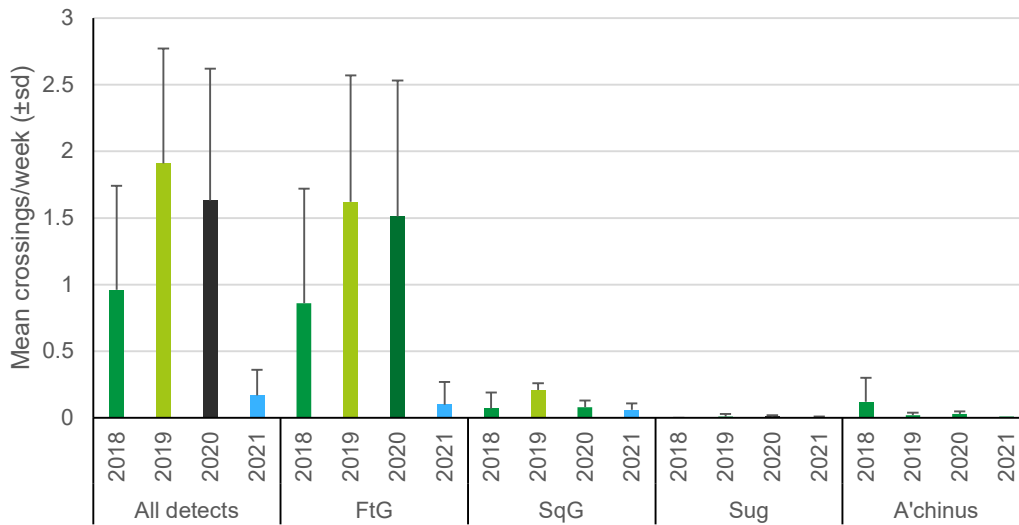
Figure 11: Comparison of mean ± SD weekly glide pole detections for 2018, 2019, 2020 and 2021. FtG = feathertail glider; SqG = squirrel glider; SuG = sugar glider; A'chinus = *Antechinus* spp.

The overall mean detection rate for 2021 was 89.4% below the 2020 level, and 91.1% below the 2019 level (Figure 12). The relative decline in detections was broadly similar across all taxa, except squirrel glider, which had a smaller proportional decrease. Feathertail glider detections declined by 93.4% and squirrel glider by 25%. Yellow-bellied gliders, which were detected on nine occasions at GP2 and GP3 during 2019, were not detected at glide poles during the 2021 monitoring period.

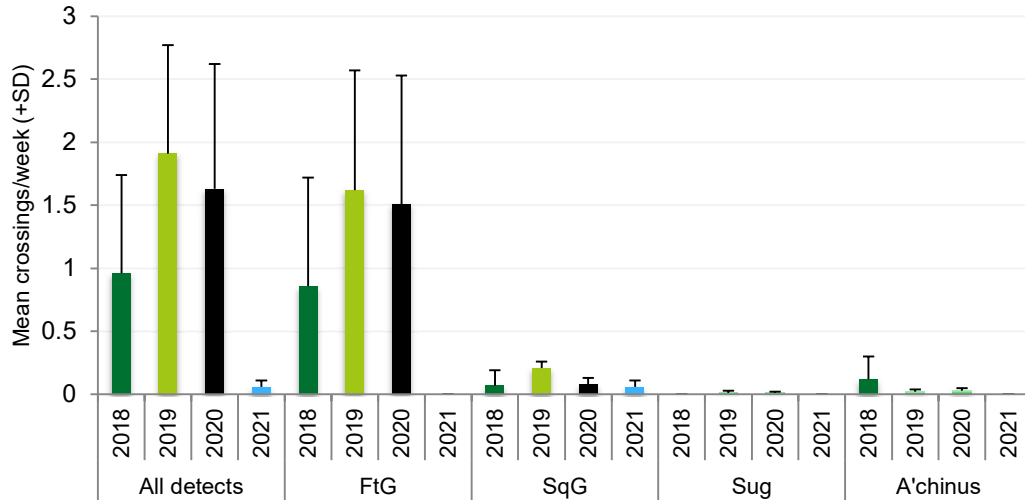
Figure 12: Comparison of mean \pm SD weekly glide pole detections for 2018, 2019, 2020 and 2021 in sections 1 and 2. FtG = feathertail glider; SqG = squirrel glider; SuG = sugar glider; A'chinus = *Antechinus* spp.

Comparison of glide pole data for sections 1 and 2 further emphasises the substantial decline in 2021 (Figure 13). Squirrel glider was the only species that maintained a reasonable detection rate, although there is evidence of a declining trend in squirrel glider detections since 2019.
