# **Woolgoolga to Ballina Pacific Highway upgrade**

**Operation Phase Threatened Mammals  
Monitoring Program: Connectivity Structure  
and Road Mortality Monitoring,  
sections 1 to 11**

Annual Report 2020-21

Sandpiper Ecological

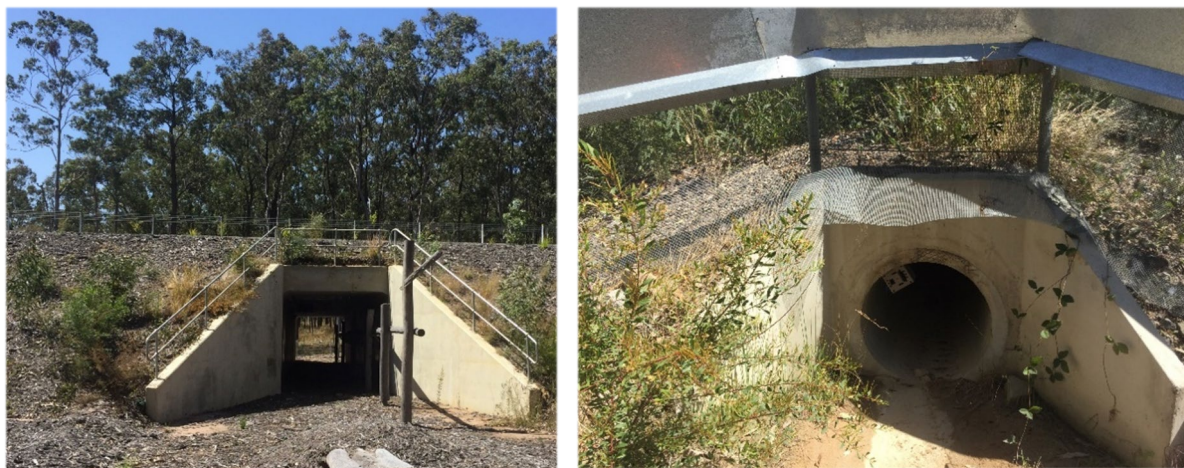
**Plate 1:** The majority of monitored box culverts contained timber post-and-rail furniture and some featured mulch spread over the concrete floor (left). Pipes did not feature fauna furniture or mulch (right).

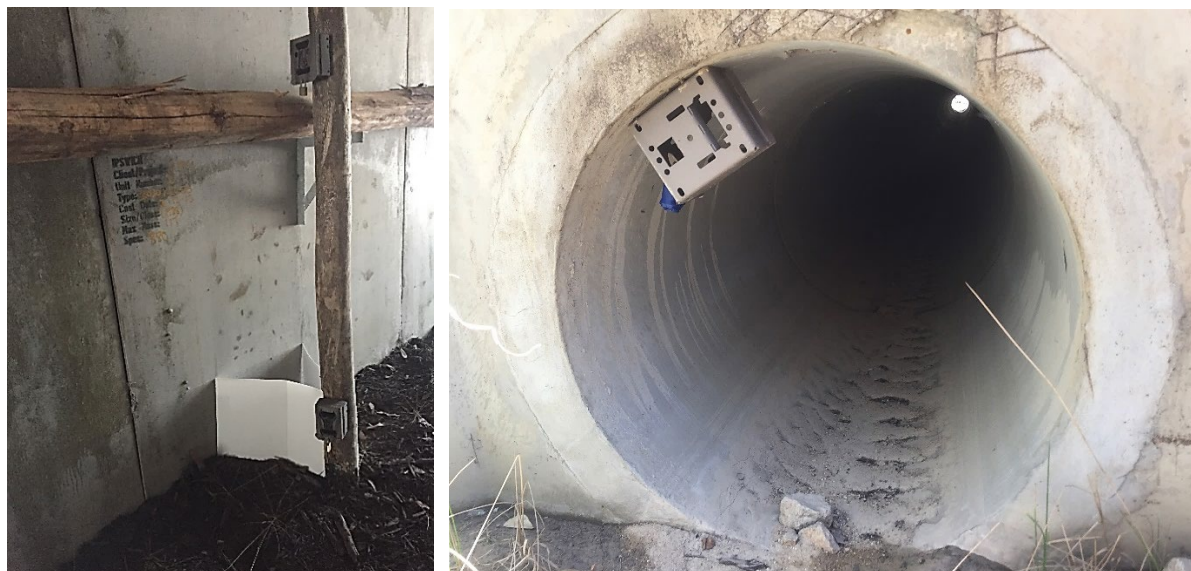
**Plate 2:** Cameras were installed on the centre post within each box culvert – one viewing along the rail and the other along the floor (left). White core-flute sheeting was placed between the side wall and the post to direct fauna past the camera.

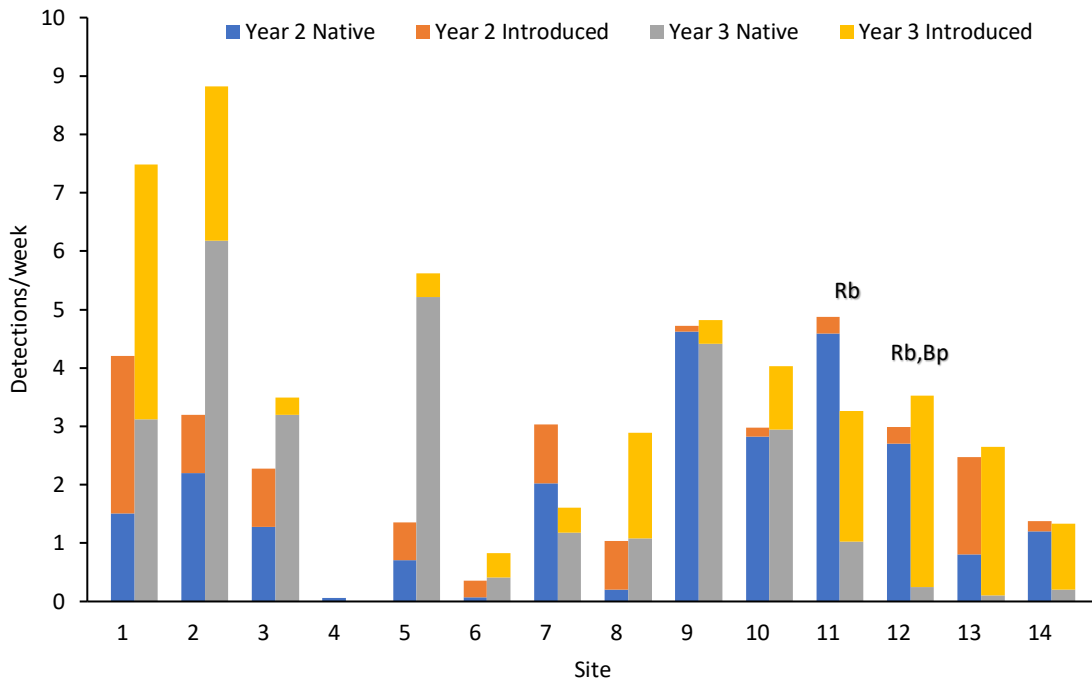
**Figure 8:** Overall camera detections/week for native and introduced species at each monitoring site for year 2 and year 3 monitoring periods. Detections are the sum of complete and incomplete crossings. Rb= Rufous bettong detection. Bp= Brush-tailed phascogale detection.

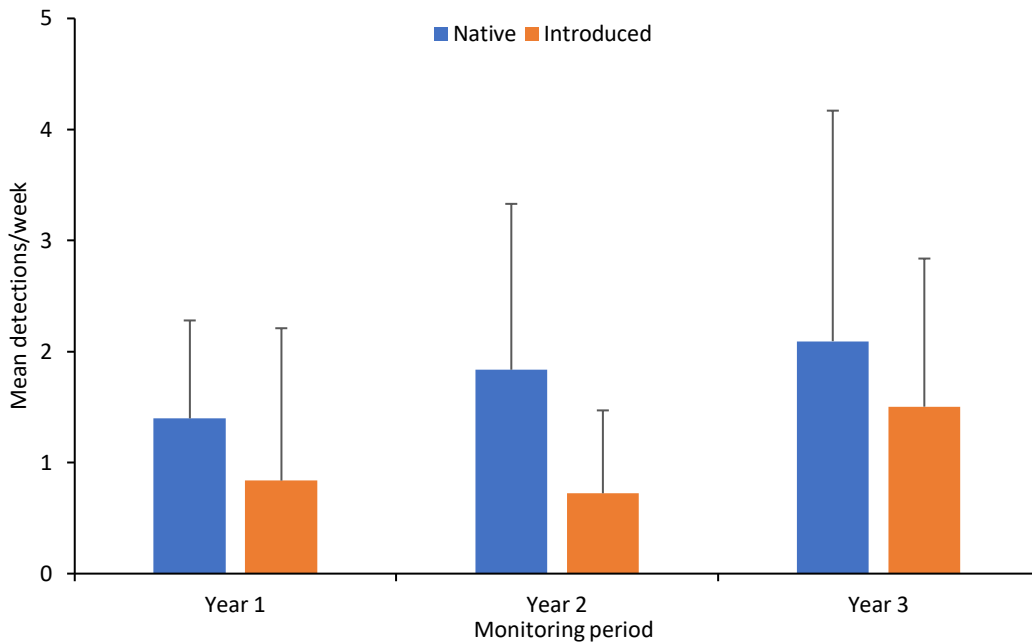
**Figure 9:** Mean number of camera detections/week/underpass (+SD) for native and introduced species during year one (n=13), year two (n=14) and year three (n = 14) monitoring periods.

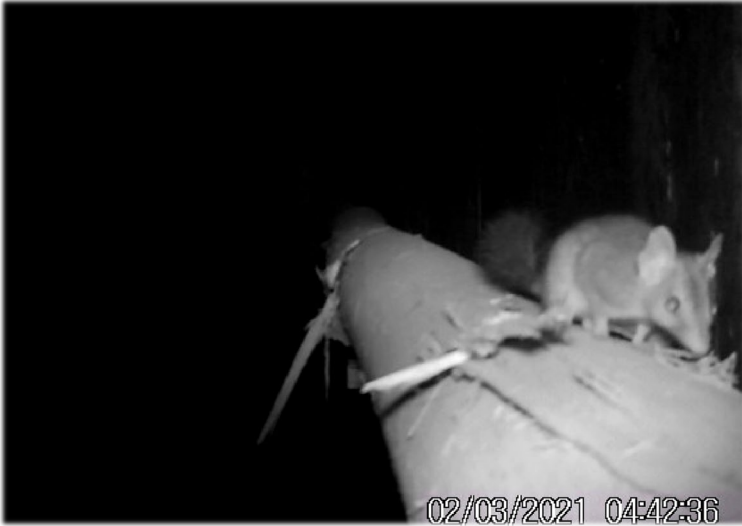
**Plate 3:** A brush-tailed phascogale was captured on video moving west on the furniture at M12 during the summer monitoring period 2021.

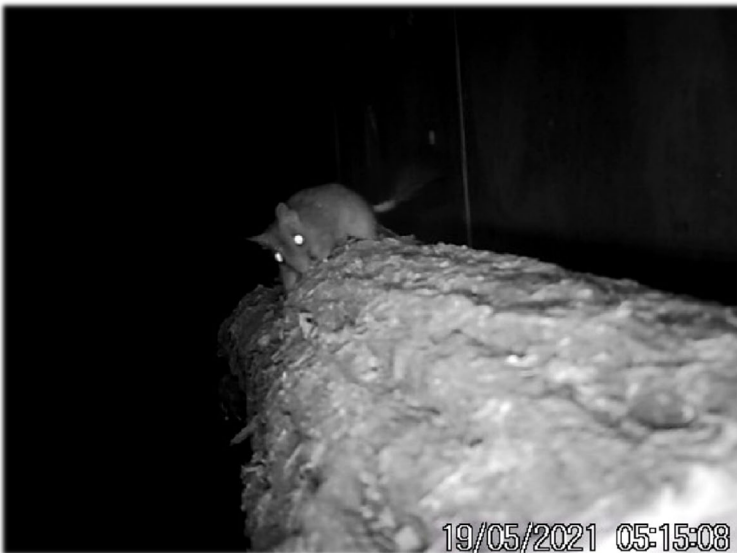
**Plate 4:** A brush-tailed phascogale was captured on video moving west on the furniture at M15 during the autumn/winter monitoring period 2021.

- Brush-tailed phascogale was recorded on the furniture at M15 on 19/5/2021 making a complete crossing westward (Plate 4, Figure 10) and a complete crossing eastward through 1200mm-diameter pipes at M16 on 2/6/2021 (Figure 11) and at M32.

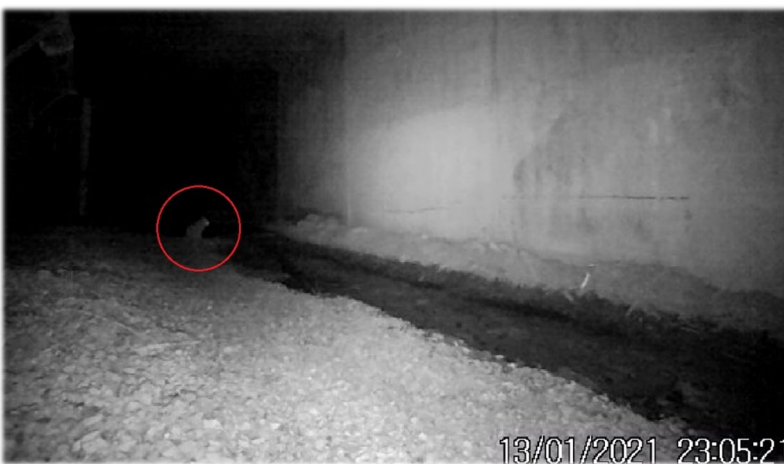
**Plate 5:** A rufous bettong was captured moving east at M11 during the summer monitoring period 2021.

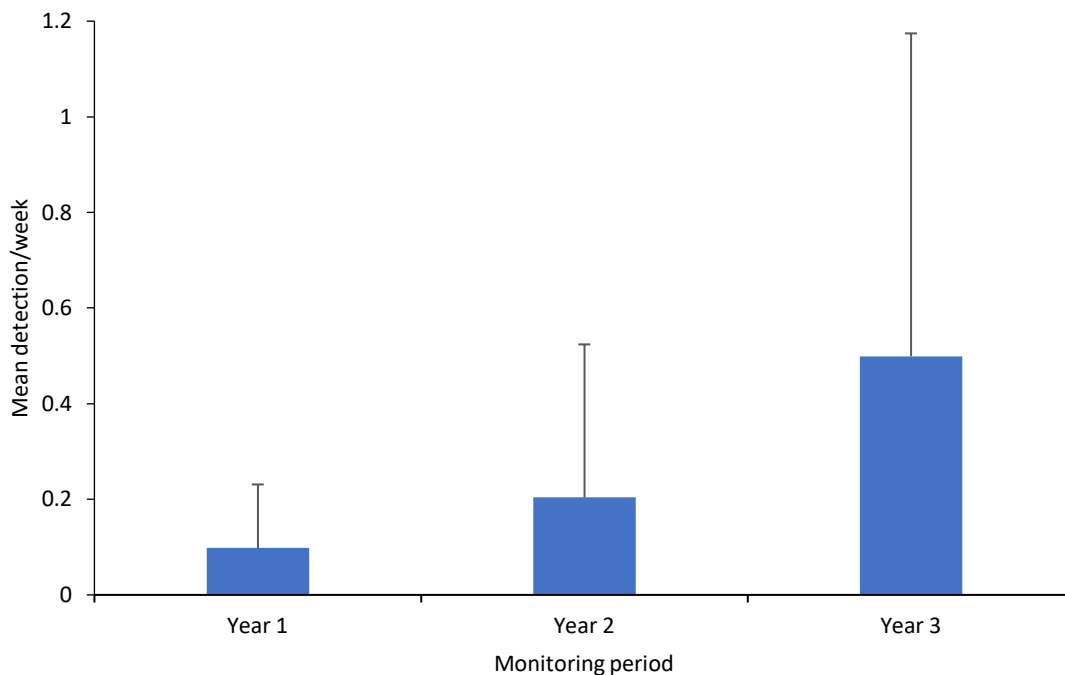
**Figure 12:** Overall mean (+SD) number of camera detections/week/underpass for introduced predators (cat, dog, fox) during year 1 (n=13), year 2 (n=14) and year 3 (n=14) monitoring periods.

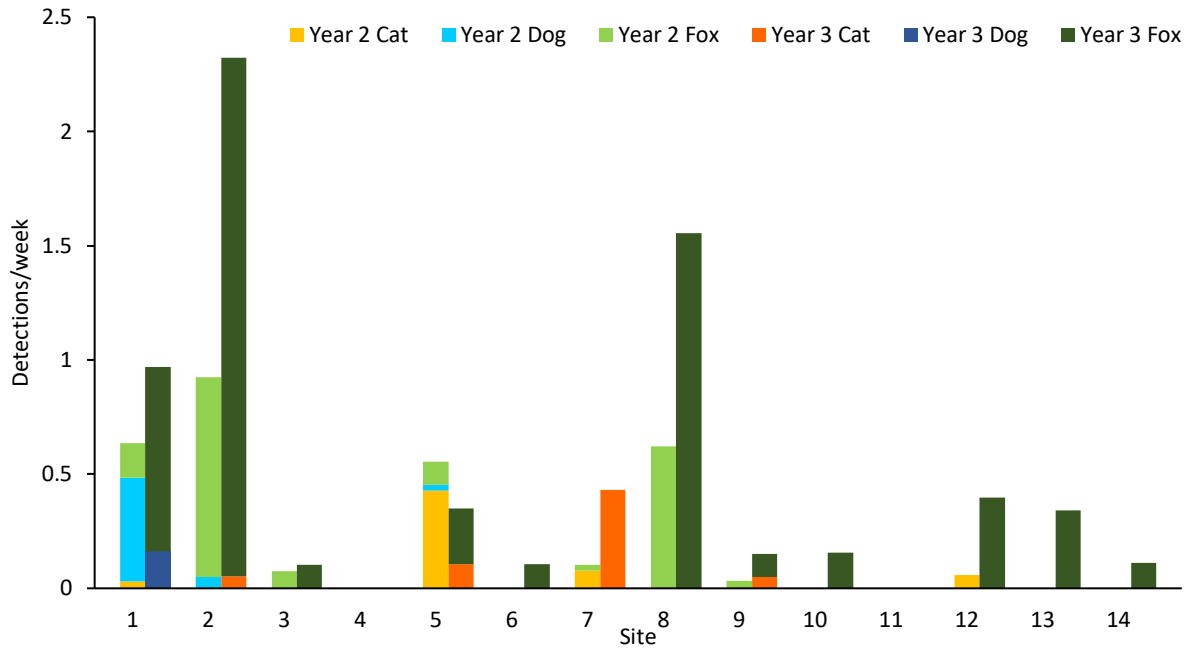
**Figure 13:** Introduced predator (cat, dog, fox) detections/week during year two and year three monitoring in Sections 1 and 2. Detections = sum of complete and incomplete crossings.

For sections 1 and 2 (underpasses M1-M14), the mean number of introduced predator detections/week/underpass increased from  $0.2 \pm 0.32$  to  $0.50 \pm 0.68$  between year two and year three – an increase of 145% (Figure 12). In year three, introduced predators were recorded at 12 of the 14 sample sites, compared to eight of 14 sites in year two (Figure 13). Foxes displayed the most obvious increase in distribution and detections. Foxes were recorded at 11 of 14 sites in year three compared to seven of 14 in year 2. This increase in distribution coincided with a substantial increase in detections. Alike year two, M2 and M8 accounted for the majority of fox detections. Dogs displayed the opposite trend with occurrence declining from three sites in year two to one in year three, and detections declining by more than 50% at the most frequently used site (M1). No dogs were recorded at sites M2 and M5 where they were detected in year 2. Over the three sample years dog numbers remained reasonably low and consistent (Figure 14). Cats were recorded at the same number of sites (i.e. 4) in years 2 and 3, although distribution changed (Figure 13). Overall, cat detections were similar between years 2 and three, and less than year 1 (Figure 14).

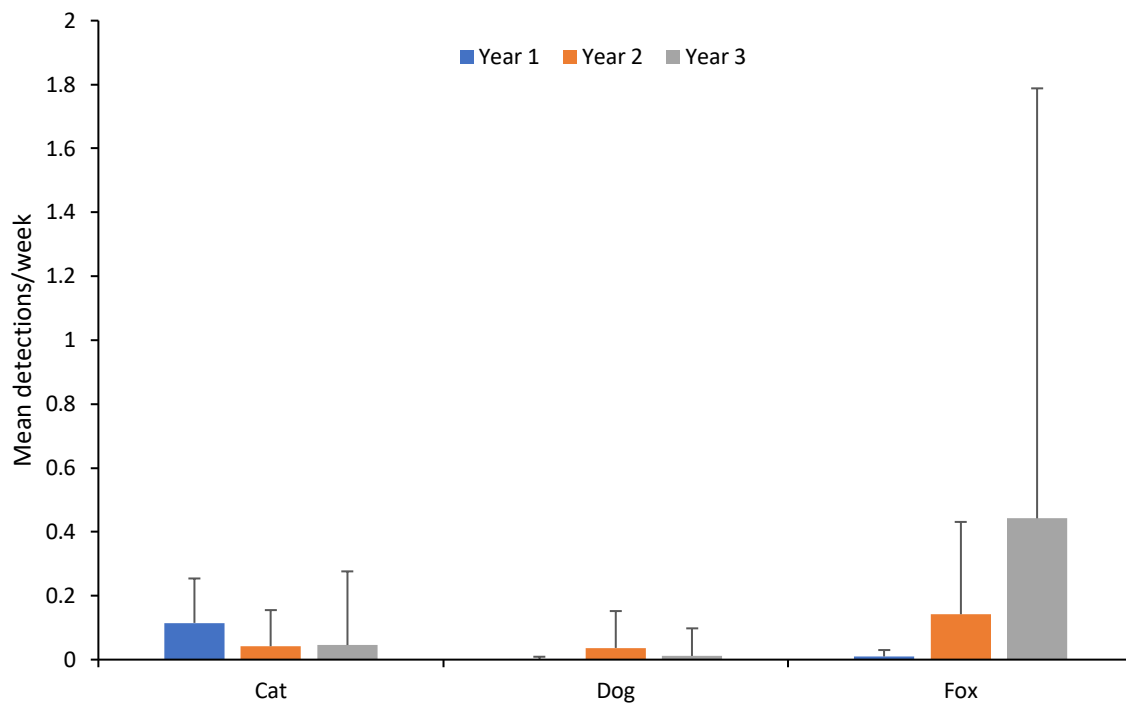
**Figure 14:** Mean (+SD) number of camera detections/week/underpass for introduced predator species (cat, dog, fox) during year 1 (n=13), year 2 (n=14) and year 3 (n = 14) monitoring periods.

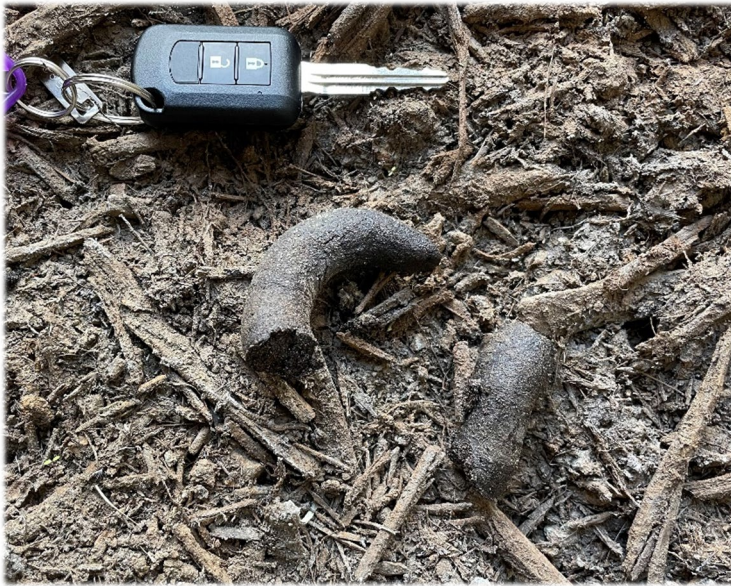
Plate 6: Short-beaked echidna scat recorded during autumn/winter at M47.

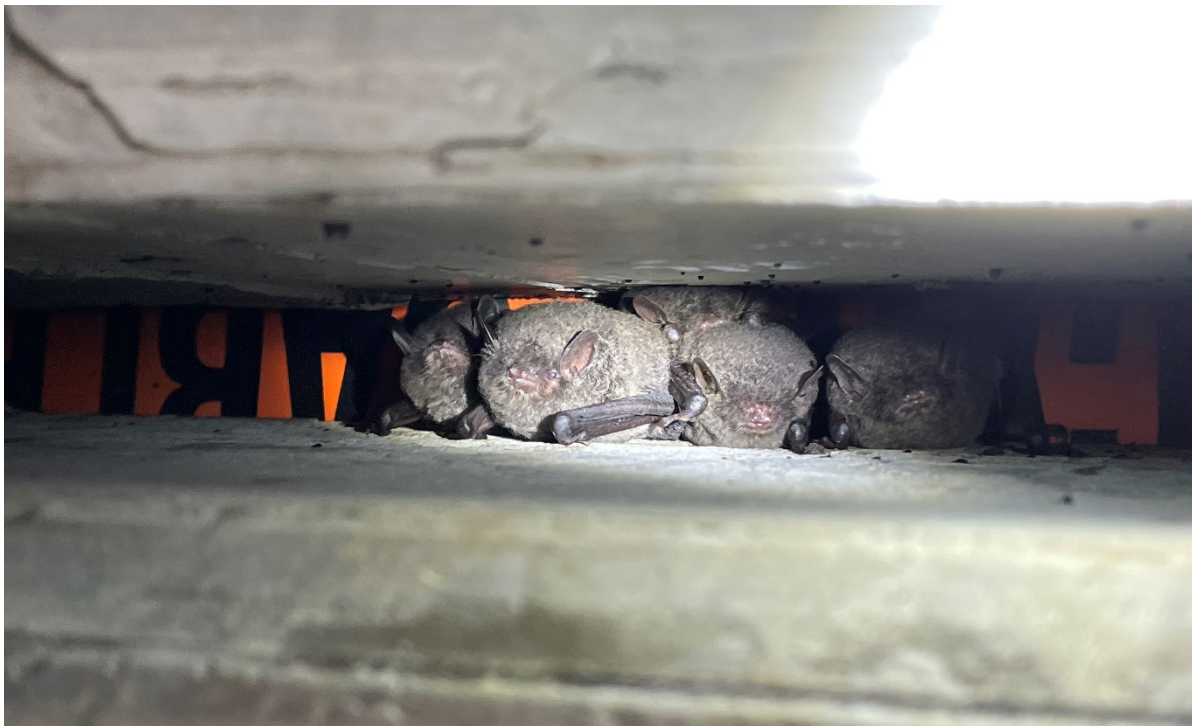
Plate 7: *Myotis macropus* roosting in culvert joints at site M36 in autumn/winter 2021.

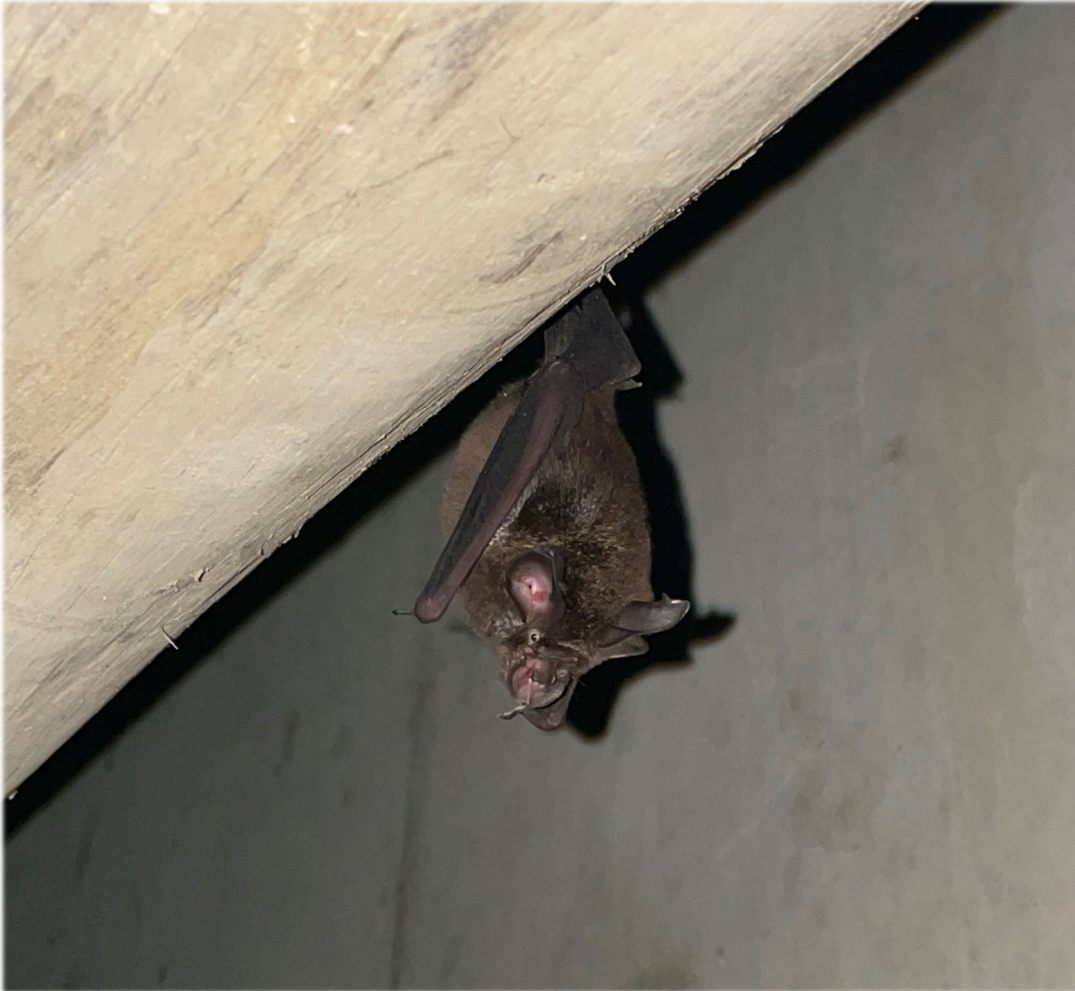
**Plate 8:** Eastern horseshoe bat (*Rhinolophus megaphyllus*) roosting in summer on the rail at M5.
