Woolgoolga to Ballina Pacific Highway Upgrade

Threatened Fish Monitoring Program Annual Report 2021

Year 1 Operational Phase Report

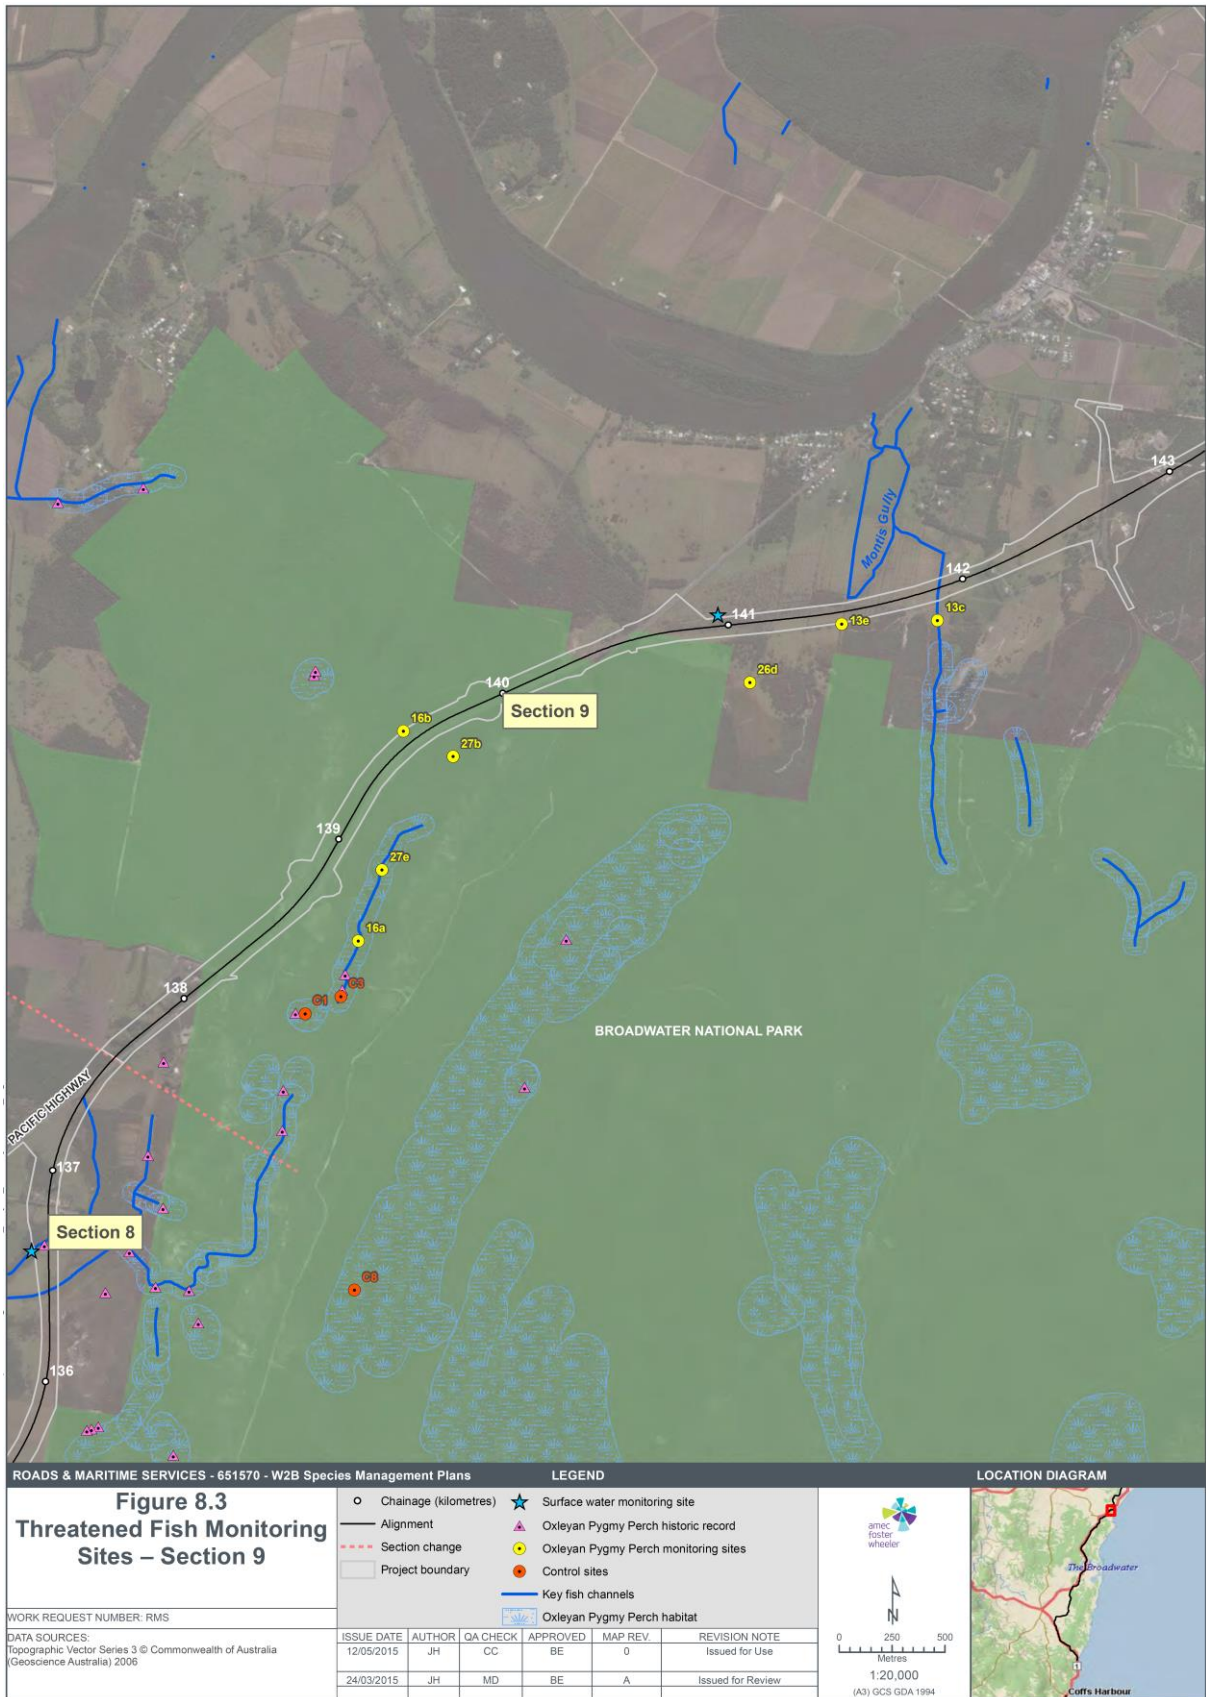
Illustration 2.4 Map of Section 9 sampling sites taken from the TFMP (RMS 2015)

The study area and location of sampling sites are displayed in **Illustrations 2.1, 2.2, 2.3 and 2.4**. A list of sampling locations is presented in **Table 2.1**.

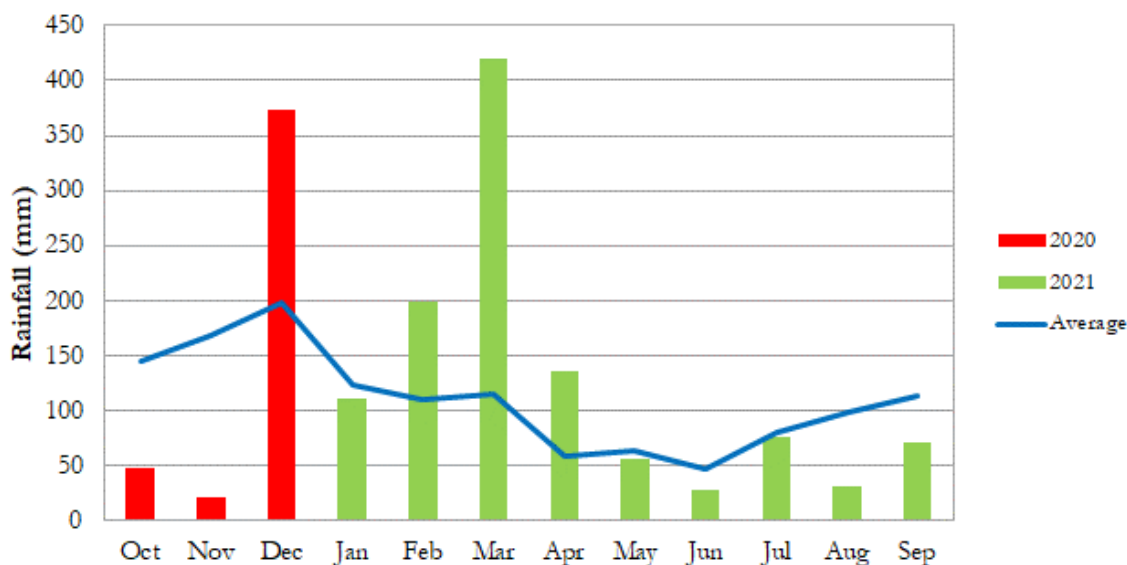
Figure 2.1 Mean monthly rainfall and total monthly rainfall from the New Italy Bureau of Meteorology station for the current reporting period.

The total rainfall for this annual reporting period was approximately 114% of the yearly average. However, approximately half of the annual rainfall was concentrated into two months, December 2020 and March 2021. (**Figure 2.1**). At the time of the May 2021 survey most sites were very wet, with water overtopping the banks at some sites. Five months of below average rainfall prior to the September 2021 survey meant that some sites were dry and most sites did not have any flow.

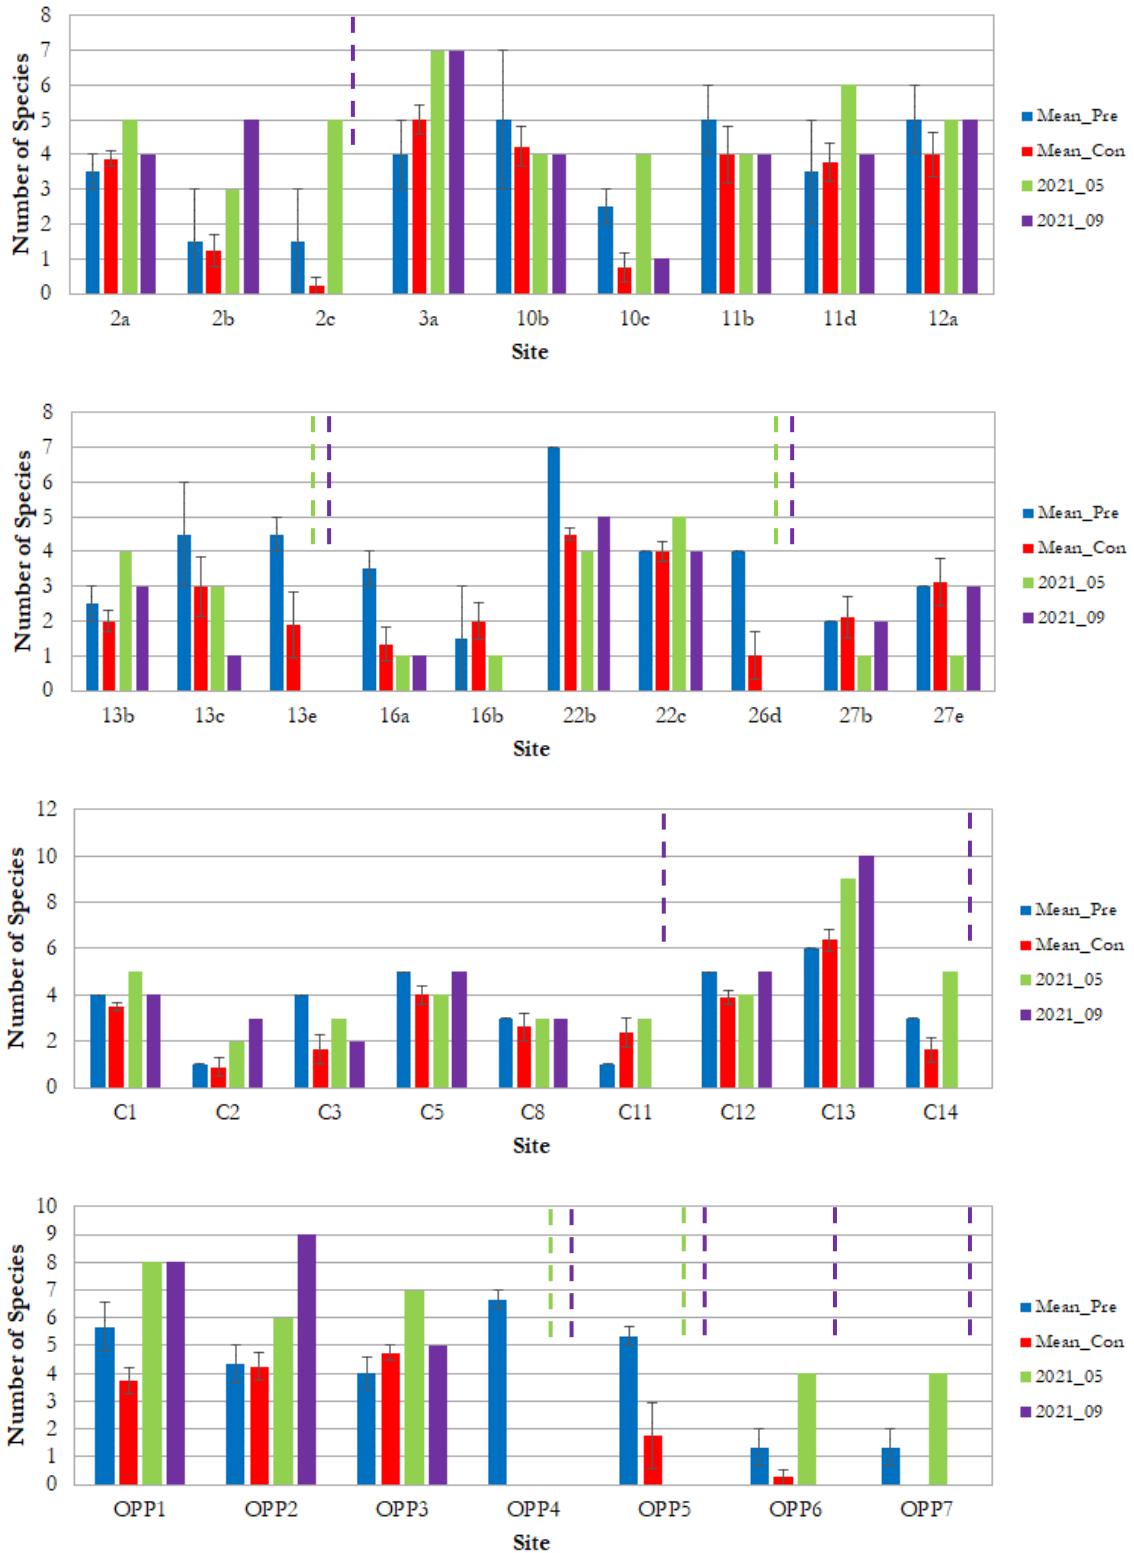
Figure 3.1 Taxonomic richness of captured fish at all sites during the May 2021 and September 2021 operational phase surveys (plotted against Mean \pm SE in preconstruction and construction phase surveys)

The results during this reporting period have been moderately variable at most impact and control sites in terms of fish diversity and abundance (Figures 3.1, 3.2 and 3.3). With very few exceptions the variation was consistent with the variability identified during the pre-

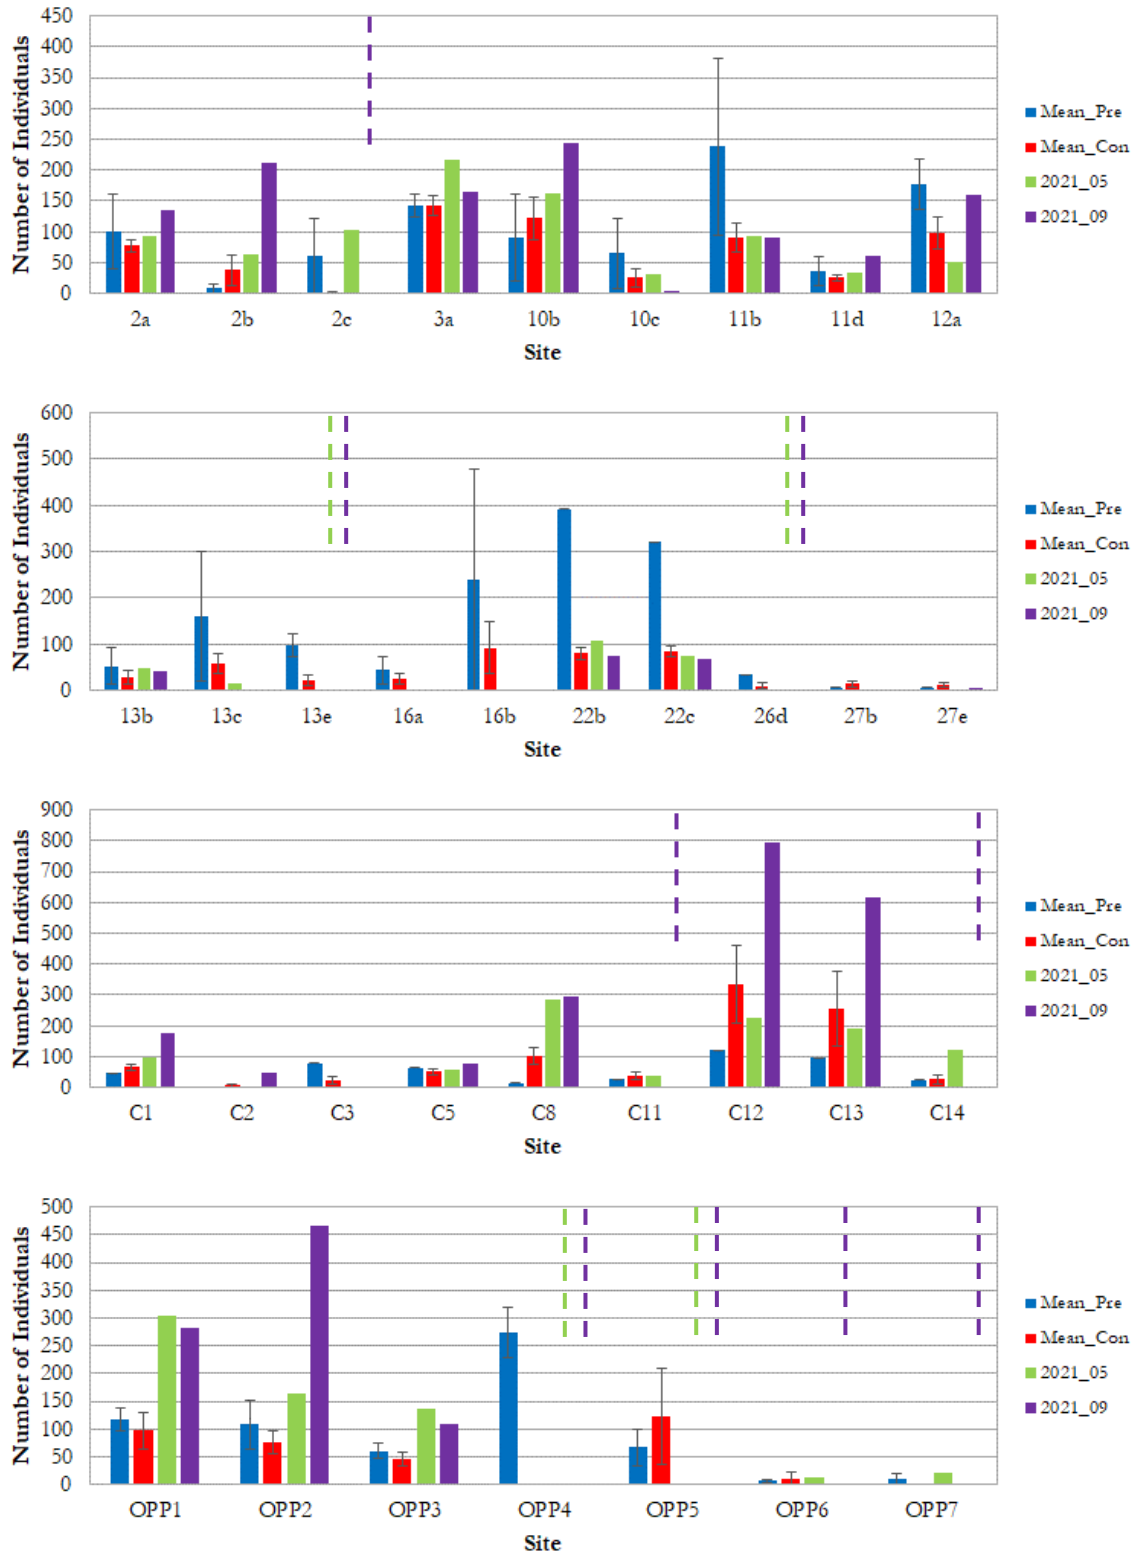
Figure 3.2 Number of captured fish at all sites during the May 2021 and September 2021 operational phase surveys (plotted against Mean \pm SE in preconstruction and construction phase surveys)

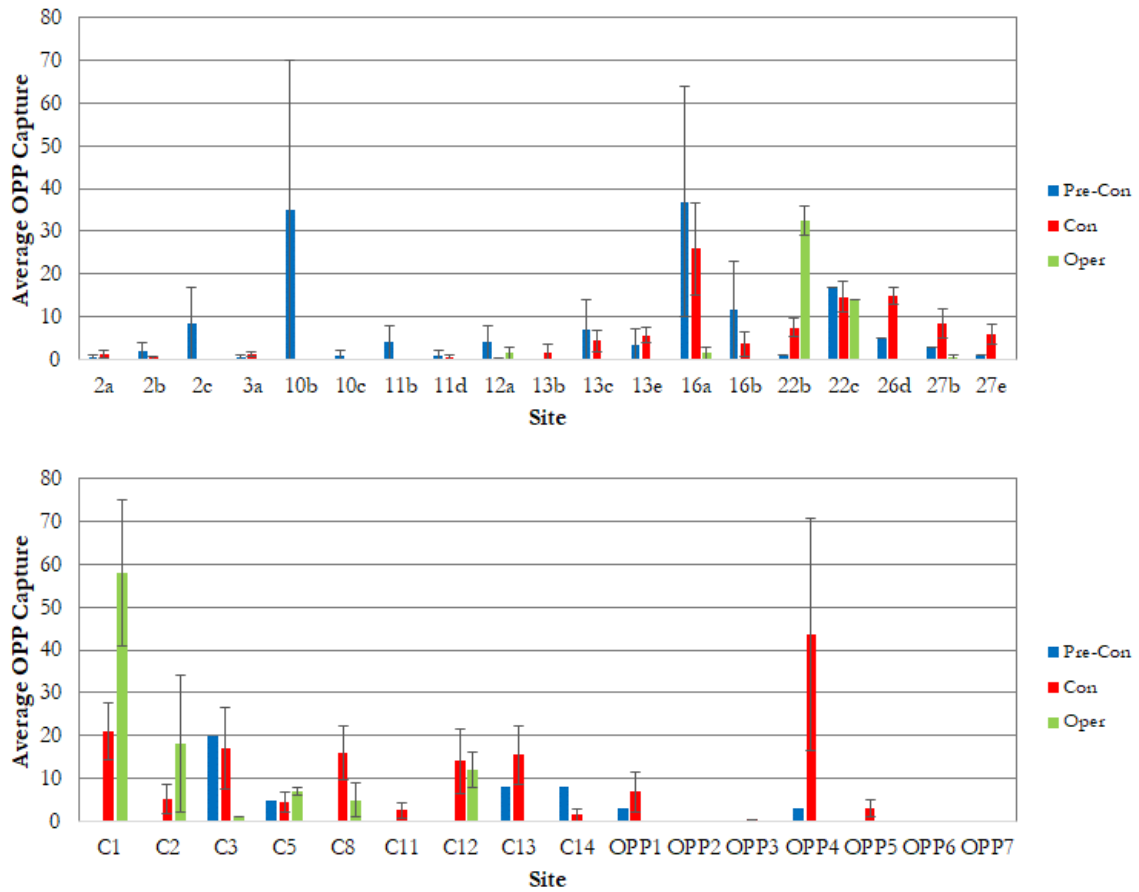
Figure 3.4 Average OPP capture per survey at all sites in pre-construction, construction and operational phase monitoring (pre-construction data from GeoLINK 2014, 2015a & 2015b, Hyder 2012)

The capture of OPP has varied significantly between sites and over time since monitoring along the W2B upgrade began in 2013. The average capture per survey at each site during pre-construction, construction and operational phase (to date) monitoring is presented in **Figure 3.4**. The figures indicate that pre-construction captures were significantly larger than construction and operational phase captures at several impact sites, including sites 2c, 10b, 10c, and 11b. However, they also indicate that construction phase captures were significantly larger at some sites, including 22b, 26d, 27b and 27e, and that operational phase captures to date have been higher at 22b. Average captures at the control sites during the operational phase monitoring to date have mostly been larger than or equivalent to captures during the pre-construction phase monitoring, the exceptions being sites C3, C13 and C14.

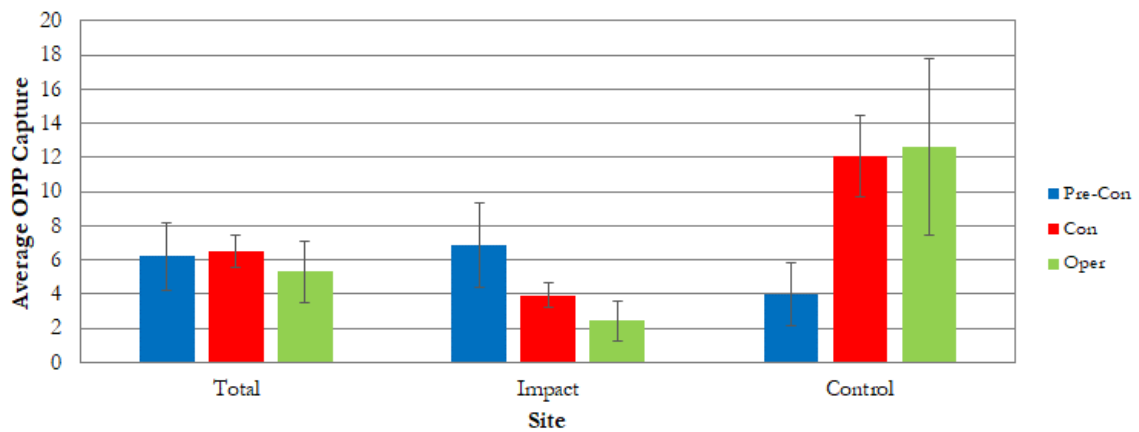
Figure 3.5 Average OPP capture at combined control and impact sites in pre-construction, construction and operational phase monitoring to date (pre-construction data from GeoLINK 2014, 2015a & 2015b, Hyder 2012). Note operational phase data is from a single year of monitoring

When the control and impact sites are considered as a group, the pre-construction and construction phase average captures per site show a reduction in the average OPP capture at impact sites in the construction and operational phase monitoring and an increase in the average capture at control sites in the construction phase monitoring (**Figure 3.5**).

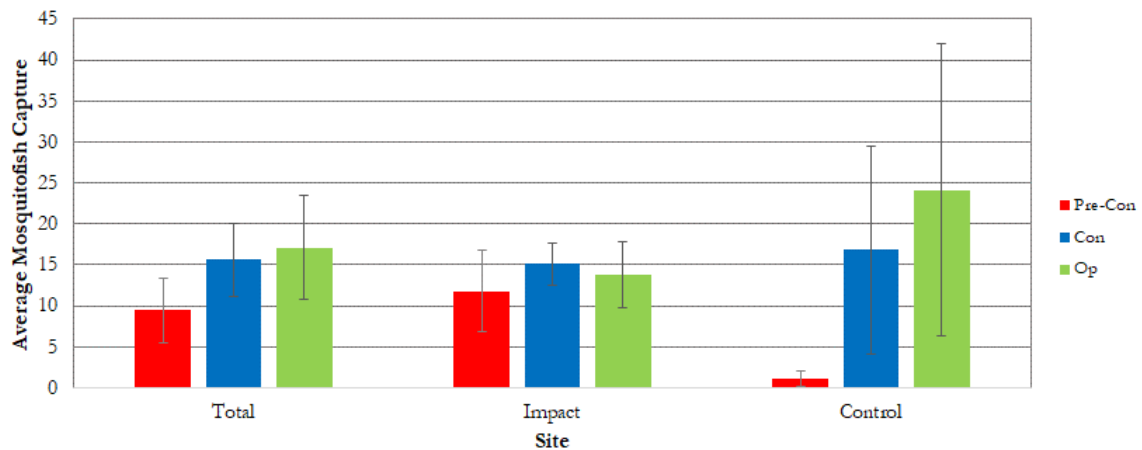
Figure 4.3 Average Mosquitofish Capture at W2B impact and control sites in the pre-construction, construction and operational phase surveys.

The numbers of Mosquitofish (*Gambusia holbrooki*) encountered at each site are of specific interest as predation by this species is identified as a Key Threatening Process under the *Biodiversity Conservation Act 2016* and they are antagonistic towards OPP. There has been variation in the numbers of Mosquitofish encountered during threatened fish surveys to date. During the surveys this year, Mosquitofish were captured in very large numbers at both control and impact sites. In comparison with the pre-construction and construction phases, the average catch of Mosquitofish to date in operational phase monitoring has increased slightly although there are high levels of variation in the dataset (**Figure 4.3**). However, the average capture at control sites has increased to a greater extent than at the impact sites. There is no evidence at present that Mosquitofish numbers are increasing as a result of disturbances associated with Pacific Highway operation.

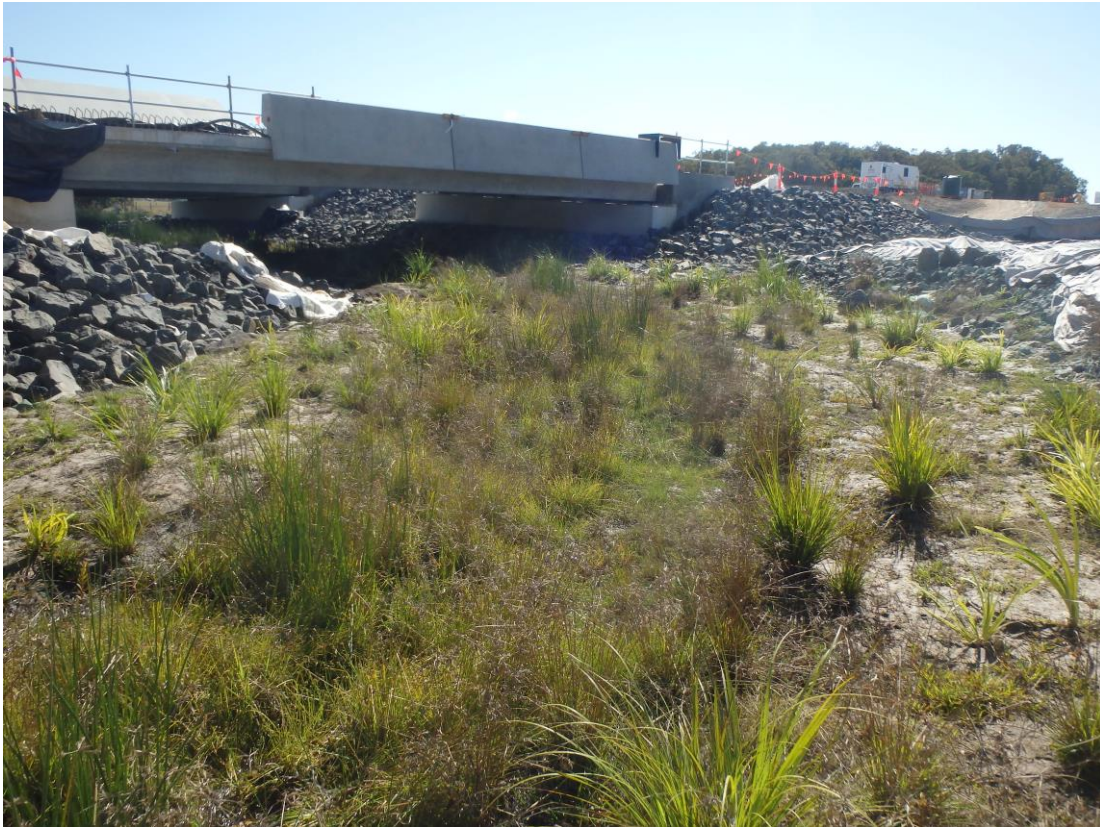
Plate 4.1 Site 13b in September 2018 after channel realignment and initial plant out.

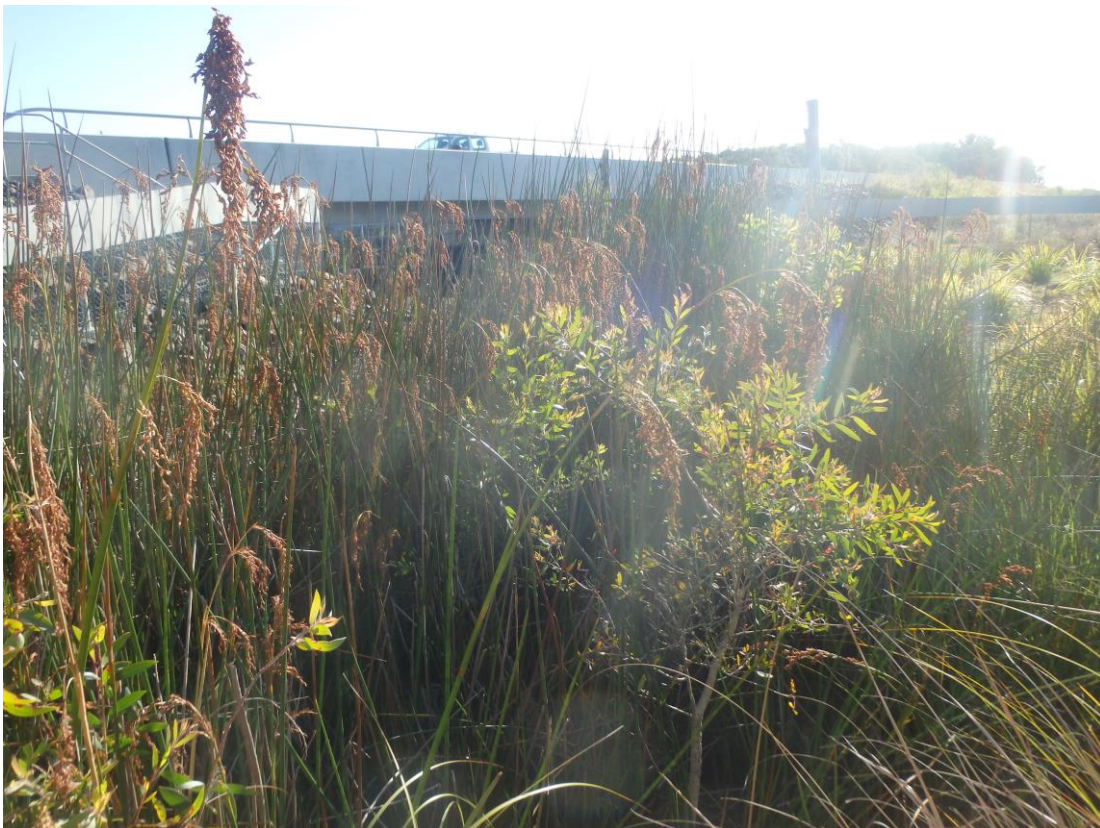
Plate 4.2 Site 13b in September 2021 showing dense emergent vegetation cover.

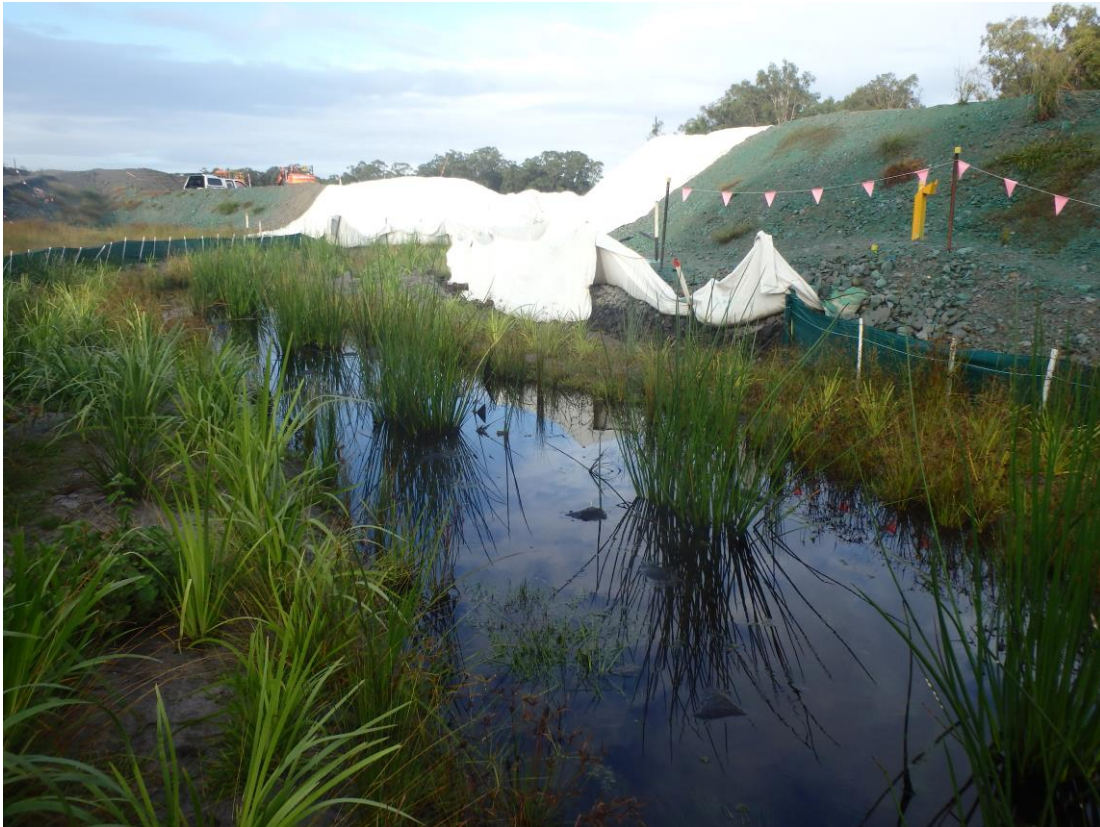
Plate 4.3 Site 12a in May 2018 after channel realignment and initial plant out.

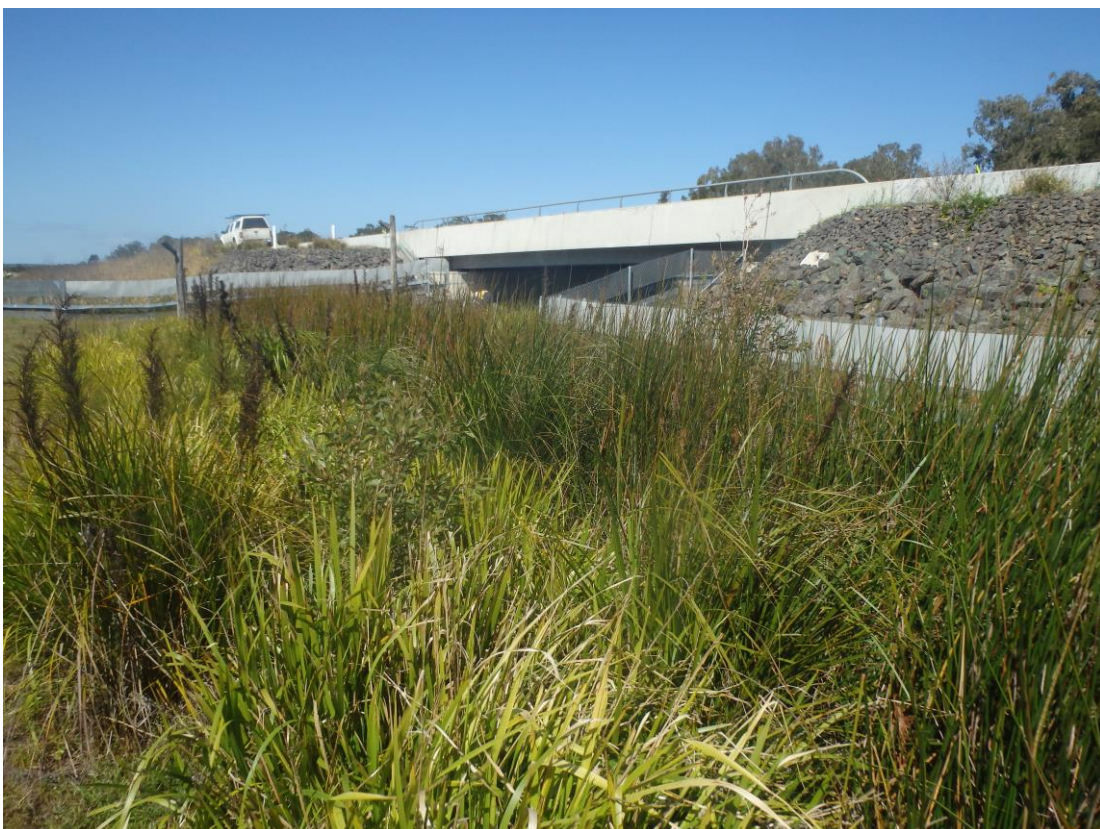
Plate 4.4 Site 12a in September 2021 showing dense emergent vegetation cover.
