Woolgoolga to Ballina Pacific Highway Upgrade

Threatened Fish Monitoring Program Annual Report 2021

Year 1 Operational Phase Report

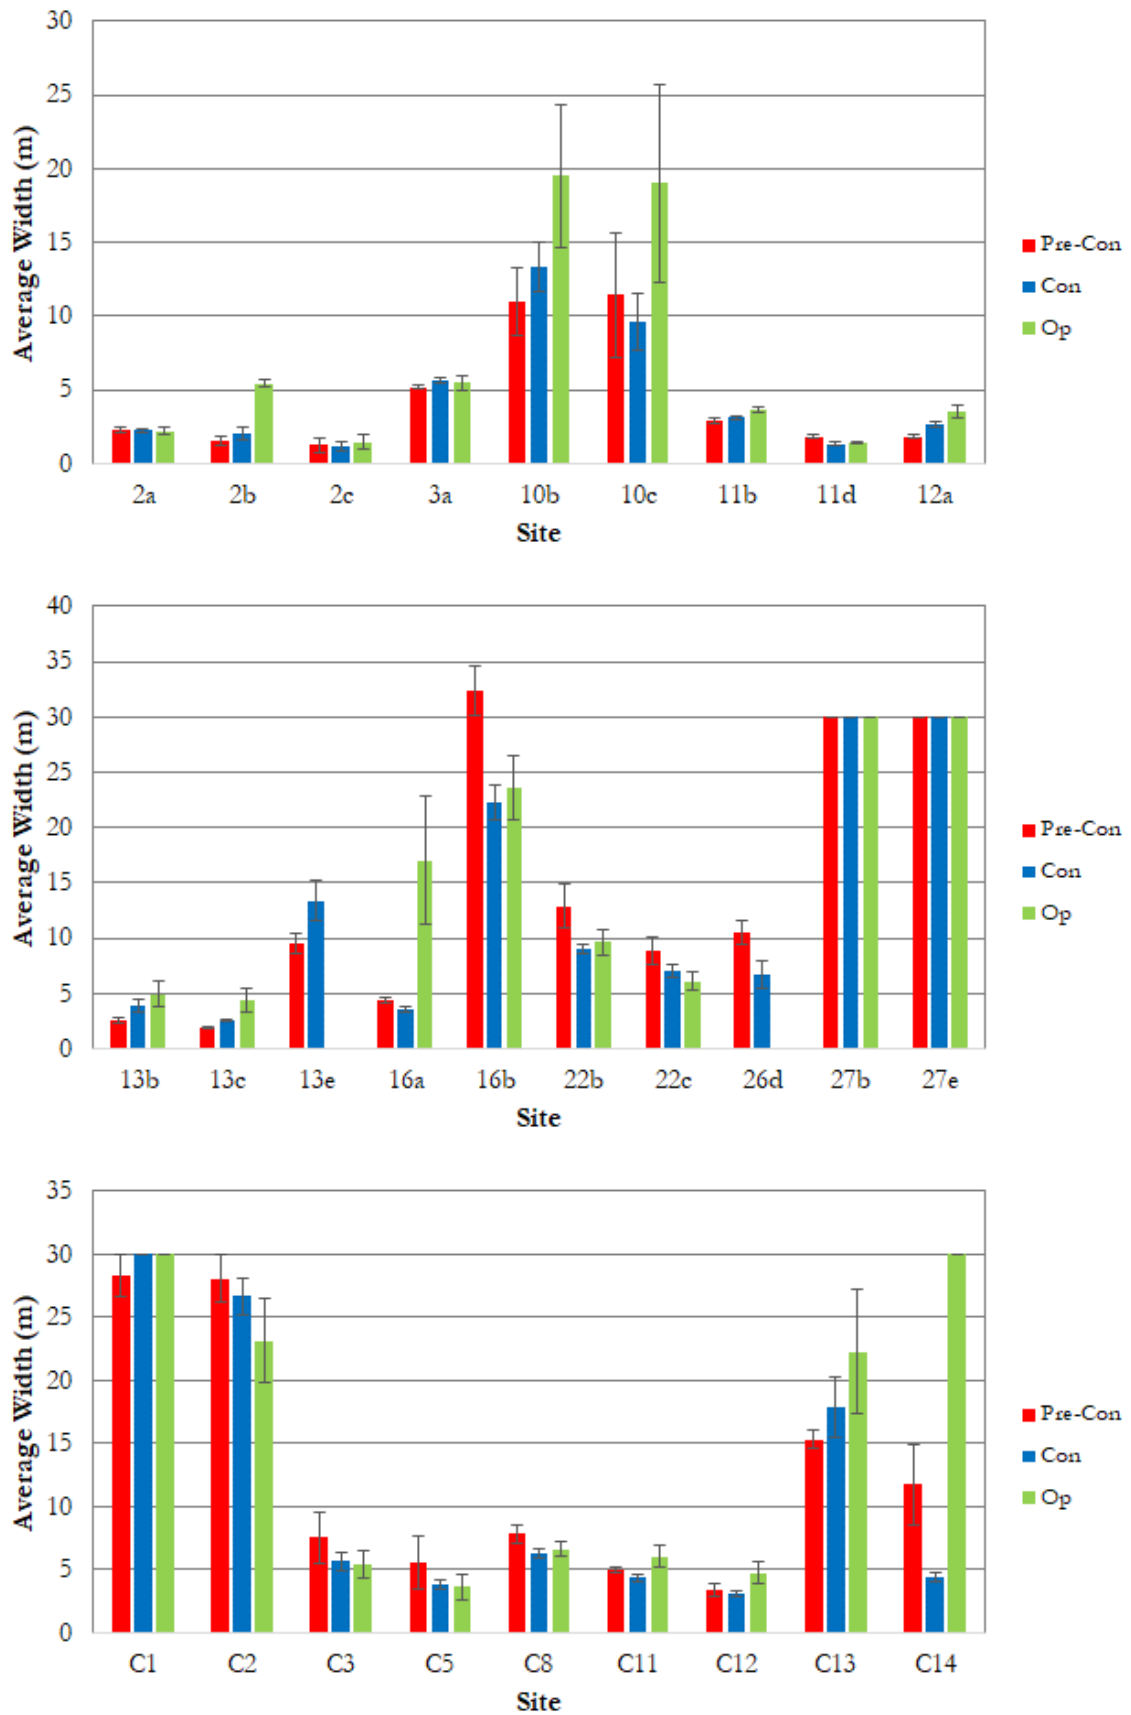
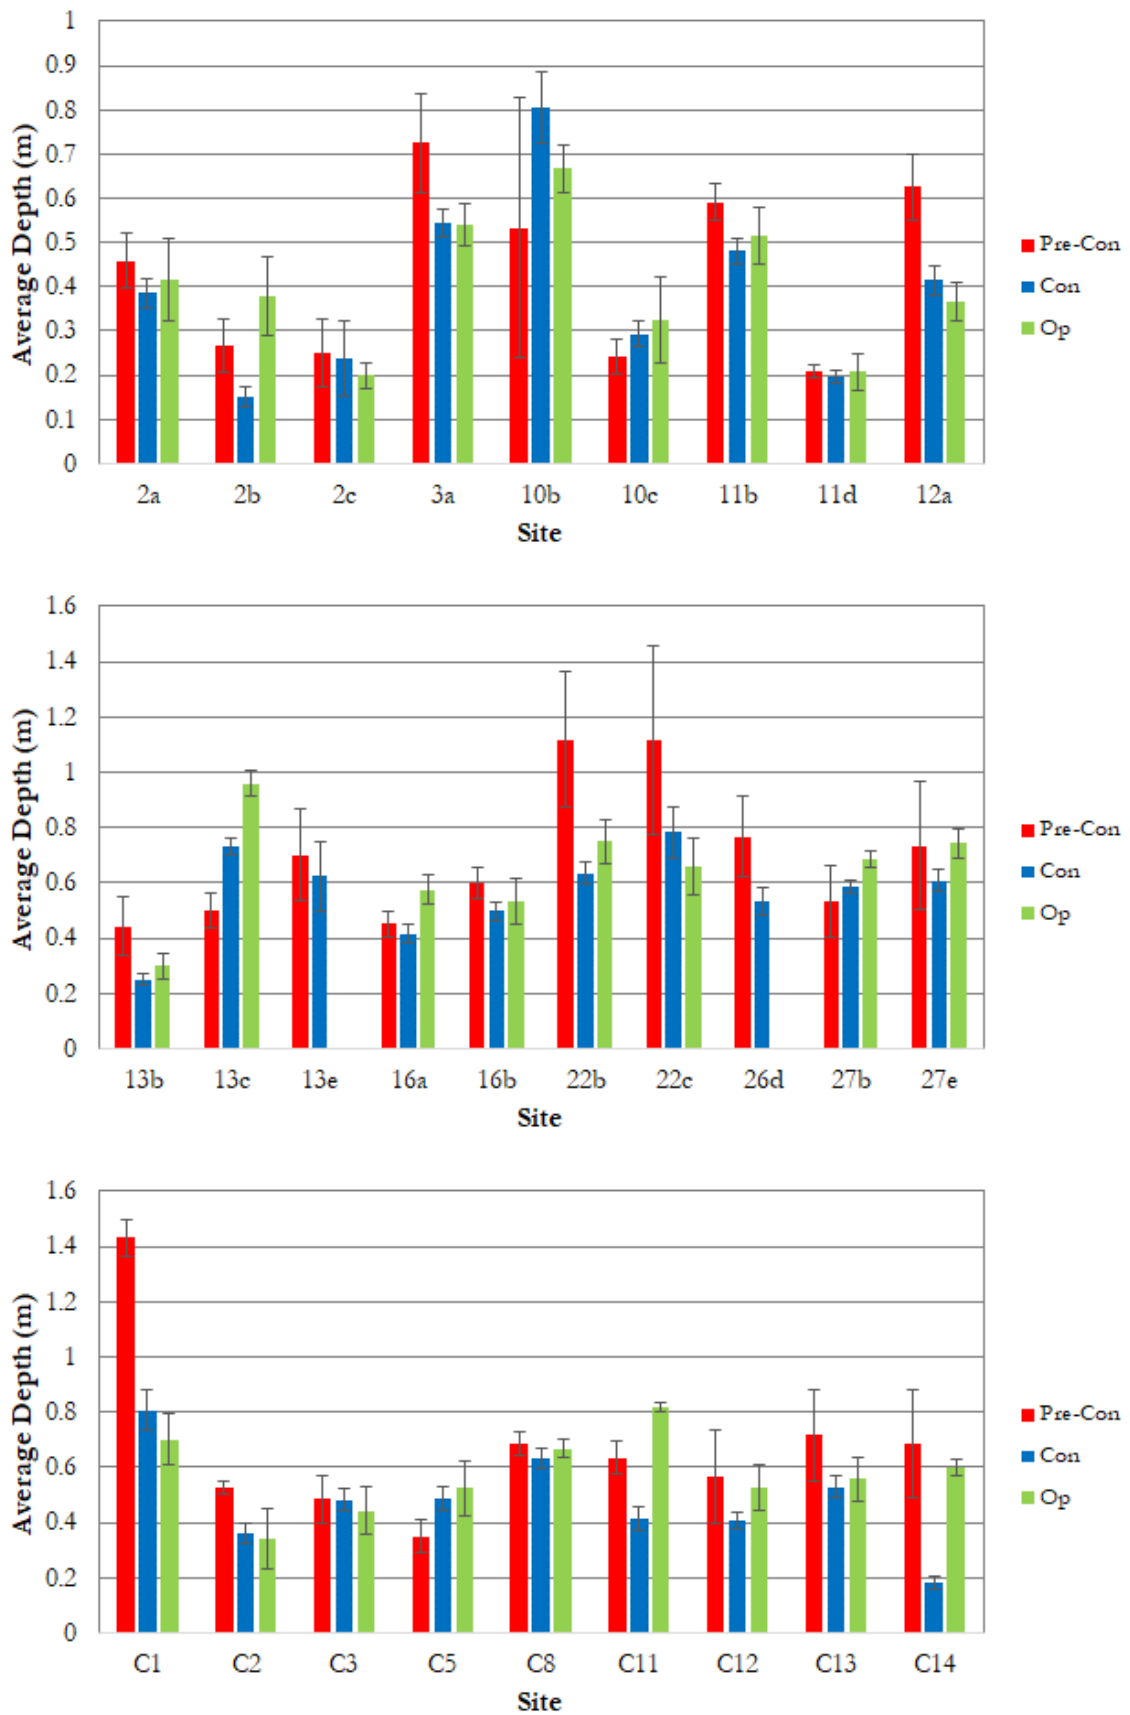
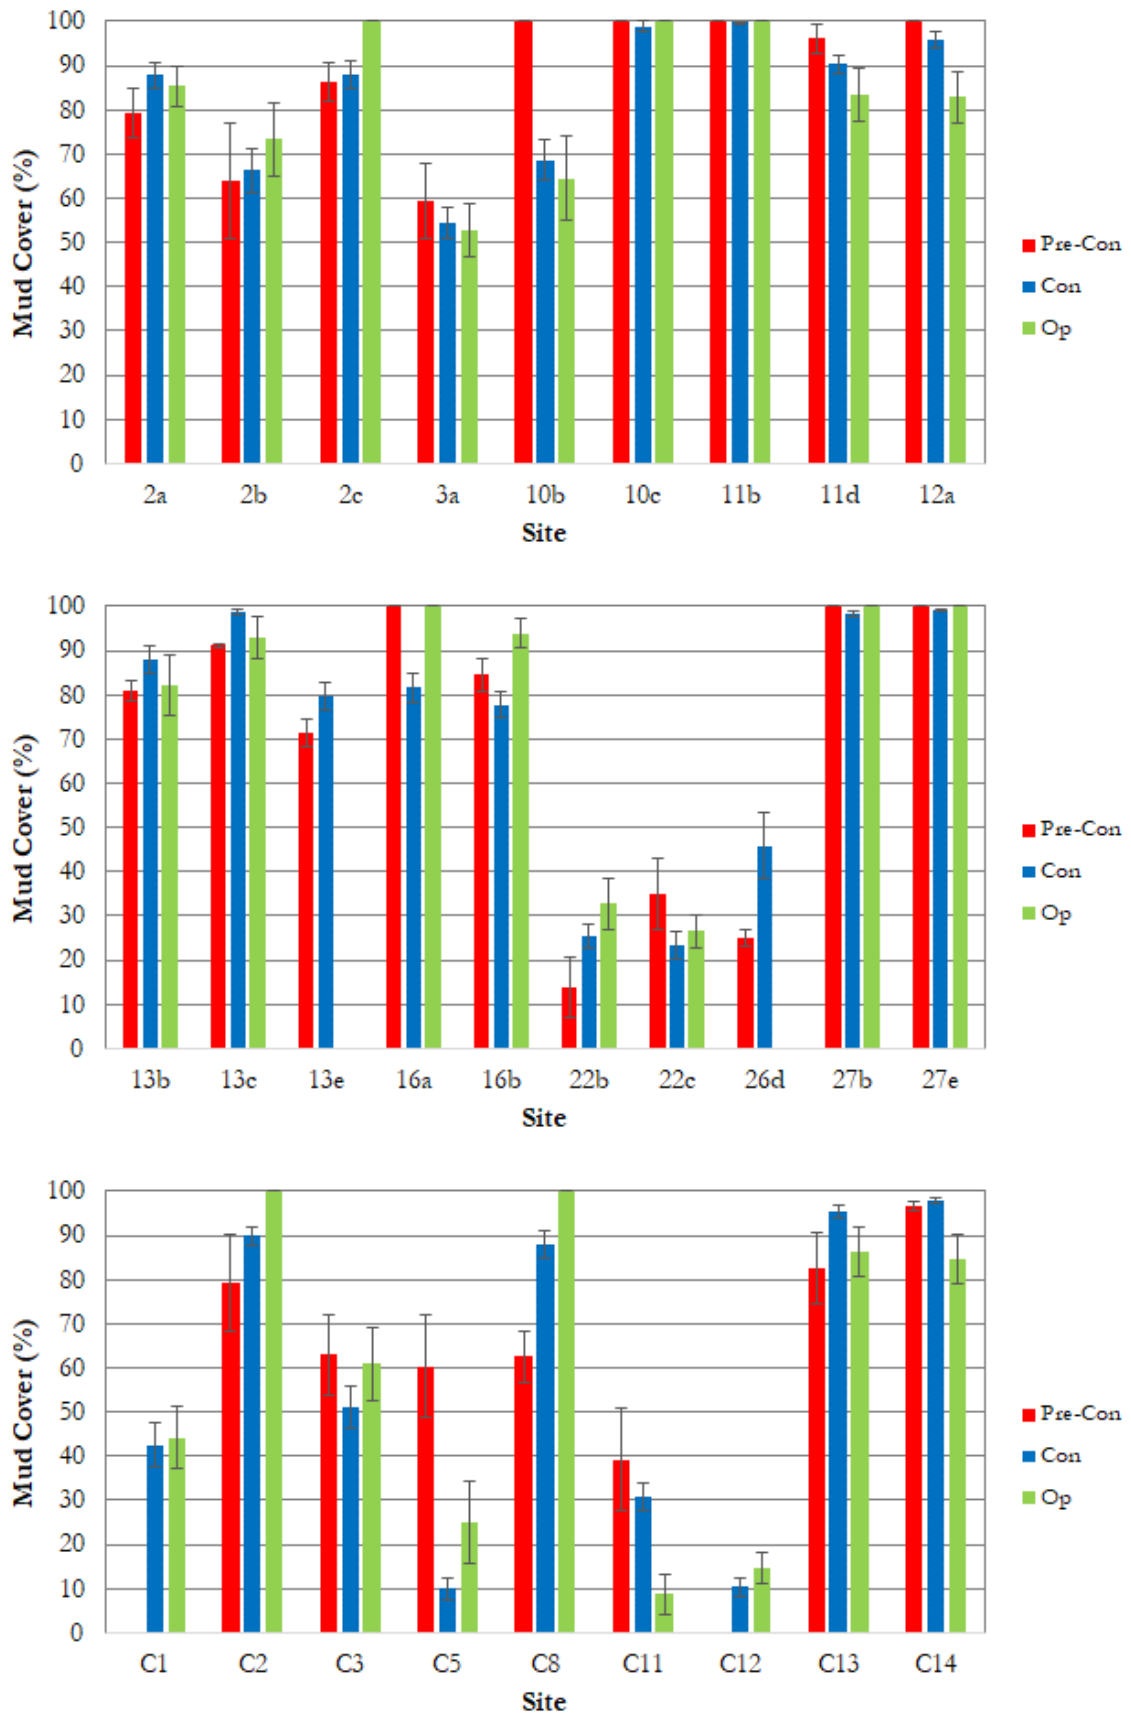
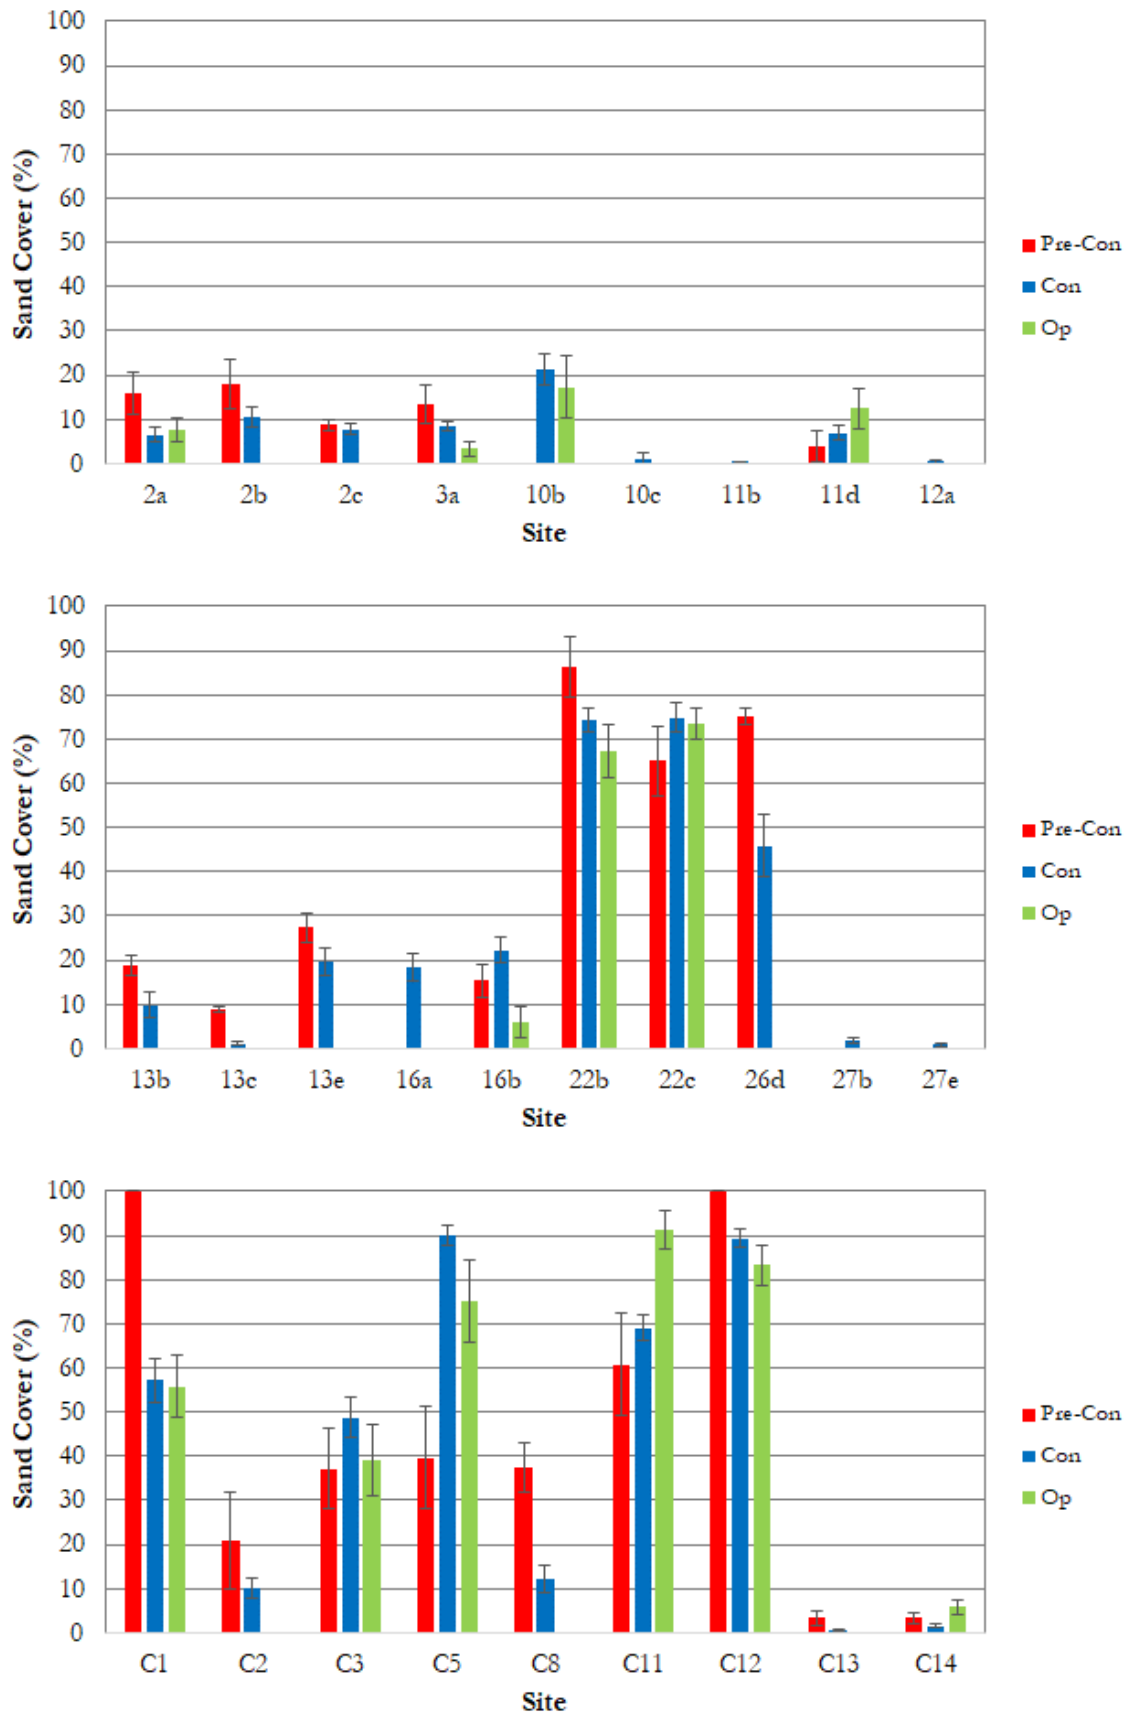
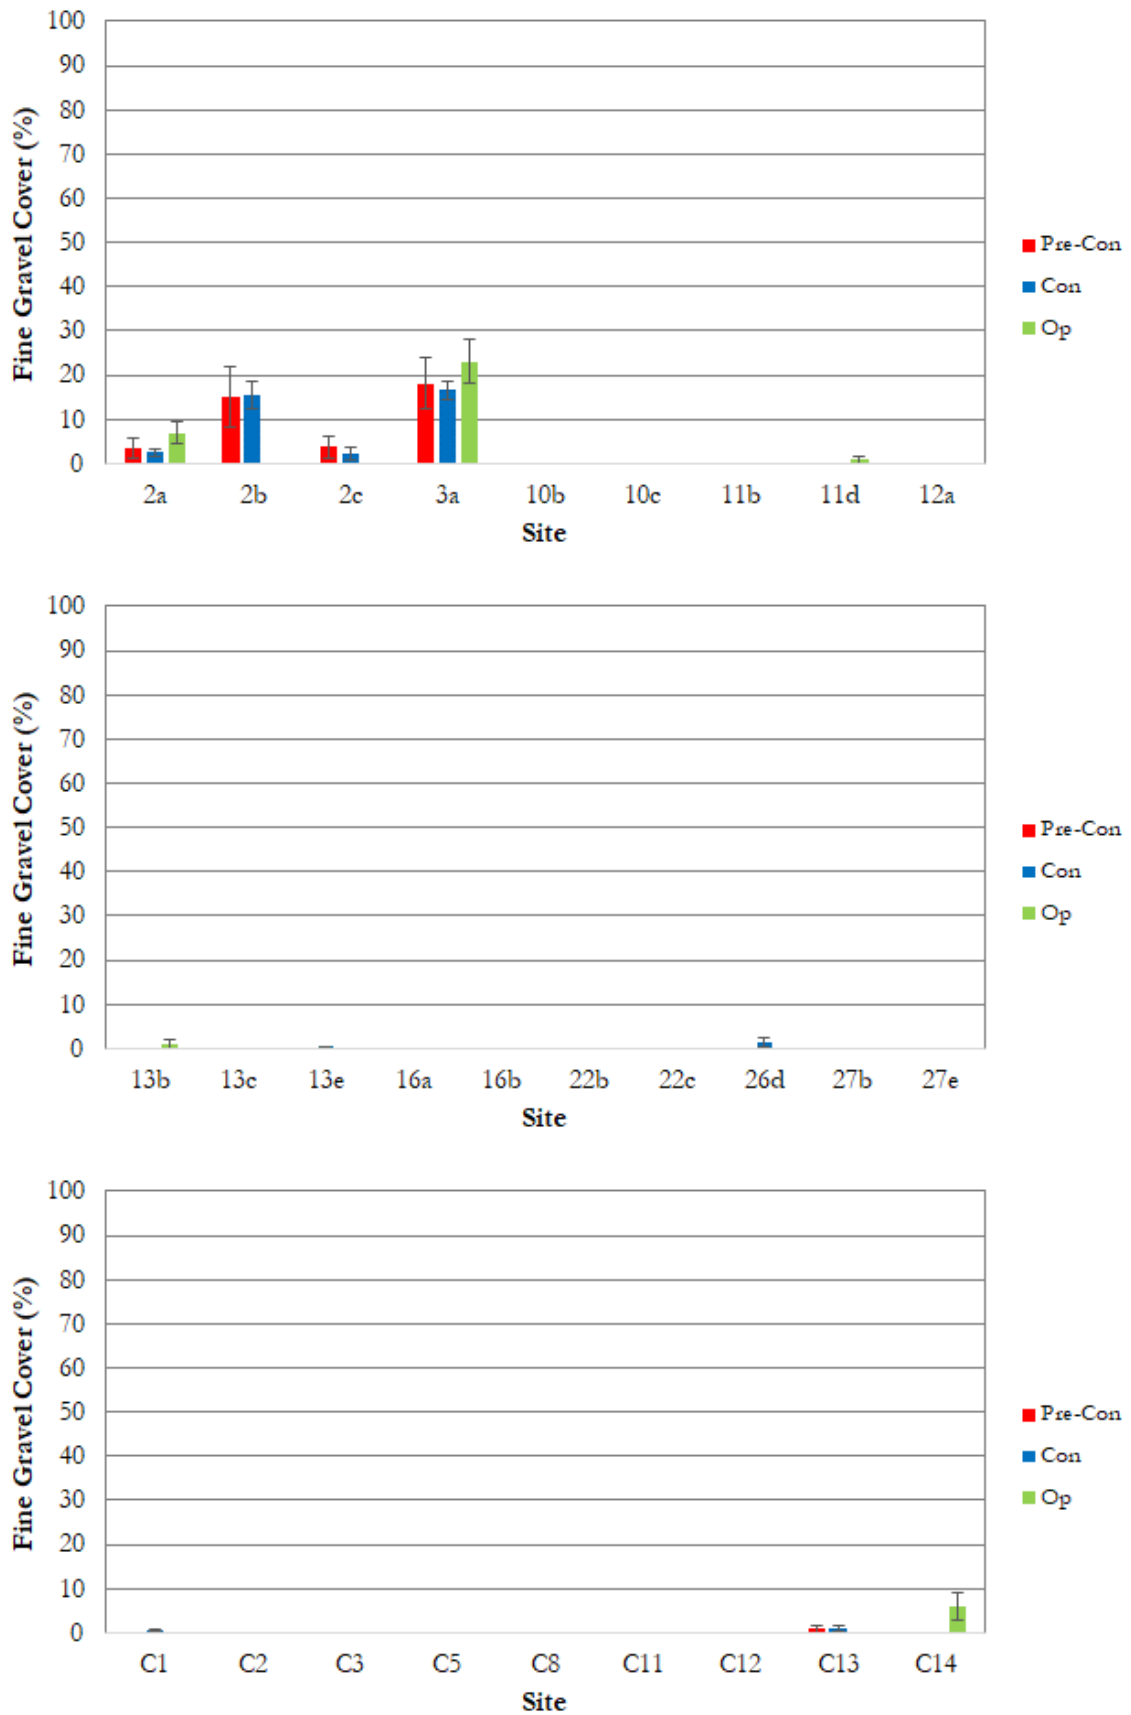
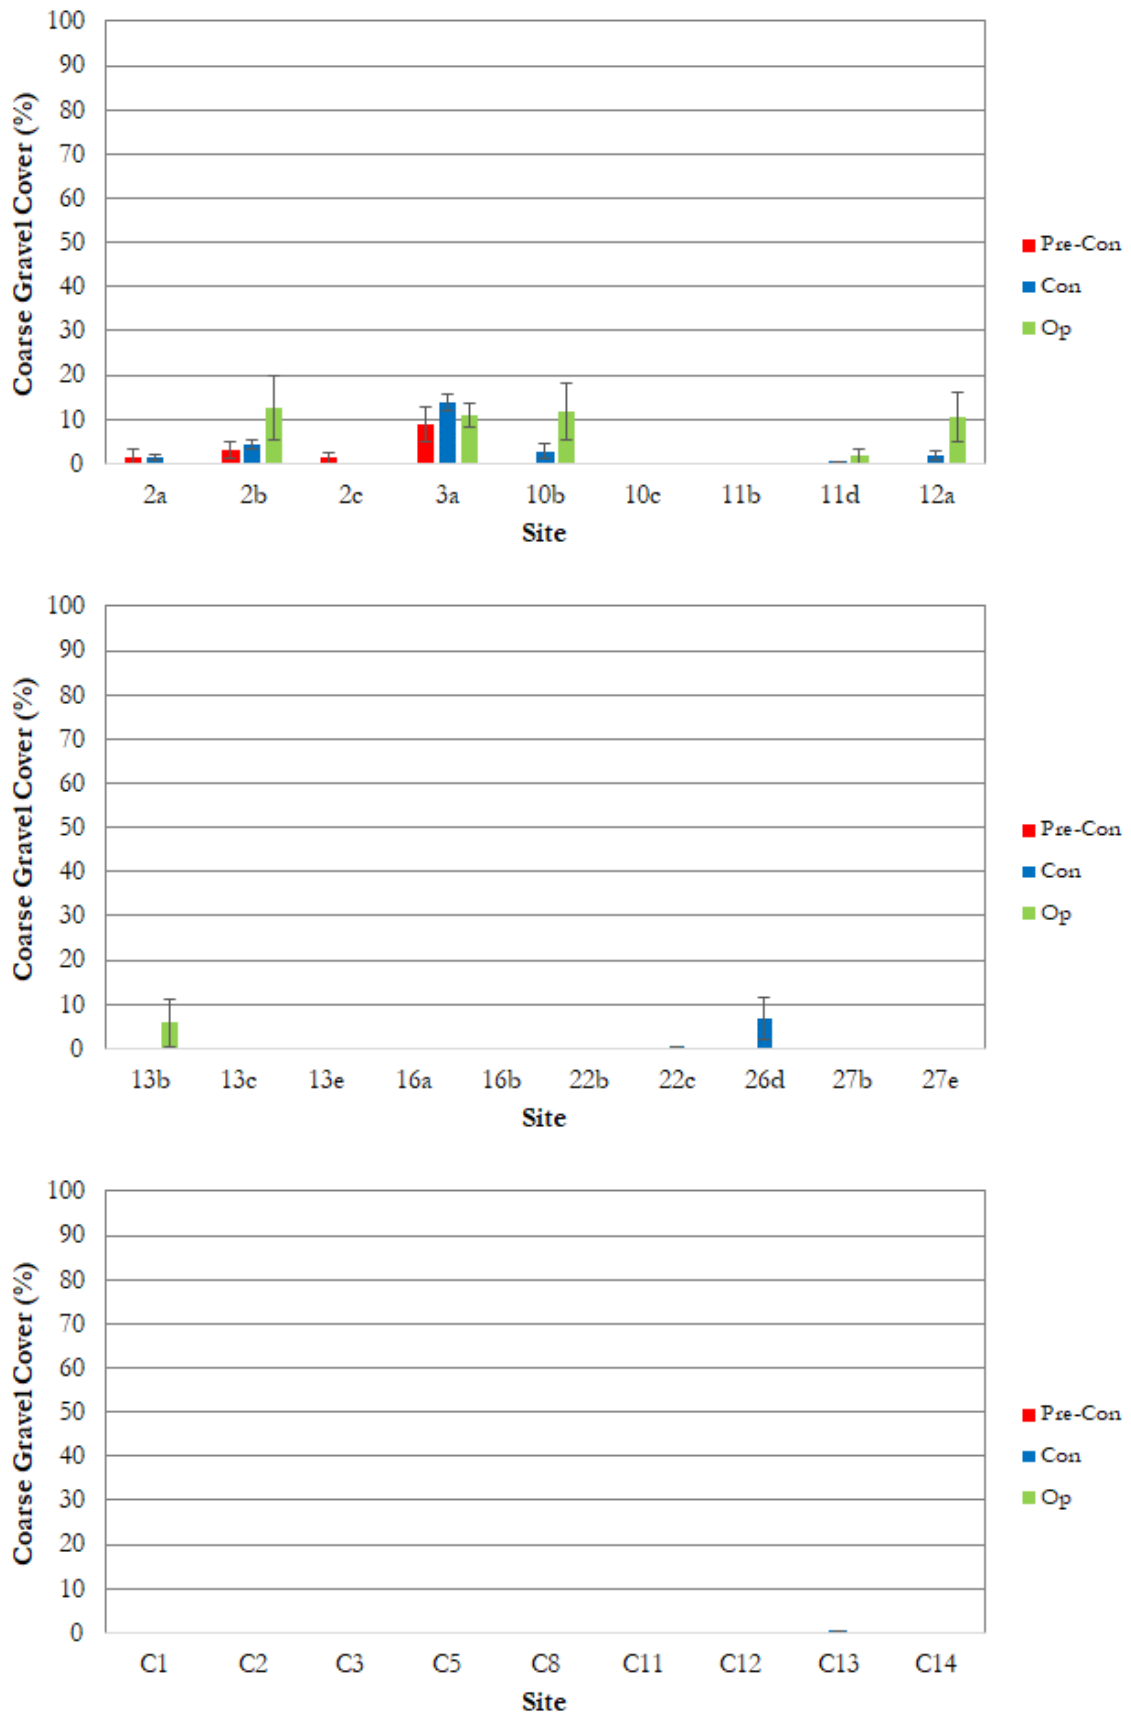
Figure A1 Average (\pm SE) habitat measurements at each site in the pre-construction and construction phases of monitoring

A graphical assessment of the habitat data collected in the pre-construction, construction and operational (to date) phases of monitoring is presented in **Appendix A**. The analysis indicates significant differences between data collected in the pre-construction, construction and operational (to date) phases at a relatively low number of sites and for some variables only. In general, the observed differences are evenly spread between the impact and control sites. Many of the differences observed are simply a function of hydrological condition, such as width and depth measurements or, in some cases, aquatic vegetation cover, benthic material, trailing vegetation and stream bank form, which can vary at some sites in relation to the water depth and width. Observer bias is also a significant factor, particularly in relation to variables such as riparian cover. Fixed point photographs at each site (presented in the final annual report) are a useful reference for determining actual differences in such cases. Several disturbances potentially relating to construction impacts were described in the final construction phase monitoring report (TfNSW 2021). Most of these resulted from necessary changes to the shape of waterways associated with crossing designs, clearing of riparian vegetation around bridge abutments and/or material use such as rock utilised as scour protection around bridge abutments. There were also some changes in vegetative cover at crossing sites, for example, where rehabilitation efforts had successfully resulted in increased emergent vegetation cover (See **Plates 4.1 to 4.4**). The results of habitat monitoring during this first year of the operational phase are similar to those of the later years of construction phase monitoring, indicating no changes associated with operation of the highway. Due to the small size of the operational phase dataset the standard errors of the means presented in **Appendix A** are large. It is expected that continued monitoring will lead to a reduction in the variability and that any emerging trends associated with operation of the highway will become clear.
