Woolgoolga to Ballina Pacific Highway upgrade

Threatened Rainforest Communities and Rainforest Plants Monitoring Program Annual Report 2021

Operation Phase Report

**Woolgoolga to Ballina Pacific Highway
Upgrade, Sections 10 & 11, Threatened
Rainforest Communities and Rainforest Plants,
Annual Monitoring Report # 5 (2021)**

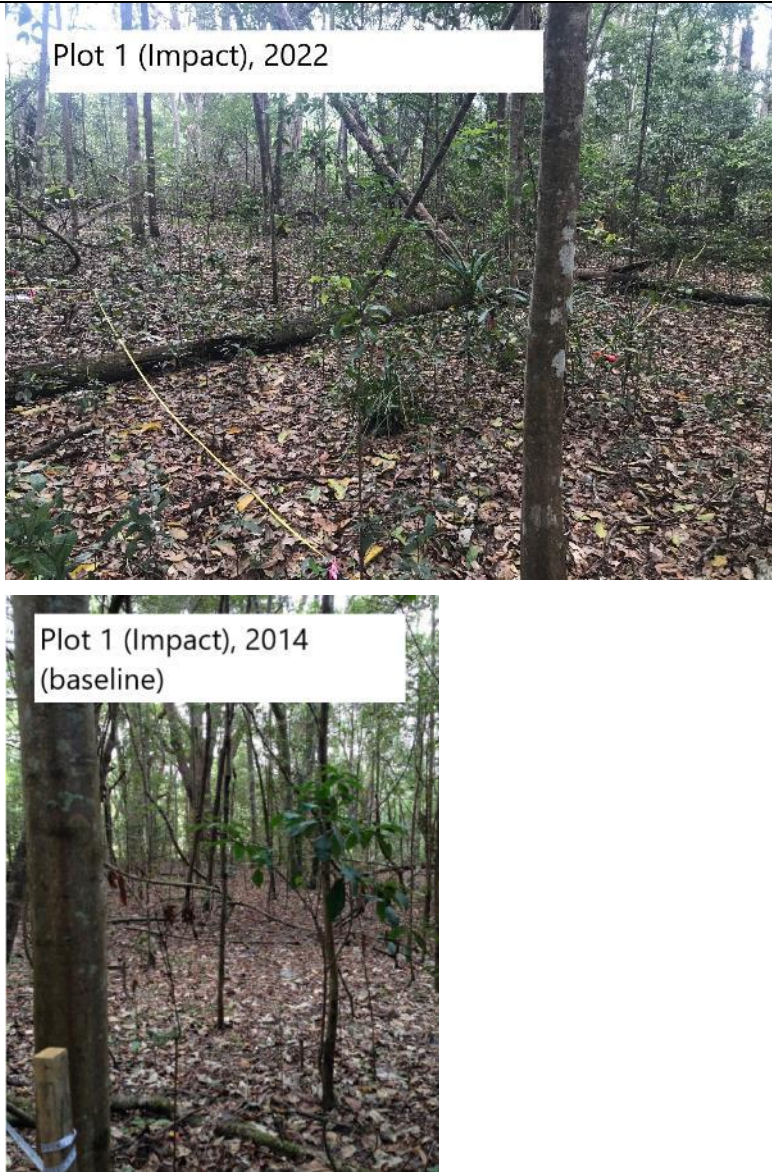
<p data-bbox="252 663 533 703">Plot 1 (Impact), 2022</p> <p data-bbox="240 1249 512 1323">Plot 1 (Impact), 2014 (baseline)</p>	<ul style="list-style-type: none"> <li data-bbox="1066 640 1310 770">• Small increase in weed abundance, esp. <i>Ochna</i>. <li data-bbox="1066 792 1278 922">• Tree fall in subplot a resulting in canopy gap. <li data-bbox="1066 945 1310 1209">• Large increase of <i>Litsea australis</i> in 0-1 m stratum, species appears to be recruiting via root-suckering. <li data-bbox="1066 1232 1310 1464">• Large decrease in vine species <i>Cissus hypoglauca</i> and <i>Smilax</i> following 2019 drought. <li data-bbox="1066 1487 1294 1648">• Medium decrease in native grass spp. following 2019 drought. <li data-bbox="1066 1671 1294 1962">• Steady recruitment of native tree species – Three-veined Laurel, Tuckeroo, Guioa, Foambark.

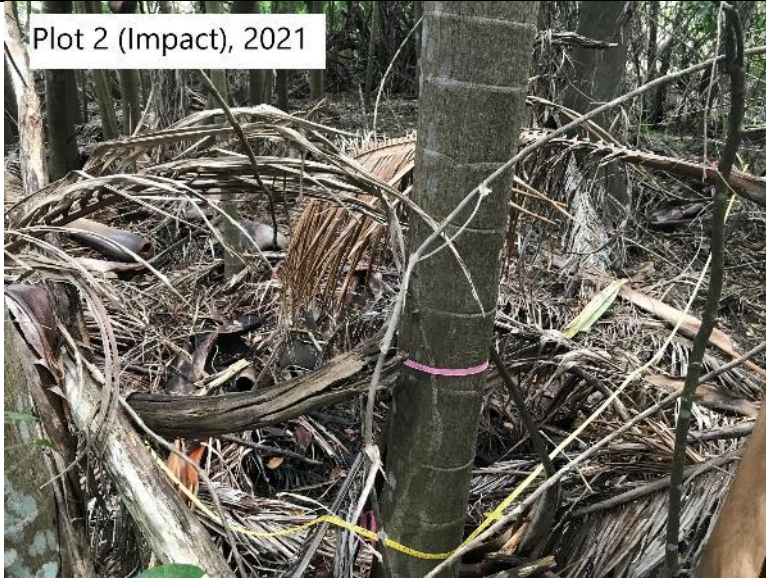
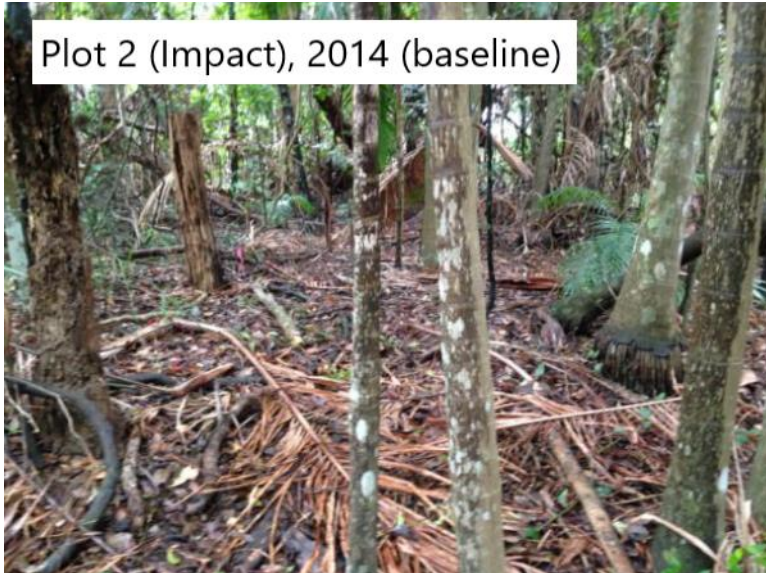
Plot 2 (Impact), 2021

- Medium increase in weed (Devil's Fig and Broad-leaved Paspalum) abundance, mostly next to clearing edge.
- Large increases in vines *Cissus hypoglauca* and Native Wisteria.
- Several annual weed species died out.
- High growth of native tree species in mid strata.

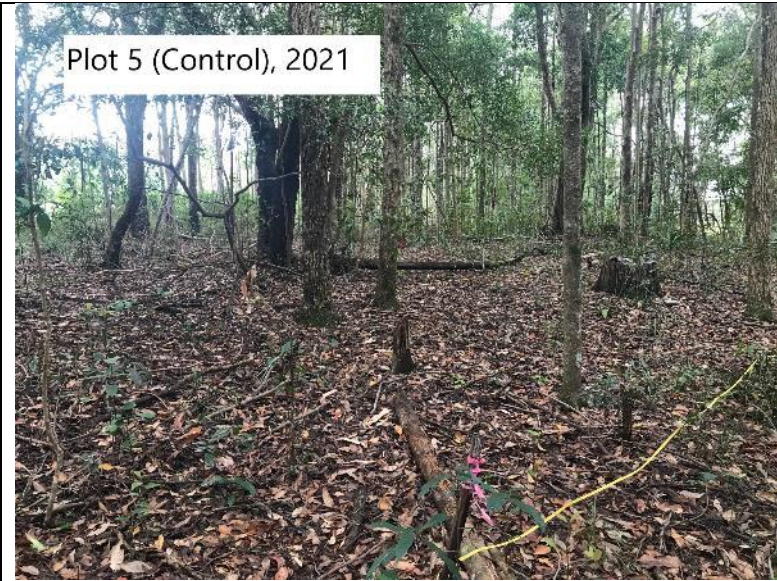
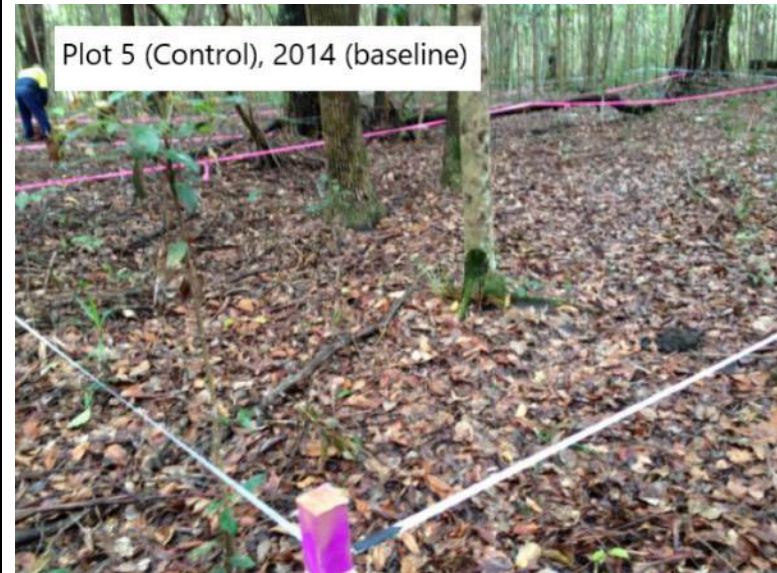
Plot 5 (Control), 2021

- Increase in *Flindersia bennettiana* recruitment.
- Increase in *Litsea australis*, esp. in 0-1 m and 1-5 m strata.
- Most species relatively unchanged.
- Newly recorded species *Cryptocarya triplinervis* and *Diospyros pentamera*.
- New recorded in plot since baseline monitoring includes *Celtis paniculata*, *Parsonia straminea*, *Pyrrosia rupestris*, *Platynerium bifurcatum*.
- Small infestation of *Ochna serrulata*, only slightly increased.
- Groundcover minimal since monitoring began and has remained unchanged.

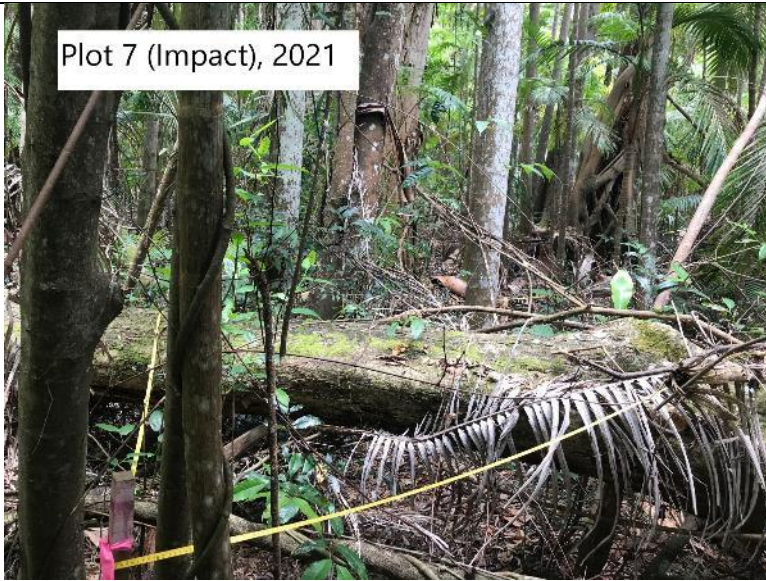
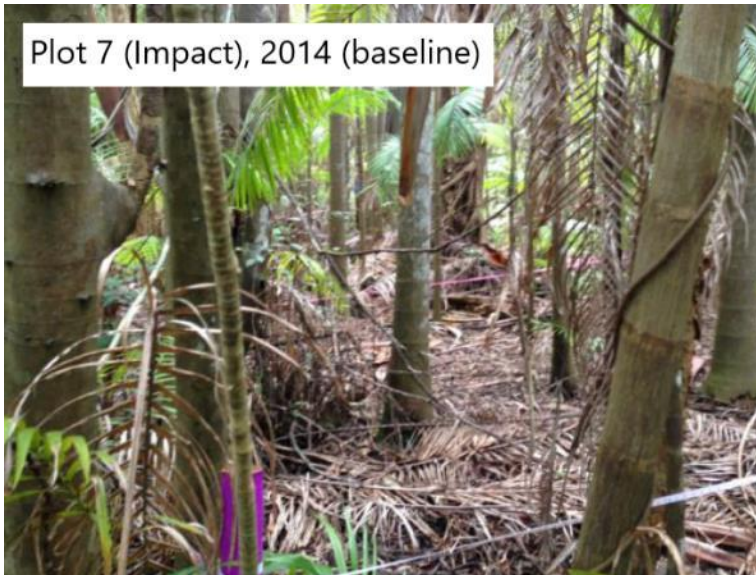
Plot 7 (Impact), 2021

- Increase in Small-leaf Privet in subplot a.
- Coastal Morning Glory (weed) invaded sub-plot a from clearing edge and has slightly increased.
- Most noticeable changes in subplot a, e.g., increase in *Trophis scandens*, *Cordyline stricta* and *Hypolepis muelleri*.
- Tree fall in subplot a resulting in small canopy gap.
- Native tree recruitment mostly Pink Doughwood and Bangalow Palm (species also dominant in canopy).

Some of the current weed infestations at the monitoring sites are more likely to cause a reduction in rainforest condition and a loss of biodiversity in the future. This is the case for infestations at sites 6, 7, and 13. At site 6 (Control) there is a patch of *Ochna* that has increased substantially since the site was first visited in 2014. The patch is likely to continue to expand as the understorey is sparse and open (minimal competition) and *Ochna* can tolerate low light-availability underneath rainforest canopies. *Ochna* is difficult and time-consuming to treat as it has a high tolerance to herbicide, meaning substantial time and resources are required to control large infestations.

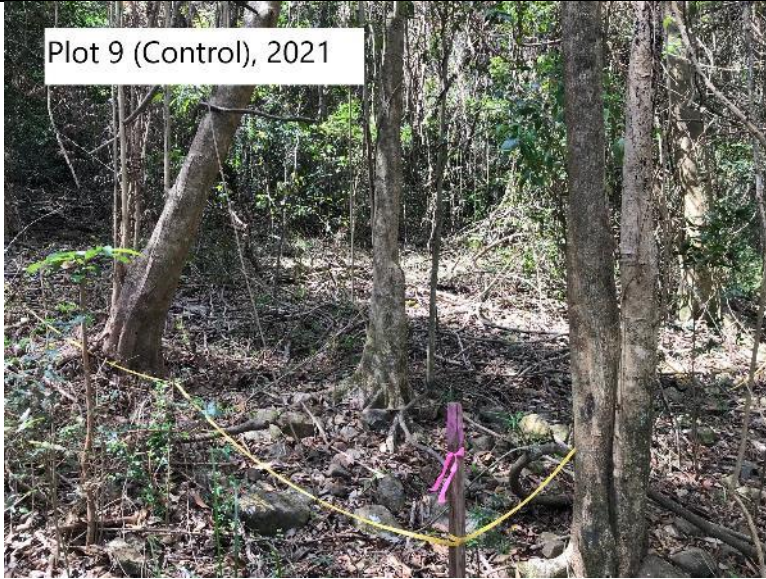
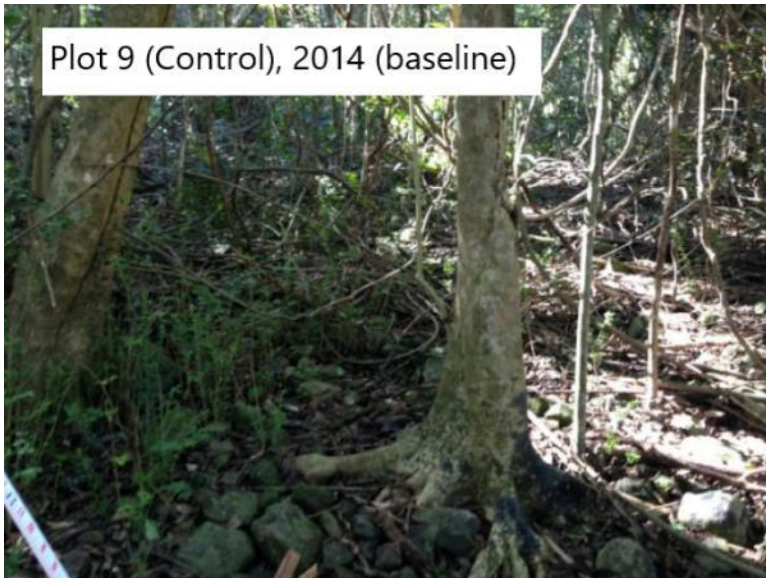
Plot 9 (Control), 2021

- Large-leaved Privet was dominant species in canopy.
- Bush regeneration work undertaken in 2020, Large-leaved Privet trees poisoned resulting in canopy gaps and increased sunlight.
- Large-leaved Privet seedling germination thick since trees poisoned.
- Increase in scrambler *Calamus muellerii*, mostly in sub-plots *b*, *c*, and *d*.
- Vine mass thick in most of plot.
- Minimal native tree recruitment since monitoring program began.
- Coastal Morning Glory recently invaded plot and beginning to increase.

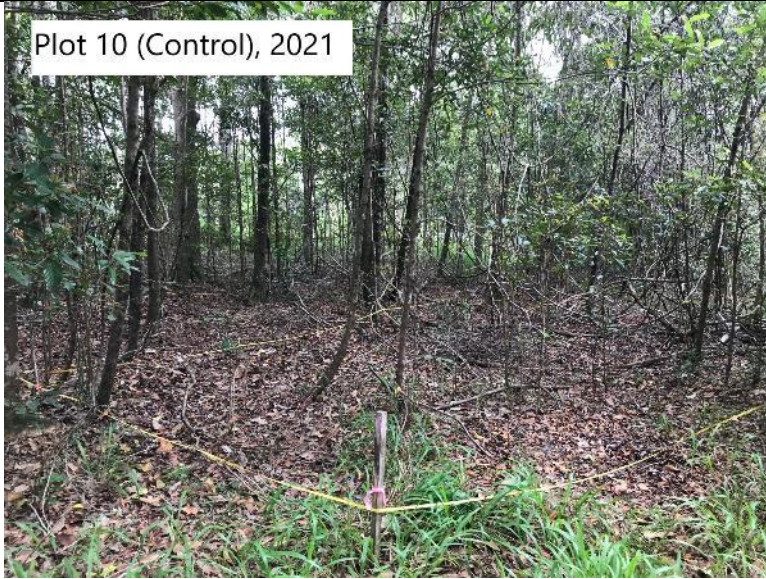
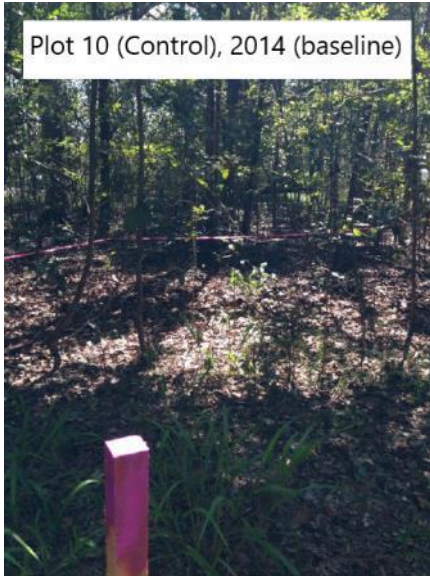
Plot 10 (Control), 2021

- Floristics of plot have remained relatively unchanged since monitoring program began.
- Plot dominated by *Litsea australis* which is recruiting via root-suckering.
- Minimal weeds throughout monitoring program.
- Minimal recruitment of native tree species.

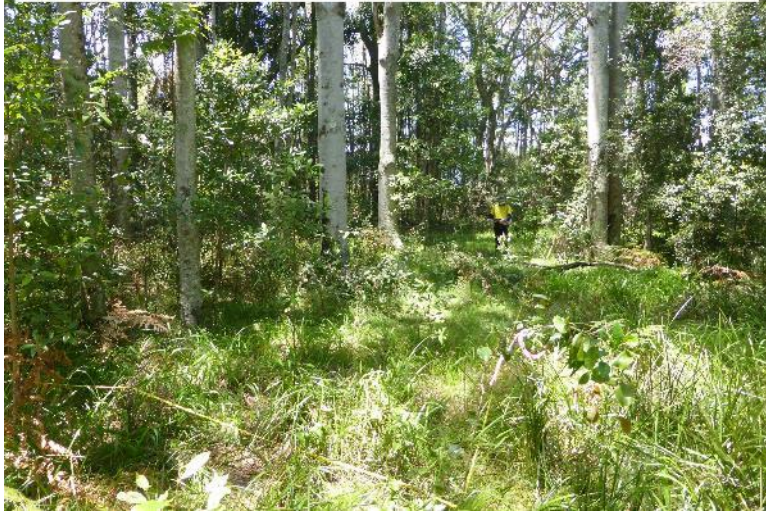
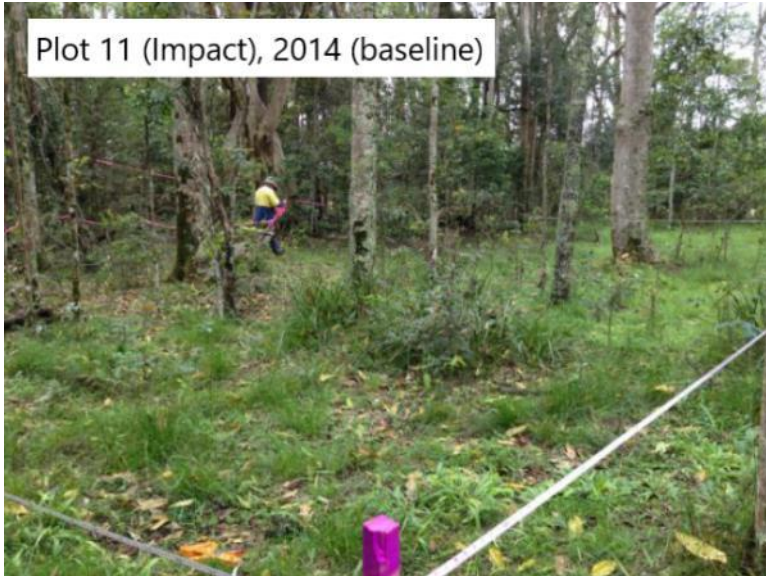
Plot 11 (Impact), SE Corner, Spring 2020

- Medium growth in mid strata of native tree species since monitoring program began.
- Small increases in weed species
Climbing Asparagus, Lantana, Ochna.
- Bush regeneration work undertaken, treatment of understorey weeds.
- Floristics in groundcover and canopy relatively unchanged.

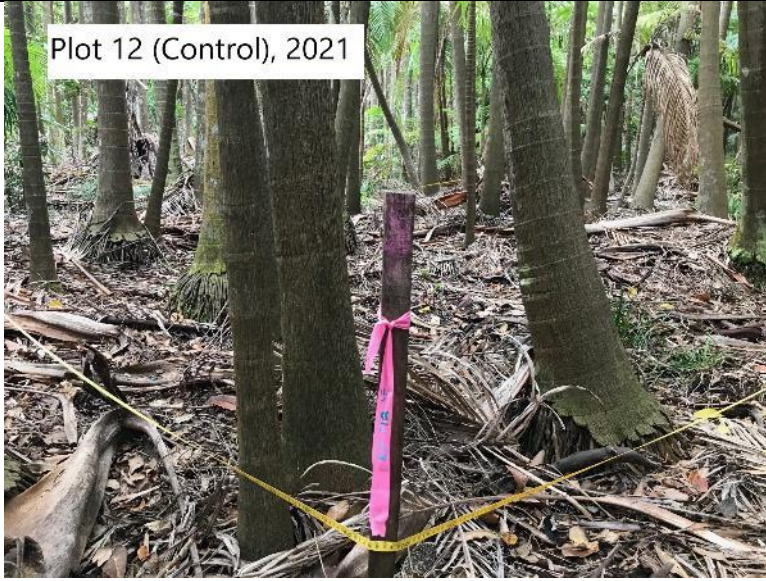
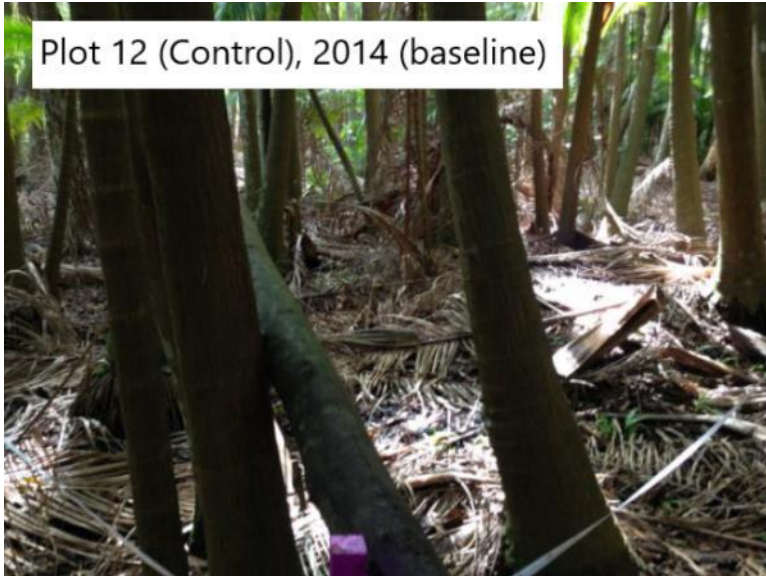
Plot 12 (Control), 2021

- Floristics of plot have remained mostly unchanged since monitoring program began.
- Weeds minimal/absent.
- Small increase in ferns *Blechnum cartilagineum* and *Hypolepis muelleri*.
- Small increase in sedge *Carex maculata*.
- Native tree recruitment low.

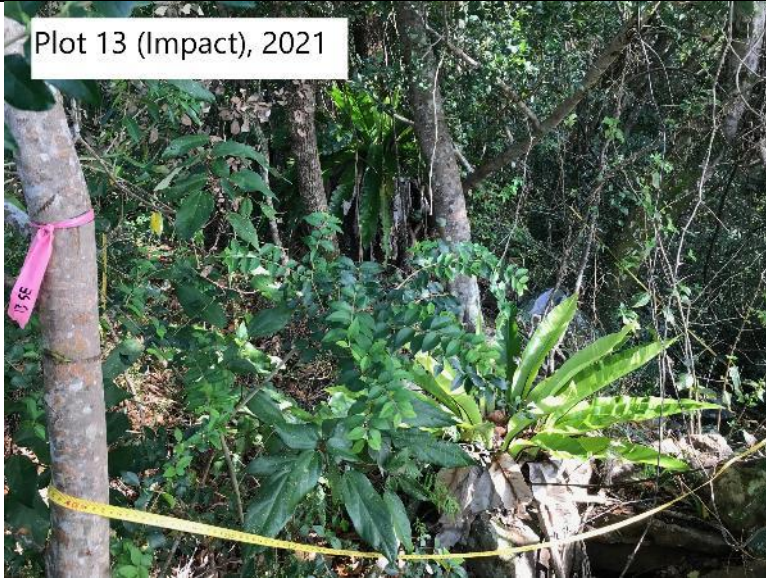
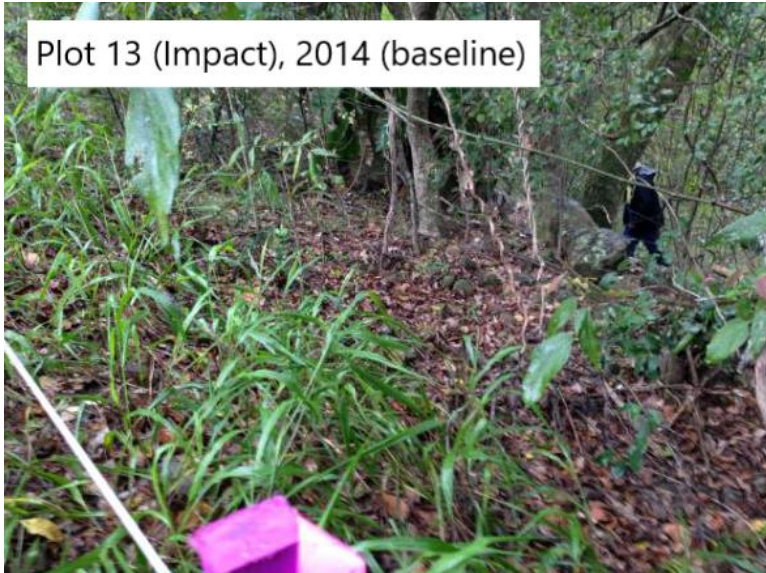
Plot 13 (Impact), 2021

- Large increase in weed abundance since monitoring program began, species including Small-leaved Privet, Broad-leaved Paspalum, Climbing Asparagus, Madeira Vine, Coastal Morning Glory, Ochna.
- Weed abundance higher in NE corner of plot at edge of clearing.
- Decrease in native grass spp.
- High growth of species in mid strata.
- Native tree recruitment includes Sweet Pittosporum, Red Kamala, Guioa.

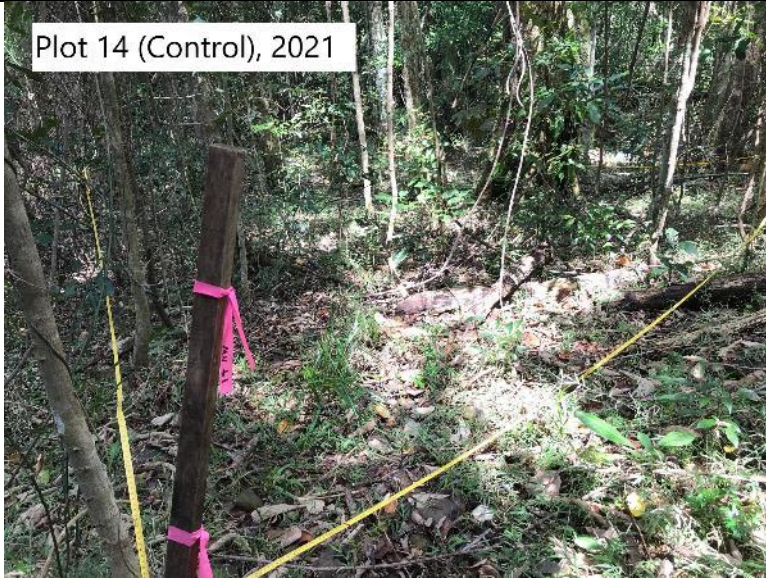
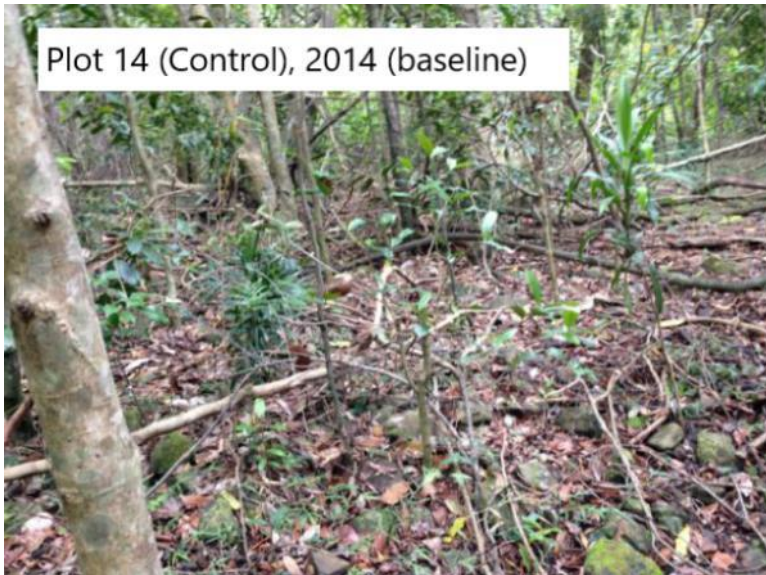
Plot 14 (Control), 2021

- Steady growth of species in mid strata.
- Increase in vine mass, esp. *Calamus muelleri*.
- Steady recruitment of native tree species – Three-veined Laurel, *Baloghia inophylla*, Guoia.
- Decrease in native grass spp.
- Increase in weed abundance in NE corner of plot where there is a canopy gap, species include Climbing Asparagus, Lantana, Broad-leaved Paspalum.

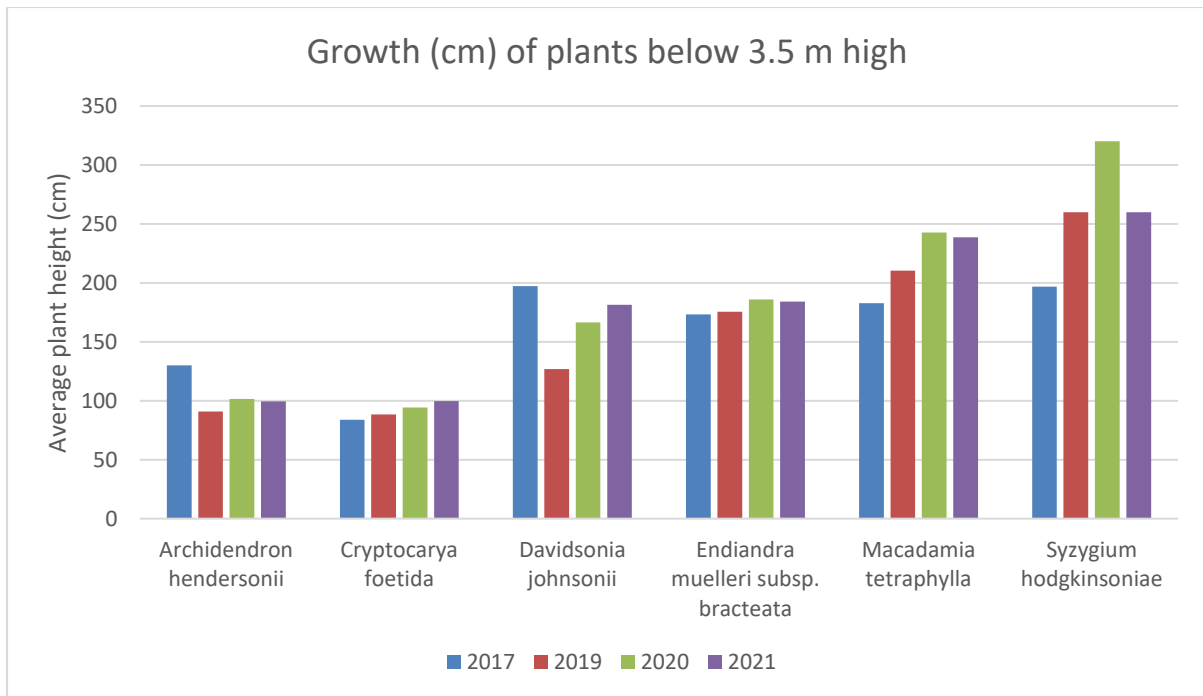
Figure 5 shows the growth of plants below 3.5 m high (see Section 3.2 for why heights above 3.5 m were excluded) for each species in 2017, 2019, 2020 and 2021. Note, Rusty Rose Walnut and Southern Ochrosia were not included in the graph because there is only one plant being monitored for these species.

Figure 5. Average plant height (cm) of threatened species in 2017, 2019, 2020 and 2021 for plants under 3.5 m high. Note, Rusty Rose Walnut and Southern Ochrosia were not included because there is only one plant being monitored for these species.

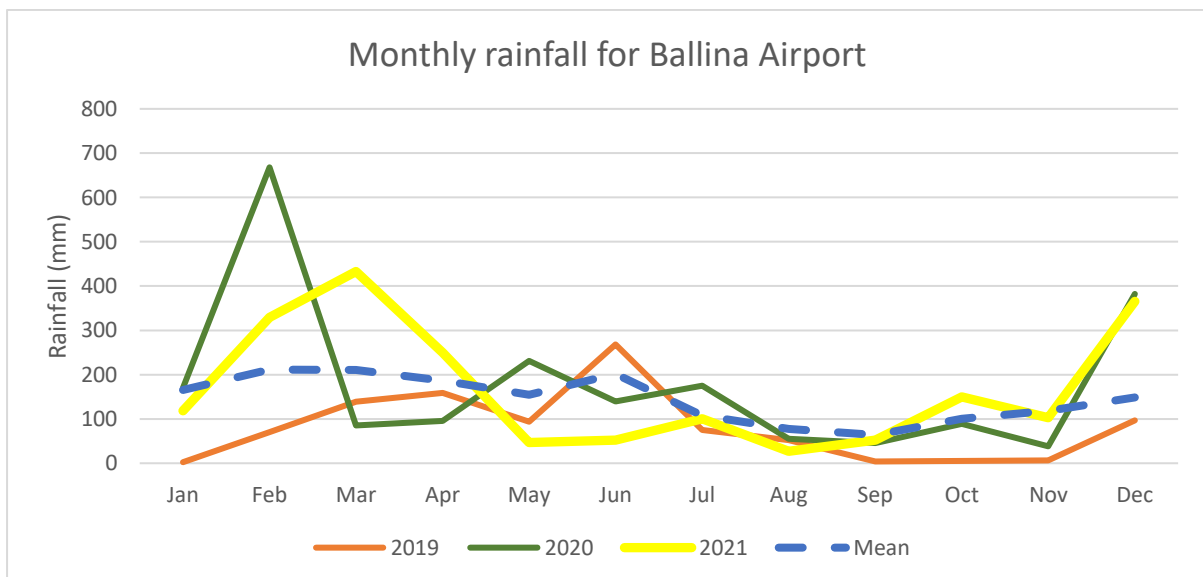
Figure 6. Monthly rainfall for Ballina Airport AWS, in 2017, 2019, 2020 and 2021, and mean monthly rainfall for 21 years (1992-2021). Data sourced from http://www.bom.gov.au/jsp/ncc/cdio/weatherData/av?p_nccObsCode=139&p_display_type=dataFile&p_startYear=&p_c=&p_stn_num=058198

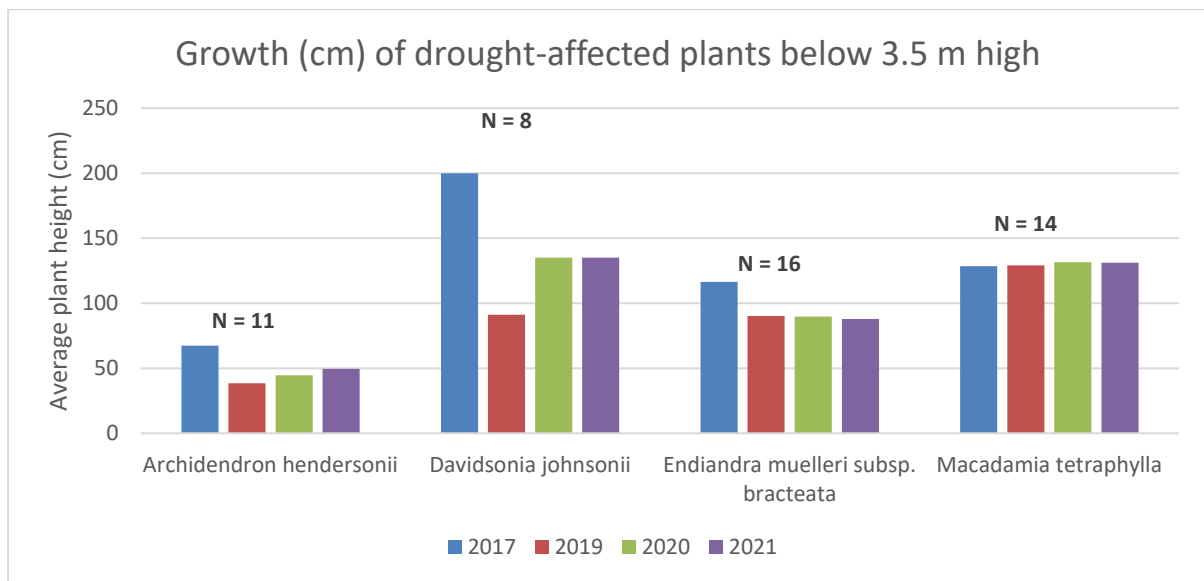
Figure 7. Average plant height (cm) of threatened species in 2017, 2019, 2020 and 2021 for drought-affected plants under 3.5 m high. *N*, sample size.

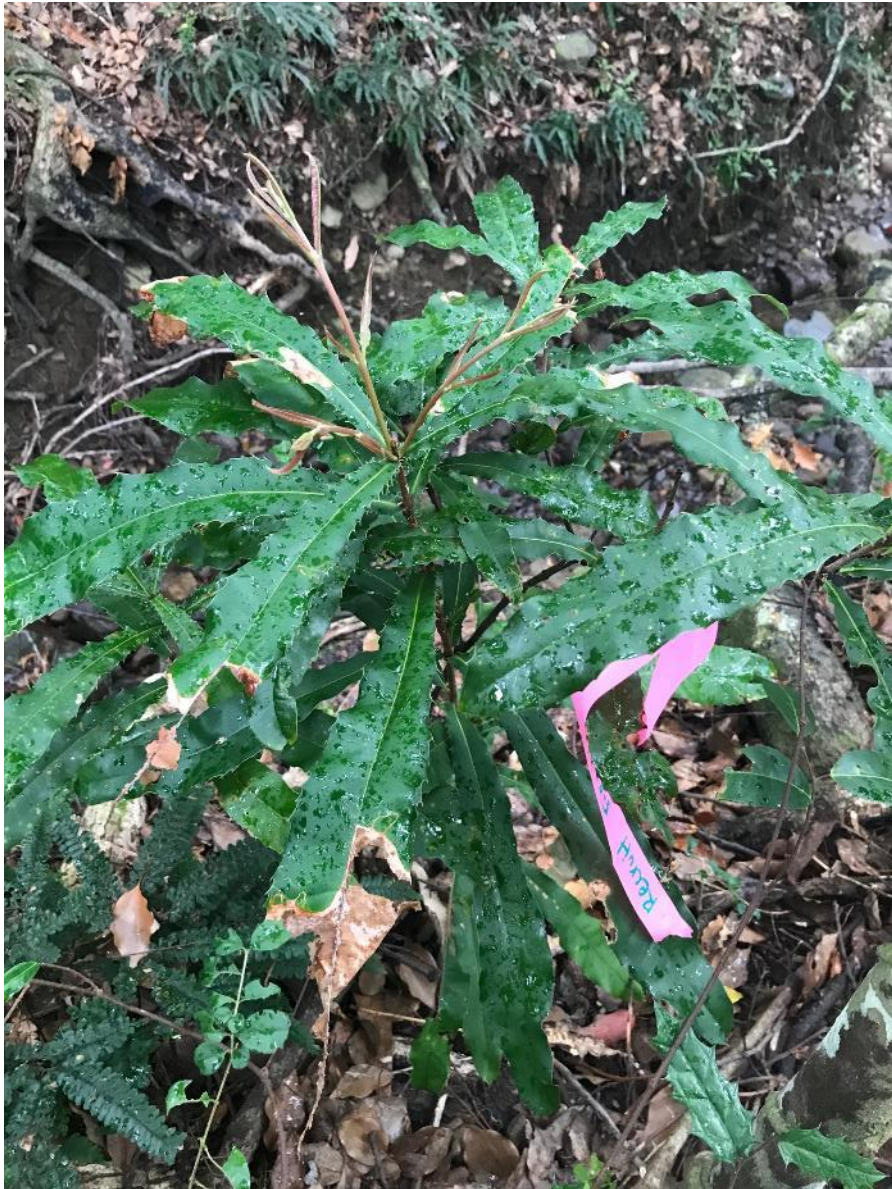
Survival/condition: 100% survival; some plants have insect damage (e.g., Plate 1, Appendix 2) but they have still survived and grown (i.e., increased in height).

Plate 1. *Macadamia tetraphylla* juvenile with leaf damage.

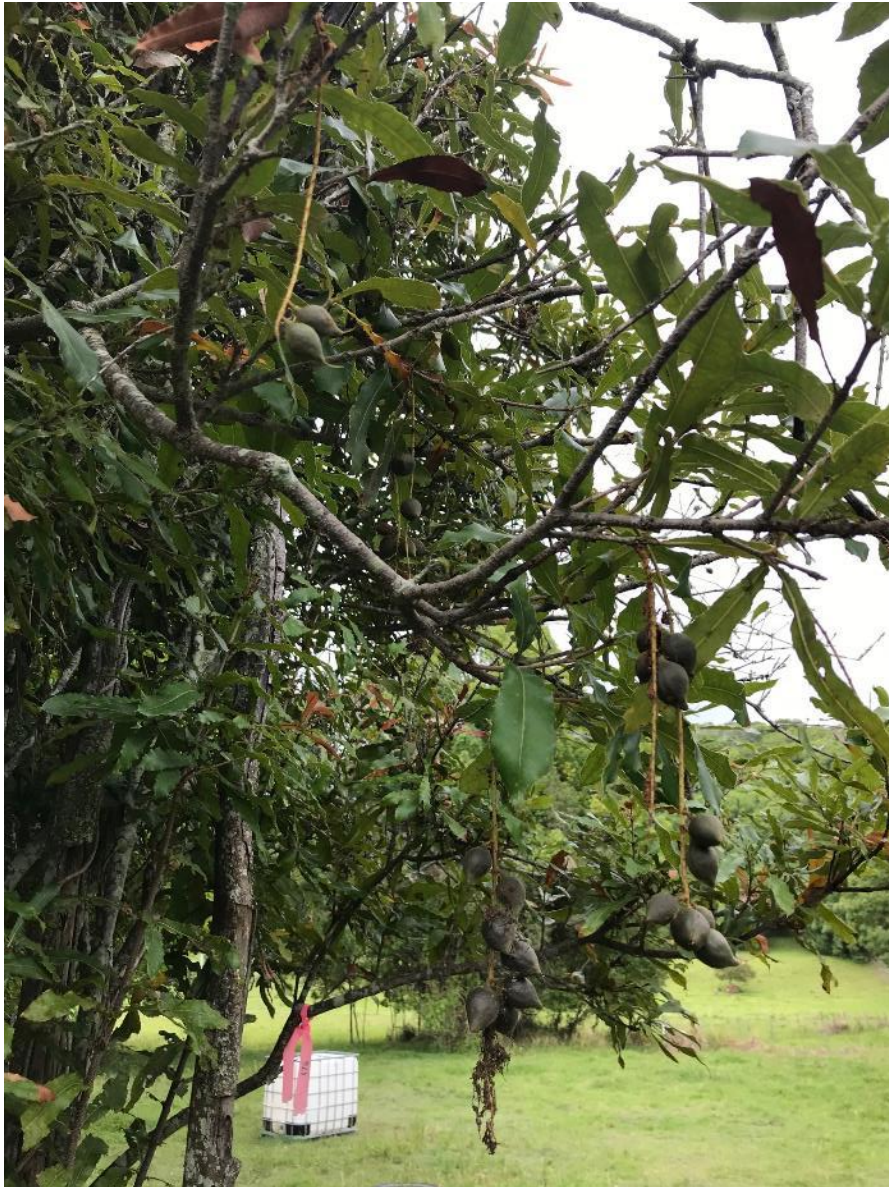
Plate 2. *Macadamia tetraphylla* fruit developing. Monitoring ID 176.

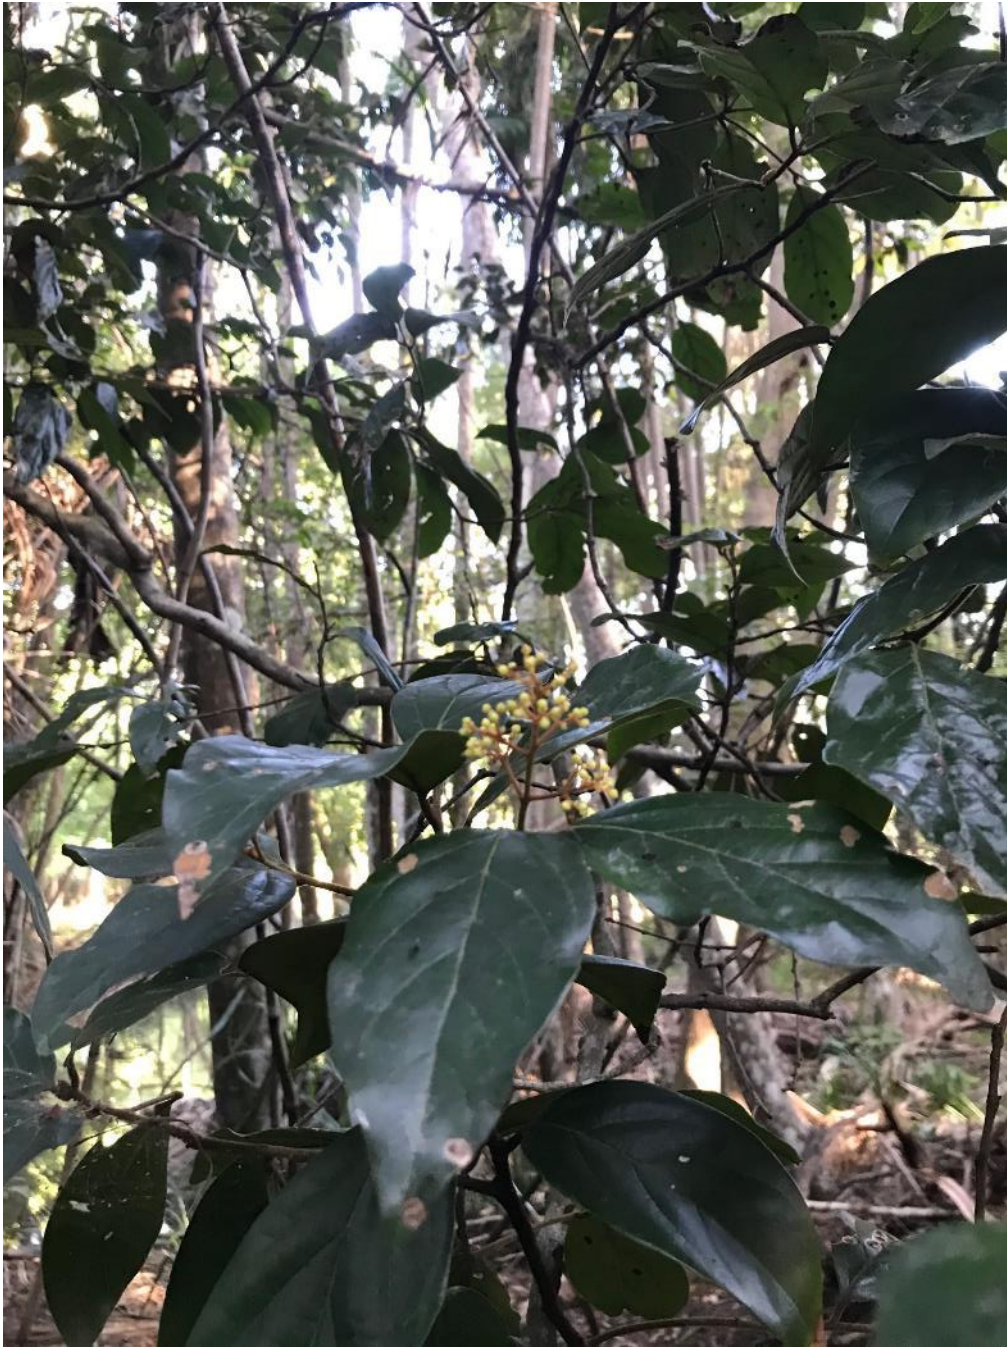
Reproduction: one plant was observed flowering in 2021 (Plate 3, Appendix 2).

Plate 3. *Endiandra muelleri* subsp. *Bracteata* flowers developing. Monitoring ID 84.

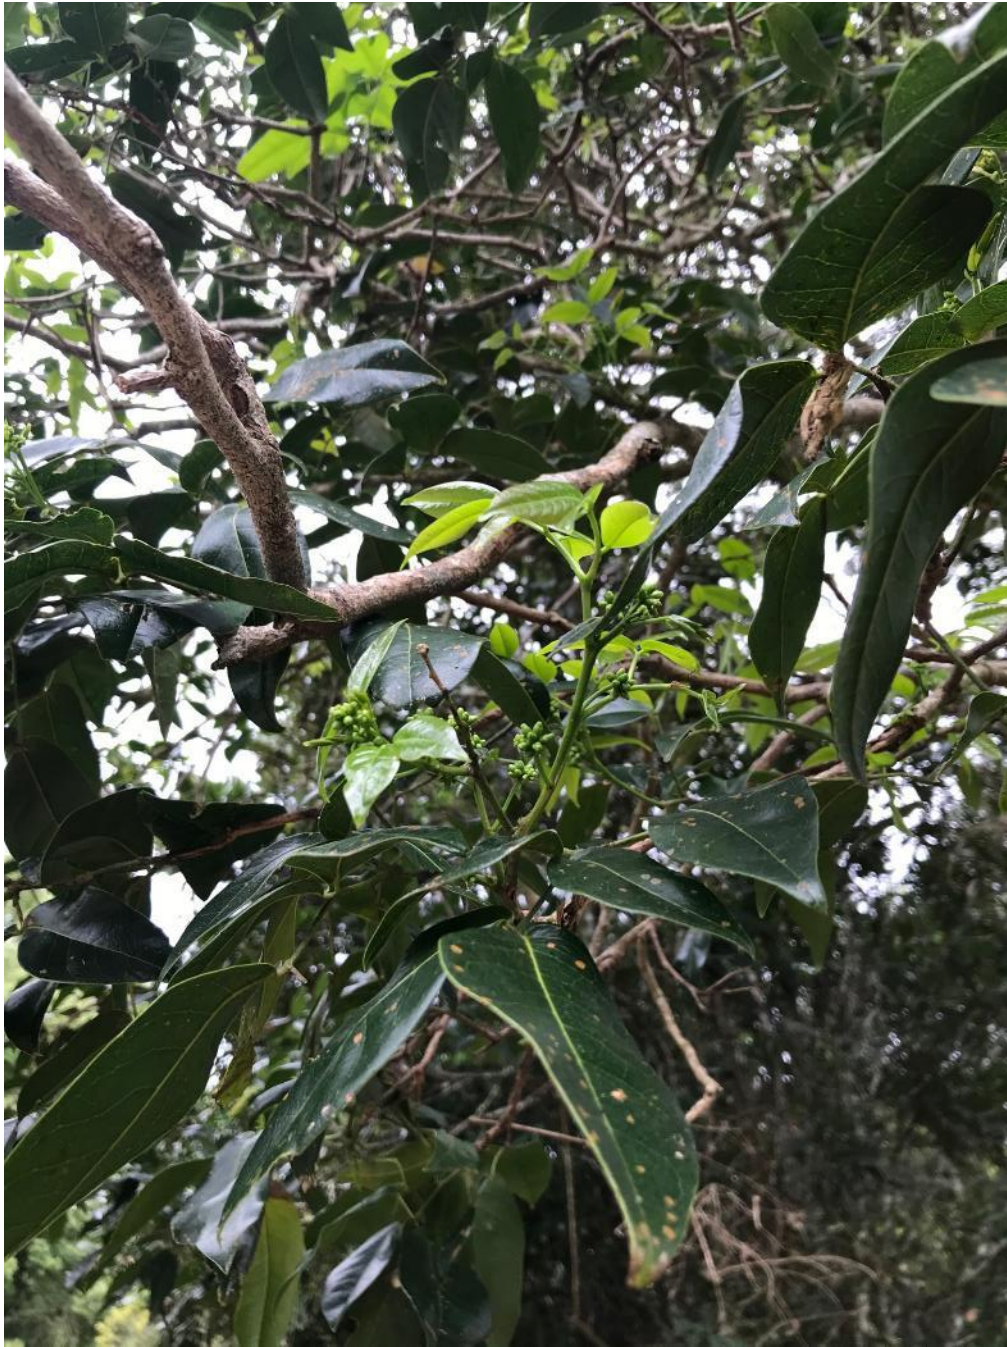
Reproduction: one plant was observed flowering in 2021 (Plate 4, Appendix 2).

Plate 4. *Archidendron hendersonii* flowers developing. Monitoring ID 169.

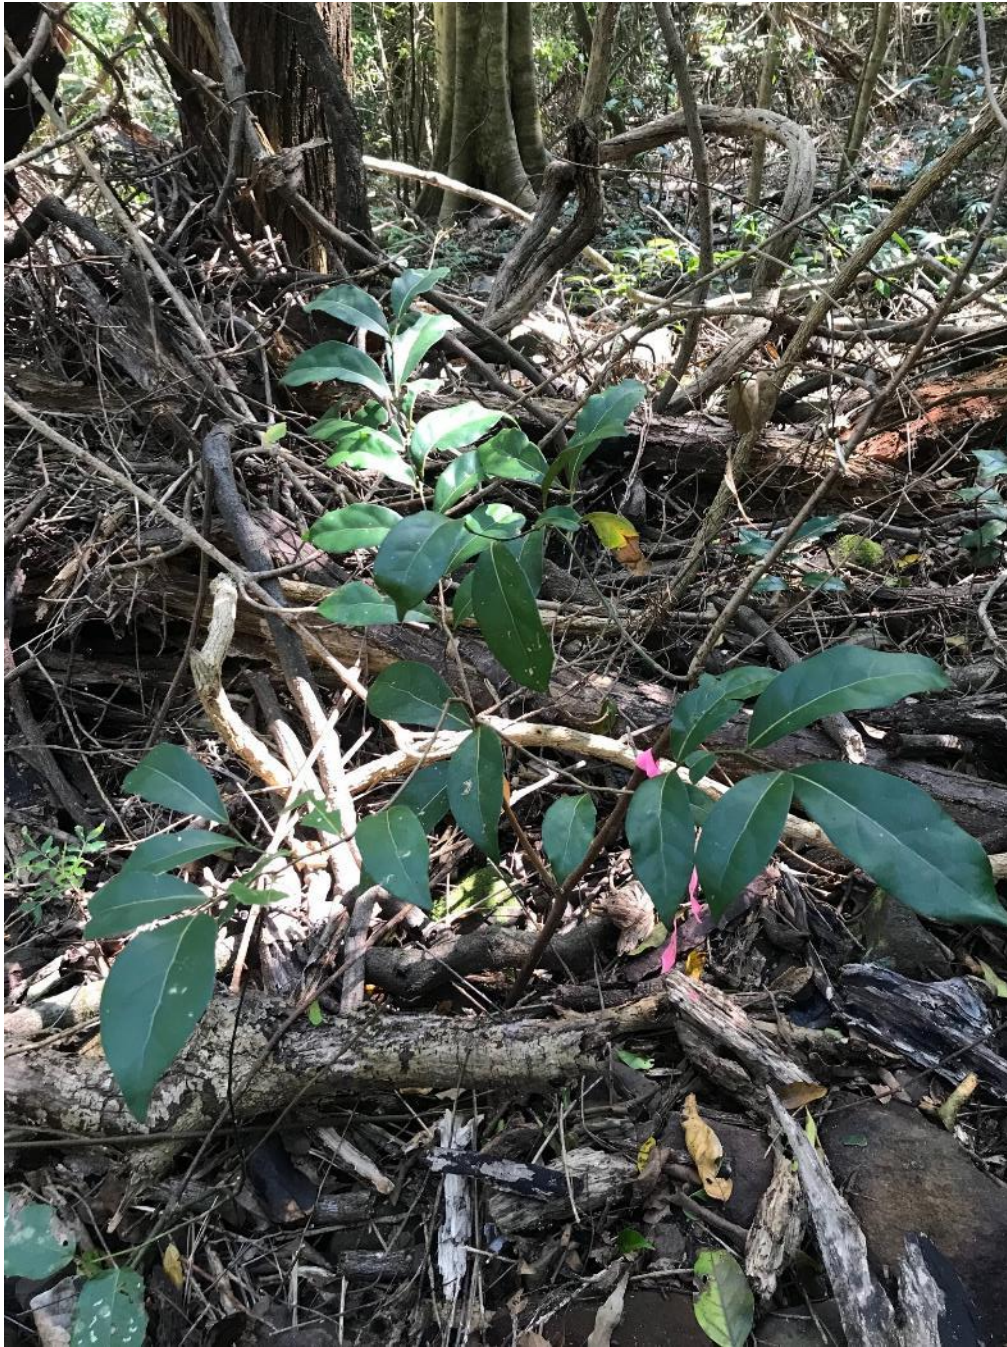
Survival/condition: survival was 100% in 2021 and plants were in healthy condition (Plate 5, Appendix 2).

Plate 5. *Cryptocarya foetida*. Monitoring ID 130.

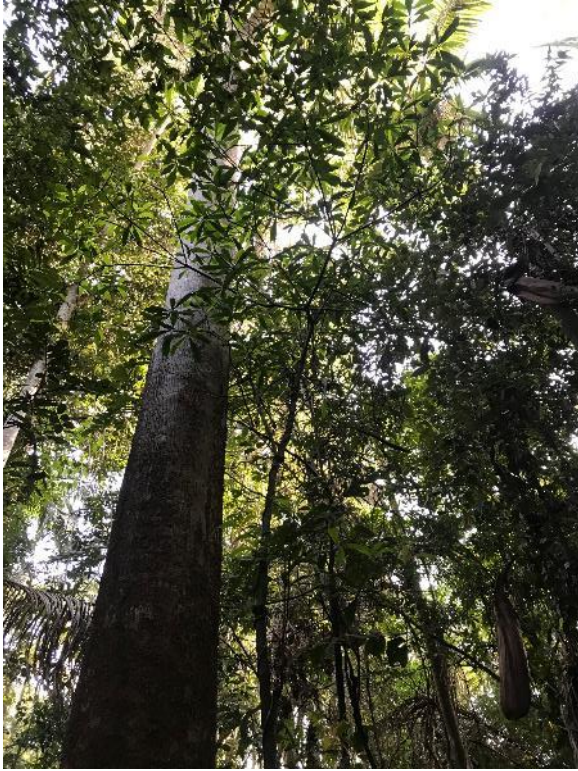
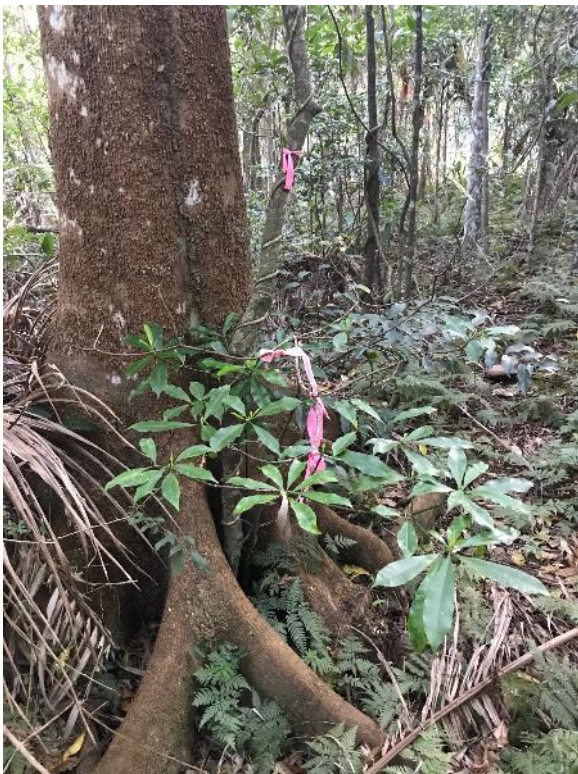
Plate 6. *Ochrosia moorei*.

Survival/condition: only one plant of this species is being monitored and this plant was in healthy condition in 2021 (Plate 6, Appendix 2).

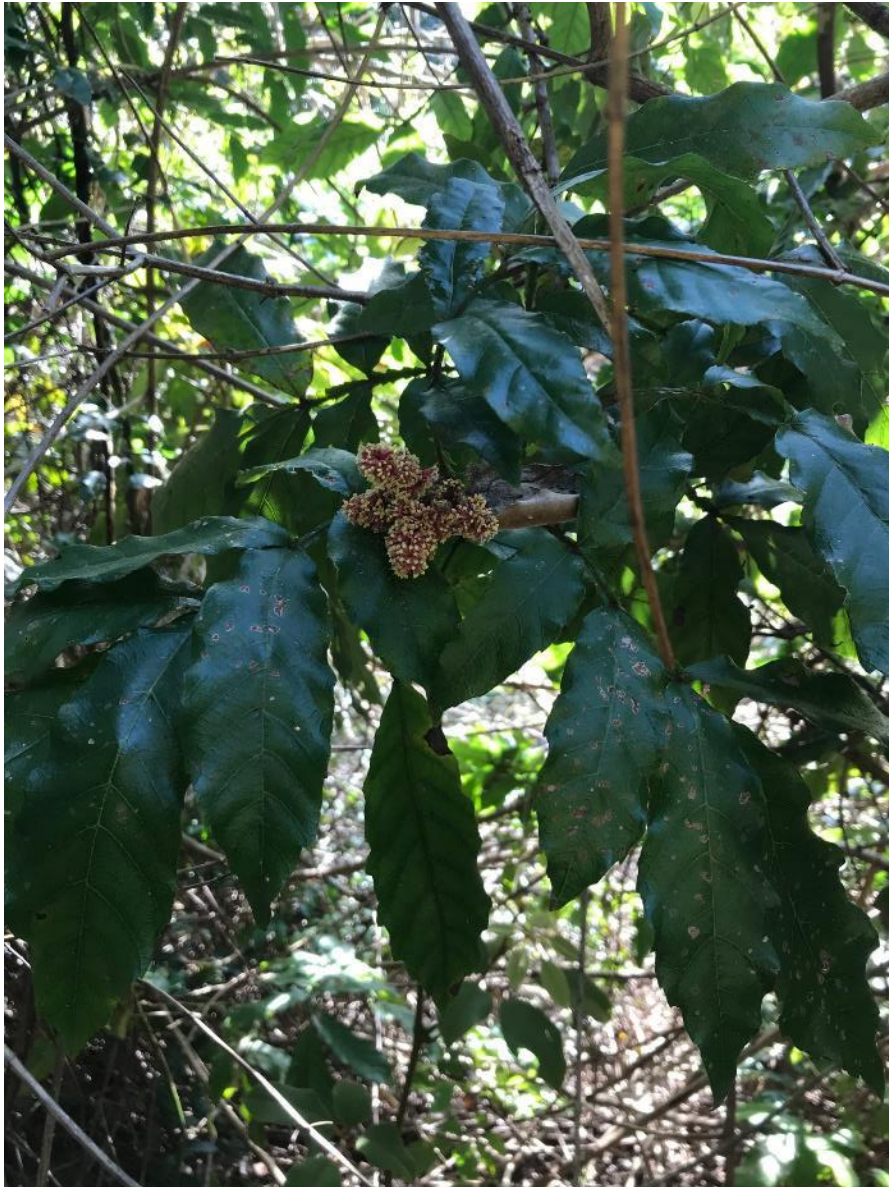
Reproduction: one plant was observed flowering in 2021 (Plate 7, Appendix 2).

Plate 7. *Davidsonia johnsonii* flowering. Monitoring ID 184.
