Oxley Highway to Kempsey

2022/2023 Annual Ecological Monitoring Report

Transport for NSW | October 2023

This report provides an update on the ecological monitoring associated with the Oxley Highway to Kempsey Pacific Highway upgrade.

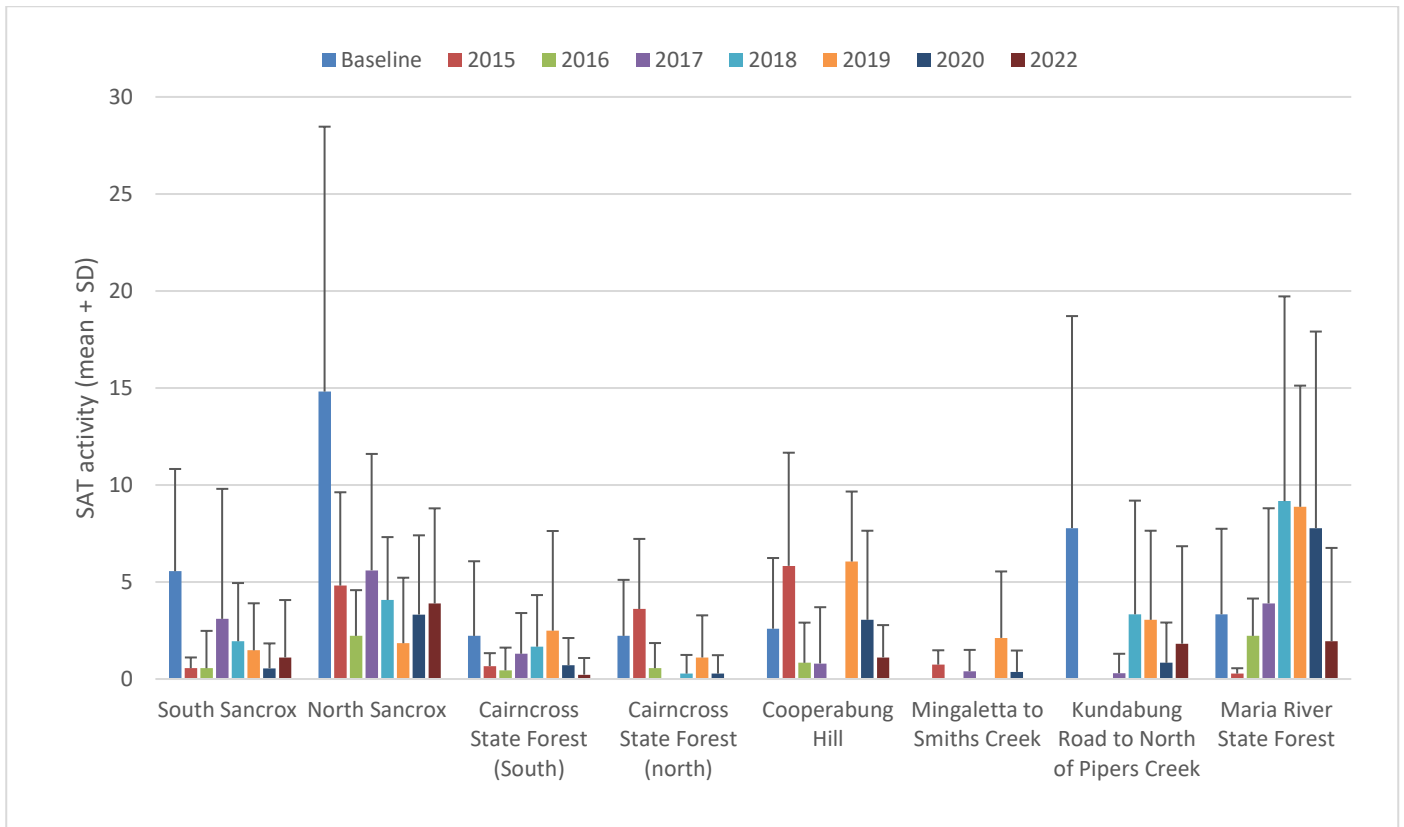
Graph 3: Koala activity across the eight monitoring areas

Monitoring area	Baseline	2015	2016	2017	2018	2019	2020	2022
South Sancrox	5.6% (SD5.3)	0.6% (SD1.3)	0.6% (SD1.9)	3.1% (SD6.7)	1.9% (SD3.0)	1.5% (SD2.4)	0.6% (SD1.3)	1.1% (SD3.0)
North Sancrox	14.8 (SD13.7)	4.8% (SD5.0)	2.2% (SD2.4)	5.6% (SD6.0)	4.1% (SD3.2)	1.8% (SD3.4)	3.3% (SD4.1)	3.9% (SD4.9)
Cairncross State Forest (South)	2.2% (SD3.8)	0.7% (SD1.9)	0.4% (SD1.2)	1.3% (SD2.1)	1.7% (SD2.7)	2.5% (SD5.1)	0.7% (SD1.4)	0.2% (SD0.9)
Cairncross State Forest (North)	2.2% (SD2.9)	3.6% (SD5.9)	0.6% (SD1.3)	0	0.3% (SD1.0)	1.1% (SD2.2)	0.3% (SD1.0)	0
Cooperabung Hill	2.6% (SD3.6)	5.8% (SD8.8)	0.8% (SD2.1)	0.8% (SD2.9)	0	6.1% (SD3.6)	3.1% (SD1.6)	1.1% (SD1.7)
Mingaletta to Smiths Creek	0	0.7% (SD2.2)	0	0.4% (SD1.1)	0	2.1% (3.4)	0.4% (SD1.1)	0
Kundabung Road to North of Pipers Creek	7.8% (SD10.9)	0	0	0.3% (SD1.0)	3.3% (SD5.9)	3.1% (SD4.6)	0.8% (SD2.1)	1.8% (SD5.0)
Maria River State Forest	3.3% (SD4.4)	0.3% (SD1.0)	2.2% (SD1.9)	3.9% (SD4.9)	9.2% (SD10.6)	8.9% (SD6.2)	7.8% (SD10.1)	1.9% (SD4.8)

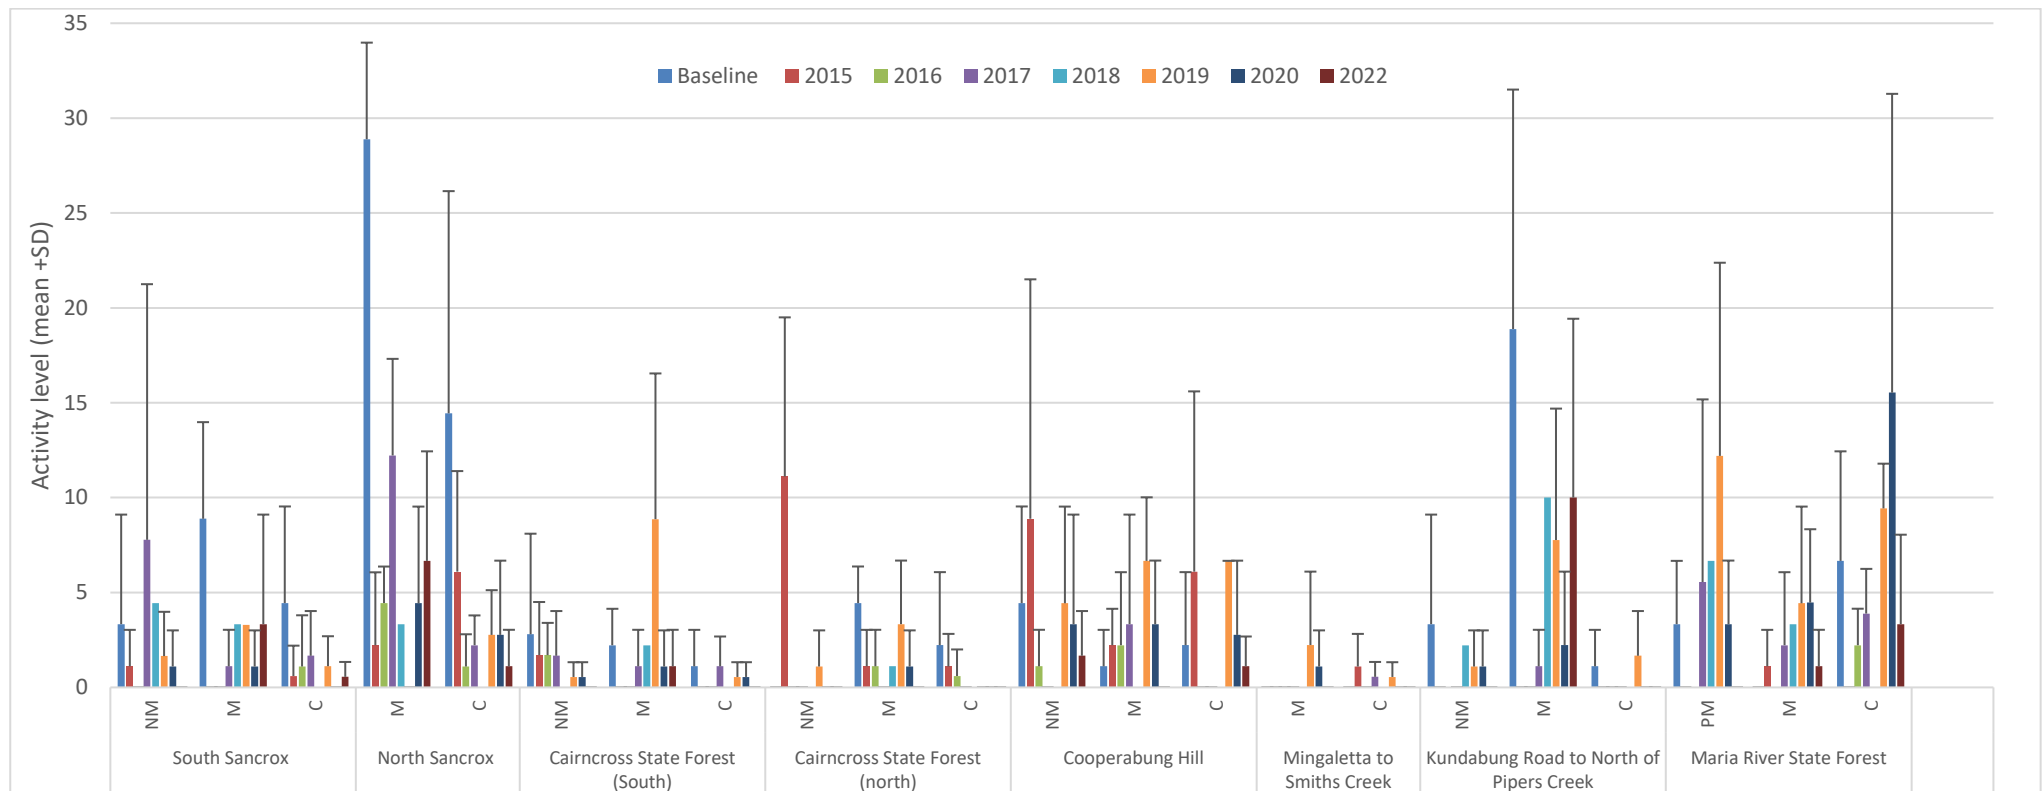
Graph 6. Mean Koala activity for cluster type within areas (mean ± SD)

Koala activity (mean activity of plots) for the treatment types is provided in Table 6 and is shown for each area in Graph 6 (mean activity of all plots within each cluster type for each area). When considering all plots or active plots only (with scats present), average activity levels were lower than baseline levels for all treatment types. The 2022 monitoring plot activity levels were highest in clusters with mitigation and lowest in clusters with no mitigation. Lewis 2014 recommends that analyses should: “Ensure any future comparison of Koala activity levels take into account the following baseline data and with a 10% tolerance level to account for variability:

When considering all plots or active plots only, activity levels for each treatment type have not decreased from the baseline surveys beyond the recommended 10% tolerance level. Nor is there a greater than 10% difference between treatment types.

NM = no mitigation; M = mitigation; C = control; PM = part mitigation.

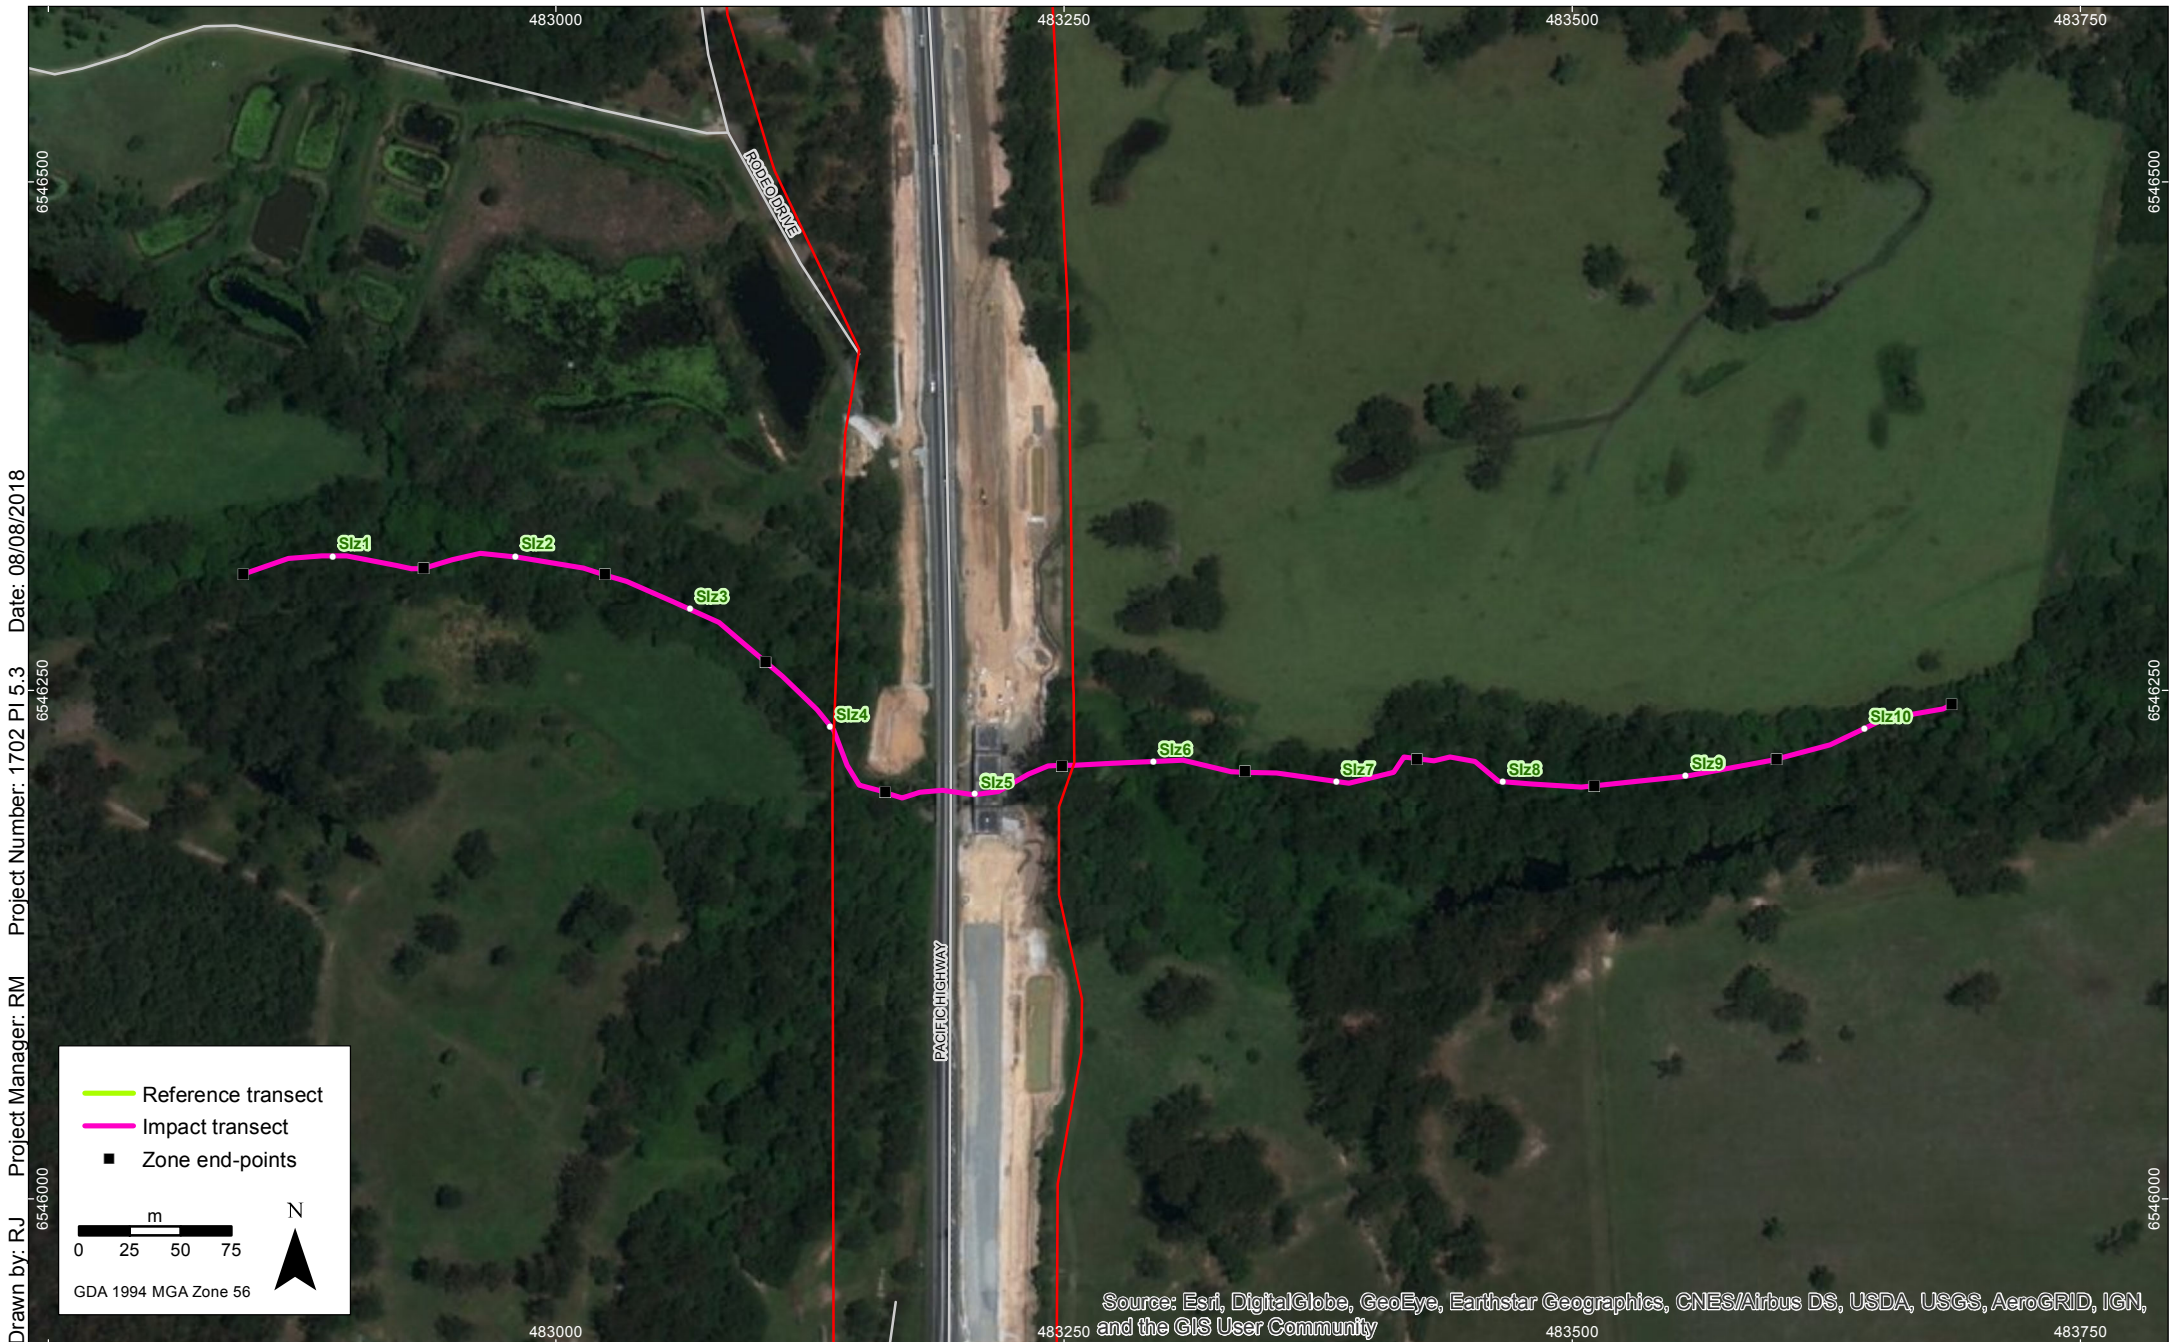
FIGURE 3
 Imagery: (c) DigitalGlobe

Giant Barred Frog monitoring: Smiths Creek impact site
 Pacific Highway Upgrade - Oxley Highway to Kempsey

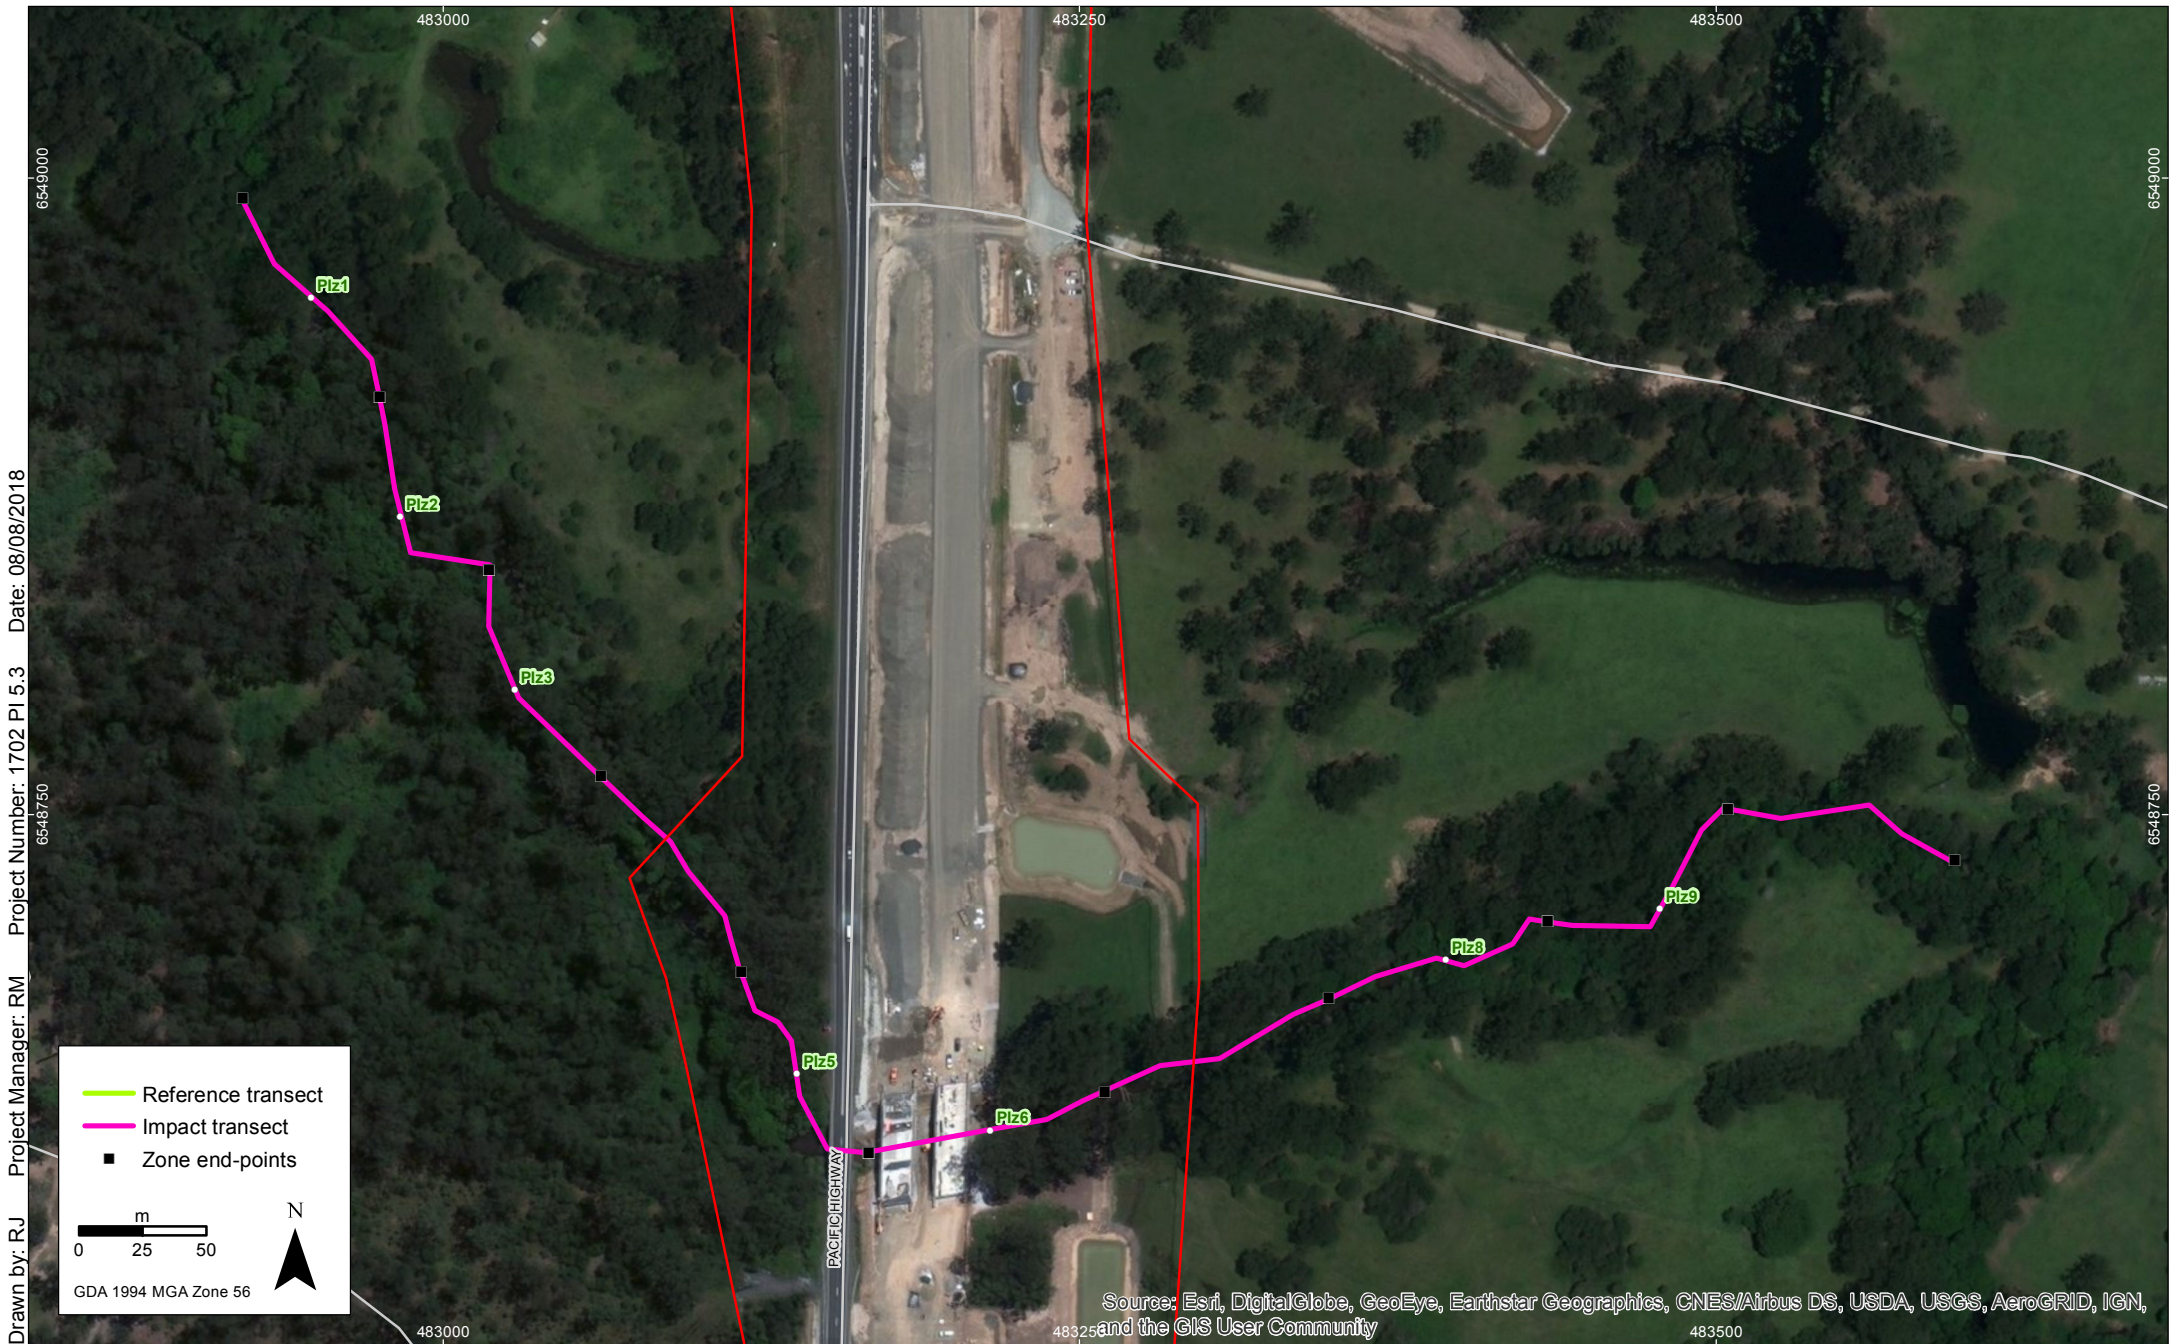
Giant Barred Frog monitoring: Pipers Creek impact site
Pacific Highway Upgrade - Oxley Highway to Kempsey

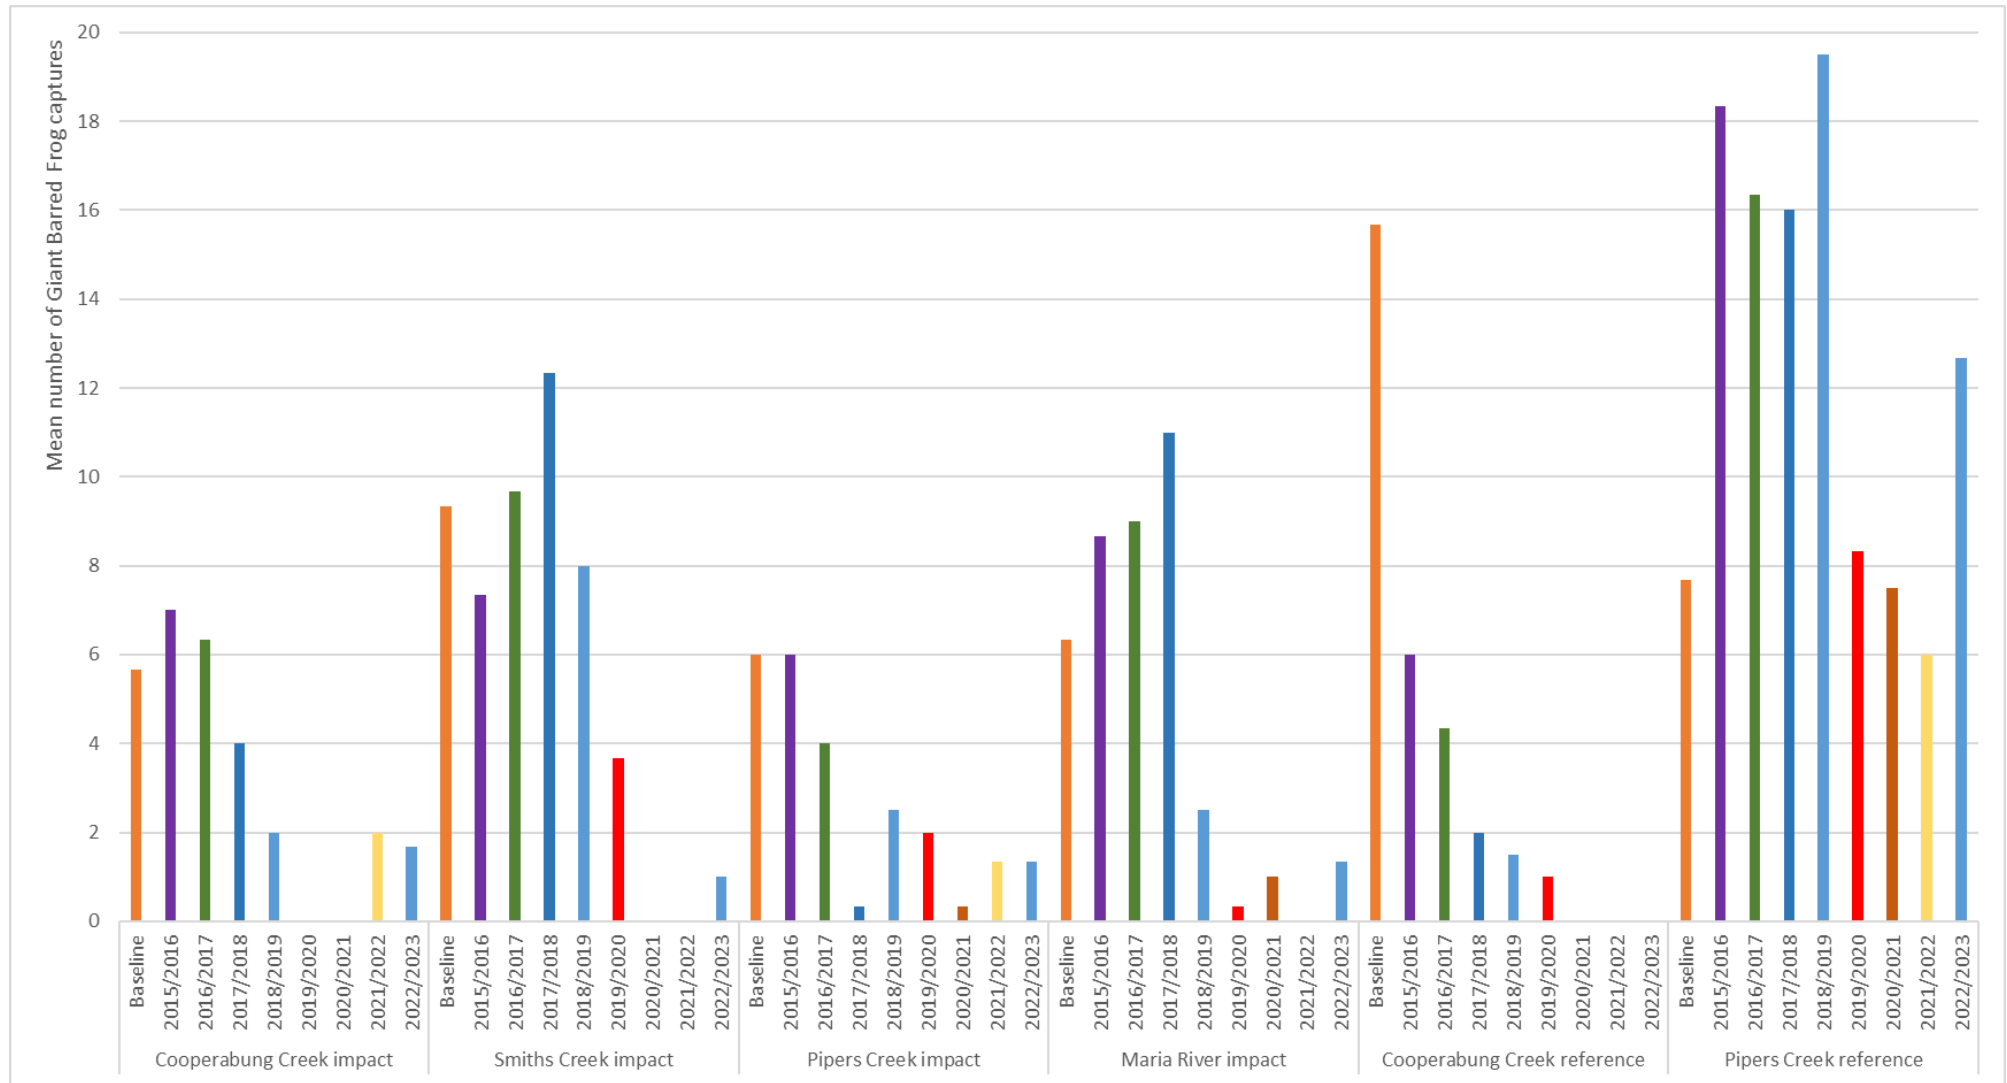
Graph 2: Mean annual Giant Barred Frog records by site

Given the lack of a distinct difference in population trends between impact and reference sites, it is not possible to attribute observed changes in frog numbers to the Project.
