Oxley Highway to Kempsey

2022/2023 Annual Ecological Monitoring Report

Transport for NSW | October 2023

This report provides an update on the ecological monitoring associated with the Oxley Highway to Kempsey Pacific Highway upgrade.

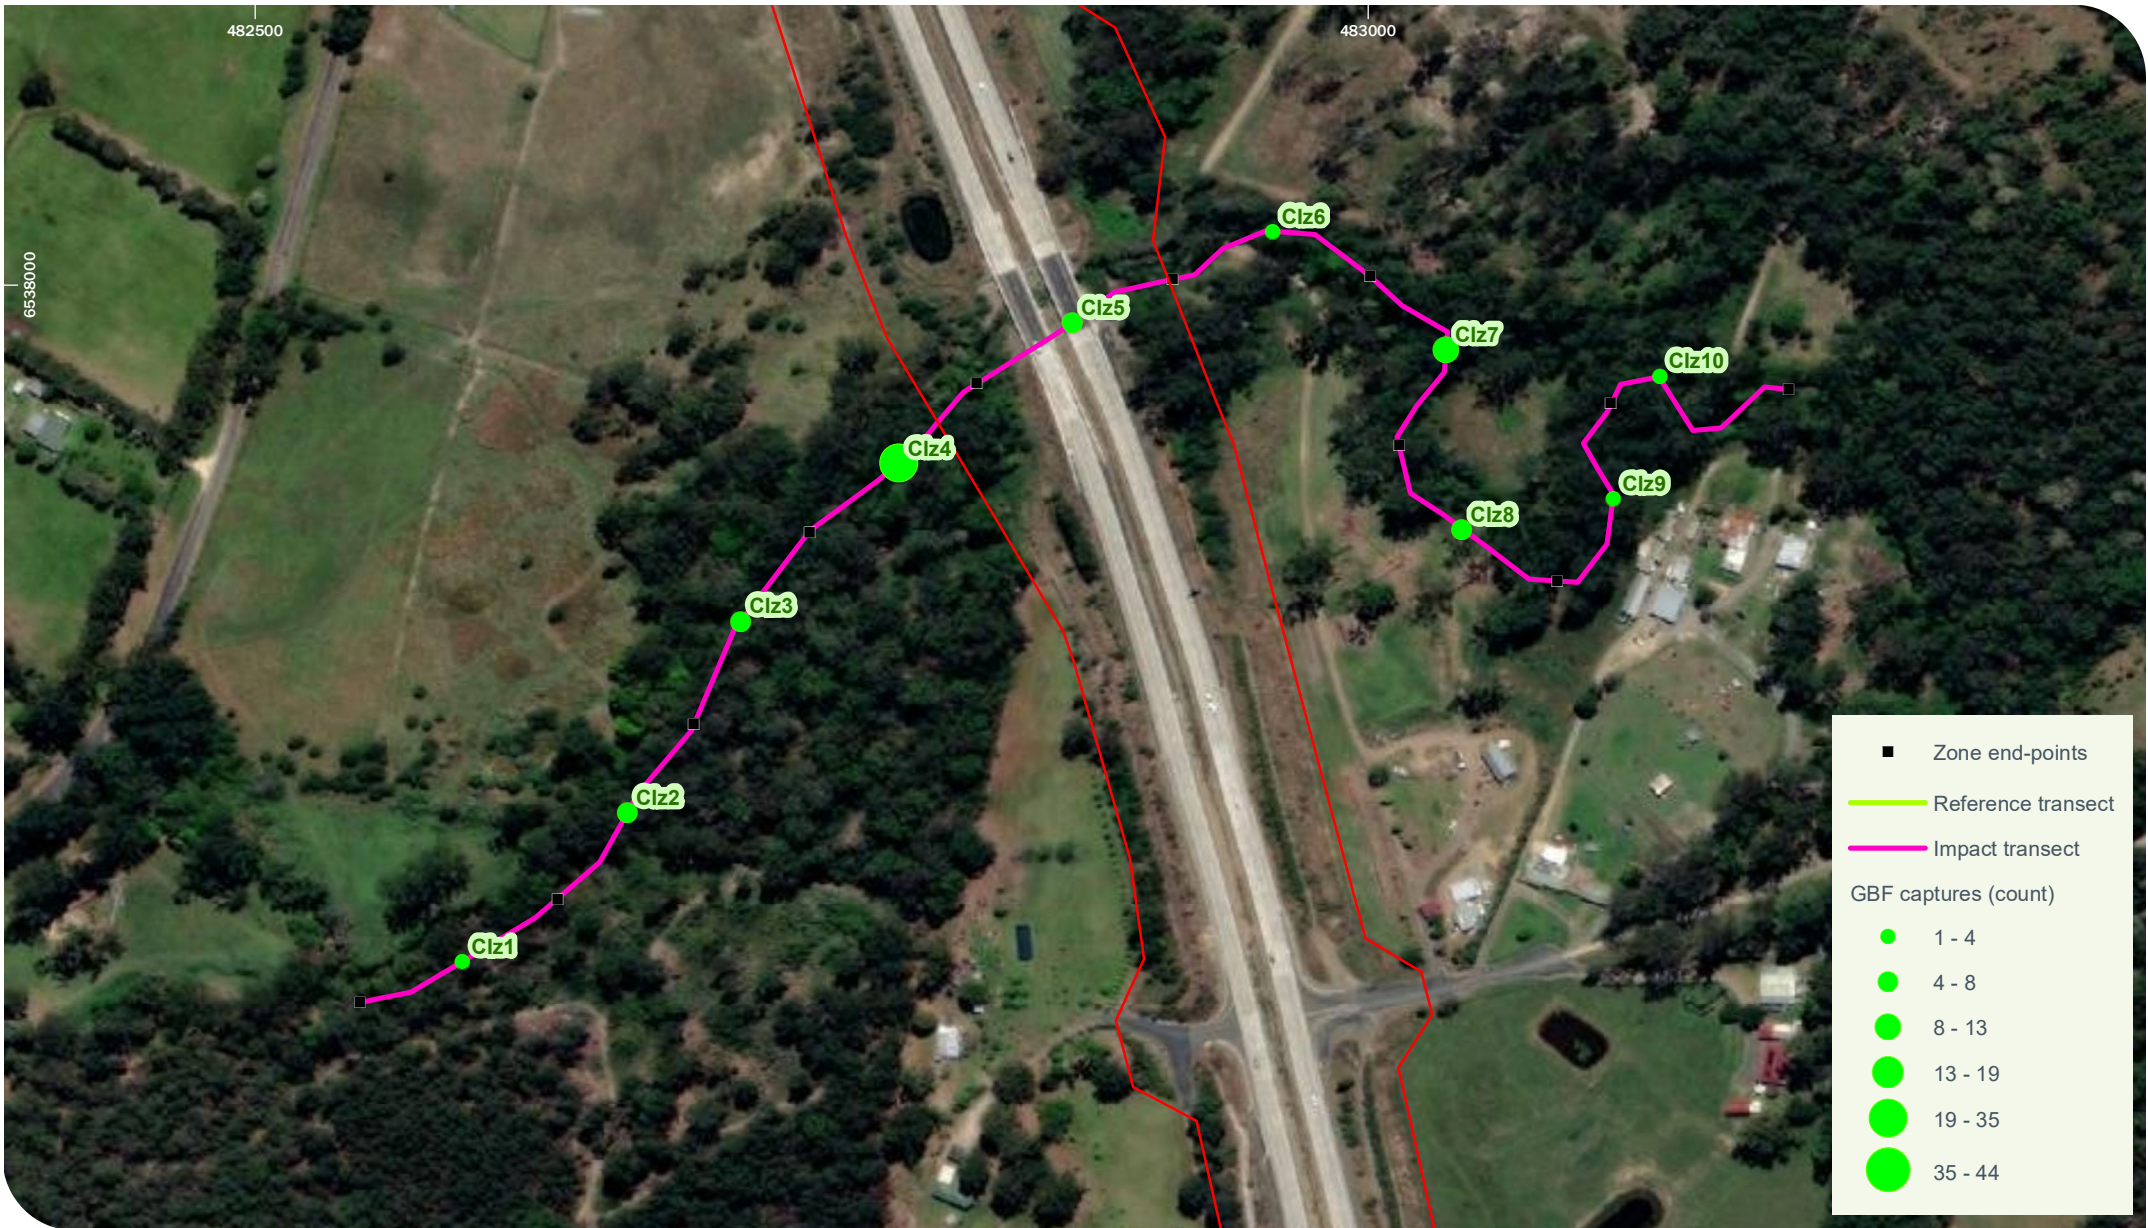
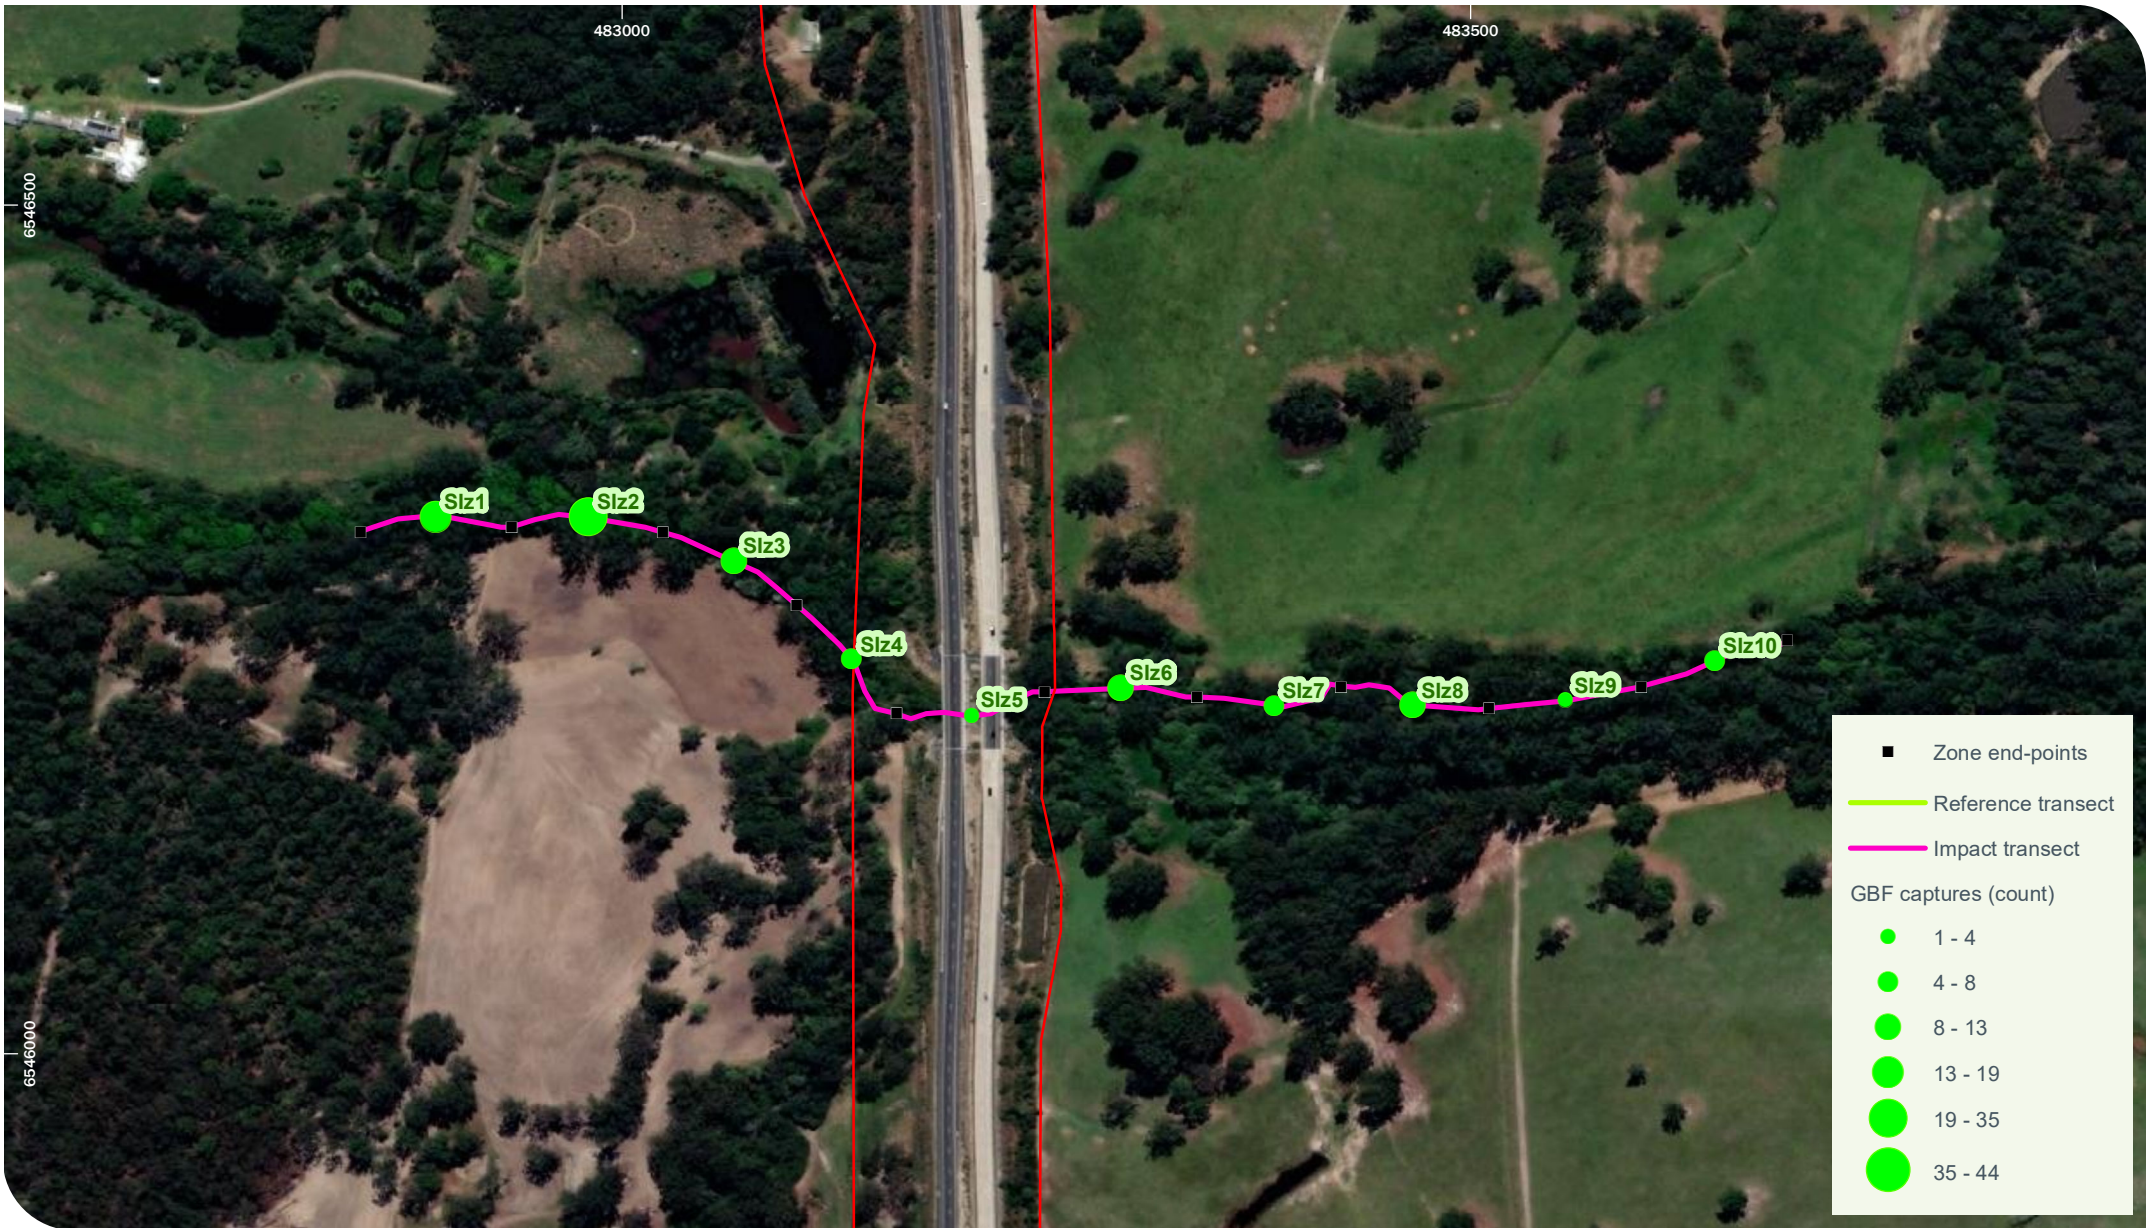
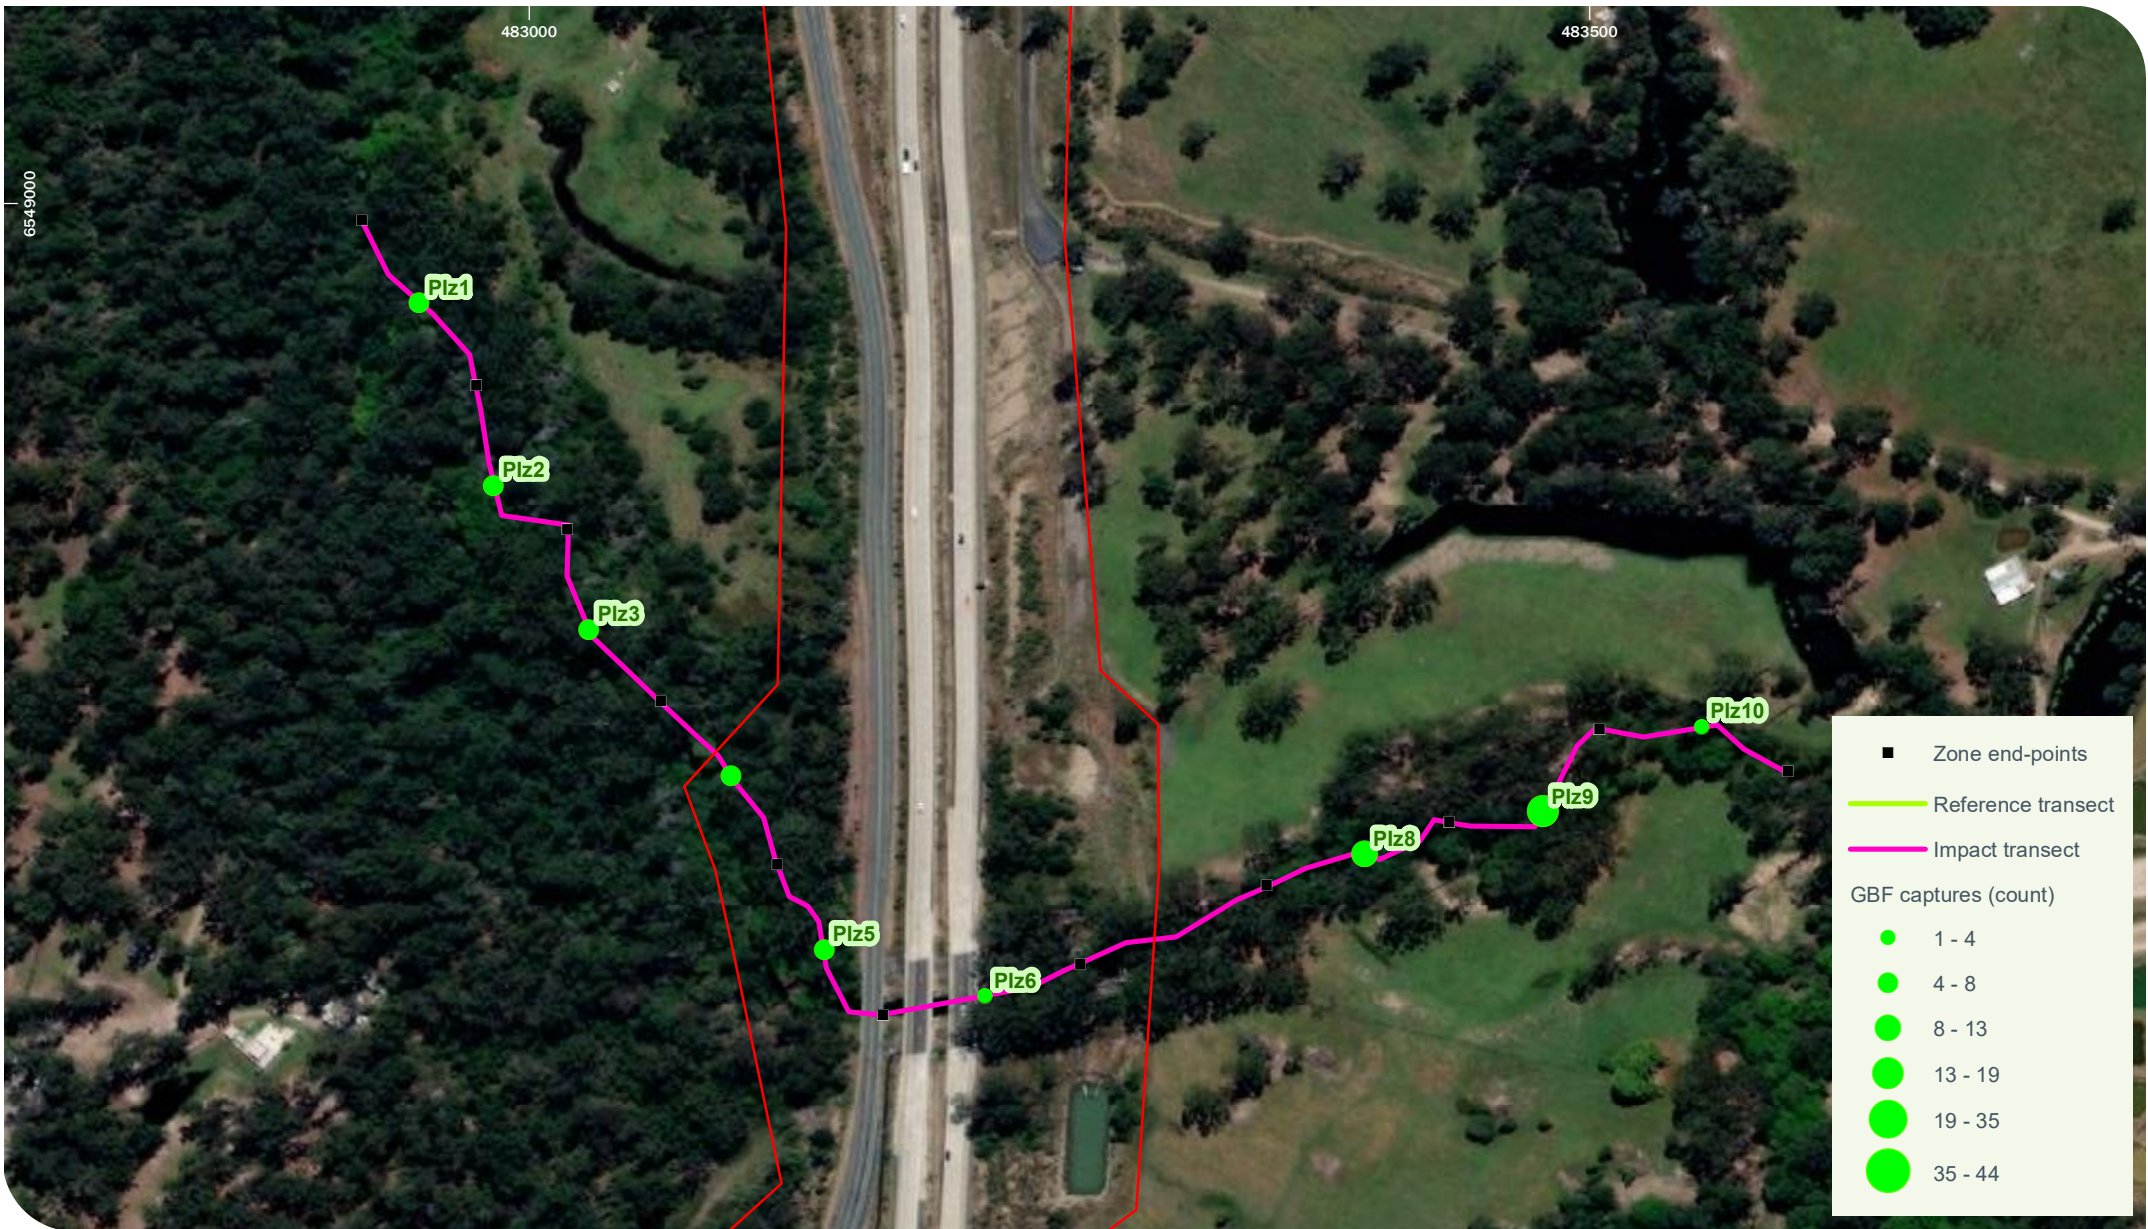
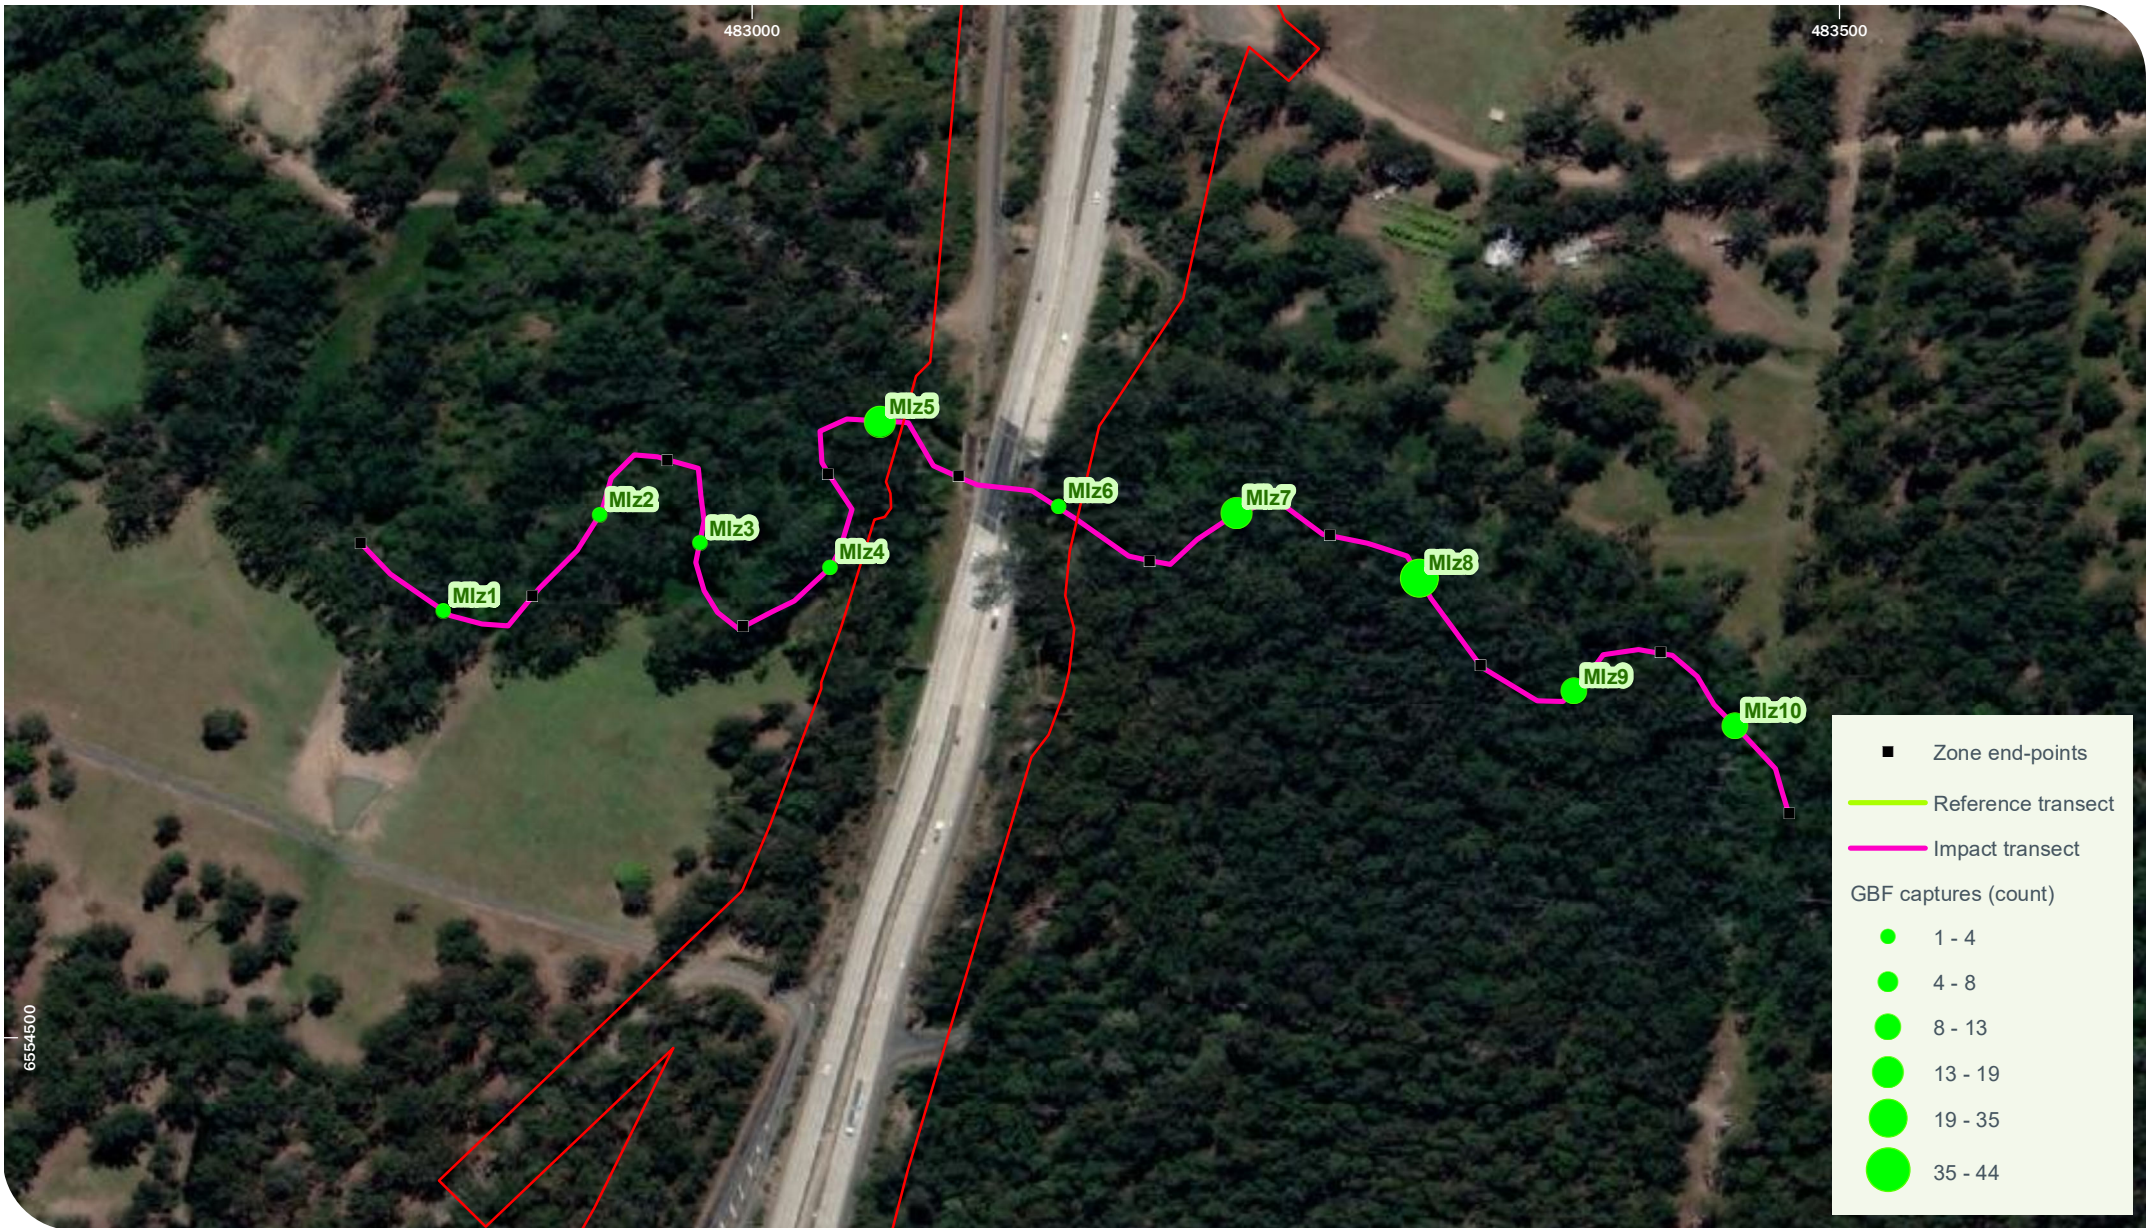
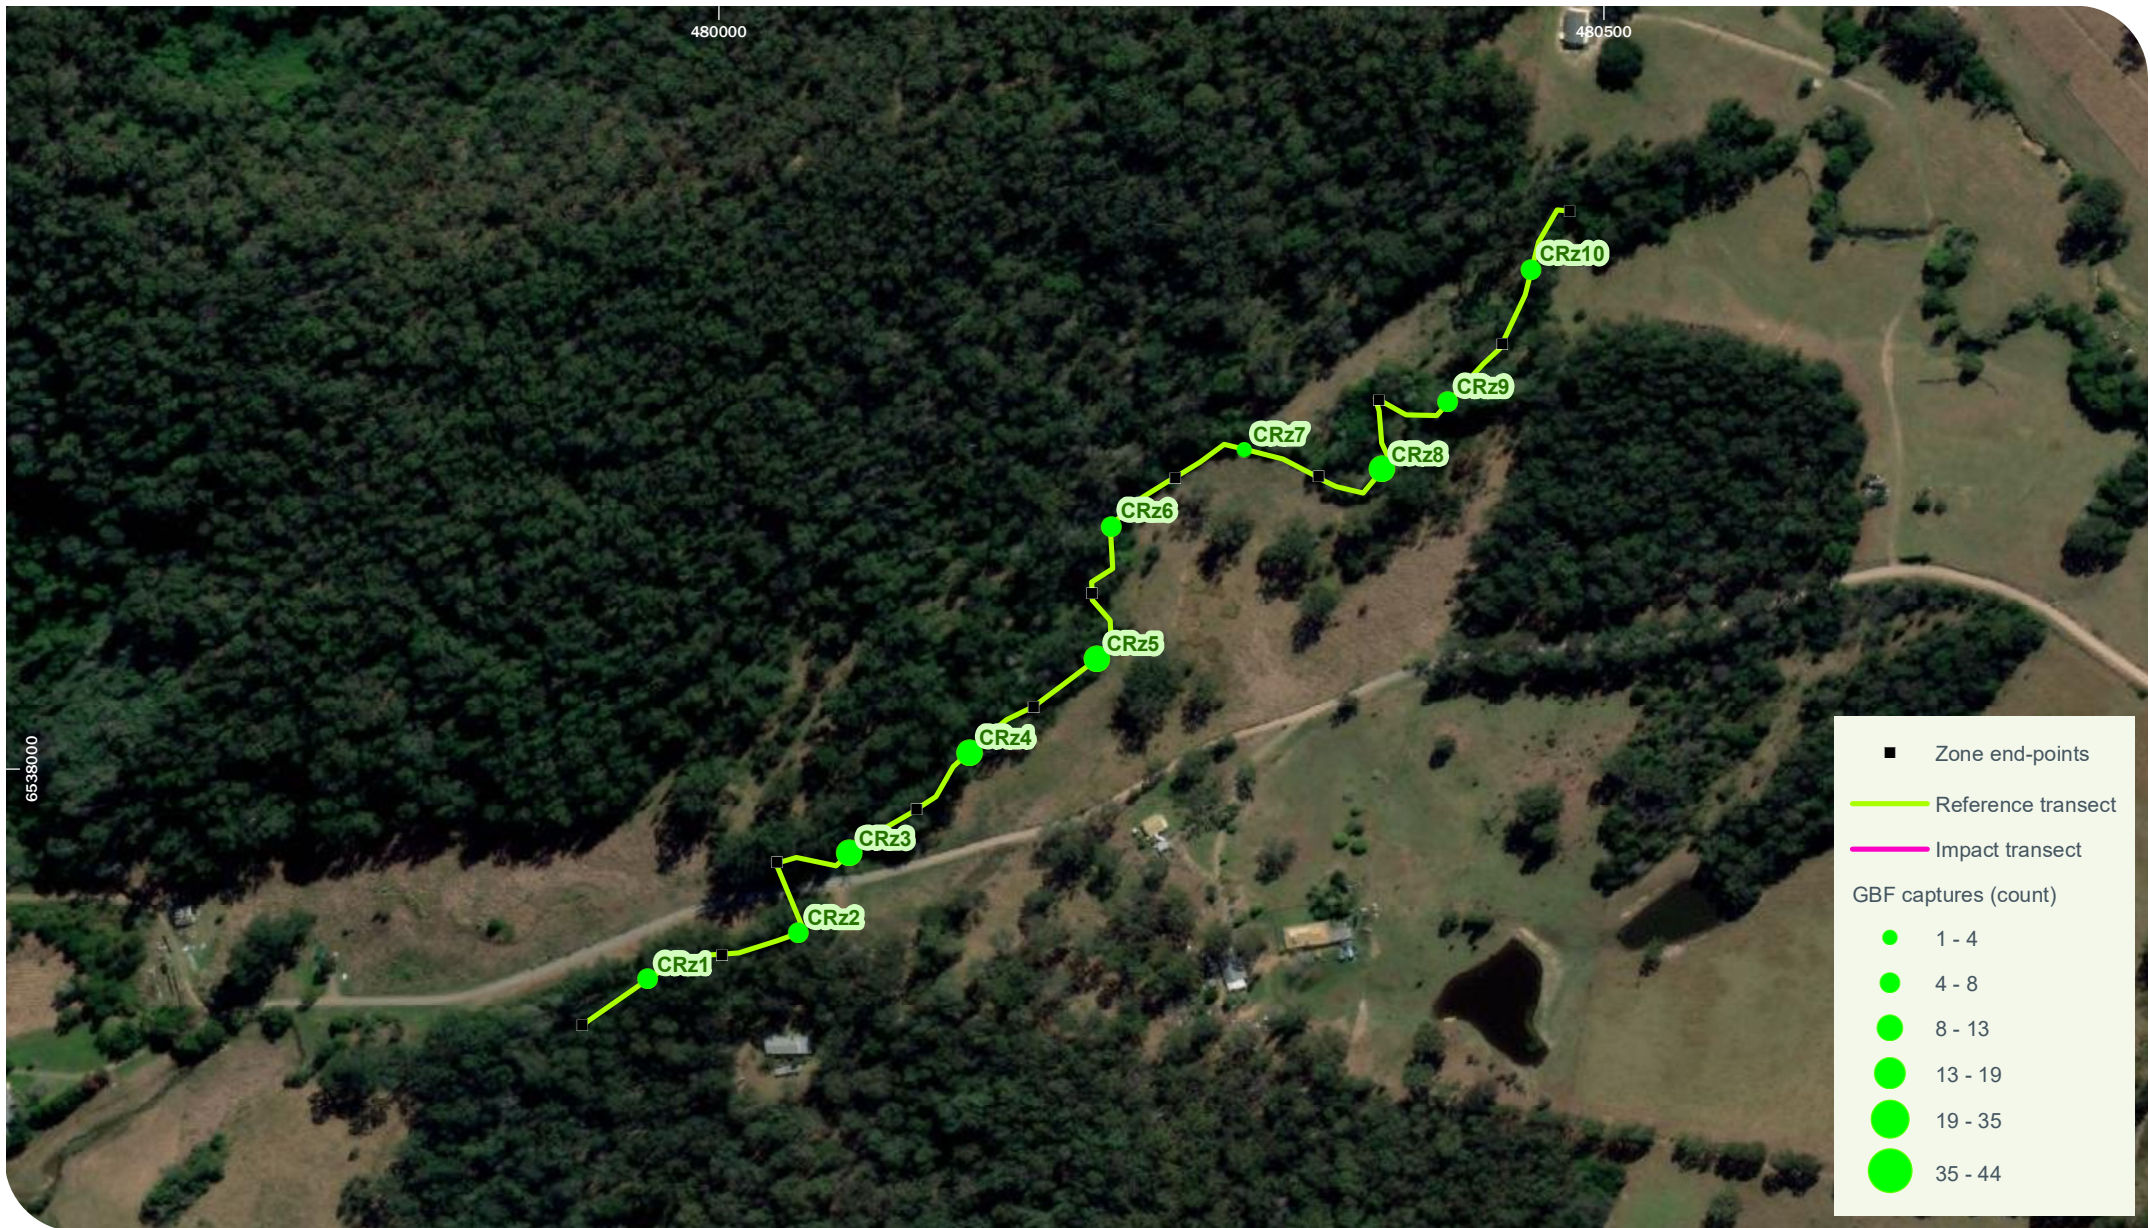
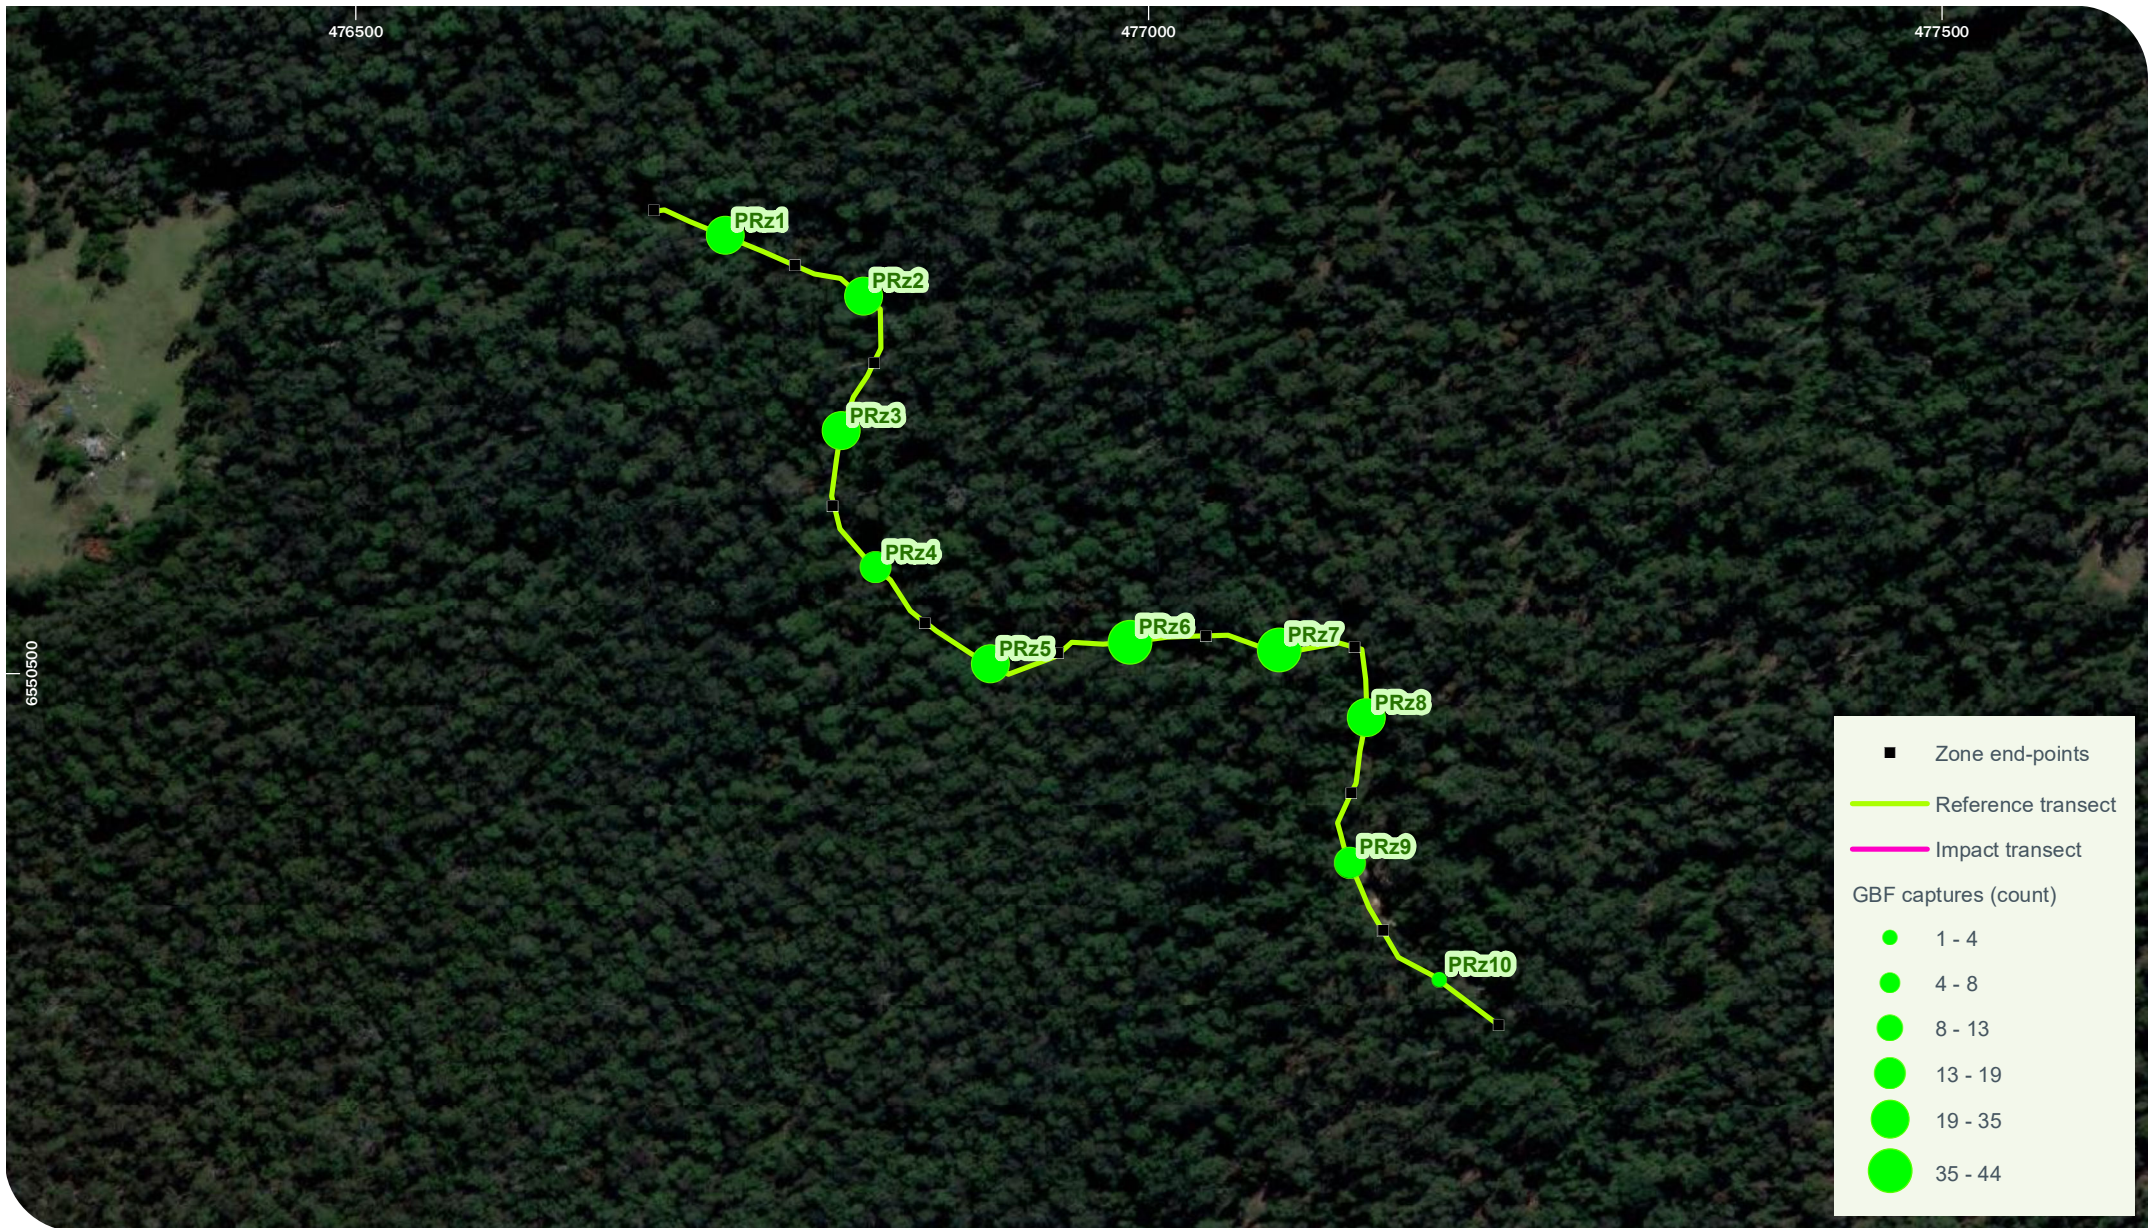
Figure 8 - Figure 13 show all capture records (i.e. cumulative records), whereby capture records (including recaptures) are shown as count ranges, where larger circles indicate larger frog counts. While density data indicates that frog distribution along the transects varies from year to year, when considering all years, frogs mostly appear to be using the entire length of the transect and there is no evidence of frogs being recorded only in one particular zone. In addition, there is no evidence of frogs being absent from zones 5 and 6. While capture frequencies within zones directly under the carriageway consistently fall into the lower range category (1-7 frogs), the low capture frequency range occurs regularly along the transects and at all sites.

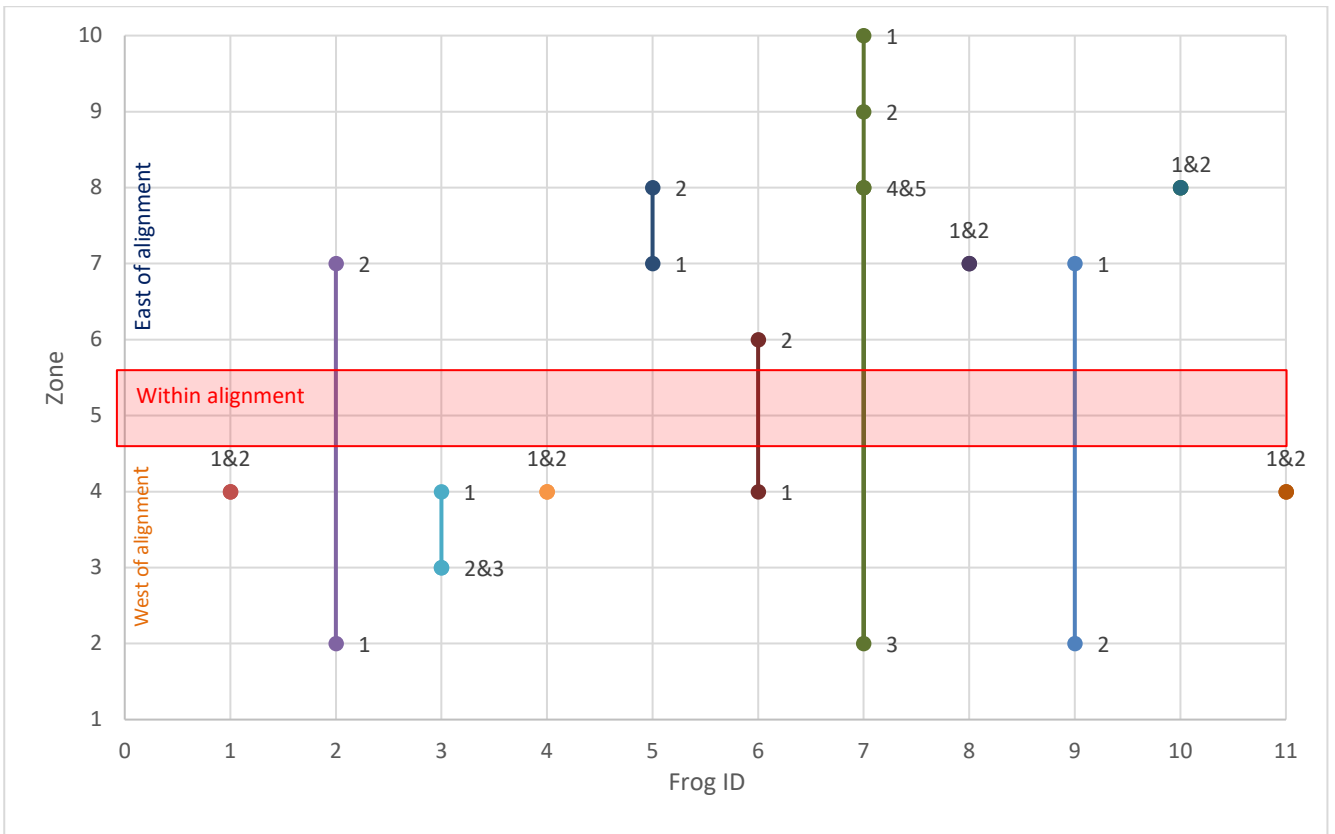
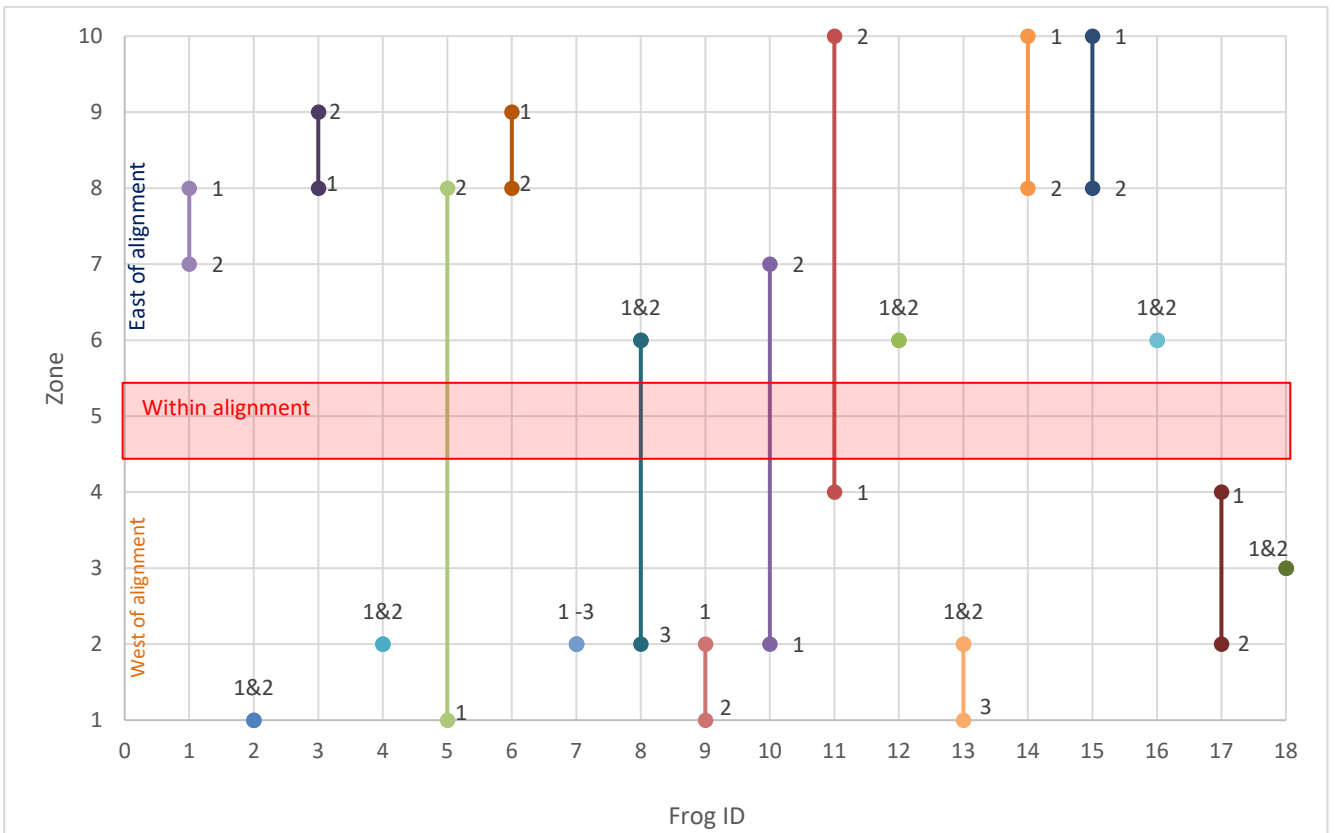
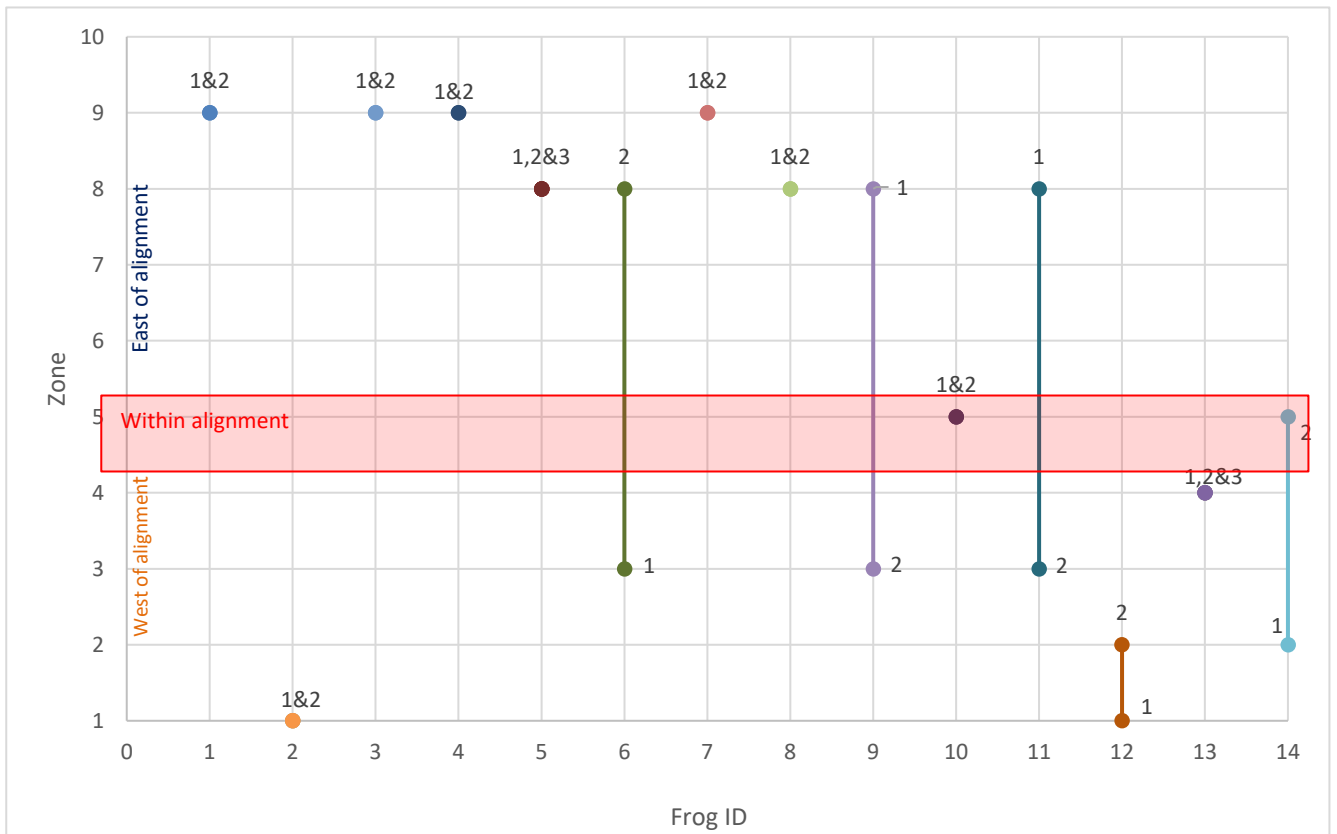
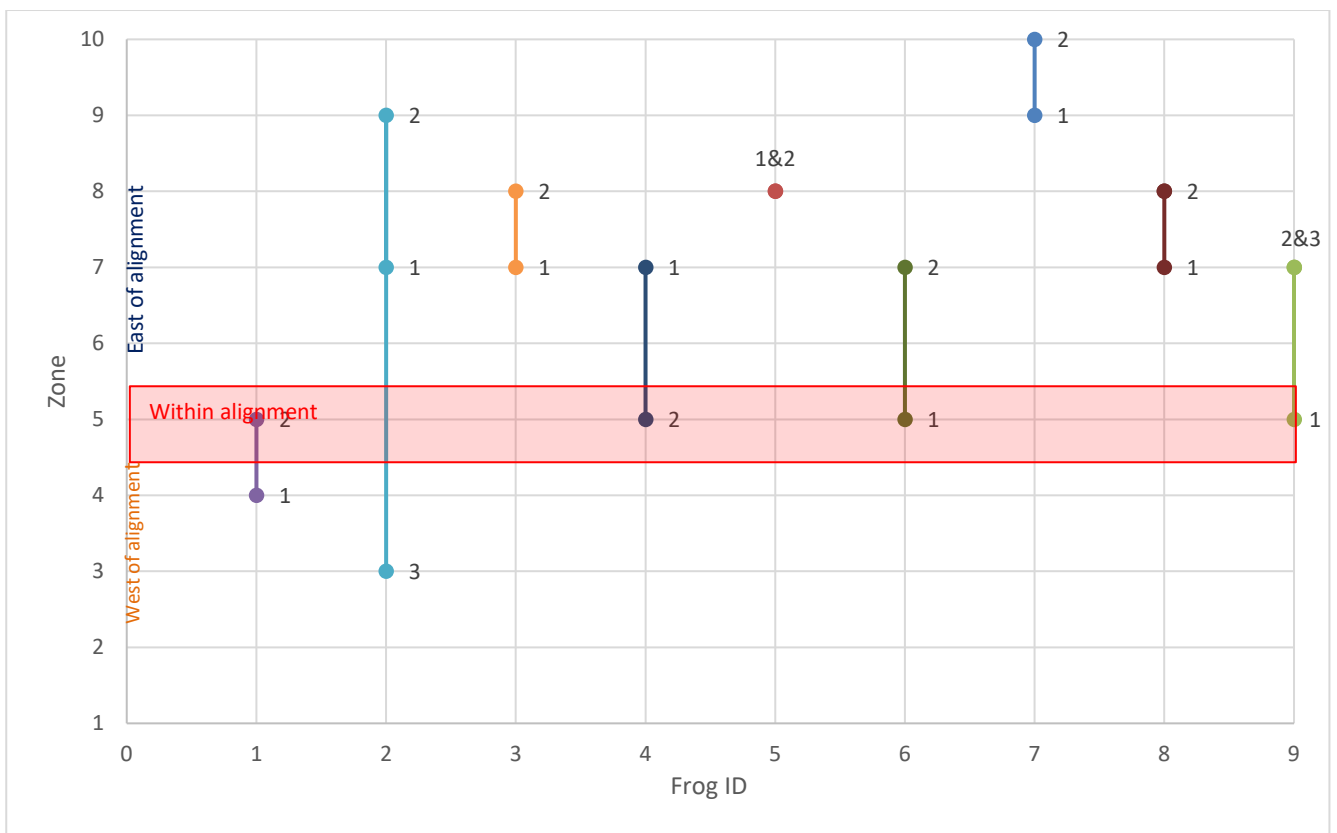
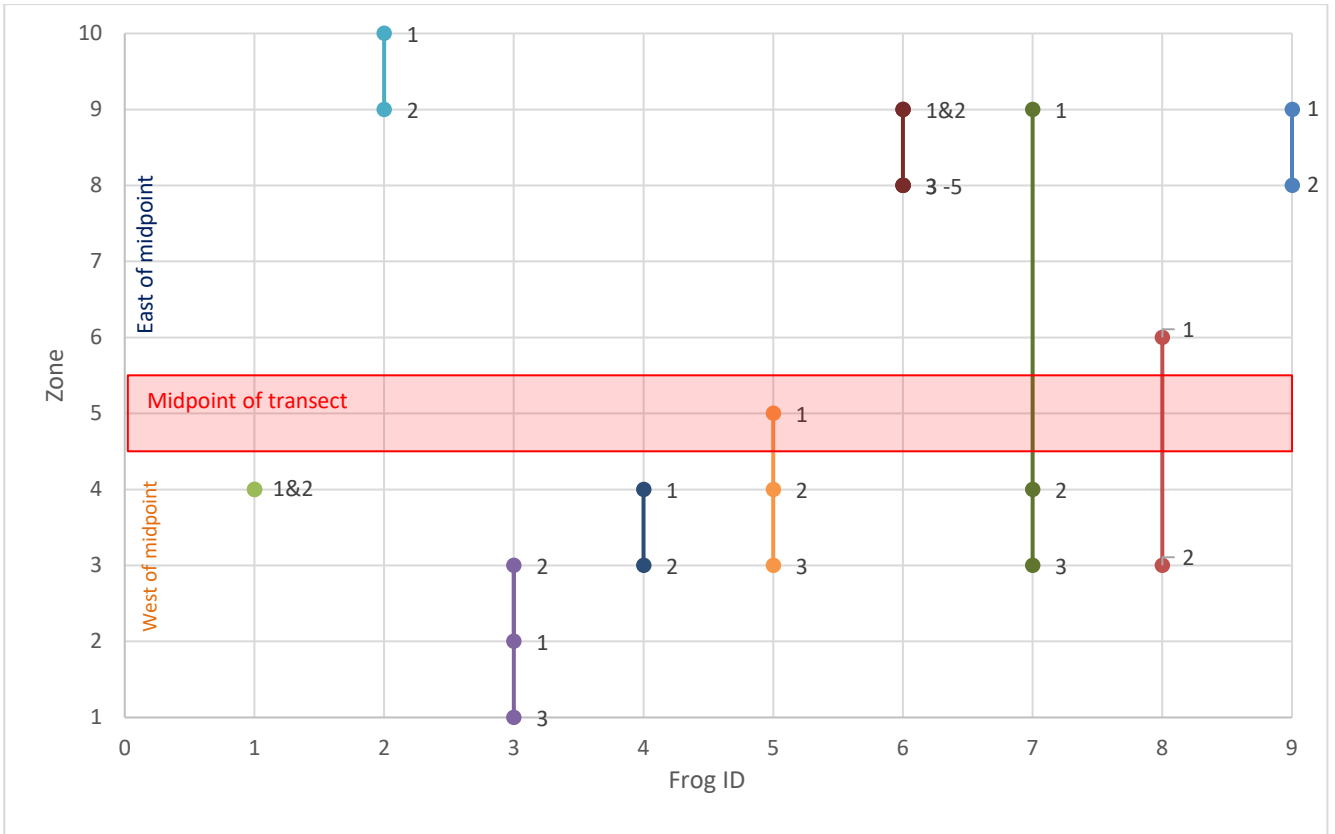
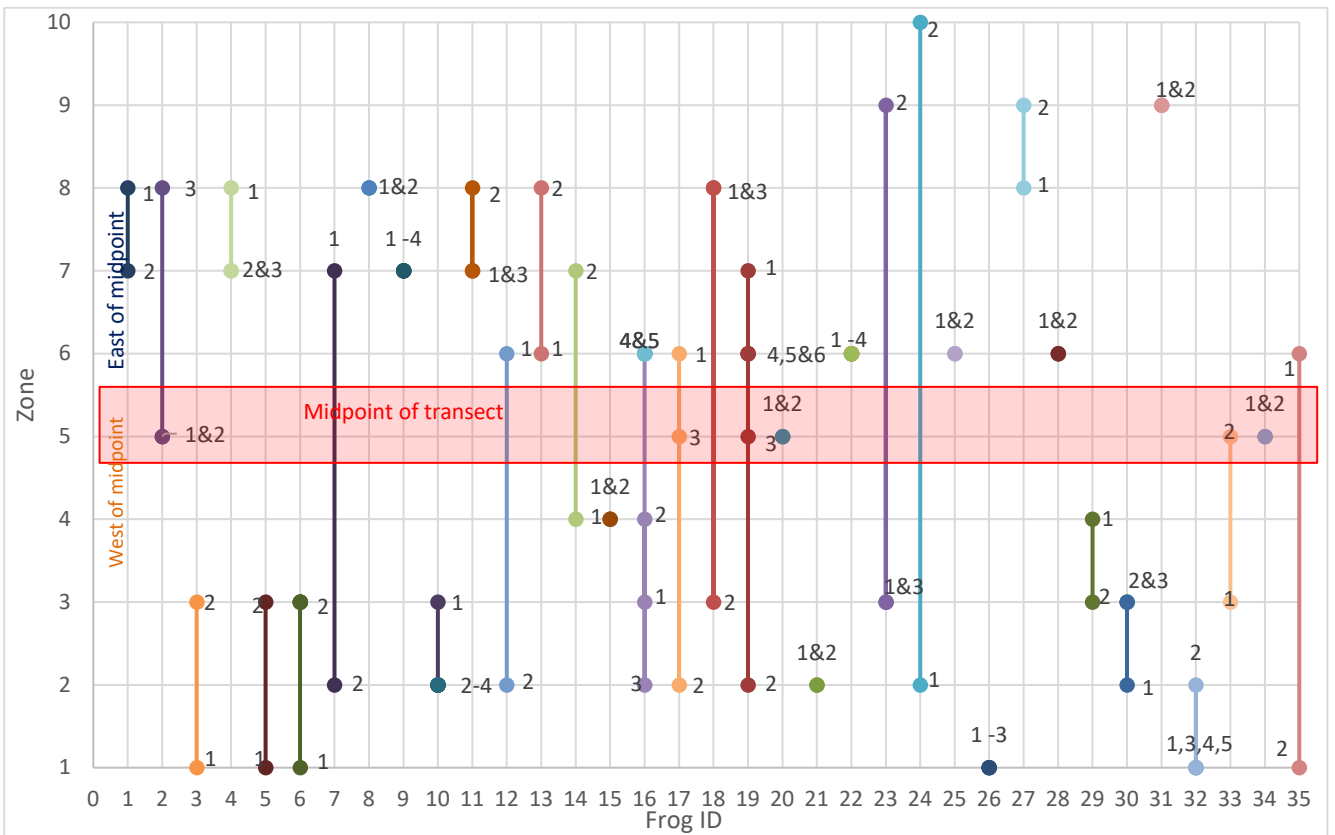
Recapture data of PIT-tagged individuals was used to determine movements along the transects, and notably, past the midpoint of the transect i.e. from one side of the carriageway to the other at the impact sites. It should be noted that this analysis does not imply that individuals that have not been found on opposite sides of the carriageway have not traversed at some time. Graph 10 - Graph 15 show the movement patterns of individual recaptured Giant Barred Frogs at each site and the data is summarised for each site below. As reference sites by their nature do not traverse the carriageway, a transect midpoint has been included to provide an indication of movements along the transects and permit comparison between reference and impact sites. The reference transect midpoint was chosen as the arbitrary location by which to assess movement along the transect (i.e. equal zones on either side). It should be noted that comparisons made between impact and reference sites do not take into account other potentially confounding factors such as site specific population ecology. Capture order is indicated by the numbers beside each capture point and a single capture point indicates recaptures within the same zone.

At the impact sites, while the monitored waterways continue uninterrupted under the carriageway, there is a distinct change in streamside vegetation within the area immediately under the carriageway. Under the carriageway at all impact sites, streamside vegetation ranges from limited to moderately dense, represented by patches of shrubs and/or *Lomandra* spp. The streamside habitat in these areas consists of native vegetation, large rocks and boulders or bare ground. Despite changes in streamside habitat immediately under the carriageway, a number of Giant Barred Frogs have been recorded traversing the carriageway. The percentage of Giant Barred Frogs found to have traversed the impact site midpoints do not appear to differ substantially from the percentage of Giant Barred Frogs found to have traversed the reference site midpoints.
