Oxley Highway to Kempsey

2022/2023 Annual Ecological Monitoring Report

Transport for NSW | October 2023

This report provides an update on the ecological monitoring associated with the Oxley Highway to Kempsey Pacific Highway upgrade.

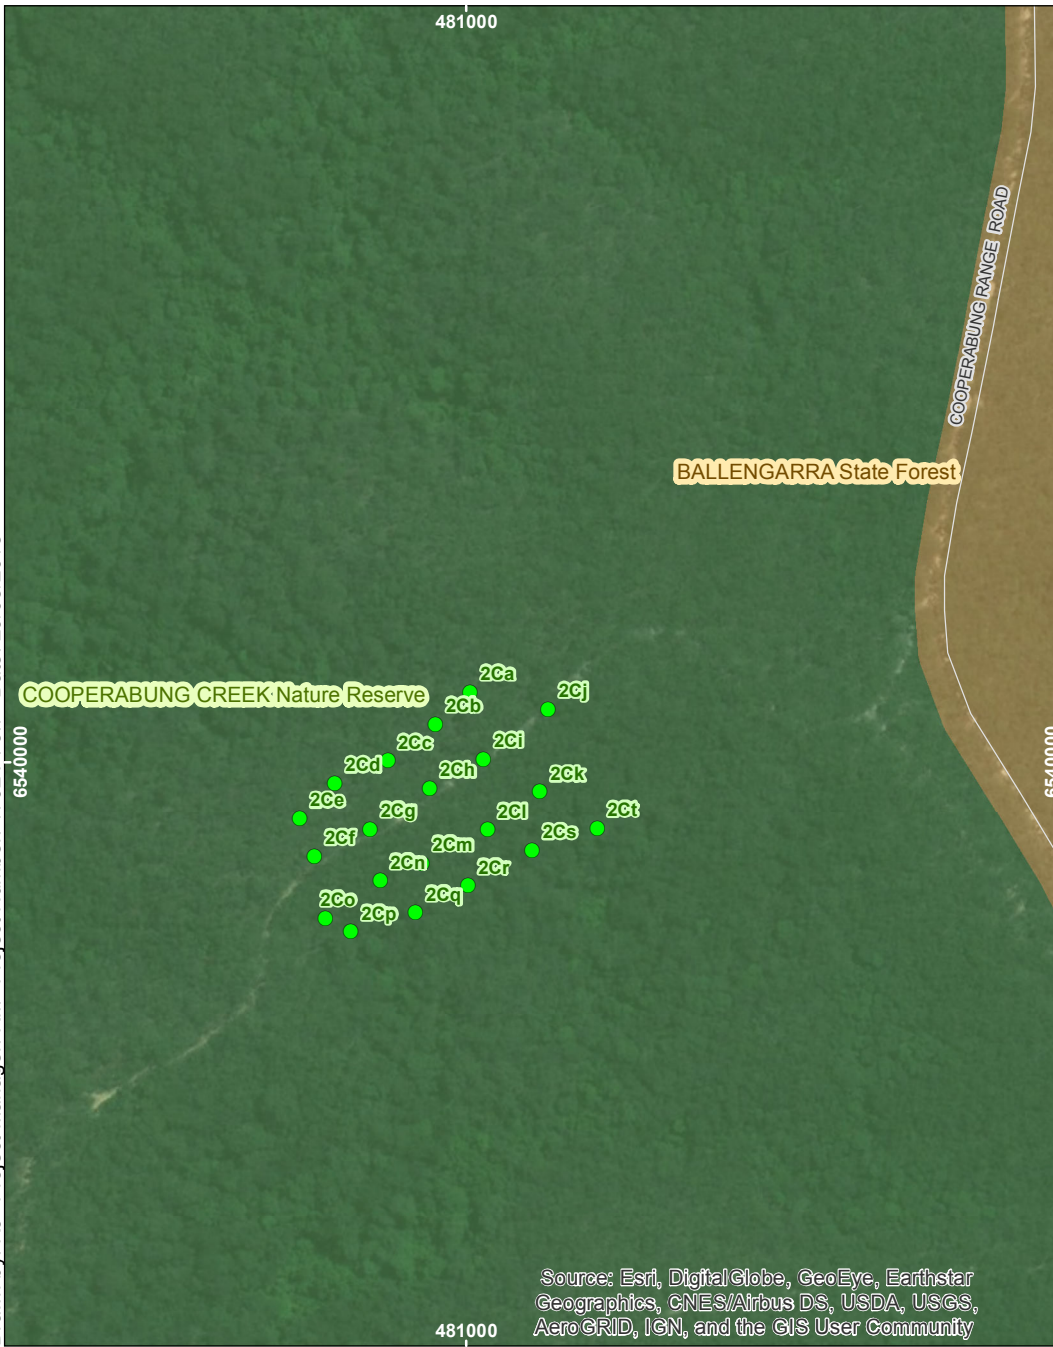
FIGURE 3

Ballengarra State Forest South: Site 2 trap locations
Squirrel Glider Monitoring: Pacific Highway Upgrade – Oxley Highway to Kempsey

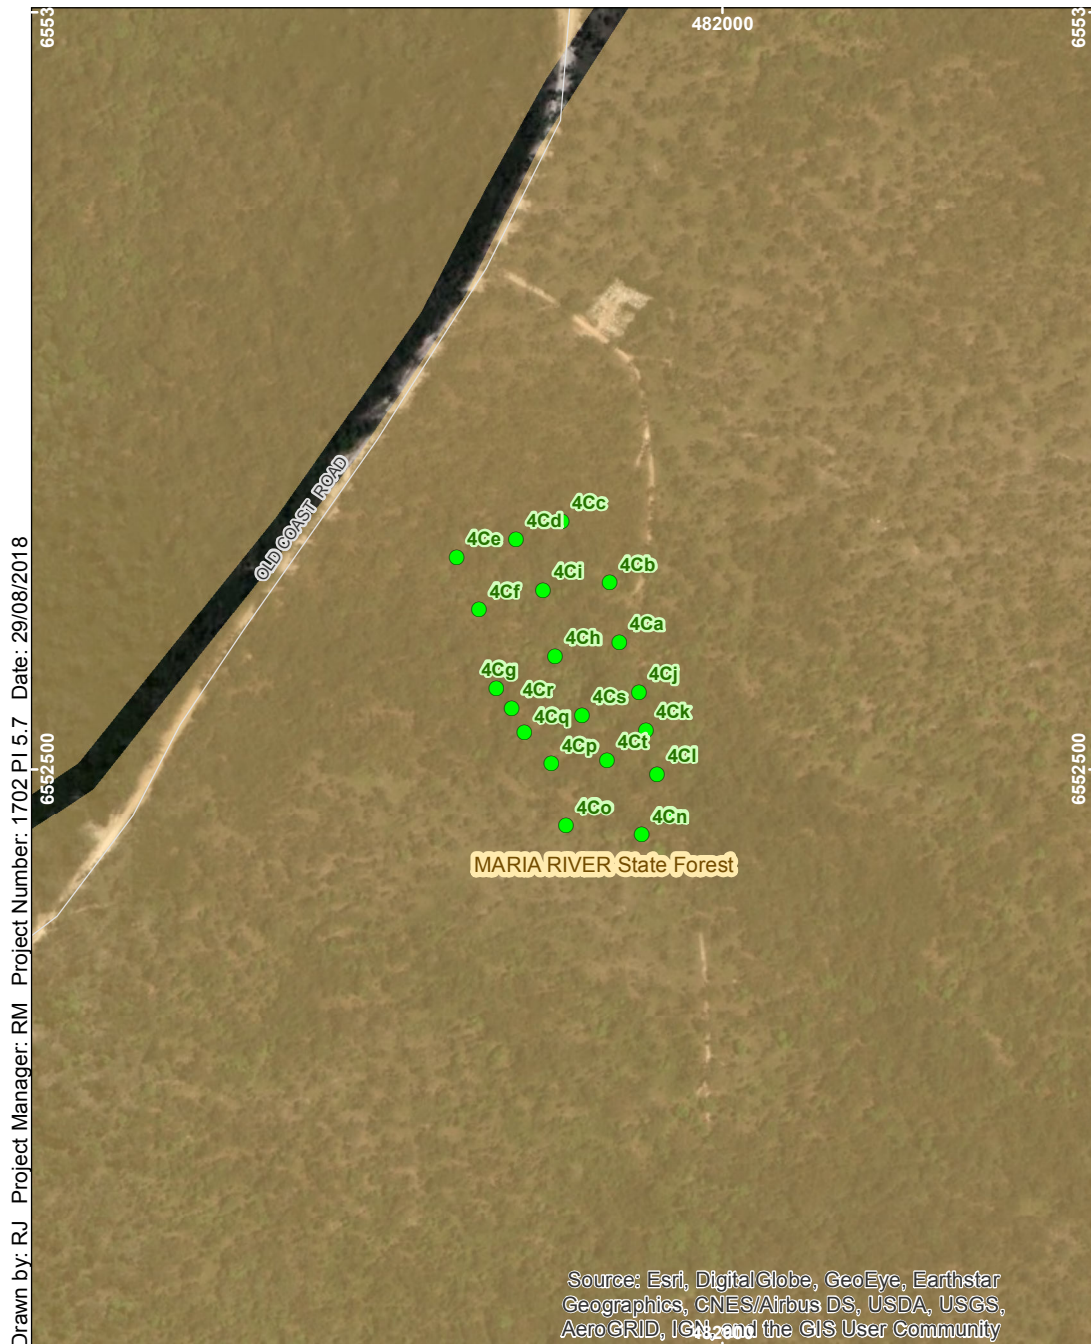
Maria River State Forest: Site 4 trap locations
 Squirrel Glider Monitoring: Pacific Highway Upgrade – Oxley Highway to Kempsey

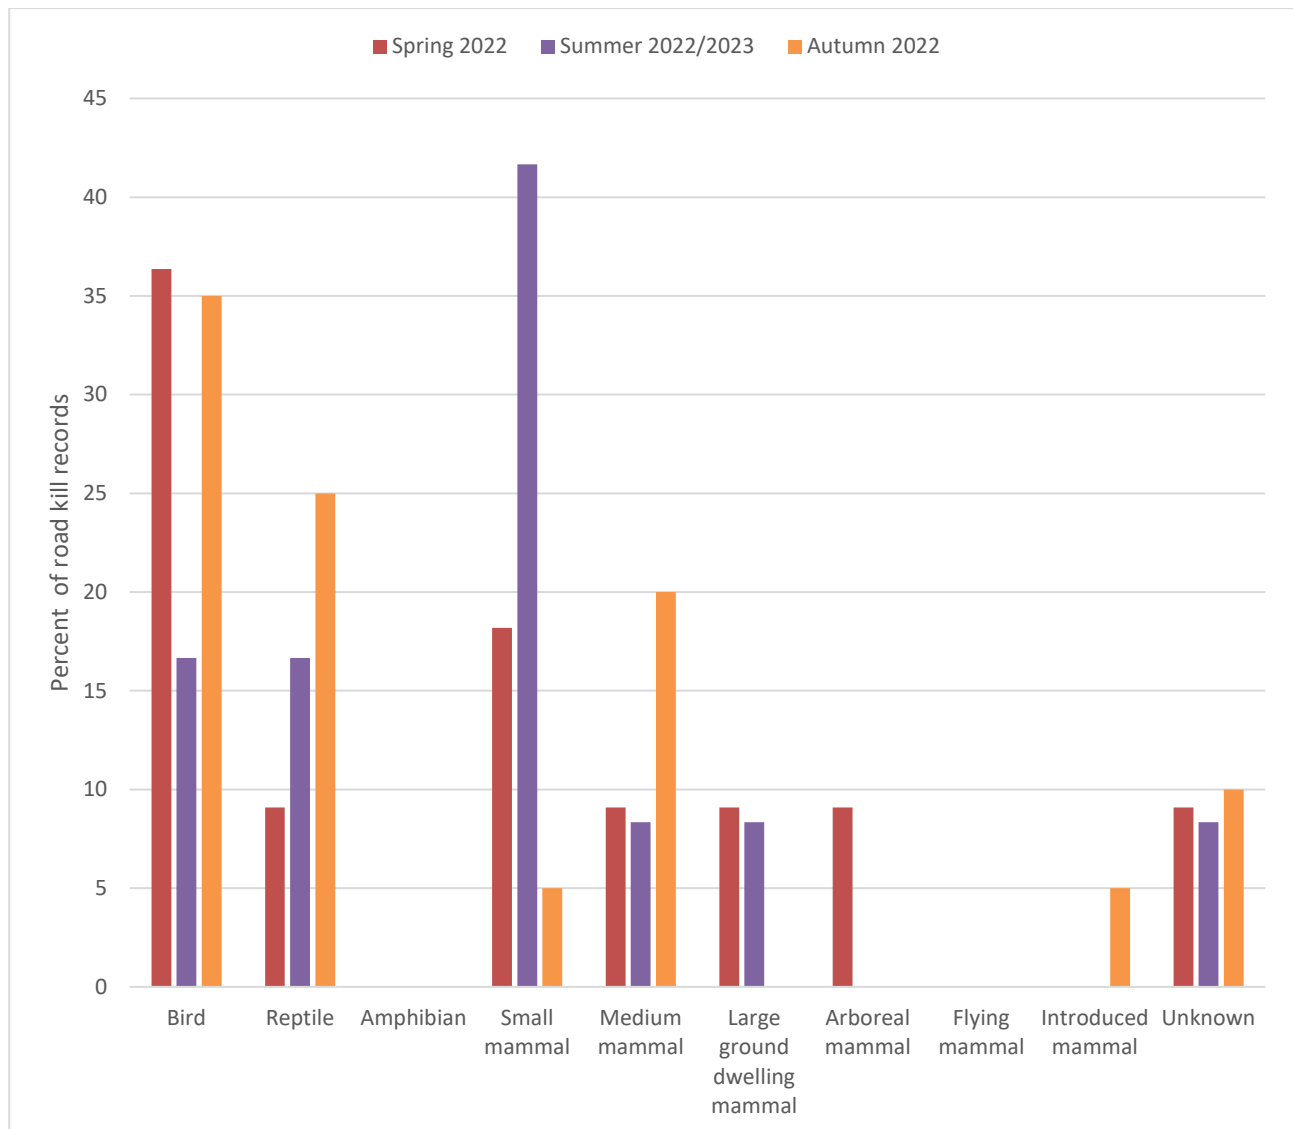
Graph 1: 2022/2023 road kill records

There were a total of 43 road kill records for the autumn, spring and summer 2022/2023 road kill monitoring events, including 20 in autumn, 11 in spring and 12 in summer. The percentage of road kill records for each fauna category for the current monitoring period is presented in Graph 1. Combining spring, summer and autumn results, birds (30.2% of road kill, n = 13), small mammals (18.6% of road kill, n = 8), reptiles (18.6% of roadkill, n = 8) and medium mammals (14.0%, n = 6), were the most commonly recorded fauna groups.

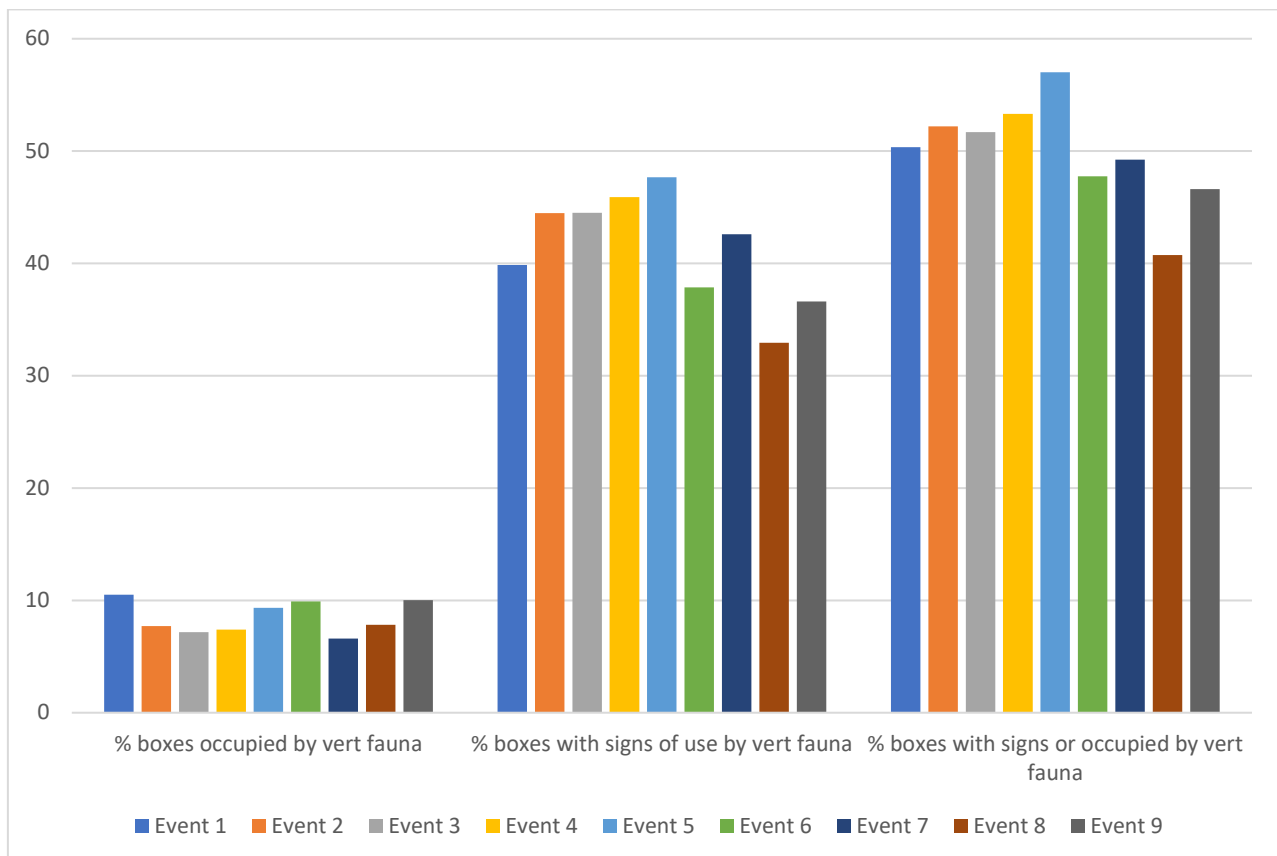
Graph 1: Nest box occupation and signs of use by native fauna

Graph 1 shows the rate of occupation and signs of use by native vertebrate fauna for all individual monitoring events to date, while Graph 2 shows the cumulative occupation for all monitoring events, i.e. the percent of all boxes available to fauna that had been occupied or showed signs of use during at least one monitoring event. While the recorded occupancy during any one monitoring event appears to fluctuate between 6% and 10%, Graph 2 shows that over 39% of boxes have been occupied on at least one occasion during inspections and that over 88% of boxes have been occupied or have shown signs of use on at least one occasion during inspections and that the percent of boxes used continues to increase each monitoring.
