# Woolgoolga to Ballina Pacific Highway Upgrade

## Threatened Fish Monitoring Program Annual Report 2022

Year 2 Operational Phase Report

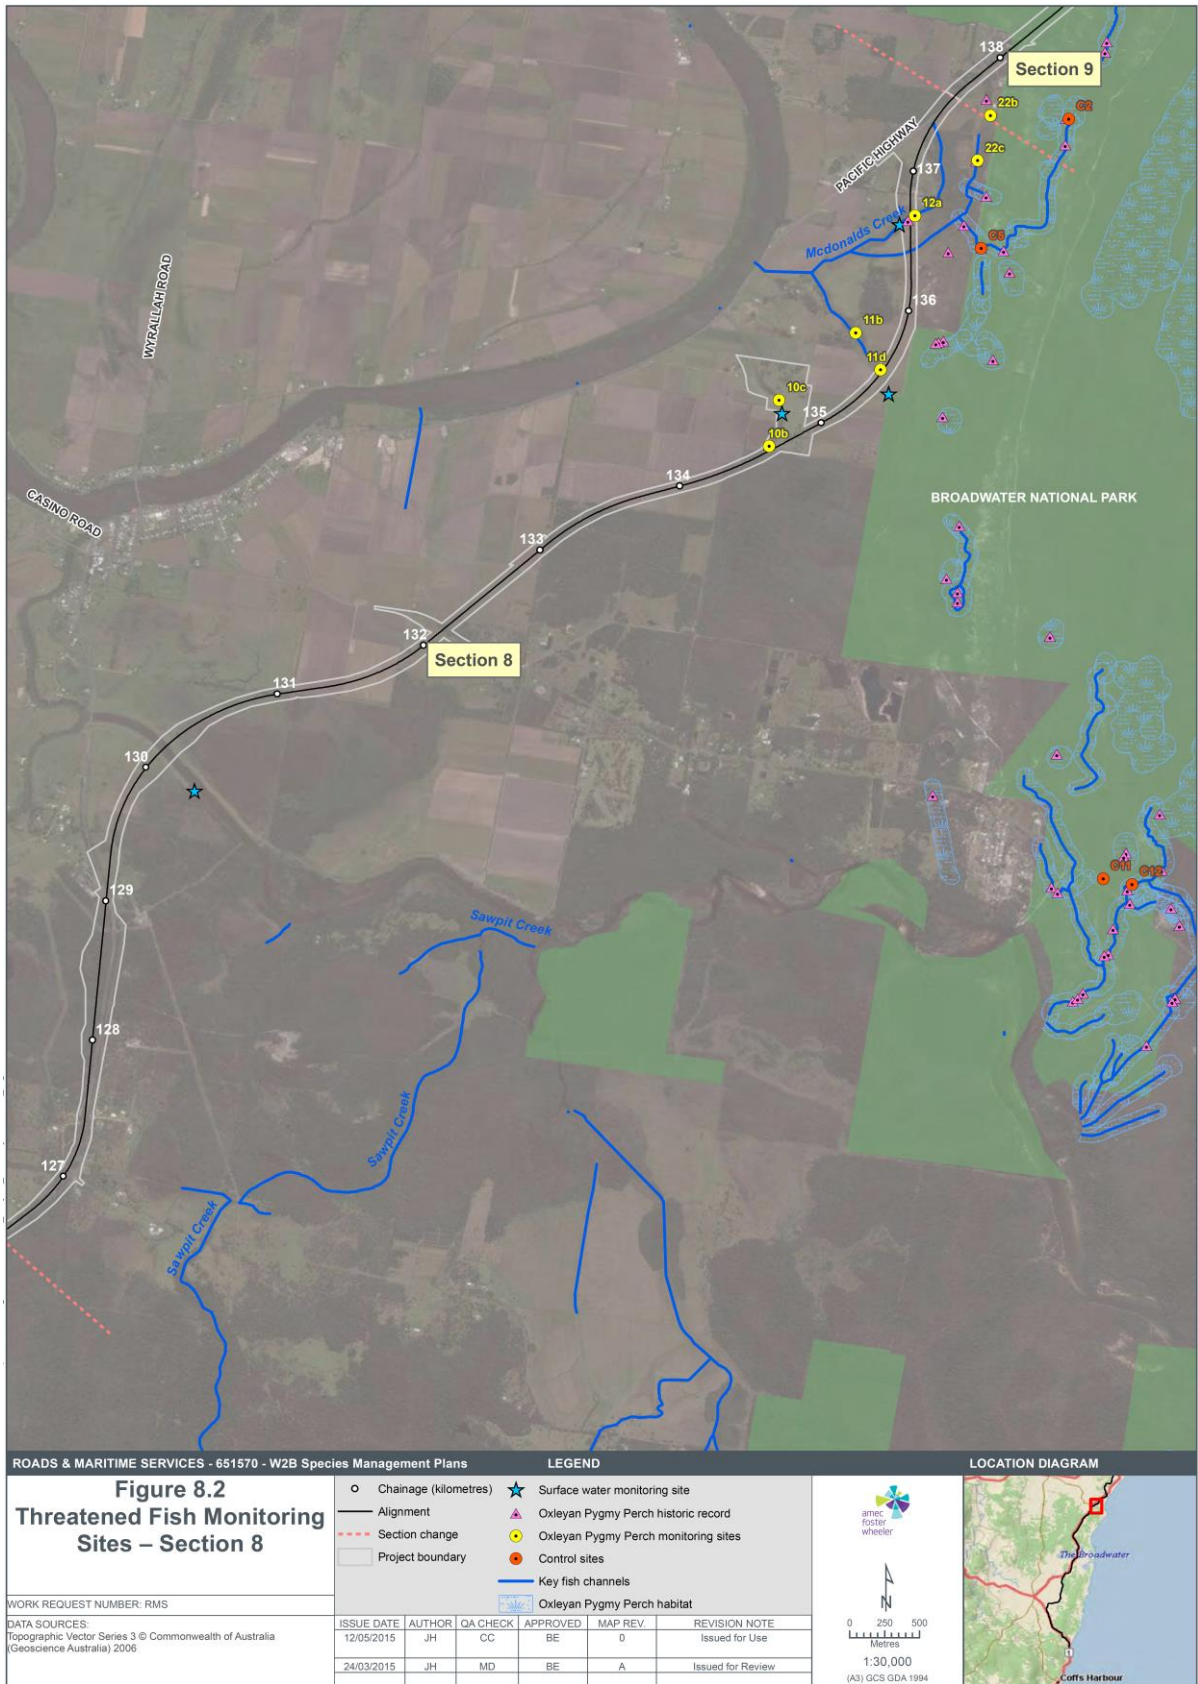
Illustration 2.3 Map of Section 8 sampling sites taken from the TFMP (RMS 2015)

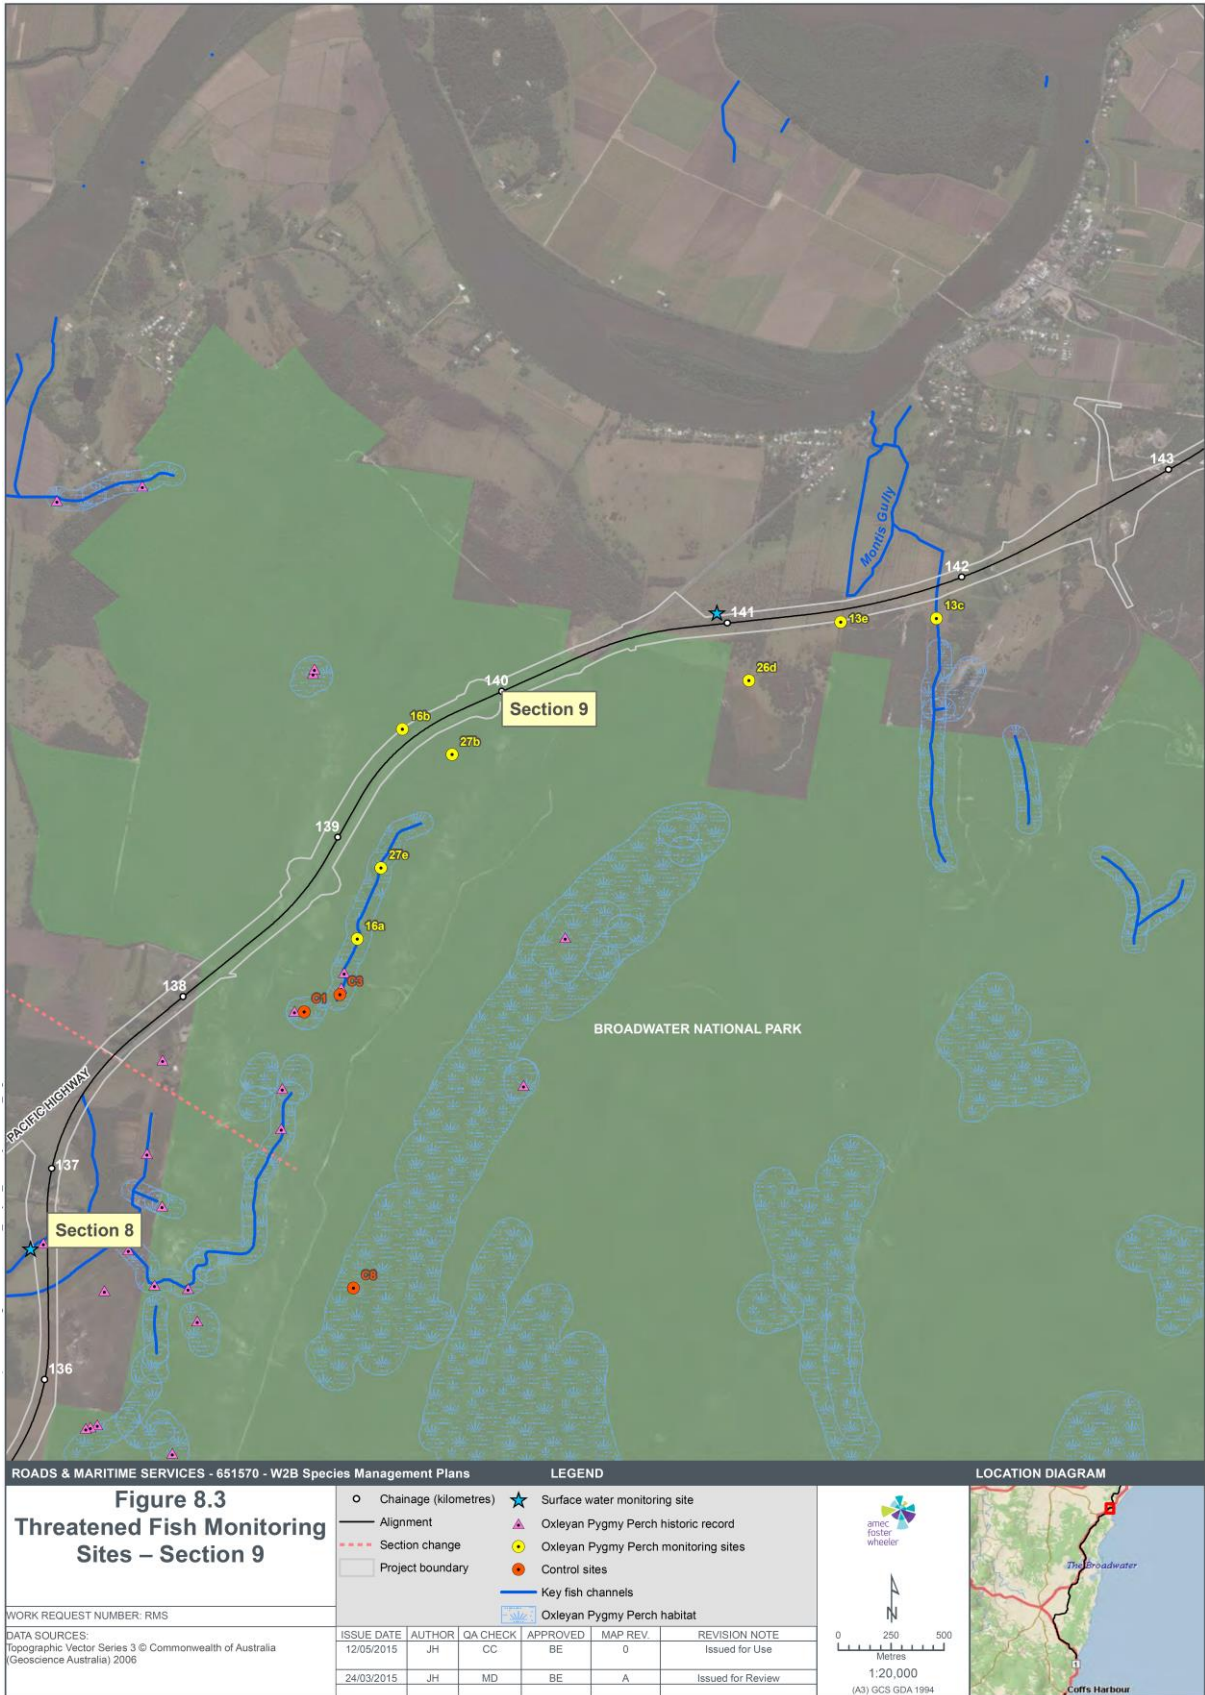
Illustration 2.4 Map of Section 9 sampling sites taken from the TFMP (RMS 2015)

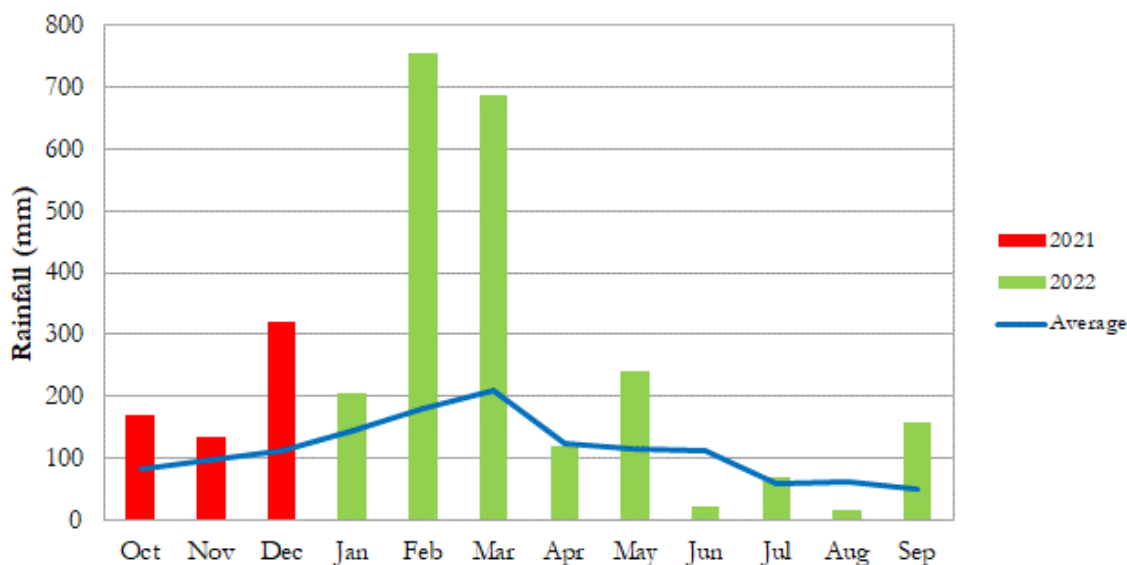
**Figure 2.1 Mean monthly rainfall and total monthly rainfall from the New Italy Bureau of Meteorology station for the current reporting period.**

The total rainfall for this annual reporting period was 215% of the yearly average. Approximately half of the annual rainfall was concentrated into two months, February and March 2022. (**Figure 2.1**). At the time of the May 2022 survey most sites were very wet, with water overtopping the banks at some sites and some sites inaccessible due to water over the access tracks. Average and low monthly rainfall in the lead-up to the September 2022 survey meant that accessibility was improved and less sites were prone to bank overtopping. Fluctuating water levels are an important consideration because they significantly change the ability to capture fish and also heavily impact the habitat measurements collected.

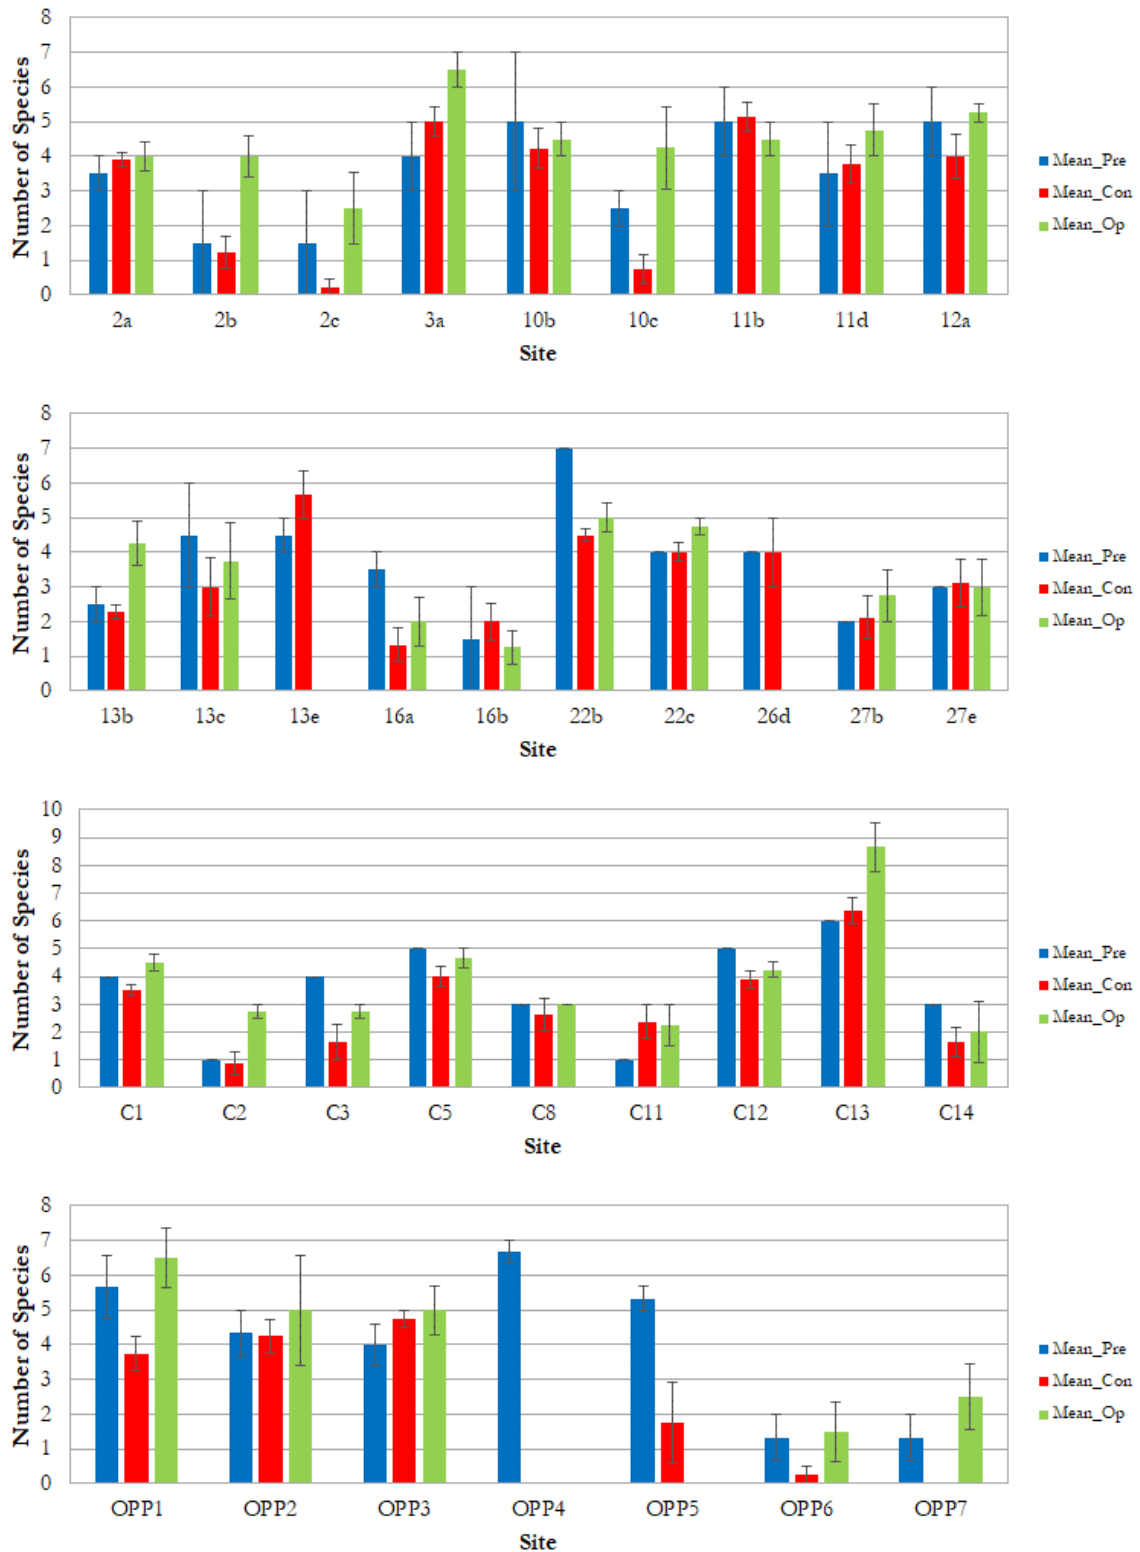
Figure 3.1 Mean  $\pm$  SE taxonomic richness of captured fish at all sites during the operational phase surveys to date (plotted against Mean  $\pm$  SE in preconstruction and construction phase surveys)

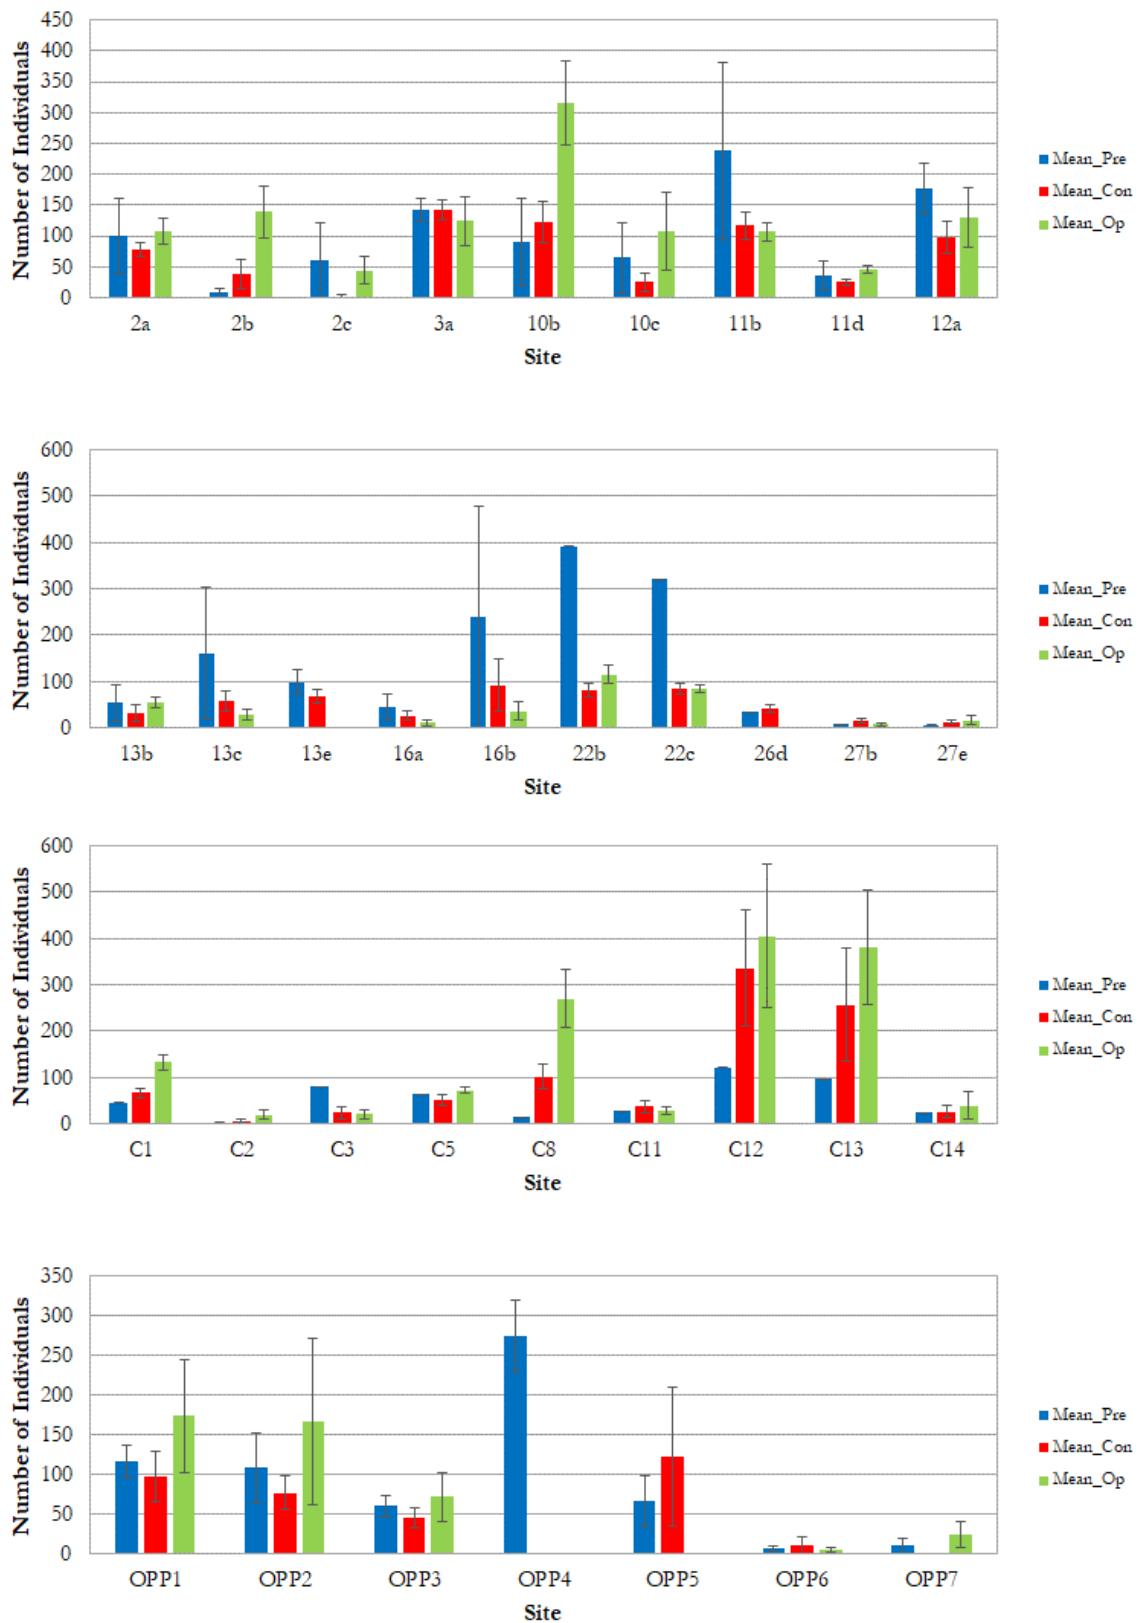
Figure 3.2 Mean  $\pm$  SE abundance of captured fish at all sites during the operational phase surveys to date (plotted against Mean  $\pm$  SE in preconstruction and construction phase surveys)

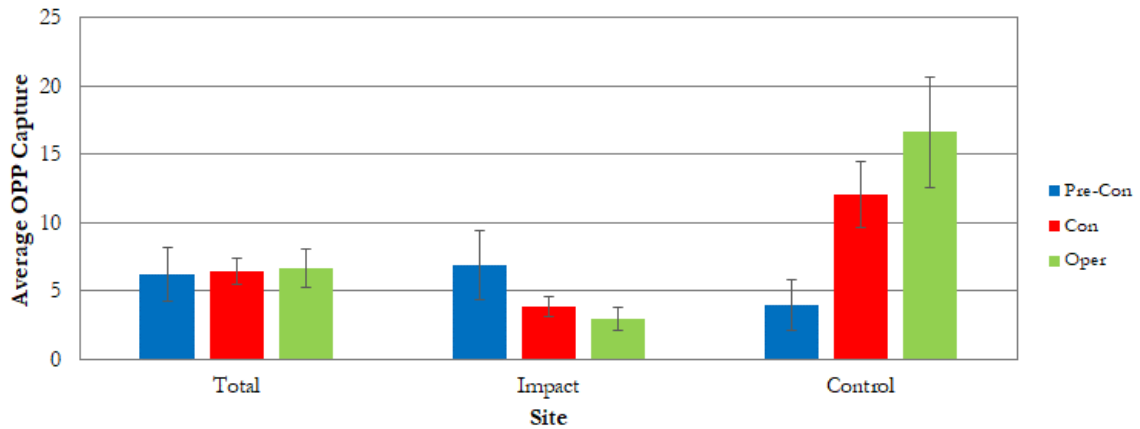
Figure 3.4 Mean ± SE OPP capture at combined control and impact sites in pre-construction, construction and operational phase monitoring to date (pre-construction data from GeoLINK 2014, 2015a & 2015b, Hyder 2012)

When the control and impact sites are considered as a group, the pre-construction and construction phase average captures per site show a reduction in the average OPP capture at impact sites in the construction and operational phase monitoring and an increase in the average capture at control sites in the construction phase monitoring (**Figure 3.4**).

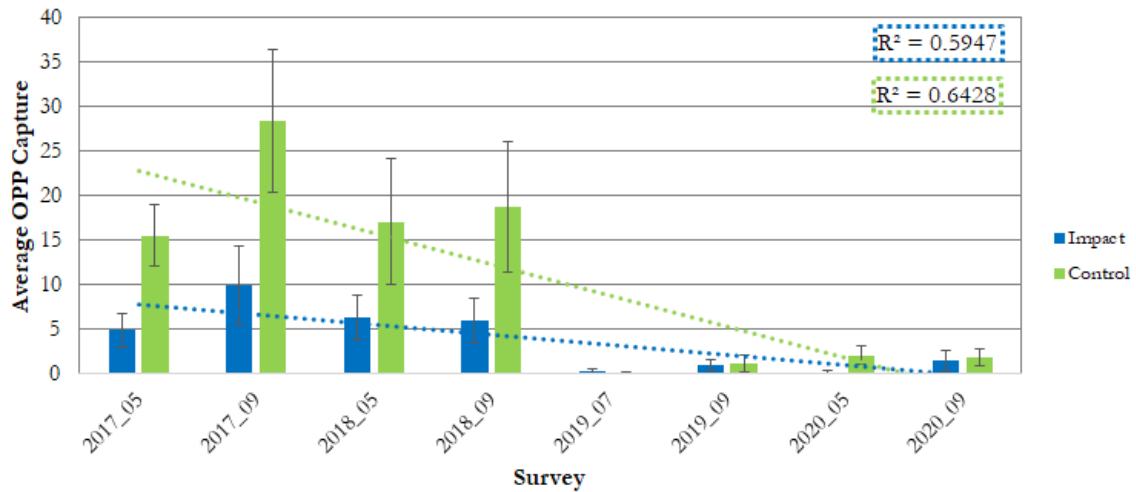
Figure 4.3 Mean ± SE OPP capture per site at impact and control sites during construction phase monitoring.

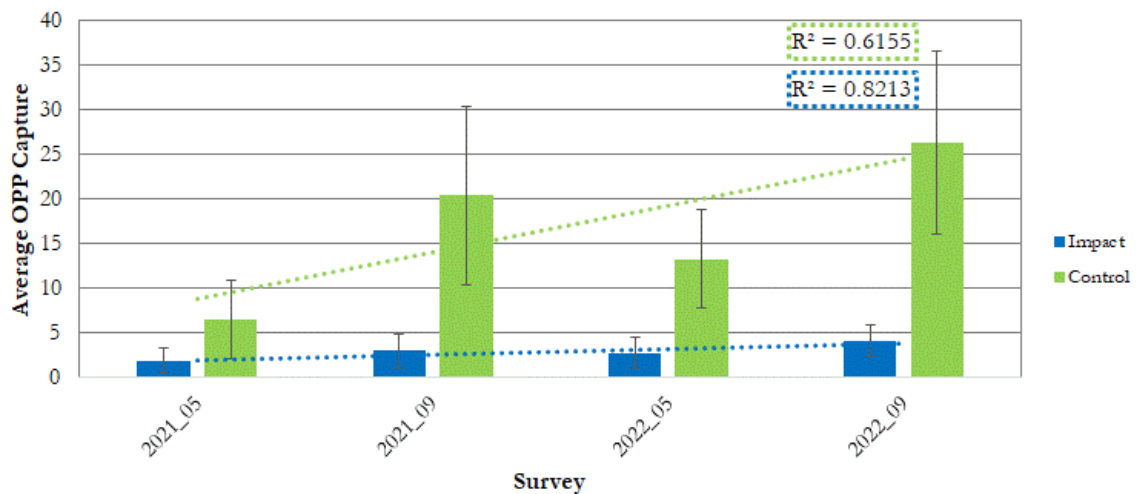
Figure 4.4 Mean ± SE OPP capture per site at impact and control sites during operational phase monitoring to date.

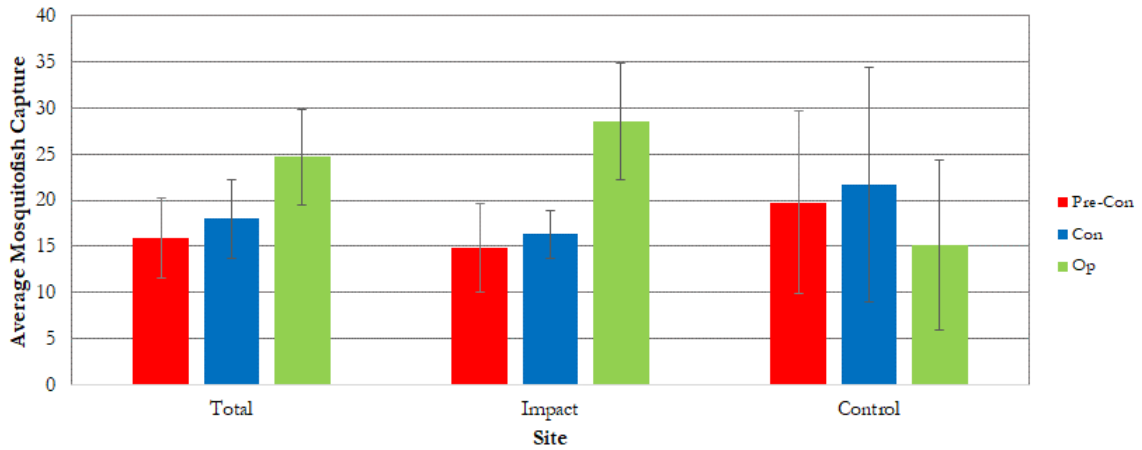
Figure 4.5 Mean  $\pm$  SE Mosquitofish Capture at all impact and control sites in the pre-construction, construction and operational phase surveys.

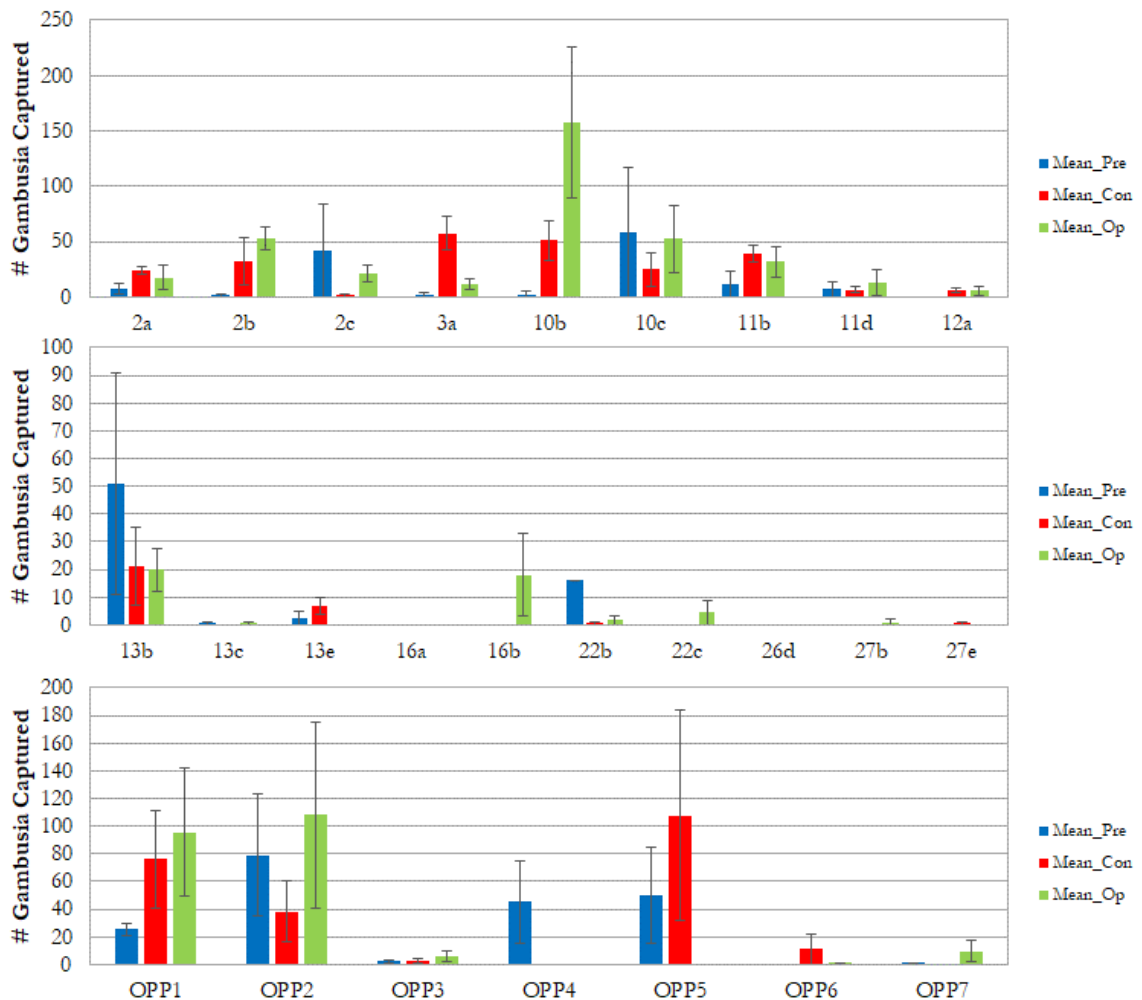
Figure 4.6 Mean  $\pm$  SE Mosquitofish capture at impact sites during each monitoring phase

The numbers of Mosquitofish (*Gambusia holbrooki*) encountered at each site are of specific interest as predation by this species is identified as a Key Threatening Process under the *Biodiversity Conservation Act 2016* and they are antagonistic towards OPP. There has been variation in the numbers of Mosquitofish encountered during threatened fish surveys to date. During the surveys this year, Mosquitofish were captured in very large numbers at both control and impact sites. In comparison with the pre-construction and construction phases, the average catch of Mosquitofish to date in operational phase monitoring has increased slightly although there are high levels of variation in the dataset (Figure 4.5). During the operational phase monitoring to date there has been an increase in the average capture of Mosquitofish at the impact sites, but not at the control sites, when compared with the pre-construction and construction phase monitoring. The increased average capture at impact sites has resulted from very strong increased captures at sites 2b, 10b, 16b, OPP1 and OPP2 (Figure 4.6).
