# Woolgoolga to Ballina Pacific Highway Upgrade

## Threatened Fish Monitoring Program Annual Report 2022

Year 2 Operational Phase Report

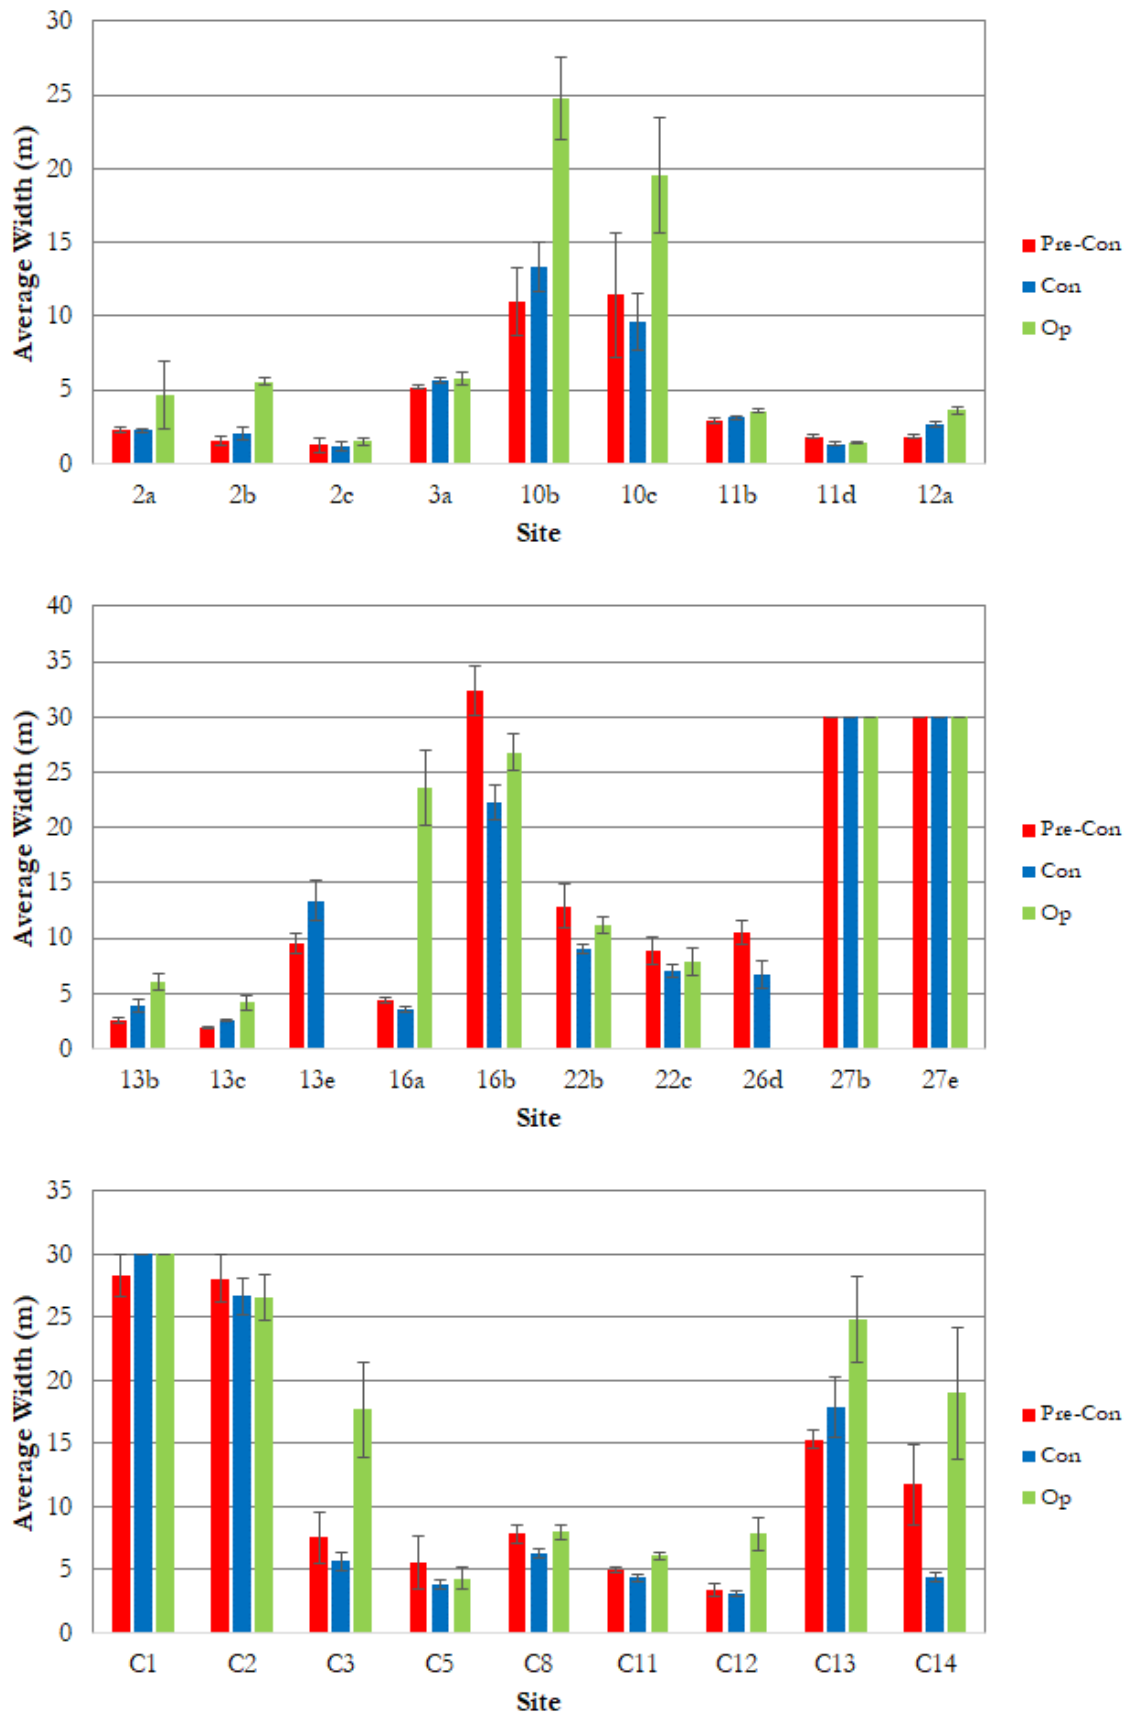
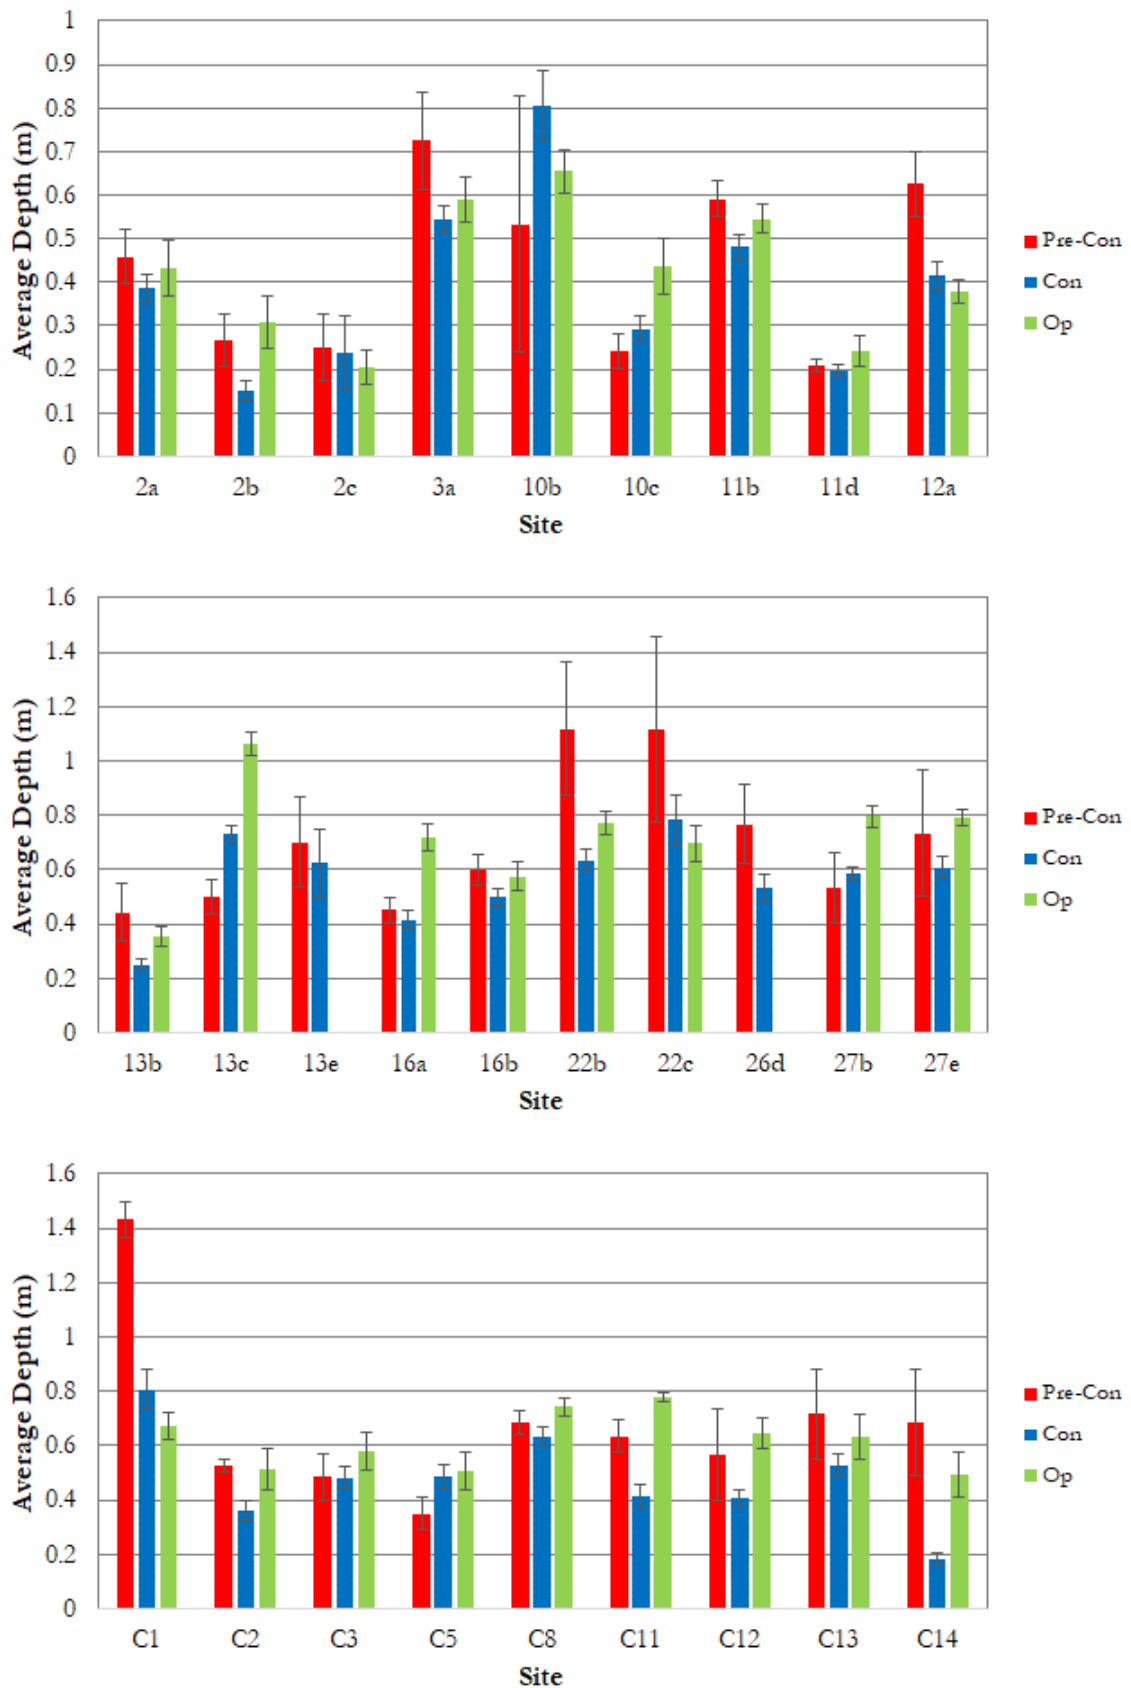
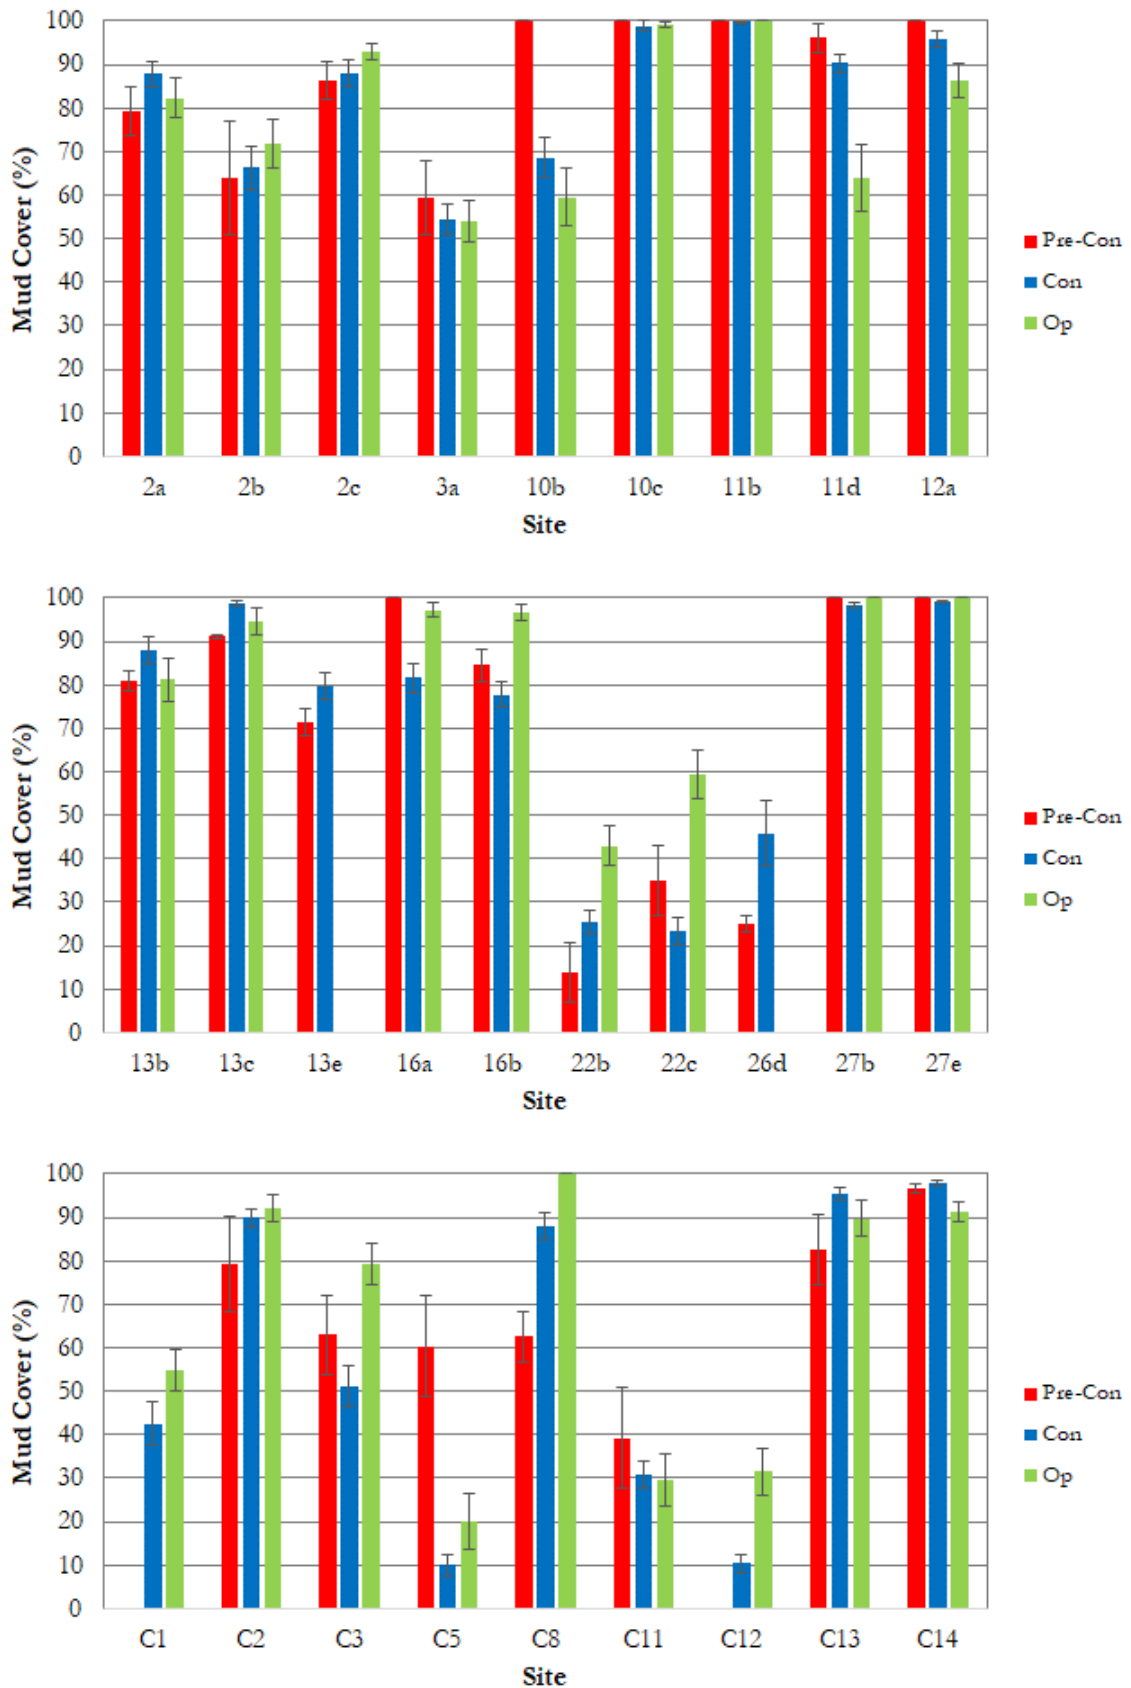
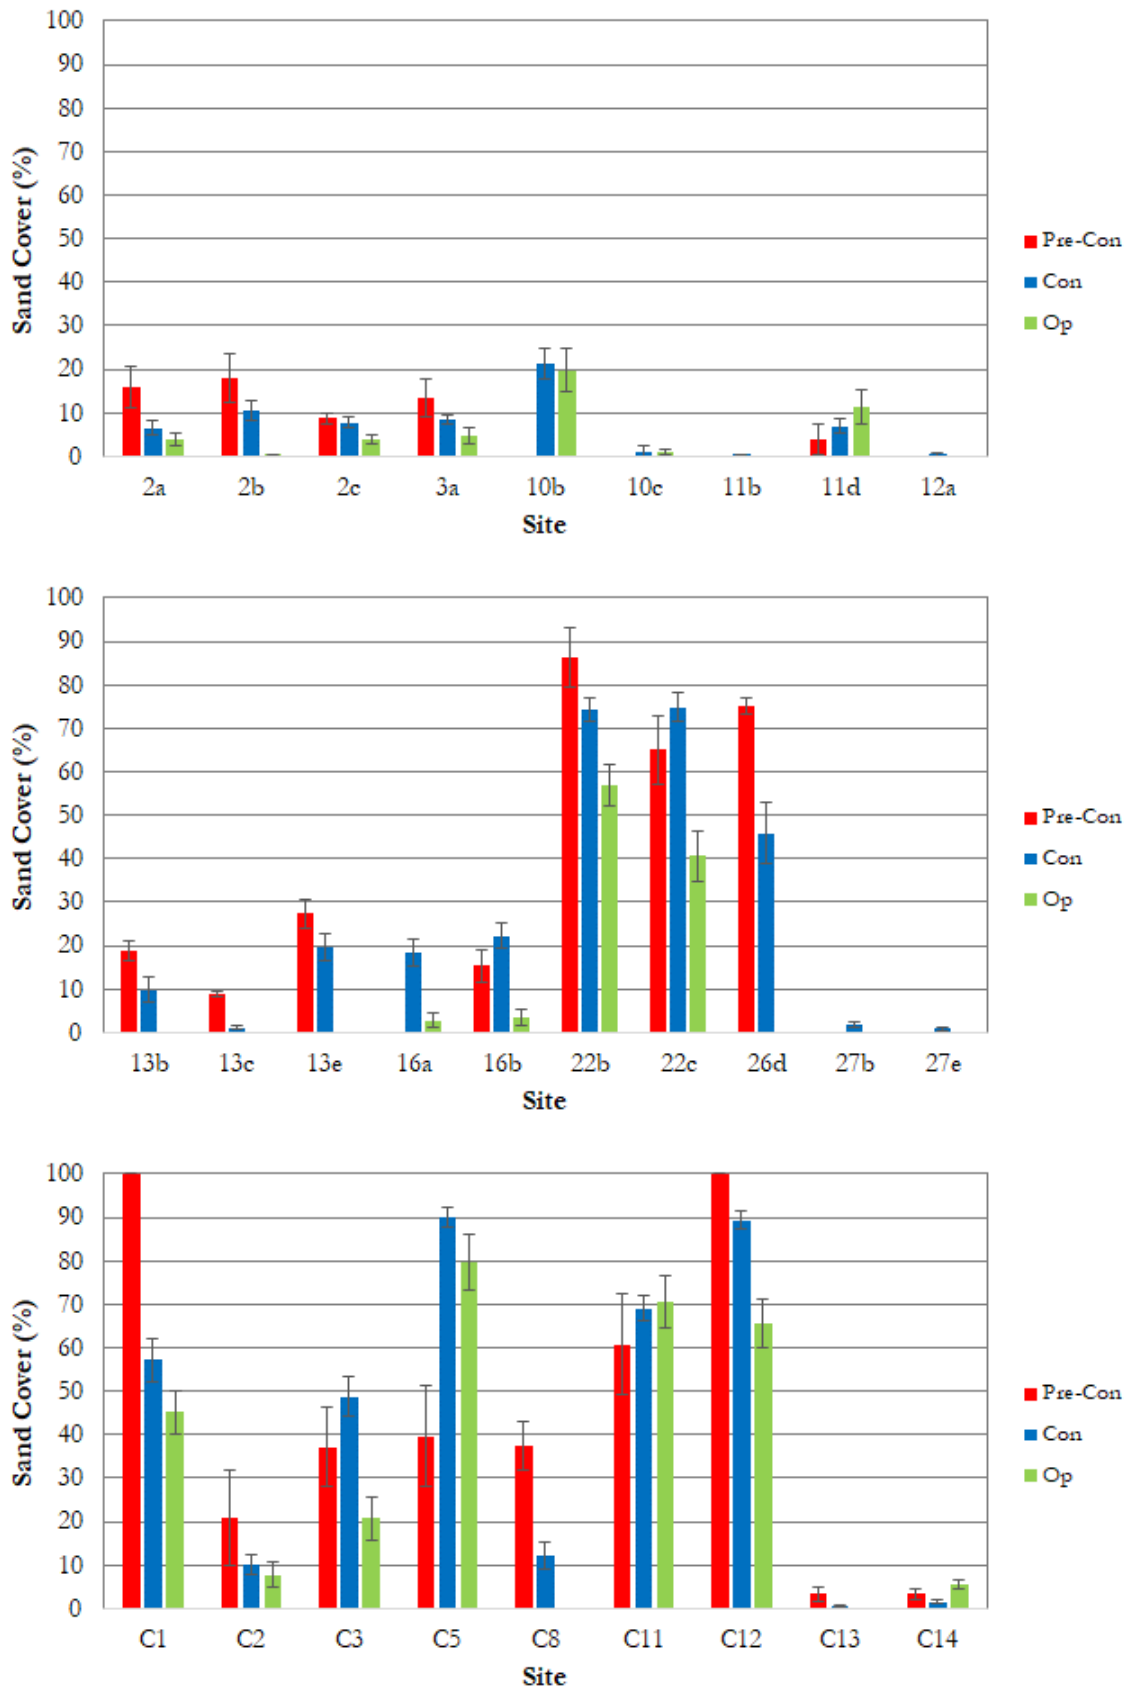
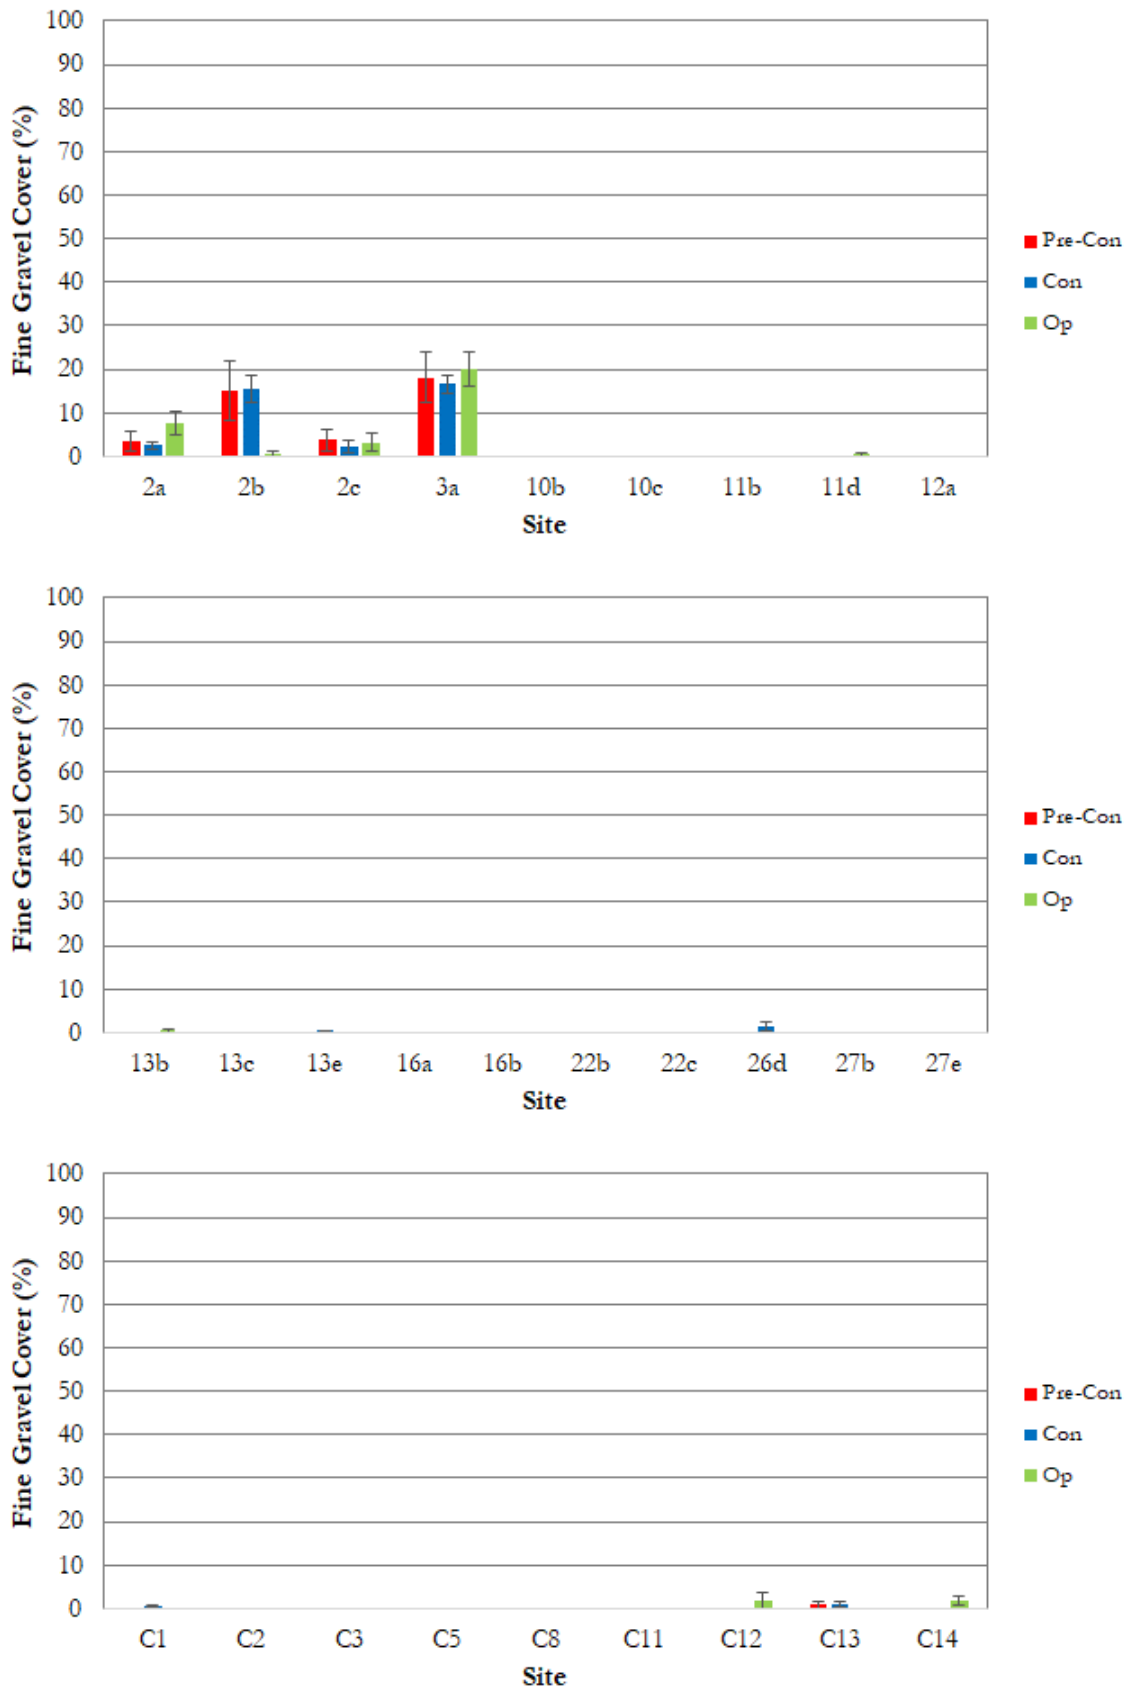
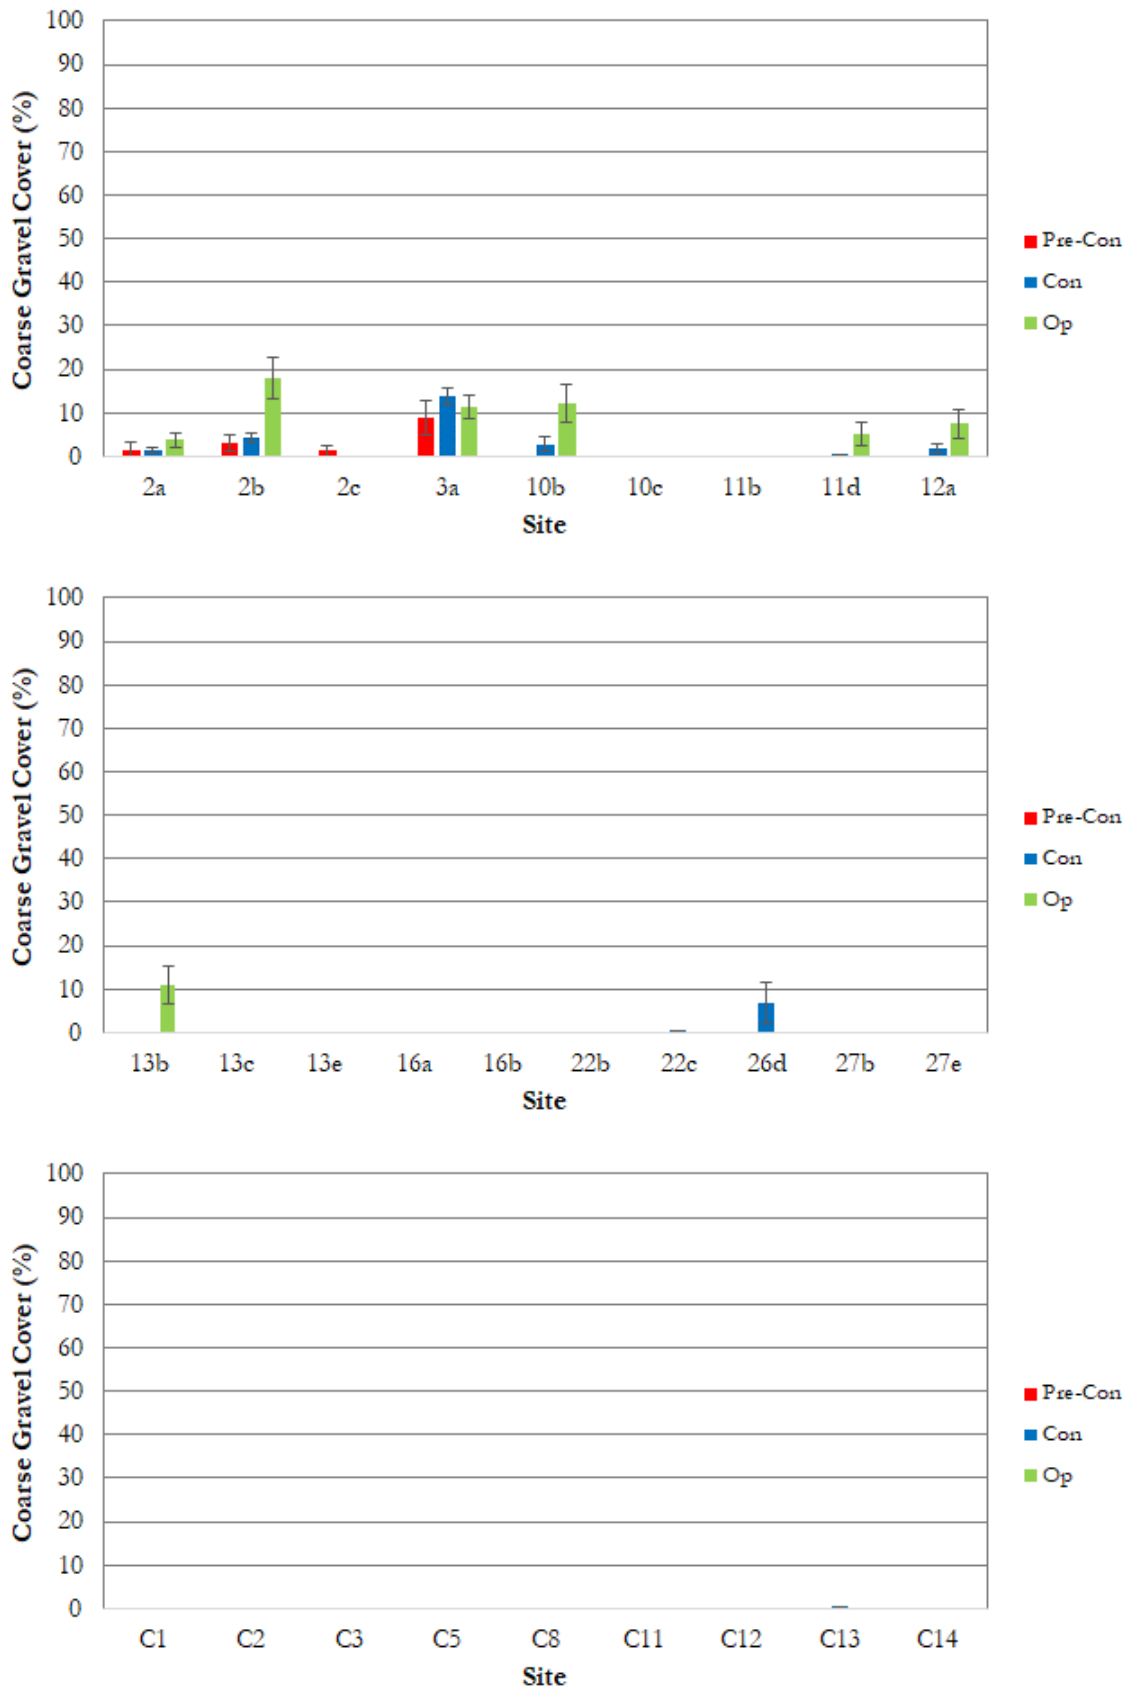
Figure A1 Average ( $\pm$ SE) habitat measurements at each site in the pre-construction, construction and operational phases of monitoring

similar to previous surveys undertaken as part of pre-construction and construction phase monitoring. A graphical assessment of the habitat data collected in the pre-construction, construction and operational (to date) phases of monitoring is presented in **Appendix A**. The analysis indicates significant differences between data collected in the pre-construction, construction and operational (to date) phases at a relatively low number of sites and for some variables only. In general, the observed differences are evenly spread between the impact and control sites. Many of the differences observed are simply a function of hydrological condition, such as width and depth measurements or, in some cases, aquatic vegetation cover, benthic material, trailing vegetation and stream bank form, which can vary at some sites in relation to the water depth and width. Observer bias is also a significant factor, particularly in relation to variables such as riparian cover. Fixed point photographs at each site (presented in the final annual report) are a useful reference for determining actual differences in such cases.
