# **Woolgoolga to Ballina Pacific Highway upgrade**

## **Operational Monitoring of In-situ Threatened Flora Species (non-rainforest)**

Annual Report 2022

Final Report

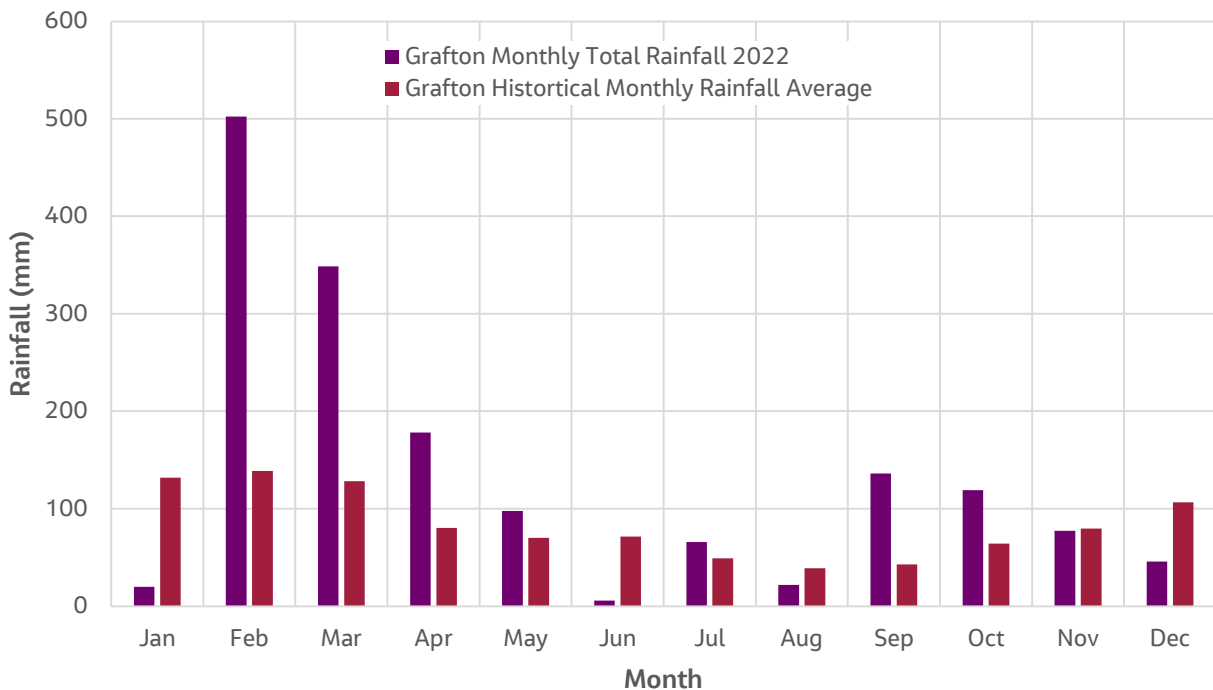
Figure 2-1 Monthly rainfall data and monthly historical average from Grafton Research Station (058077) for 2022

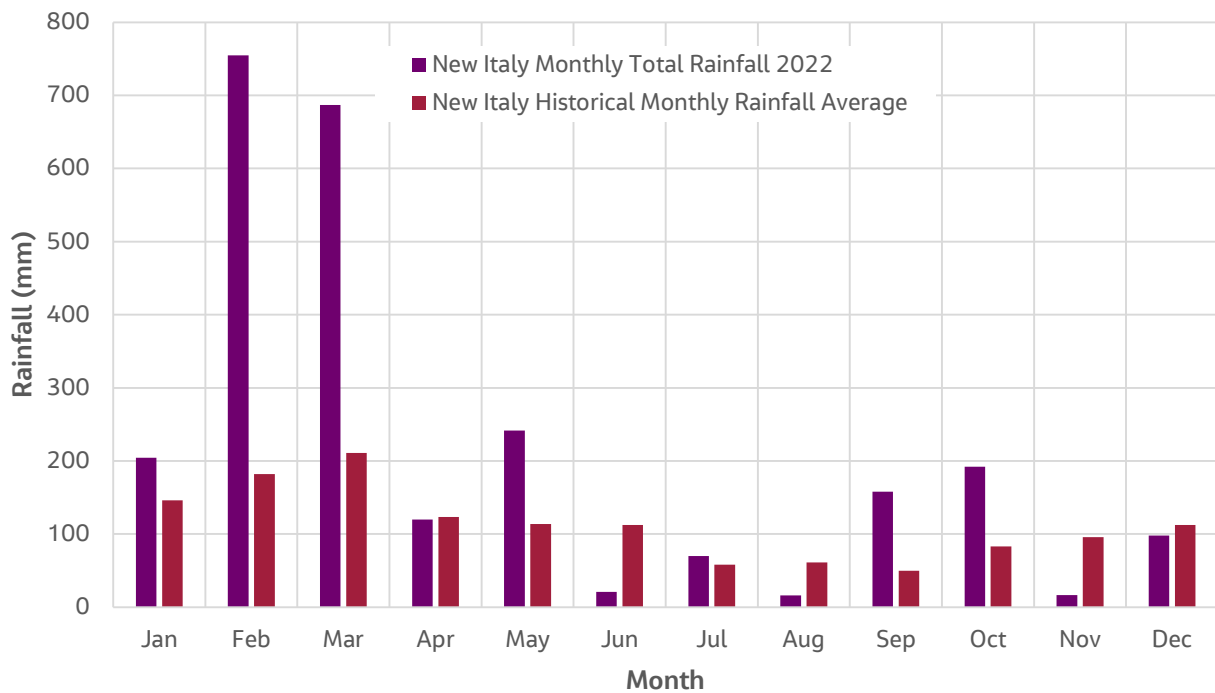
Figure 2-2 Monthly rainfall data and monthly historical average from New Italy (058097) for 2022

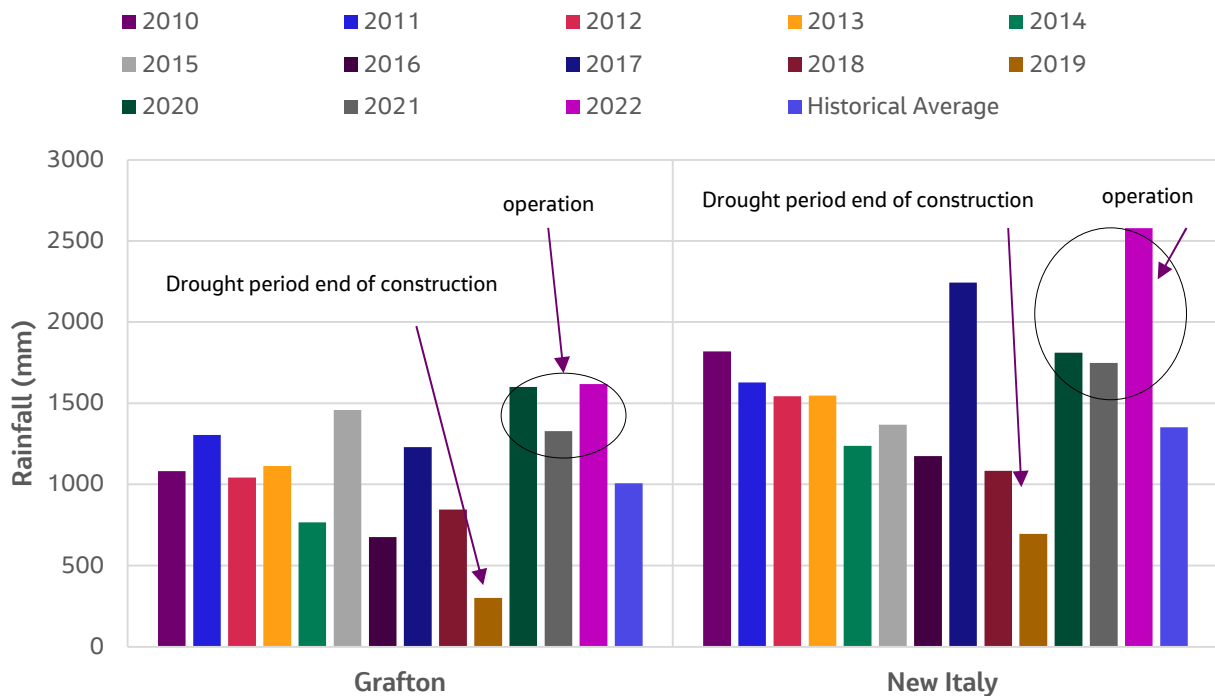
Figure 2-3 Annual and historical rainfall data from the Grafton (058077) and New Italy (058097) weather stations for the project monitoring period (2010-2022)

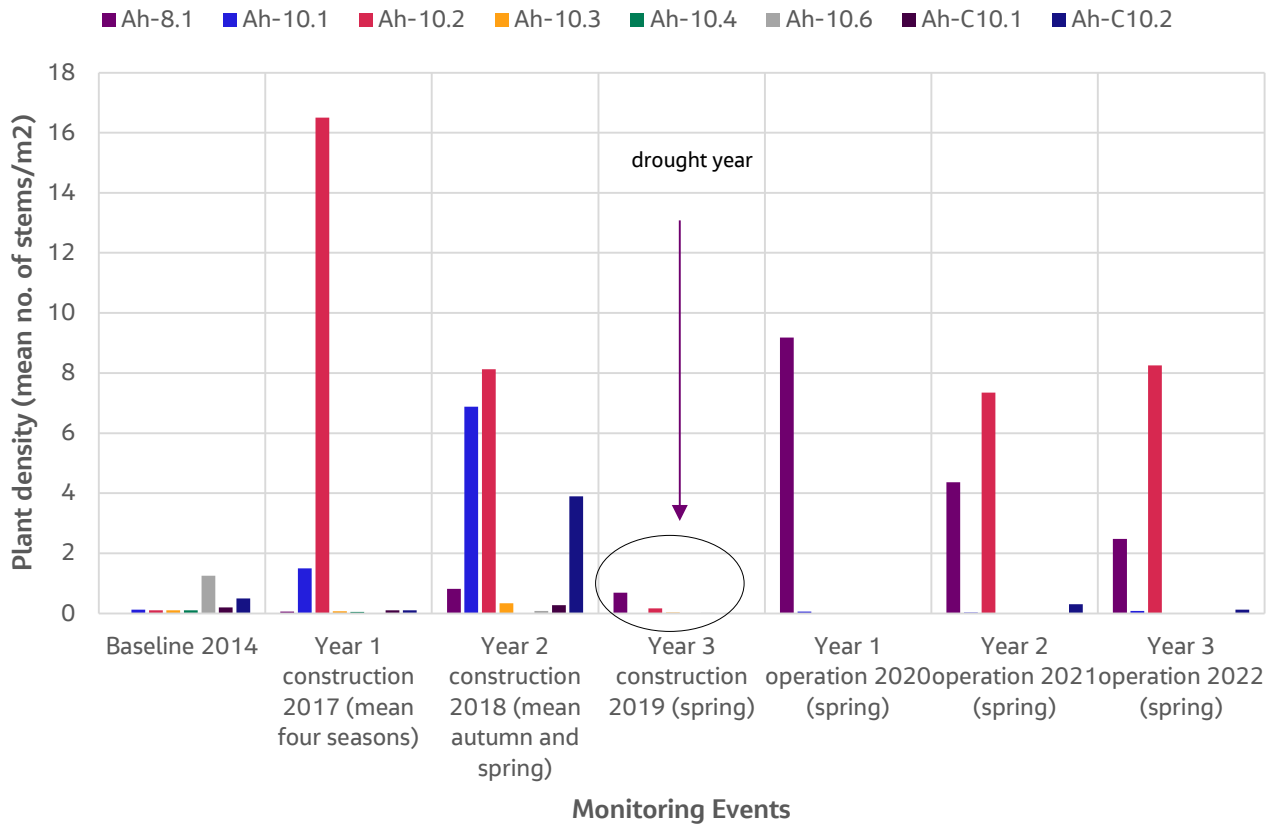
All six *Arthraxon hispidus* in-situ sites (chainage:129300-157900) and two control sites (chainage:157200-157500) were sampled in November 2022. *A. hispidus* was recorded as present at 50 % of the sites (Ah-8.1, Ah-10.1, Ah-10.2 and Ah-C10.2) and absent from the remaining 50 % (Ah-10.3, Ah-10.4, Ah-10.6 and Ah-C10.1) including both impact and control sites. Where *A. hispidus* was observed it was in very-healthy to excellent condition (score 4-5) and ranged in height from 5-15cm. *A. hispidus* is an annual species that naturally dies back each year and the abundance of plants observed at the sites surveyed as part of this monitoring program have fluctuated considerably since baseline surveys (refer **Figure 3-2**).

**Figure 3-2 Density (mean no. of stems / m<sup>2</sup>) of *Arthraxon hispidus* in each plot observed over eleven monitoring events at six in-situ sites and two control sites**

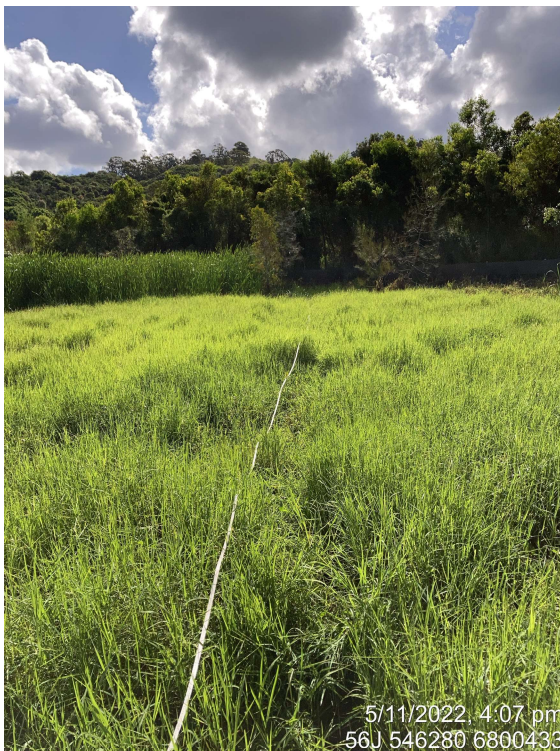
Photograph 3.1: Plot Ah10.4 Exotic species (*Paspalum*) and native Rice Grass (*Leersia hexandra*). *Arthraxon hispidus* has not been recorded here during operation, which is a result of competition.

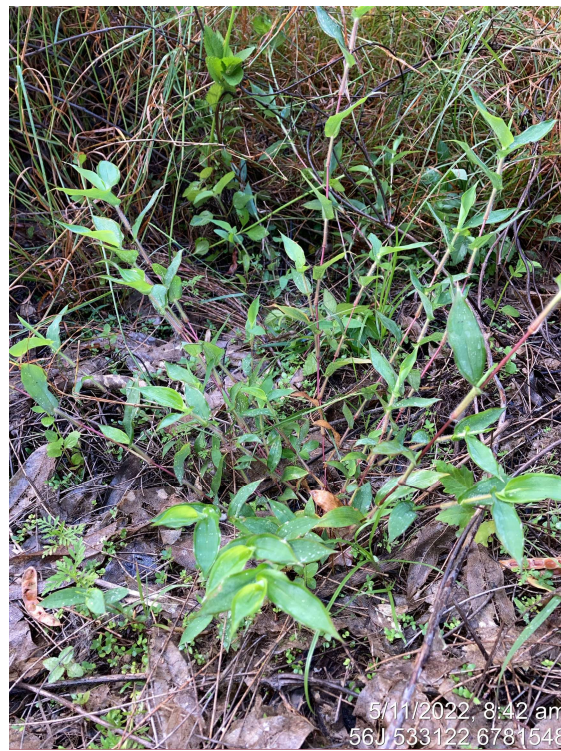
Photograph 3.2: *Arthraxon hispidus* continuing to grow in spaces amongst exotic and native ground covers (Ah-8.1).

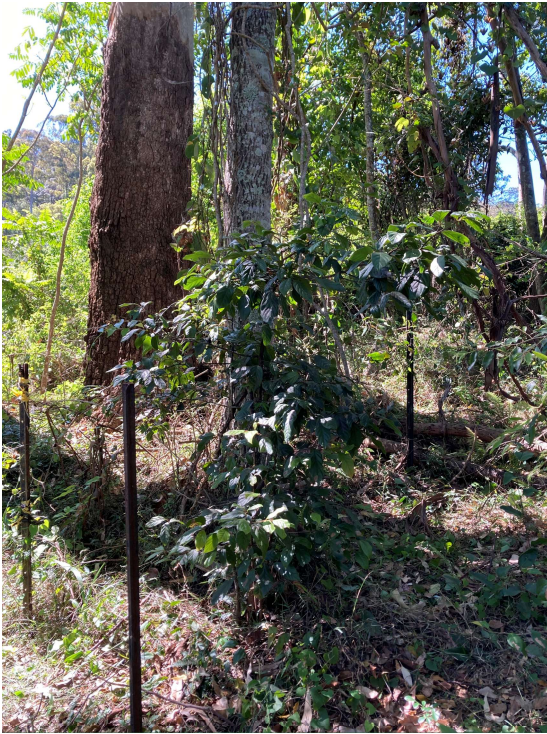
Photograph 3-3: *E. muelleri* subsp. *bracteata* at in-situ site Emb-4.1 showing star pickets that were removed

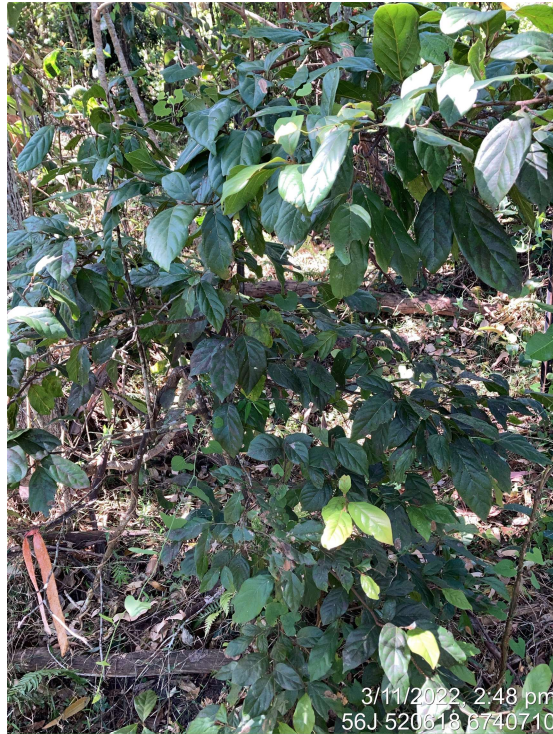
Photograph 3-4: New growth on *E. muelleri* subsp. *bracteata*.

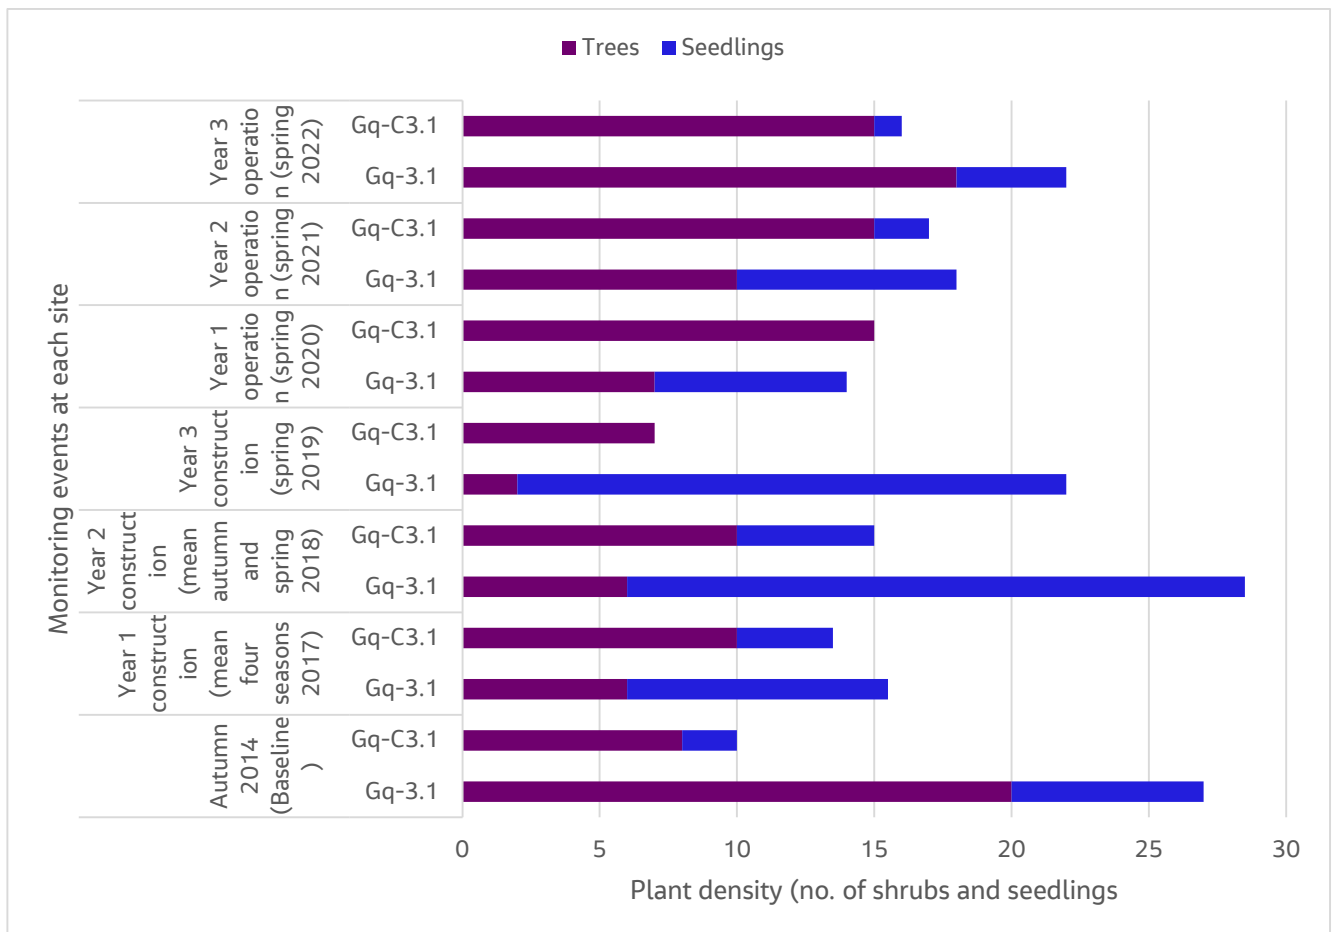
Figure 3-3 Number of *G. quadricauda* shrubs and seedlings observed over eleven monitoring events (2014 [n=1], mean results for 2017 [n=4], mean results for 2018 [n=2], 2019 [n=1], 2020 [n=1], 2021 [n=1] and 2022 [n=1] at in-situ and control site).

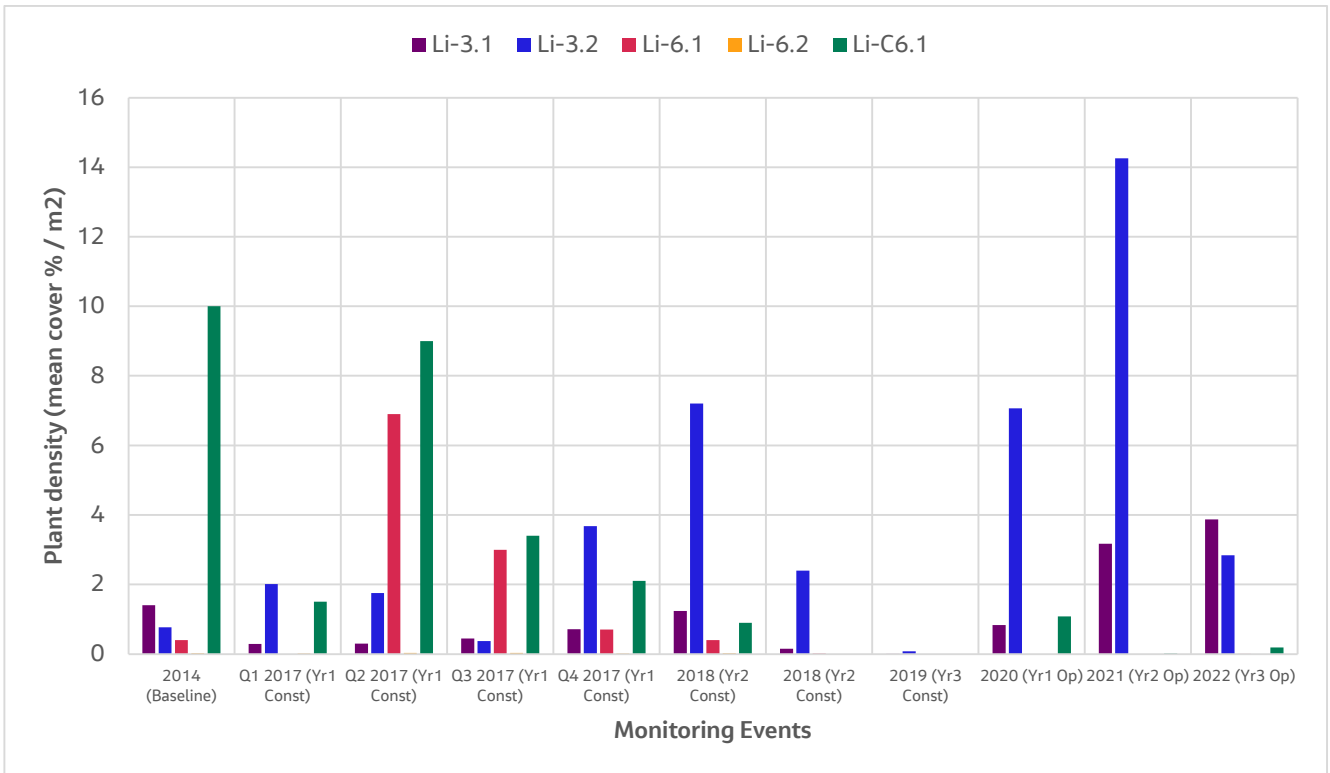
Figure 3-4 Density (mean no. of stems / m<sup>2</sup>) of *Lindsaea incisa* observed over eleven monitoring events at four in-situ sites and one control site.

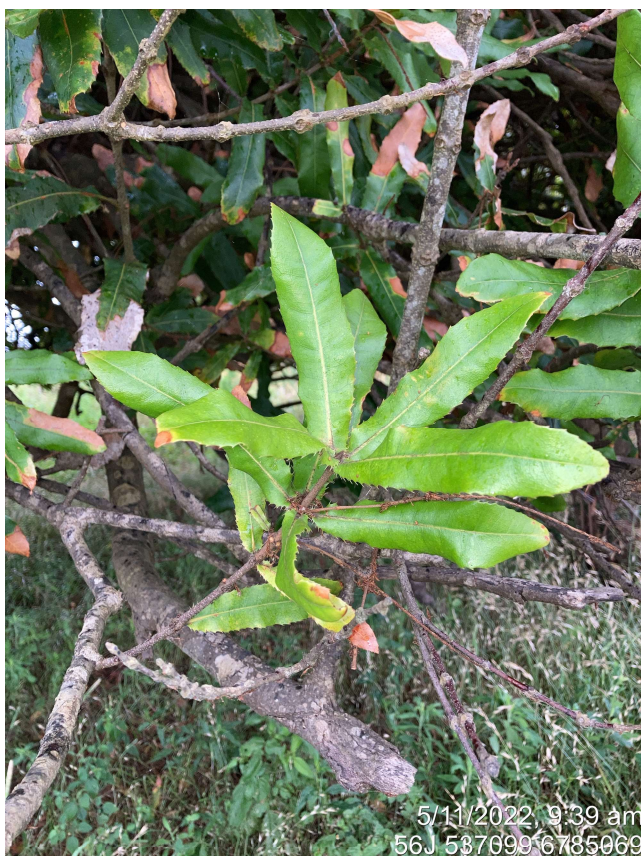
Photo 3.5. *Macadamia tetraphylla* - new shoots in lower branches following flooding and heavy rainfall periods in early 2022

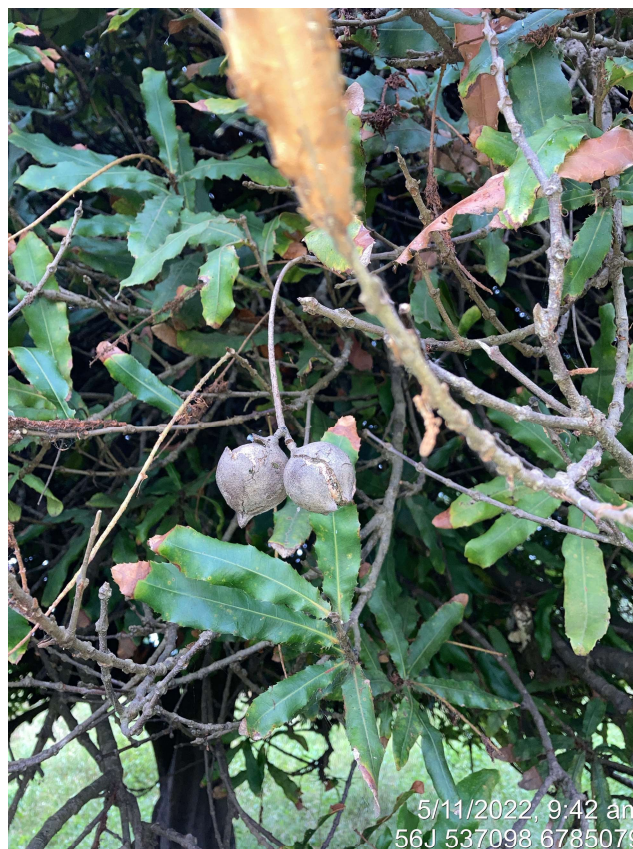
Photo 3.6. *Macadamia tetraphylla* - old woody fruits

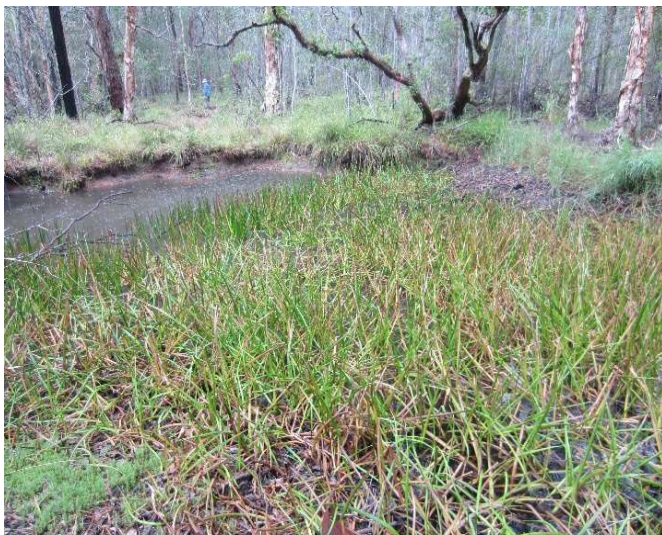
Photograph 3-7 Pre-construction phase at in-situ site Mt-7.2 showing healthy population of *M. triglochinos* (May 2014)

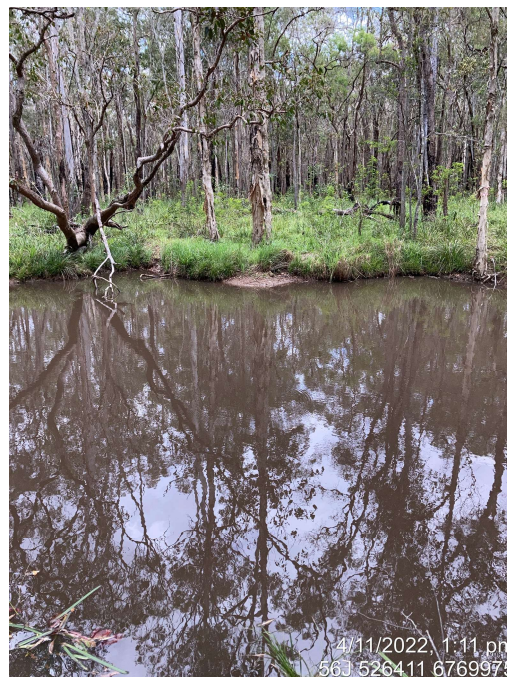
Photograph 3-8. Year 3 operational phase (2022) at in-situ site Mt-7.2 showing absence of plants over previous distribution. The depth of water on the northern bank is evident

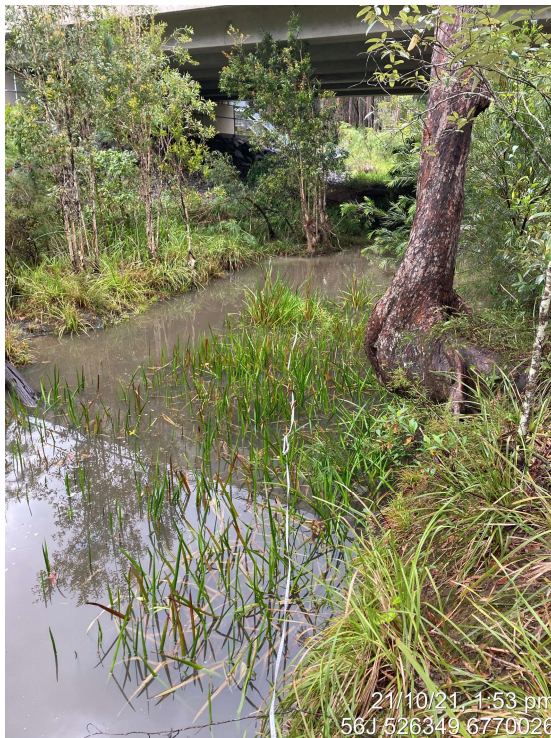
Photograph 3-9: Year 2 operational phase at in-situ site Mt-7.3 showing population recover on west side of the north bound carriage way

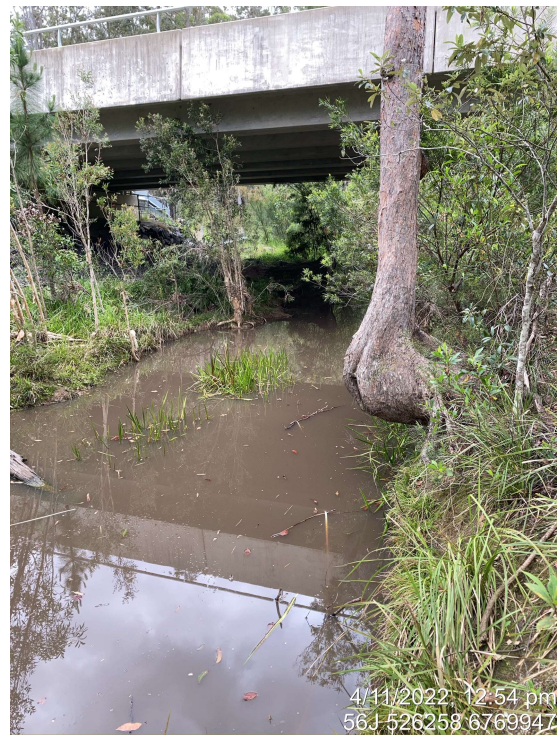
Photograph 3-10: Year 3 operational phase at in-situ site Mt-7.3 following the February major flood event showing decreased area of occupation

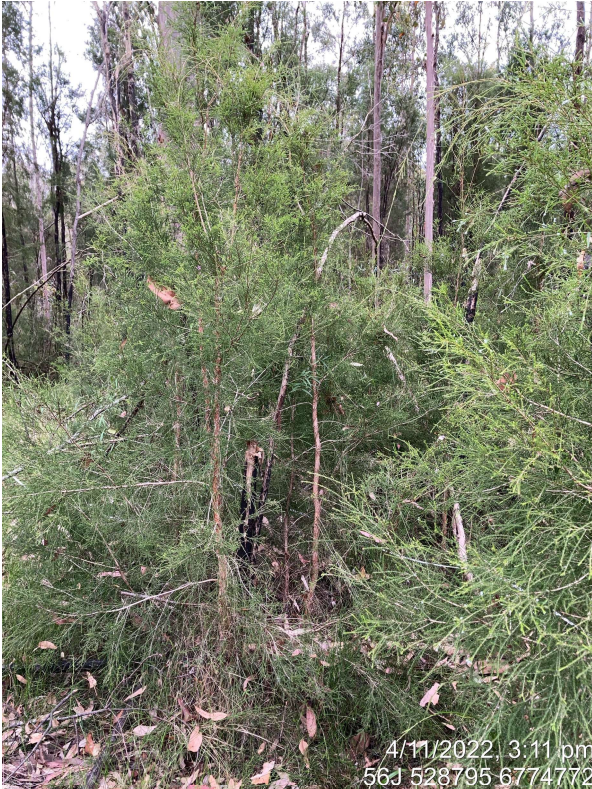
Photograph 3-9: *Melaleuca irbyana* in year 3 operation phase survey (November 2022) at in-situ site Mi-7.1. Dead trunk in centre of photograph new growth after fire.

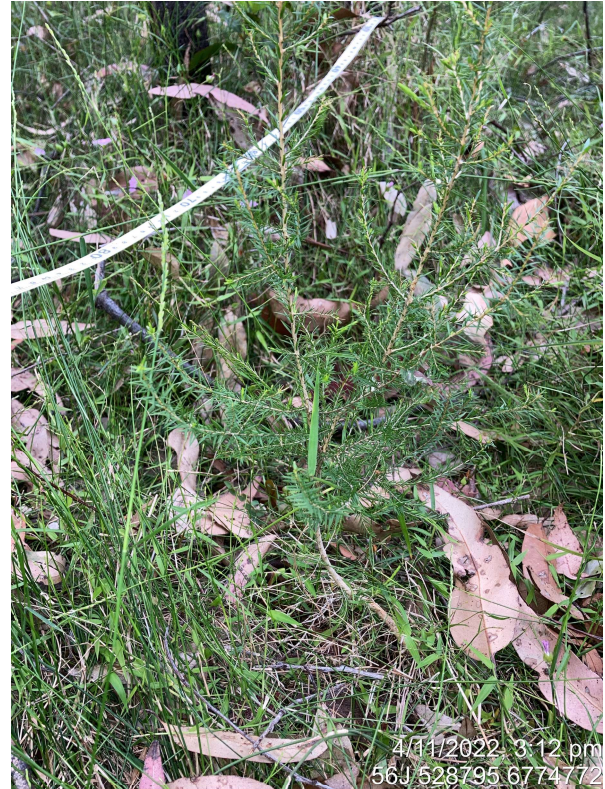
Photograph 3-10: Juveniles plants were commonly counted in 2022 (3 years post-fire) demonstrating the species response to fire.

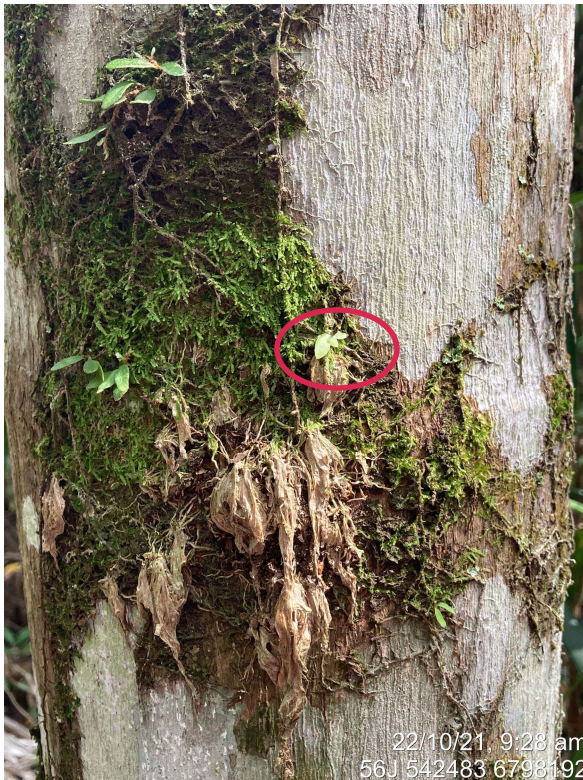
Photograph 3-11: *Oberonia titania* (in October 2021) on edge of forest clearing at in-situ site Ot-10.1 (facing west) showing desiccation

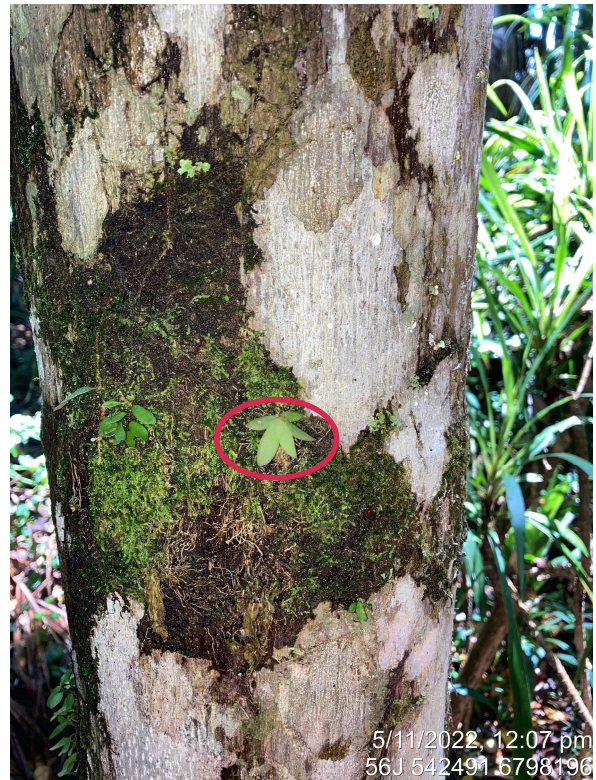
Photograph 3-12. The same individual from the left photograph in November 2022, there is no desiccation and plant has doubled in size in Year 3 operation

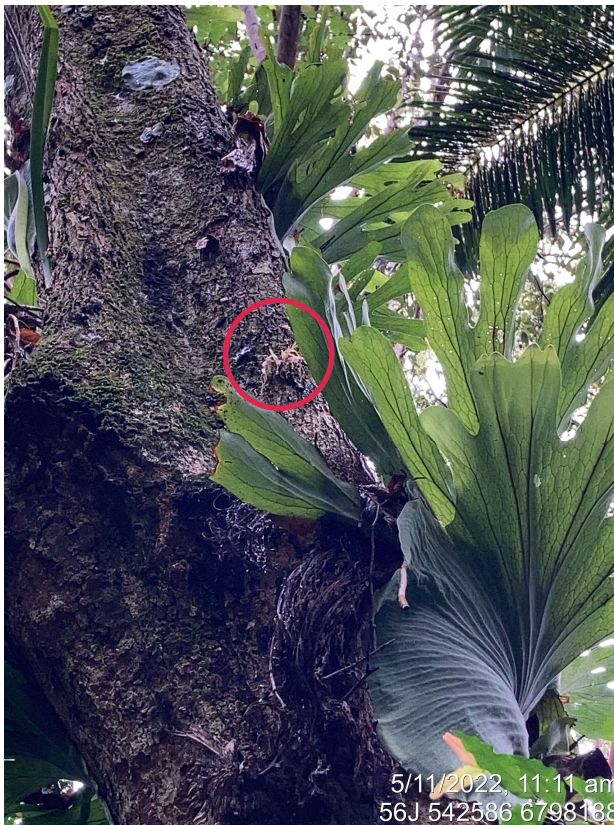
Photograph 3-13: *Oberonia titania* at the control plot showing signs of senescence and natural dieback. The lifespan of the species is unknown

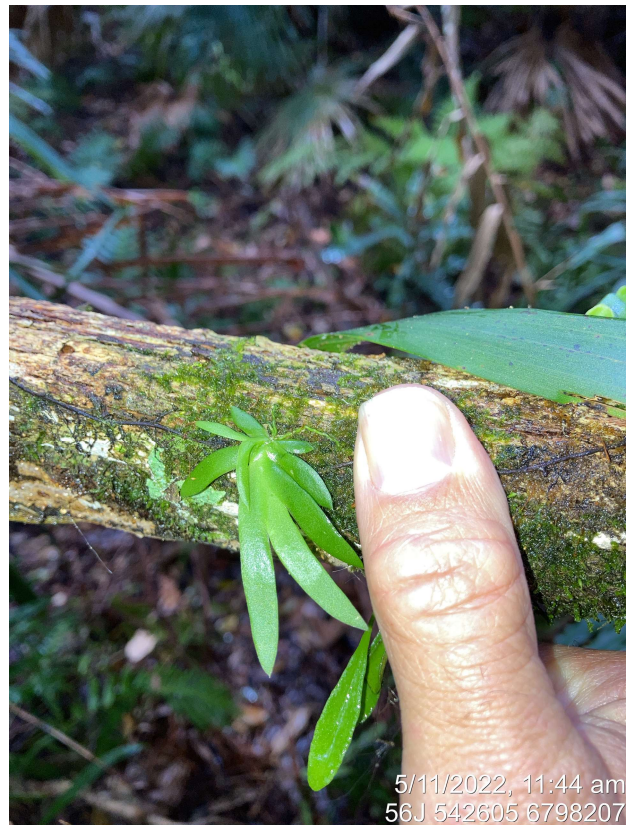
Photograph 3-14: *Oberonia titania* new plant at the control plot located adjacent to Photo 3-13

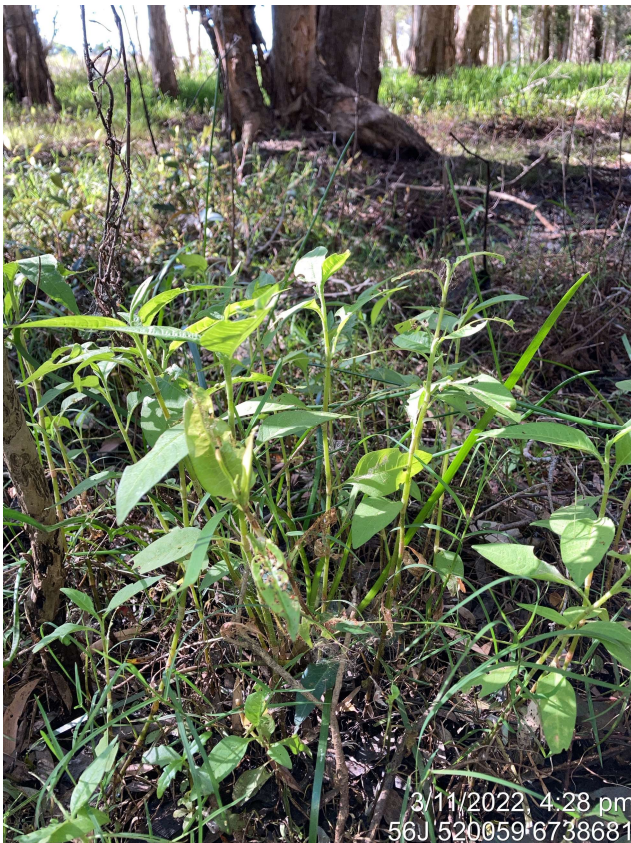
Photograph 3.15. *Persicaria elatior* from impact plot Pe4.1, plants have returned here after 3 -year absence following drought

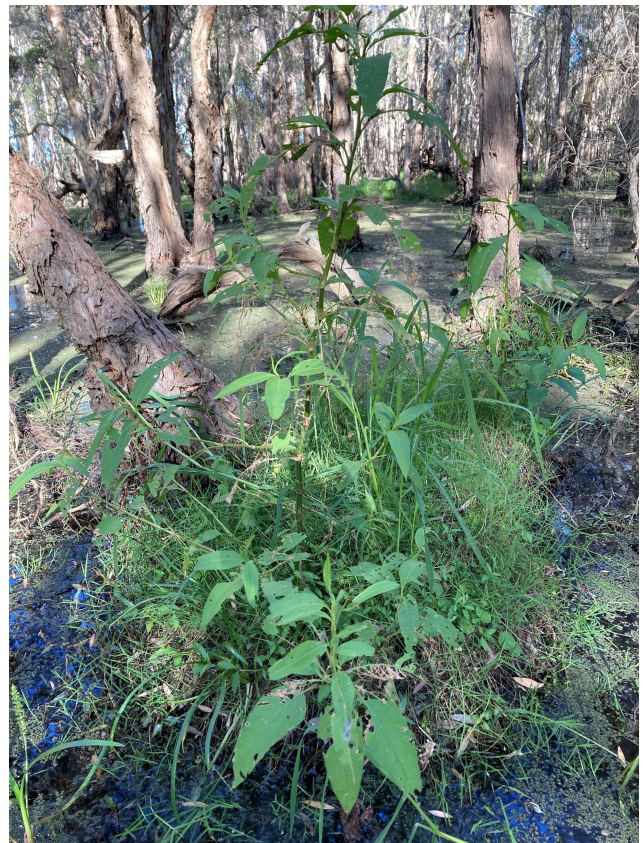
Photograph 3.16. Healthy *Persicaria elatior* growing on small soil mound in inundated swamp. This plant was around 2m tall

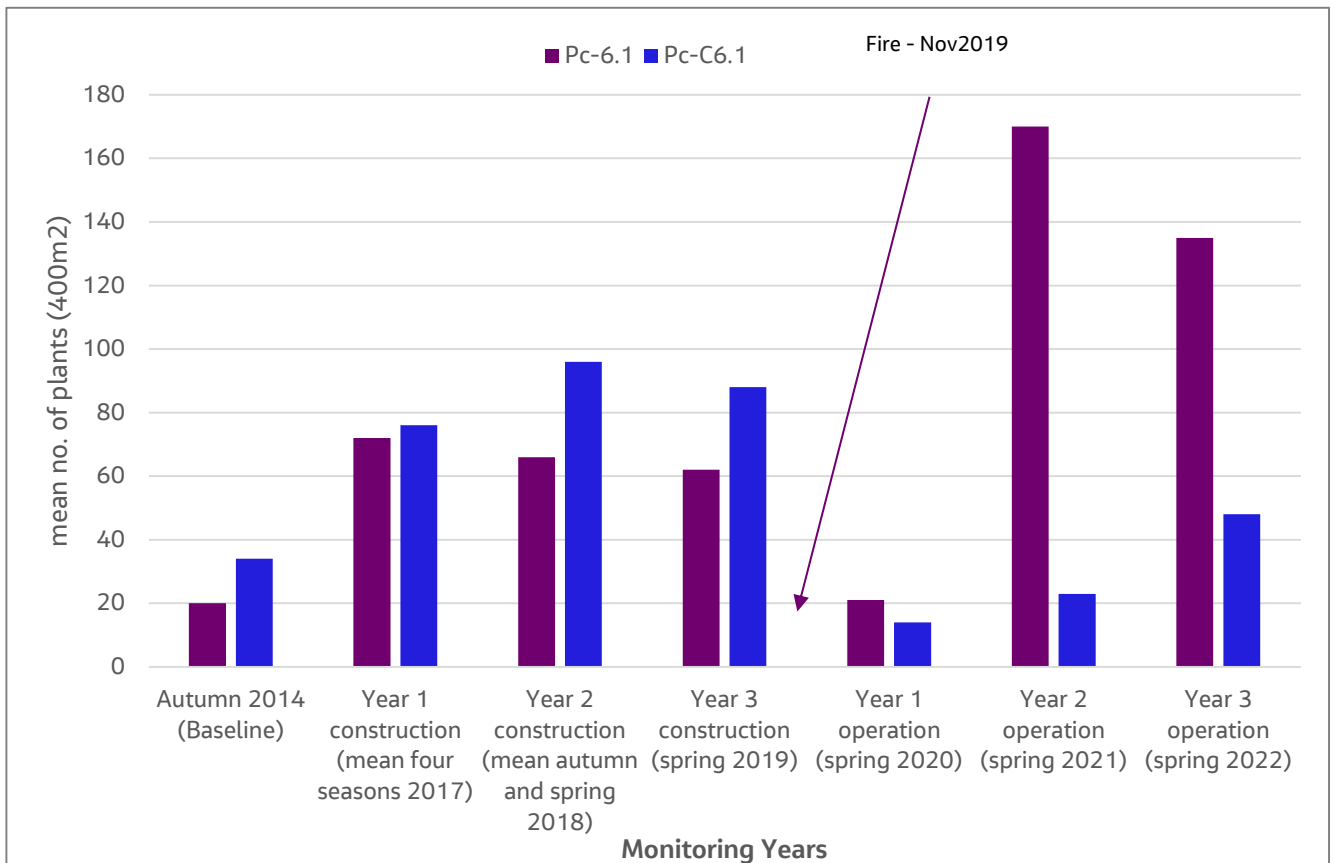
Figure 3-7 Mean number of *Prostanthera cineolifera* plants over ten monitoring events (baseline, construction and operation) at in-situ site (Pc-6.1) and control site (Pc-C6.1).
