Warrell Creek to Nambucca Heads Pacific Highway Upgrade

Annual Ecological Monitoring Report

February 2022 - February 2023

Transport for NSW | May 2023

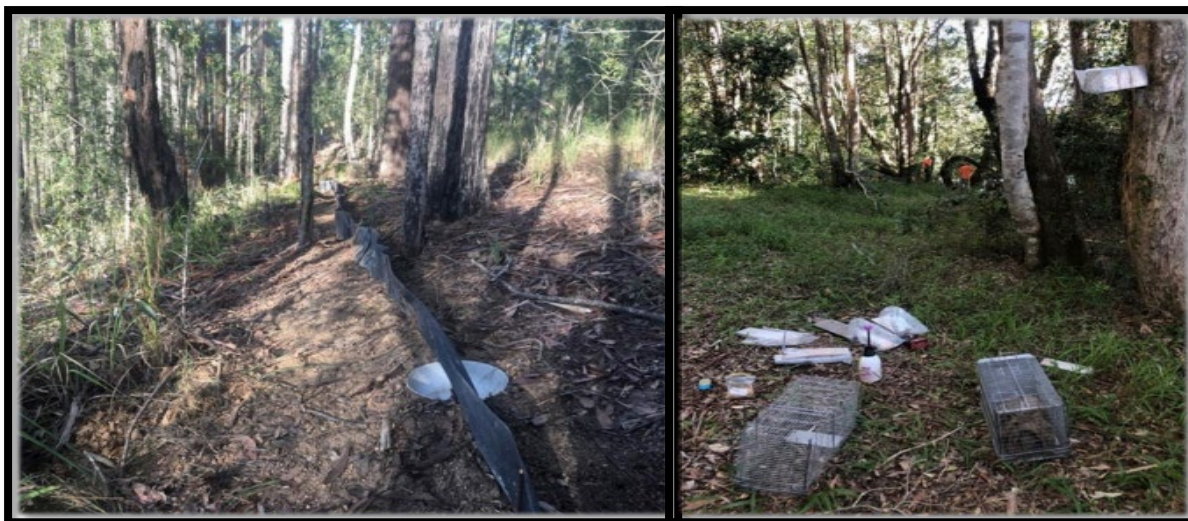
Plate 3: Example of a pitfall trap line installed during adjacent habitat surveys (L). Setting up traps in adjacent habitat at site 1 (R).

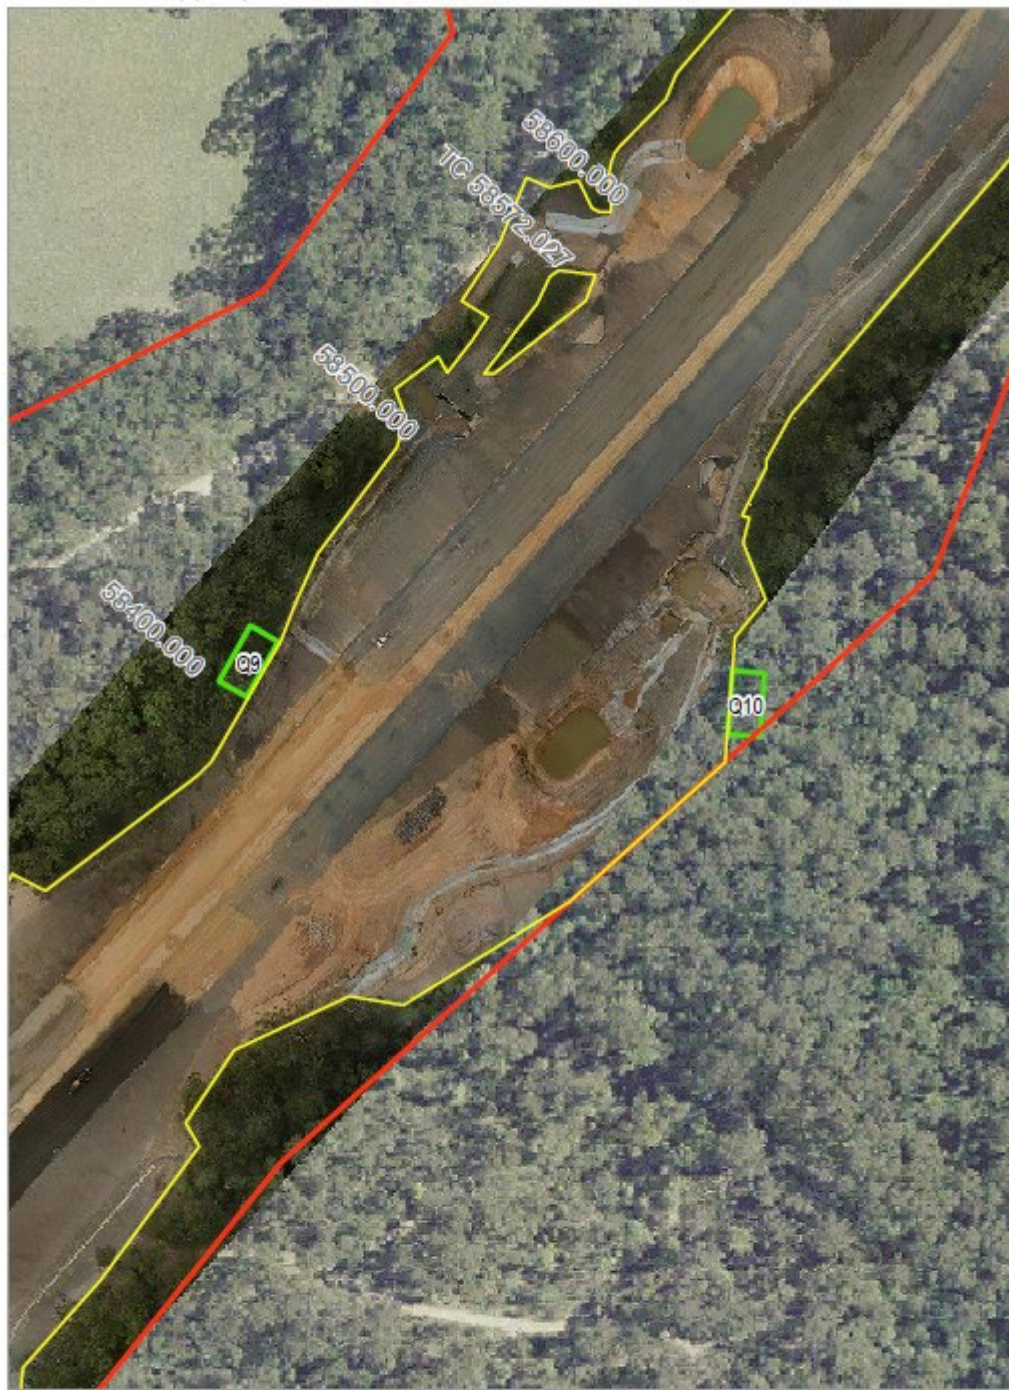
Slender Marsdenia and Woolls' Tylophora Habitat Monitoring Locations

Figure 11: Slender Marsdenia and Woolls' Tylophora Habitat monitoring quadrats 9 and 10, WC2NH. Map sourced from GeoLINK (2017).

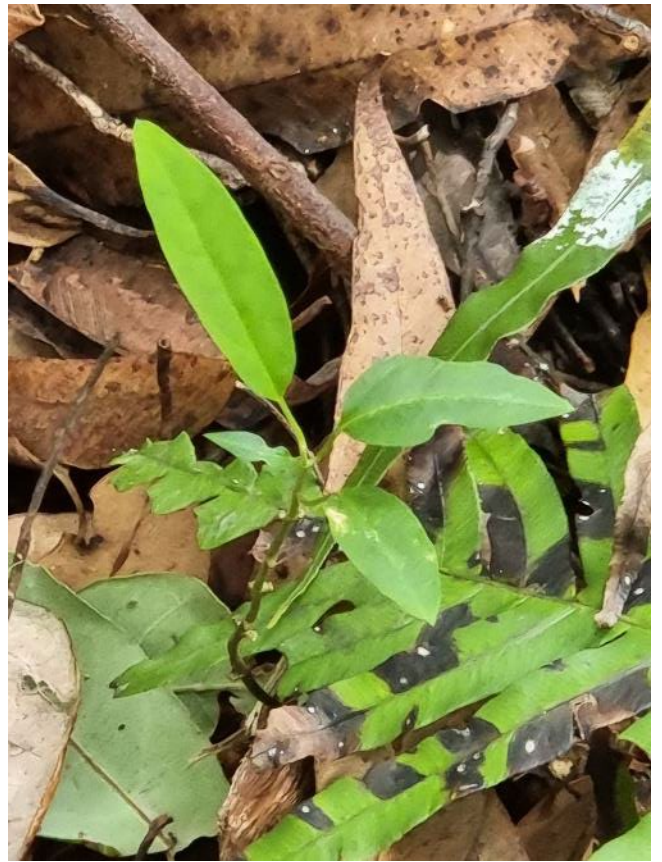
Plate 7: Top left. Recipient Site 7b no. 3, healthy, tall.

Plate 8: Top right. Recipient Site 7b no. 32, small plant 20 cm high, healthy.

Plate 9: Bottom left. Recipient Site 7b, view of habitat showing shady understory with dense ground layer of Gristle Fern (*Blechnum cartilagineum*).

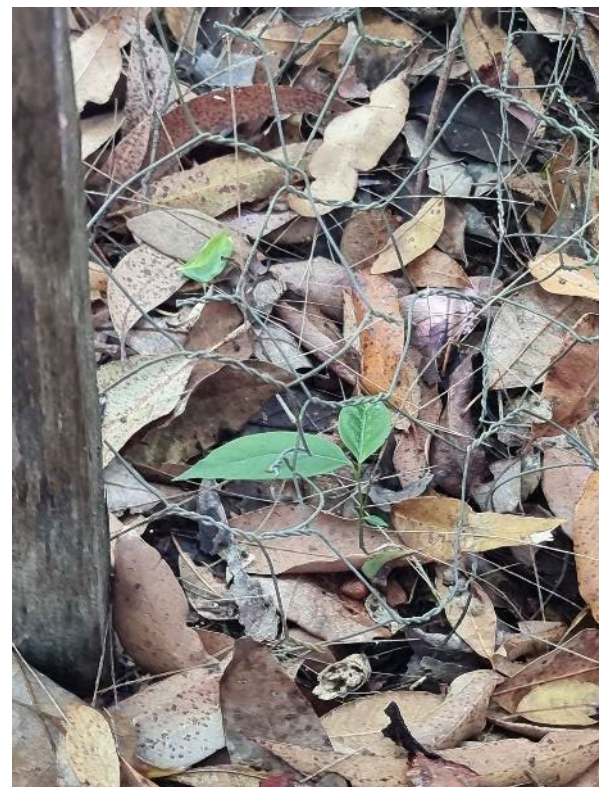
Plates 10 and 11: Recipient Site 5a. Top left plant no. 11, healthy tall. Top right plant no. 2, a small shoot. Bottom left plant no. 1, tall with few leaves. Bottom right plant no. 13, small plant with two leaves after eight years (this may be a recent shoot, but the plant hasn't grown any higher in eight years).

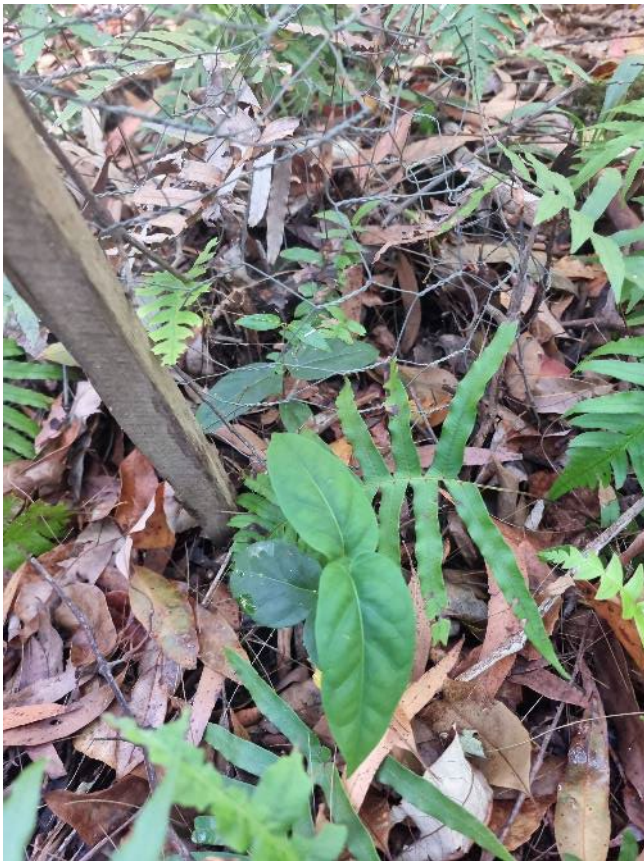
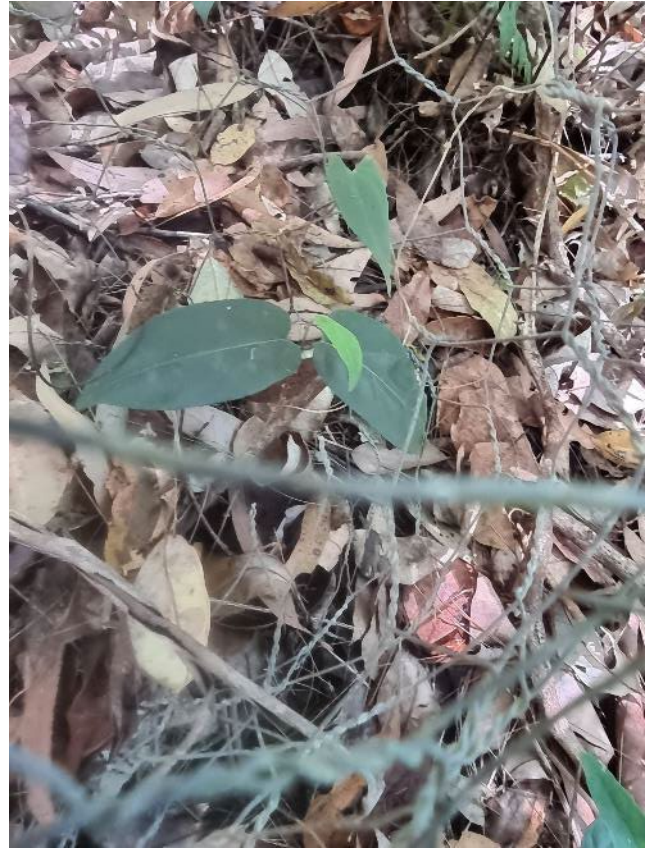
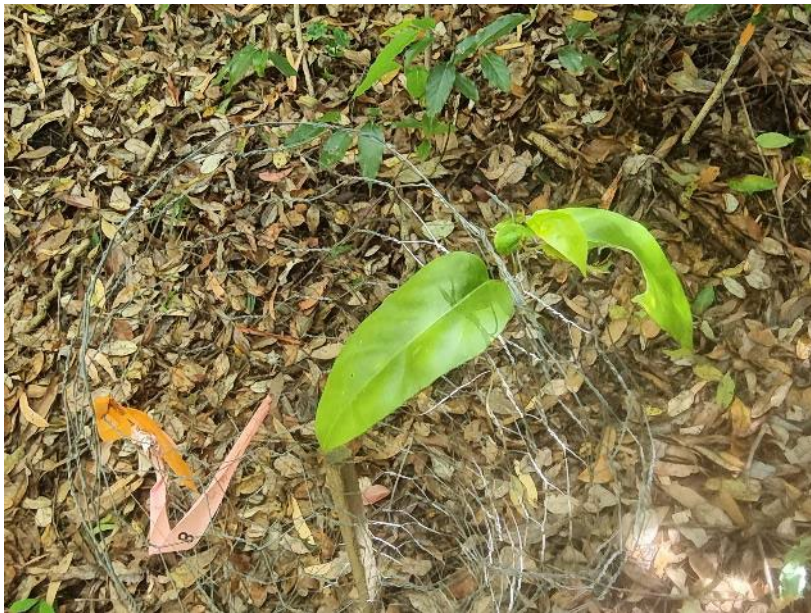
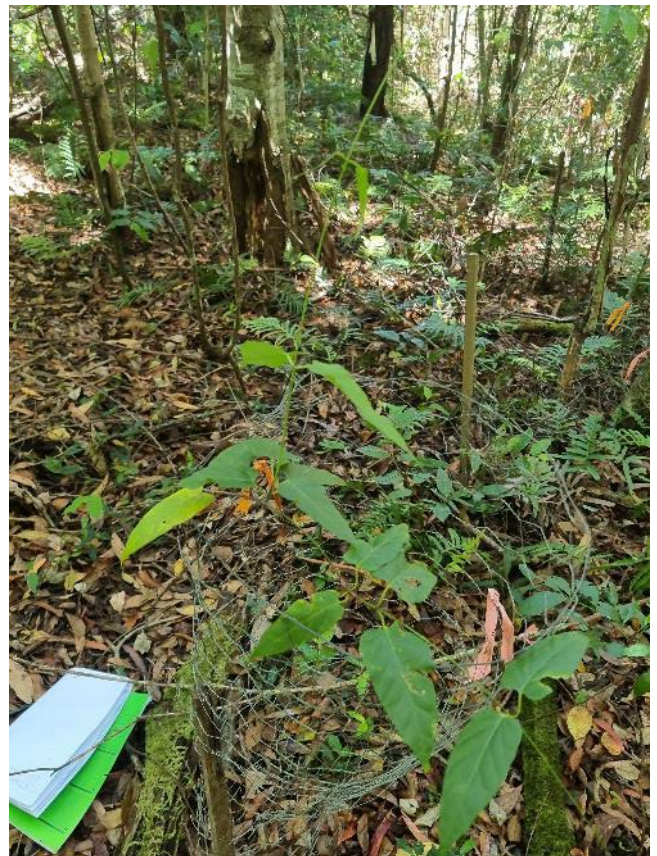
Plates 12 and 13: Recipient Site 5b. Approximately half the Marsdenia's translocated to this site turned out to be Large-flowered Marsdenia (*M. liisae*), a rare species, but not listed as threatened. It has larger leaves than *M. longiloba*. Three photos are *M. liisae*, bottom right is *M. longiloba*, plant no. 14.

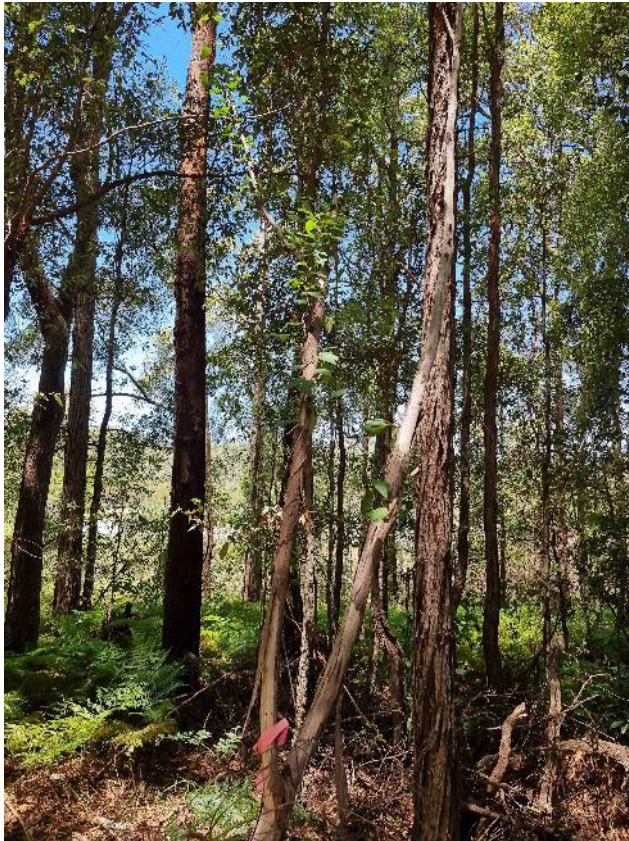
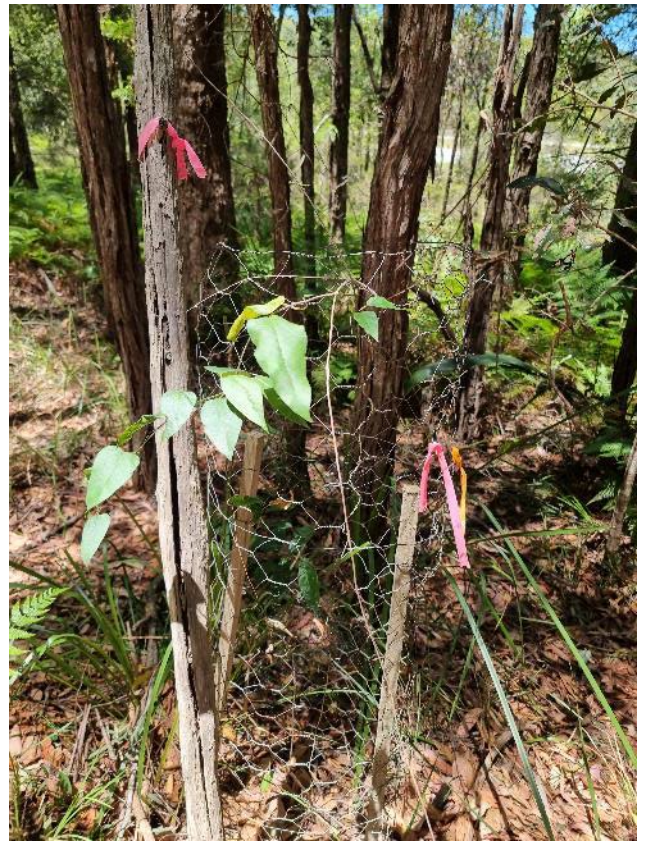
Plates 14 to 16: Recipient site 3.

Top left – plant no. 2 about 5 metres high with the assistance of a dead sapling placed for it to climb up into young trees.

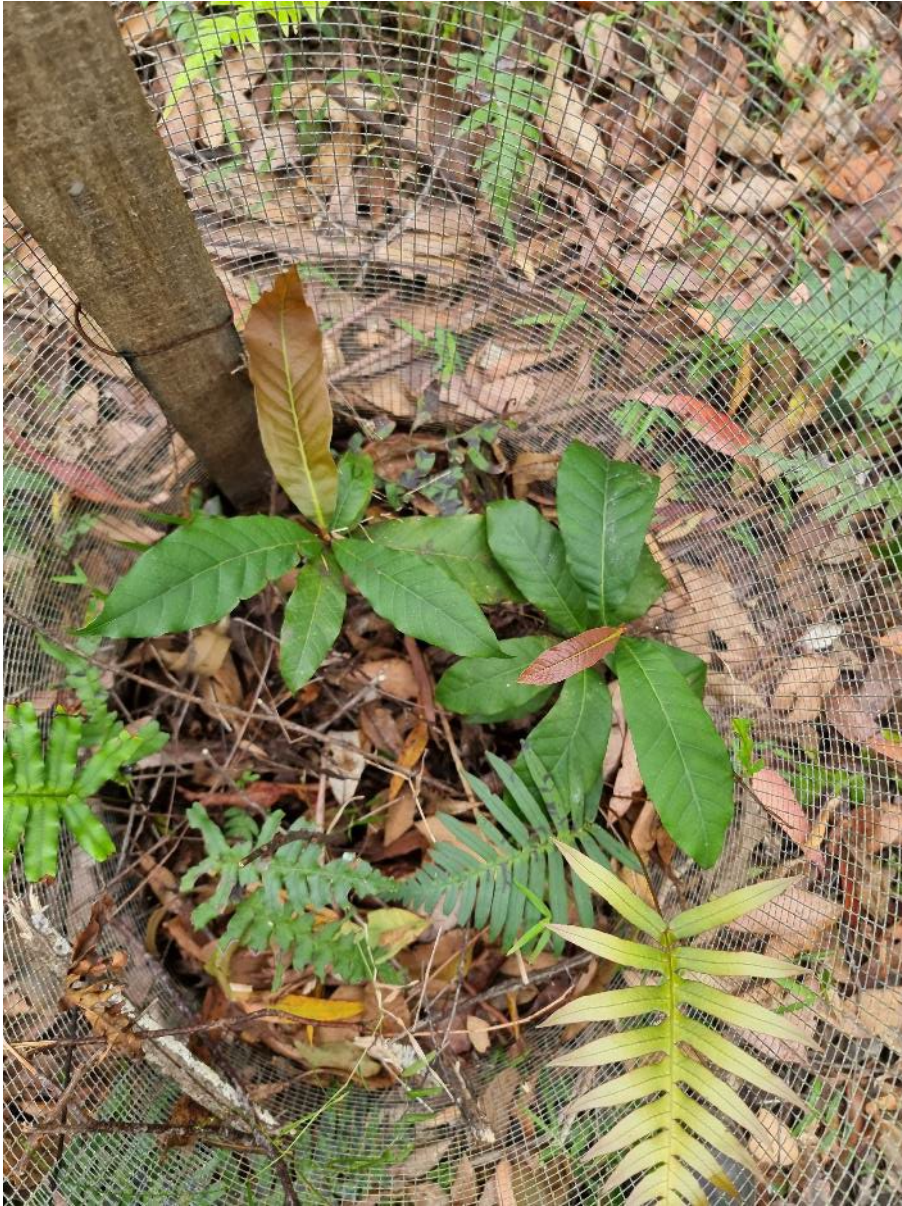
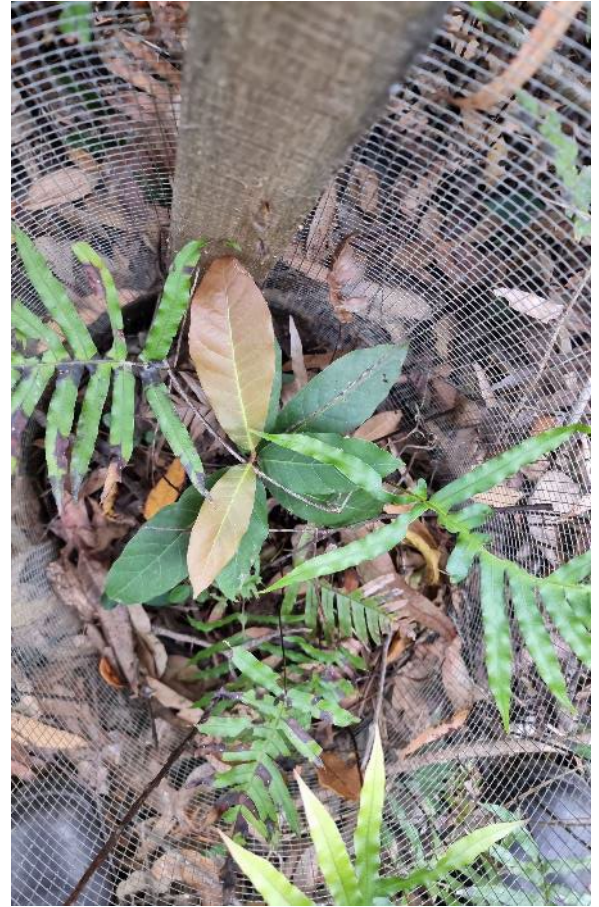
22and 23: Recipient Site 7a. Rusty Plum translocated by direct seeding locally collected seed into protective wire mesh cylinders. Three seeds were placed in each cylinder. After five years, two seedlings survive in one cylinder and one in the other. The seedlings are about 25 cm high and healthy, but slow growing. .

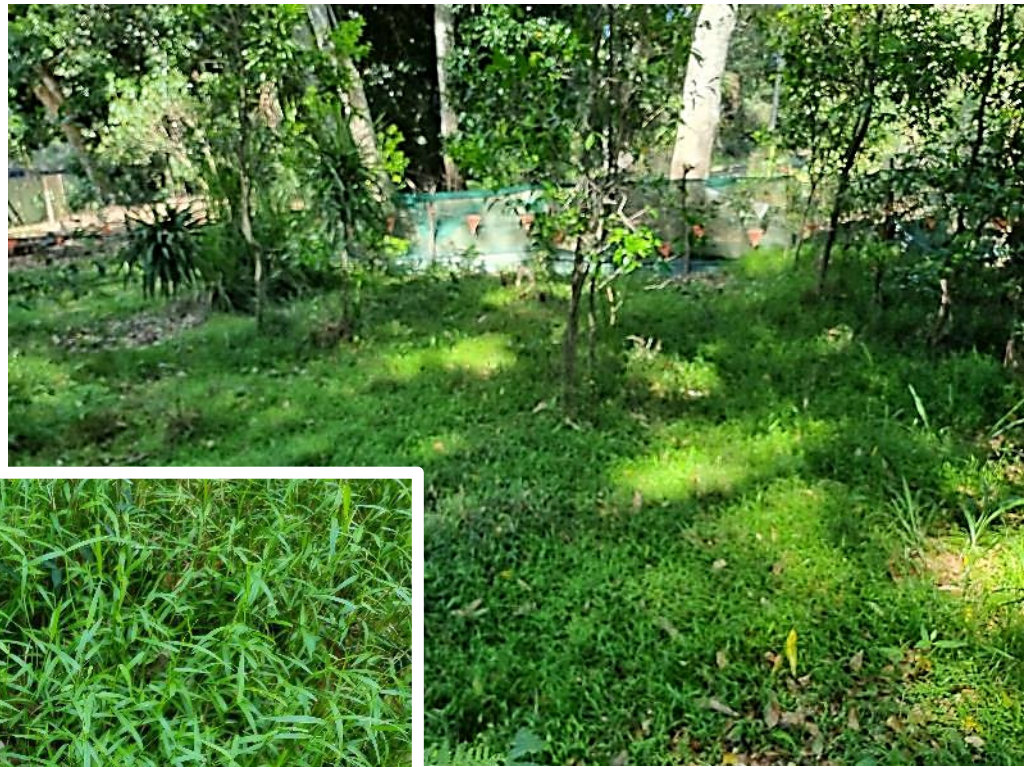
Plates 25 to 27: Floyds Grass Recipient Site 9a

Top – southeast end of Recipient Site 9a with dense *Ottochloa gracillima* (a native mat forming grass) suppressing Floyds Grass

Bottom – close-up of some Floyds Grass which has a flattened stem and arching, blunt tipped leaf blades. *Ottochloa* is in the bottom left bottom corner of this photo and has more pointed, straight leaf blades.

In December 2022, the total area of Floyds Grass was estimated at 10 m² or about 5% of the fenced area referred to above. Rather than a continuous cover of Floyds Grass, as recorded in previous years, occurrence in the 10 m² was fragmented. The section in the southeast corner of the fenced area where Floyds Grass had been dominant, was dominated by *Ottochloa* this year – see Plates 25 to 31. Overall, Floyds Grass appears to have declined by more than 50% compared to last year.

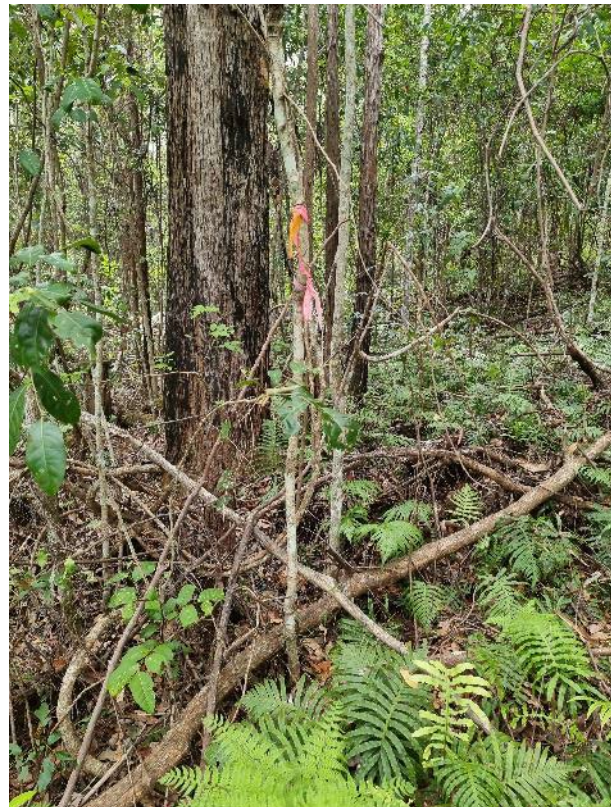
Plates 35 and 36: Slender Marsdenia no. 132 off Old Coast Road next to the highway.

This small patch of stems has maintained similar height for eight years. The plant in the photo to the right grew about 1.5 m high then died back to the ground. The small plant above had grown where the previous stem had died back so is probably from the same plant's root system.

These stem dynamics are similar to those observed in the translocated plants.

At ML132 shoots remained small (<10 cm high). Stems at ml-72, ml-138 and ml-63 occur at Cockburns Lane (same site as in-situ Rusty Plum) were small and one 1 m high.

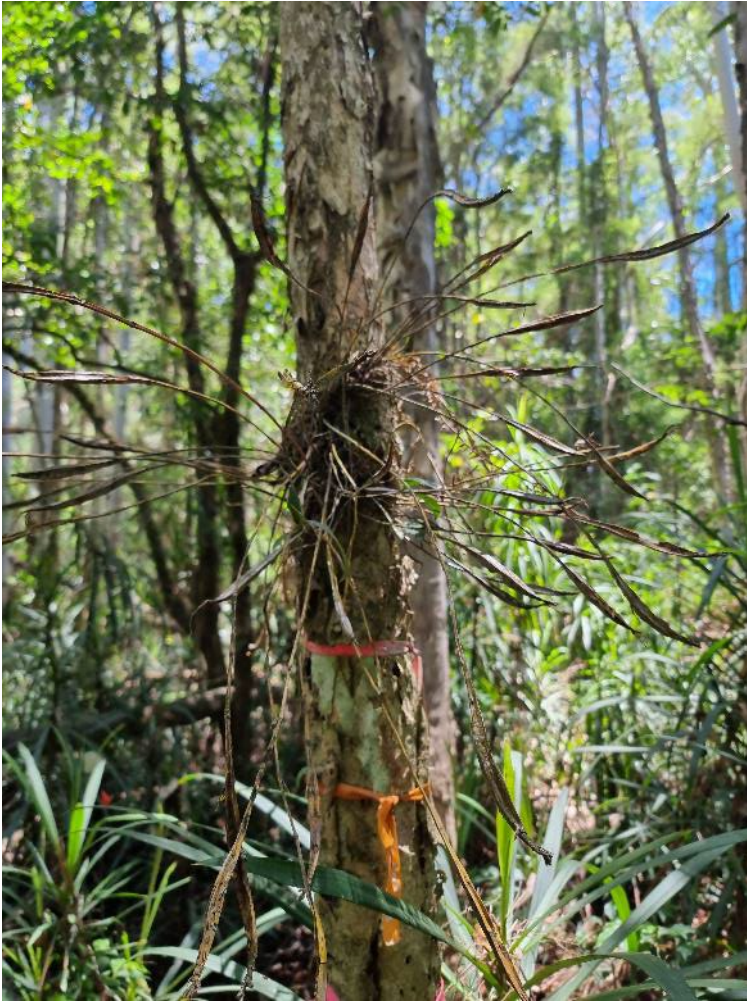
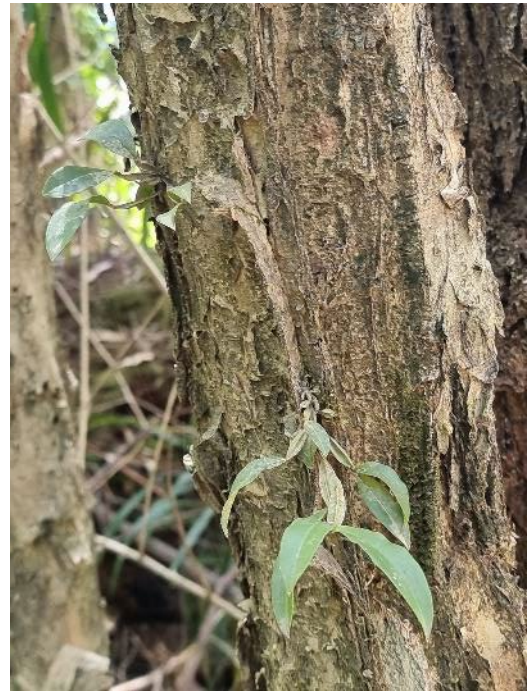
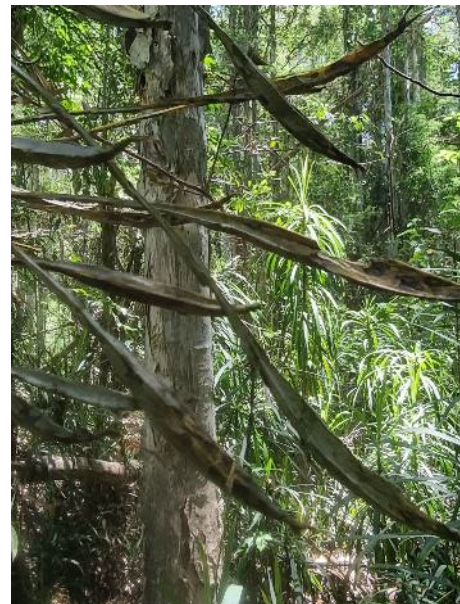
Plates 37 to 39: Top left – in situ orchid clump growing low down on a *Melaleuca stypheloides* trunk, the same situation as the translocated clump above.

Top right – small orchid recruits growing on the trunk below the main clump above. Unless these are vegetative shoots from the orchid's roots on the tree bark, they must be seedlings, indicating a pollinator was present during flowering and a pod formed. As no pods have been recorded in eight years, the seed event was probably 10 years ago or more, indicating the seedlings grow very slowly.

Bottom right – pseudobulbs heavily damaged by grazing insects or slugs, similar to the transplanted plants.

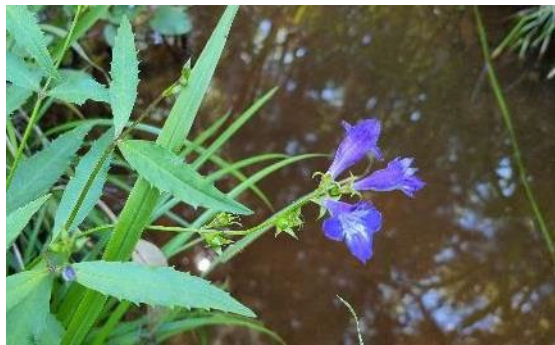
Plates 41 and 42. In situ Koala Bells growing on small creek bank next to Old Coast Rd.

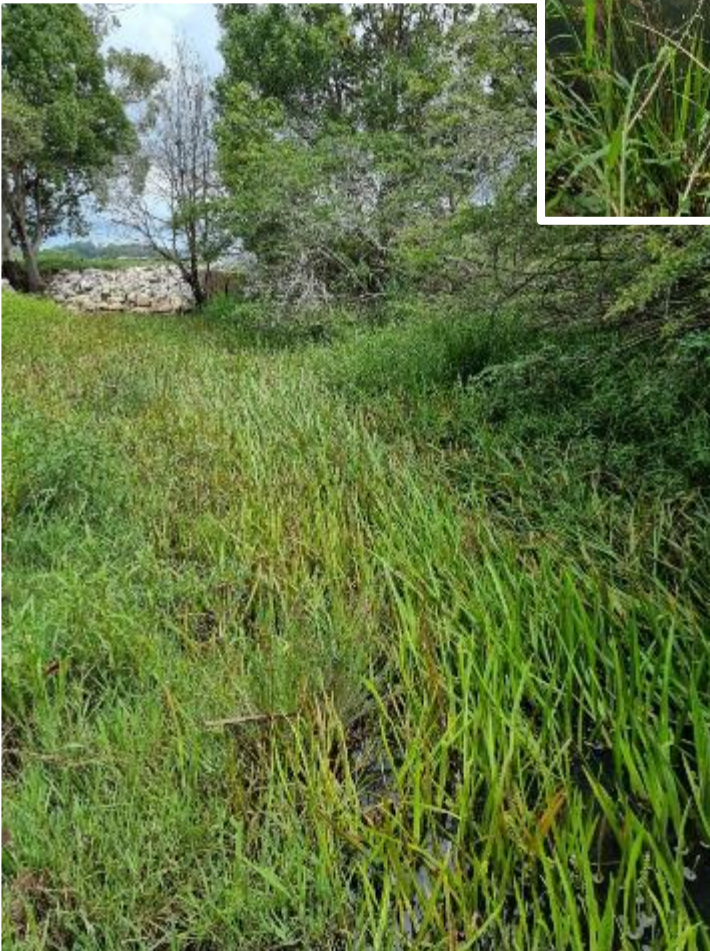
Maundia off footprint at Site 10
within road reserve

Summer 2022

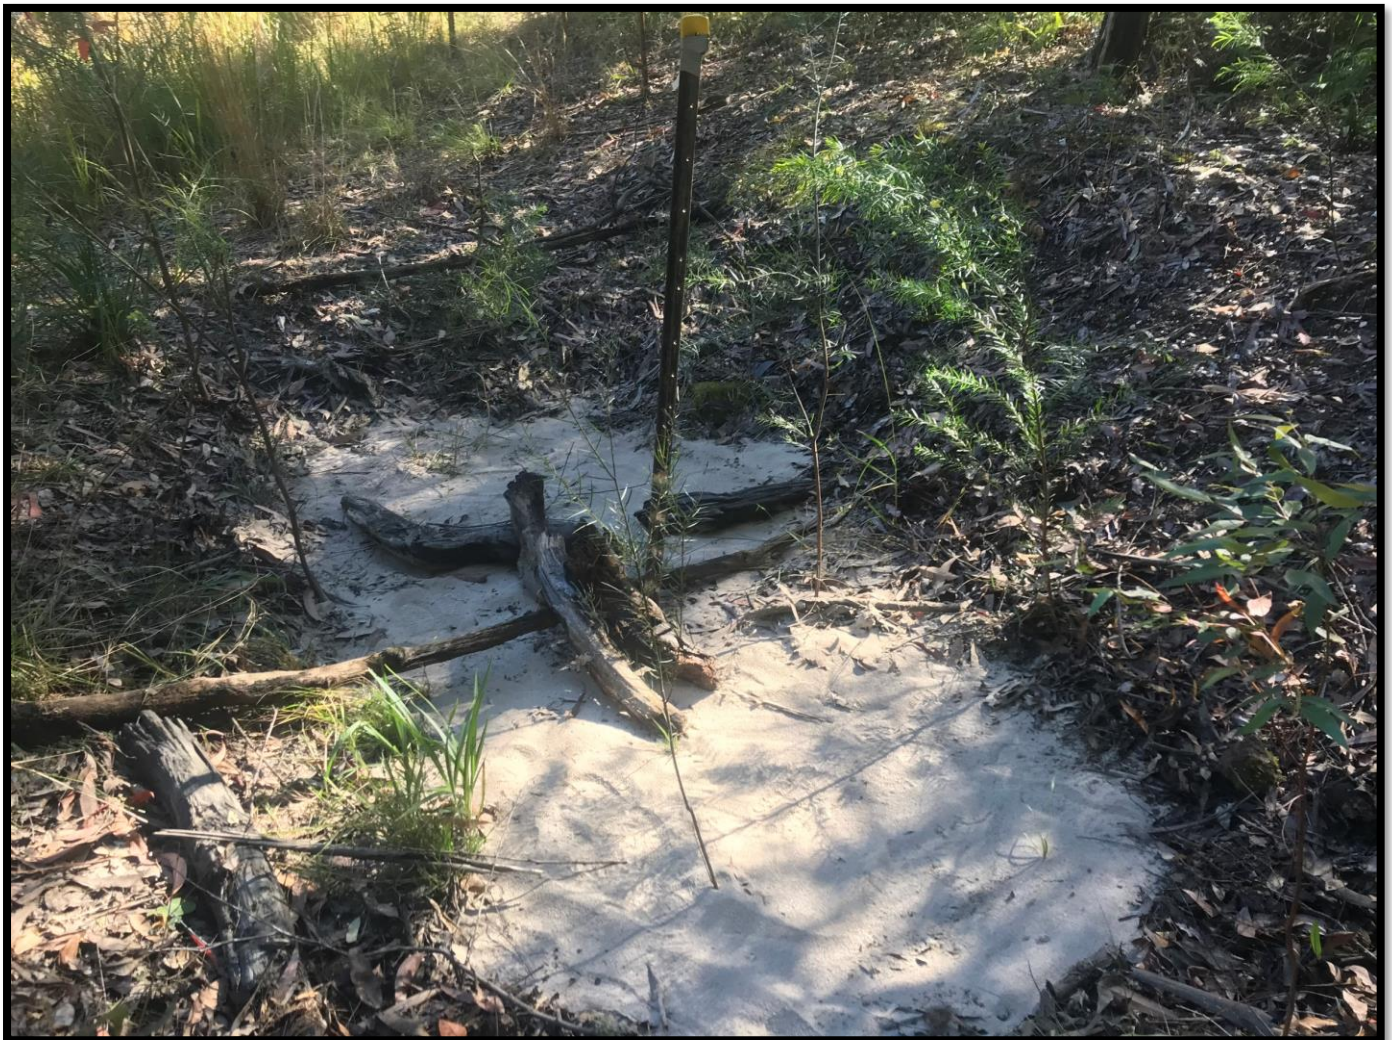
Figure 5: Application of bentonite to pond 1 at site 2N during August 2021, WC2NH.

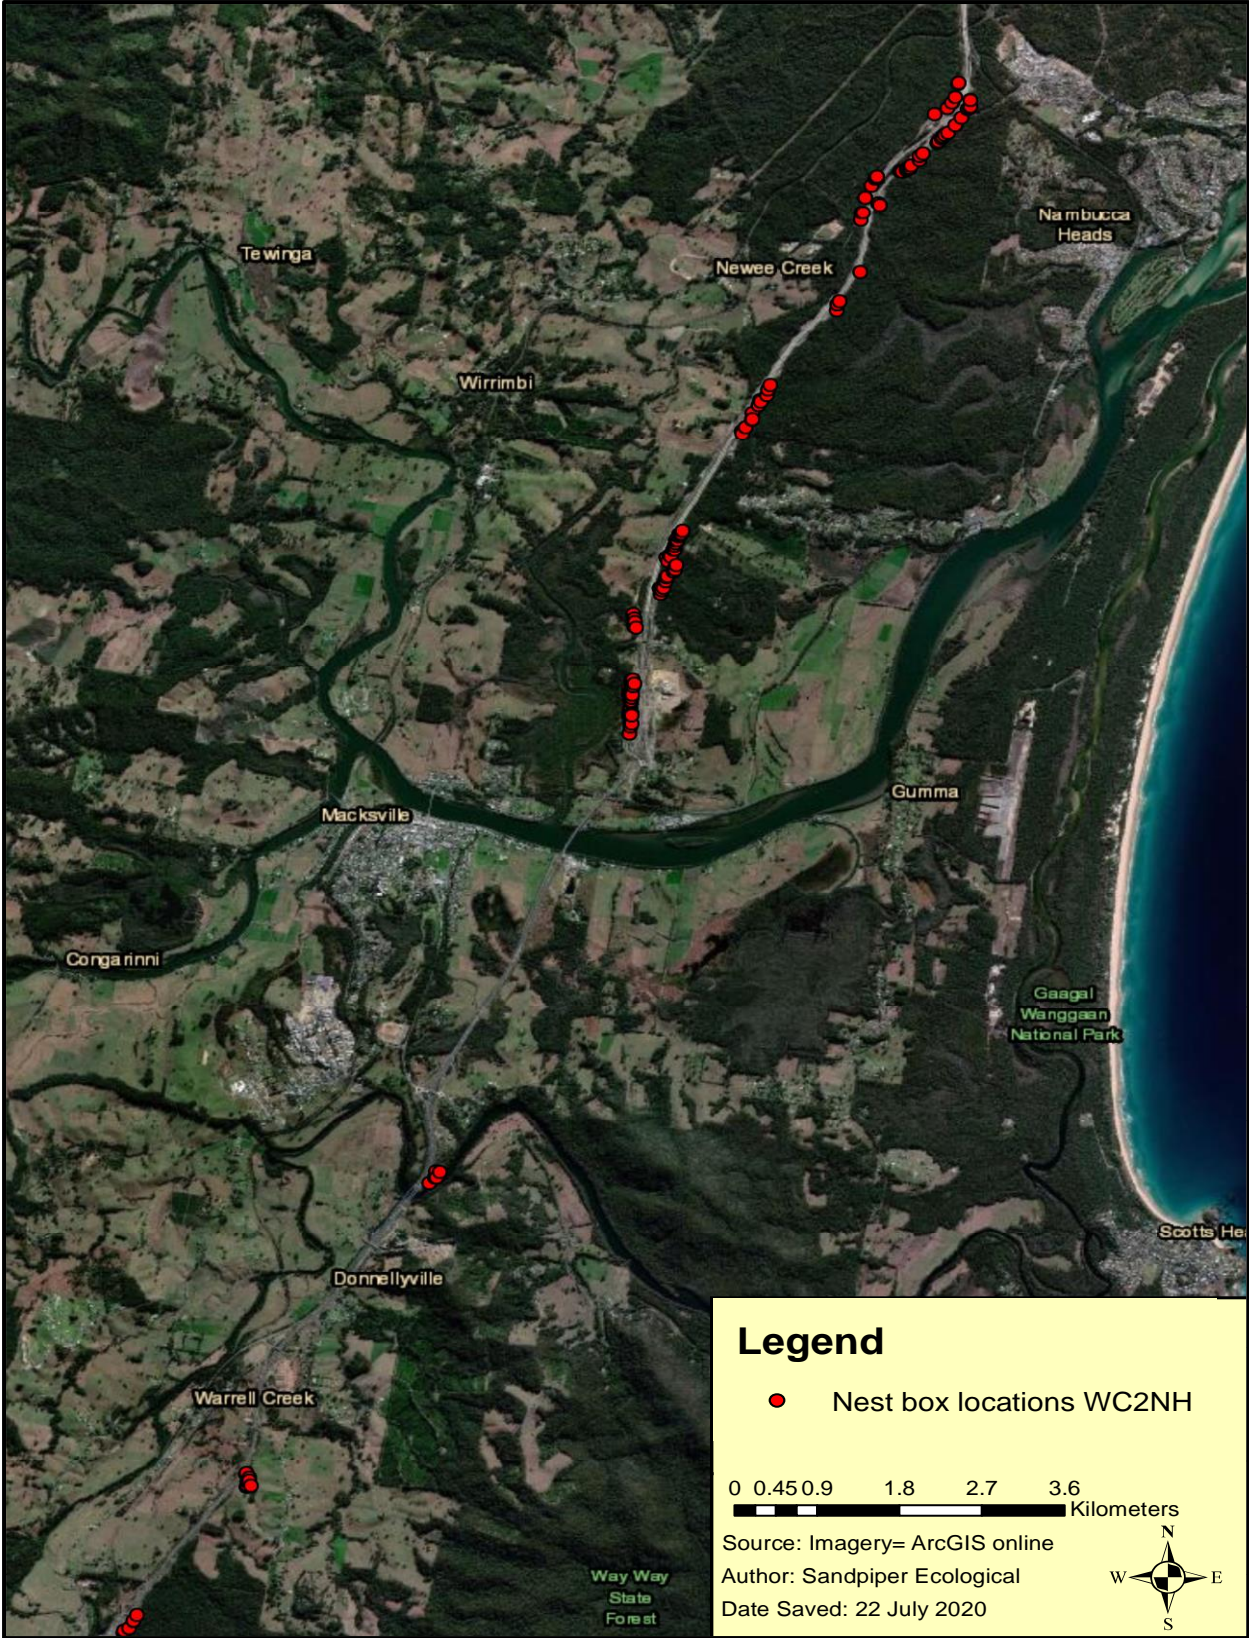
Figure 1. Nest box locations adjacent to the WC2NH alignment.

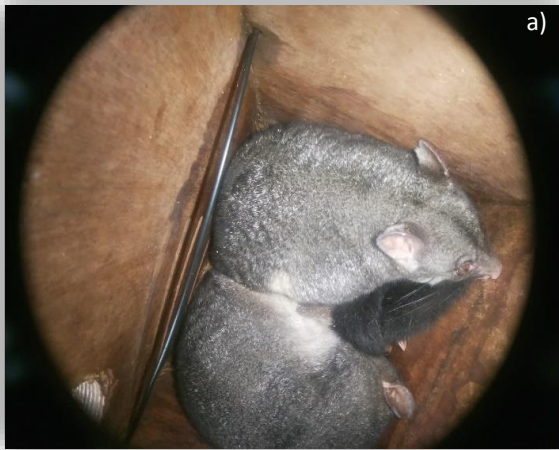
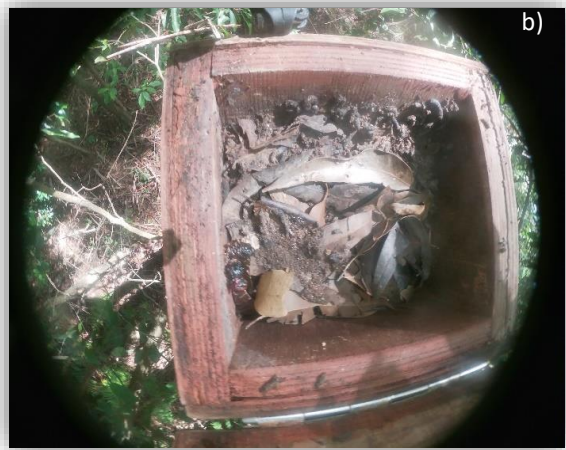
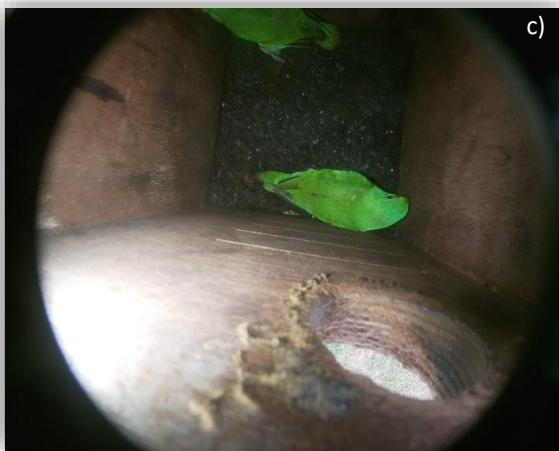
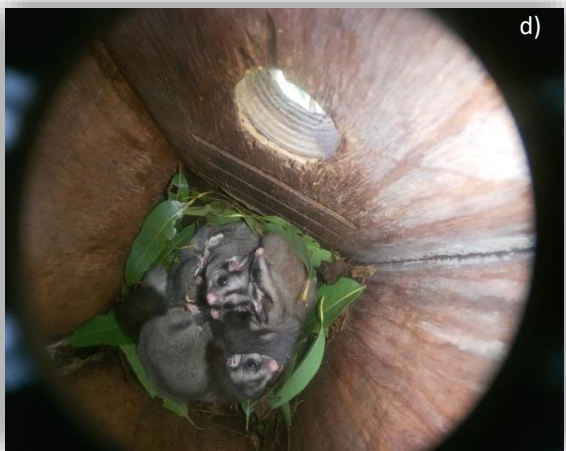
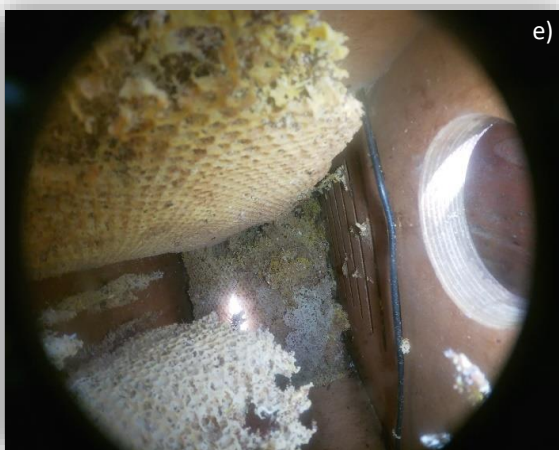
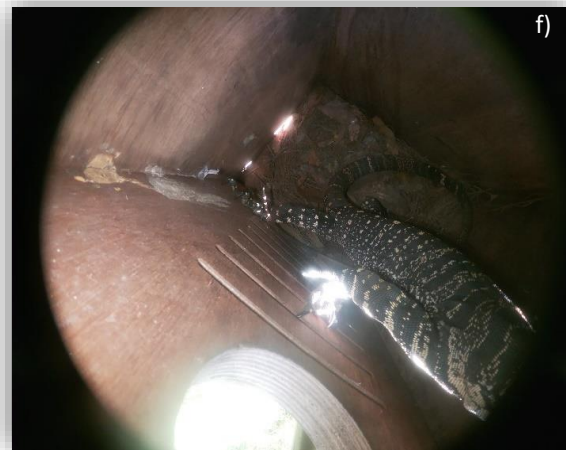
Plate 1: Fauna recorded during year four operational nest box inspections at WC2NH (a) Short-eared brushtail possum using a possum box. (b) *Antechinus* spp. nest with latrine deposited in corner of microbat box. (c) Scaly-breasted lorikeets using a small glider box. (d) Sugar glider x 4 recorded in a small glider nest box. (e) An abandoned European beehive in a parrot/lorikeet box (f) Lace monitor in a large glider box.
