Warrell Creek to Nambucca Heads Pacific Highway Upgrade

Commonwealth Approval EPBC 2013/7101
Annual Compliance Report
February 2022 – February 2023

Transport for NSW | May 2023

**Operational Phase Monitoring of Threatened Flora
Translocations, In-situ Threatened Plants and Slender Marsdenia and Woolls'
Tylophora Habitat Condition on the Warrell Creek to Nambucca Heads Highway
Project – Year 5 (2022)**

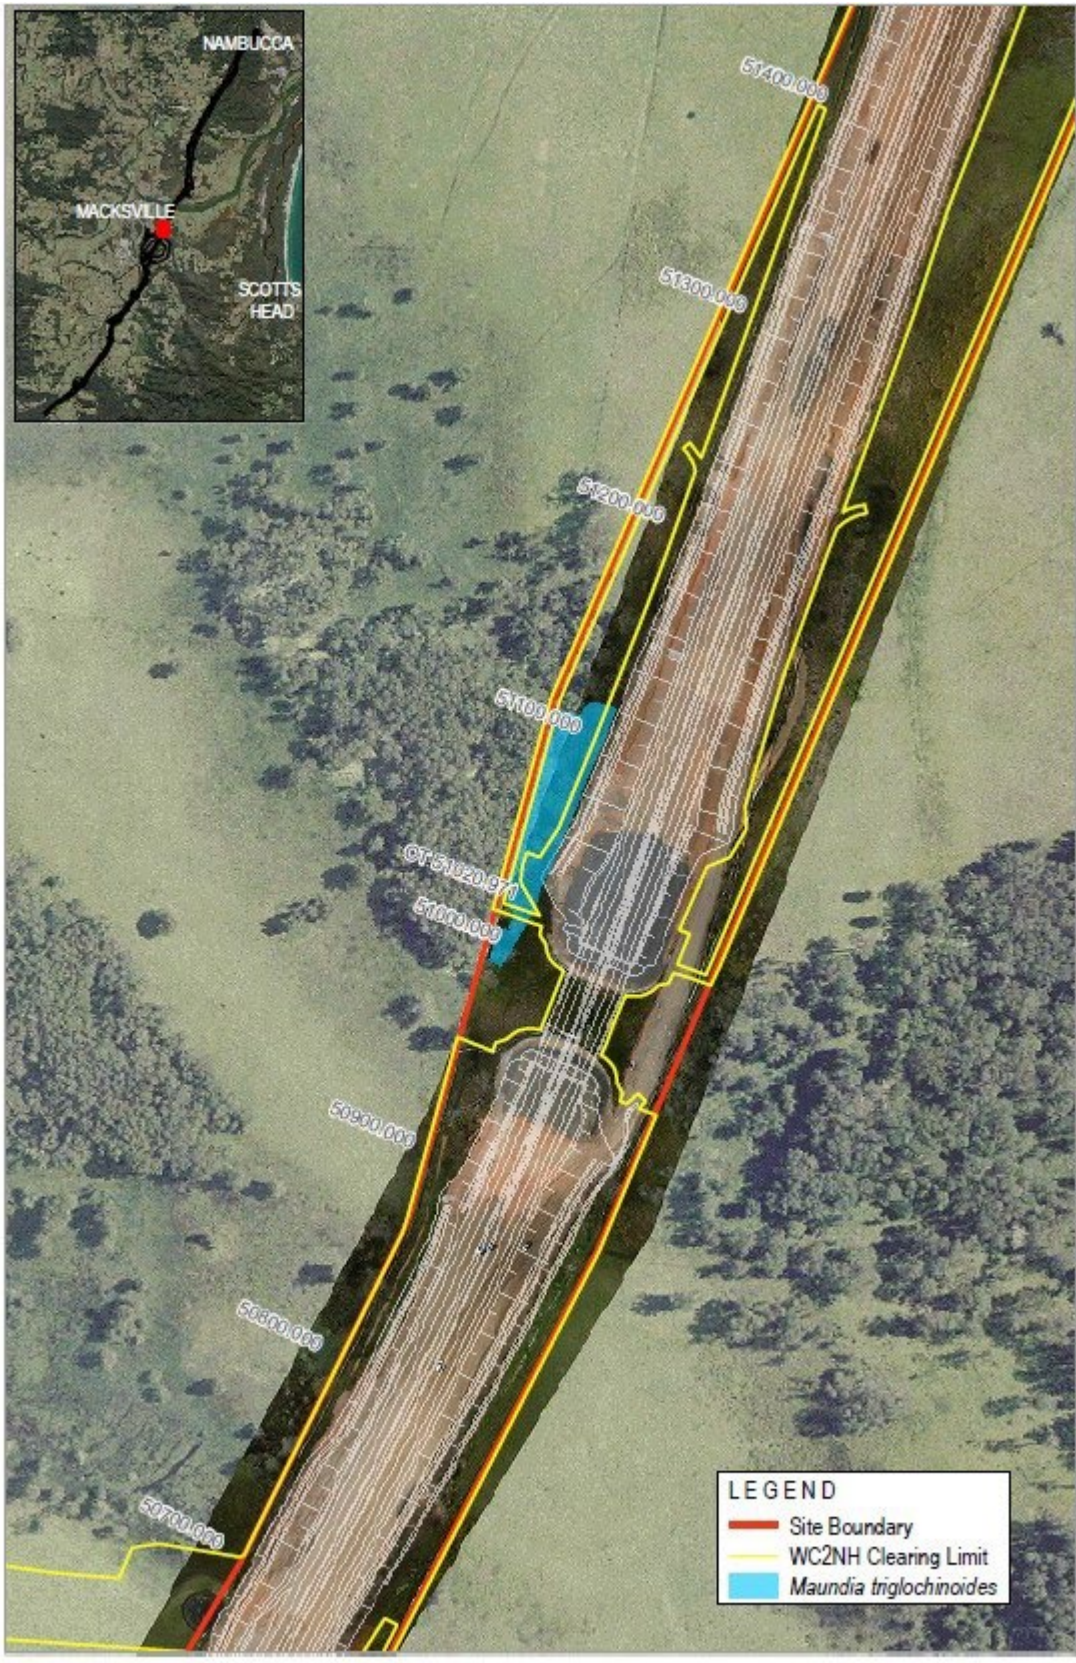
Figure 5: In-situ Slender Marsdenia and Rusty Plum at Cockburns Lane, WC2NH. Map sourced from GeoLINK (2017).

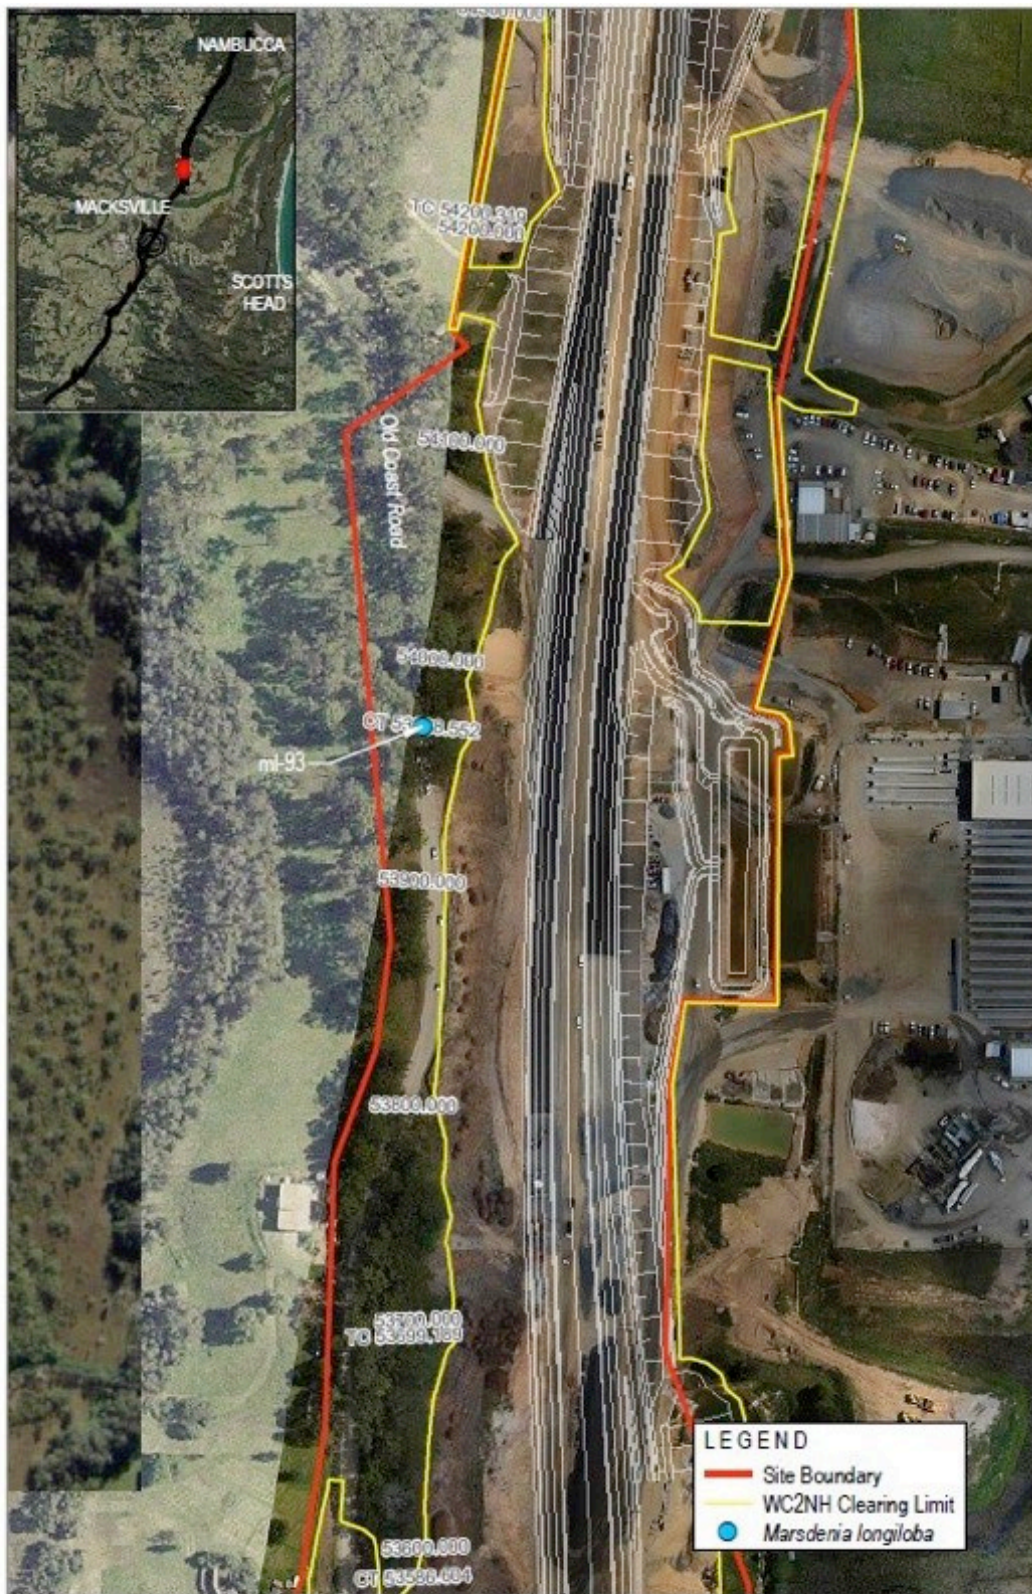
Figure 6: Maundia population at Nambucca Floodplain, WC2NH. Map sourced from GeoLINK (2017).

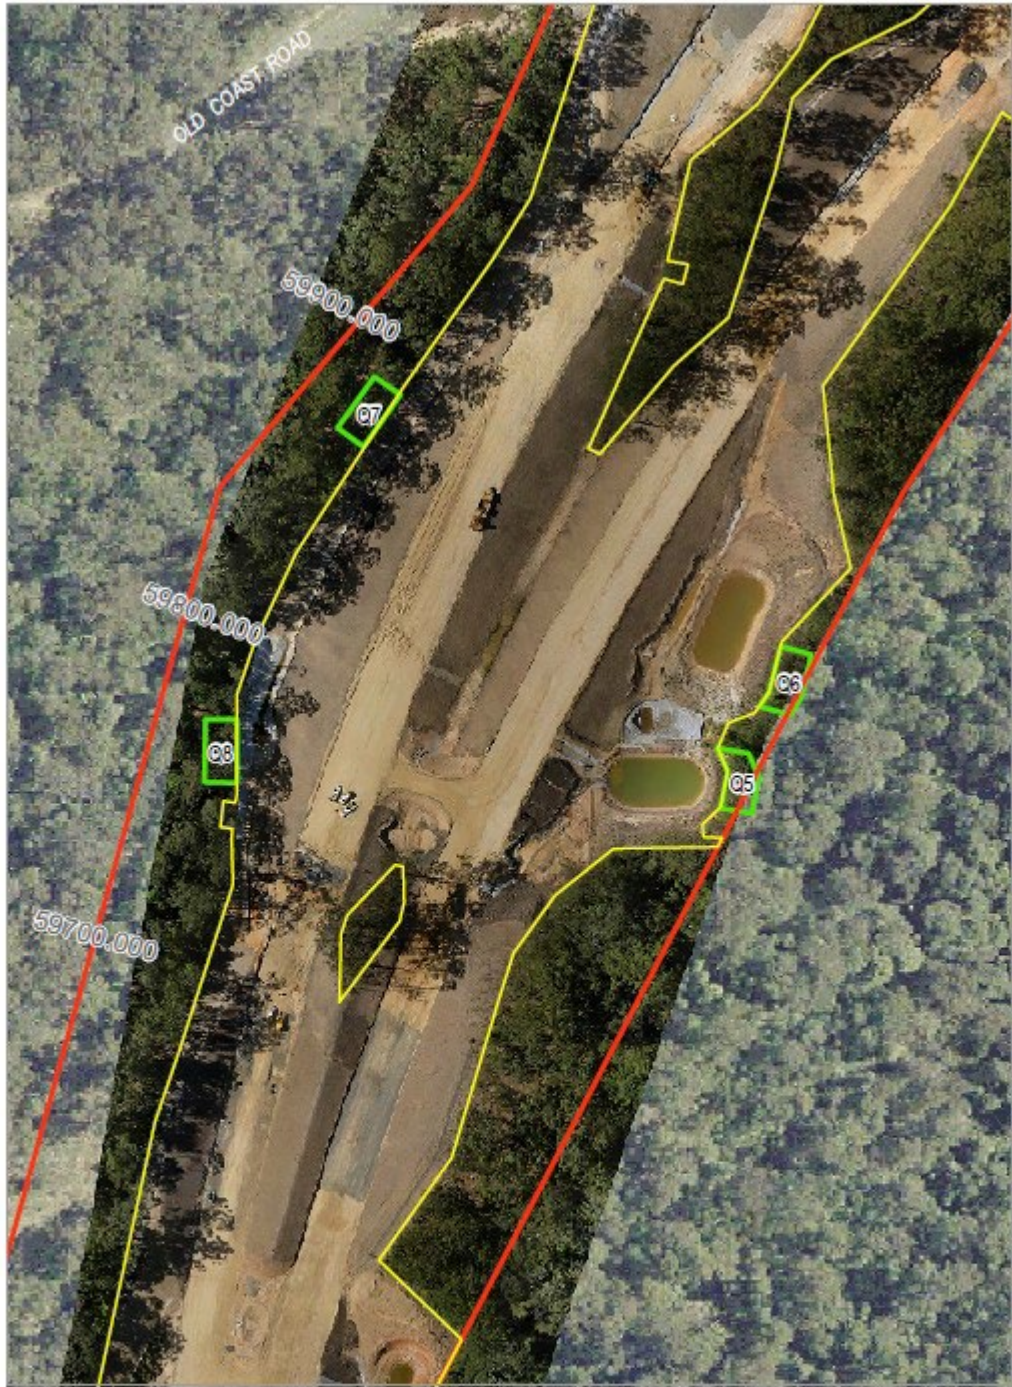
Figure 10: Slender Marsdenia and Woolls' Tylophora Habitat monitoring quadrats 5, 6, 7 and 8, WC2NH. Map sourced from GeoLINK (2017).

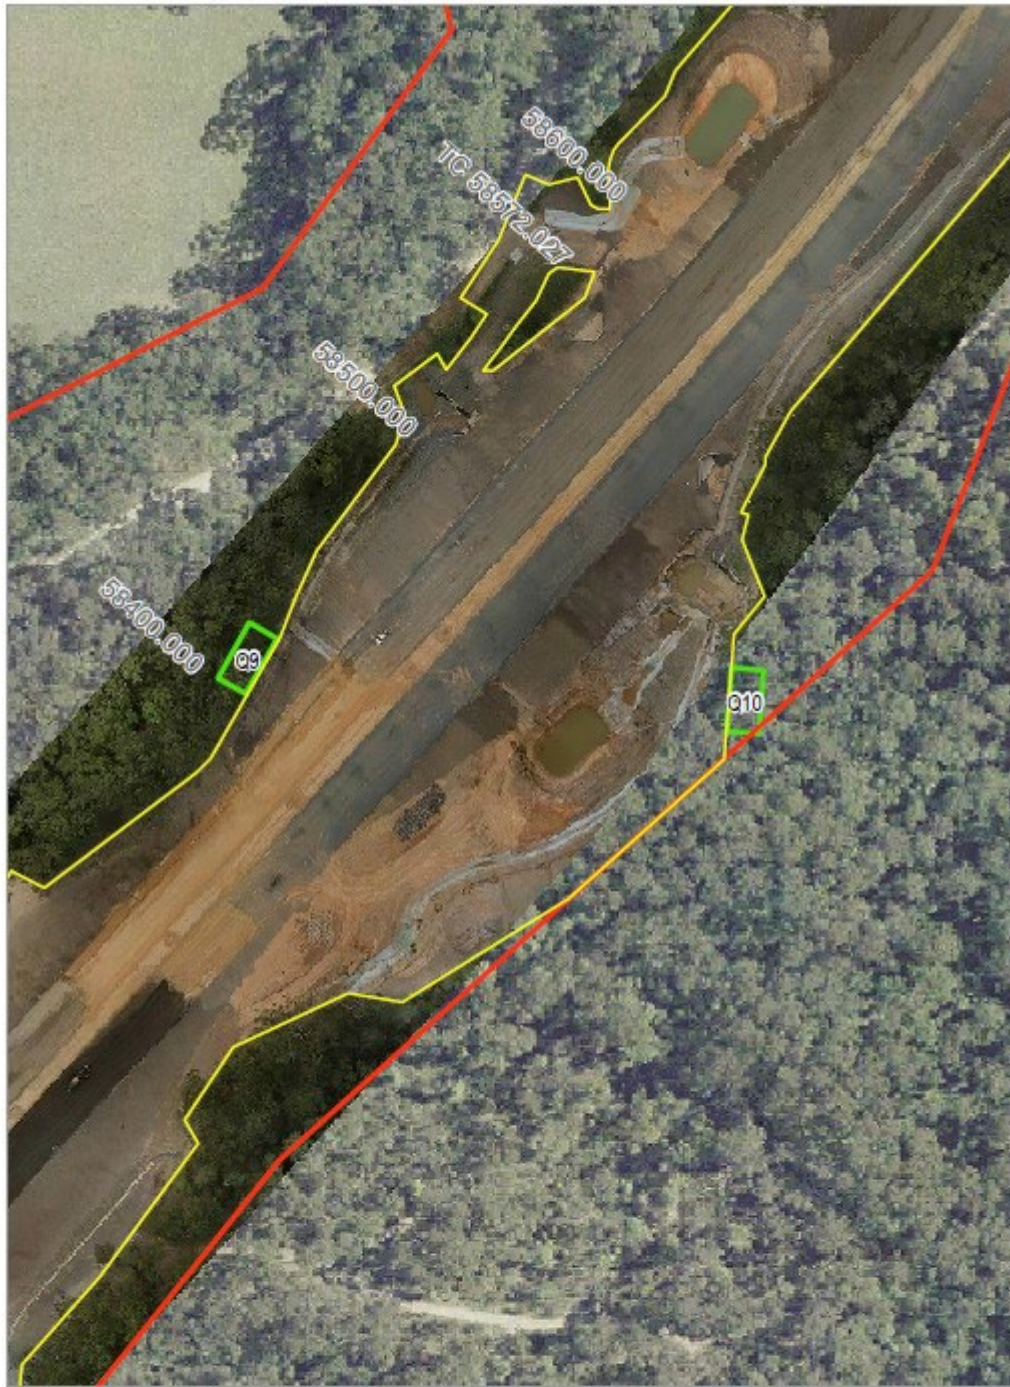
Figure 11: Slender Marsdenia and Woolls' Tylophora Habitat monitoring quadrats 9 and 10, WC2NH. Map sourced from GeoLINK (2017).

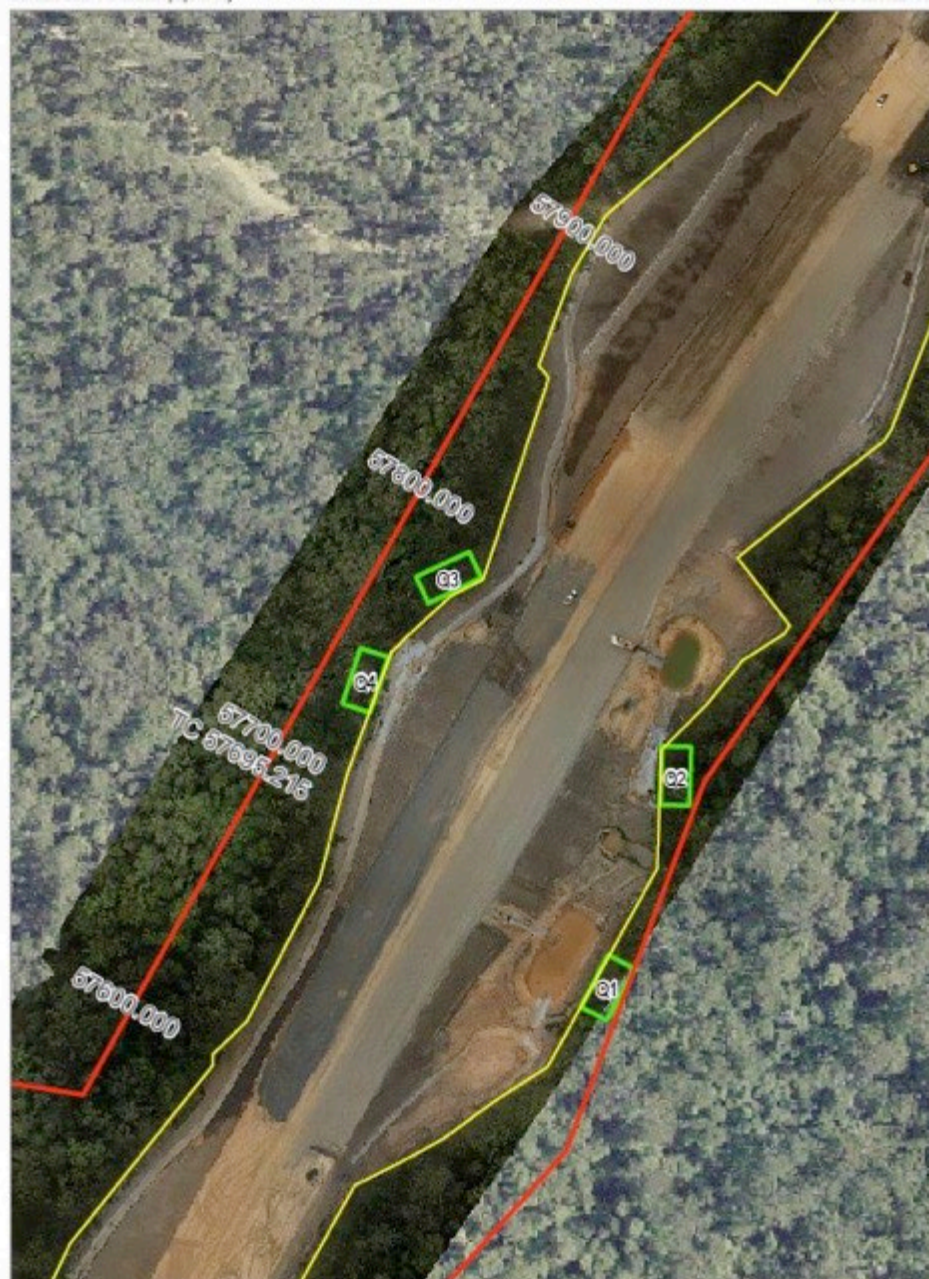
Figure 12: Slender Marsdenia and Woolls' Tylophora Habitat monitoring quadrats 1, 2, 3 and 4, WC2NH. Map sourced from GeoLINK (2017).

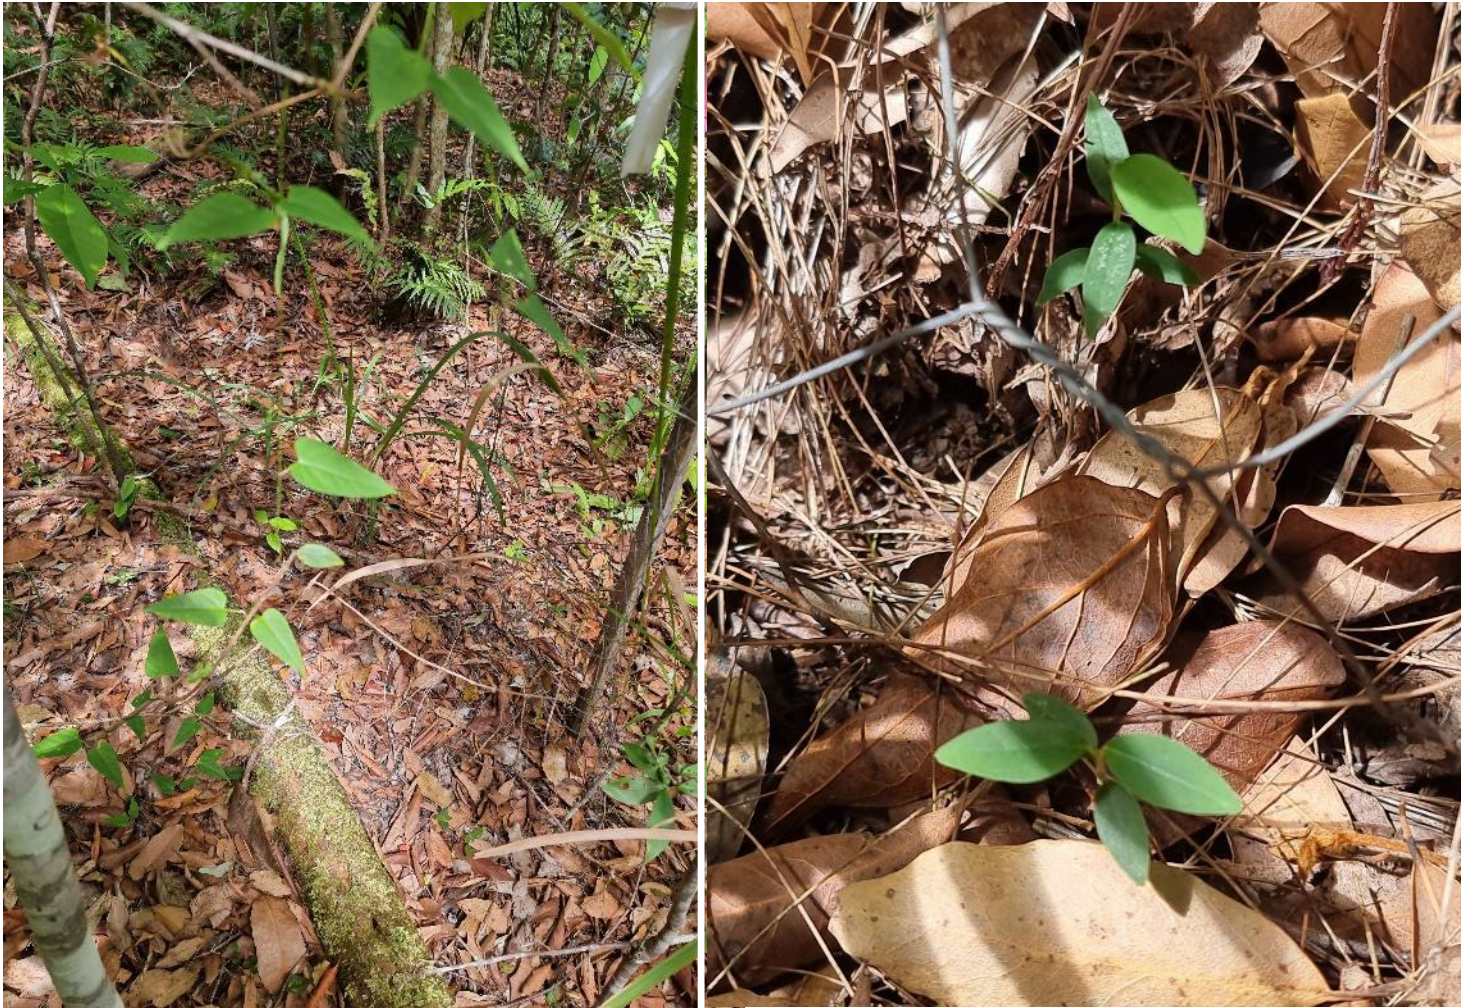
Plate 17 and 18: Recipient Site 1. Left - plant no. 19 about 80 cm high. Right - plant no. 14 consisting of two small shoots that shot from roots underground in the last 12 months.

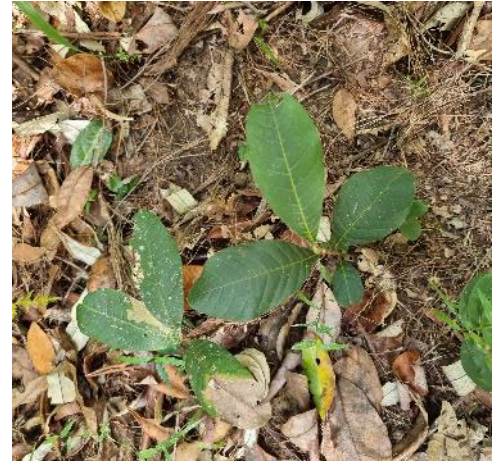
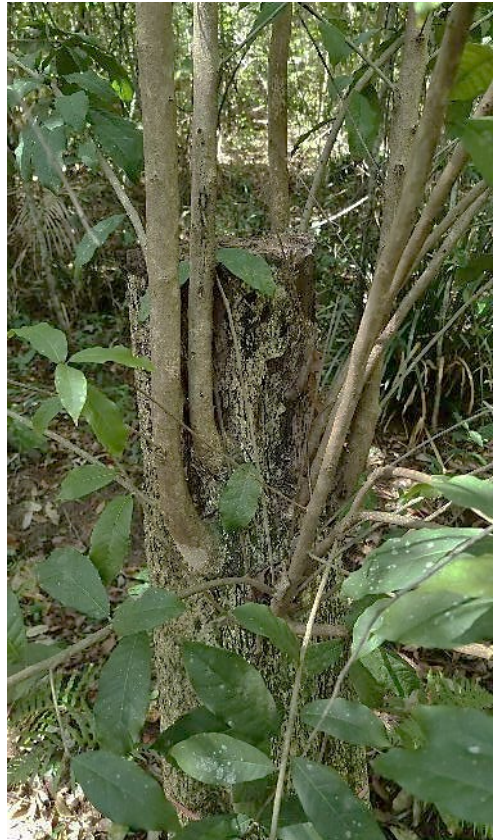
Plates 19 to 21: Left – transplanted Rusty Plum after eight years has regrown from stump of bare rooted tree.

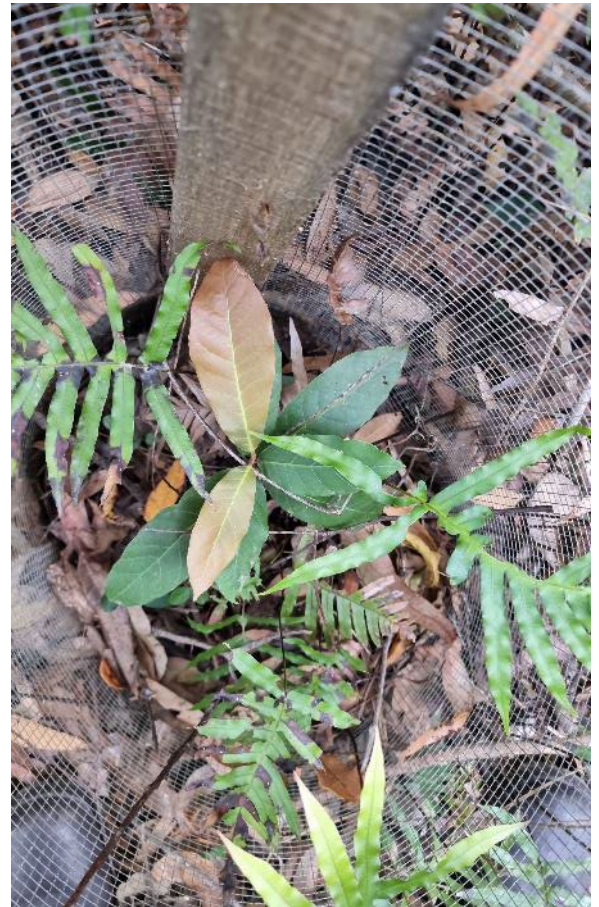
22and 23: Recipient Site 7a. Rusty Plum translocated by direct seeding locally collected seed into protective wire mesh cylinders. Three seeds were placed in each cylinder. After five years, two seedlings survive in one cylinder and one in the other. The seedlings are about 25 cm high and healthy, but slow growing. .

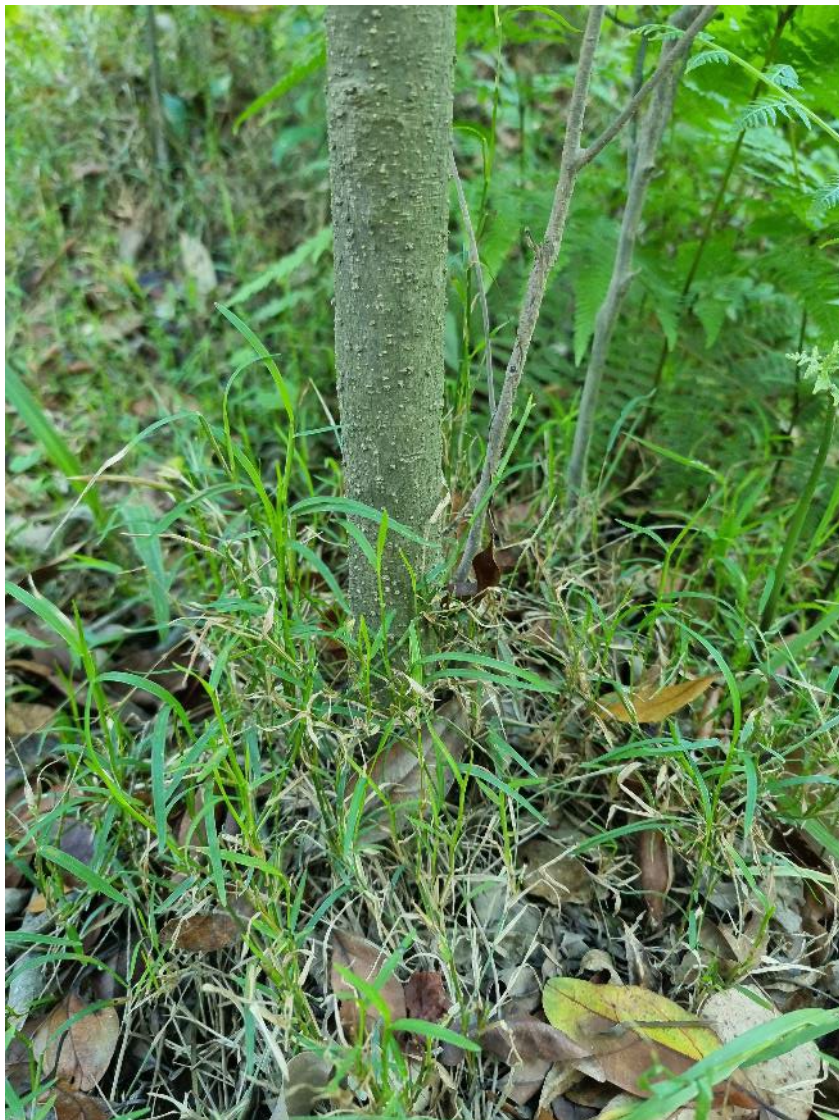
Plate 29: Recipient Site 9a.
Floyds Grass tries to escape smothering *Ottochloa* and Harsh Ground Fern by using the stems of small woody plants for support to climb above them, seen here.

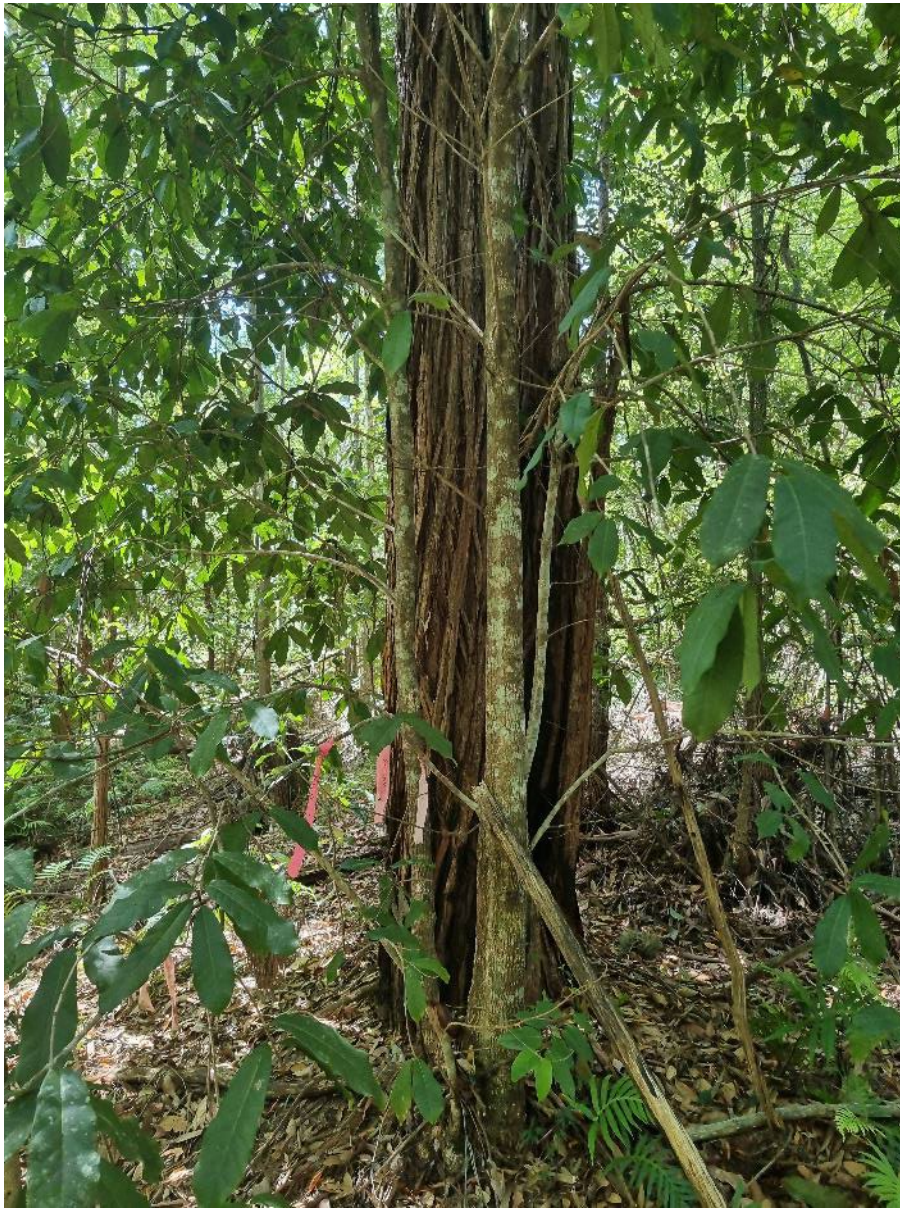
Plate 40: In situ Rusty Plum growing close to a turpentine with stringy bark behind, near Recipient Site 1

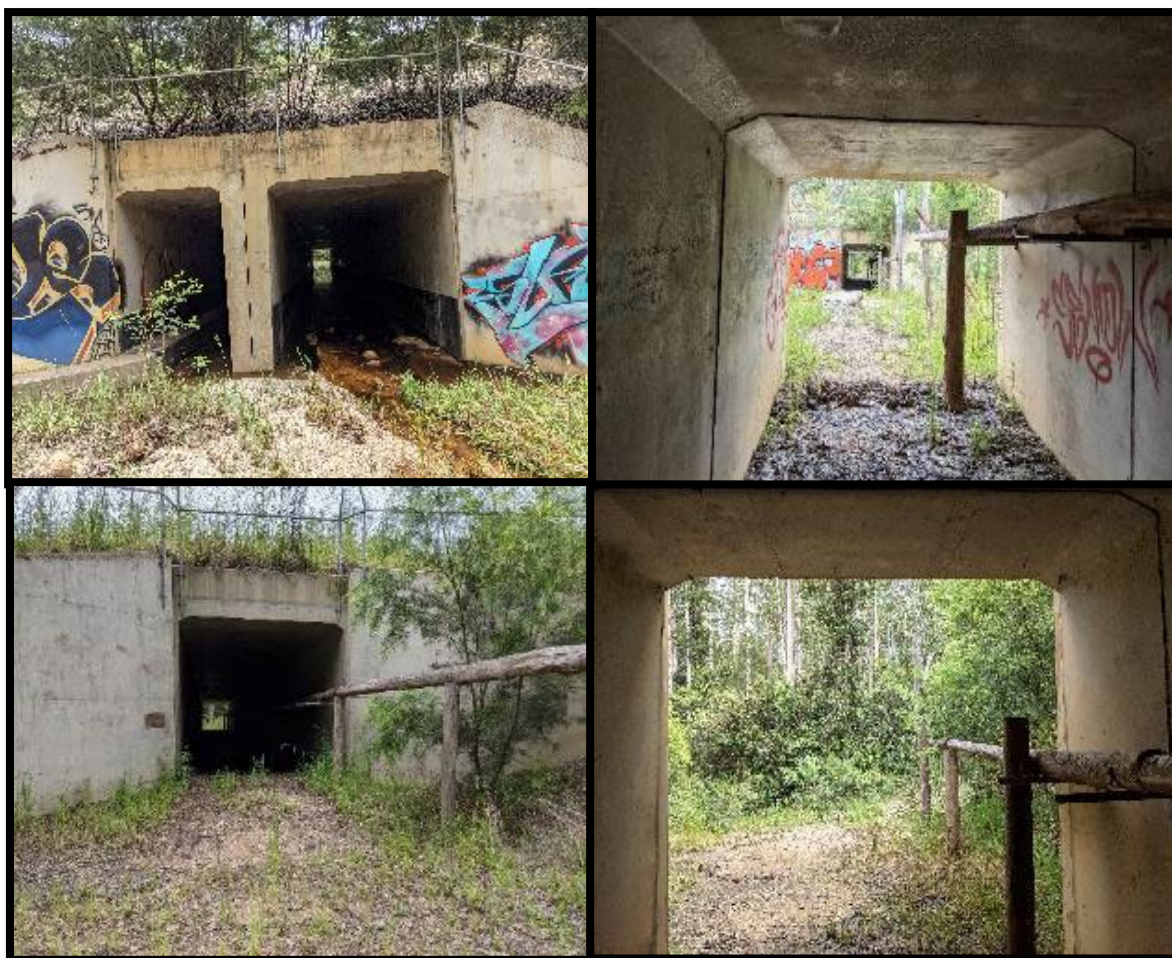
Plate 1. Dual box culverts with designated wet passage at site 5 (top left). Split median box culverts at site 9 and 10 (top right). Fauna furniture entering (bottom left) and exiting site 8 (bottom right).

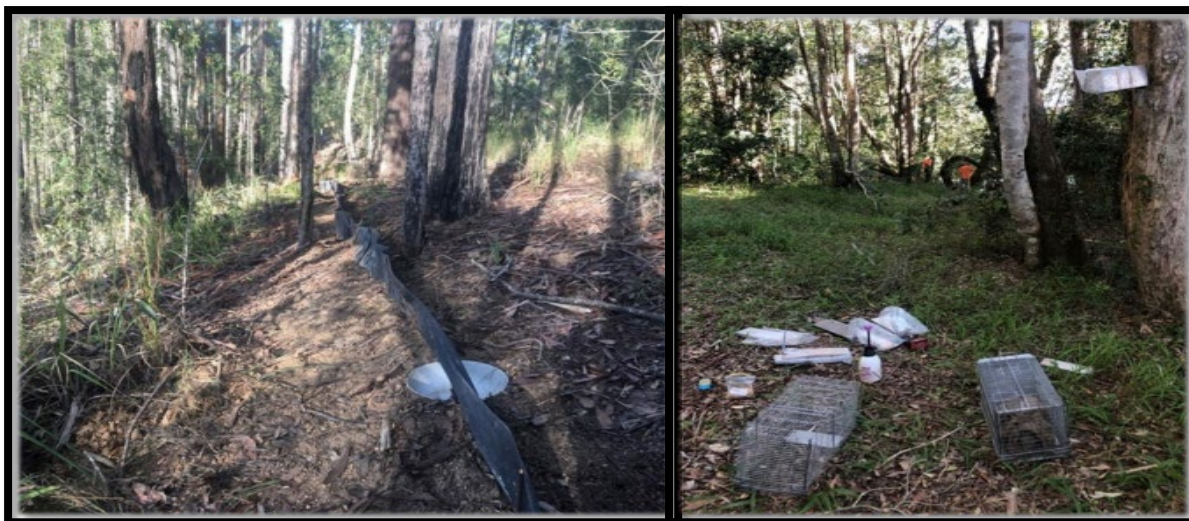
Plate 3: Example of a pitfall trap line installed during adjacent habitat surveys (L). Setting up traps in adjacent habitat at site 1 (R).

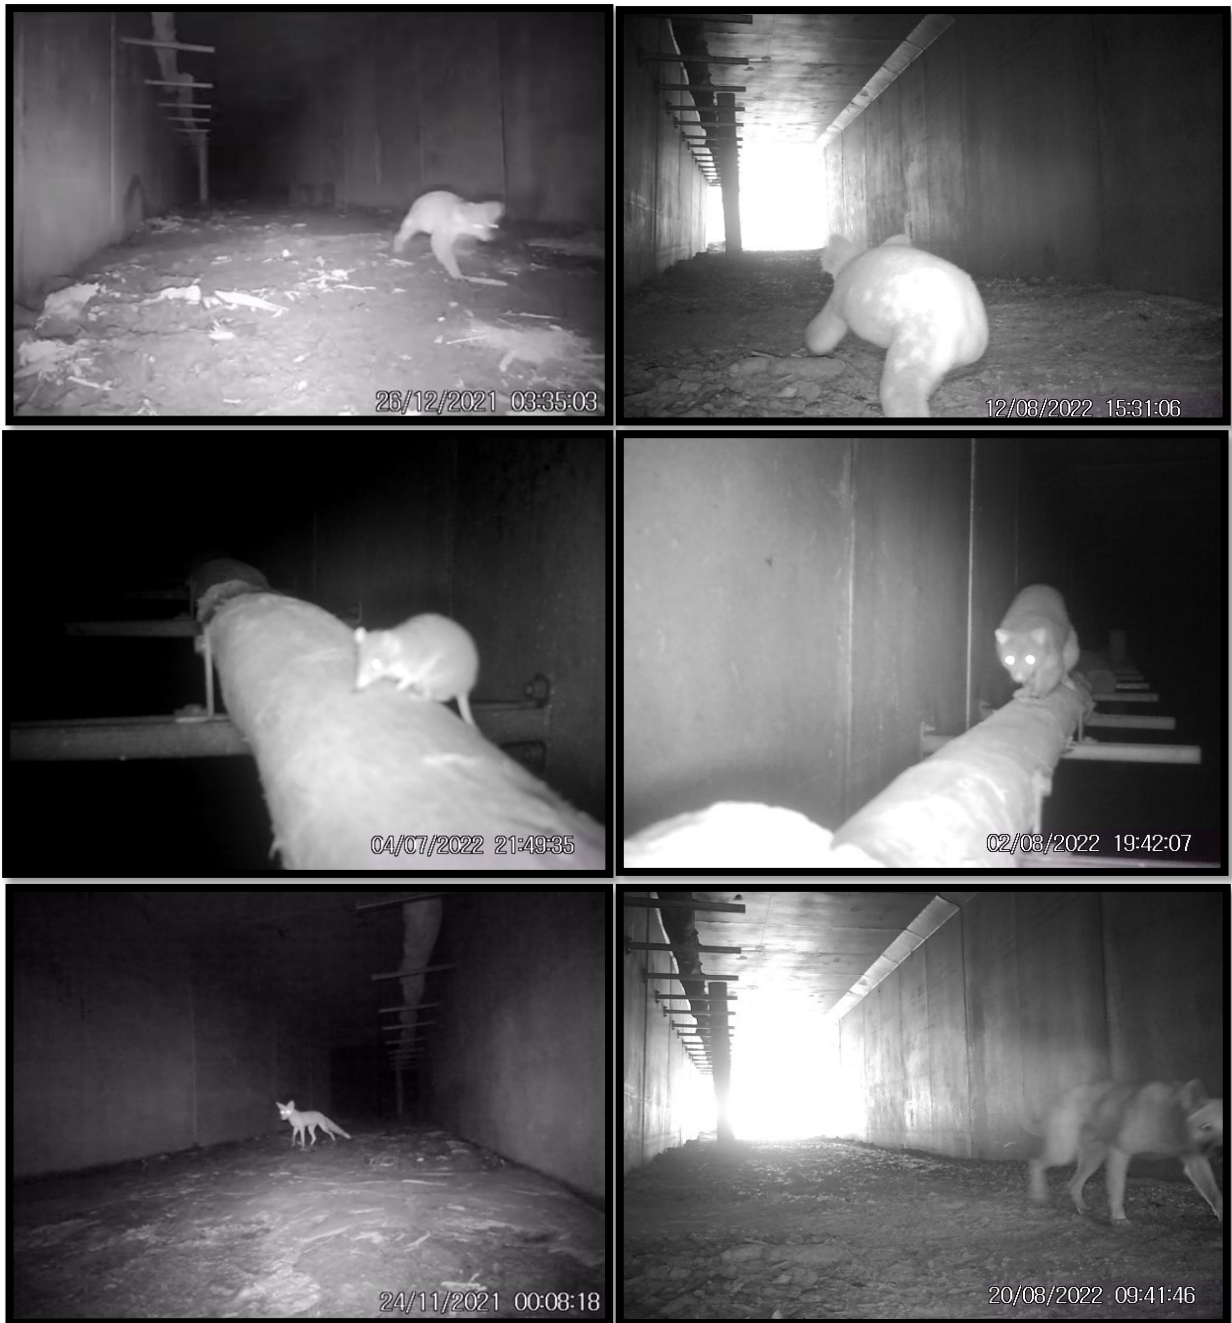
Plate 4: Koala recorded travelling west at site 4 during spring/summer monitoring (Top left). Koala using the culvert floor to travel east at 11/12 split median during winter (Top right). Antechinus spp. using the furniture at site 7 (Middle left). Short-eared brushtail possum travelling west at site 8 on the furniture (Middle right). Fox heading west at split median 9/10 (Bottom left). Wild dog travelling west at split median 11/12 (Bottom right).

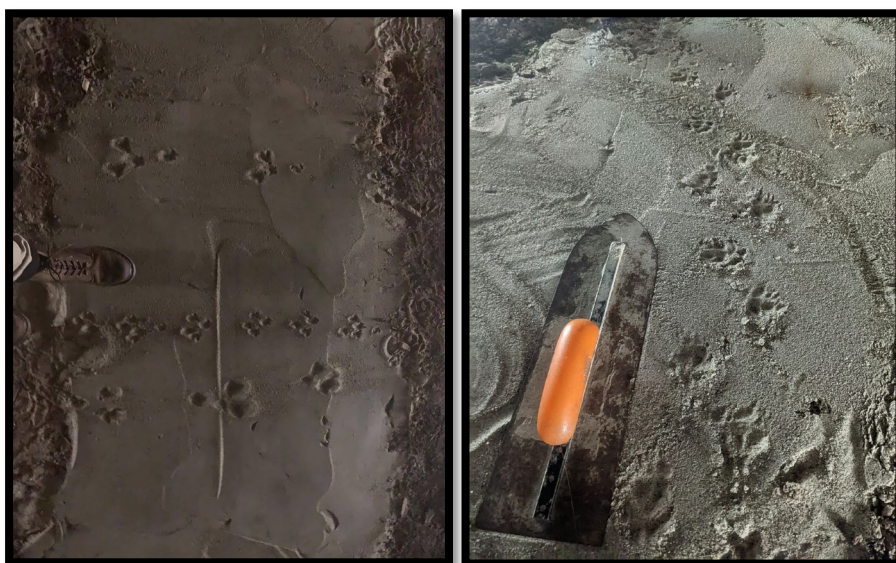
Eleven species and fauna groups were recorded on sand pads in year four operational monitoring (Appendix B, Table B2, Plate 5). Of the native species, swamp wallaby was the most frequently recorded fauna species, with tracks identified at sites 1, 2, 3, 4, 7, 8 and 9/10 (Appendix B, Table B2). Of the smaller cover-dependent fauna groups (i.e., small mammals, reptiles and amphibians), probable *Antechinus* spp. (sites 11/12, 9/10, 7, 8 and 5/6), probable frog (site 3 and 11/12) and medium lizard/skink (11/12) were recorded during inspections (Appendix B, Table B2). Other than the medium lizard and probable frog records, no species or groups were recorded in addition to those identified by cameras.

Plate 5: Bandicoot tracks (east and west) and bounding rodent tracks at site 8 during winter surveys (Left). Short-beaked echidna tracks heading east through the culvert at site 2 (Right).

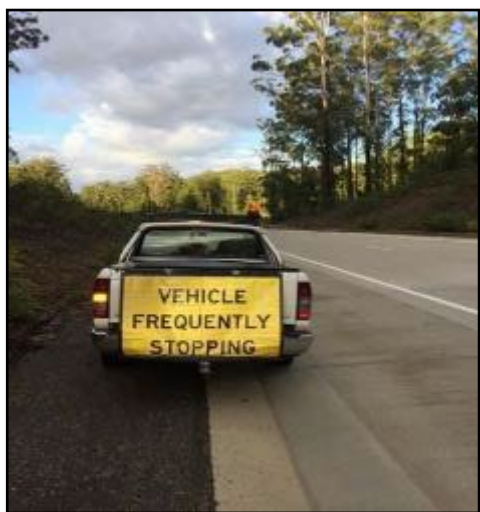
Surveys were conducted by a two-person team from a constantly moving vehicle driven at 80-90km/hr in the left lane. The vehicle was equipped with an amber (flashing) light and warning sign (Plate 1). The team consisted of a driver and an ecologist passenger with experience identifying road-killed fauna. During each monitoring month, surveys were undertaken weekly and commenced within three-four hours of sunrise. The ecologist scanned the road surface and road shoulder for fauna during each survey. When road-killed fauna was detected, the species or fauna group was recorded using a hand-held tape recorder, and a “drop pin” showing the site location was placed on an iPad running Motion-X. Fauna records considered likely to be an unidentified target species (i.e., spotted-tailed quoll, koala, grey-headed flying-fox, giant barred frog) were inspected more closely from a safe location. At the completion of each survey, the audio recordings were played back, and data were uploaded to Microsoft Excel on a desktop computer, with GPS coordinates downloaded from the iPad.

Plate 1: Work vehicle with signage, flashing amber light and indicators.

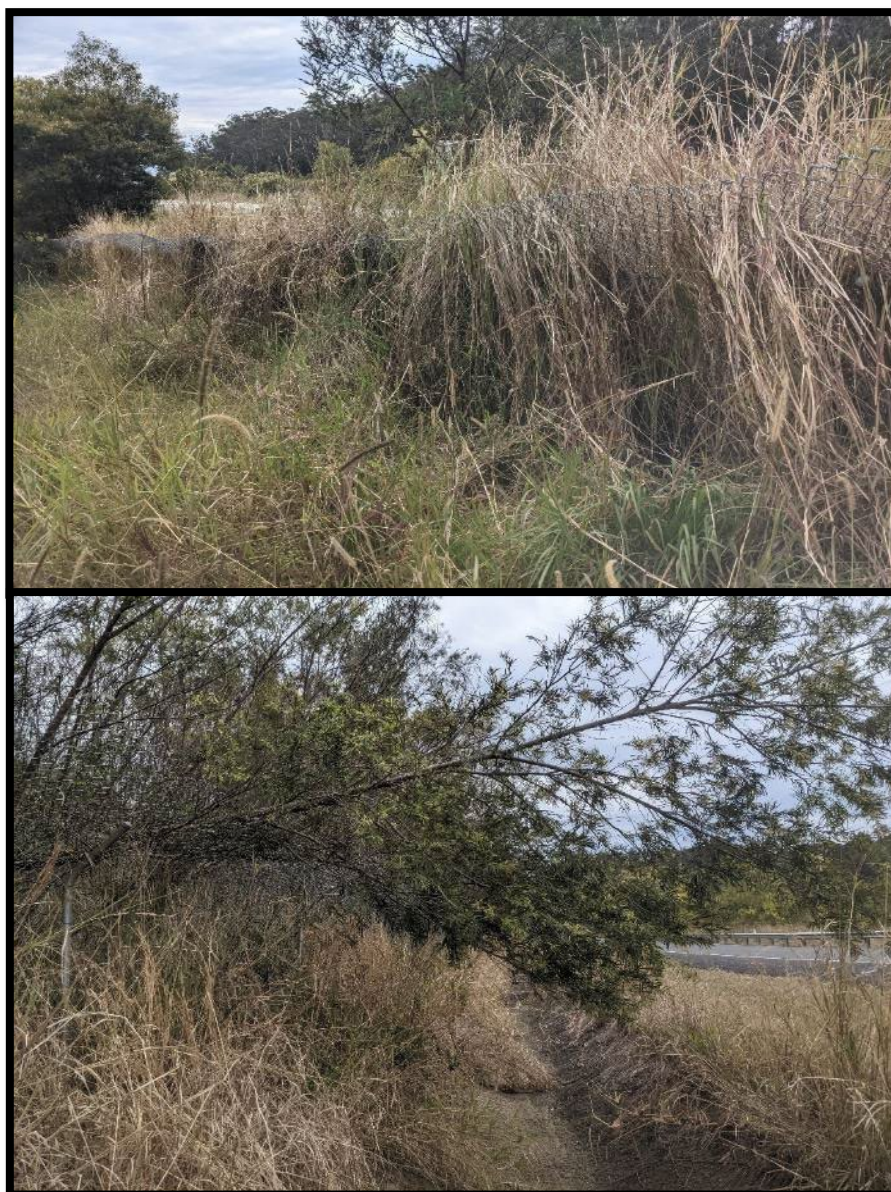
Fifty-three fence issues were recorded during the 2022 winter inspection (Table 6, see Appendix A, Table A2). The most frequently encountered issue was sections of vegetation overgrowth (28) followed by a tree/branch growing through or over the fence (8), tree/branch fallen on the fence (5), gaps around drains (4), gaps around gates (3), return wire uplift (3), unlocked gate (1) and fence top collapse (1) (Table 6). Overall, the structural integrity of the exclusion fence was sound, with the prominent issue being vegetation overgrowing, overhanging, or protruding through the fence (Table 6).

Results from the exclusion fence inspection show 12 issues are considered a high priority (potential for threatened fauna including koala or quoll to access alignment), 13 moderate (potential to facilitate small common fauna movement onto the alignment), and 23 low (likely to become an issue over time) (Table 6). Priority issues include moderate-sized (>100mm diameter) trees or branches that are growing through or over the exclusion fence (5), trees or branches fallen on the fence (5), gaps around drains (1), and a gate unlocked (1) (for full details see Appendix A, Table A2). Most issues of vegetation overgrowth and trees/branches on the fence are attributed to *Acacia* spp. regrowth on and around the batters north of Mattick Road (Plate 2, Appendix A, Table A2). Also, dense grasses growing through and over the fauna fence were a feature of fence inspections along the alignment (Plate 2, Appendix A, Table A2).

Plate 2: Thick grass protruding through and over the fauna fence north of Mattick Road (Top). *Acacia* spp. overhanging fauna fence adjacent to old coast road (Bottom).

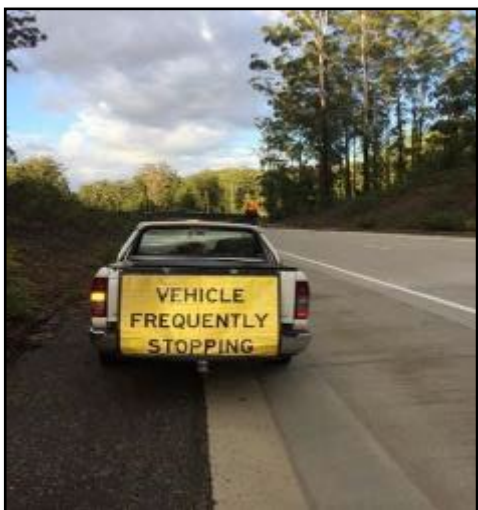
Plate 1: Work vehicle with signage, flashing amber light and indicators.
