W2B Section 3 – 11 Microbat Management Plan 2022-2023 Annual Monitoring Report

Transport for NSW

Project Name	W2B S3 – 11 Microbat Management Plan 2022-2023 Annual Monitoring Report
Project Number	5728
Project Manager	Phoebe Smith
Prepared by	Samantha Patch and Phoebe Smith
Reviewed by	Josie Stokes
Approved by	Josie Stokes
Status	Final
Version Number	2
Last saved on	20 November 2023

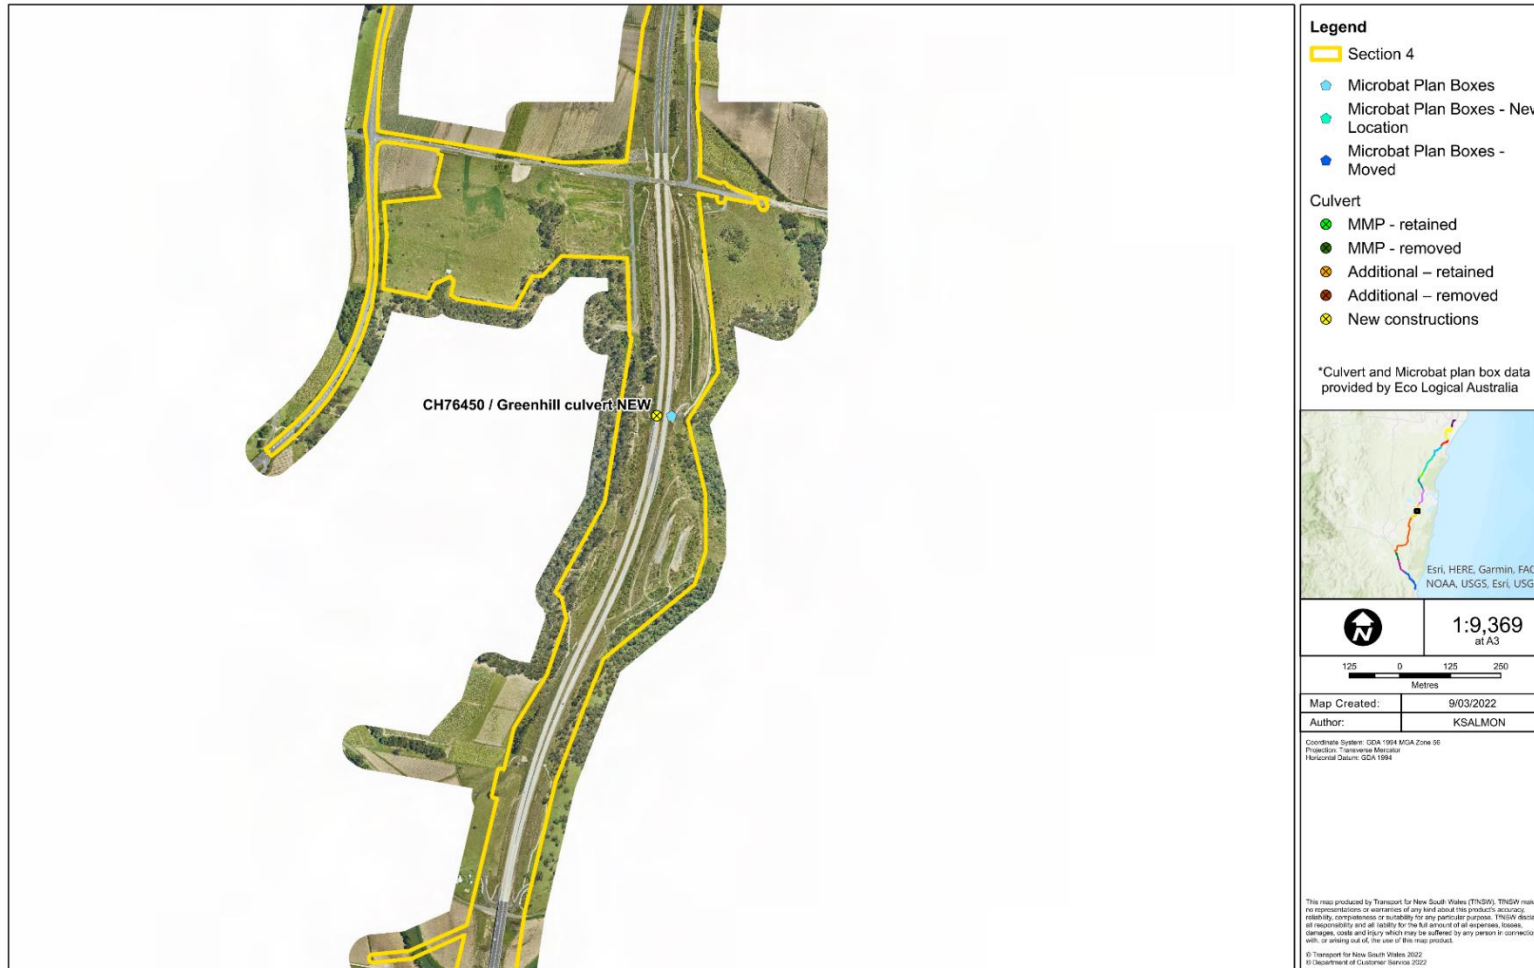
WOOLGOOLGA TO BALLINA - SECTION 4

Figure 2: Section 4 Greenhill culvert Microbat Management Plan, subject drainage structure and bat box location.

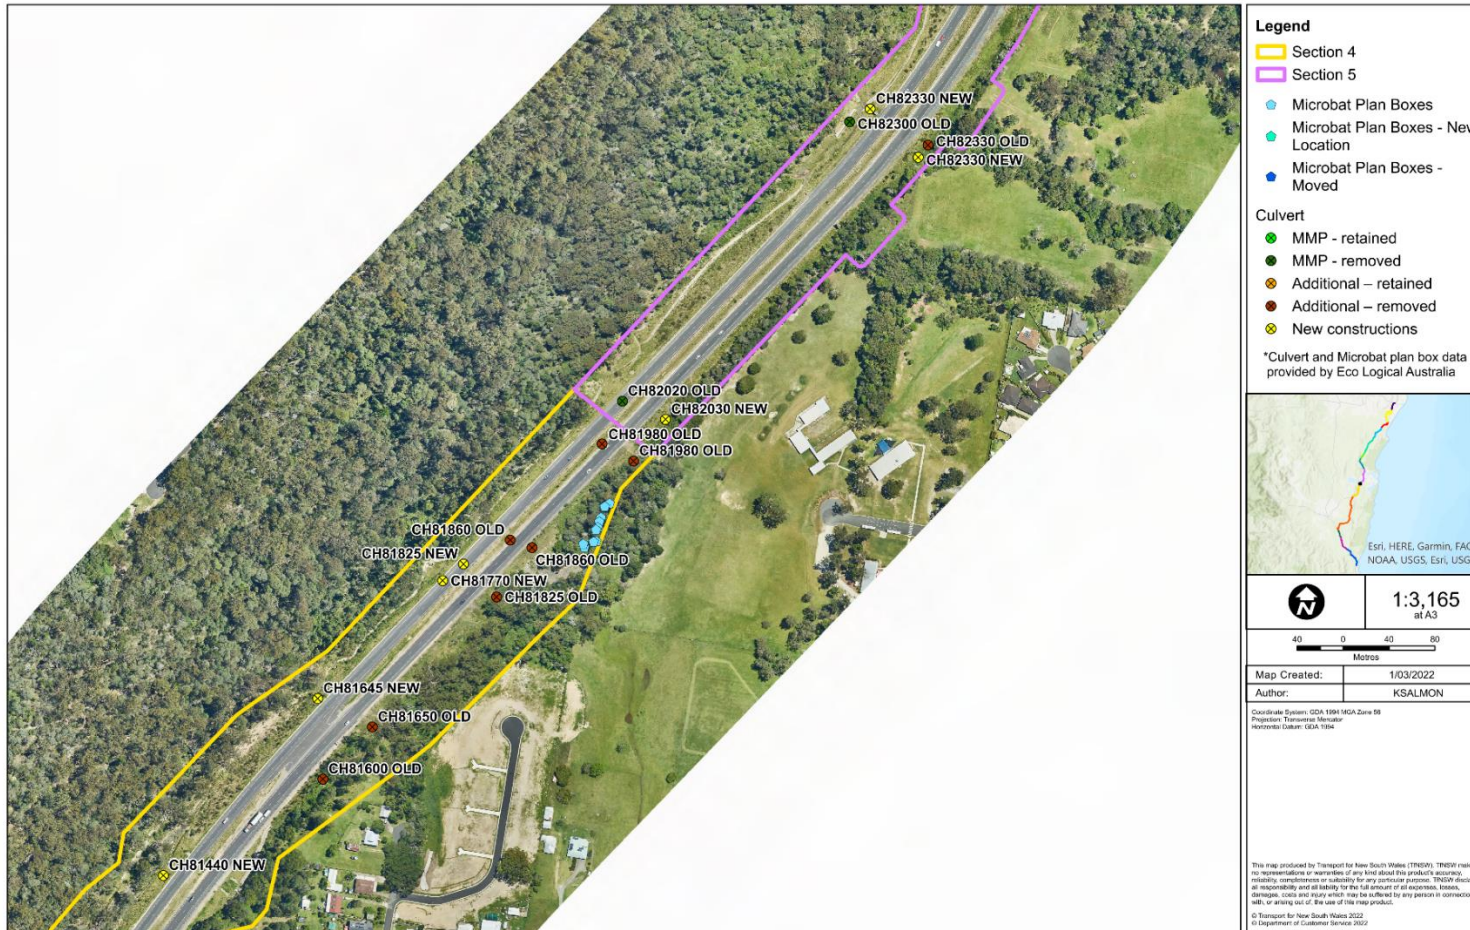
Figure 3: Section 4 / 5 Maclean Cut south Microbat Monitoring Plan, subject drainage structures and bat box locations.

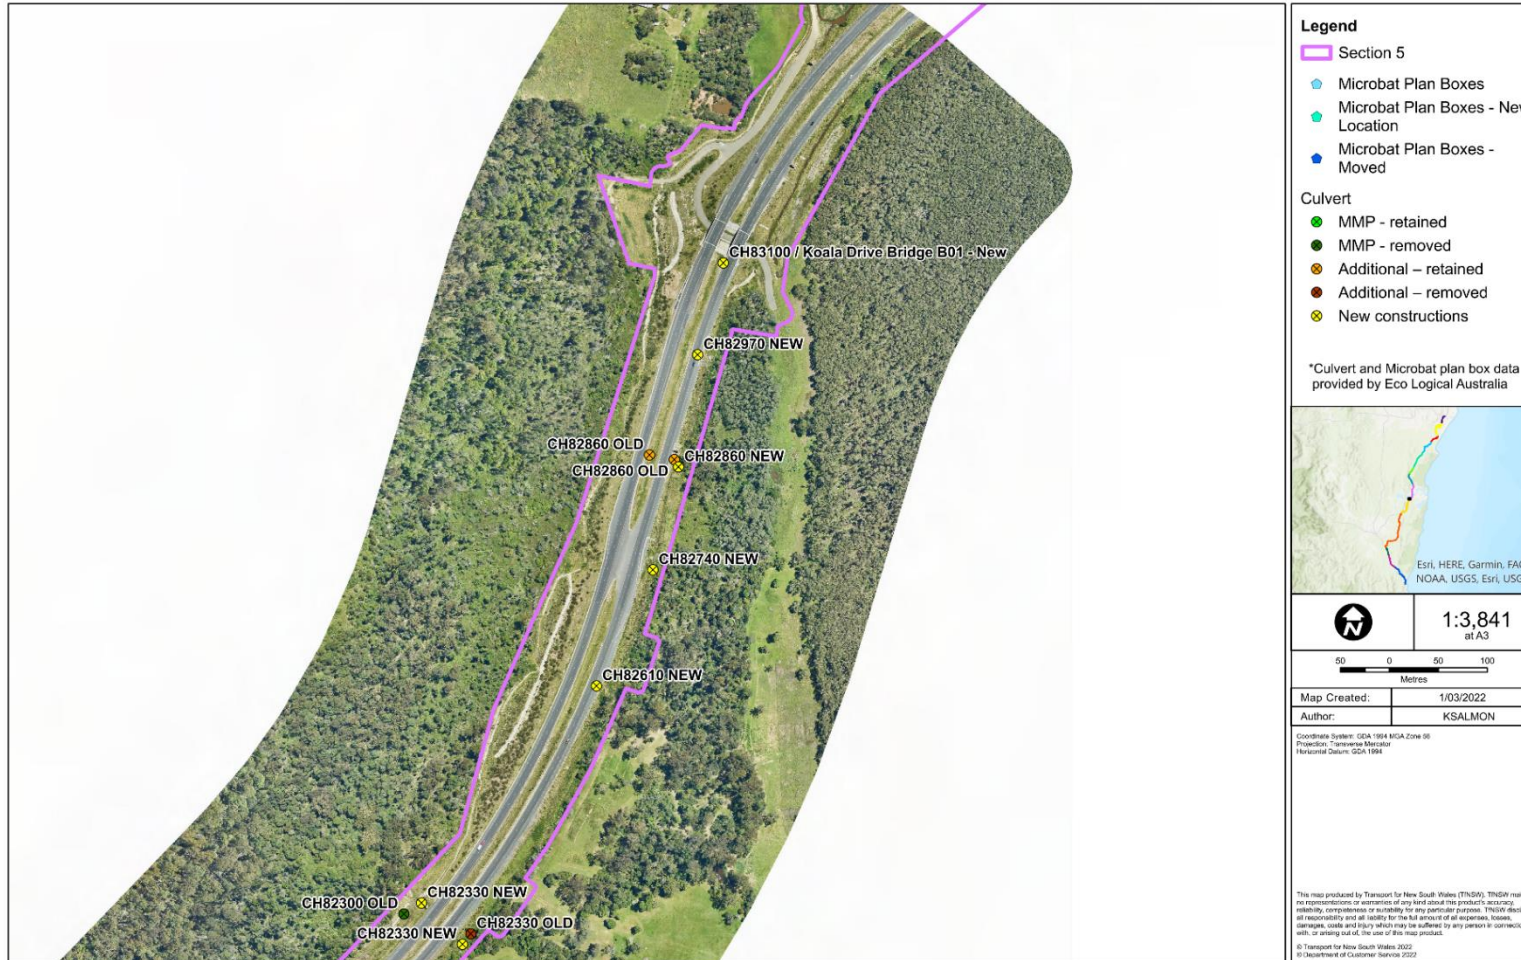
WOOLGOOLGA TO BALLINA - SECTION 5 MACLEAN CUT NORTH

Figure 4: Section 5 Maclean Cut north Microbat Monitoring Plan, subject drainage structures and bat box locations.

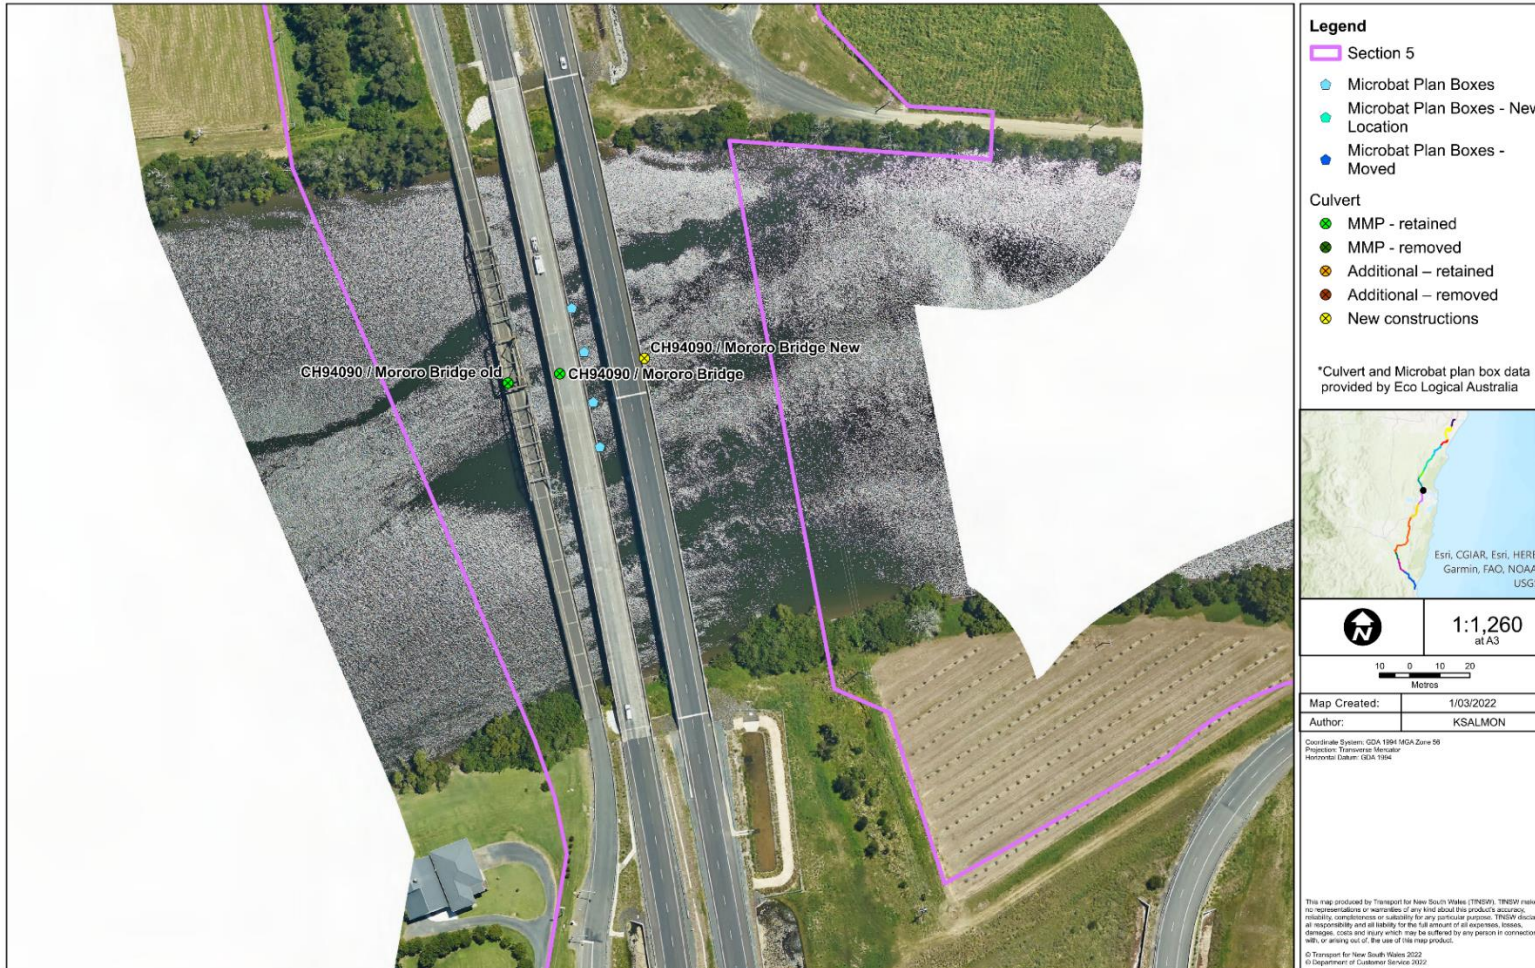
WOOLGOOLGA TO BALLINA - SECTION 5 MORORO BRIDGE

Figure 5: Section 5 Mororo Bridge Microbat Monitoring Plan, subject drainage structures and bat box locations.

Ten bat boxes that form part of the control sites in the MMP were installed at Serpentine Creek (six boxes installed in March 2015 as part of a separate project) and Mororo Bridge (four boxes installed in 2013 as part of a separate project) prior to the commencement of the W2B highway upgrade project by GeoLINK. Subsequently, and based on the MMP, pre-clearing survey reports and ELA calculations, a further 28 bat boxes were installed as temporary replacement habitat by ELA at sites spread between Glenugie and Oakey Creek (Table 3, and Figure 1 - Figure 11).

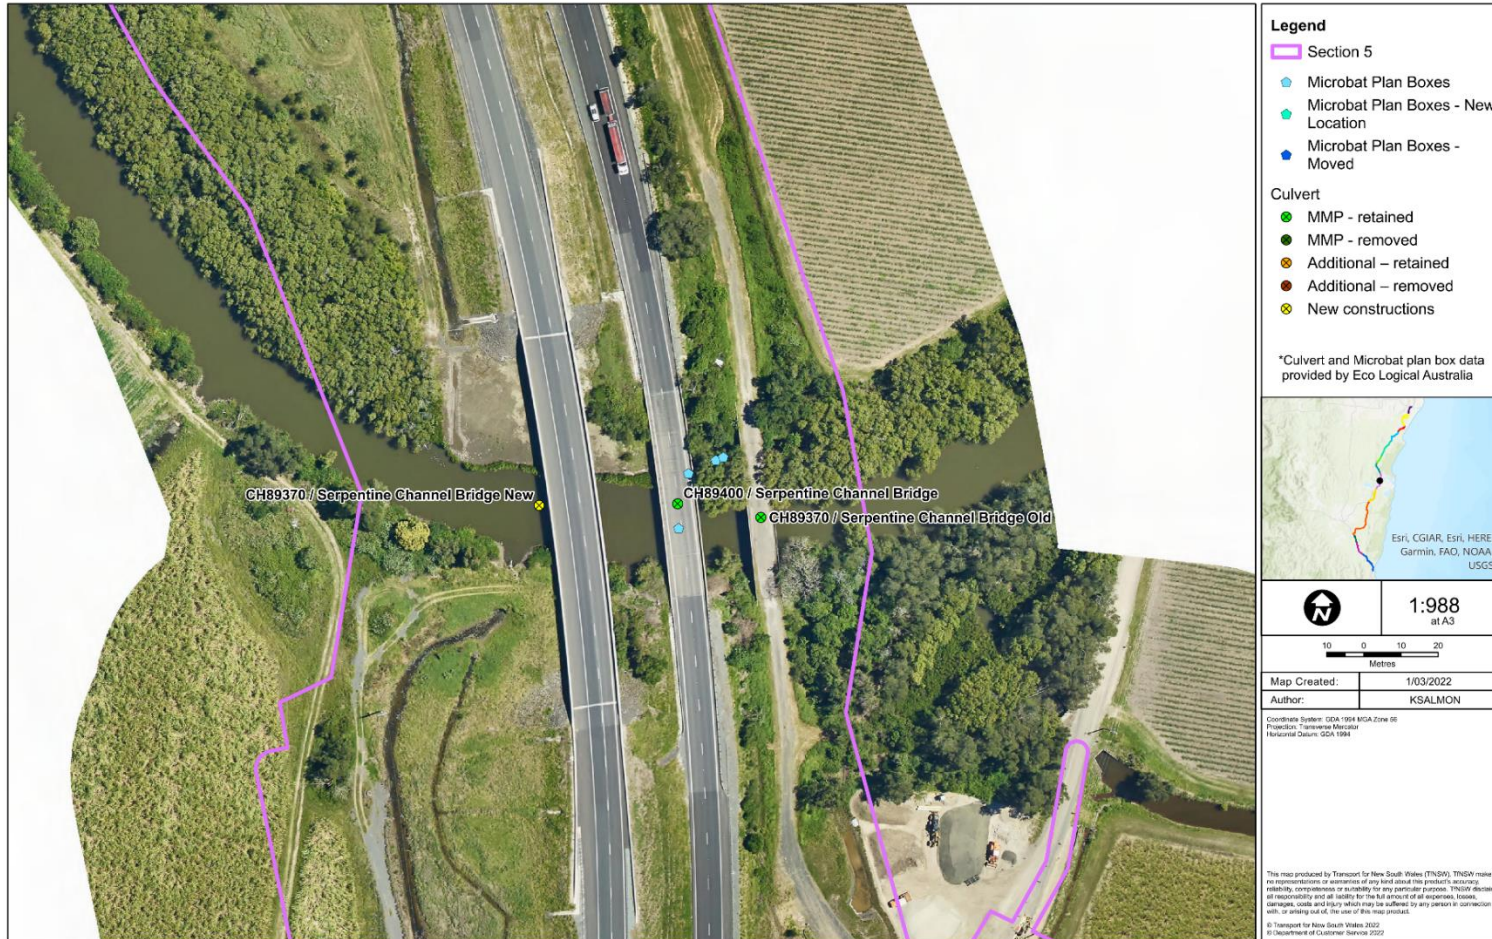
WOOLGOOLGA TO BALLINA - SECTION 5 SERPENTINE CREEK

Figure 6: Section 5 Serpentine Creek Microbat Monitoring Plan, subject drainage structures and bat box locations.

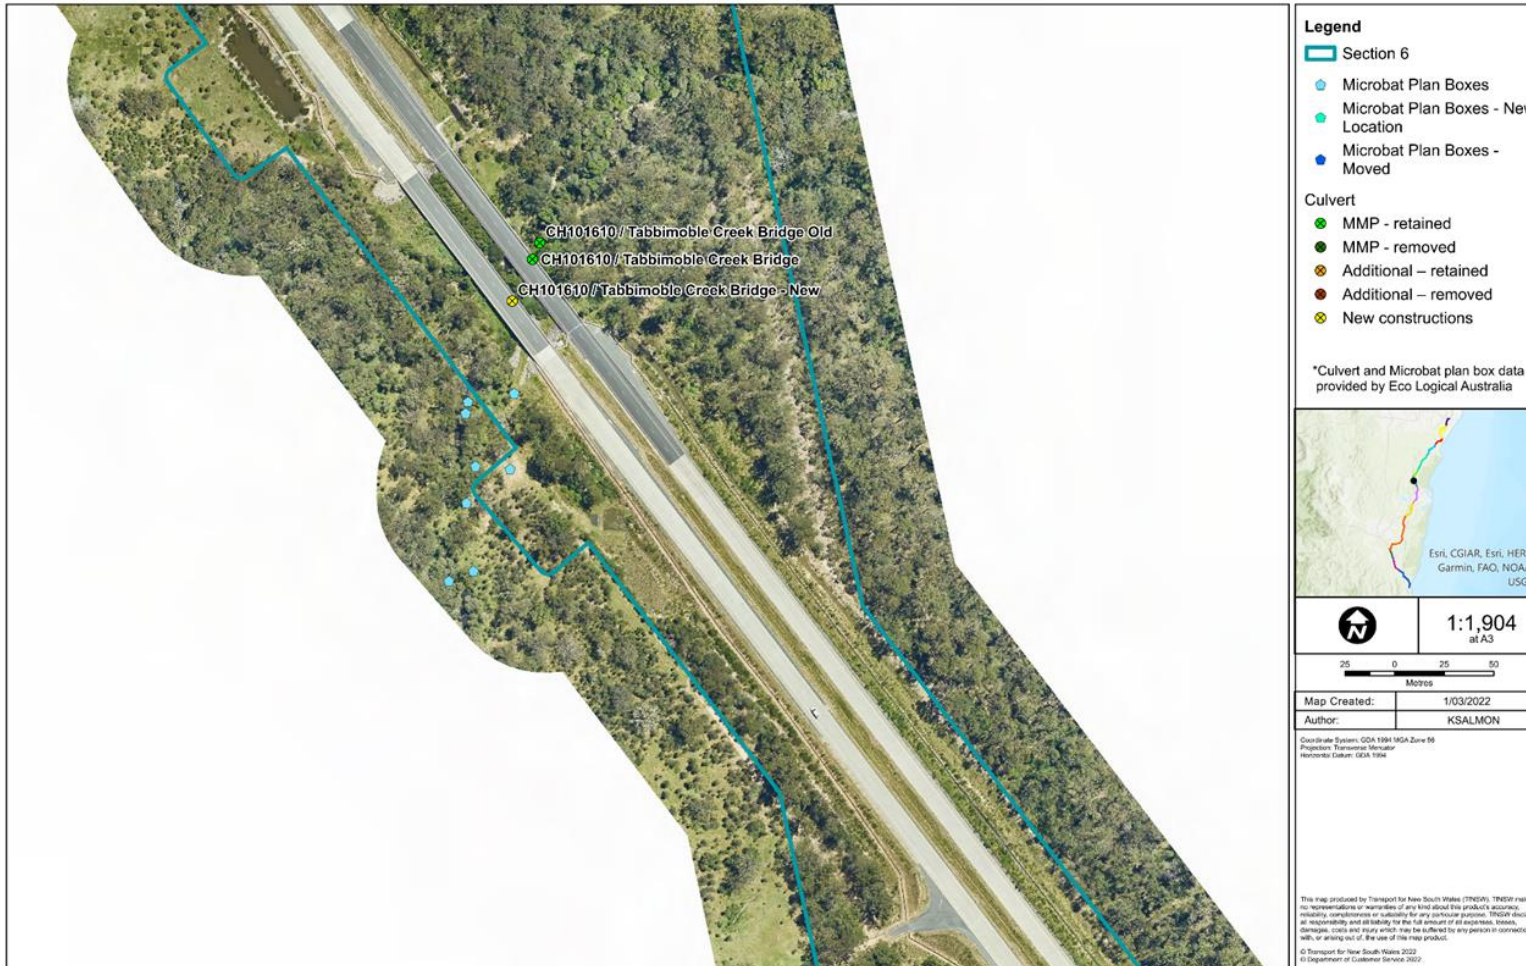
WOOLGOOLGA TO BALLINA - SECTION 6 TABBIMBLE CREEK

Figure 7: Section 6 Tabbimble Creek Bridge Microbat Monitoring Plan, subject drainage structures and bat box locations.

Little Bent-winged Bat (*Miniopterus australis*) and Large Bent-winged Bat (*Miniopterus orianae oceanensis*) are known from several locations along the W2B highway alignment. Both species tend to form large over-Wintering colonies numbering in the hundreds to thousands of individuals within various structures along the Pacific Highway between Halfway Creek and Woodburn and are present on-site between February / March and September each year. Two key over-Wintering roosts for Bent-winged Bats that were not be removed or extended within Sections 3-11 of the W2B project are the bridges over Tabbimoble Creek located in Section 6 (Figure 7 and Figure 8).

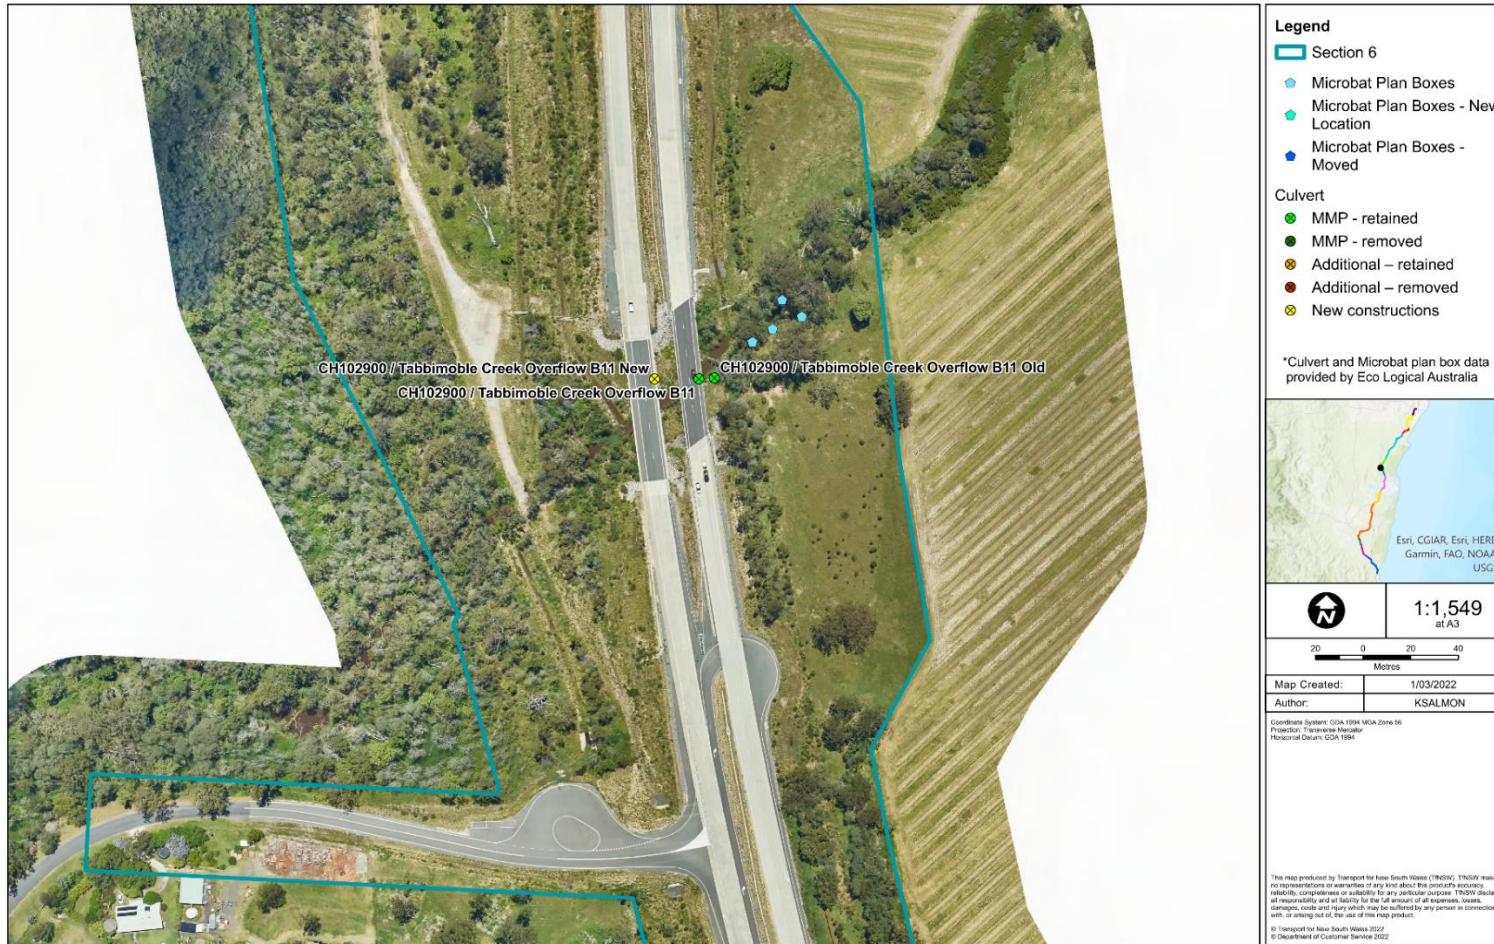
WOOLGOOLGA TO BALLINA - SECTION 6 TABBIMBLE CREEK OVERFLOW

Figure 8: Section 6 Tabbimble Creek Overflow Bridge Microbat Monitoring Plan, subject drainage structures and bat box locations.

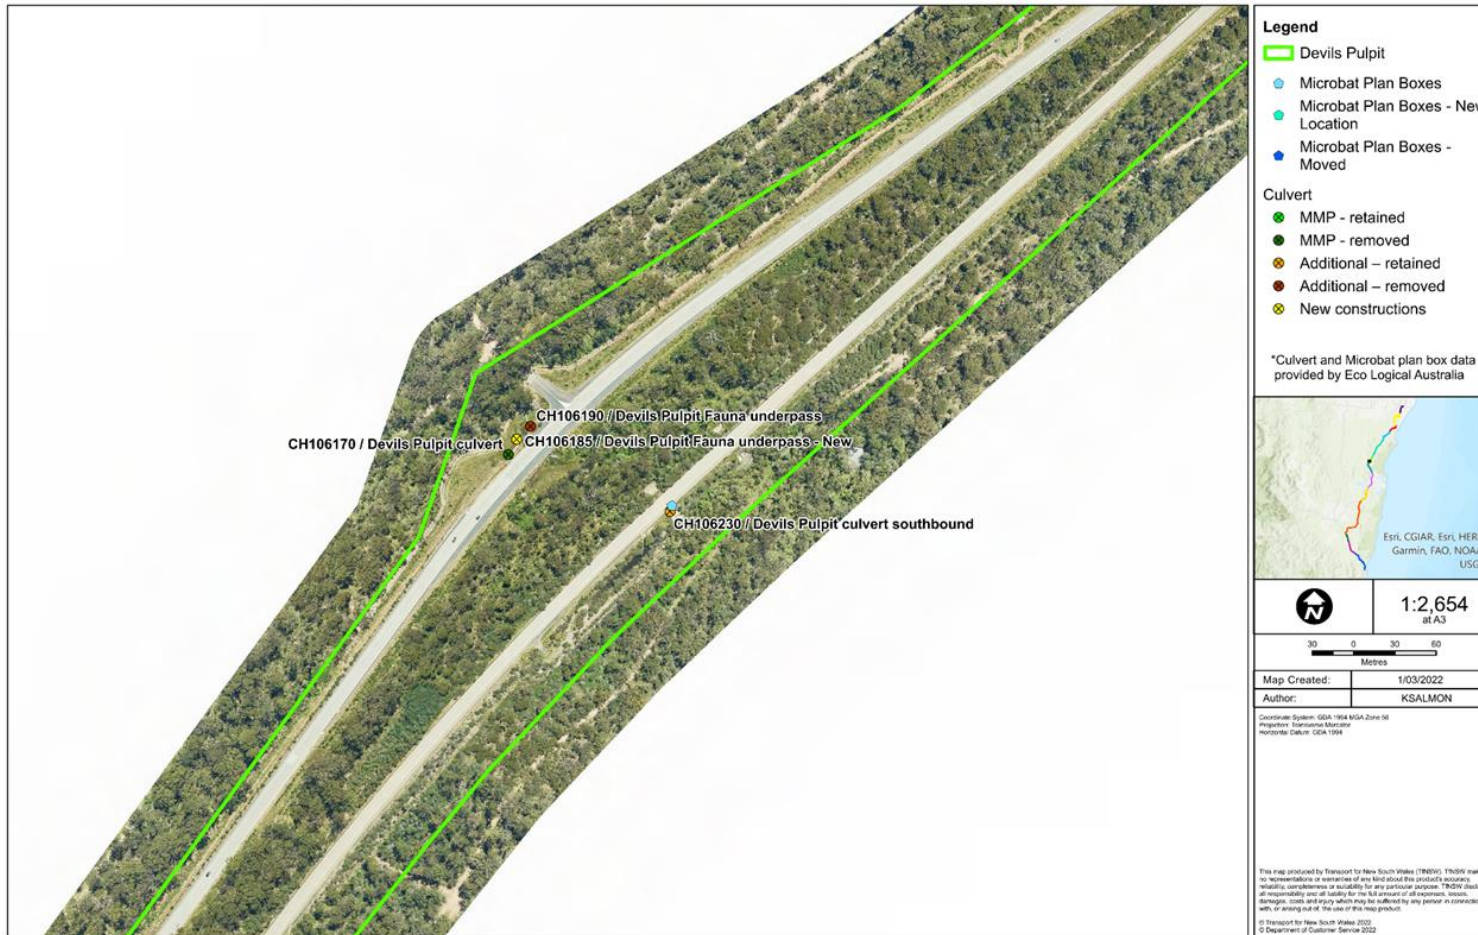
WOOLGOOLGA TO BALLINA - SECTION DEVILS PULPIT

Figure 9: Devil’s Pulpit section Microbat Monitoring Plan, subject drainage structures and bat box locations.

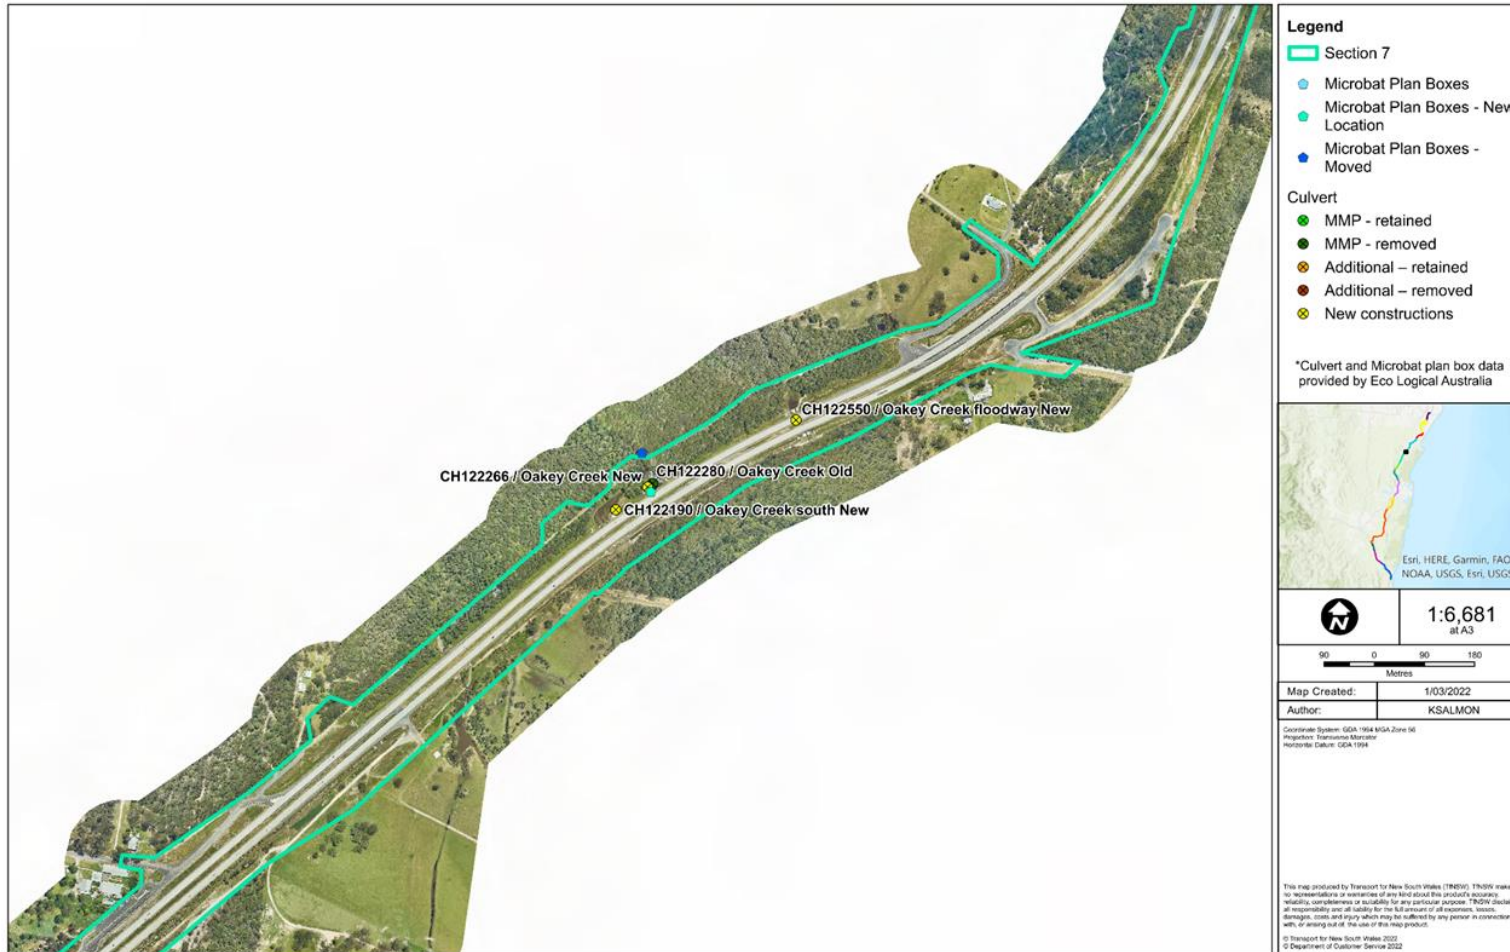
Figure 10: Section 7 Oakey Creek Microbat Monitoring Plan, subject drainage structure and bat box location.

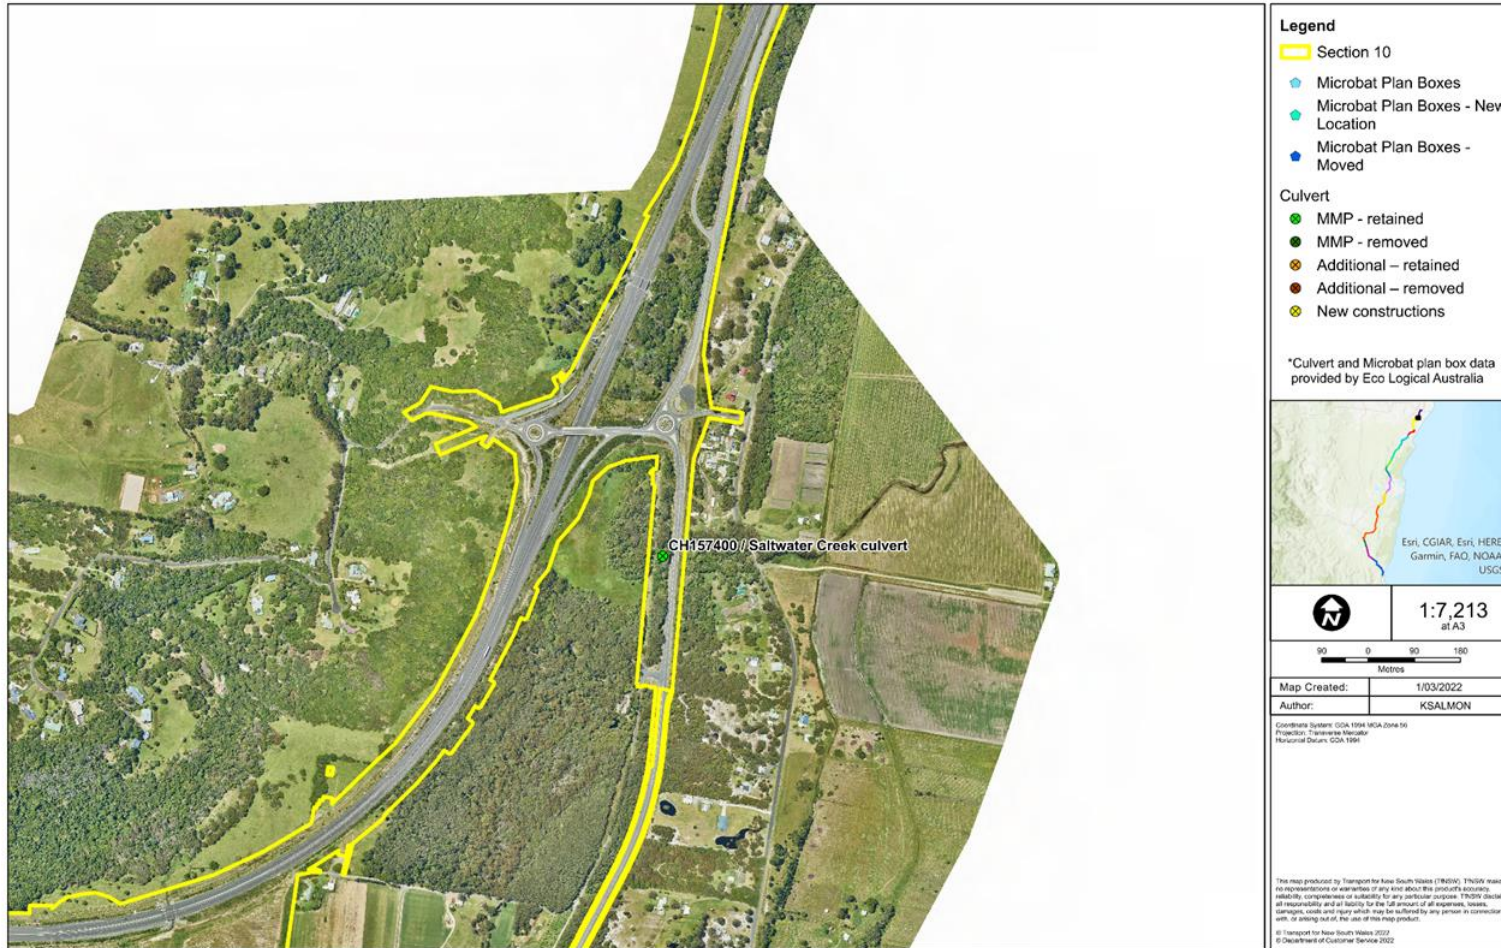
Figure 11: Section 10 Saltwater Creek Microbat Monitoring Plan, subject drainage structure location.

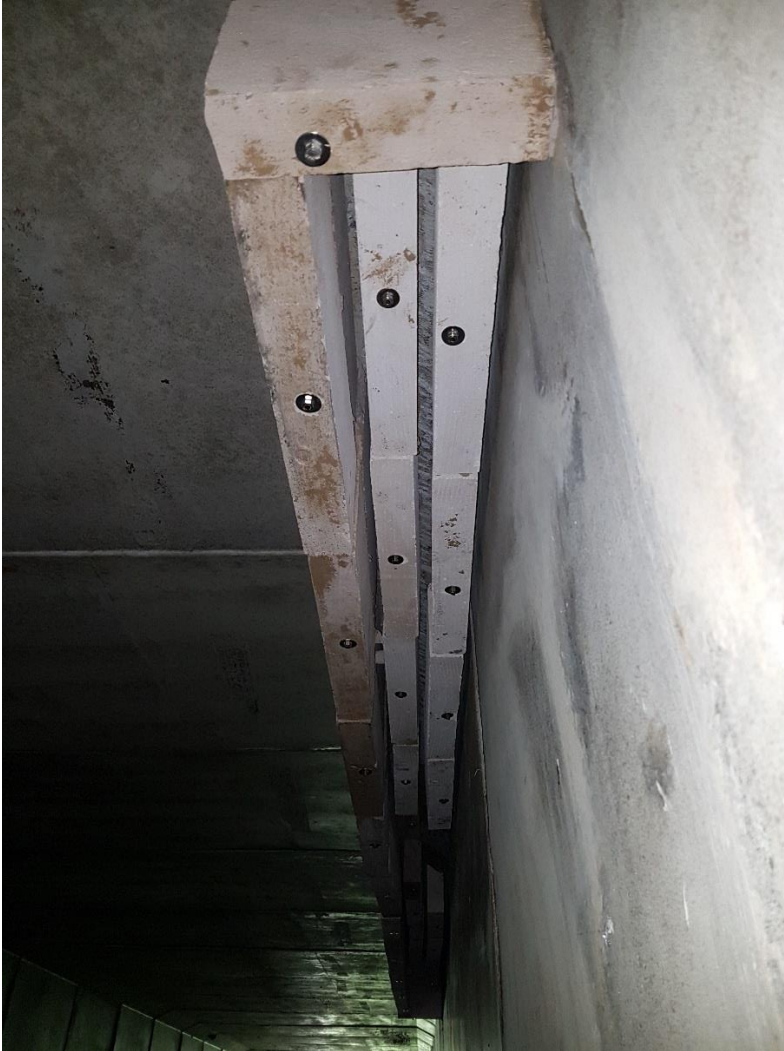
Plate 1: Prototype Hebel box designed to accommodate up to 2,000 Bent-winged Bats, installed in a box culvert at Glenugie CH 31400, March 2019.

approximately 2000 Bent-winged Bats constructed from Hebel blocks was installed in a culvert under the existing Pacific Highway at CH 31400 in early 2019. This Bent-winged Bat box was designed to provide permanent replacement habitat and to replicate the expansion jointing gaps used by Bent-winged Bats in the Bebo Arch at CH 34900 (Figure 1 and Plate 1).

The additional monitoring at Glenugie Culvert Bent-winged Bat Box (CH 31400) indicate greater use of this Hebel box by bats than has been recorded at any time in the past. Inspection of the Bent-winged Bat box at CH 31400 has recorded five Little Bent-winged bats during the August 2022 monitoring. Past monitoring events have only recorded evidence of microbat use within the Bent-winged Bat box at CH 31400.

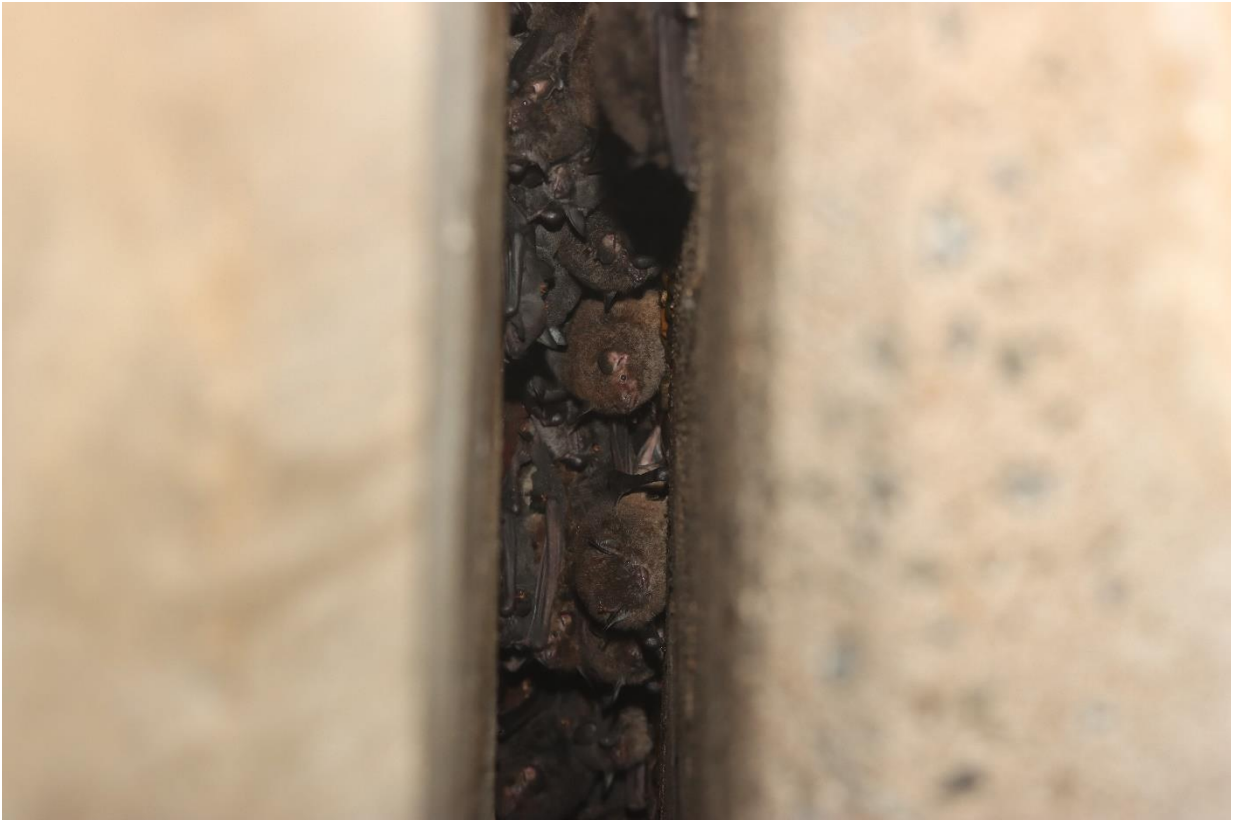
Plate 2: Cluster of Southern Myotis (including pups) recorded at Old Serpentine Bridge February 2022

Similar to previous monitoring events, Old Serpentine Creek Bridge supports a large number of Southern Myotis. There were over 100 Southern Myotis recorded roosting and breeding with large guano piles beneath in Old Serpentine Creek Bridge. Evidence of a successful breeding event in February 2022 is illustrated in Plate 2 with pups present. During July 2019 monitoring, Old Serpentine Creek Bridge also supported Large Bent-winged Bats during winter. The number of Large Bent-winged Bats at this site is characterised by large fluctuations with anywhere between no Bent-winged Bats present and up to 131 (recorded once only during pre-construction surveys). This suggest that Serpentine Channel Bridges appears to represent temporary roosting for Bent-winged Bats.

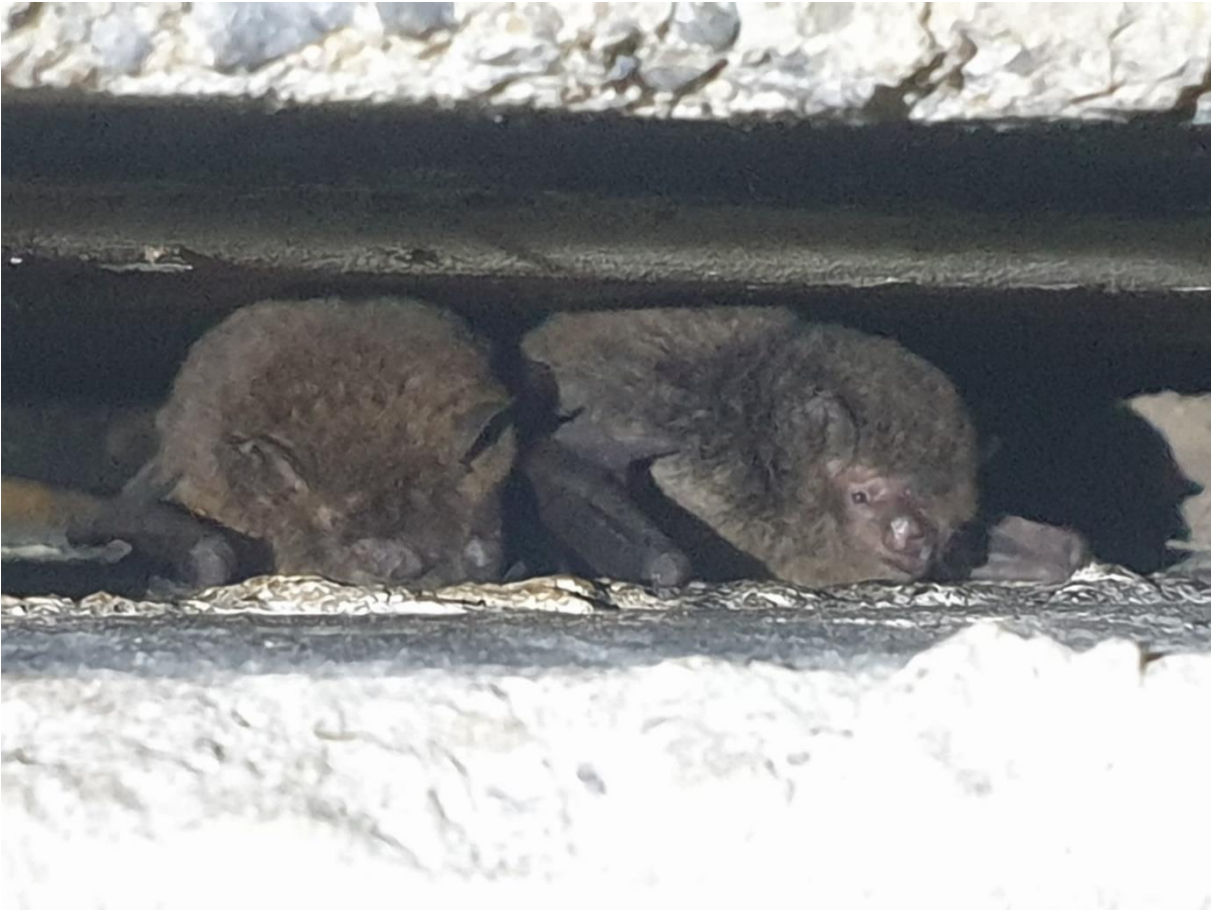
Plate 3: Two Southern Myotis recorded at Saltwater Creek, February 2022

The results for Saltwater Creek culvert during the February 2022 monitoring period indicate continuous use of this culvert by bats. Saltwater Creek culvert recorded two Southern Myotis (Plate 3). Previous monitoring events have recorded occupancy of a small number of Little Bent-winged Bats (12 LtBW in July 2019, 1 LtBW in October 2019, 1 LtBW in Jan/Feb 2020). Baseline surveys at Saltwater Creek culvert recorded up to one Large Bent-Winged Bat.

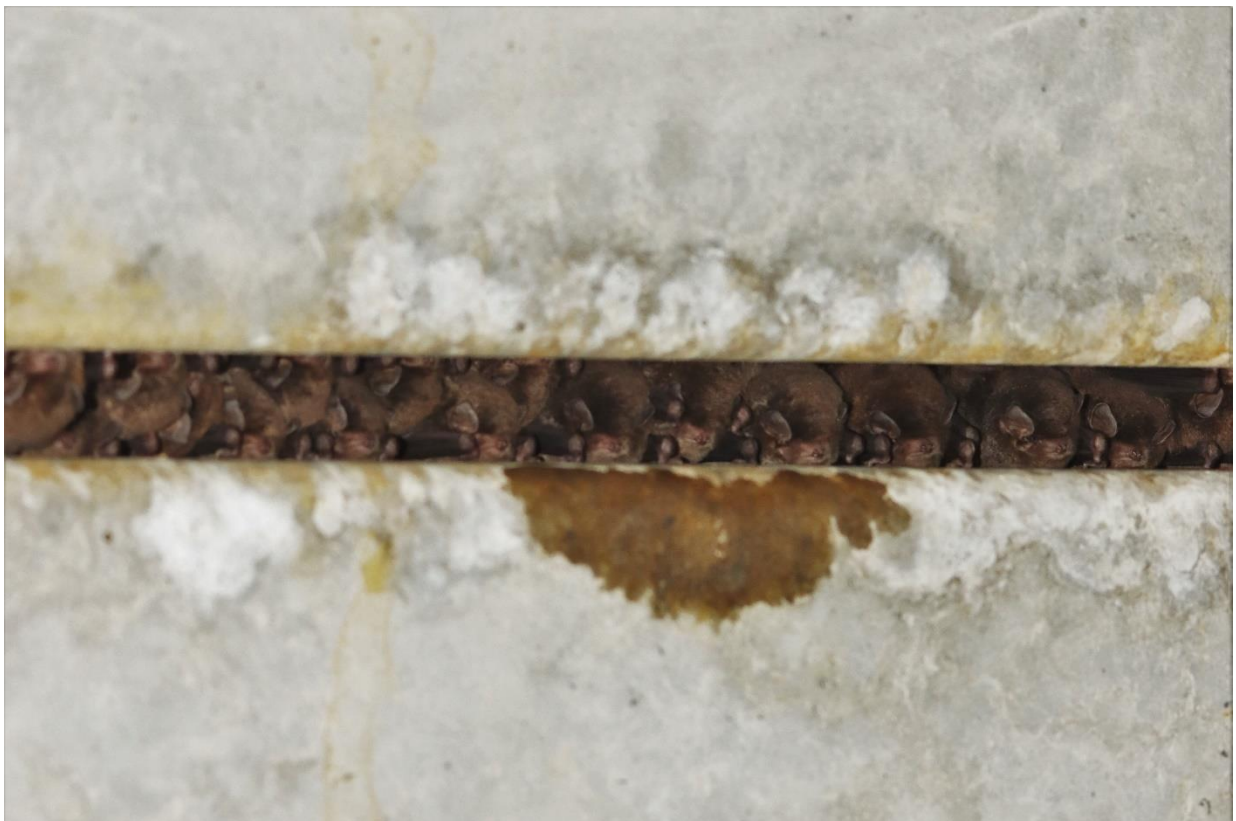
Plate 4: Large Cluster of Little Bent-Winged Bats recorded at Old Tabbimoble Creek Bridge, August 2022

This additional monitoring in Winter 2022 and Summer 2023 recorded similar numbers and species of microbat present to previous years, indicating a fluctuation between seasonal events. During winter Little Bent-winged Bats were more dominate than in Summer. During Winter 2022 monitoring Tabbimoble Creek recorded 65 Little Bent-winged Bats, three Large Bent-winged Bats and two *Nyctophilus* sp (Plate 4). Prior to commencement of works Old Tabbimoble Creek recorded up to 553 Little Bent-winged Bats in July 2014. Old Tabbimoble Creek Overflow Bridge recorded greater than 500 Little Bent-winged Bats, four Large Bent-winged Bats, five Southern Myotis and 1 *Nyctophilus* sp. The results for Old Tabbimoble Overflow Creek Bridge during the Winter 2022 monitoring indicate greater use of Little Bent-winged Bats than has been recorded at any time in the past.

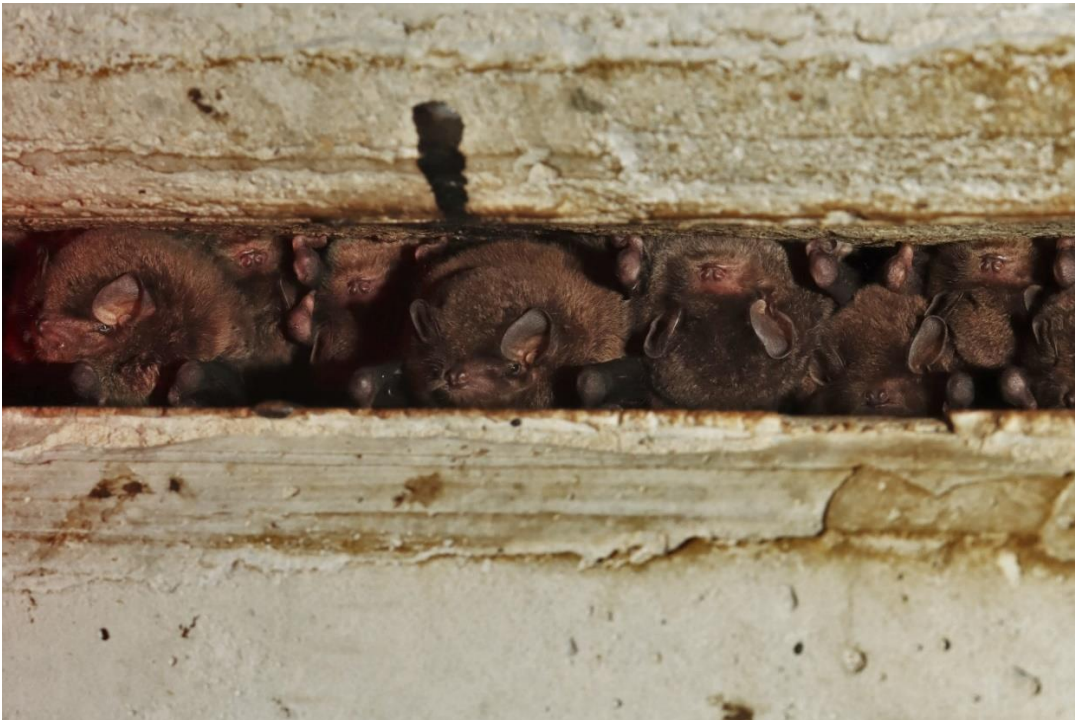
Plate 5: Little Bent-winged Bats at Glenugie Link Culvert (CH35075), August 2022

Additional monitoring of Glenugie Link Culvert (CH 35075) in August 2022 indicated an increase in Little Bent-winged Bats from February 2022 to August 2022. Greater than 1000 Little Bent-winged Bats and 12 Large Bent-winged Bats were recorded within Glenugie Link Culvert (CH 35075) during the August 2022 monitoring (Plate 5). Glenugie Link Culvert appear to represent temporary roosting habitat for Bent-winged Bats. The new culverts contain roosting habitat with a capacity for >2000 Bent-winged Bats in the expansion joins designed to provide microbat roosting habitat and in roughened concrete patches on the obvert of the culverts.

The newly constructed Glenugie Link Culvert (CH35075) built in place of Bebo Arch contains good bat habitat which was implemented within the culvert design. Large numbers of Little Bent-winged Bats and some Large Bent-winged Bats have been observed occupying Glenugie Link Culvert (CH35075) during the Winter monitoring. Roosting habitat includes the widened expansion joints which ascertain bat numbers similar to that observed in the original Bebo arch. Glenugie Link Culvert (CH35075) contain roosting habitat for > 2000 Bent-winged Bats in the widened expansion jointing gaps created in the mid sections of each cell of both sets of 4 culverts at this location.

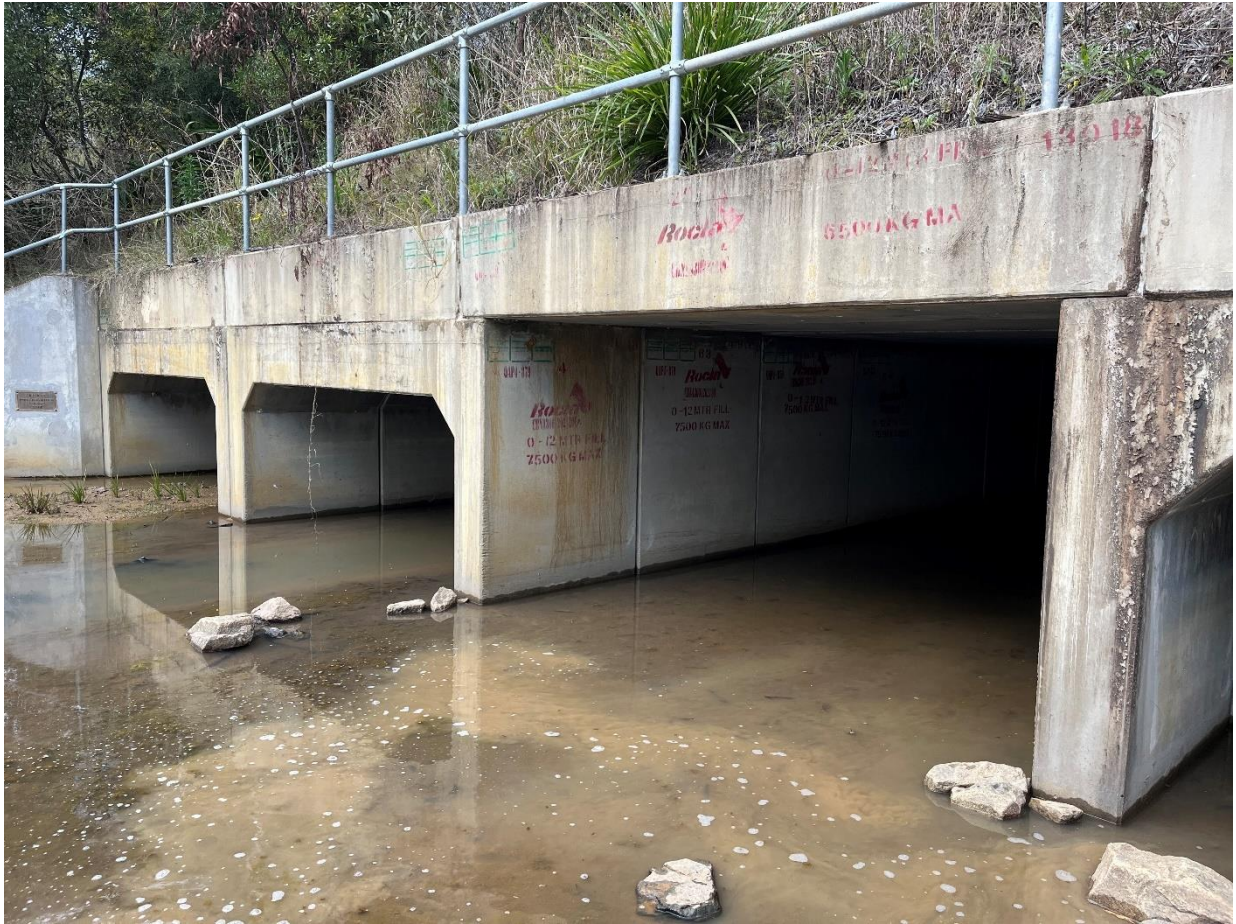
Plate 6: Newly constructed Picaninny Creek four cell culvert (CH 35880), Eight Mile Lane, Glenugie Link, Section 3A

The newly constructed Picaninny Creek Culvert (CH 35880) is a longer but lower four cell concrete box culvert (Plate 6). Similar to past monitoring events, February 2022 monitoring only recorded evidence of bat use by light guano. Additional monitoring events in August 2022 and February 2023 recorded no Southern Myotis within the newly constructed Picaninny Creek Culvert (CH 35880). However, during the August 2022 monitoring period two Little Bent-winged bats and one Large Bent-winged Bat was recorded within the tallest box culvert out of the four. Although it is used by bats as evident by additional August 2022 monitoring the low height of this culvert makes it unlikely to be used by Southern Myotis (Plate 6).

Similar to the previous microbat monitoring report, there is a lack of evidence that a maternity colony of Southern Myotis has been able to re-establish within the newly constructed culverts at Picaninny Creek and Pheasants Creek on Eight Mile Lane. Whilst there have been observations of small groups and individual Southern Myotis at the new Pheasants Creek culvert, no evidence of breeding has been observed and the numbers are below those recorded prior to construction commencing. As such corrective actions were undertaken. During the additional monitoring undertaken in August 2022 expansion foam within lift holes and expansion joints was removed. This was aimed at encouraging uptake by Southern Myotis. However, the February 2023 monitoring resulted in no evidence of microbats reoccurring within the Original Picaninny Creek culvert. Nevertheless, monitoring only occurred 6 months later over one monitoring period and perhaps too early to determine whether Southern Myotis populations will return. It is recommended that another monitoring event occurs at Eight Mile Lane to survey the reoccurrence of Southern Myotis.
