W2B Section 3 – 11 Microbat Management Plan 2022-2023 Annual Monitoring Report

Transport for NSW

Project Name	W2B S3 – 11 Microbat Management Plan 2022-2023 Annual Monitoring Report
Project Number	5728
Project Manager	Phoebe Smith
Prepared by	Samantha Patch and Phoebe Smith
Reviewed by	Josie Stokes
Approved by	Josie Stokes
Status	Final
Version Number	2
Last saved on	20 November 2023

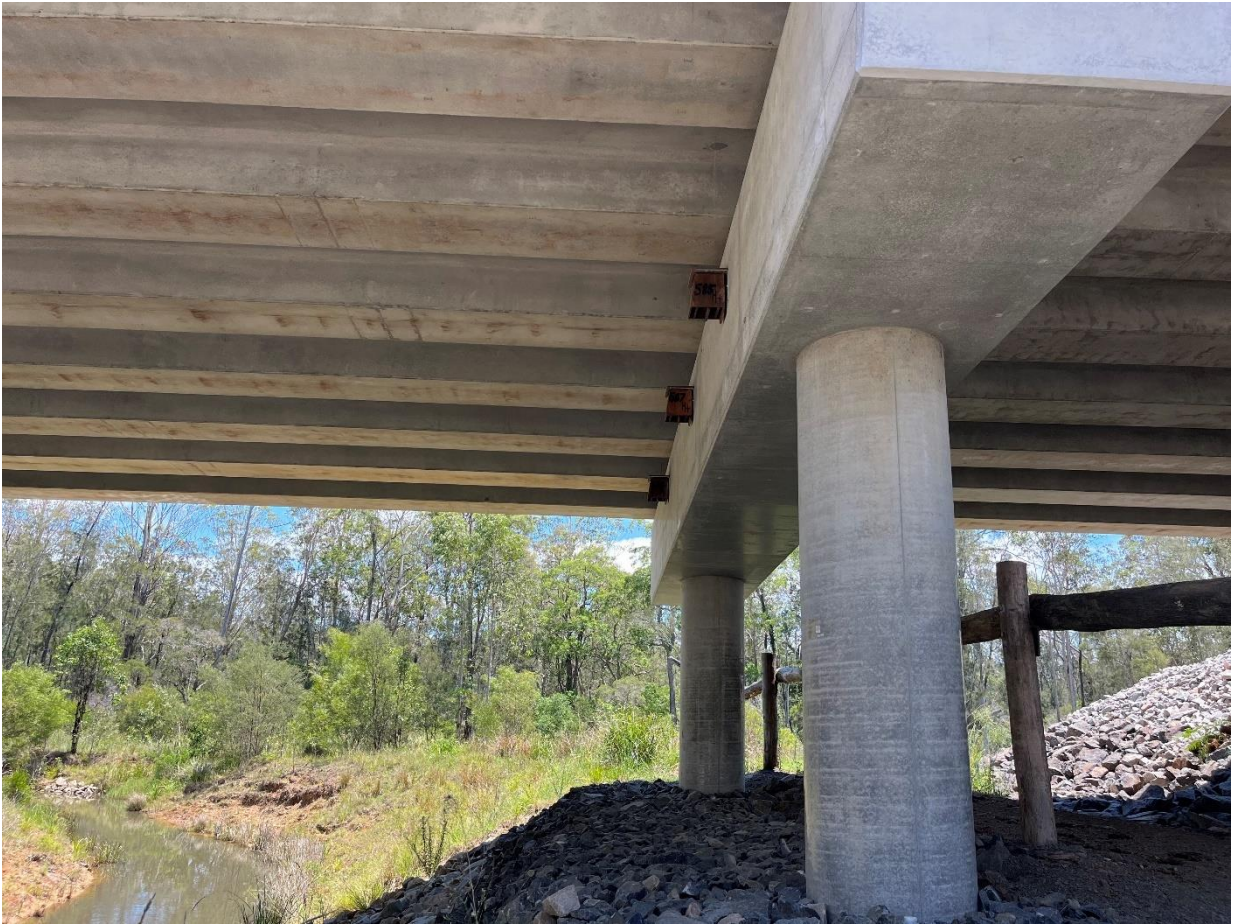
Plate 7: Three x four chambered bat boxes installed beneath the new Pheasants Creek Bridge, February 2023

To date there has been no evidence of the re-establishment of a maternity colony of Southern Myotis at Picaninny or Pheasants Creek. The three x four chambered bat boxes installed in trees along Pheasants Creek have never been used. These boxes were installed beneath the new Pheasants Creek Bridge in February 2021 (Plate 7). No microbats have been recorded within these boxes.

Similar to the previous microbat monitoring report, there is a lack of evidence that a maternity colony of Southern Myotis has been able to re-establish within the newly constructed culverts at Picaninny Creek and Pheasants Creek on Eight Mile Lane. Whilst there have been observations of small groups and individual Southern Myotis at the new Pheasants Creek culvert, no evidence of breeding has been observed and the numbers are below those recorded prior to construction commencing. As such corrective actions were undertaken. During the additional monitoring undertaken in August 2022 expansion foam within lift holes and expansion joints was removed. This was aimed at encouraging uptake by Southern Myotis. However, the February 2023 monitoring resulted in no evidence of microbats reoccurring within the Original Picaninny Creek culvert. Nevertheless, monitoring only occurred 6 months later over one monitoring period and perhaps too early to determine whether Southern Myotis populations will return. It is recommended that another monitoring event occurs at Eight Mile Lane to survey the reoccurrence of Southern Myotis.

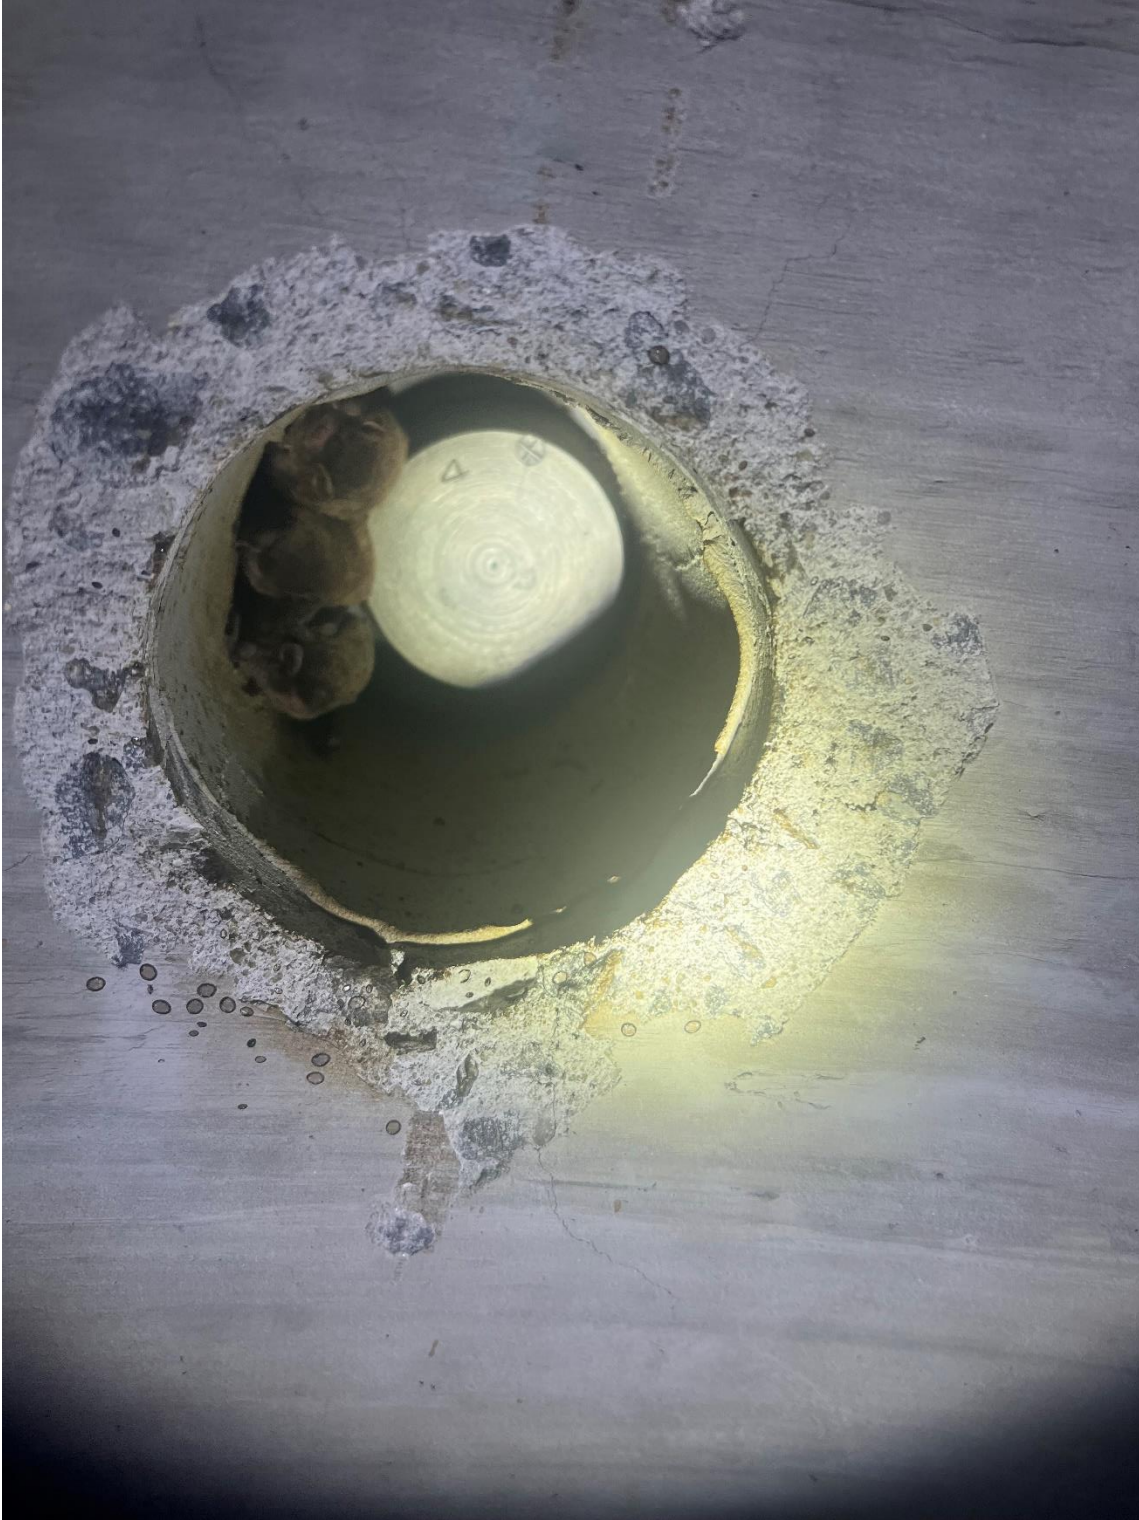
Plate 8: Three Little bent-wing Bats recorded at Maclean Cut (CH 82330), August 2022

There were no microbats recorded in the culverts at Maclean Cut by ELA during the February 2022 monitoring, however there was evidence of small to moderate sized aggregation having been present between monitoring events in the form of guano piles beneath exclusion joins in one of the culverts (CH 82030). Additional monitoring undertaken in August 2022 also recorded guano within CH 82030 and four Little Bent-winged Bats in another culvert (CH 82330) (Plate 8). This is the first-time microbats have been recorded within the new culverts at Maclean Cut.

*In 2019/20 it was found culverts at Maclean cut did not have the required capacity to accommodate up to 650 Bent-winged Bats and boxes showed no signs of utilisation. A larger style Bent-winged Bat box was installed at Greenhill culvert to augment the existing culvert in June 2021, resulting in LtBW aggregating during Winter. Due to lack of microbat habitat (as determined by previous monitoring events) the remaining Maclean cut impact sites were excluded from monitoring.

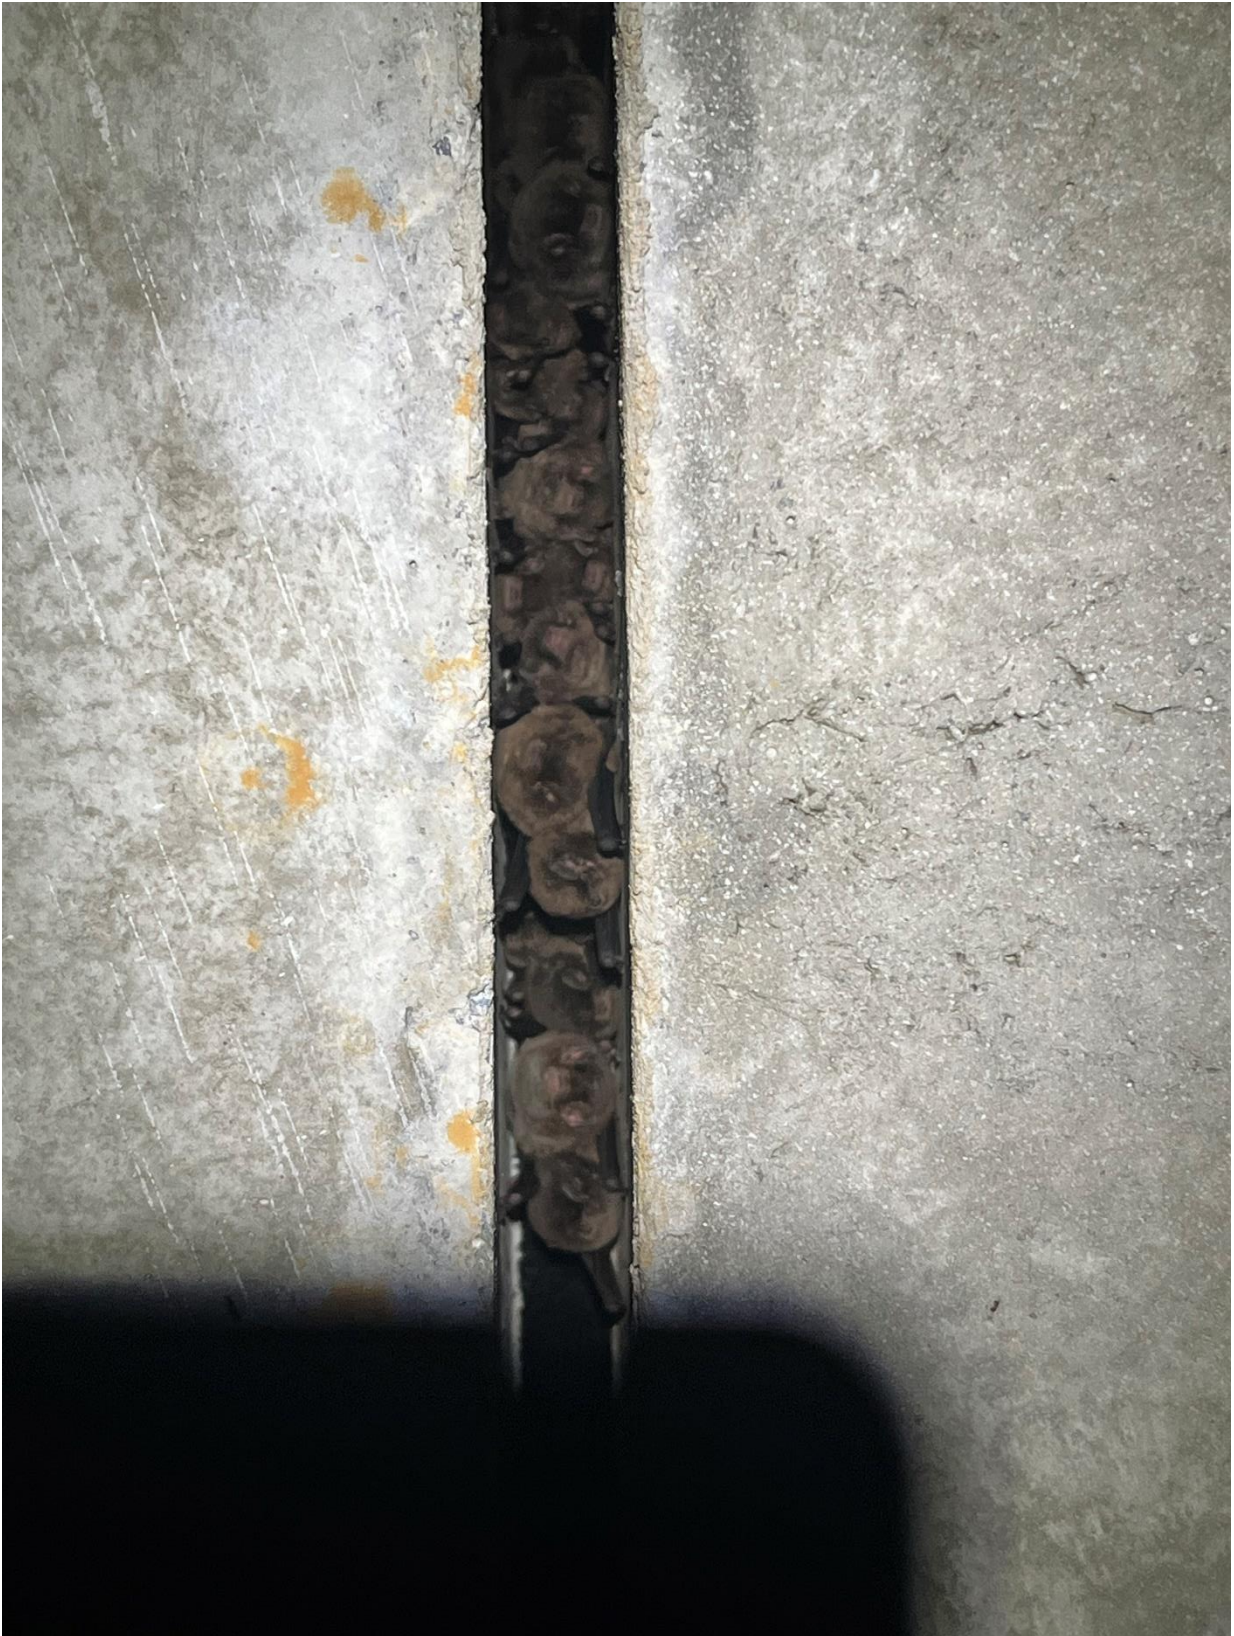
Plate 9: Little Bent-wing Bats recorded at Greenhill Box culvert (CH 76450), August 2022

Greenhill Box culvert and a Bent-winged Bat Box constructed from Hebel blocks were implemented into the monitoring to compensate habitat loss of Maclean Cut Culverts. During February 2022 monitoring no microbats were recorded. As mentioned previously the low number may be due to the Summer migration away from Winter roosting sites to Summer maternity sites by Bent-winged Bats. Additional Winter 2022 monitoring of the Greenhill Box culvert recorded approximately 26 Little Bent-winged bats and one *Nyctophilus* sp. within one of the expansion cracks (Plate 9). This is the most microbats recorded within Greenhill Box culvert since monitoring commenced. No microbats were recorded within the Bent-winged Bat Box installed in Green Hill Box Culvert. Greenhill Box Culvert may surpass as a potential alternative roosting site to Maclean Cut culverts, however additional Winter monitoring would be required to determine this.

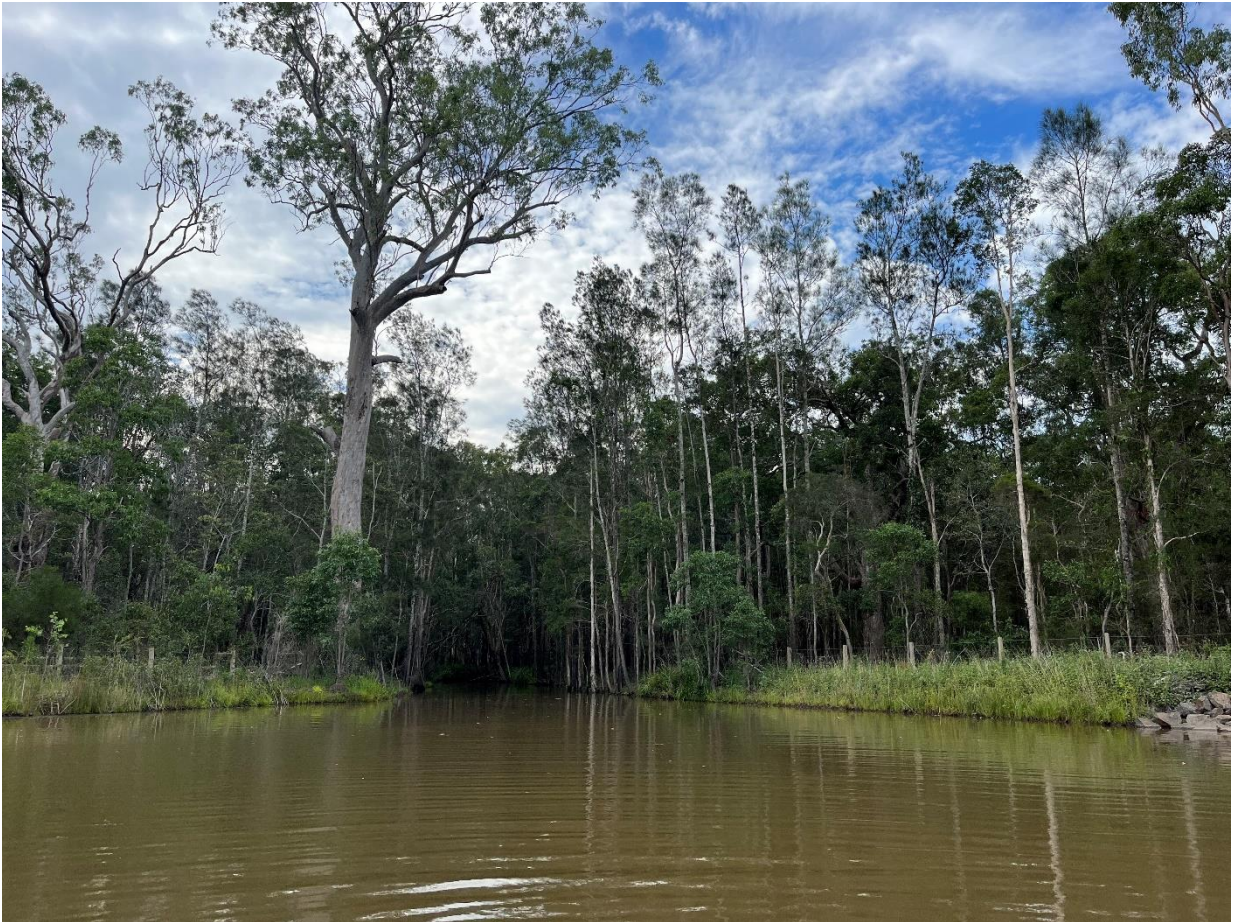
Plate 10: *Melaleuca* spp. forest outside of Oakey Creek Culverts, February 2023

Due to excess rainfall prior to February 2022 monitoring event, water levels and flow within Oakey Creek culverts were too high to inspect. Only one culvert at Oakey Creek could be inspected during the February 2022 monitoring period. New Oakey Creek Overflow (CH 122550) recorded three adult Southern Myotis and one Juvenile during February 2022. The results from the additional monitoring undertaken in February 2023 at Oakey Creek indicates greater use of these culverts by bats than has been recorded previously and signs of breeding. A total of 21 Southern Myotis were recorded throughout the three culverts. New Oakey Flat culvert (CH 122190) contained five Southern Myotis, one of which was a subadult. New Oakey Flat (CH 122280) recorded six Southern Myotis within the bat box and three Southern Myotis in the culvert. New Oakey Creek Overflow (CH 122550) recorded. Field observations noted suitable *Melaleuca* forest habitat with fly ways surrounding Oakey Creek culverts (Plate 10).

In comparison, the results at Oakey Creek culverts are encouraging for Southern Myotis despite low occupancy seen in previous monitoring events. This may have been due to high water levels as a result of heavy rainfall throughout late 2020 to mid-2022 producing debris and potentially excluding microbats from the culvert. However, during February 2023 monitoring Oakey Creek indicates greater use of these culverts by Southern Myotis than has been recorded previously and signs of breeding. It is recommended another monitoring event occurs at Oakey Creek to survey Southern Myotis numbers.

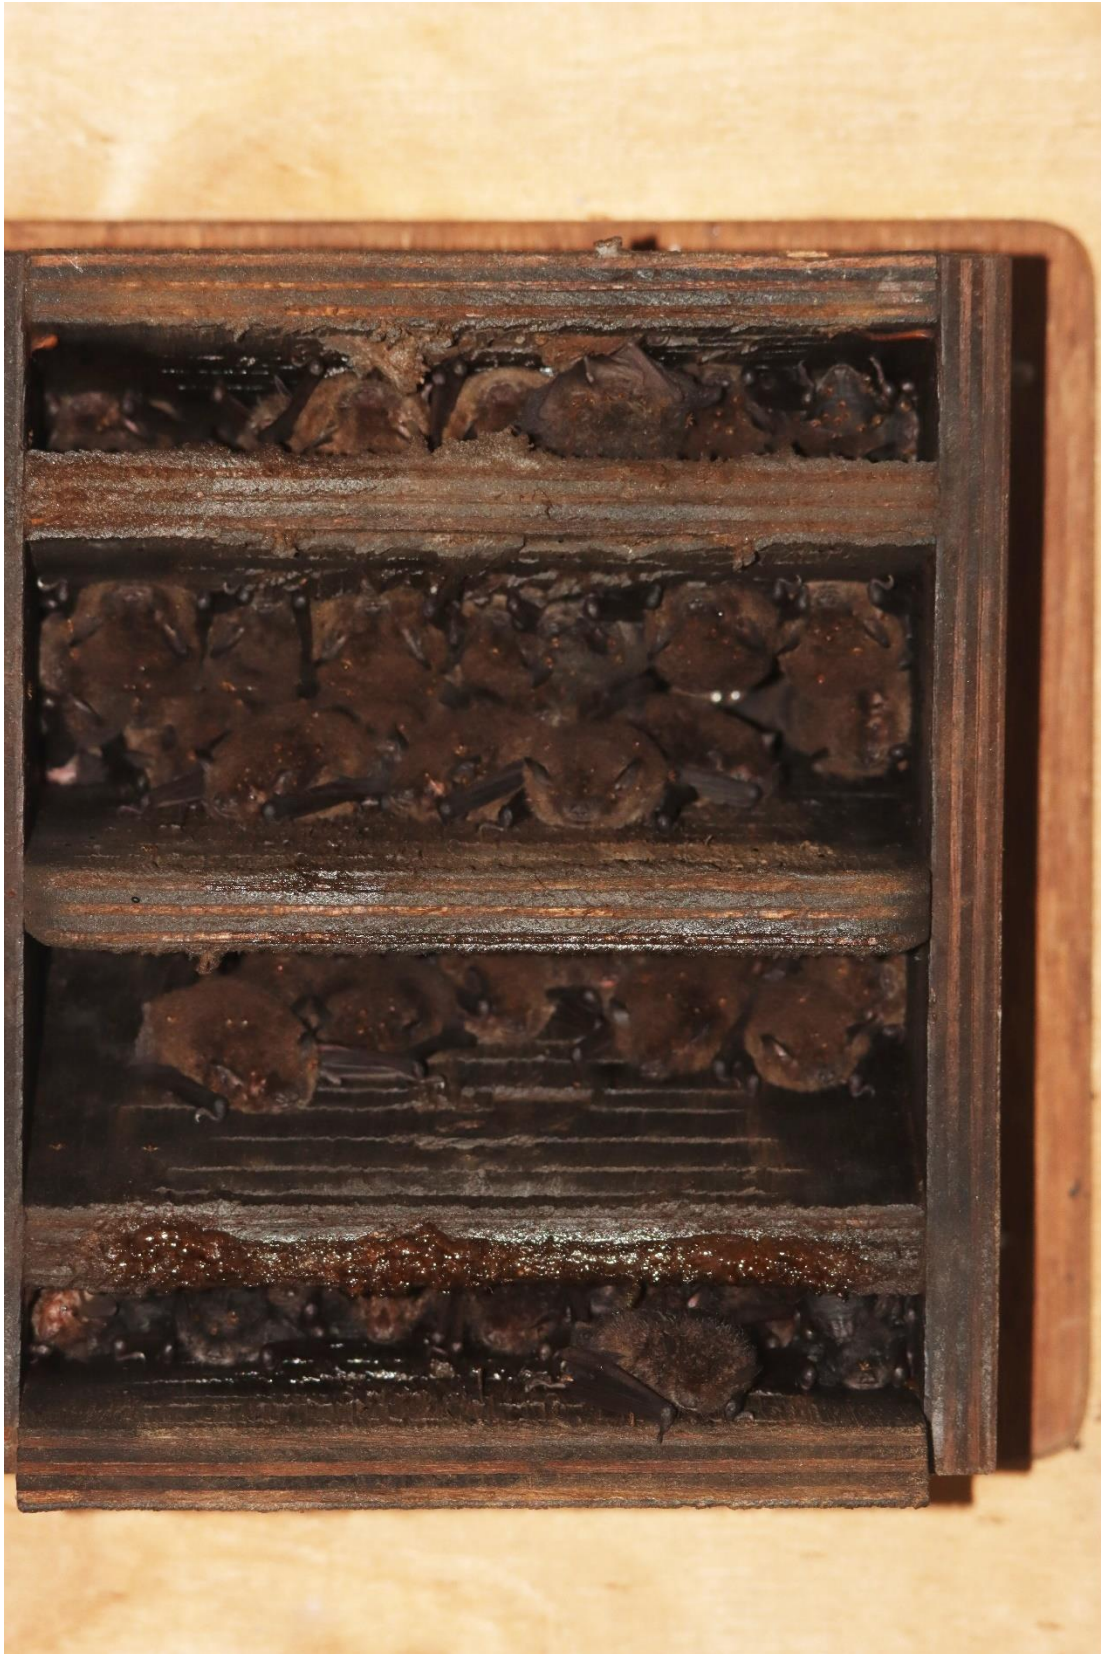
Plate 11: Southern Myotis (with pups) in bat boxes beneath Mororo Bridge, February 2022

The four timber bat boxes (four chambered) installed beneath Mororo bridge continue to support a permanent colony of Southern Myotis. Over 200 Southern Myotis were recorded roosting in the four timber bat boxes (Four Chambered) in February 2022. The number of Southern Myotis is similar to that recorded during baseline surveys which recorded between 127 up to 255+ Southern Myotis. The Summer 2022 result indicates that the Southern Myotis population centred on Mororo Bridge and Old Serpentine Bridge are in good health.

Southern Myotis were known to have maternity colonies located along the W2B project alignment. Mororo bridge was one of the only known maternity colonies which was not removed or extended as part of the W2B project alignment. Mororo Bridge south, has supported a permanent colony of Southern Myotis within four bat boxes installed beneath the bridge from before construction commenced, throughout construction and into the operational phase of the project. It is recommended, although not required as part of the W2B project, that the additional boxes be constructed from a
