Commonwealth approval EPBC 2013/6963 conditions compliance tracking and management annual report

**Nambucca Heads to Urunga Pacific Highway
Upgrade**

February 2023 – January 2024

Underpass and adjacent habitat
monitoring – operational phase year
seven (2023)

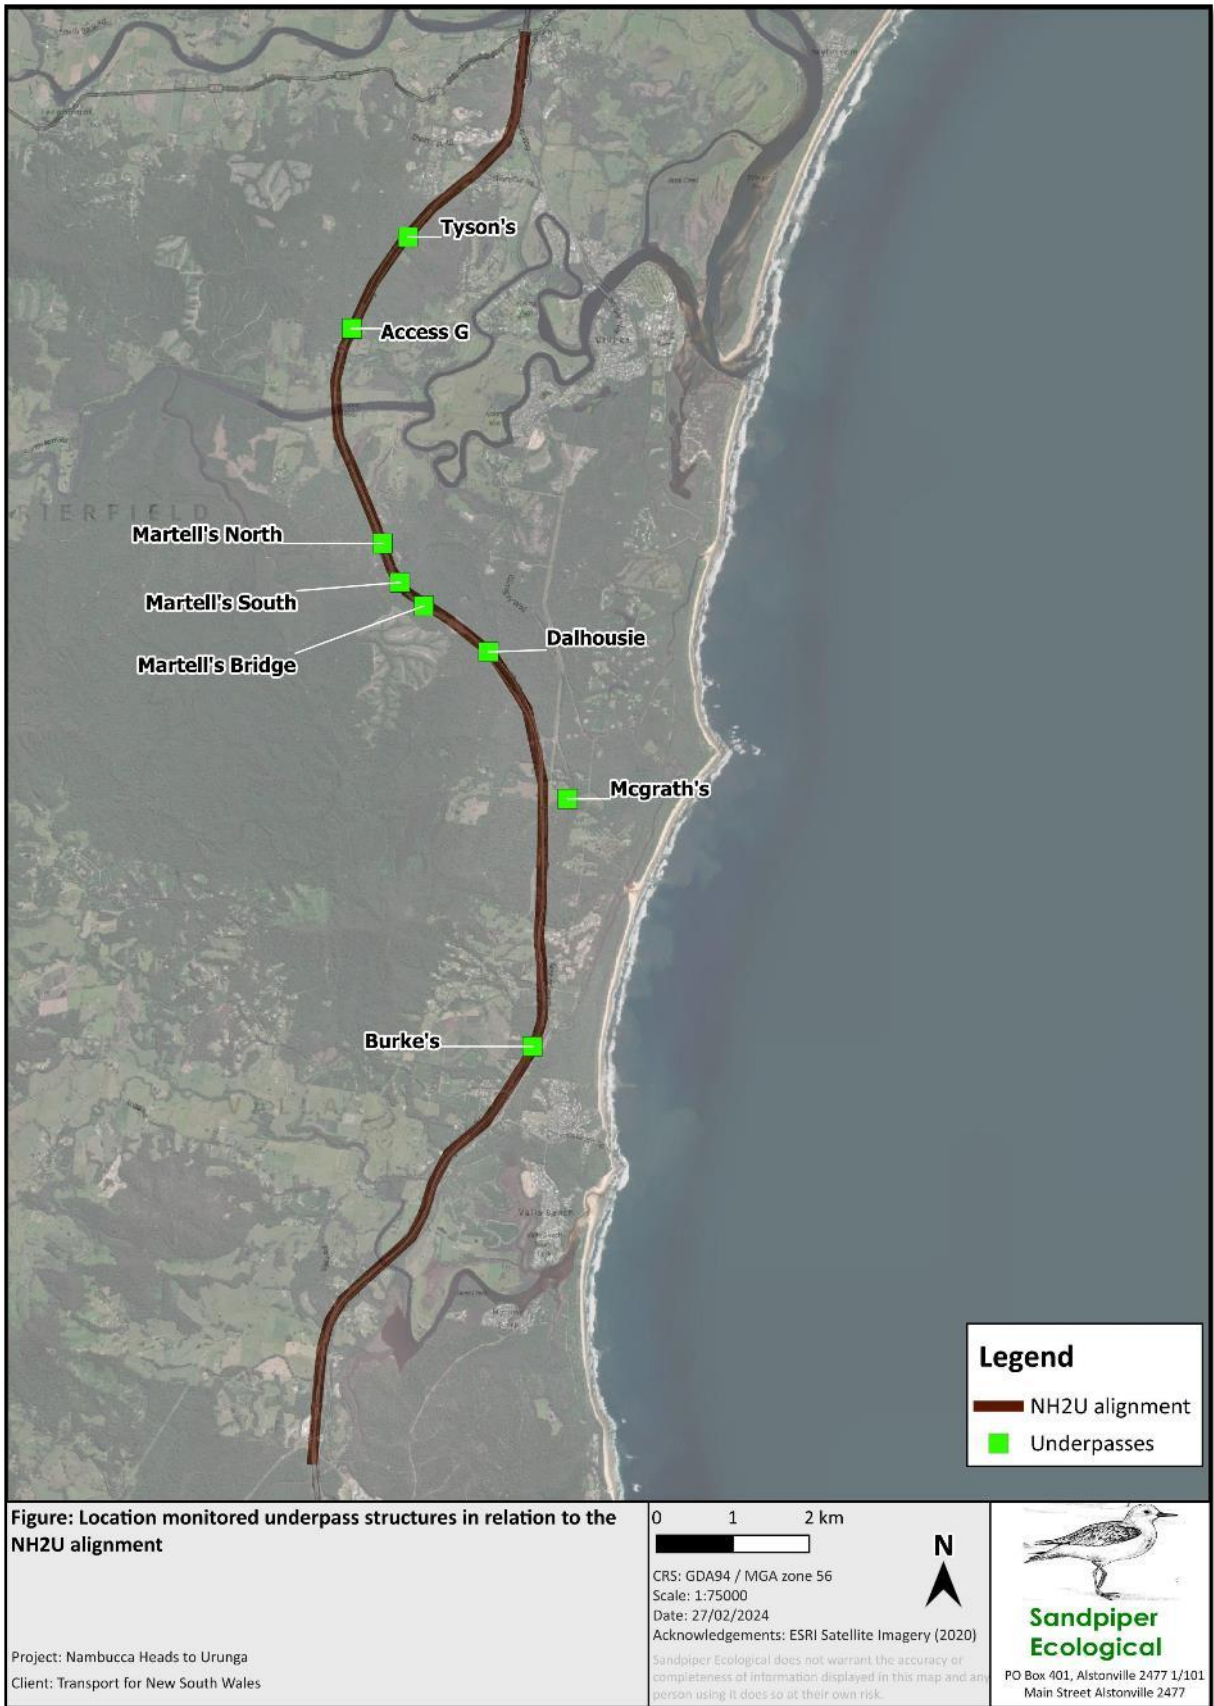
Figure 1: Location of underpass structures monitored during year seven operational monitoring at NH2U, 2023.

The NH2U project extends for 22km from Link Road, Nambucca Heads in the south to Waterfall Way, Urunga in the north. The single reference and seven impact sites monitored during 2023 were spaced along the NH2U Pacific Highway upgrade alignment between chainage 68470 (Burke's) and 80220 (Tyson's Flat) (Figure 1). The context of each impact site differed and included: vegetated median (Dalhousie & Tyson's); underpass with adjoining service roads (Burke's); combined structures situated within vegetated medians (Dalhousie and Tyson's) and a small bridge underpass (Martells bridge). The reference site at McGrath's Creek was located under the old Pacific Highway, 280m east of the alignment (Figure 1).

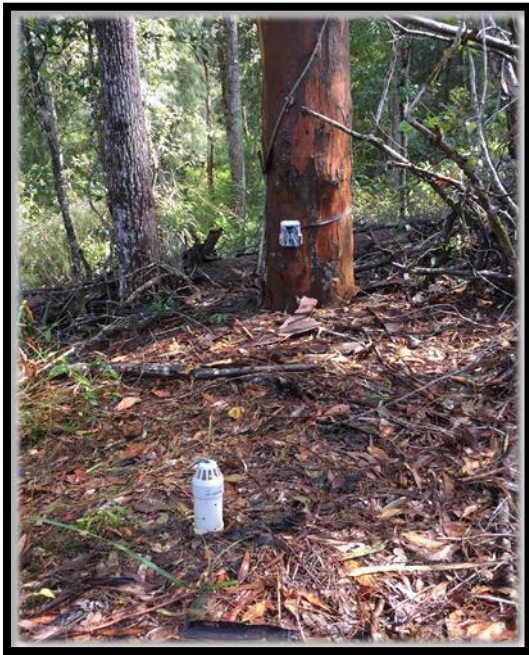
Scoutguard KG680V and bushnell cameras were deployed in habitat adjoining each underpass. One camera was installed on a tree on the east and west side of each underpass within 50m of the underpass entrance and orientated towards a bait station containing chicken and tuna oil (Plate 1). Four cameras (2/side) were installed at McGrath's Creek control site to detect fauna on both sides of the creek. Cameras were set to take a burst of three photos with a ten-second delay between activation. Cameras were installed at approximately 0.5m above ground and positioned 2.5m from a bait station. Cameras were deployed for four weeks during each sampling period (i.e. autumn and spring) and were operational during the period of underpass monitoring. For full details please see Appendix B, Table B1.

Plate 1: Adjacent habitat camera trap set up showing camera mounted on a tree directed at a bait station.

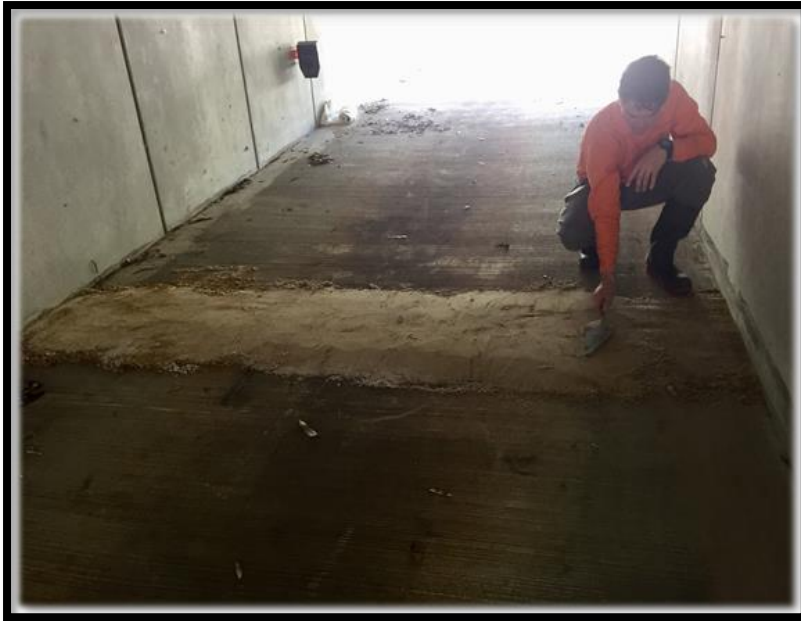
To complement camera monitoring, sand pads were installed in the center of each cell at each site. Sand pads were installed using a 1:1 mix of brickie’s sand and beach sand and smoothed out with a cement trowel at the start of monitoring and after each inspection (Plate 2). Pads were approximately 1m wide and 50mm deep. A small channel (200mm wide) was left in the center of pads in combined structures to allow for drainage. Sand pads were monitored for a minimum of four consecutive days during each monitoring period. The change in method from previous years (when pads were checked weekly) was to align sampling with the method used on the Warrell Creek to Nambucca Heads (WC2NH) project and reduce the loss of data from washouts.

Plate 2: Sand pad installation at Tyson's underpass.

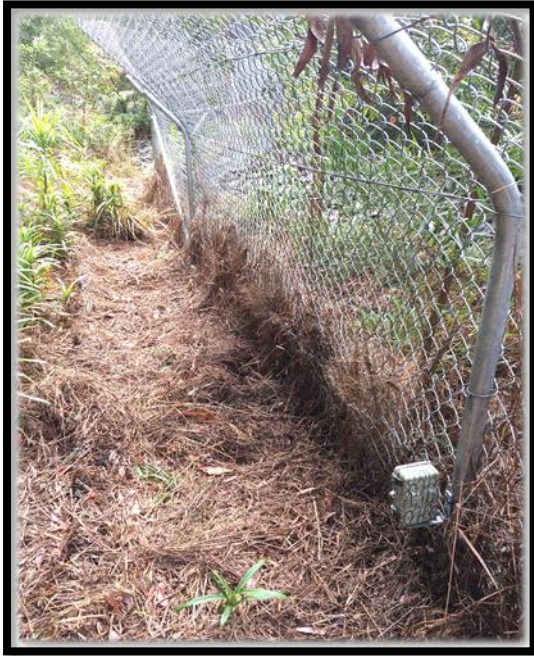
Fence cameras were installed at all sites except McGraths. The setup involved installation of a camera on each side of each culvert entrance (total of 28 cameras). Cameras were attached to a bracket fixed to a fence post at approximately 400mm above ground and orientated along the fence towards the underpass entrance (Plate

3). Distance from the culvert entrance ranged from 10m to 60m and depended on obtaining a reasonable line of sight. Ground vegetation was trimmed using pruning shears and a brushcutter at all sites in autumn to improve visibility and reduce the incidence of false triggers. A combination of scoutguard KG680V and swift 3c cameras were used at all sites. Cameras were scheduled to arm at 4pm and disarm at 9am. Cameras were set to take a series of three photos with a ten second delay between activation. See full details of exclusion fence monitoring in Appendix B, Table B9.

Plate 3: Typical exclusion fence camera set up. It shows a Scoutguard KG680V camera attached to a steel bracket fixed to a fence post.

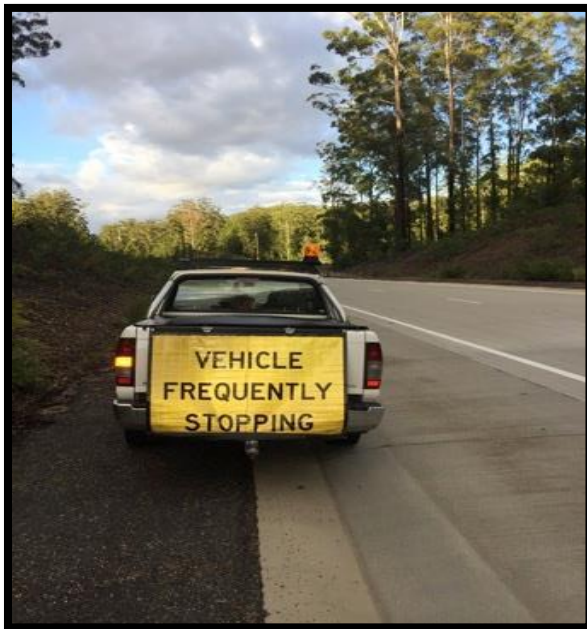
Plate 4: Work vehicle with signage, flashing amber light and indicators

Road-kill surveys were conducted by a team consisting of a driver and an ecologist passenger who had experience identifying road-killed fauna. The surveys were conducted from a moving vehicle driven at a speed of 80-90km/hr in the left lane. The vehicle was equipped with an amber light (flashing) and a warning sign (Plate 1) to alert other drivers.

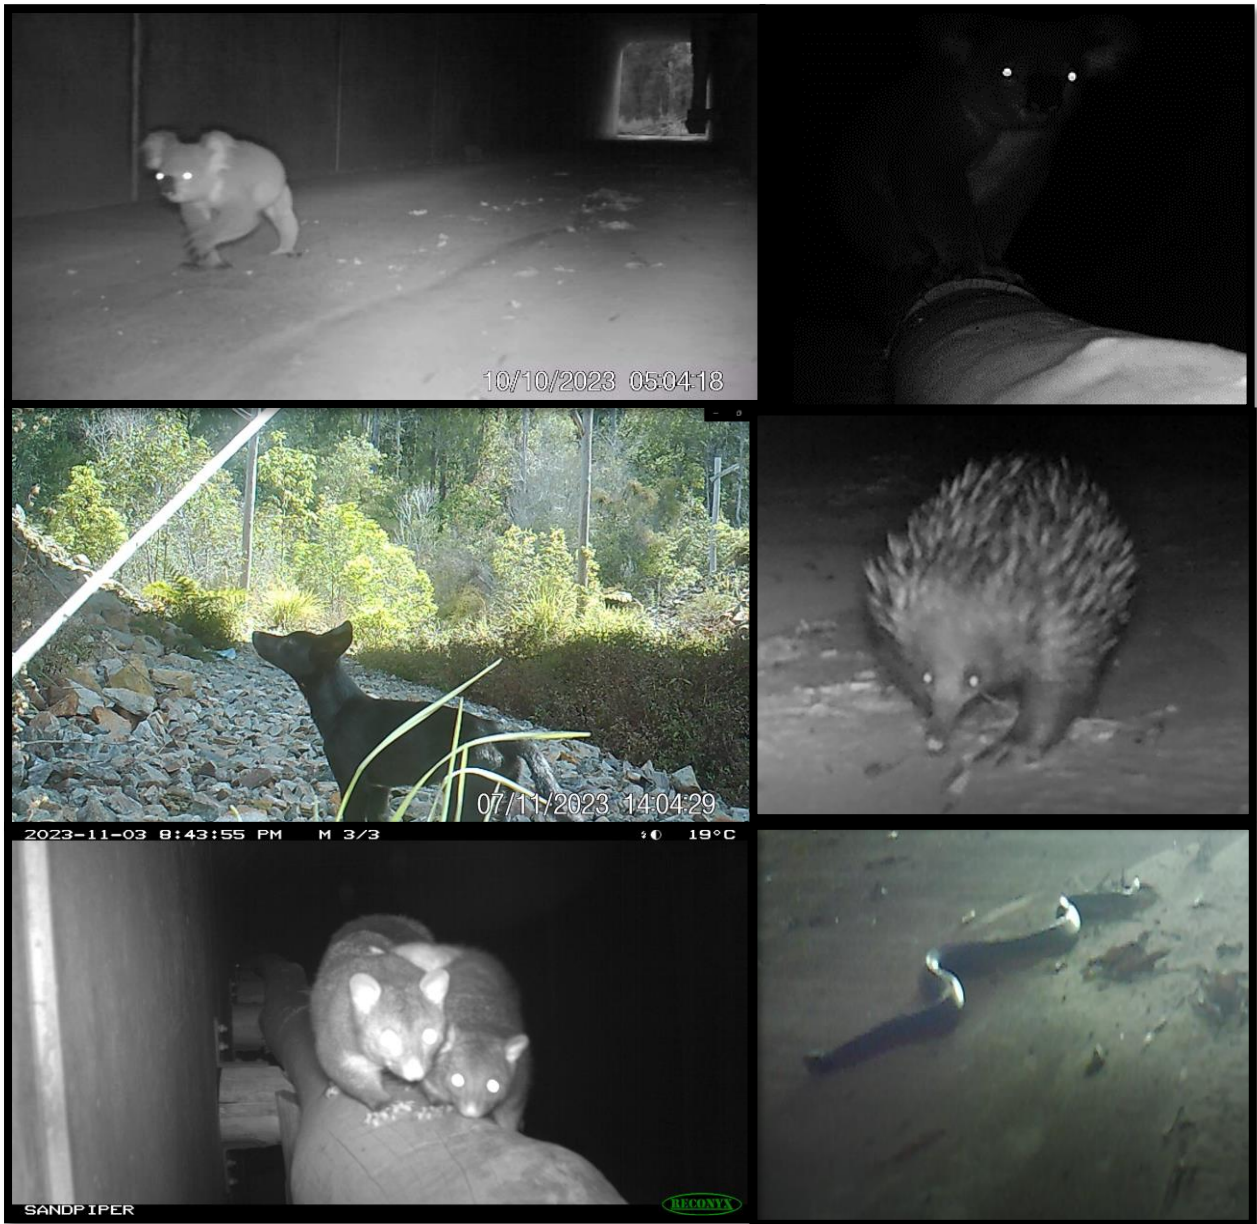
Plate 5: Images of fauna utilising underpasses during year seven monitoring. Koala crossing using the culvert floor at Access G (Top left). Koala using the fauna furniture at Tyson's (Top right). Dog crossing at Martell's Bridge (Middle Left). Short-beaked echidna using the culvert floor at Tyson's (Middle right). Two short-eared brushtail possums using the fauna furniture at Dalhousie (Bottom Left). Red-bellied black snake using the culvert floor at Burkes (Bottom Right).

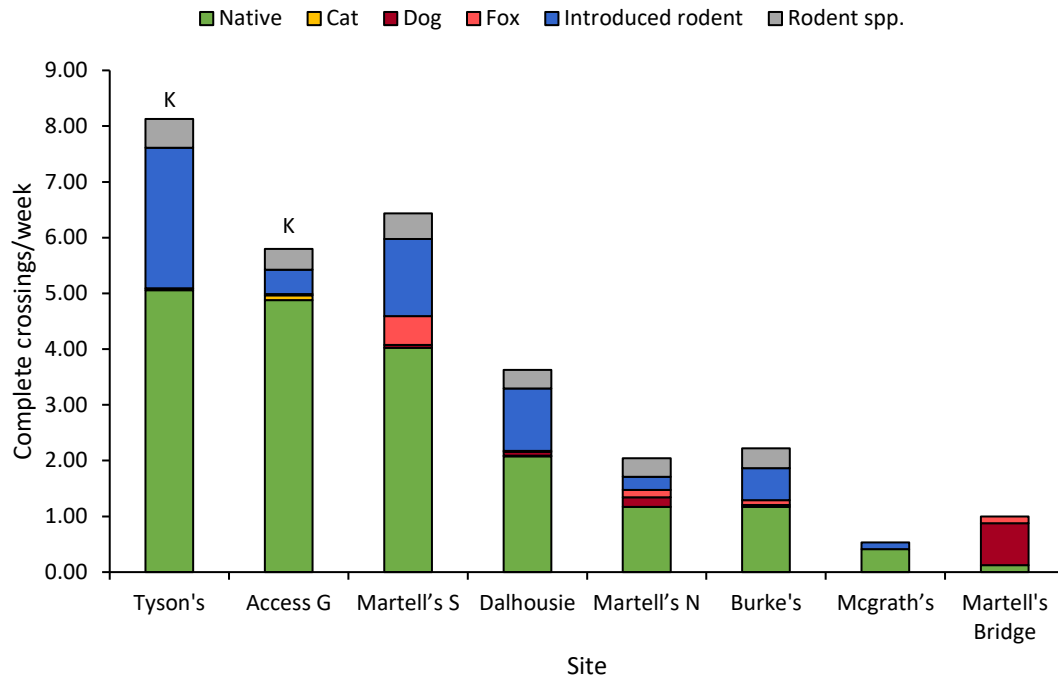
Complete crossings (CC) by native species were observed at all sites with the frequency of crossings differing among the underpass locations. Tyson's recorded the highest native fauna use with an average of 5.06 CC per week (Figure 2: Total complete crossings (cc)/week/site by native species, feral predators (cat, dog, red fox) introduced rodents (combined black rat and house mouse), and rodent spp. (unconfirmed whether native or introduced) at each site during year seven (combined autumn and spring) operational monitoring, NH2U, 2023. K = indicates complete crossing by koala. Figure 2). Access G and Martell's South also showed considerable activity with 4.88 and 4.03 CC per week, respectively (Figure 2). Martell's Bridge and McGrath's exhibited notably fewer crossings by native fauna, at 0.13 and 0.41 CC per week, respectively. Martell's Bridge was the only site where crossings by native species were not the most frequent, with feral predators,

Figure 2: Total complete crossings (cc)/week/site by native species, feral predators (cat, dog, red fox) introduced rodents (combined black rat and house mouse), and rodent spp. (unconfirmed whether native or introduced) at each site during year seven (combined autumn and spring) operational monitoring, NH2U, 2023. **K** = indicates complete crossing by koala.

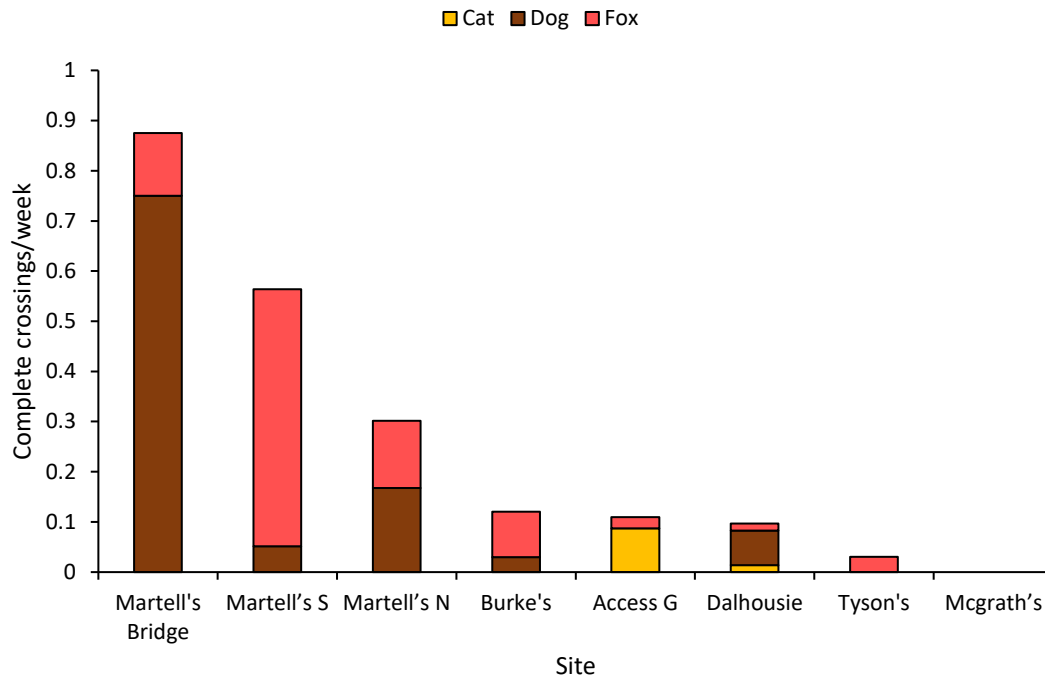
Feral predators were recorded at all impact sites with no detections at the McGraths creek reference site (Figure 3). The highest combined use across all sites was recorded for dog (1.07cc/week), followed by red fox (0.93cc/week) and cat (0.10cc/week) (Figure 3). Dog was recorded at five sites with the highest use at Martell's Bridge (0.75cc/week) and Martell's North (0.17cc/week) (Figure 3). Fox was recorded at all sites (except McGrath's) with the highest activity at Martell's South (0.51cc/week) and Martell's North (0.13cc/week) (Figure 3). Cat was recorded at two sites and exhibited relatively low use of underpasses ranging from 0.09cc/week at Access G and 0.01cc/week at Dalhousie (Figure 3).

Figure 3: Complete crossings (cc)/week/site by feral predators during operational monitoring of underpasses at NH2U, 2023.

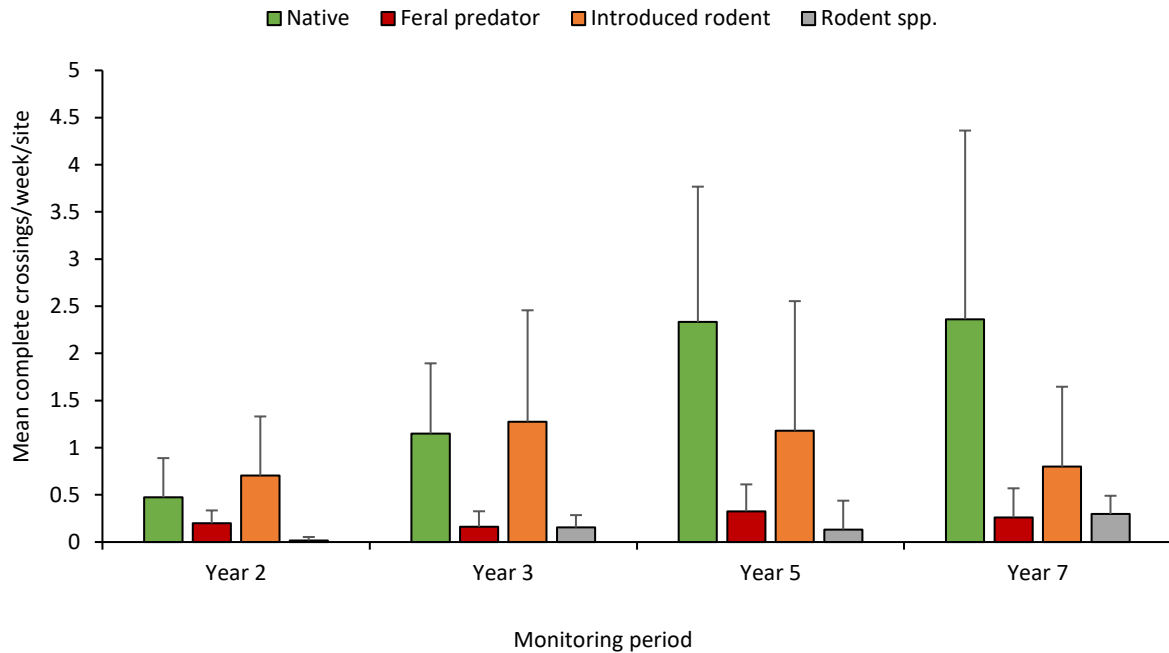
Underpass use by native fauna has progressively increased from years two to seven of operational monitoring (Figure 4). Initially the underpass usage rate of 0.47 ± 0.42 cc/week/site in year two increased to 1.14 ± 0.74 cc/week/site in year three. This upward trend persisted, reaching 2.33 ± 1.43 cc/week/site in the year five with a slight increase to 2.36 ± 1.99 cc/week/site in year seven. Overall, the trend suggests a rapid initial increase in the usage of underpasses during the earlier years (years two, three and five), followed by a stabilisation in the usage rate from years five to seven (Figure 4).

Figure 4: Mean (+SD) number of complete crossings (cc)/week/site by natives, feral predators (combined cat, dog, red fox), introduced rodents (black rat and house mouse) and other rodents (rodent spp. = unidentified rodents) during operational monitoring at NH2U, 2023. Year two = 2018, Year three = 2019, Year five = 2021 and Year seven = 2023.

Underpass usage by rodents has been variable during operational monitoring (Figure 4). Usage by introduced rodents showed an initial increase from 0.70 ± 0.63 cc/week/site in year two to a peak of 1.28 ± 1.18 cc/week/site in year three, before experiencing a decline to 1.18 ± 1.37 cc/week/site in year five and further to 0.80 ± 0.85 cc/week/site by Year seven (Figure 4). In contrast, rodent spp. usage remained relatively low initially at 0.02 ± 0.04 cc/week/site in year two, then increased to 0.15 ± 0.13 cc/week/site in year three, slightly decreased in year five, and increased to 0.30 ± 0.19 cc/week/site in year seven (Figure 4).

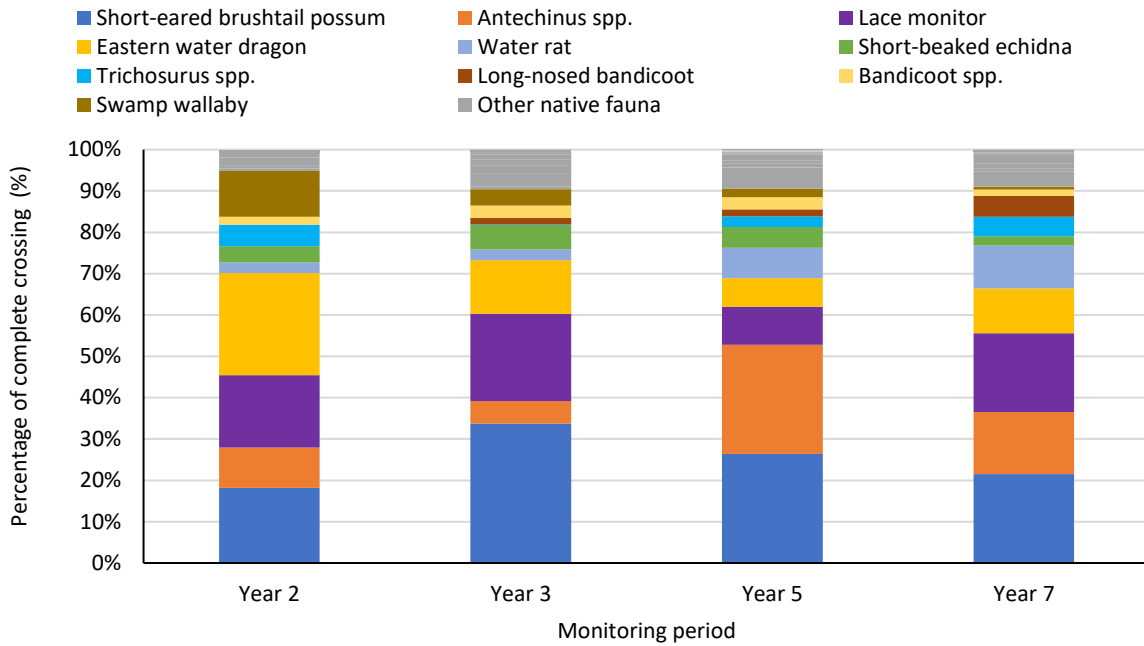
Ten native fauna species/groups constituted >90% of the recorded complete crossings for native fauna during each year of operational monitoring (Figure 5). In order of use, this included the short-eared brushtail possum, antechinus spp., lace monitor, eastern water dragon, water rat, short-beaked echidna, *Trichosurus* spp. (either short-eared or common brushtail possum), long-nosed bandicoot, bandicoot spp. (either long-nosed bandicoot or northern brown bandicoot), and swamp wallaby (Figure 5). Short-eared brushtail possum usage remained relatively high throughout the monitoring period, peaking at 33.71% in year three. Water rat and *Antechinus* spp. tended to increase over time, with *Antechinus* spp. peaking at 26.40% in year five. In contrast, the swamp wallaby and eastern water dragon exhibited a general decline in their use of the underpasses over time (Figure 5). Lace monitor, long-nosed bandicoot, bandicoot spp., short-beaked echidna, and *Trichosurus* spp. showed some variability in their usage patterns but remained relatively constant overall (Figure 5).

Figure 5: Percentage of complete crossings for the ten most frequently recorded native species or groups during operational monitoring at NH2U. Data represent the proportion of total crossings completed by each species. Year two = 2018, Year three = 2019, Year five = 2021, Year seven = 2023.

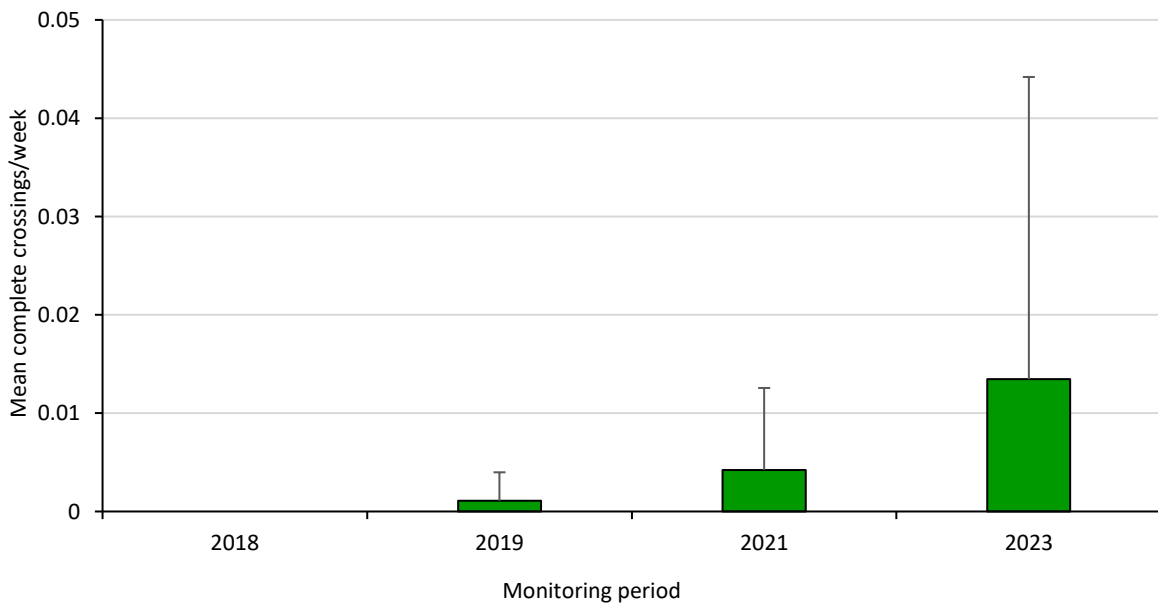
Two threatened species have been recorded using underpasses at NH2U including spotted tailed quoll and koala. Spotted tailed quoll was recorded using the furniture to make a complete crossing at Martell's south once in year three (Sandpiper, 2020a). There has been a gradual temporal increase in koala usage of the underpasses (Figure 6). No koalas were observed in the second year of operational phase monitoring, with an initial rate of 0.001 ± 0.002 cc/week/site recorded in year three (Figure 6). This rate increased to 0.004 ± 0.008 cc/week/site in year five and further to 0.013 ± 0.03 cc/week/site in year seven with records of complete crossings at Access G and Tyson's (Table 3). Previous operational monitoring records include two complete koala crossings at the Dalhousie and Martell's North underpasses in spring year five. Koala crossings have now been confirmed at four of the seven impact sites (Tyson's, Dalhousie, North Martell's and Access G), with confirmed crossings at Tyson's in years three, five, and seven.

Figure 6: Mean (+SD) number of complete crossings (cc)/week/site by koala during operational monitoring at NH2U. Year two = 2018, Year three = 2019, Year five = 2021 and Year seven = 2023. No crossings were recorded in 2018.

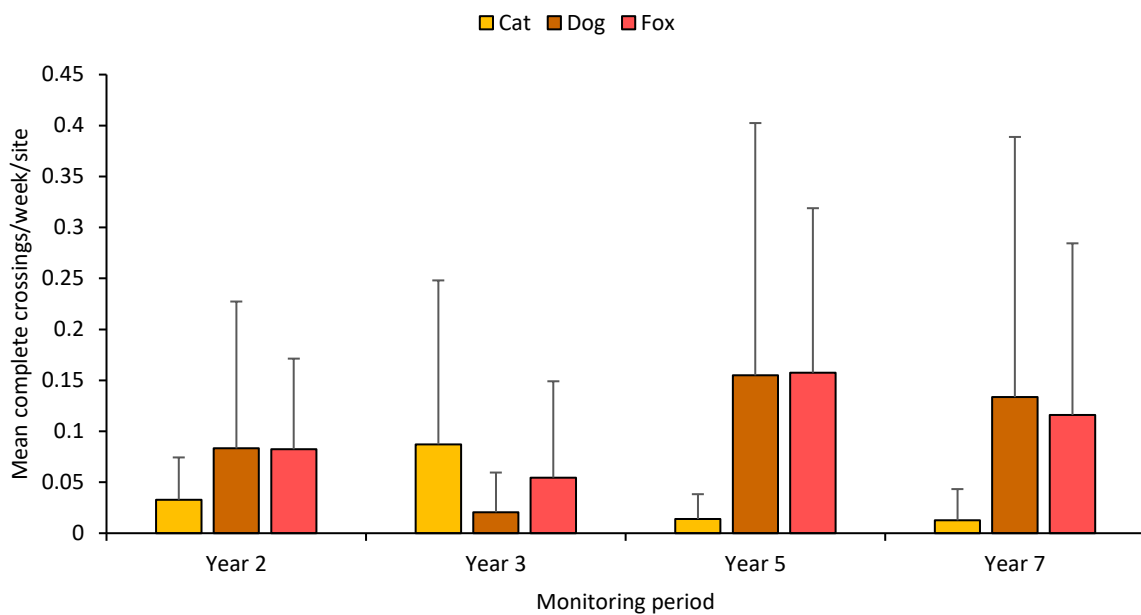
Underpass use by feral predators varied between monitoring years and between species (cat, dog, red fox). In Year two, the general feral predator usage was relatively low at 0.20 ± 0.14 cc/week/site (Figure 7). Usage decreased slightly in Year three to 0.16 ± 0.16 cc/week/s with a notable decrease in dog usage from 0.08 ± 0.14 cc/week/site to 0.02 ± 0.04 cc/week/site, alongside an increase in cat usage to 0.09 ± 0.16 cc/week/site (Figure 7). Feral predator use increased in Year five to 0.33 ± 0.28 cc/week/site which was largely influenced by an increase in dog and fox usage to 0.16 ± 0.25 cc/week/site and 0.16 ± 0.16 cc/week/site, respectively, while cat usage declined to 0.01 ± 0.02 cc/week/site (Figure 4 and Figure 7). Overall feral predator usage declined by 21% from year five to Year seven when the combined rate was 0.26 ± 0.31 cc/week/site. This decline was due to a minor reduction in dog and fox usage, while cat usage remained low.

Figure 7: Mean (+SD) number of complete crossings (cc)/week/site by cat dog and red fox during operational monitoring at NH2U, 2023. Year two = 2018, Year three = 2019, Year five = 2021 and Year seven = 2023

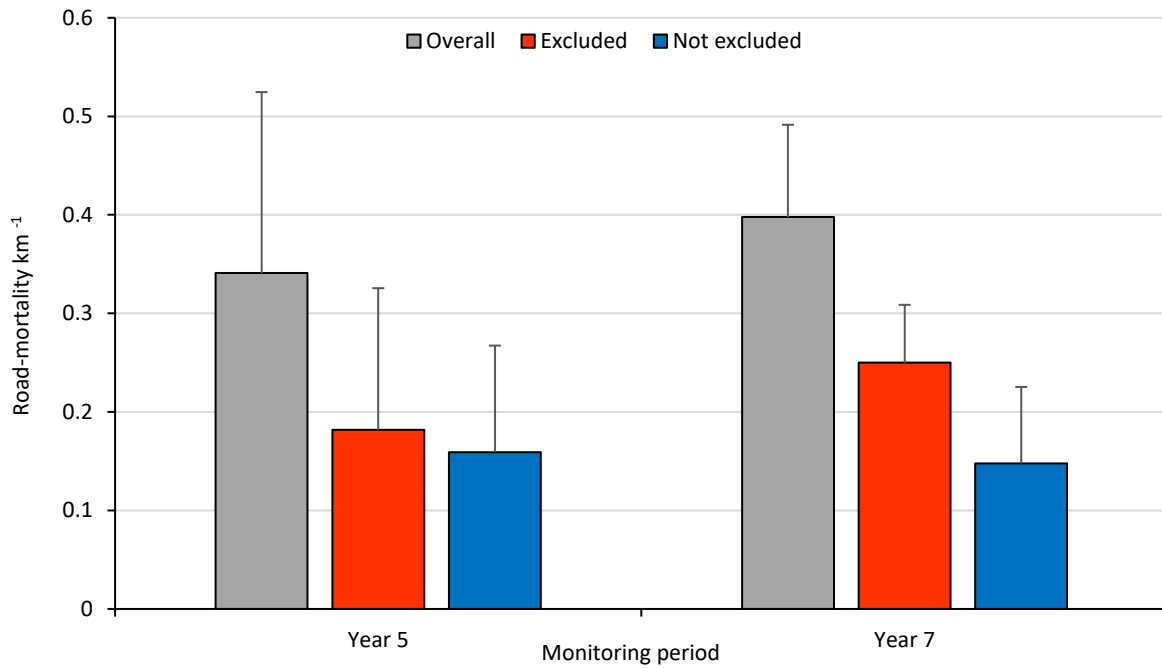
The road-kill rate increase marginally from 0.34 ± 0.18 in year five to 0.40 ± 0.09 individuals/km in year seven (Figure 8). Road-kill rates for fauna not impeded by exclusion fences (i.e., birds, rodents, small reptiles) remained relatively consistent, with a slight decrease from 0.16 ± 0.11 individuals/km in year five to $0.15 \pm$

0.08 individuals/km in year seven. In contrast, road-kill rates for fauna typically impeded by exclusion fences increased from 0.18 ± 0.14 individuals/km to 0.25 ± 0.06 individuals/km during the same period.

Figure 8: Annual comparison of mean fauna road-mortalities per km (+SD) during years 5 and 7 of operational monitoring at NH2U, n=4 for each year. Data from years 2 and 3 are excluded due to the method change from pedestrian to vehicle-based surveys starting in year five.
