Threatened Species Management

Monitoring of Threatened Flora

Pacific Highway Upgrade: Woolgoolga to Ballina

Sections 1 & 2 – July 2016

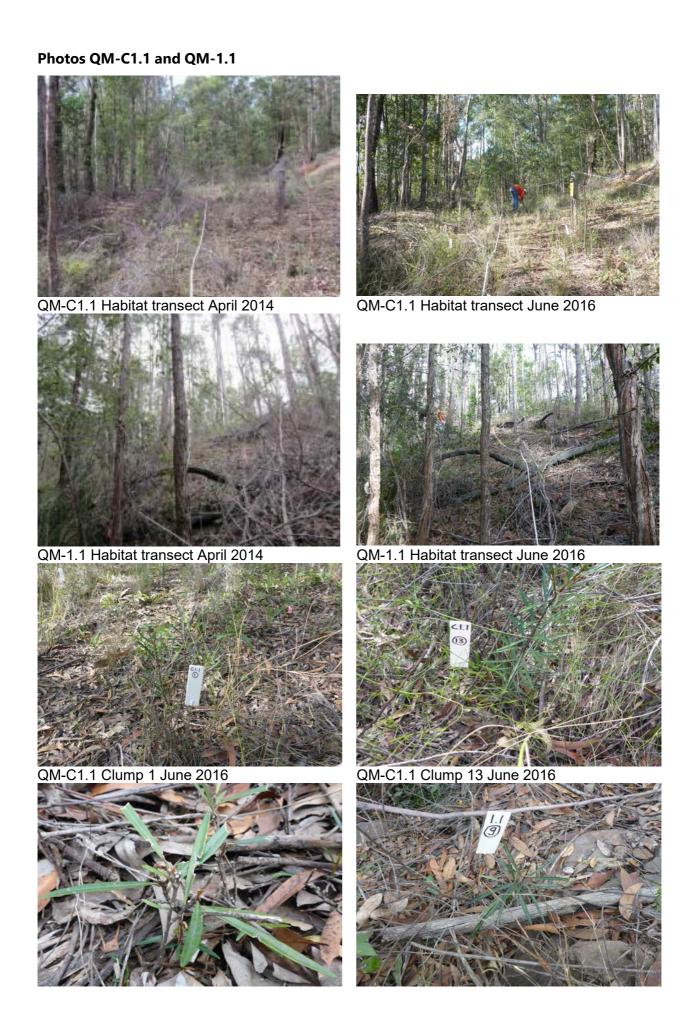
Site data detail QM-C1.1 and QM-1.1

exotic	0	0	0	0
Weed Species	None	None	None	None
Weed abundance	None	None	None	None
Recruitment (canopy/mid)	Yes	Yes	Yes	Yes
Disturbance	Graded trail and clearing for fence construction, plants have regenerated on trail	Graded trail and clearing for fence construction, plants have regenerated on trail	Trail construction upslope	Not obvious
Comments	Dieback natural habit of species	Dieback exacerbated by dry season preceding?	Some plants resprouting after being smothered with leaf litter	Dieback exacerbated by dry season preceding?
Comments 2		Boundary location, review options for future tenure of adjacent parcel.		
Abundance summary	19 stems	35 stems in 15 clumps	54 stems	174 stems in 21 clumps
