GMC ENVIRONMENTAL CONSULTING

HW10 Pacific Highway Upgrade, Woolgoolga to Ballina – Koala Revegetation, Section 10

2018/19 Annual Inspection Report

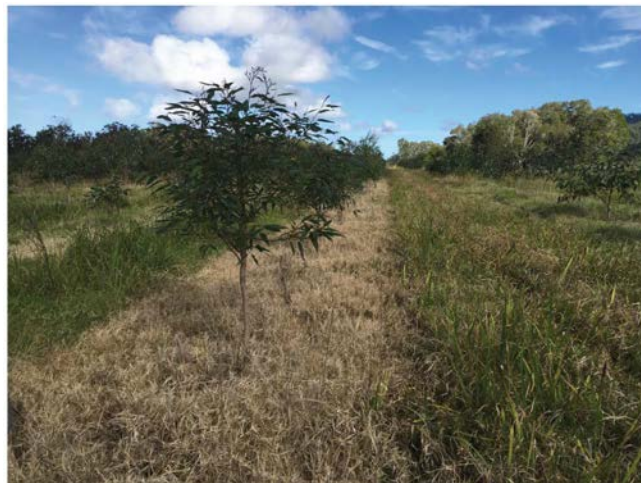
Figure 10. Weed Control

Tree heights are now also reducing the impact of weeds. Most tree heights across all planting zones are now above weed height and thus not competing as much for sunlight. Greater tree heights is also making weed control herbicide spraying more effective and easier to undertake.

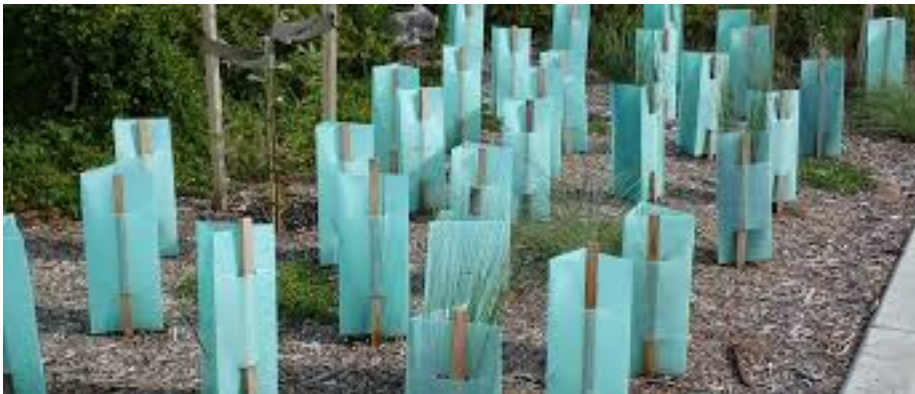
Figure 11. Core flute guards

The 2018, an additional planting was undertaken along Wardell Road (Figure 6) which is an area that was identified as a high wallaby grazing risk area. Rather than fencing this site, 900mm core flute guards were utilised to protect trees from wallaby grazing.

The guards have been effective in grazing control and in June 2019 these guards started to be removed as tree heights have started to exceed the guard height. Continued guard removal will proceed through 2019.

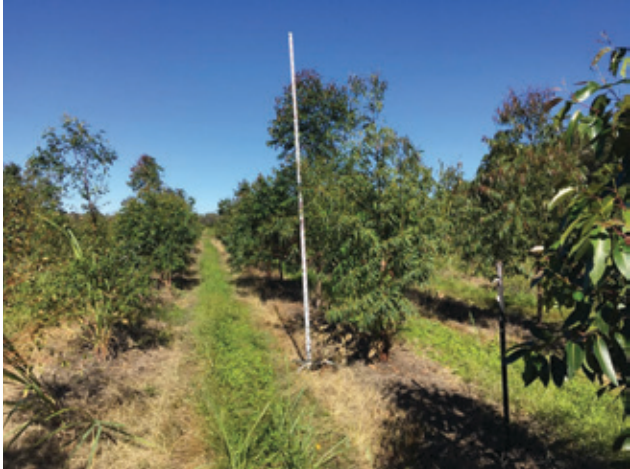
| Site 1 | | | | | | | | | |
|---|---|---|---|---|---|--|---|---|---|
| Planting Area: | 19.1 | GPS Location: | -28.55.651S/153.27.265E | Quadrant Area: | 4hec | Planting Date: | 23/3/17 | Date: | 27 June 2019 |

| Site 1 | | | | | | | | | |
|---|---|---|---|---|---|--|---|---|---|
| Density of Trees: | 1/16m2 | Average Tree Height: | 2 - 4m | No. of Visible Dead Stems: | 3 | | | | |
| Environmental Weeds: | Weed/grasses well under control. Remaining issue is volunteer sugar cane. Weed control via 3 monthly Glufosinate Ammonium row spraying and row slashing | | | | | | | | |
| Acacia Survival: | Very few acacias evident | | | | | | | | |

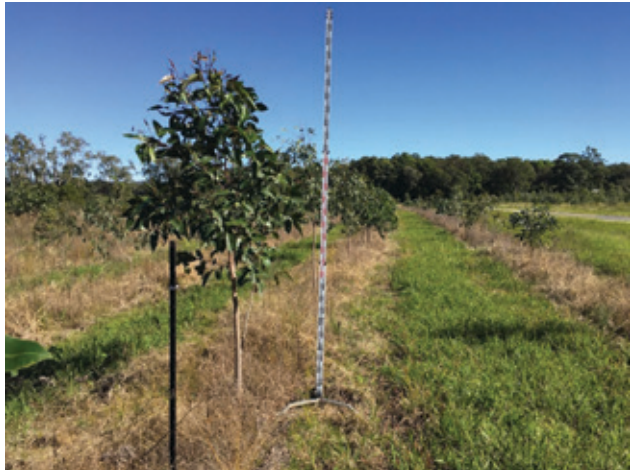
| Site 1 | | | | | | | | | |
|---|---|---|---|---|---|--|---|---|---|
| Planting Area: | 19.2 | GPS Location: | -28.55.910S/153.27.359E | Quadrant Area: | 2 hec | Planting Date: | 24/3/17 | Date: | 27 June 2019 |

| Site 1 | | | | | | | | | |
|---|---|---|---|---|---|--|---|---|---|
| Density of Trees: | 1/16m2 | Average Tree Height: | 1.5 - 3m | No. of Visible Dead Stems: | 1 | | | | |
| Environmental Weeds: | Verbena and Ageratum still present but generally well controlled with continual weed spraying with Glufosinate Ammonium. Row slashing also continually undertaken. | | | | | | | | |
| Acacia Survival: | Very few acacias evident | | | | | | | | |

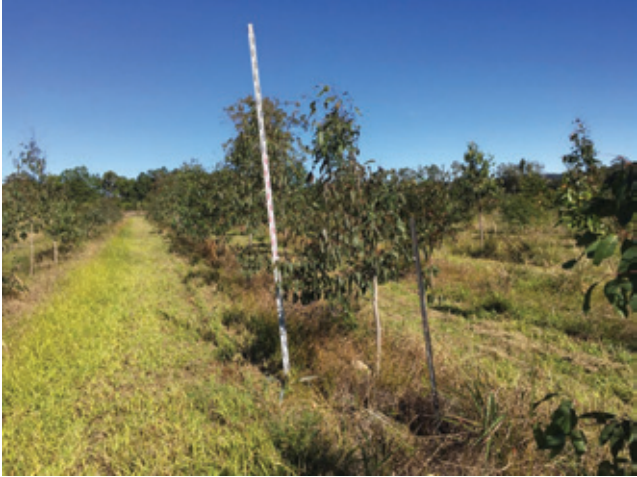
| Site 3 | | | | | | | | | |
|---|---|---|---|---|---|--|---|---|---|
| Planting Area: | 19.3 | GPS Location: | -28.55.873S/153.27.418E | Quadrant Area: | 0.3hec | Planting Date: | 24/3/17 | Date: | 27 June 2019 |

| Site 3 | | | | | | | | | |
|---|---|---|---|---|---|--|---|---|---|
| Density of Trees: | 1/16m2 | Average Tree Height: | 2 - 3m | No. of Visible Dead Stems: | 0 | | | | |
| Environmental Weeds: | Generally very good weed control now being achieved with only some Verbena observed. Three monthly Glufosinate Ammonium spraying and row slashing being utilised for weed control. | | | | | | | | |
| Acacia Survival: | Very few acacias evident | | | | | | | | |

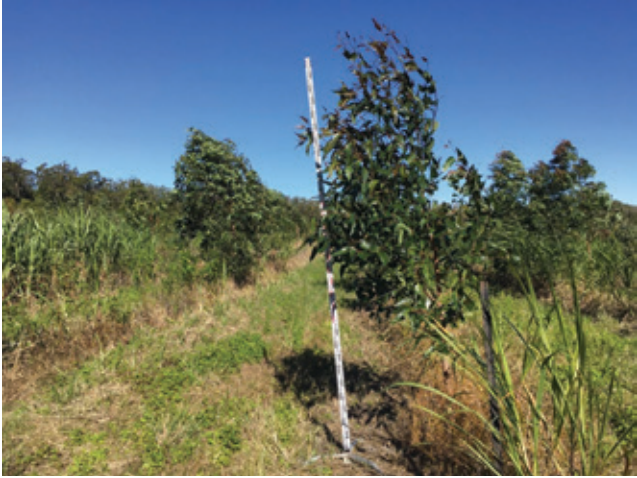
| Site 3 | | | | | | | | | |
|---|---|---|---|---|---|--|---|---|---|
| Planting Area: | 19.5 | GPS Location: | | Quadrant Area: | 4.5 hec | Planting Date: | 17/3/17 | Date: | 27 June 2019 |

| Site 3 | | | | | | | | | |
|---|---|---|---|---|---|--|---|---|---|
| Density of Trees: | 1/16m2 | Average Tree Height: | 2 - 4m | No. of Visible Dead Stems: | 1 | | | | |
| Environmental Weeds: | Volunteer cane and Cotton Weed are the main weed issues but these are generally being controlled with regular Glufosinate Ammonium spraying. | | | | | | | | |
| Acacia Survival: | Very few acacias evident | | | | | | | | |
| Comments: | This area was affected by a summer dry period and required supplementary watering. This watering kept the trees alive with nil losses. Tree growth and survival in this PA is very good. Wallaby fence was removed this year. Nil replacements required. | | | | | | | | |

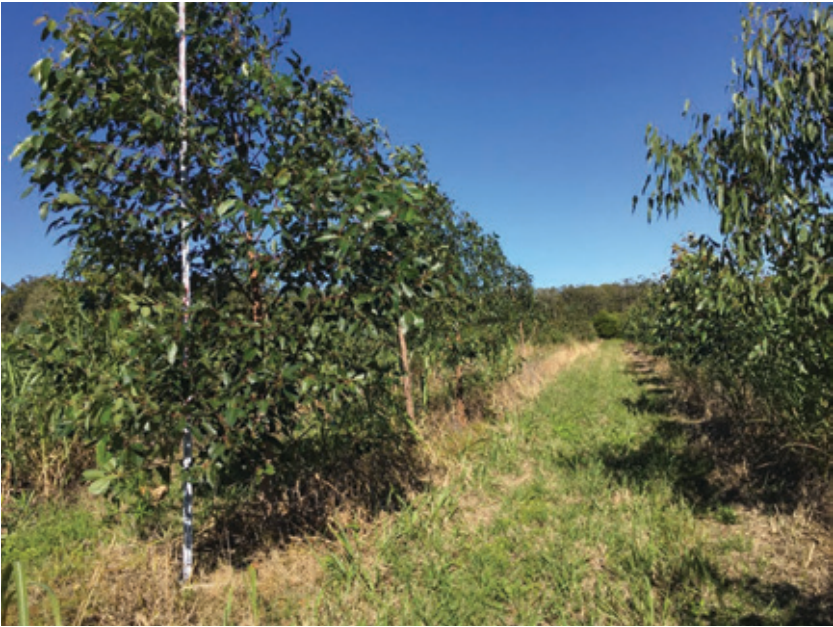
PA19.5 tree growth

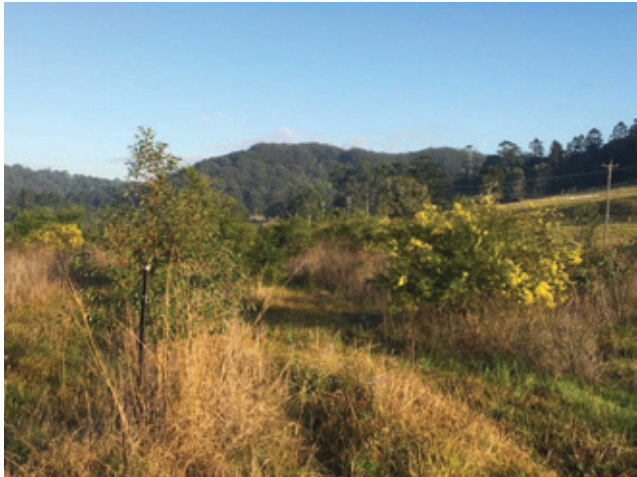
| Site 9 | | | | | | | | | |
|---|---|---|---|---|---|--|---|---|---|
| Planting Area: | 11.8 | GPS Location: | 28.55.40S/153.26.47E | Quadrant Area: | 1 hec | Planting Date: | 4/4/17 | Date: | 29 June 2019 |

| Site 9 | | | | | | | | | |
|---|---|---|---|---|---|--|---|---|---|
| Density of Trees: | 1/m2 | Average Tree Height: | 2.5m | No. of Visible Dead Stems: | 0 | | | | |
| Environmental Weeds: | Setaria Grass under trees but continuous spraying and slashing keeping it under control. Wallaby fence still in place. | | | | | | | | |
| Acacia Survival: | Excellent survival in higher areas but poorer growth in lower inundated zones | | | | | | | | |

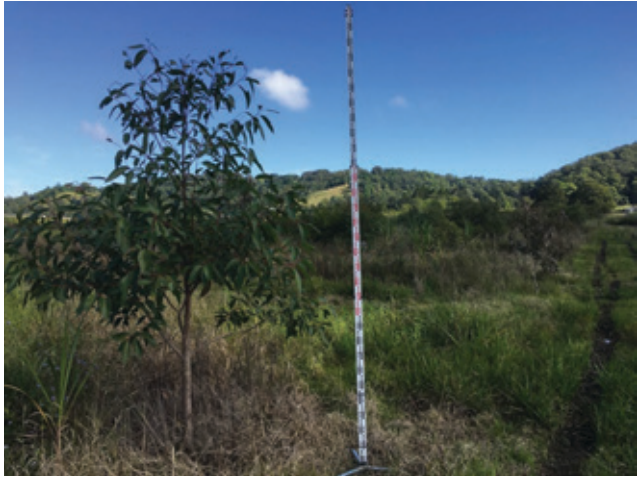
| Site 9 | | | | | | | | | |
|---|---|---|---|---|---|--|---|---|---|
| Planting Area: | 11.7 | GPS Location: | 28.55.41S/153.26.47E | Quadrant Area: | 1.1 hec | Planting Date: | 10/4/17 | Date: | 29 June 2019 |

| Site 9 | | | | | | | | | |
|---|---|---|---|---|---|--|---|---|---|
| Density of Trees: | 1/4m2 | Average Tree Height: | 2.5m | No. of Visible Dead Stems: | 0 | | | | |
| Environmental Weeds: | Setaria Grass under trees but continuous spraying and slashing keeping it under control. Wallaby fence still in place. | | | | | | | | |
| Acacia Survival: | Very good survival and growth at higher areas out of inundation | | | | | | | | |
| Comments: | <p>Very wet soils with poor drainage compared with PA11.8. Trees well established but a lot slower growth than those areas with better drainage.</p> <p>Weed control generally effective but with the wetter soils more spaying is required than other sites.</p> | | | | | | | | |

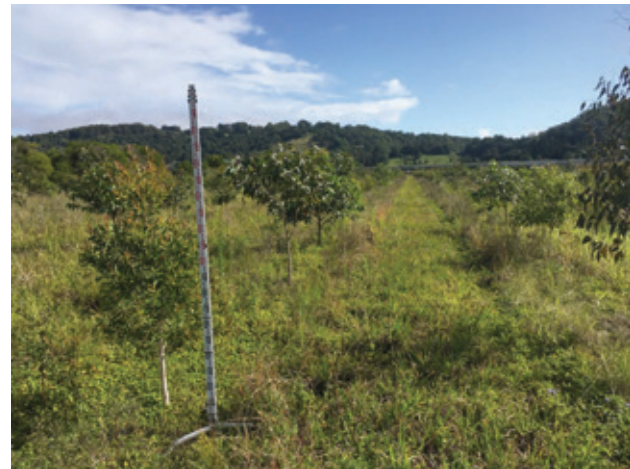
| Site 11 | | | | | | | | | |
|---|---|---|---|---|---|--|---|---|---|
| Planting Area: | 14.2 | GPS Location: | 28.55.47S/153.26.46E | Quadrant Area: | 1.4 hec | Planting Date: | 6/4/17 | Date: | 29 June 2019 |

| Site 11 | | | | | | | | | |
|---|---|---|---|---|---|--|---|---|---|
| Density of Trees: | 1/16/m2 | Average Tree Height: | 1.9m | No. of Visible Dead Stems: | 0 | | | | |
| Environmental Weeds: | Continuous weed control effectively suppressing weeds Wallaby fence has been removed. | | | | | | | | |
| Acacia Survival: | Good acacia survival in elevated areas but poor survival in lower wet areas | | | | | | | | |

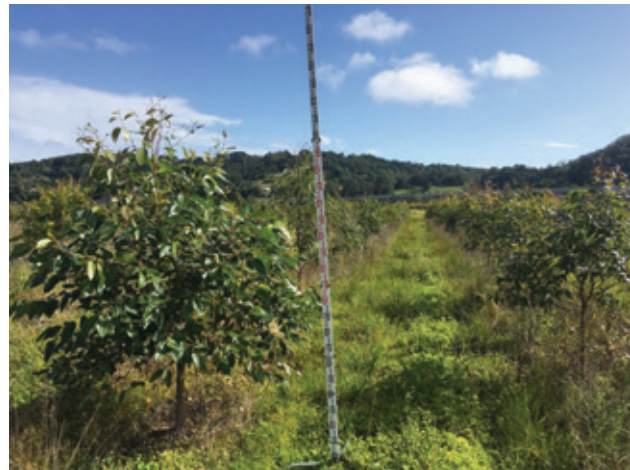
| Site 11 | | | | | | | | | |
|---|---|---|---|---|---|--|---|---|---|
| Planting Area: | 14.1 | GPS Location: | 28.55.50S/153.26.46E | Quadrant Area: | 2 hec | Planting Date: | 6/4/17 | Date: | 29 June 2019 |

| Site 11 | | | | | | | | | |
|---|---|---|---|---|---|--|---|---|---|
| Density of Trees: | 1/16/m2 | Average Tree Height: | 2m | No. of Visible Dead Stems: | 0 | | | | |
| Environmental Weeds: | Continuous weed control effectively suppressing weeds Wallaby fence has been removed. | | | | | | | | |
| Acacia Survival: | Very poor survival as planting area in lower ground and constantly inundated | | | | | | | | |

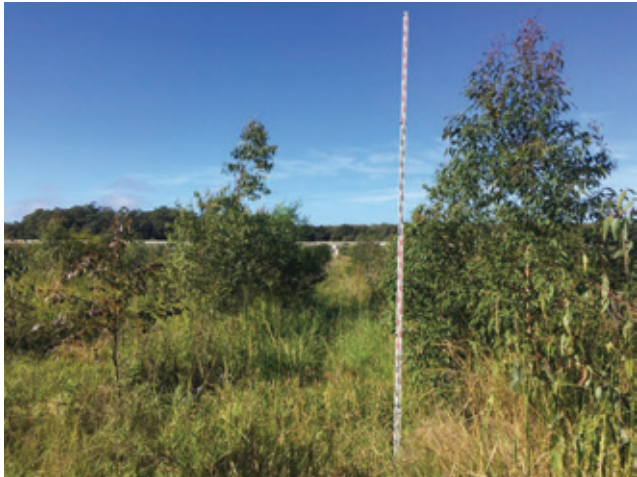
| Site 21 | | | | | | | | | |
|---|---|---|---|---|---|--|---|---|---|
| Planting Area: | 10.5 - 11.5 | GPS Location: | 28.55.47S/153.26.35E | Quadrant Area: | 0.5 hec | Planting Date: | 5/4/17 | Date: | 29 June 2019 |

| Site 21 | | | | | | | | | |
|---|---|---|---|---|---|--|---|---|---|
| Density of Trees: | 1/16/m2 | Average Tree Height: | 2.8m | No. of Visible Dead Stems: | 1 | | | | |
| Environmental Weeds: | Pasture grasses. Generally really good control through spraying and slashing but trees are generally all above grass heights | | | | | | | | |
| Acacia Survival: | Good acacia survival and growth as planting is on a slope | | | | | | | | |

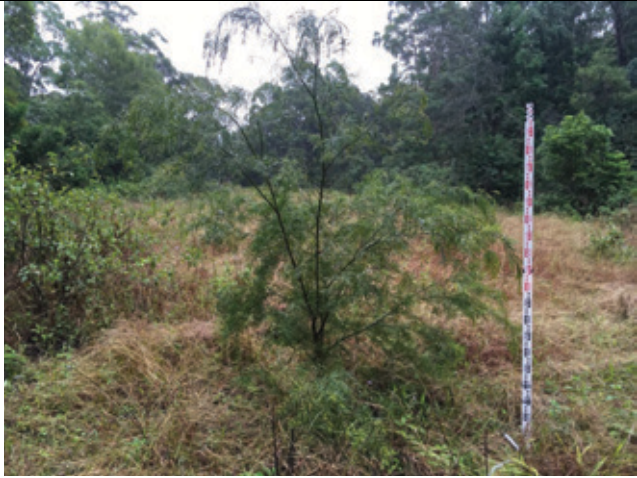
| Site 21 | | | | | | | | | |
|---|---|---|---|---|---|--|---|---|---|
| Site 22 | | | | | | | | | |

| Site 21 | | | | | | | | | |
|---|---|---|---|---|---|--|---|---|---|
| Density of Trees: | 1/16/m2 | Average Tree Height: | 1.5m | No. of Visible Dead Stems: | 0 | | | | |
| Environmental Weeds: | Pasture grass | | | | | | | | |
| Acacia Survival: | Average acacia growth and survival which matches eucalyptus species | | | | | | | | |
| Comments: | Very tough environment on this site as it used to be an old quarry site. Very little top soil and generally a rocky base. As such tree establishment and growth have been slow. This area could receive another round of replacement plantings to boost tree numbers. | | | | | | | | |

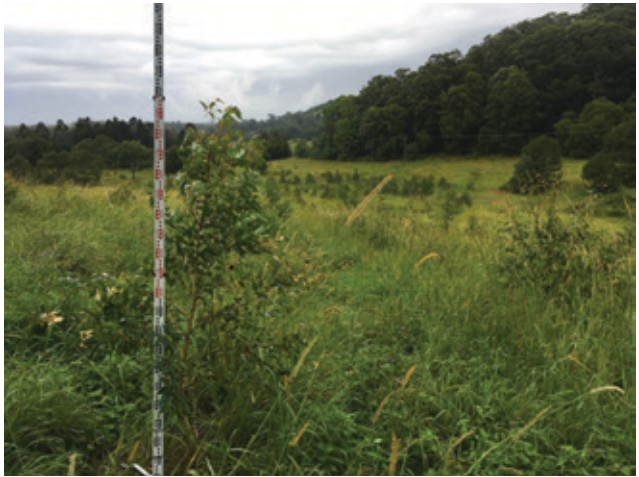
| Site 23 | | | | | | | | | |

| Site 23 | | | | | | | | | |
|---|---|---|---|---|---|--|---|---|---|
| Density of Trees: | 1/16/m2 | Average Tree Height: | 2m | No. of Visible Dead Stems: | 0 | | | | |
| Environmental Weeds: | Setaria Grass | | | | | | | | |
| Acacia Survival: | Nil survival | | | | | | | | |
| Comments: | Good growth and establishment at the base of the slope but slower growth on the rocky slopes. Setaria Grass continues to affect tree growth even with continuous spraying. Some replacement planting could be undertaken in this section to increase tree densities.. | | | | | | | | |

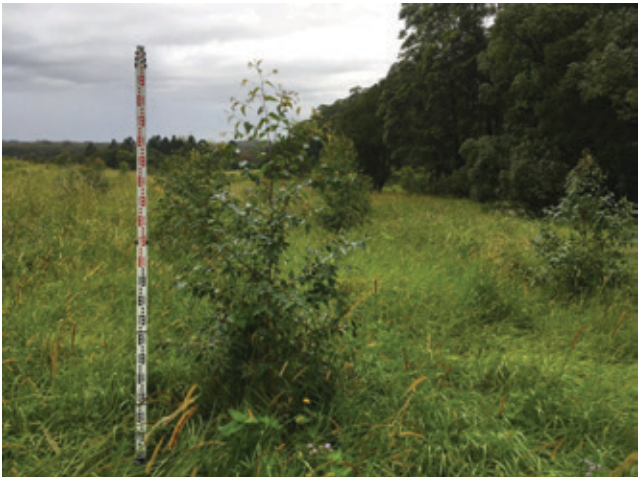
| Site 23 | | | | | | | | | |
|---|---|---|---|---|---|--|---|---|---|
| Site 24 | | | | | | | | | |

| Site 23 | | | | | | | | | |
|---|---|---|---|---|---|--|---|---|---|
| Density of Trees: | 1/16/m2 | Average Tree Height: | 2m | No. of Visible Dead Stems: | 0 | | | | |
| Environmental Weeds: | Setaria Grass | | | | | | | | |
| Acacia Survival: | Nil | | | | | | | | |
| Comments: | Some growth and establishment. Setaria Grass continues to affect tree growth even with continuous spraying. Some replacement planting could be undertaken in this section to increase tree densities. | | | | | | | | |

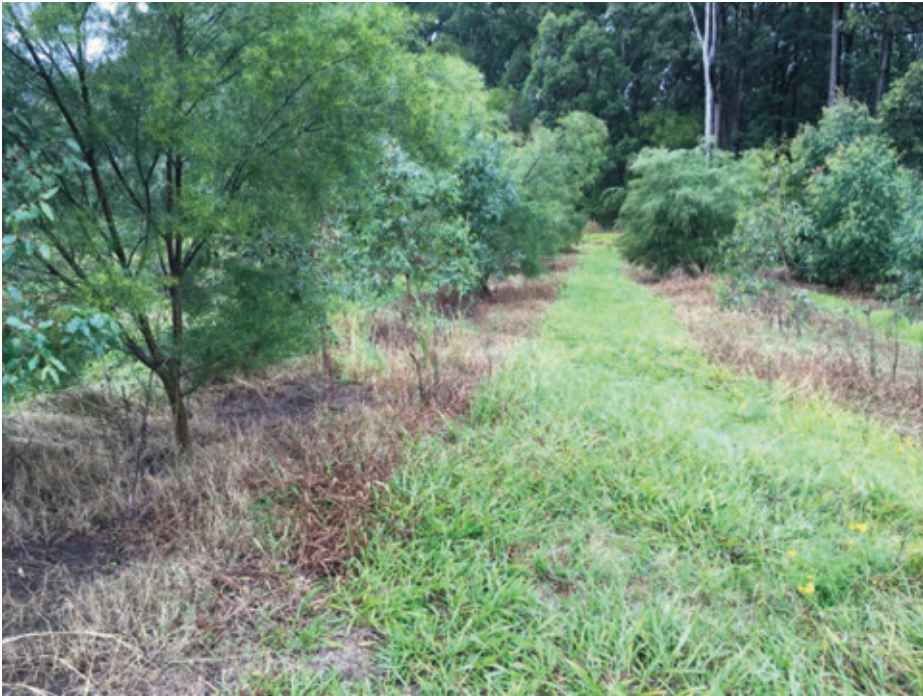
Weed control PA9's

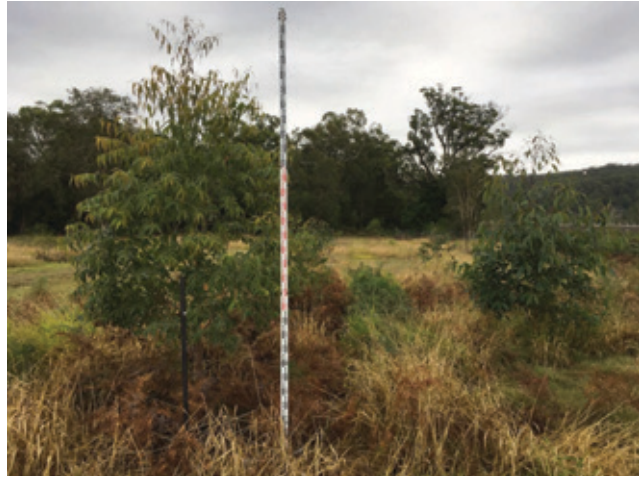
| Site 34 | | | | | | | | | |

| Site 34 | | | | | | | | | |
|---|--|---|---|---|---|--|---|---|---|
| Density of Trees: | 1/16/m2 | Average Tree Height: | 2-2.5m | No. of Visible Dead Stems: | 0 | | | | |
| Environmental Weeds: | Pasture grasses - under control Wallaby fence still in place. | | | | | | | | |
| Acacia Survival: | Only a few observed | | | | | | | | |
| Comments: | PA is located on sandy soils. As such, with these poor nutrient and moisture holding capabilities, tree growth is very slow compared to the rest of the project. Weed control working well. Dry/hot period in Dec/Jan did result in some losses. Replacement planting recommended to increase density of planting area. | | | | | | | | |

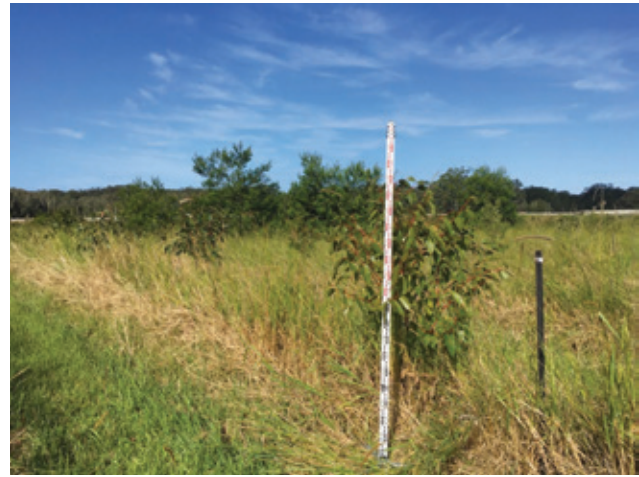
| Site 34 | | | | | | | | | |
|---|--|---|---|---|---|--|---|---|---|
| Site 35 | | | | | | | | | |

| Site 34 | | | | | | | | | |
|---|--|---|---|---|---|--|---|---|---|
| Density of Trees: | 1/16/m2 | Average Tree Height: | 2m | No. of Visible Dead Stems: | 1 | | | | |
| Environmental Weeds: | Pasture grasses - battling to keep under control increased continual spraying and slashing required. Wallaby fence not removed | | | | | | | | |
| Acacia Survival: | Good acacia survival | | | | | | | | |
| Comments: | Very wet soils at the bottom of the slope. That and continued battle with controlling grasses is causing a slower growth rate in comparison to other areas surrounding this site. While growth is slower there is good tree establishment. The acacias in the area are growing very well and are around 4m tall. No replacement planting required. | | | | | | | | |

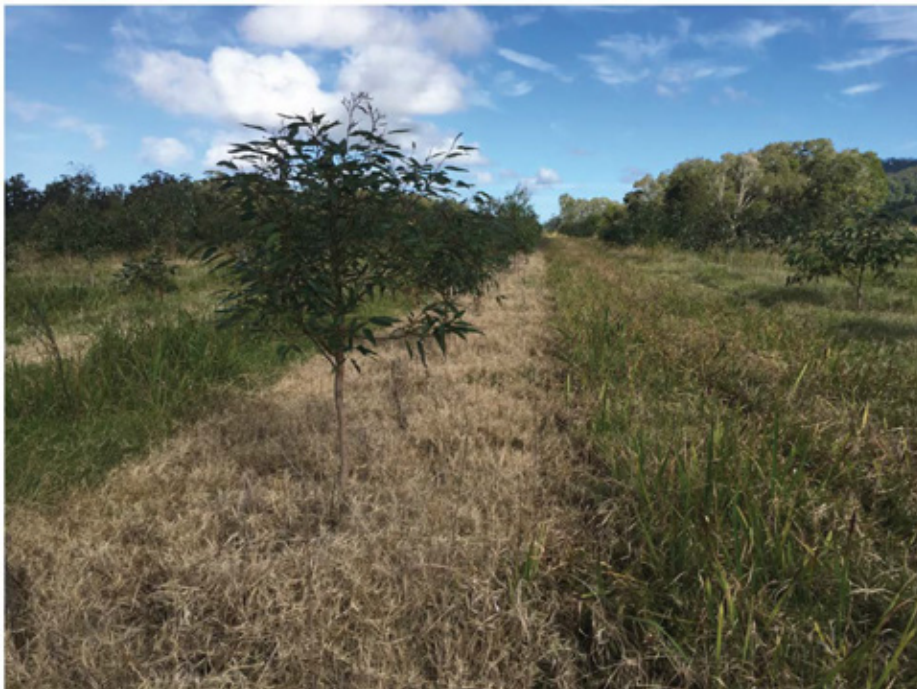
PA6.1 Weed control

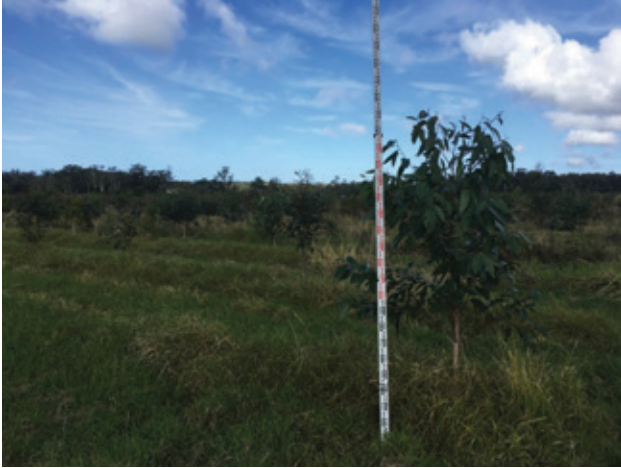
| Site 40 | | | | | | | | | |

| Site 40 | | | | | | | | | |
|---|---|---|---|---|---|--|---|---|---|
| Density of Trees: | 1/16/m2 | Average Tree Height: | 3m | No. of Visible Dead Stems: | 5 | | | | |
| Environmental Weeds: | Pasture grasses - continual spraying and slashing keeping grass and weeds under control. Wallaby fence removed. | | | | | | | | |
| Acacia Survival: | Very good | | | | | | | | |

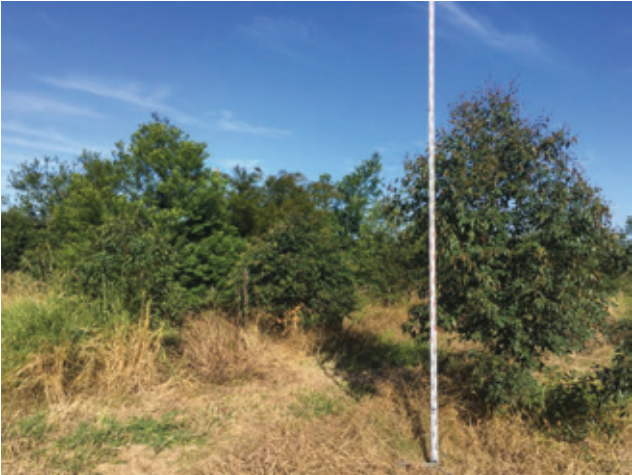
| Site 40 | | | | | | | | | |
|---|---|---|---|---|---|--|---|---|---|
| Site 41 | | | | | | | | | |

| Site 40 | | | | | | | | | |
|---|---|---|---|---|---|--|---|---|---|
| Density of Trees: | 1/16/m2 | Average Tree Height: | 3m | No. of Visible Dead Stems: | 3 | | | | |
| Environmental Weeds: | Pasture grasses - battling to keep under control increased continual spraying and slashing required. Wallaby fence not removed | | | | | | | | |
| Acacia Survival: | Very good | | | | | | | | |
| Comments: | Very good tree growth and establishment by both eucalyptus and acacias. Weed control only just effective and needs to be on-going. | | | | | | | | |

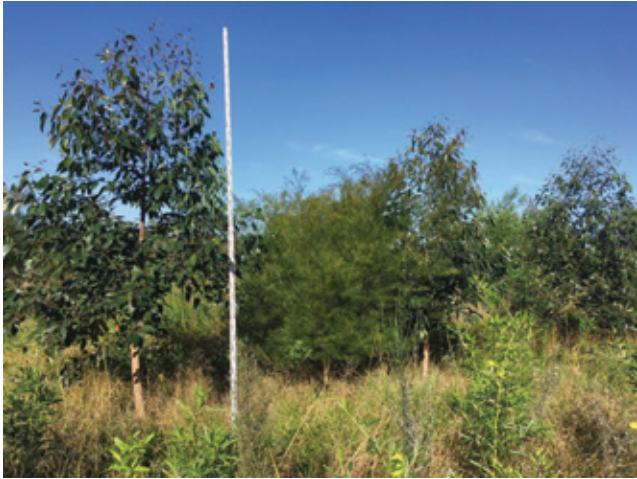
| Site 46 | | | | | | | | | |

| Site 46 | | | | | | | | | |
|---|--|---|---|---|---|--|---|---|---|
| Density of Trees: | 1/16/m2 | Average Tree Height: | 3.5m | No. of Visible Dead Stems: | 1 | | | | |
| Environmental Weeds: | Good effective weed/grass control via regular slashing and spraying. | | | | | | | | |
| Acacia Survival: | Very good | | | | | | | | |

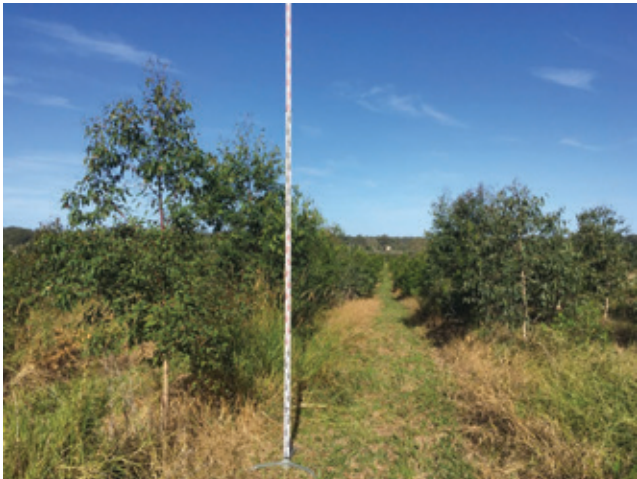
| Site 46 | | | | | | | | | |
|---|--|---|---|---|---|--|---|---|---|
| Site 47 | | | | | | | | | |

| Site 46 | | | | | | | | | |
|---|--|---|---|---|---|--|---|---|---|
| Density of Trees: | 1/16/m2 | Average Tree Height: | 4m | No. of Visible Dead Stems: | 2 | | | | |
| Environmental Weeds: | Good effective weed/grass control via regular slashing and spraying. | | | | | | | | |
| Acacia Survival: | Very good | | | | | | | | |

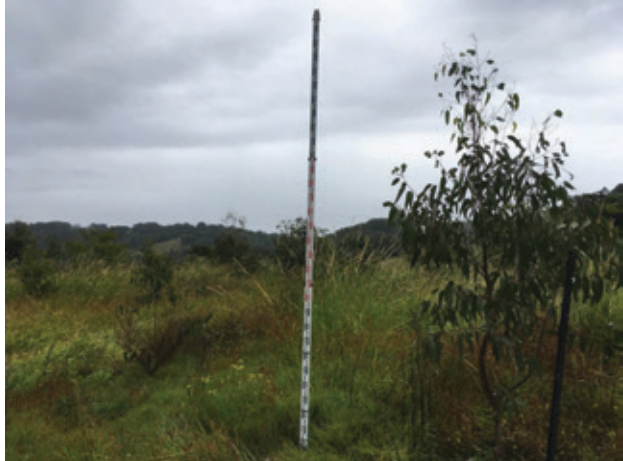
| Site 44 | | | | | | | | | |

| Site 44 | | | | | | | | | |
|---|---|---|---|---|---|--|---|---|---|
| Density of Trees: | 1/16/m2 | Average Tree Height: | 3m | No. of Visible Dead Stems: | 0 | | | | |
| Environmental Weeds: | Seteria grass | | | | | | | | |
| Acacia Survival: | Good survival | | | | | | | | |

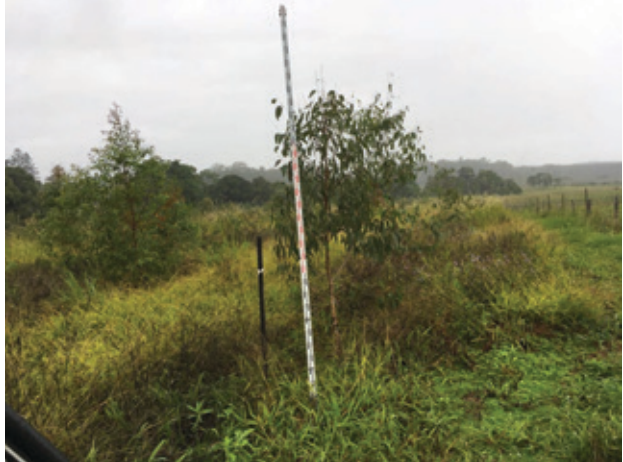
| Site 44 | | | | | | | | | |
|---|---|---|---|---|---|--|---|---|---|
| Site 45 | | | | | | | | | |

| Site 44 | | | | | | | | | |
|---|---|---|---|---|---|--|---|---|---|
| Density of Trees: | 1/16/m2 | Average Tree Height: | 2.5-5m | No. of Visible Dead Stems: | 0 | | | | |
| Environmental Weeds: | Seteria grass - but well under control. | | | | | | | | |
| Acacia Survival: | Good | | | | | | | | |
| Comments: | Very good tree growth (>5m in places). The trees have established very well in this area with very good tree growth especially near the creek line. Weed control managing the Seteria grass well. Wallaby fence till in place. | | | | | | | | |
