Pacific Highway Upgrade Nambucca Heads to Urunga Operational Phase

Threatened Flora Monitoring Annual Report Year 4 – 2020/21

Transport for NSW | 09 February 2021 | Final Report

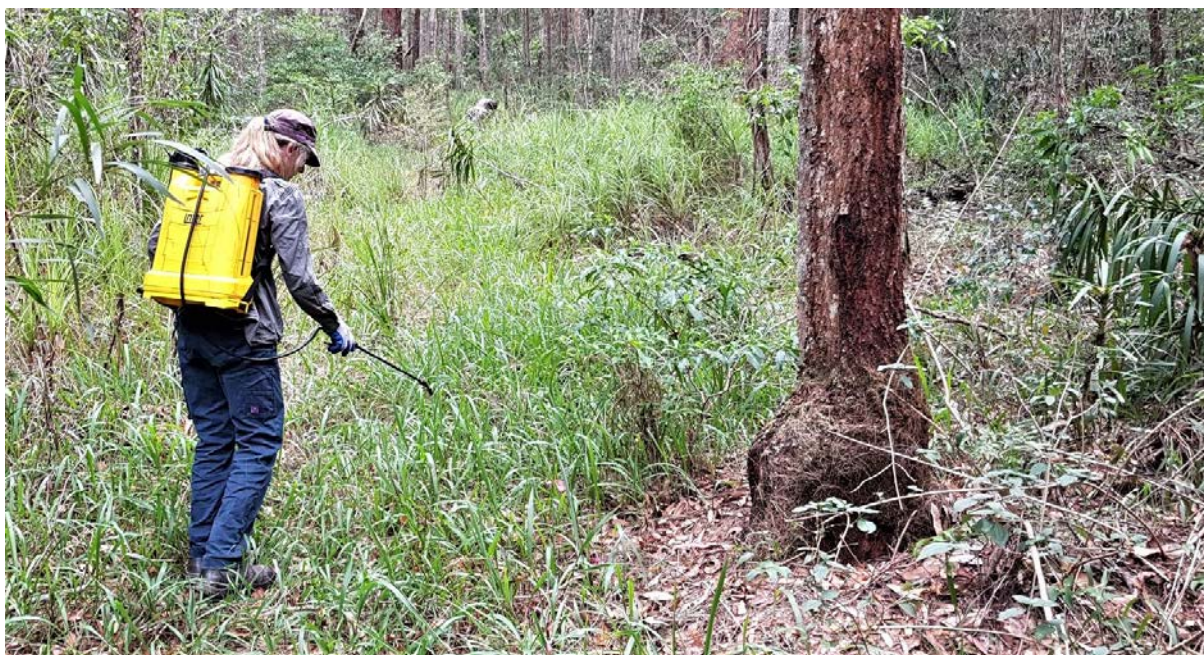
Figure 5: Spot-spraying of Broad-leaved Paspalum in TA1.

The first weed treatment at TA1 was performed on 25th November 2020 by New Earth Regeneration (three personnel). Treatment involved hand removal and cut and paint of Lantana plants (Figure 4) and targeted spot-spraying of Broad-leaved Paspalum (Figure 5) in the vicinity of the Rusty Plum translocations and enhancement plantings.
