W2B Sections 3 – 11 Microbat Management Plan
2019/20 Annual Monitoring Report

Pacific Complete

Project Name	W2B S3 – 11 Microbat Management Plan 2019 Annual Monitoring Report
Project Number	5728
Project Manager	Alicia Scanlon
Prepared by	Alicia Scanlon, Skye O’Brien, Samantha Patch and Liz Brown
Reviewed by	Frank Lemckert, Sophie Powrie
Approved by	Andrew Walsh
Status	Final
Version Number	2
Last saved on	15 March 2022

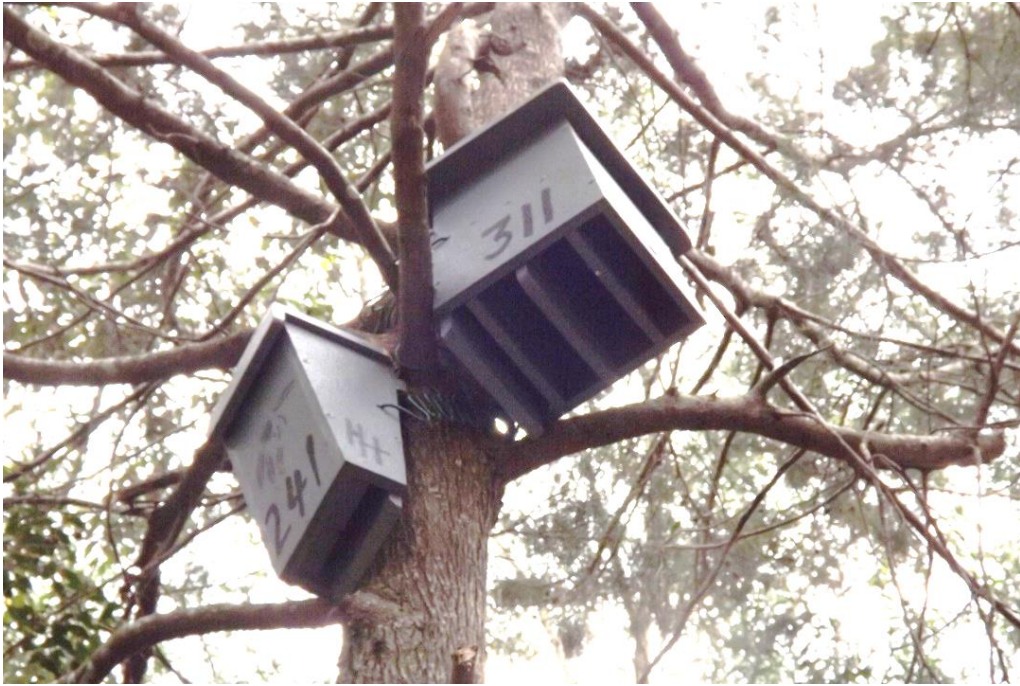
Plate 2: A single chamber bat box (LHS) and a four-chambered bat box (RHS) constructed from Cyplas in a tree adjacent to the impacted structures in Section 4, Maclean Cut.

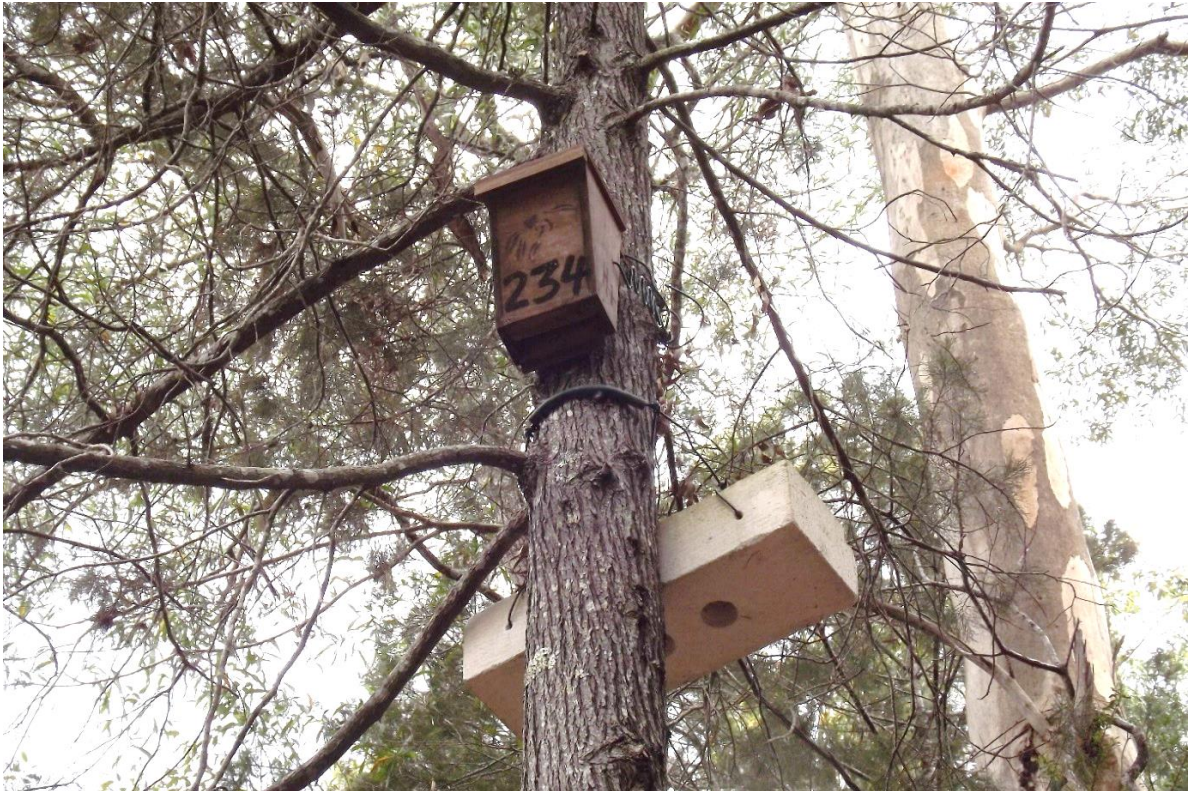
Plate 3: A single chamber timber bat box (upper feature) and a Hebel bat box with four core holes (lower feature behind tree trunk) installed in a tree adjacent to impacted structures in Section 4, Maclean Cut.
