Woolgoolga to Ballina Pacific Highway upgrade

**Operational Monitoring of In-situ
Threatened Flora Species (non-rainforest)**

Annual Report 2021

Transport for NSW

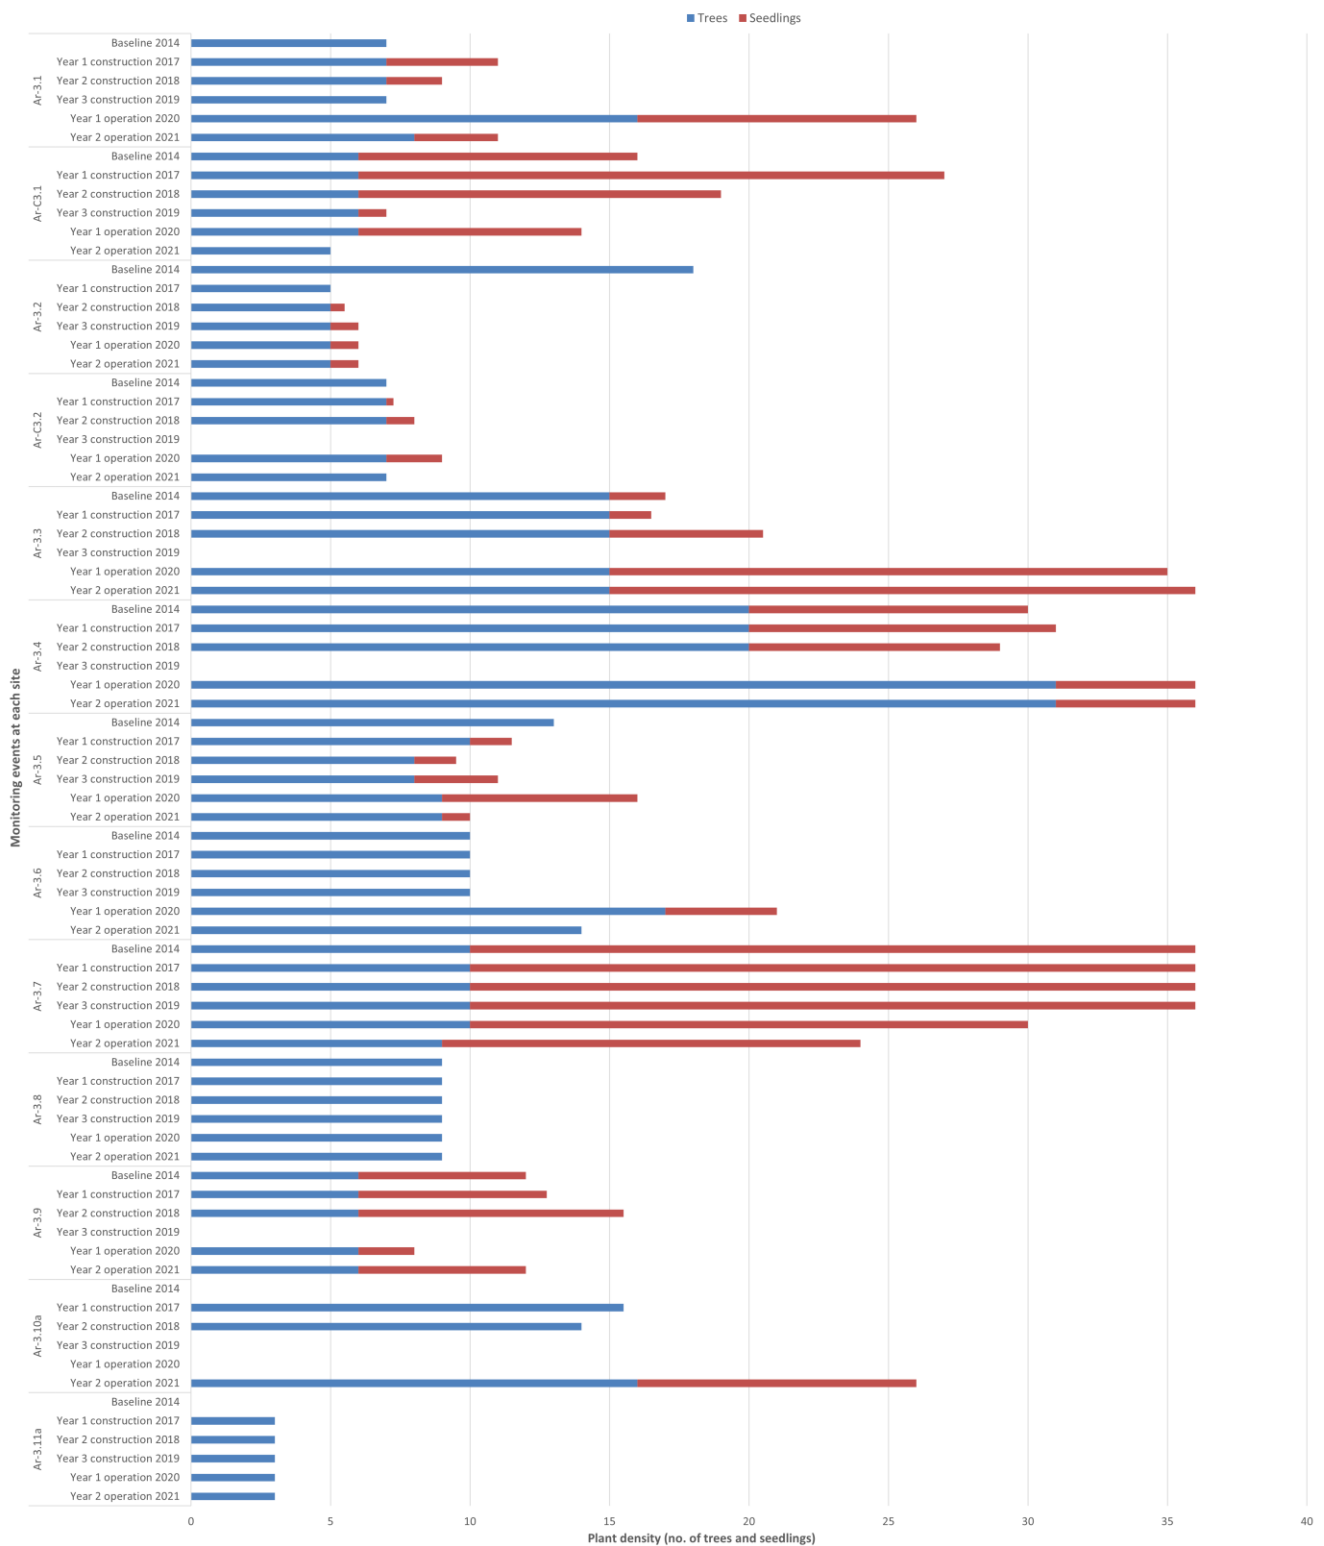
The data from the Year 2 operation monitoring of *A. robur* has remained relatively stable with some minor declines in the number of plants across several sites however recruitment was also reported in most plots. The most notable changes in tree abundance from the 2021 surveys was at site Ar-3.10a with a recorded total of 16 new plants which has significantly increased from having recorded no plants in 2020. Likewise, the most notable changes in seedling abundance from the 2021 surveys were at sites Ar-C3.1, Ar-C3.2, Ar-3.3, Ar-3.9 and Ar-3.10a. The highest increase in seedling abundance was recorded at Ar-3.10a with a total of 10 new seedlings which has significantly increased from having recorded no seedlings in 2020 (refer to **Figure 3-1**). Recent under scrubbing by private landholder has impacted ArC3.1 by removing all native small trees and shrubs from the site, (including the plot and juvenile *Angophora robur*) and has resulted in a significantly lower mid-storey cover of native plants. Mature trees remain in good condition. This impact is not project related and affects the control plot.

No baseline data exists for sites Ar-3.10a and Ar-3.11a that were established in 2017. These sites were surveyed in 2021 and *A. robur* were found to be in excellent condition. This was particularly evident at site Ar-3.10a due to an overall increase in tree and seedling abundance, whereas site Ar-3.11a has remained consistent with the results recorded in 2020 in terms of tree and seedling abundance.

Figure 3-1 Number of *A. robur* trees and seedlings observed over eleven monitoring events (2014 [n=1], mean results for 2017 [n=4], mean results for 2018 [n=2], 2019 [n=1], 2020 [n=2] and 2021 [n=1] at eleven in-situ sites and two control sites).

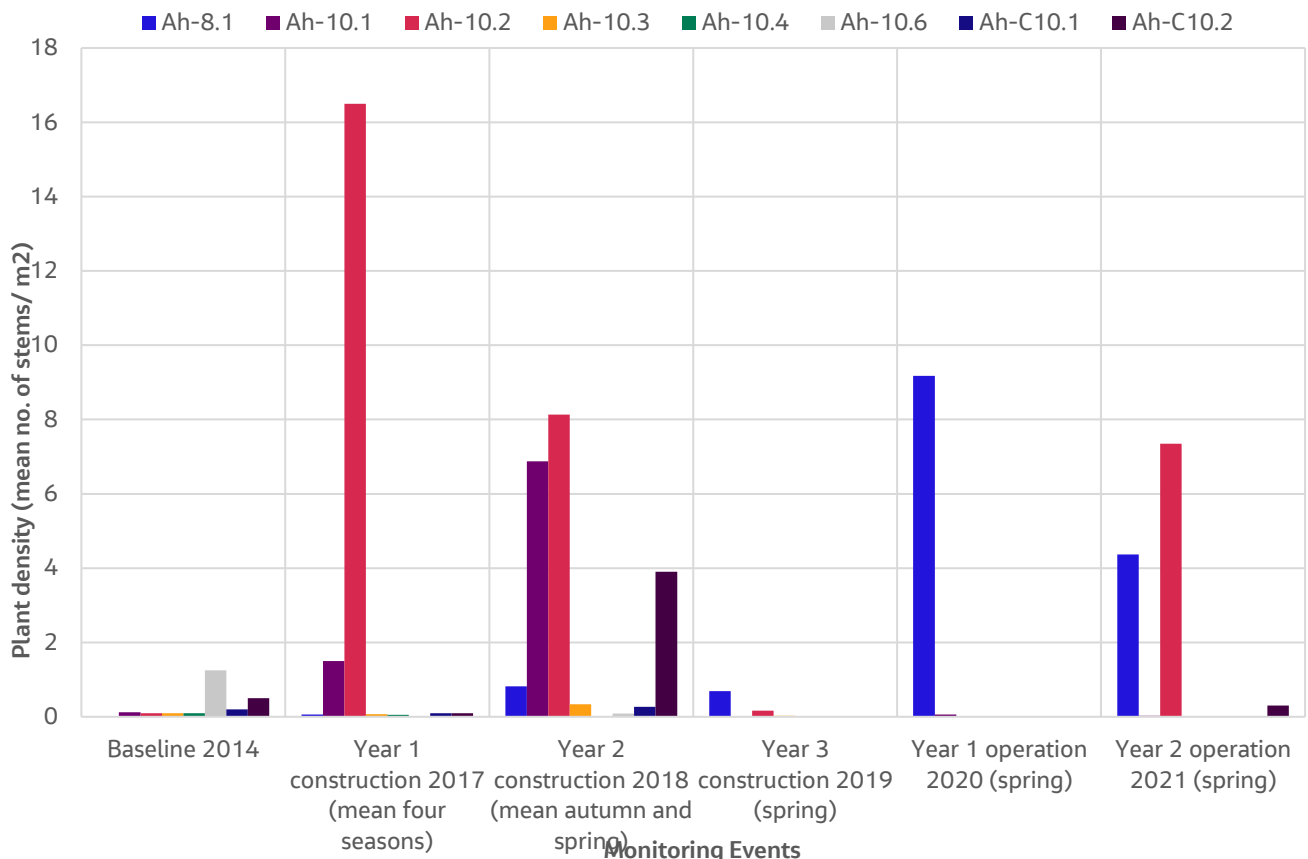
A. hispidus is an annual species that naturally dies back each year and the abundance of plants observed at the sites surveyed as part of this monitoring program have fluctuated considerably since baseline surveys (refer Figure 3-2). The soil moisture for all sites was recorded as very wet with some sites demonstrating standing surface water which has likely promoted this species to re-establish especially with regards to site Ah-10.2 which has noticeably spiked to 7.35 (mean no. of stems/m²) in 2021, a result that is closely aligned with that of Year 2 construction in 2018 of 8.13 (mean no. of stems/m²). These observations in 2021 are considered primarily the result of above average rainfall and wet conditions experienced in some preceding months leading up to the 2021 surveys (refer Figure 2-2) compared to the drought conditions in 2019/20. However, the absence of *A. hispidus* at the remaining four sites have been reported as having dense weed invasion since baseline monitoring which has likely been the result of minimal to no plants recorded at most of these sites especially over the last two monitoring events in Year 3 construction 2019 and Year 1 operation 2020.

Figure 3-2 Density (mean no. of stems / m²) of *Arthraxon hispidus* in each plot observed over ten monitoring events at six in-situ sites and two control sites

Competition with other plants continues to be a threat to *A.hispidus* and the wetter conditions in 2021 has cause increase in cover of some weeds. This is primarily by exotic species such as *Ageratum houstonianum*, *Paspalum dialatatum*, *Commelina benghalensis*, *Senecio madagascariensis*, *Verbena littoralis* and *Ambrosia artemisiifolia* forming dense groundcover (refer **Photograph 3.1 and 3.2**). This is particularly evident at sites Ah-8.1, Ah-10.3, Ah-10.4, Ah-10.6 and Ah-C10.1, where it appears *A.hispidus* plants are being out-competed. Similarly, this is also happening at Ah-C10.1 with the native grass *Leersia hexandra*. *A.hispidus* appears to prefer small clearings and disturbed sites that have been slashed or grazed and this is a consequence of strong competition with native and exotic greases and weeds which share this favoured moist low-lying habitat. This problem may be exacerbated by the removal of cattle from these properties, which have been previously managed through grazing. Cattle removal has occurred in some locations during the construction period. **Table 3-1** shows the change in weed cover and number of weed species for all sites over all monitoring periods. This impact is not project related.

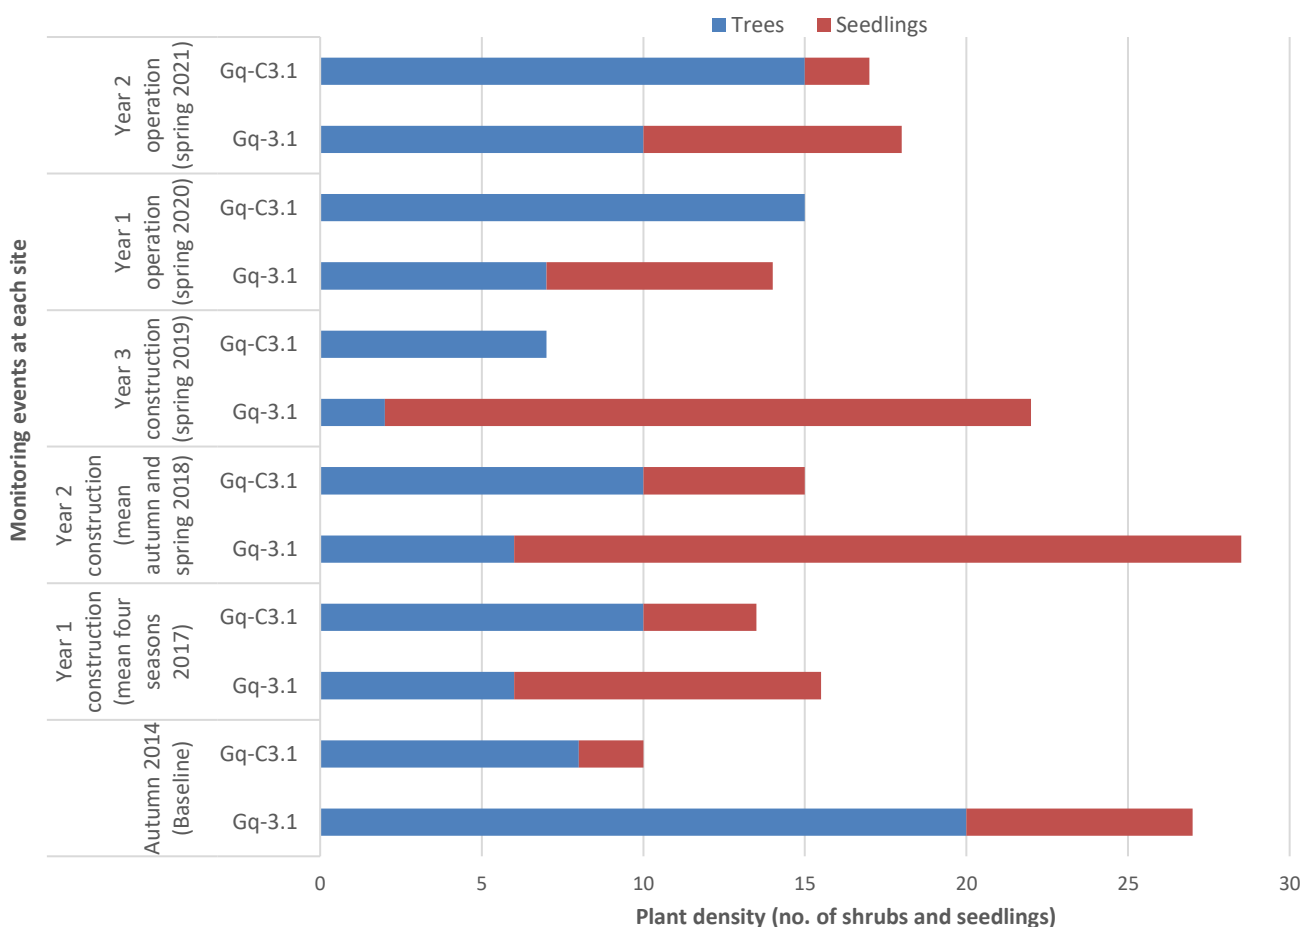
Shrub abundance at Gq-C3.1 remained at 15 individuals in 2021, however an increase in 2 seedlings was observed in 2021 in comparison to the results from 2020. Plant height ranged from 30 cm to 1.8 m with occurrence of new buds and shoots. Overall plants were assessed as being in excellent condition with new shoots and seeds observed on a number of plants.

Figure 3-3 Number of *G. quadricauda* shrubs and seedlings observed over ten monitoring events (2014 [n=1], mean results for 2017 [n=4], mean results for 2018 [n=2], 2019 [n=1], 2020 [n=1] and 2021 [n=1] at in-situ and control site).

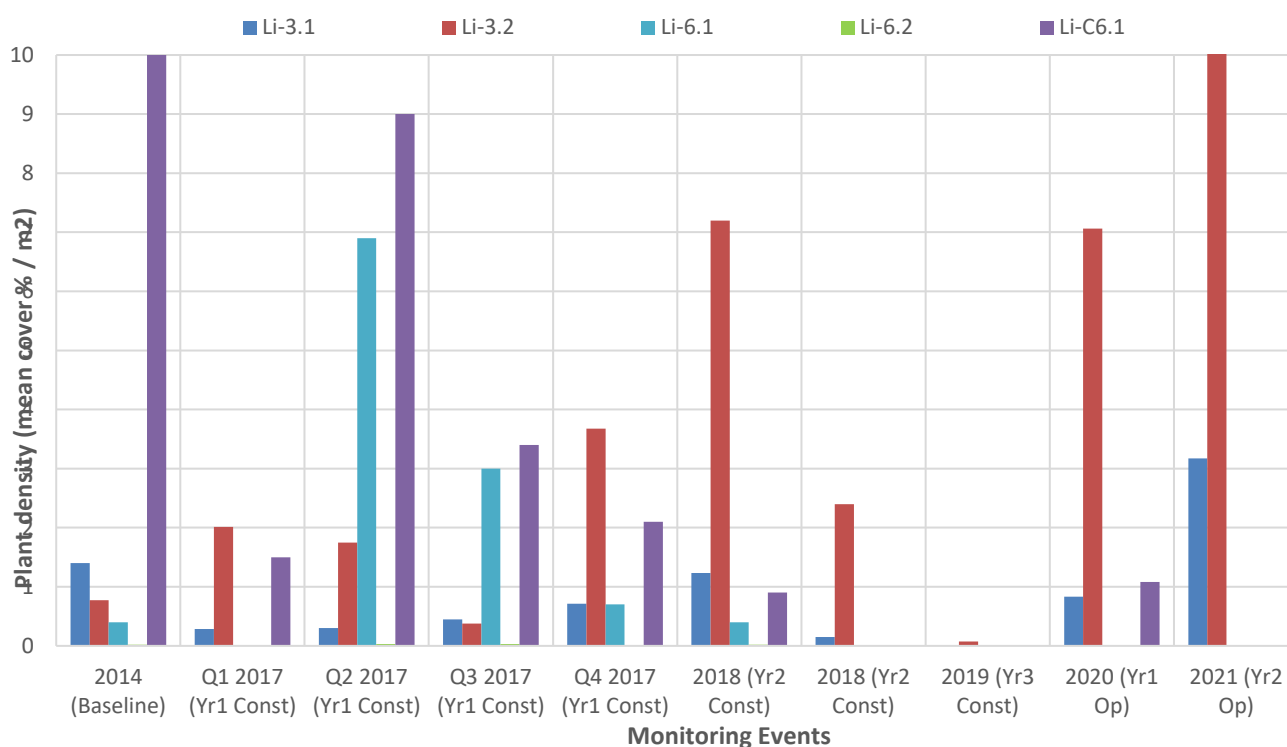
In contrast however, plants at the control plot to the south (Li-C6.1) had recovered following the fire. No plants were recorded at the plot in 2018 and 2019, although an area of 30 m² of the plot contained young plants that were recorded in November 2020, 12 months after fire. It is unsure why plants have re-appeared at the control plot compared with the two nearby impact plots, this is probably a result of dense post-fire recovery of competing shrubs. During the 2021 monitoring event, Li-C6.1 demonstrated a decline in plant density with a result of 0.01 (mean cover % / m²) in comparison to 1.08 (mean cover % / m²) recorded in 2020.

Figure 3-4 Density (mean no. of stems / m²) of *Lindsaea incisa* observed over ten monitoring events at four in-situ sites and one control site.

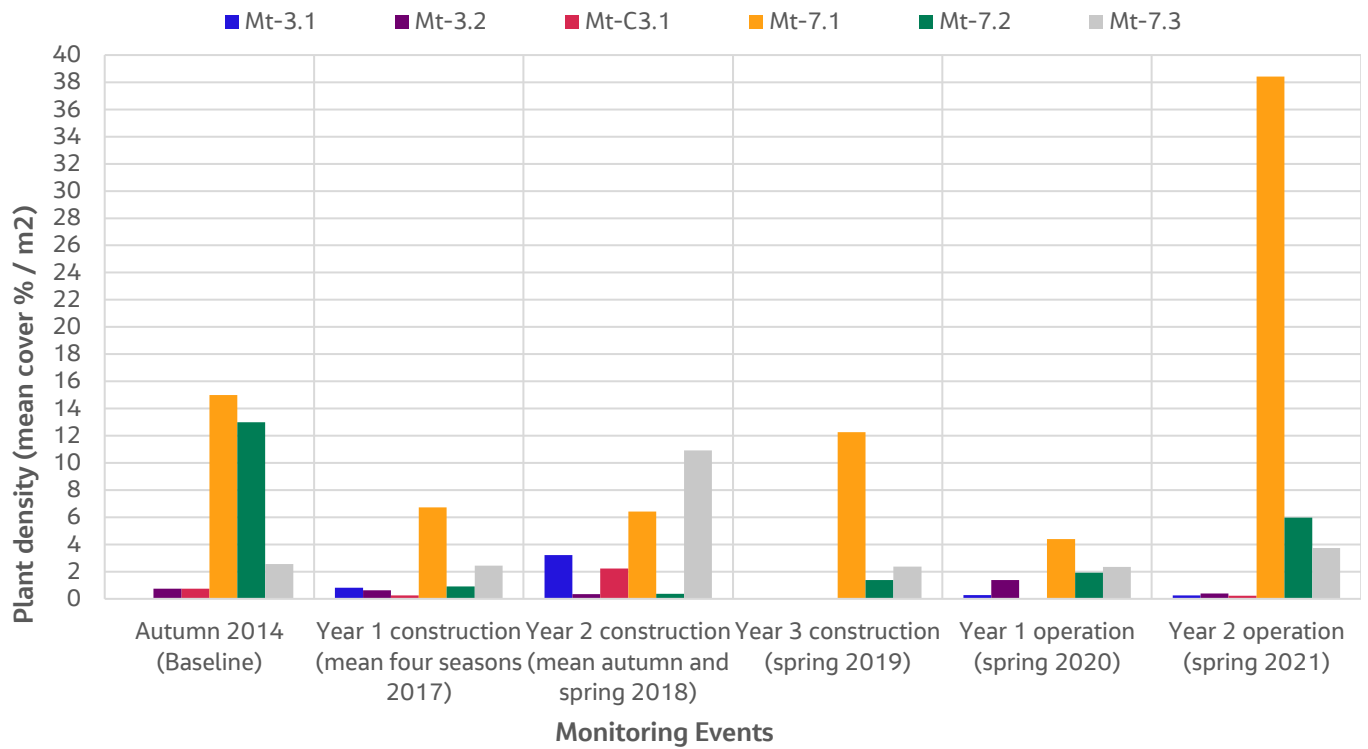
The recovery of the *M. triglochinosides* population at in-situ site Mt-7.2 from inadvertent indirect impacts during Year 1 construction in 2017 is evident. The area of occupancy was 13 m² in 2018, and increased to 29 m² in 2019 and 2020, and has increased significantly in 2021 to 104 m² which reflects the increased rainfall and flushing of the stream (refer **Photograph 3-6**).

The mean percent cover of *M. triglochinosides* at in-situ site Mt-7.3 has changed temporally during the monitoring program. This site is directly within the corridor. The mean cover was at 80% in the baseline survey and remained similar at 86% during year 1 construction and 100 % in year 2. In year 3, works associated with bridge construction reduced the cover to 56% in 2019 and to 22% in 2020 with significant shading over the plots. In spring 2021 the site was showing evidence of good recovery, and plants have spread to the east and west of the bridge in areas not previously occupied, although absent below the bridge, which is expected. The cover is now at 50% (refer **Photograph 3-8**). These plants are located in the approved construction corridor.

Figure 3-5 Density (mean cover % / m²) of *Maundia triglochinooides* observed over ten monitoring events at five in-situ sites and one control site

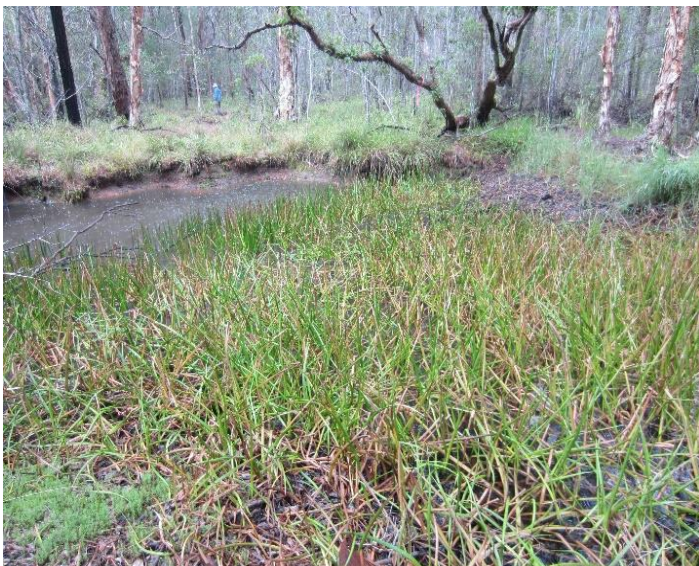
Photograph 3-5: Pre-construction phase at in-situ site Mt-7.2 showing healthy population of *M. triglochinooides* (May 2014)

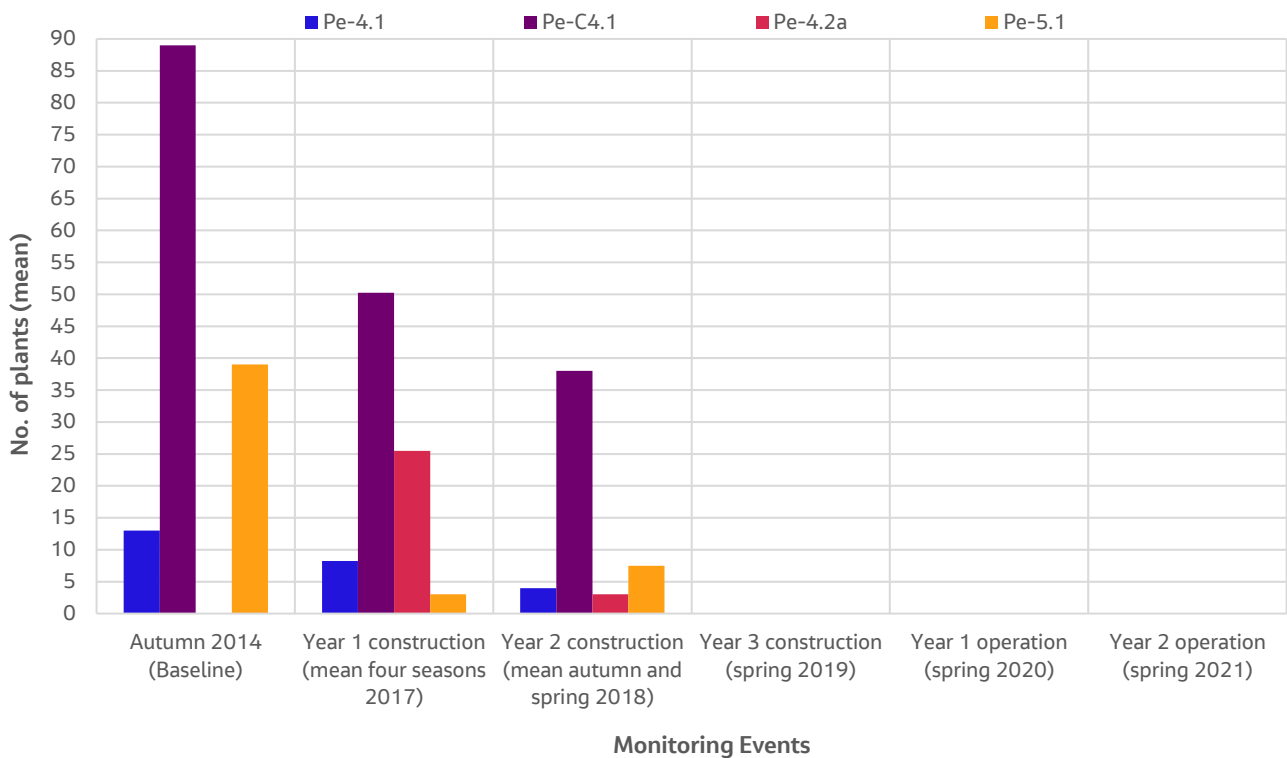
These changes are most likely directly related to the lower-than-average annual rainfall that the region had experienced in four of the last six years, as opposed to above average annual rainfall in the four years prior to baseline surveys (refer **Figure 2-3**). Particularly low rainfall in Year 3 construction monitoring (Grafton Research Station received 31 percent of the historical annual average in 2019 – refer **Figure 2-3**) resulted in the eventual drying out of standing water at all four monitoring sites. From the 2021 surveys, the in-situ sites Pe-4.1 was noted as having damp soil moisture and Pe-5.1 had 10 cm of surface water. In contrast, the soil moisture at the in-situ Pe-4.2a was recorded as dry.

These declines are considered not project related. Monitoring for the 2021 W2B Translocation Report (Benwell 2022) in Yaegl NR, near the in-situ plots has identified that the species is a fast growing annual, and not a perennial. If high waters recede during drought and there is no damp soil, then germination does not occur. This

is evident at the monitoring plots, where standing water was absent through 2019 and the soil dry, and the plants have not returned to these plots. Refer to **Figure 3-6** for a summary of results.

Figure 3-6 Mean number of *Persicaria elatior* plants over ten monitoring events (baseline and construction) at three in-situ sites and one control site. No baseline data exists for site Pe-4.2a as it was added in 2017.
