# Warrell Creek to Nambucca Heads Landscape Rehabilitation Monitoring Operational Phase Annual Report 2022/2023

ECOS Environmental Pty Ltd

14/9/2023

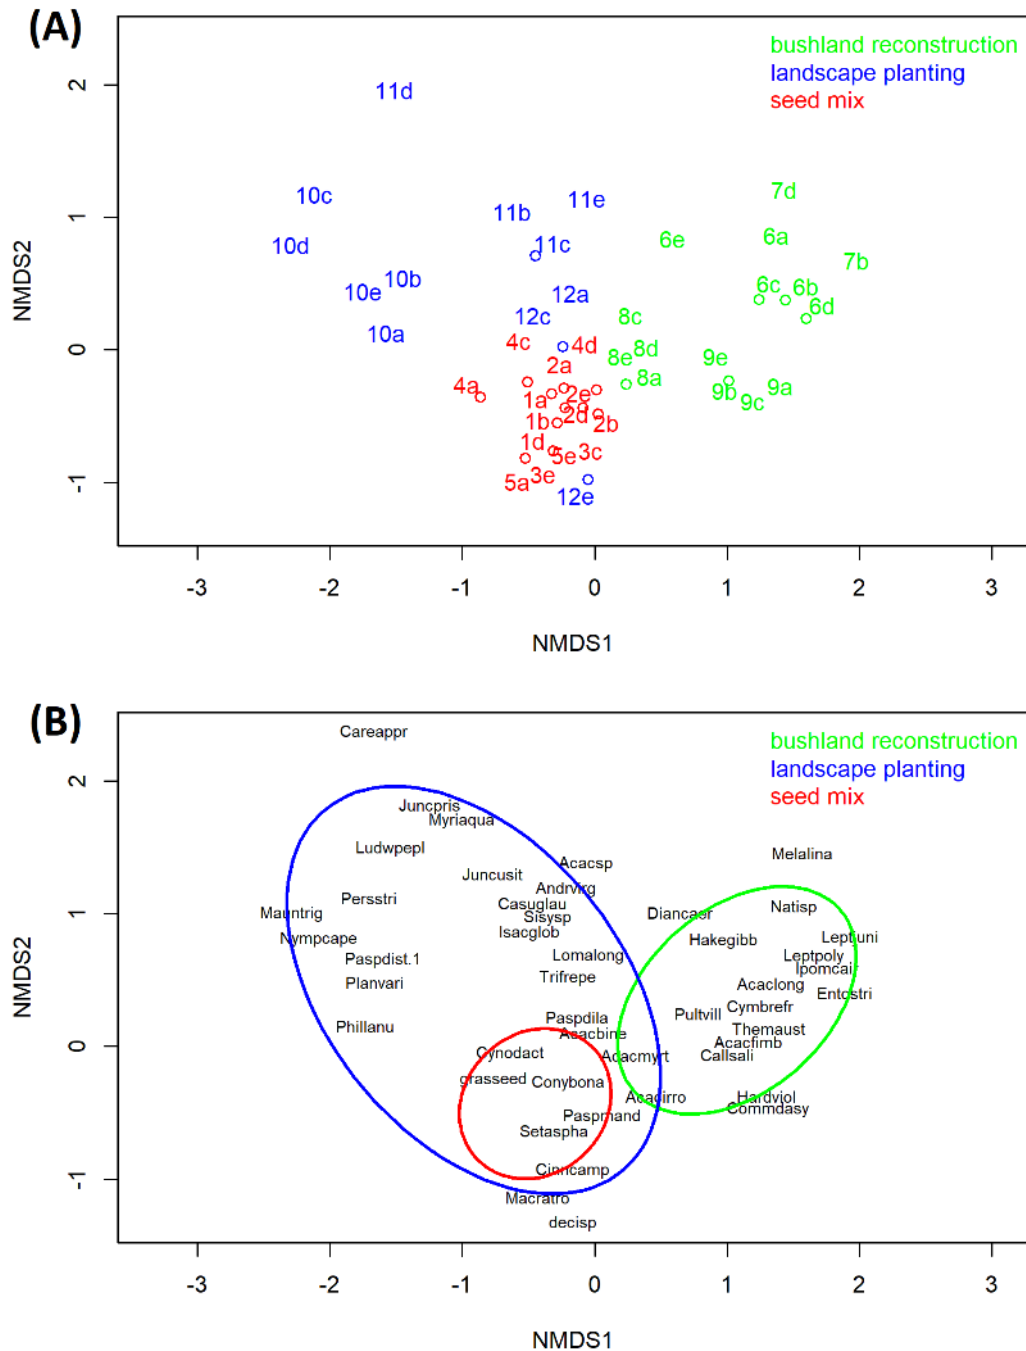
**Figure 2.** Non-metric multidimensional scaling of Transects of three landscape rehabilitation treatments. Stress = 0.15. Graph A shows the Transects in ordination space, where the closer Transects are in 2-d space, the more similar they are in terms of species composition. (a to e subscripts refer to the 10 m sub-transects). To reduce clutter, the *orditorp* function of the *vegan* package was used. Graph B shows species most characteristic of each treatment. Species names are abbreviated to the first four letters of genus and species. This analysis based on 2019 monitoring data, was carried out three years after the landscaping treatments were implemented in 2016 and highlights the difference in species composition of vegetation established by the three landscaping treatments.

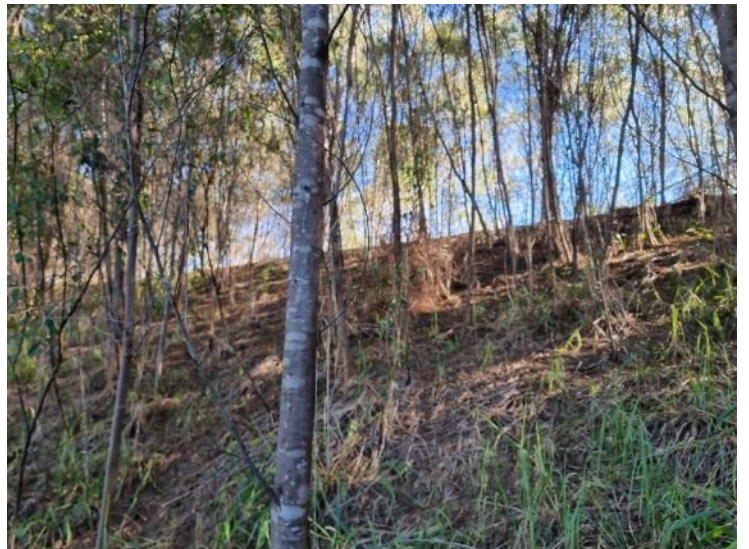
Embankment between streamline and highway adjacent to Plot 11. Dense *Acacia fimbriata*, five years old, has suppressed *Setaria sphacelata*. Bottom of photo on lower right shows sparse *Setaria* under *Acacia* near slope base compared to dense *Setaria* on Site 11 in the open (see photos above). The ground is covered by brown *Acacia* leaf litter. *Acacia* density > one per 4 m<sup>2</sup>.
